APPENDIX B – MMM GROUP LTD. CONCEPTUAL GATE CHAMBER DESIGN EXISTING CONDITION ASSESSMENTS REPORT

Re: RFP No. 818-2014 - Professional Consulting Services for Developing Conceptual Concepts for Gate Chamber Designs for Storm Relief Sewer Systems

CONCEPTUAL GATE CHAMBER DESIGN EXISTING CONDITION ASSESSMENTS

Prepared for:
The City of Winnipeg

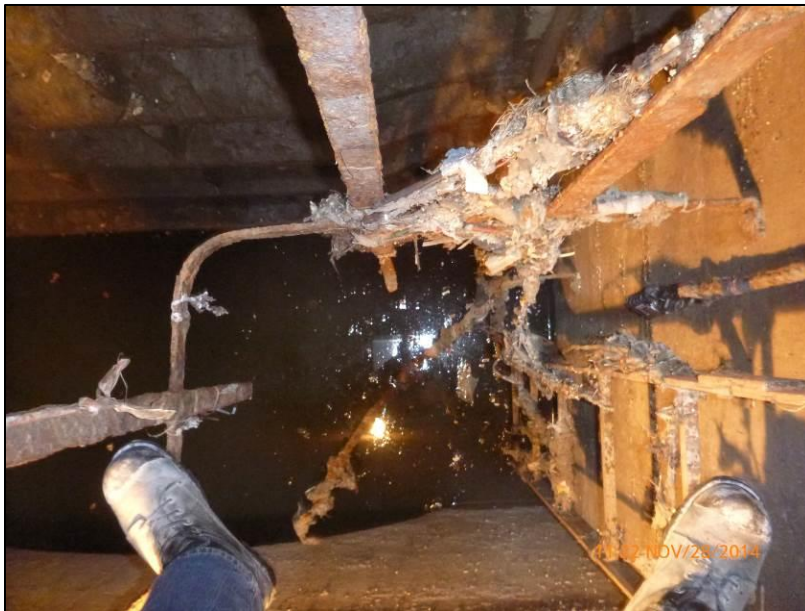
Photograph No. 7

Corrosion on ladder cage, downstream chamber

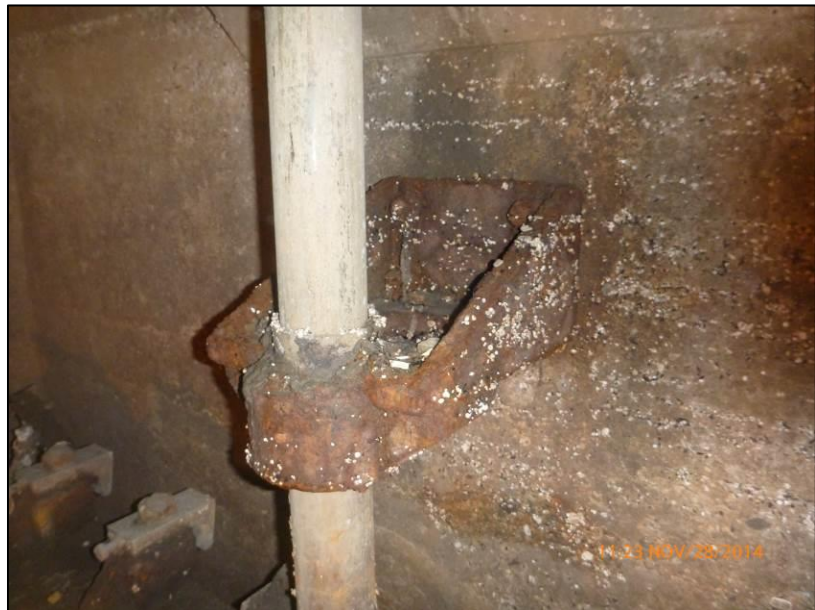
Photograph No. 8

Corrosion on gate stem guide
