THE CITY OF WINNIPEG
PUBLIC WORKS DEPARTMENT
ENGINEERING DIVISION
BRIDGE OPERATIONS BRANCH
106 - 1155 PACIFIC AVE

SASKATCHEWAN AVE T.B. (OMAND'S CREEK)
EAST ABUTMENT PILE CAP REPAIR

DESIGNED BY: DNB	DRAWN BY: DNB	DWG NO: B144-09-01
CHECKED BY: DNB	DATE: OCT 15/2009

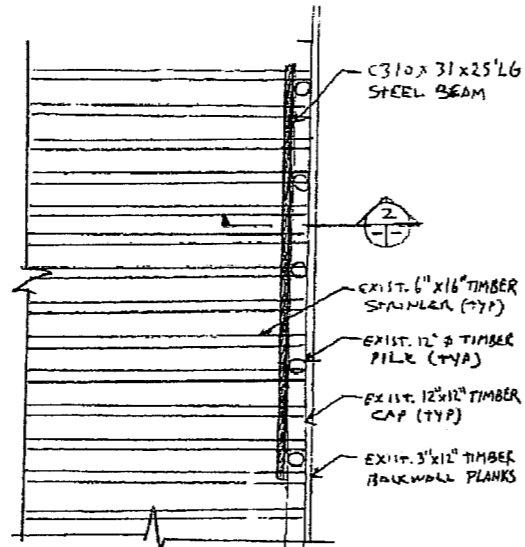
1 PLAN
N.T.S.

- EXIST. 2' x 4" TIMBER DECK, ASPHALT W/S AND GUARDRAIL NOT SHOWN FOR CLARITY.
- STEEL BEAM MAY BE SPLICED TO REDUCE WEIGHT INTO MANAGEABLE PIECES.

1. REMOVE EXISTING TIMBER PILE STRAP BOLTS & STRAPS.
2. INSTALL SHIMS ON SIDE OF CAP AND PILES.
3. INSTALL NEW C310 X 31 BEAM.
4. INSTALL NEW C310 X 31 PILE POSTS.
5. SHIM EXISTING STRINGERS TIGHT TO NEW C310 X 31 BEAM.
6. FILL CRAULS IN EXIST. TIMBER CAP WITH CONCRETE GROUT AND SLOPE TO DRAIN.
