PAVEMENT CORE REPORT

Pavement Core Report for Ness Avenue EB, Rutland Street to Queen Street

Pavement Core Report for Ness Avenue EB Overdale Street to Rutland Street

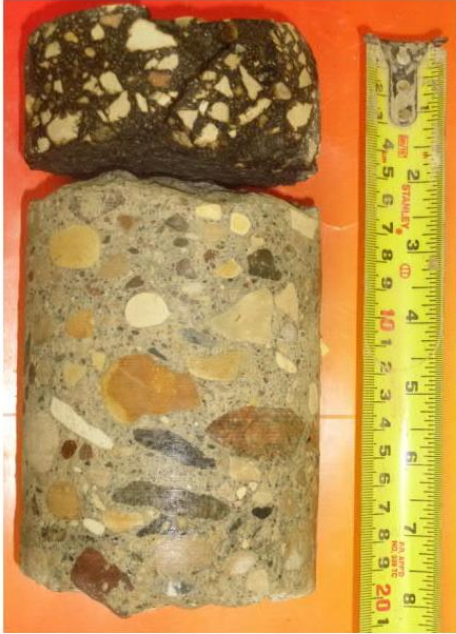
Core no. 1

Core No.	Core Location	Pavement Structure Thickness (mm)			Comments
		Asphalt	Concrete	Total	
1	Ness Avenue, eastbound curb lane, 1 m from curb, 25 m east from Rutland Street	45	150	195	<ul style="list-style-type: none"> Asphalt pavement not bonded to concrete surface Moderate deterioration of concrete pavement at bond line with asphalt pavement; sound concrete below 70 mm from top of pavement Granular base below pavement
2	Ness Avenue, eastbound curb lane, 1 m from curb, 30 m east from Inglewood Street	50	185	235	<ul style="list-style-type: none"> Asphalt pavement not bonded to concrete surface Sound concrete below asphalt pavement Granular base below pavement
3	Ness Avenue, eastbound curb lane, 1 m from curb, 25 m west from Collegiate Street	55	190	245	<ul style="list-style-type: none"> Asphalt pavement not bonded to concrete surface Sound concrete below asphalt pavement Granular base below pavement

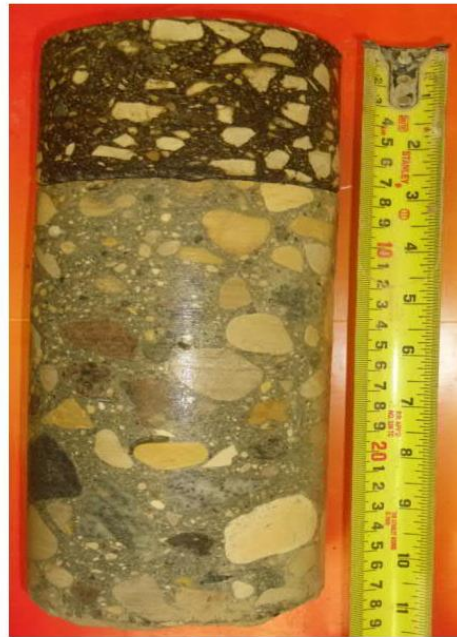
Core no. 4

4	Ness Avenue, eastbound median lane, 0.5 m from curb, 42 m east from Collegiate Street	75	205	280	<ul style="list-style-type: none"> Asphalt pavement not bonded to concrete surface Sound concrete below asphalt pavement Granular base below pavement
5	Ness Avenue, eastbound curb lane, 1 m from curb, 35 m east from Roseberry Street	55	205	260	<ul style="list-style-type: none"> Asphalt pavement not bonded to concrete surface Sound concrete below asphalt pavement Granular base below pavement
6	Ness Avenue, eastbound curb lane, 1 m from curb, 30 m east from Parkview Street	60	200	260	<ul style="list-style-type: none"> Asphalt pavement not bonded to concrete surface Sound concrete below asphalt pavement Granular base below pavement

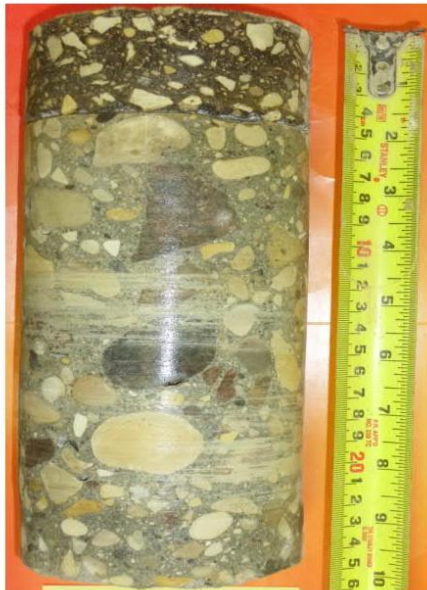
Core no. 7

Core No.	Core Location	Pavement Structure Thickness (mm)			Comments
		Asphalt	Concrete	Total	
7	Ness Avenue, eastbound curb lane, 1 m from curb, 30 m east from Marjorie Street	45	205	250	<ul style="list-style-type: none"> Asphalt pavement not bonded to concrete surface Sound concrete below asphalt pavement Granular base below pavement
8	Ness Avenue, eastbound median lane, 0.5 m from curb, 32 m west from Berry Street	45	190	235	<ul style="list-style-type: none"> Asphalt pavement not bonded to concrete surface Sound concrete below asphalt pavement Granular base below pavement
9	Ness Avenue, eastbound curb lane, 1 m from curb, 30 m west from Brooklyn Street	40	185	225	<ul style="list-style-type: none"> Asphalt pavement not bonded to concrete surface Sound concrete below asphalt pavement Granular base below pavement
10	Ness Avenue, eastbound curb lane, 1 m from curb, 25 m east from King Edward Street	30	195	225	<ul style="list-style-type: none"> Asphalt pavement not bonded to concrete surface Slight deterioration of concrete pavement at bond line with asphalt pavement; sound concrete below 50 mm from top of pavement Granular base below pavement

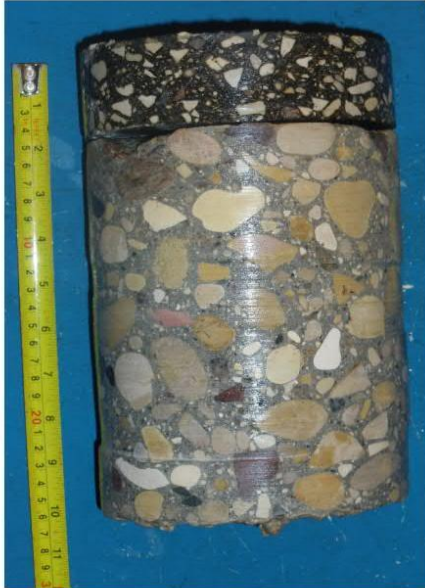
Core no. 1

Core No.	Core Location	Pavement Structure Thickness (mm)			Comments
		Asphalt	Concrete	Total	
1	Ness Avenue, centreline of eastbound curb lane, 13 m west from alley between Overdale Street and Winchester Street	40	200	240	<ul style="list-style-type: none"> Asphalt pavement not bonded to concrete surface Sound concrete below asphalt pavement Limestone base below pavement
2	Ness Avenue, centreline of eastbound curb lane, 13 m west from alley between Winchester Street and Linwood Street	30	200	230	<ul style="list-style-type: none"> Asphalt pavement not bonded to concrete surface Sound concrete below asphalt pavement Limestone base below pavement
3	Ness Avenue, centreline of eastbound curb lane, 55 m west from Lyle Street	100	185	285	<ul style="list-style-type: none"> Asphalt pavement not bonded to concrete surface Sound concrete below asphalt pavement Limestone base below pavement
4	Ness Avenue, eastbound median lane, 0.5 m from curb, 31 m west from Albany Street	40	200	240	<ul style="list-style-type: none"> Asphalt pavement not bonded to concrete surface Minor deterioration of concrete pavement at bond line with asphalt pavement; sound concrete below 50 mm from top of pavement Limestone base below pavement

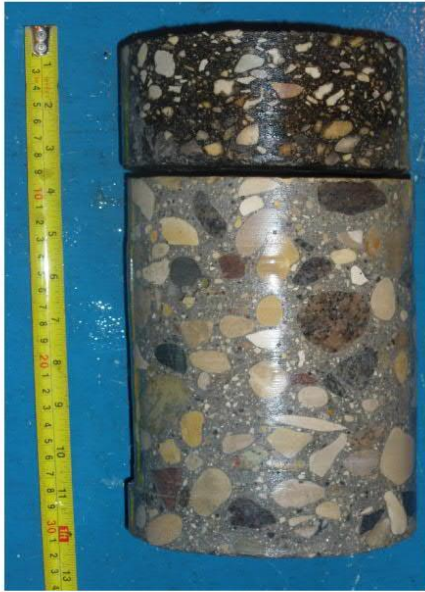
Core no. 5

5	Ness Avenue, centreline of eastbound curb lane, 12 m west from alley between Albany Street and Truro Street	70	200	270	<ul style="list-style-type: none"> Asphalt pavement not bonded to concrete surface Sound concrete below asphalt pavement Limestone base below pavement
6	Ness Avenue, centreline of eastbound curb lane, 6 m east from alley between Truro Street and Sackville Street	60	205	265	<ul style="list-style-type: none"> Asphalt pavement not bonded to concrete surface Sound concrete below asphalt pavement Limestone base below pavement

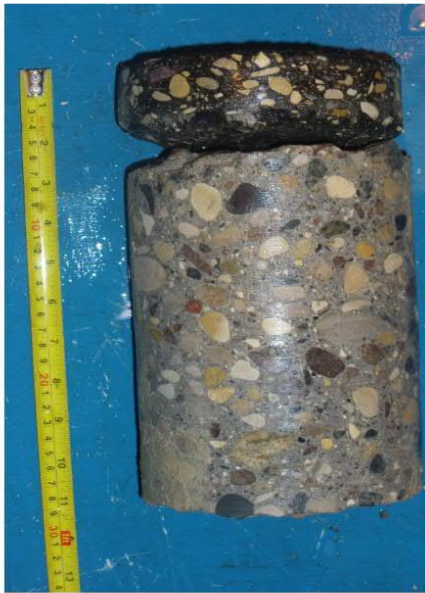
Core no. 7

Core No.	Core Location	Pavement Structure Thickness (mm)			Comments
		Asphalt	Concrete	Total	
7	Ness Avenue, centreline of eastbound curb lane, 33 m east from Sackville Street	50	200	250	<ul style="list-style-type: none"> Asphalt pavement not bonded to concrete surface Moderate deterioration of concrete pavement at bond line with asphalt pavement; sound concrete below 70 mm from top of pavement Limestone base below pavement
8	Ness Avenue, eastbound median lane, 0.5 m from curb, 10 m west from alley between Amherst Street and Rutland Street	55	235	290	<ul style="list-style-type: none"> Asphalt pavement not bonded to concrete surface Sound concrete below asphalt pavement Limestone base below pavement
