## **APPENDIX C – FEBRUARY 2015 MONITORING REPORT**

File No. 0015 008 00

**RE Lyndale Drive –Ave. Taché to Gauvin St.  
2014 Riverbank Monitoring Results**

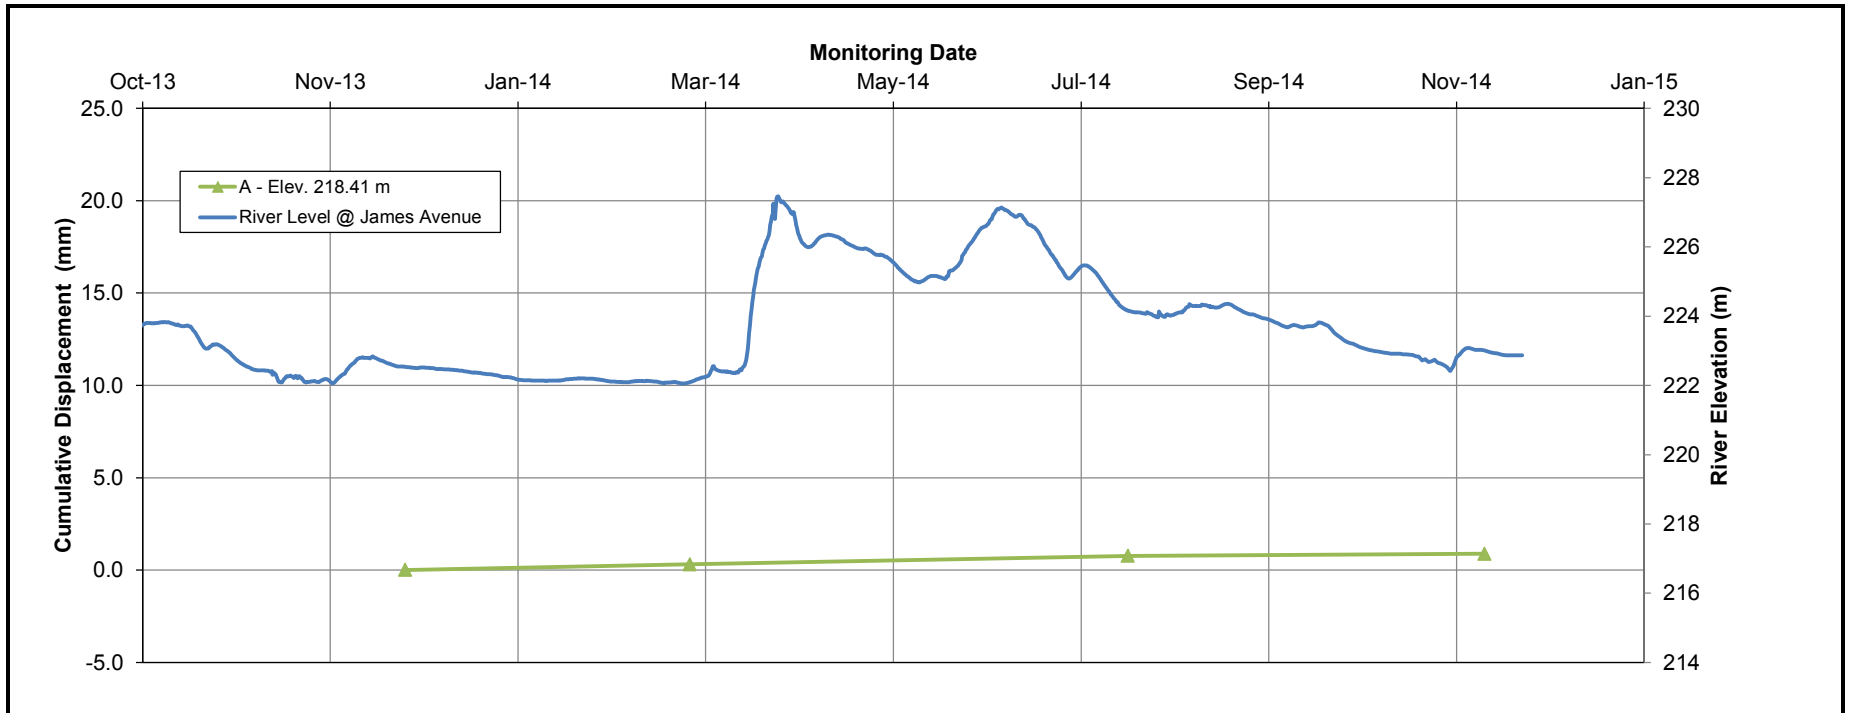
Project No. 0015 008 00  
Project Title Lyndale Drive Retaining Wall Assessment  
Client City of Winnipeg  
Slope Inclinator No. SI-9

**Cross Section D:** About 15 mm of horizontal displacement was observed in the upper 4 m of SI-9 between October 2013 and December 2014. This is not considered indicative of a differential (shear) displacement associated with a deep-seated failure surface but rather may be attributed to shallow translational movement of a layer of fill at this location. In the mid-bank area, about 2 mm of horizontal displacement was observed in SI-8 over the same time period at about Elev. 218.5 m (about 1.2 m above till) along with about 5mm of near surface displacement attributable to environmental effects. The movements at SI-8 are close to the resolution of the monitoring probe and do not indicate any active riverbank instabilities at this location.
