Crosier Kilgour & Partners Ltd.

December 16, 2014

Our File No. 2014-0593

**Re: Machray Park
Structural Assessment**

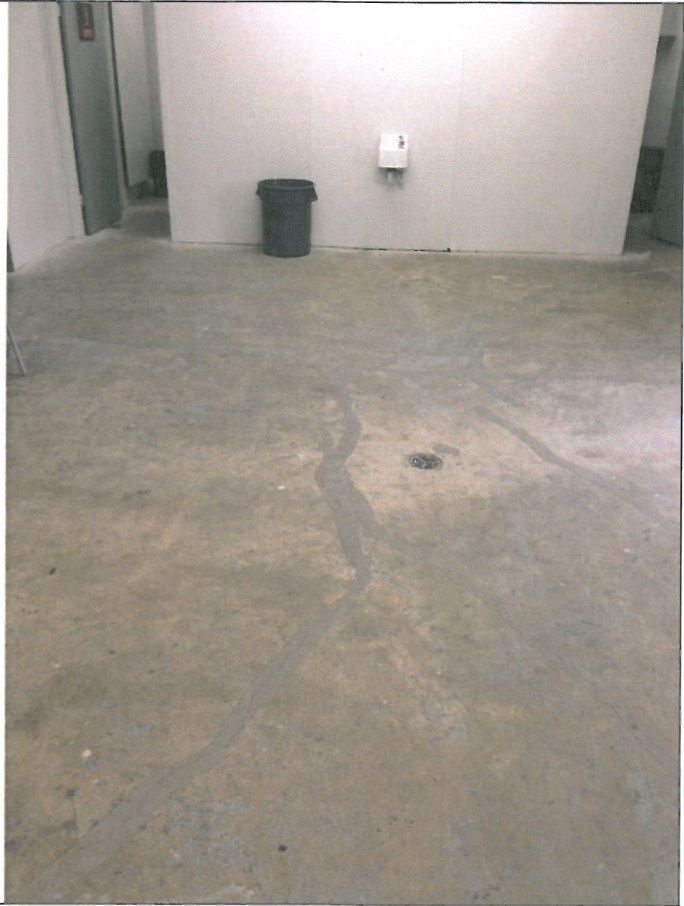
The floor system, being a slab-on-grade, is susceptible to soil movement below. In Winnipeg, slabs-on-grade are predominantly supported on a highly plastic clay which is susceptible to movement with changes in moisture content. That is, as its moisture content increases, the clay swells and conversely, as its moisture content decreases, the clay shrinks. Any foundation or floor slab resting on this soil is therefore subject to movement either up or down. The potential for differential movement can be minimized by maintaining a consistent moisture content within the soil. Items that can be done to help maintain a stable moisture content include ensuring that excess water does not get under the foundation by extending rain water leaders out and sloping the ground adjacent to the house away from the foundation wall. In addition, large trees should not be planted near the foundation, as they draw large amounts of water out of the soil and cause it to shrink.

The floor system has experienced some cracking as a result of soil movement (see photograph Number 1). In 1978, during the addition of the storage room, a 2" concrete topping was added to the existing concrete floor, likely in an effort to cover up cracks and re-level the floor. This topping has also cracked and since been filled with a repair material. Although cracked, the floor remains in usable condition.

Photograph #1:
Repaired concrete slab-on-grade.

Any walls to be constructed on the slab-on-grade should be detailed with slip joints at the top to allow for future movement.

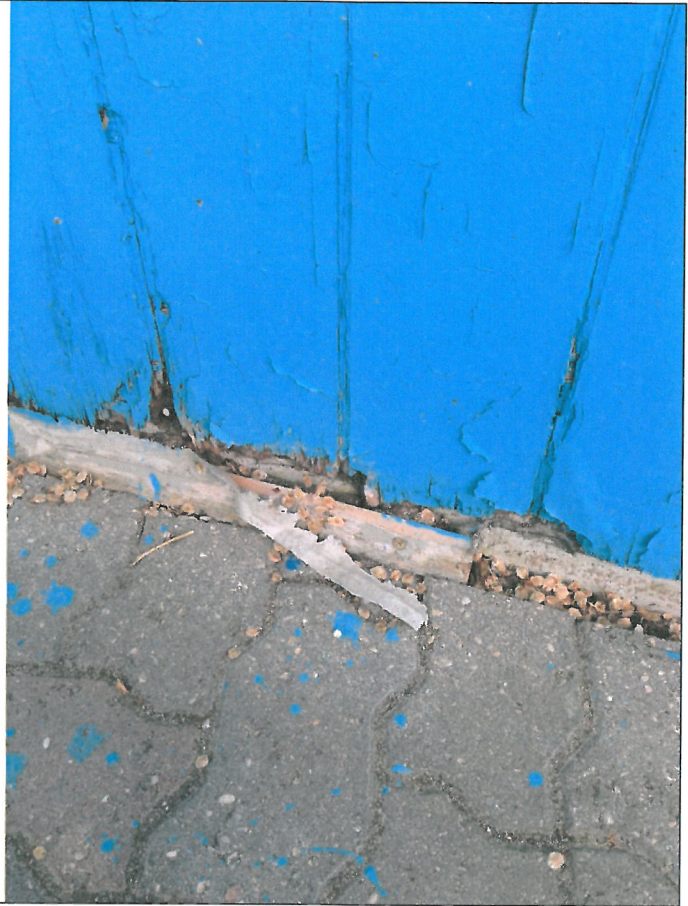
With the main floor elevation being at grade, the base of the exterior walls have been exposed to long term moisture. As a result, many areas of wood cladding have rotted. In some locations, this rot was observed to extend into the sill plate of the wood stud bearing wall (see photograph number 2).

Photograph #2:
Evidence of rot along wall bottom.

As part of any remedial work, an allowance should be carried to remove up to 24" of cladding to inspect all the sill plates around the perimeter and replace those that are rotted with pressure treated wood. To protect the wall system into the future, grading around the building should be redone to maintain drainage away from the structure.
