## **APPENDIX B – COMMUNITY ROW WASTEWATER PUMPING STATION HOIST DEVICES AND LIFTING CAPACITIES REPORT**

## 1.0 LIFT STATION INFORMATION

| <b>Station Name:</b> | <u>Community Row Lift Station</u> |
| <b>Date of Inspection:</b> | <u>February 17, 2010</u> |

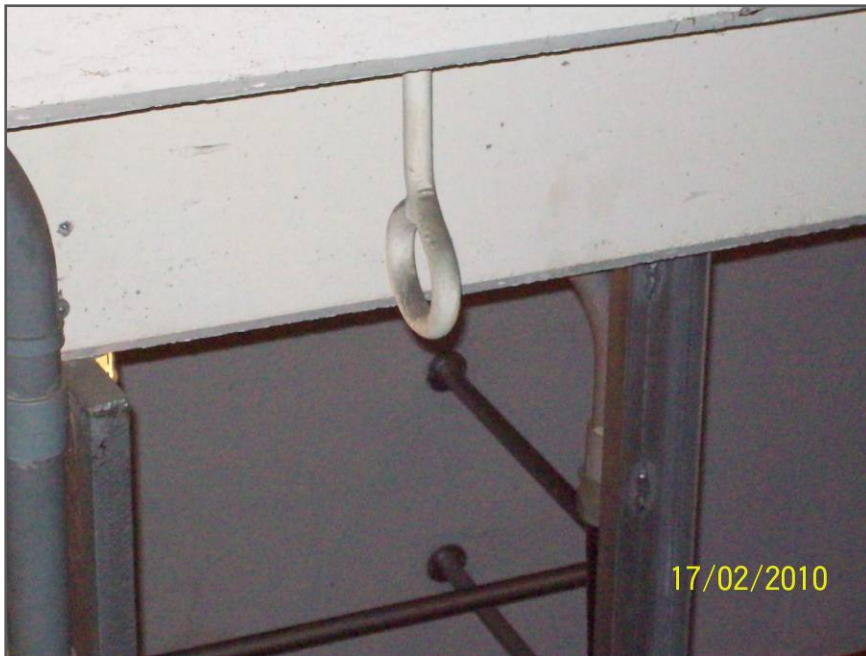
**Photograph No. 1**

The third floor motor room and fourth floor pump room and the each contain 2 eye-shaped hooks, which are all fabricated of 25.4mm diameter steel rod and are embedded into the underside of the concrete floor above. The pump room additionally contains 2 plate hooks embedded into the underside concrete floor above. Severe corrosion was observed on the plate hooks with significant loss of sectional area.

The four (4) eye-shaped hooks were analyzed for pullout resistance of the embedment and tension resistance of the hook. The thickness of the cast-in-place concrete was not observed, therefore, the concrete thickness was estimated to be 200mm and an embedment length of 150mm was assumed. The pullout resistance was governing factor, which was calculated to be 3.6 tons. However, due to many assumptions, it is recommended that an additional factor of safety of 3.6 be applied to the hooks, to yield a **load rating of 1.0 ton**.

Typical bottom floor eye-shaped hook

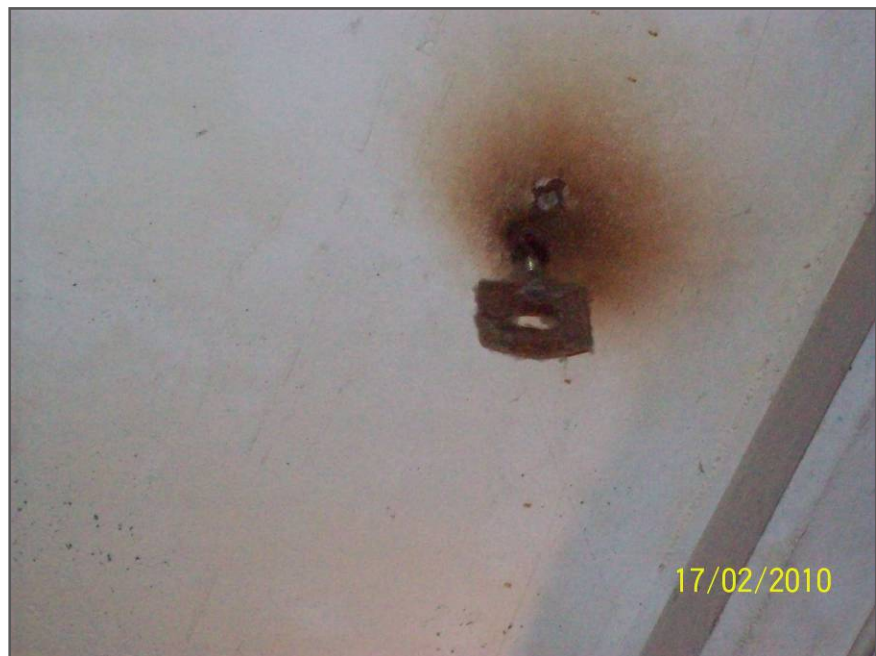
**Photograph No. 2**

The two (2) steel plate hooks were analyzed, and a resistance of 3.4 tons was determined. However, due to the observed loss of sectional area cause by the corrosion, no load rating can safely be assigned. They should be deemed unsafe to use and should be replaced.

Typical bottom floor plate hook

| Ref. | Description | Priority |
|---|---|---|
| 4.3 | Remove and replace 2 steel plate hooks in the bottom floor pump room. | B |

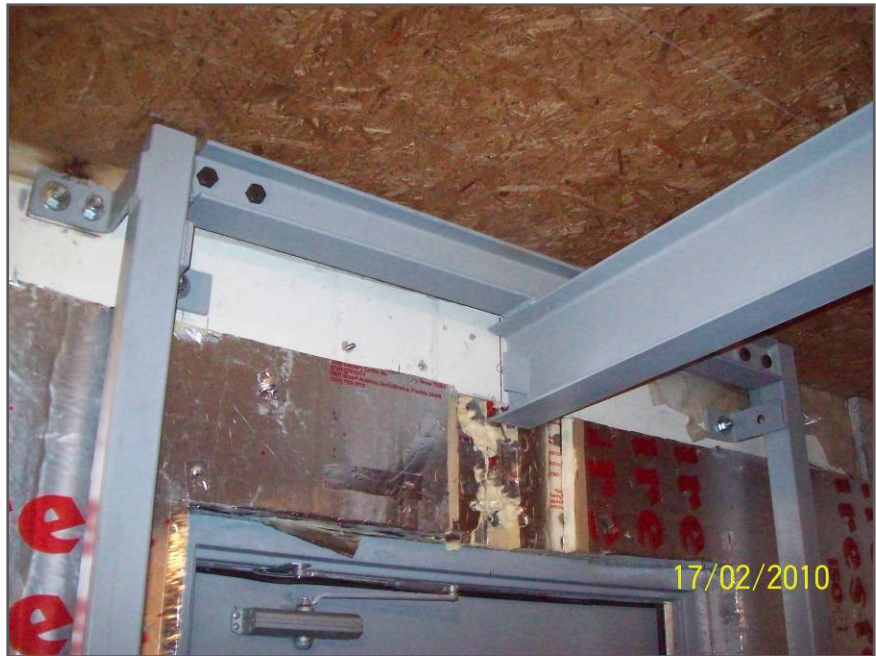
**Photograph No. 3**

The main floor has a lifting beam system consisting of an S200x27 beam that spans approximately 5440mm that carries a trolley with a posted 2.0 tons rating. One end of the S200x27 beam is welded to the underside of a W100x19 beam spanning 1520mm supported by HSS 76x76 columns on each side. On the other end, the S200x27 beam is supported by a bolted clip angle connection to steel beam that is a part of the roof framing. Excessive projection of three (3) anchor bolts was observed on one of the HSS column supports, two (2) at the clip angle connection near the column top and one (1) at the base plate. It is assumed that the anchors have not been installed to their design embedment. It appears that sections of pipe were used as spacers between the washers and nuts. It was also observed that the system was currently condemned; however, it does not appear to be appropriately locked and/or tagged out.

The beam system on the main floor was analyzed for bending resistance of the S-beam and the supporting W-beam, column shear resistance and weld resistances of the connections. Bending resistance of the S-beam was the governing factor, which was calculated to be 3.0 tons. However, due to the fact that the beam is currently condemned, MMM cannot safely assign a load rating for the system.

Main floor lifting beam system over access door

| Ref. | Description | Priority |
|---|---|---|
| 4.1 | Repair or Lockout /Tagout W200x27 lifting beam system | A |

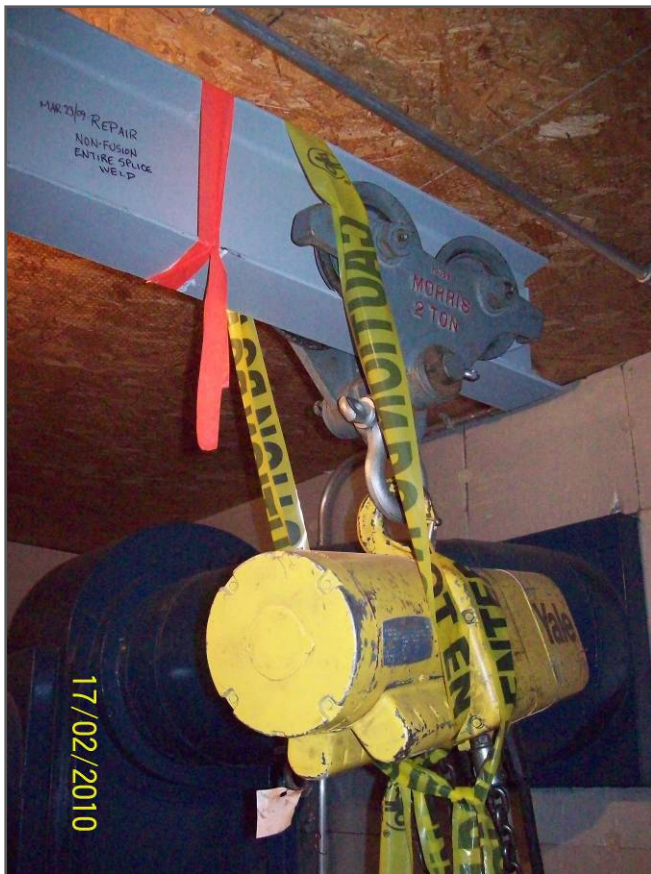
**Photograph No. 4**

Main floor lifting beam system and trolley
