ASBESTOS INVENTORY CONTROL

BID OPPORTUNITY 1179-2016

APPENDIX 2

Building Name:	Billy Mosienko Arena	Inspection Date:	February 16, 2016
Building Code:	AR-08	Inspected By:	James Neufeld & Ryan Matthews
Building Address:	709 Keewatin Street	Construction Date:	1975

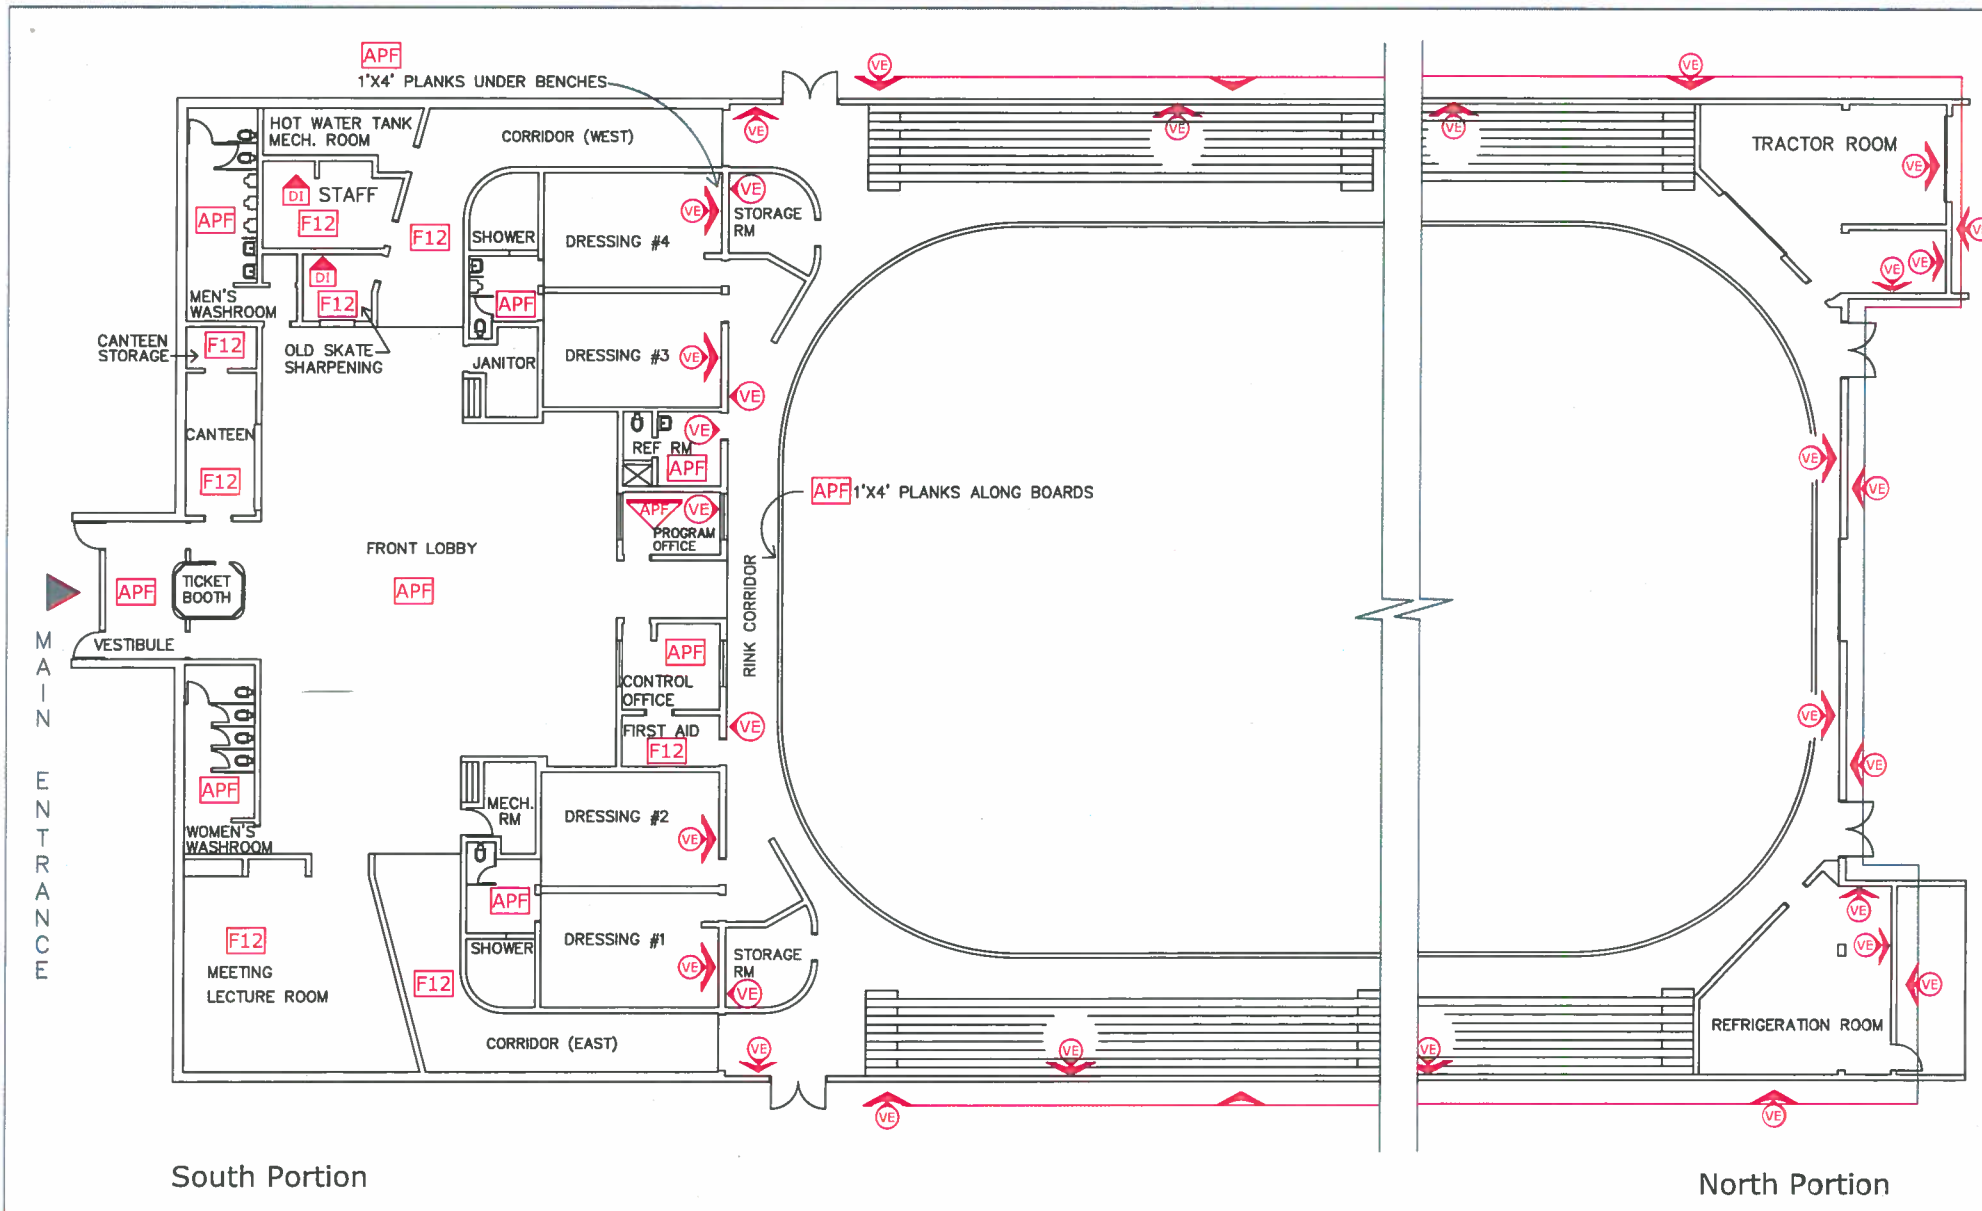
AR-08

Material Location	Material Description	Drawing Label	Material Condition	Testing Status	Date M/Y	Test %	Est. %
Front Lobby	Asphalt Plank Floor (1' x 4' Planks)	APF	Good	TESTED	Nov'12	3	
Women's Washroom	Asphalt Plank Flooring (1' x 4' Planks)	APF	Good				3
	Pipe Fitting Insulation	PF	Good	TESTED	Nov'12	0	
Meeting/Lecture Room	Pipe Fitting Insulation	PF	Good	TESTED	Nov'12	0	
	12x12 Floor Tile	F12	Good	TESTED		2-5	
East Corridor	12x12 Floor Tile	F12	Good	TESTED		2-5	
West Corridor	12x12 Floor Tile	F12	Good	TESTED		2-5	
Mechanical/Furnace Room (east)	Pipe Fitting Insulation	PF	Good				
Control Office	Pipe Fitting Insulation	PF	Good				
Program Office	Asphalt Plank Floor (1' x 4' Planks)	APF	Good				3
	Asphalt Plank Floor (1' x 4' Planks) - under carpet	APF	Good				3
First Aid Room - beside office	12x12 Floor Tile	F12	Good	TESTED		2-5	
Canteen	12x12 Floor Tile	F12	Good	TESTED		2-5	
	Pipe Fitting Insulation	PF	Good

Canteen Storage Room	12x12 Floor Tile	F12	Good			2-5	
Men's Washroom	Pipe Fitting Insulation	PF	Good	TESTED	Nov'12	0	
	Asphalt Plank Flooring	APF	Good				3
Men's Washroom Supply Room	Pipe Fitting Insulation	PF	Good				0
Old Skate Sharpening Room	12x12 Floor Tile	F12	Good	TESTED		2-5	
	Duct Insulation	DI	Good				
	Pipe Insulation	PI	Good				0
Staff Room/Kitchen	12x12 Floor Tile	F12	Good	TESTED		2-5	
	Duct Insulation	DI	Good				
Hot Water Tank/Mechanical Room	Pipe Fitting Insulation	PF	Good	TESTED	Nov'12	0	
Rink Corridor	Asphalt Plank Floor (1' x 2' Planks - 1 Row 1' x 4' Planks)	APF	Good			3	
	Asphalt Plank Floor (1' x 2' Planks)						0
Dressing Rooms 1 - 4	Asphalt Plank Flooring (1' x 2' Planks)		Good				0
Dressing Room 4	Asphalt Plank Floor (1' x 4' Planks 1 Row under Benches)	APF	Good			3

Material Location	Material Description	Drawing Label	Material Condition	Testing Status	Date M/Y	Test %	Est. %
	Asphalt Plank Floor (1' x 2' Planks)						0
Dressing Rms 1 & 2 Washroom / 3 & 4 Washroom	Asphalt Plank Floor (1' x 4' Planks)	APF	Good				3
	Pipe Fitting Insulation	PF	Good				0
Dressing Room 1 & 2 Shower Rm	Pipe Fitting Insulation	PF	Good	TESTED	Nov'12	0	
Referee Room (Washroom)	Asphalt Plank Flooring (1' x 4' Planks)	APF	Good				3
	Pipe Fitting Insulation	PF	Good				0
Dressing Room 3 & 4 Shower Rm	Pipe Fitting Insulation	PF	Good	TESTED	Nov'12	0	
Tractor Room	Pipe Fitting Insulation	PF	Good	TESTED	Nov'12	0	
Plant Room	Pipe Fitting Insulation	PF	Good	TESTED	Nov'12	0	
Exterior block walls of ice shed and wall between ice shed and front portion (south) of building	Contains Vermiculite Insulation (Which May Contain Asbestos)	VE	Good	TESTED			Trace
Exterior block walls of lobby, washrooms and meeting room of building - south portion	Walls randomly inspected and appeared to be empty
