ASBESTOS INVENTORY CONTROL

Building Name:	Pan Am Pool - Building	Inspection Date:	April 15, 2015
Building Code:	PI-13	Inspected By:	A Brodbeck & W Dawson
Building Address:	25 Poseidon Bay	Construction Date:	1967

PI-13

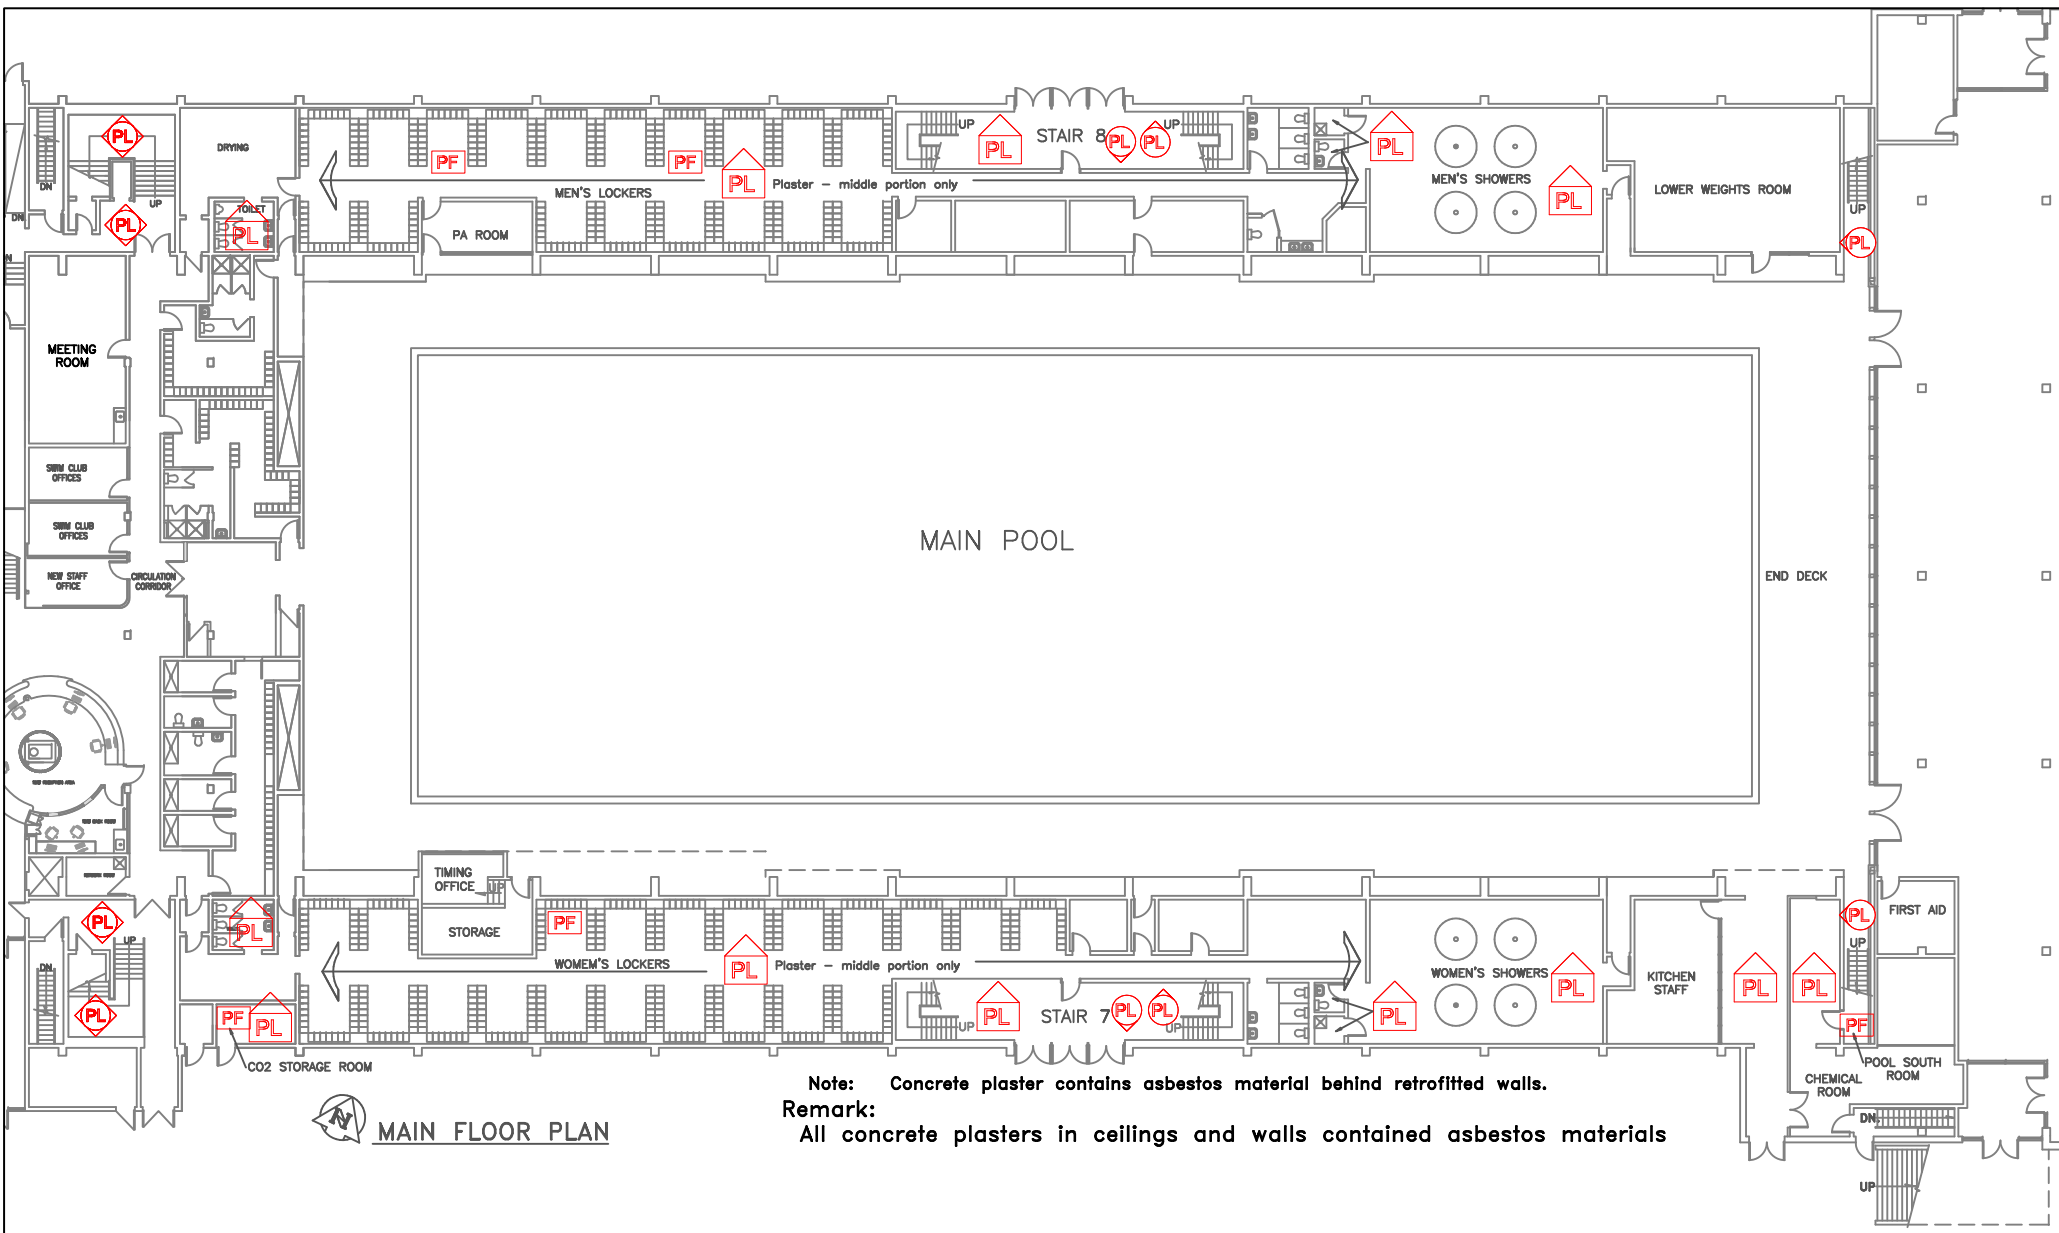
MAIN FLOOR PLAN

Note: Concrete plaster contains asbestos material behind retrofitted walls.
Remark: All concrete plasters in ceilings and walls contained asbestos materials

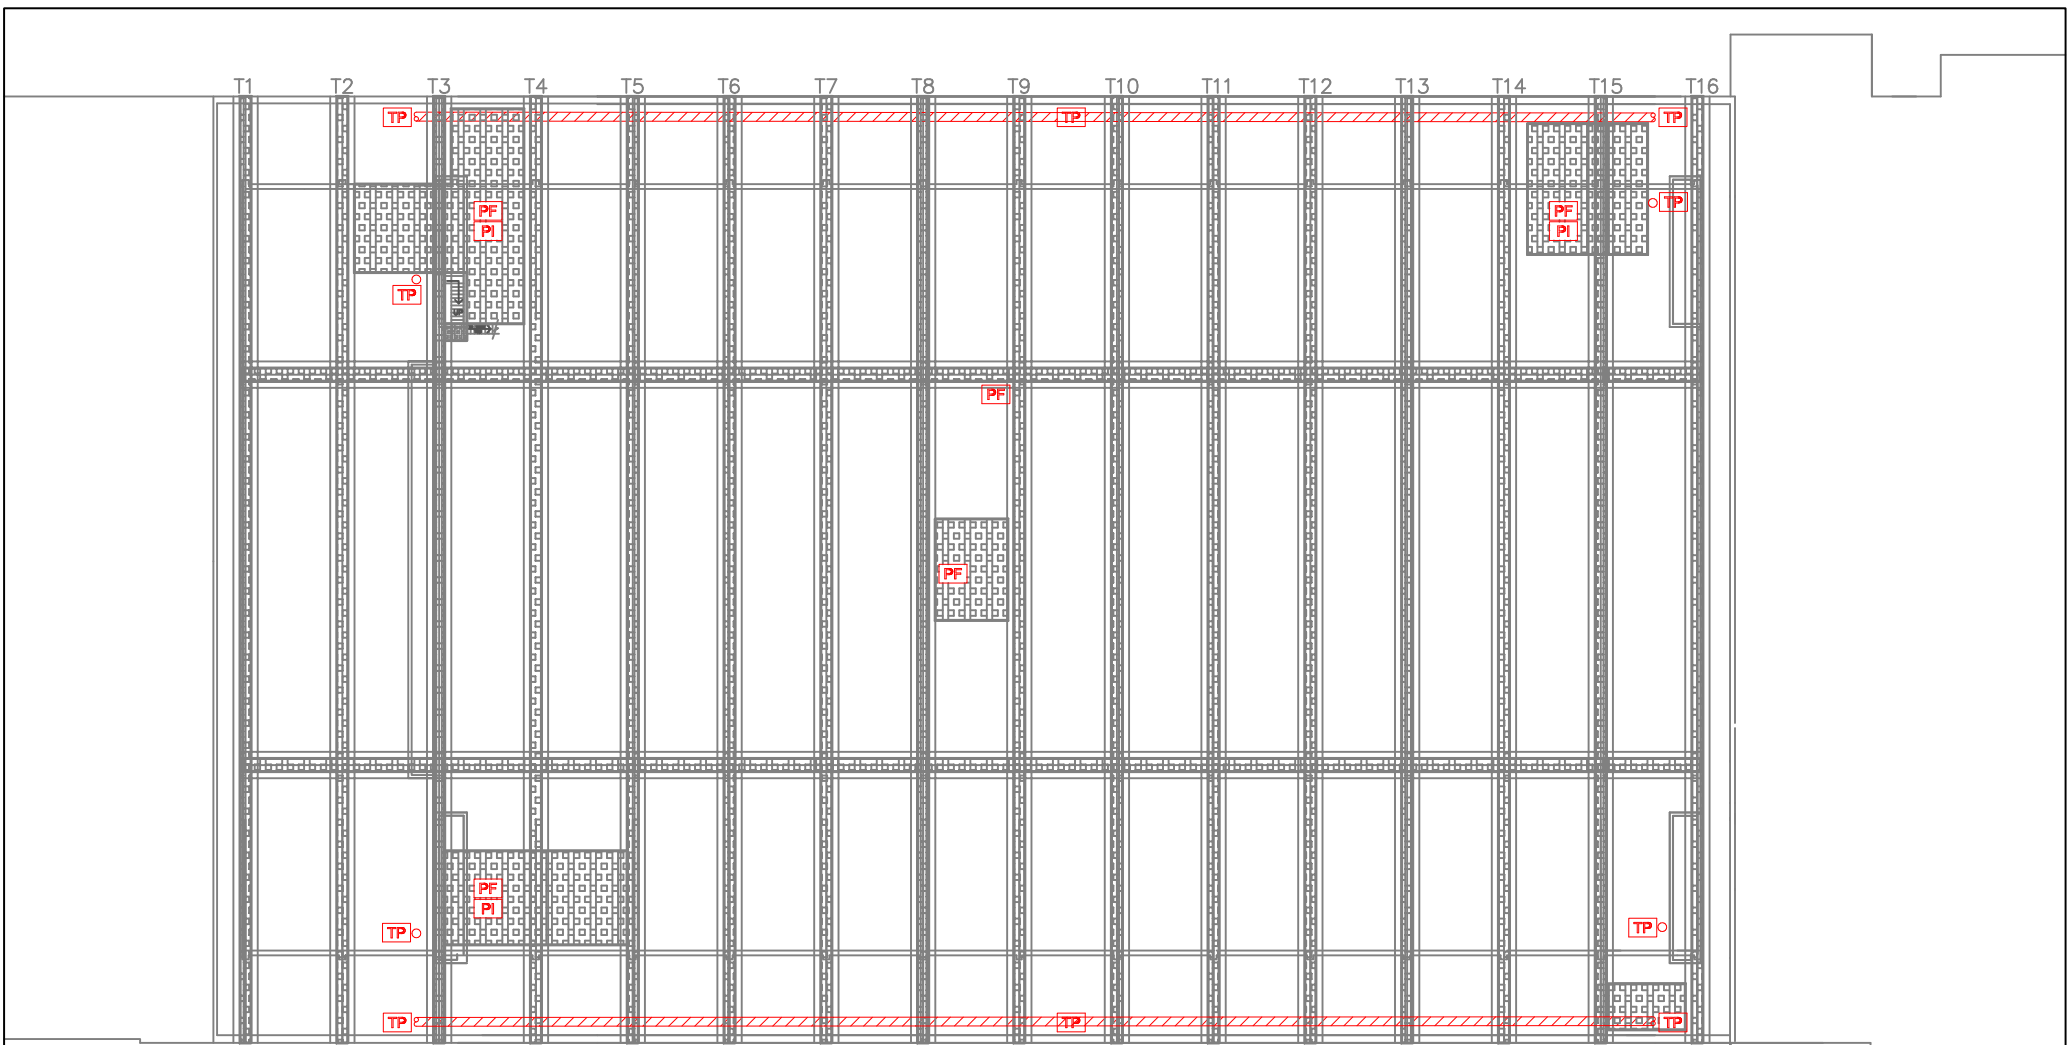
**ROOF CATWALK PLAN**

Remark:
- Asbestos containing pipe fittings are through out catwalk area in various locations.
