ASBESTOS INVENTORY CONTROL

Building Name:	Strathcona Rec Centre (See also DC-02)		Inspection Date:	June 9, 2016		
Building Code:	RC-24		Inspected By:	James Neufeld & Ryan Matthews		
Building Address:	233 McKenzie Street		Construction Date:

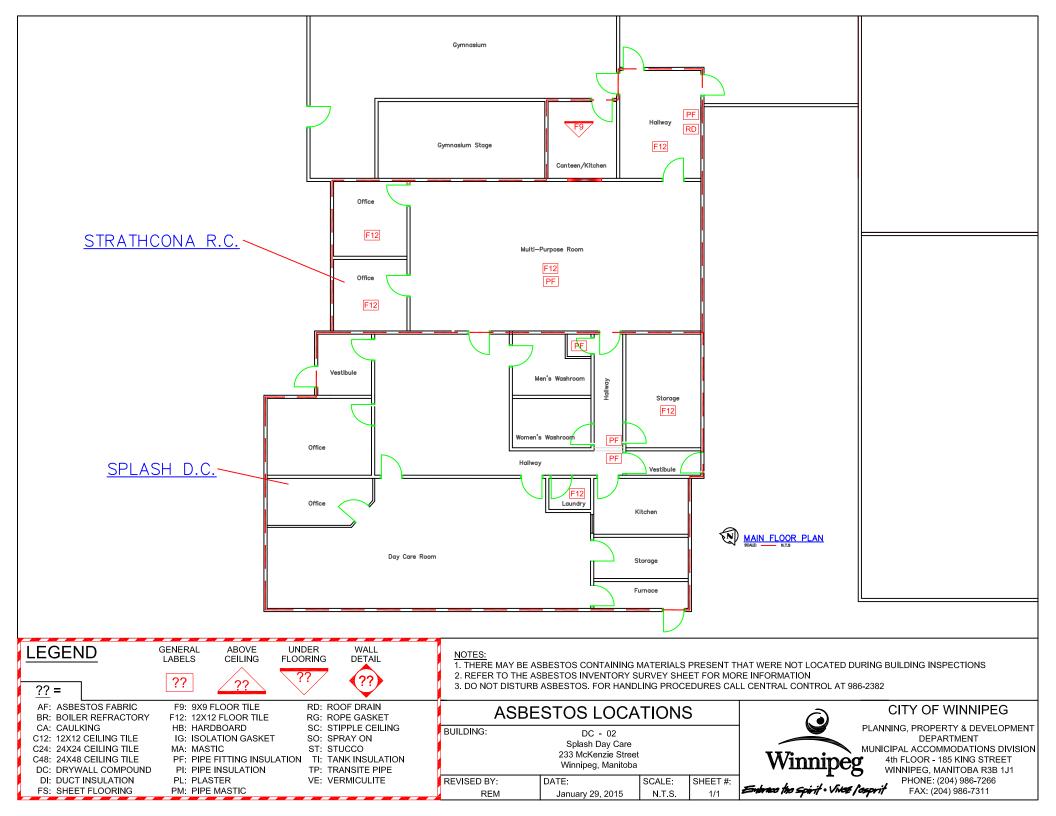
RC-24

Drawing	Material	Testing	Date	Test	Est.
Material Location	Material Description	Label	Condition	Status	M/Y	%	%
Daycare Section							
Mechanical/Furnace Room	Pipe Fitting Insulation	PF		TESTED		0	
Daycare Kitchen	Pipe Fitting Insulation	PF	Good				0
Daycare East Hallway	Pipe Fitting Insulation	PF		TESTED		0	
Daycare North Hallway	Pipe Fitting Insulation	PF	Good	TESTED		60	
Laundry Room	12x12 Floor Tile	F12	Good				2 - 5
Daycare - North Storage Room	12x12 Floor Tile	F12	Good				2 - 5
RC Section							
RC - Multi Purpose Room	12x12 Floor Tile	F12	Good	TESTED		2 & 5	
	Pipe Fitting Insulation	PF	Good				60
RC - Offices	12x12 Floor Tile	F12	Good				2 - 5
RC - Kitchen	9x9 Floor Tile (Possibly Under Sheet Flooing)	F9	Good				
RC - North Hallway	Pipe Fitting Insulation	PF	Good	TESTED		60	
	Roof Drain	RD	Good				
				1
