COVER PAGE

Station Name:	<u>Burrows Lift Station</u>
Location of Station:	<u>2080 Burrows Avenue</u>
Date of Inspection:	<u>January 22, 2010</u>
Inspected By:	<u>Damir Muhurdarevic, EIT</u>
Inspecting Firm:	<u>MMM Group Limited (MMM)</u>
Client:	<u>City of Winnipeg – Water and Waste Department</u>

2.0 OBSERVATIONS

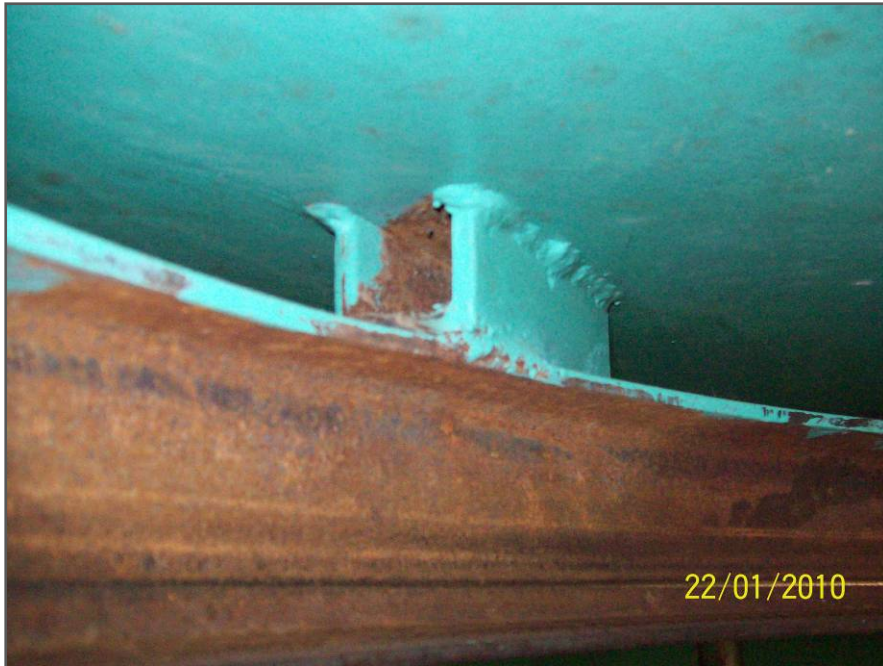
Photograph No. 1

The floor below ground, the Dakota chamber room, has a semi-circular S75x8 lifting beam whose upper flange is welded to three (3) sections of HSS 38x38x4.8mm, which are in turn welded to anchor plates that have been cast into the cast-in-place concrete slab at the top of the chamber. The anchor plate is not visible and was not inspected. The lifting beam has a sliding trolley mounted on it with a posted rating of 0.5 ton. Significant corrosion but no loss of structural area was observed in the beam during the inspection.

Analysis of the lifting beam system in the Dakota chamber was done; the S-beam was checked for moment resistance, and the S-beam to HSS weld connection as well as the HSS to cast-in-place concrete slab weld connection. The governing factor was the moment resistance in the beam, which was calculated to be 1.25 tons. However, it is recommended that a safety factor of 2.5 be applied to beam, to yield a **load rating of 0.5 ton**. It is recommended that the currently posted trolley rating is acceptable.

Lifting beam located in the Dakota component of the lift station

Ref.	Description	Priority
4.1	Paint S75x8 Beam in the Dakota Chamber room, to prevent further corrosion	B

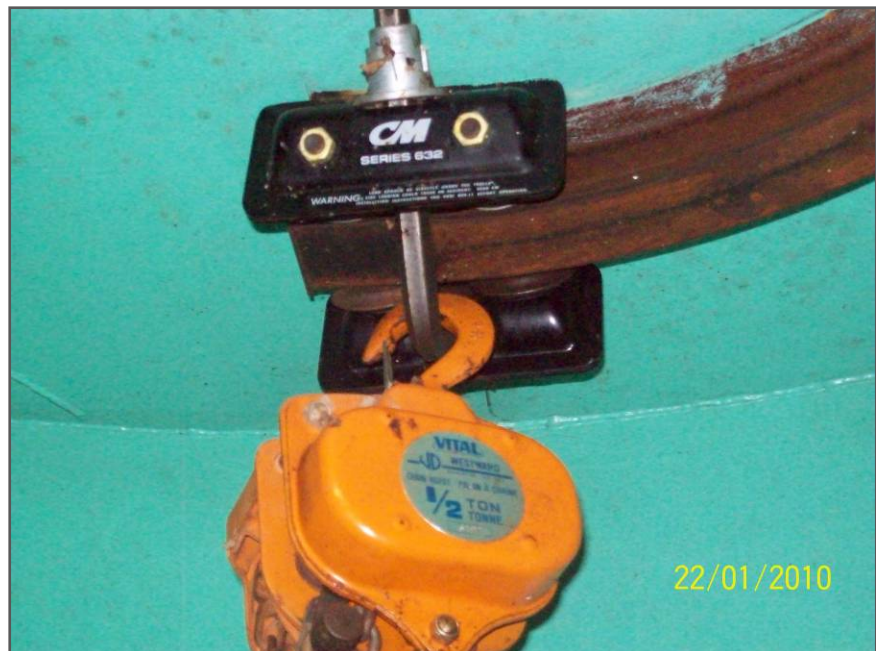
Photograph No. 2

Sliding hook detail of the lifting beam located in the Dakota component of the lift station
