REVISION NO. 2  
**Hazardous Building  
Materials  
Assessment**

St. John's Library,  
500 Salter Street,  
Winnipeg, Manitoba

March 15, 2017

Pinchin File: 200012.005

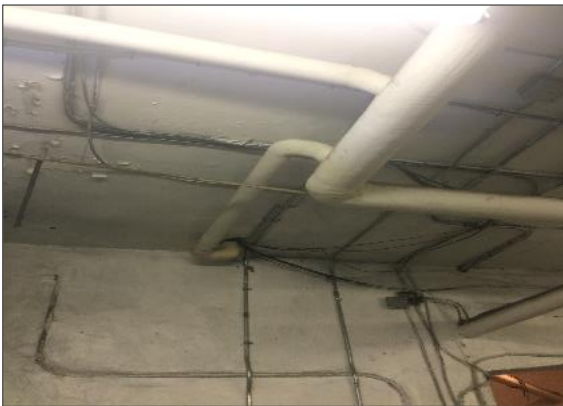
Non-asbestos parping cement is present on pipe system fittings of the how water heating system within the basement of the building (Samples 0002A-C).

Photo #1: Non-asbestos parping cement present on pipe system fittings throughout the basement.

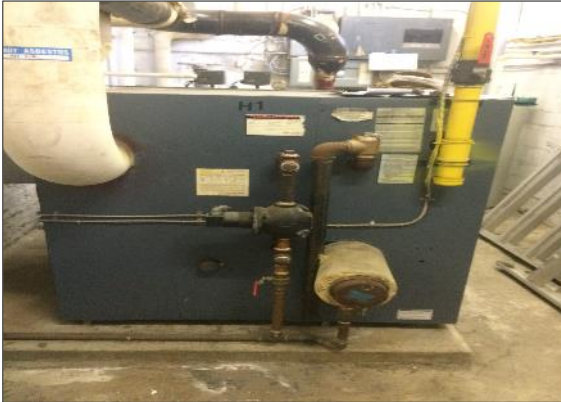
Boiler in the boiler room is jacketed with metal. It was common within this era of construction for manufactures to have installed asbestos-containing refractory materials beneath the metal jacketing. The metal jacketing was not removed during this assessment. Destructive testing will be required prior to demolition of boiler.

Photo #2: Refractory materials suspect to contain asbestos may be present beneath metal jacketing of boiler.

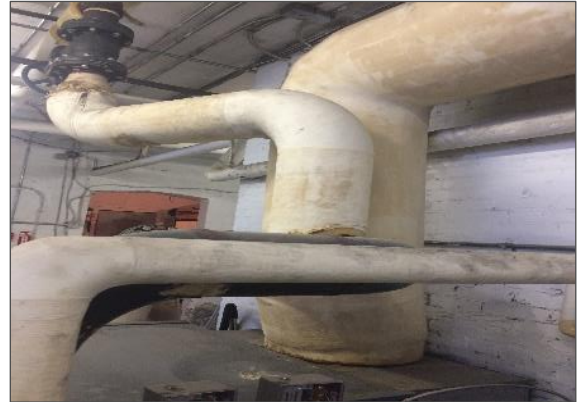
The boiler breeching in the boiler room is insulated with non-asbestos fibreglass and jacketed with canvas.

Photo #3: Non-asbestos fiberglass present on boiler breaching.

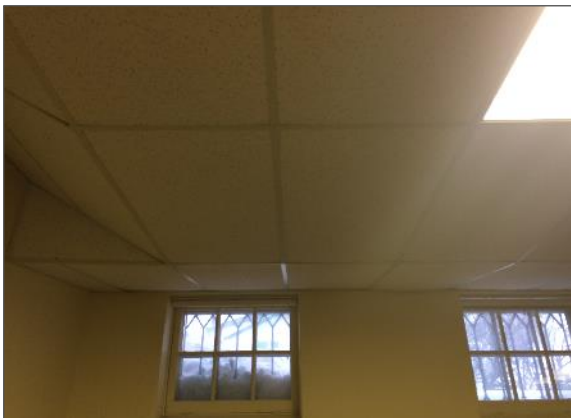
Non-asbestos acoustic ceiling tiles are present within the basement washrooms and meeting room. The ceiling tiles were determined to be non-asbestos based on the date code stamped on the back of the tile (1998).

Photo #4: Non-asbestos acoustic ceiling tiles within the basement washrooms and meeting room.

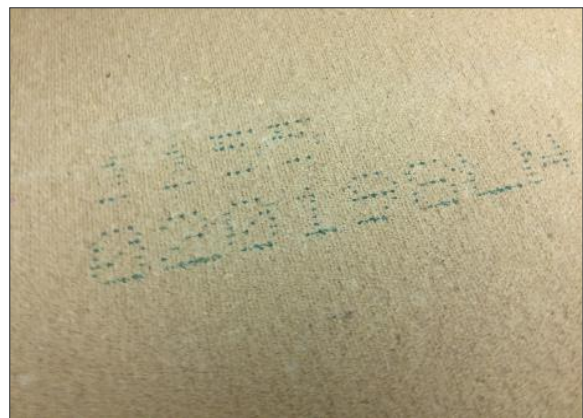
Photo #5: Back of tiles date stamped 02/01/98 year of production.

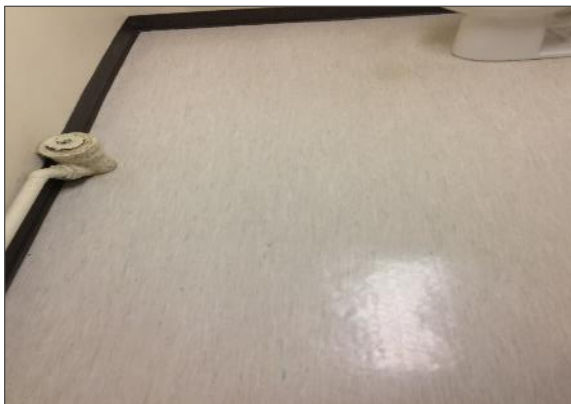
Photo #6: Non-asbestos vinyl sheet flooring with rubber backing within bathrooms.

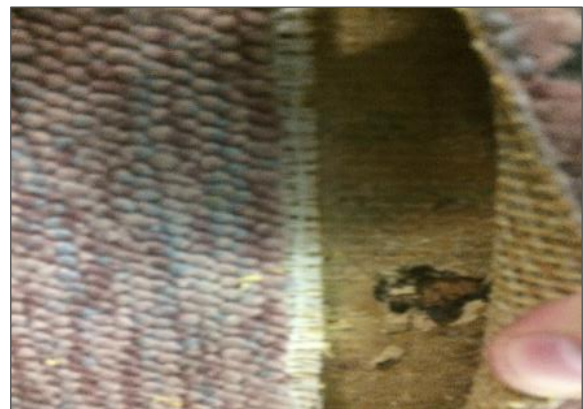
Photo #7: Non-asbestos 9" x 9" square pattern, vinyl sheet flooring under carpet within the staff room (Samples 0004A-C & S0011).

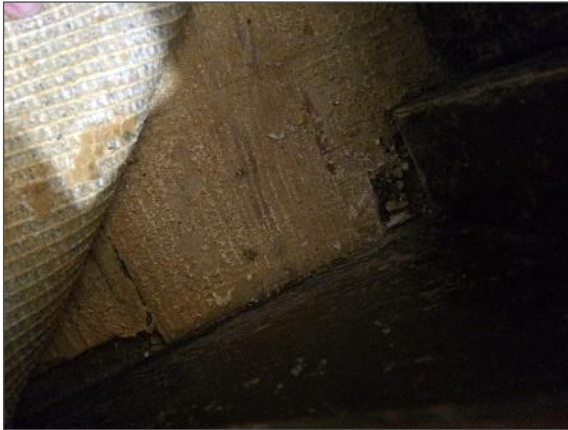
Photo #8: Non-asbestos battle ship flooring under carpeting within the basement corridor (Samples 0010).

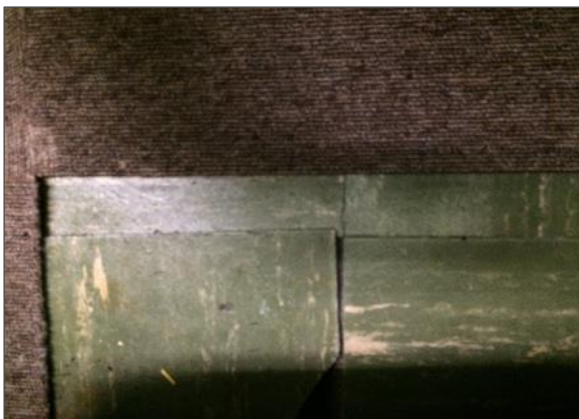
The vinyl floor tiles and mastic are non-friable and are covered with carpet.

Photo #9: Asbestos-containing green floor tiles under carpet within the main floor library.

Remove all ACM prior to renovation, alteration, maintenance or demolition work or if ACM may be disturbed by the work.

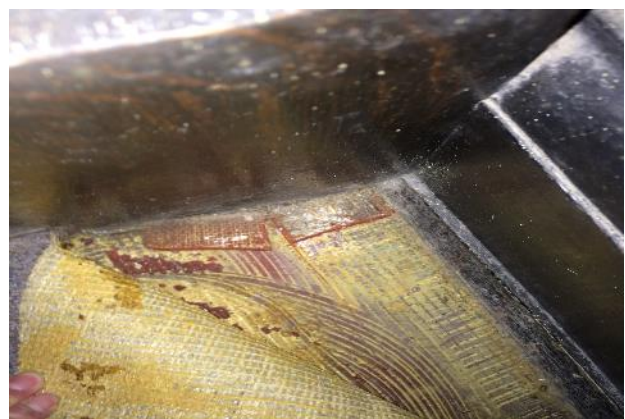
Photo #10: Asbestos-containing vinyl floor tiles present under carpeting within the south stairwell.
