***-FINAL REPORT-***

**MILLENNIUM LIBRARY PARKADE**

**ENTRANCE AND EXIT RAMP STUDY**

**Project No. 2016-150**

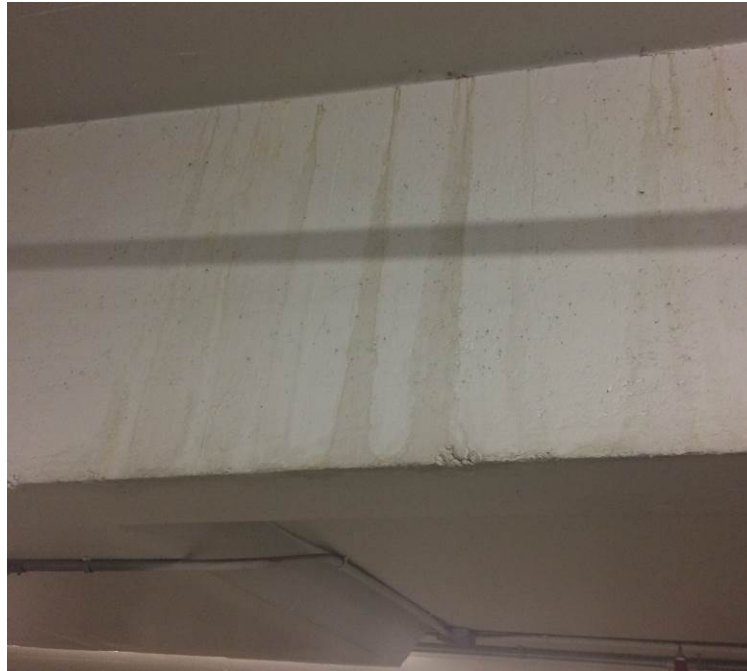
1. The underside of the ramp exhibited areas of brown staining/streaks along the interior walls of the ramp, likely from the water stop or waterproofing failing and/or corrosion as shown in Figure 1.

**Figure 1 – Staining along interior wall beneath Ramp 2.**

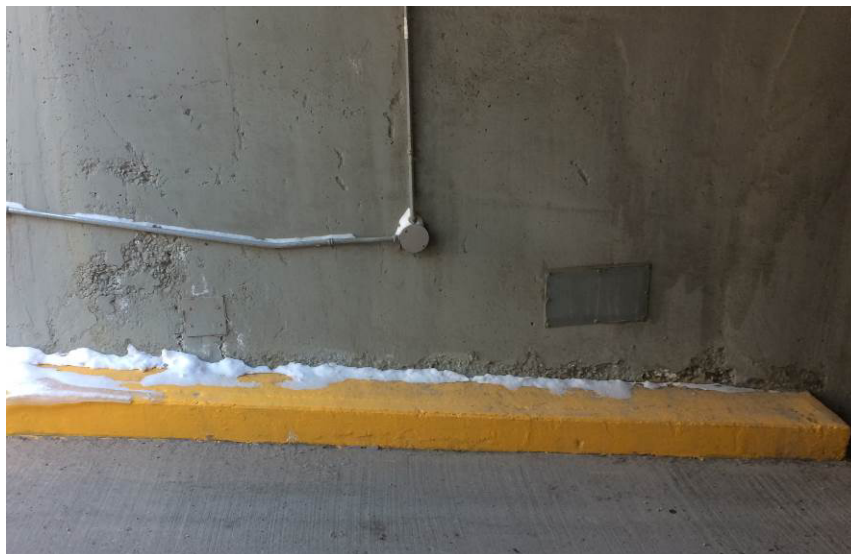
1. The exposed foundation walls on the exterior egress ramp exhibit localized areas of concrete delamination, spalls, freeze thaw deterioration, thin cracks and areas of previous repair as shown in Figure 2.

**Figure 2 – Deteriorated concrete along outer wall of Ramp 3.**

4. The exposed cast-in-place foundation walls on ramps 3, 5 and 6 require some localized concrete repair. The existing architectural coating on the exposed cast in place foundation walls is in good condition. This was part of the previous repair program conducted. Consideration should be given to removing the coating and exposing the concrete only in areas where surface repairs are required. Cost allowances for repairs of these items have been included in the estimate below.
5. The trench drain at the base of ramp 5 should be removed and replaced by virtue of the condition of the concrete surrounding the underside of the drain. This will require concrete and plumbing demolition and replacement.
6. The joint between the ramp 2 suspended slab, and the interior retaining wall requires an injectable repair to address the water stop or waterproofing that is potentially failing.

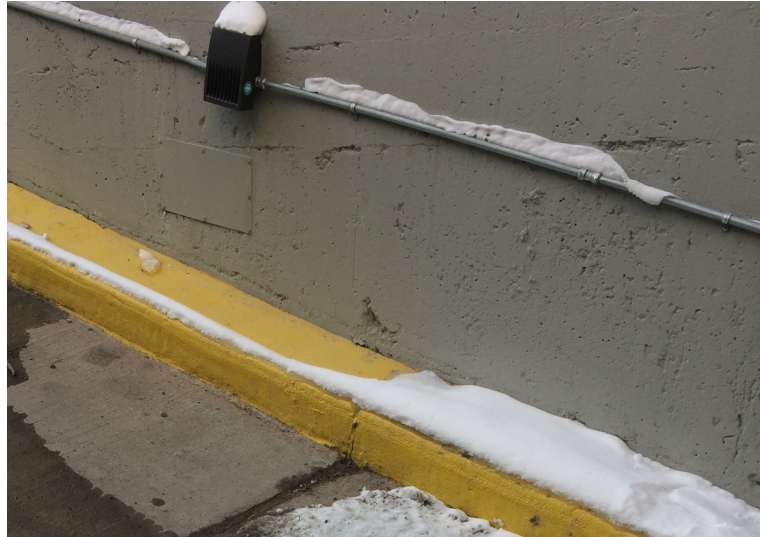
1. The exposed foundation walls on the exterior egress ramp exhibit localized areas of concrete delamination, spalls, freeze thaw deterioration, thin cracks and areas of previous repair as shown in Figure 3.

**Figure 3 – Concrete along outer wall of Ramp 4.**

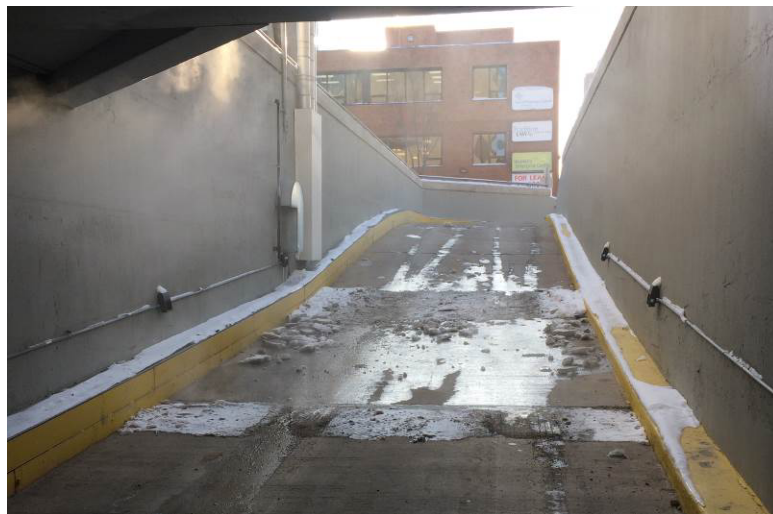
2. The exposed foundation walls on the exterior egress ramp have been coated with an architectural coating. The coating appears to be in good condition with a few localized areas of failure and exposed concrete.
3. The ramp topping displayed the most visible signs of wear and deterioration at this location.
4. Failed sections of the snow melt system were clearly visible through the accumulation of snow and ice on regions of the ramp as shown in Figure 4.

**Figure 4 – Failed sections of Ramp 5 snow melt system**

6. Discussions with maintenance staff indicate that the in-slab rubber hoses have been the main point of failure. Leaks have occurred in the hoses, and the failed circuits have been capped off at the copper headers. The hoses were described as extremely brittle.
7. The underside of the ramp exhibited several areas of light brown staining around cracks, potentially from the waterproofing failing and/or corrosion in conjunction with the leaking in-slab rubber hoses.
8. The underside of the trench drain exhibits leakage and general distress.

2. Replace all the original glycol distribution piping downstream of the both mechanical rooms, including the in-slab rubber hoses, with crosslinked polyethylene (PEX-a) tubing and installing a distribution header in each mechanical room. This excludes the Smith street piping that was replaced in 2011. Costs for complete replacement of these items have been included in the estimate below.

1. To allow the replacement of the in-slab components listed above, the removal and replacement of the entire area of concrete topping on ramps 3, 5 and 6 will be required. As part of this work the waterproofing and rigid insulation should also be removed and replaced. Costs for replacement of these items have been included in the estimate below.
2. Remove and replace the concrete curbing that borders the outer laneway on ramps 3, 5, and 6.
3. Remove and replace the glycol loop encasements that borders the inside laneway on ramps 3, 5, and 6.

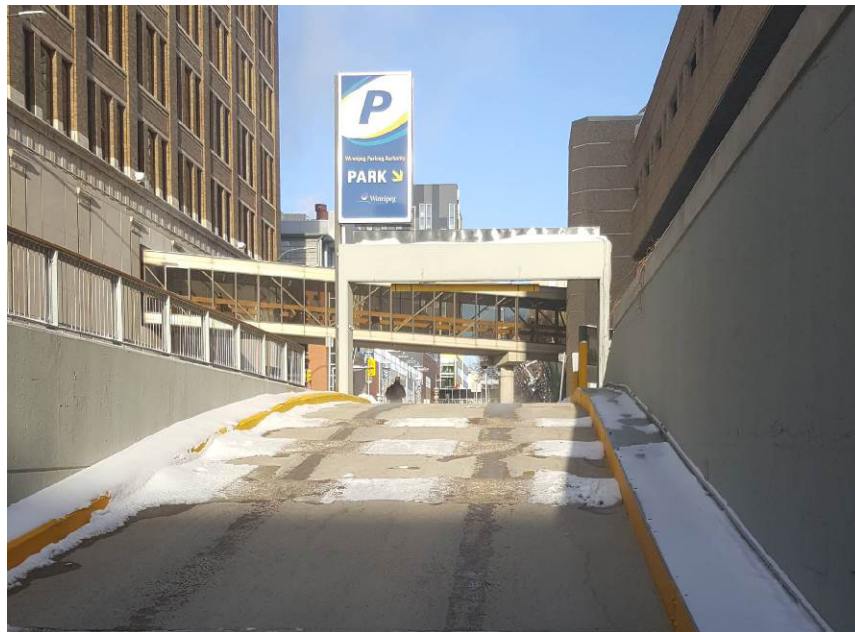
1. The exposed foundation walls on the exterior egress ramp exhibit localized areas of concrete delamination, spalls, freeze thaw deterioration, thin cracks and areas of previous repair.
2. The exposed foundation walls on the exterior egress ramp have been coated with an architectural coating. The coating appears to be in good condition with a few localized areas of failure and exposed concrete.
3. Failed sections of the snow melt system were clearly visible though the accumulation of snow and ice on regions of the ramp as shown in Figure 5.

**Figure 5 – Failed sections of Ramp 6 snow melt system.**

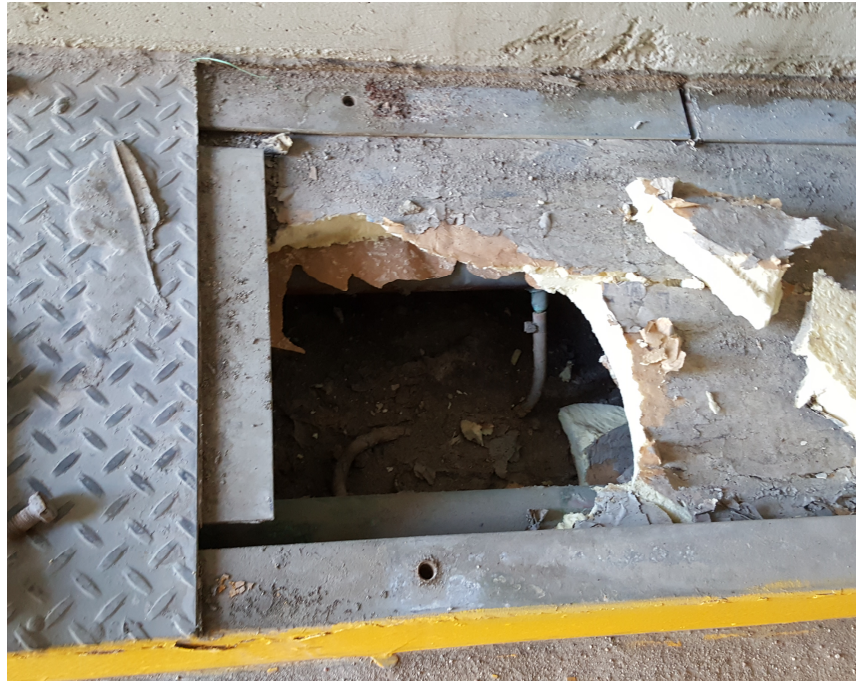
4. The ramp is served by 2" copper supply and return headers in a curb on the side of the ramp. 3/8" rubber-type distribution hoses run in the ramp slabs and connect to the copper headers with clamps as shown in Figure 6.

**Figure 6 – Glycol distribution hoses from header in Ramp 6.**

5. Discussions with maintenance staff indicate that the in-slab rubber hoses have been the main point of failure. Leaks have occurred in the hoses, and the failed circuits have been capped off at the copper headers. The hoses were described as extremely brittle.
6. The underside of this ramp could not be accessed for investigation and observations since it is a slab on grade.

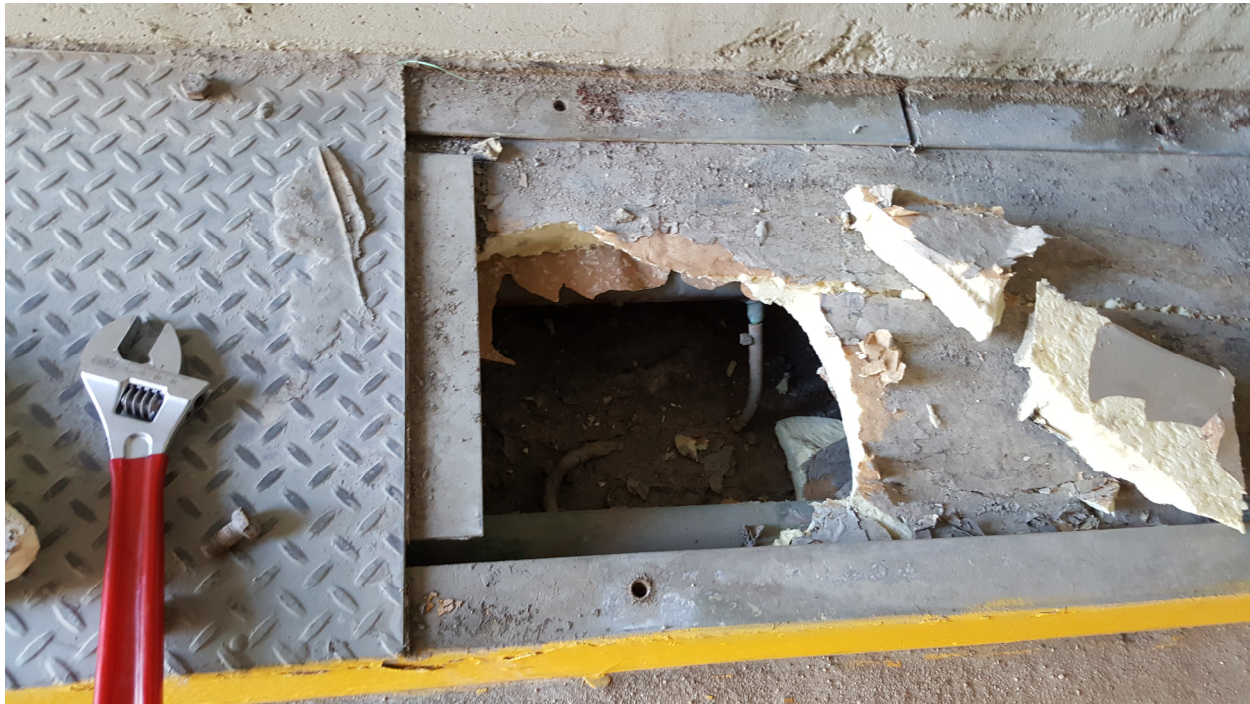
The remaining three ramps are served by 2" copper supply and return headers in a curb on the side of the ramp. 3/8" rubber-type distribution hoses run in the ramp slabs and connect to the copper headers with clamps as shown in Figure 1.

**Figure 1 - Glycol distribution hoses from header**

Based on discussions with City of Winnipeg maintenance staff, the in-slab rubber hoses have been the main point of failure. Leaks occurred in the hoses and the failed circuits were capped off at the copper headers. The hoses were described as extremely brittle and the Donald street glycol system was operating at one half its design pressure as higher system pressures caused additional leaks in the hoses. This type of system has been noted for the failure of the rubber tubing system in many installations over the years.

Based on the site conditions described above, we recommend replacing all the original glycol distribution piping downstream of the mechanical rooms, including the in-slab rubber hoses, with crosslinked polyethylene (PEX-a) tubing and installing a distribution header in each mechanical room. This excludes the Smith street piping that was replaced in 2011. Consideration could be given to replacing only the in slab rubber hoses and keeping the copper headers running along the side of the ramps but balancing valves would need to be installed in the curb for each loop which may not be possible given the limited space.

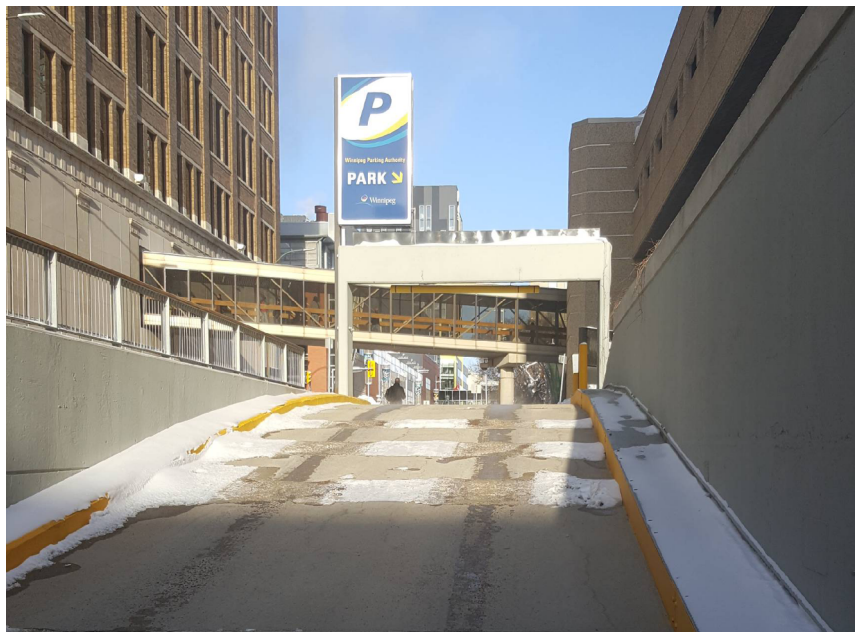
During our site review, we observed that sections of the Donald street snow melt system have failed and no longer keep the ramps free of snow as shown in Figure 2. Both Smith street ramps were fully operational, though the exit ramp is of the same age as the Donald street ramps.

**Figure 2 - Failed Sections of Donald street snow melt system**

Replacement of the boilers should also be considered as they have reached the end of their projected service life (25 years).
