OVIVO FIELD SERVICE REPORT

*FIELD SERVICE ENGINEER: MAREK ROKOSH *DATE(S) ONSITE: NOV 24, 2015 *CHARGE #: FOW0150019

Contractor Name/Address:	*SERIAL #: 11798-1	*Equipment: Primary Clarifier #3 *Type: Dorcan Traveling Bridge *Size:
Other Contact Names: Wally Gretschnan (Lead Mechanic) Email Address: wgretschnan@winnipeg.ca Phone:	Sales Agent Name: Dan Landry (Mequipco) Phone#: 204-982-1040

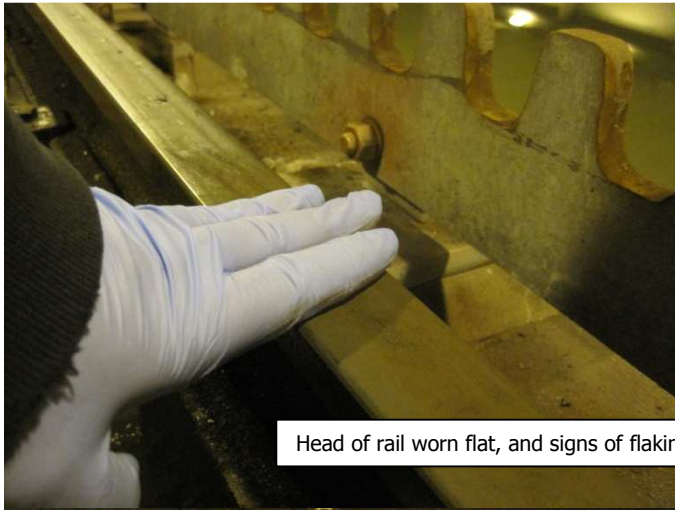
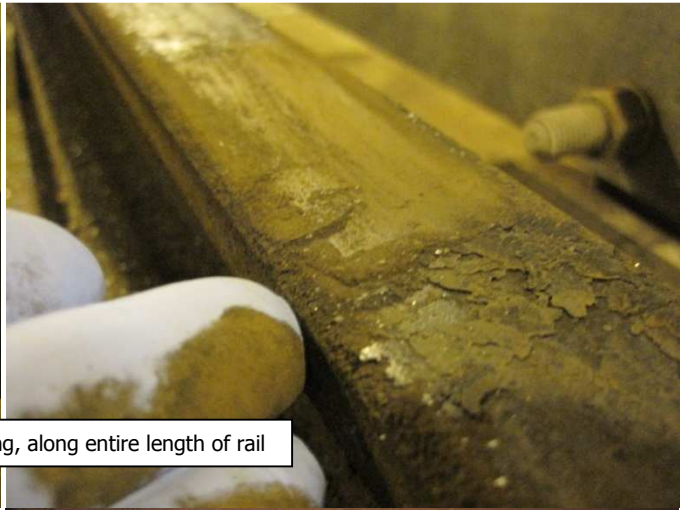
- The head of the rail is worn completely flat along the entire length of the rail.
- Along the entire length of the rail, there are signs that the rail may be flaking, but it is unclear if the flakes are from rail itself, or if they had fallen from the festoon rail above.
- At most rail splice plates, the splice plates themselves are worn on the upper edge of the splice plate, and the heads of the splice bolts are also worn.
- Some rail clips were found to be missing entirely.
- In numerous locations, the rail clip mounting hardware was found to be worn and/or damaged.

These findings indicate that the North truck of the bridge has 'dropped' to a lower elevation, and is now riding much closer to the floor than what the original design called for.

Head of rail worn flat, and signs of flaking, along entire length of rail

- To bring the bridge back up to its correct elevation, both the North and South rails should be replaced. In addition, the running wheels (both flanged wheels on the North truck and both flat wheels on the South truck) should be replaced. Ovivo recommends replacement of these wheels as complete assemblies – wheels, axles and bearings.

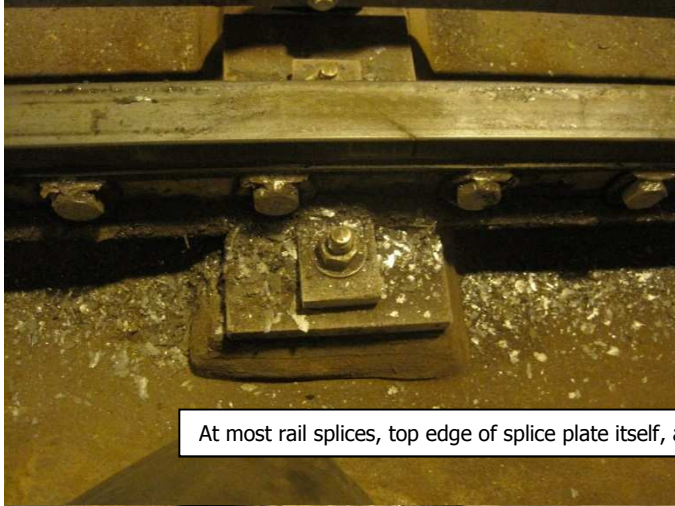
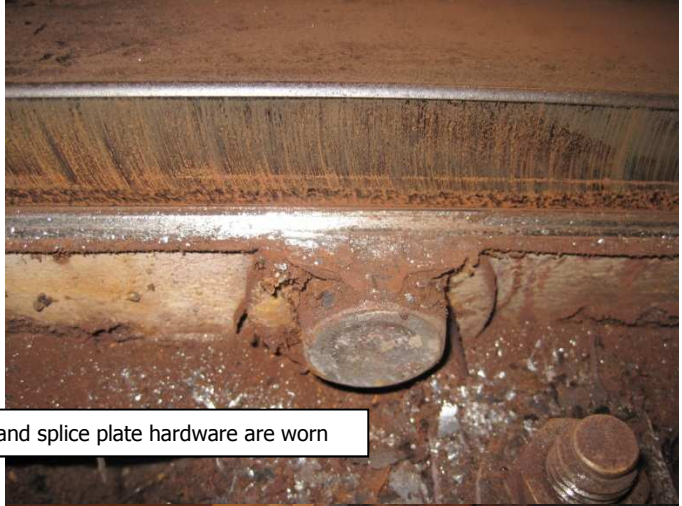
At most rail splices, top edge of splice plate itself, and splice plate hardware are worn

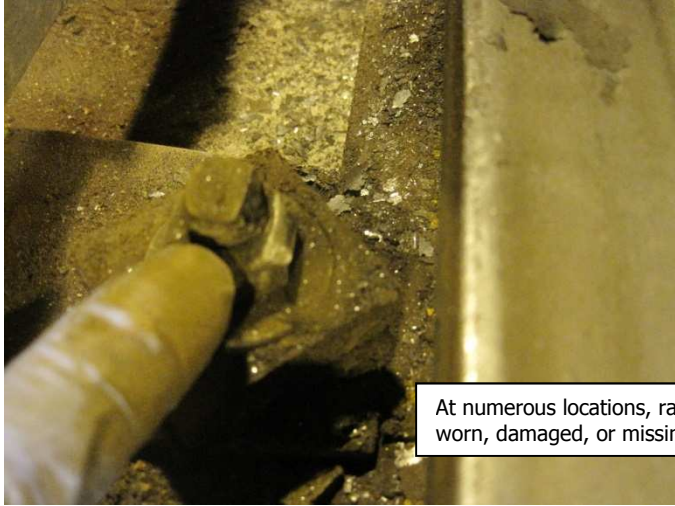
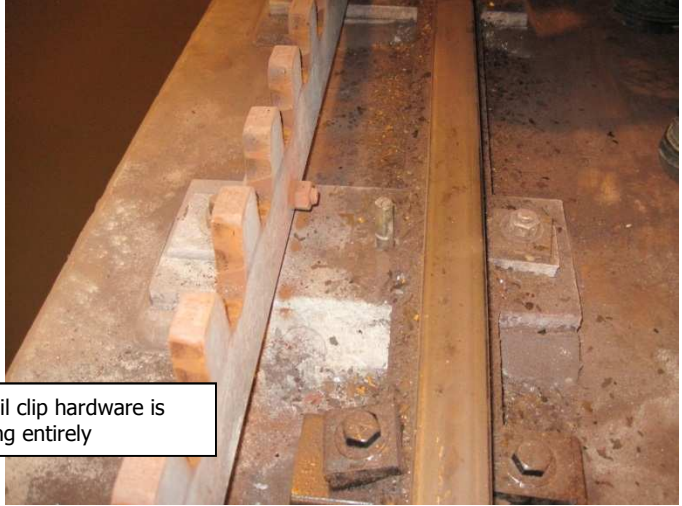
At numerous locations, rail clip hardware is worn, damaged, or missing entirely

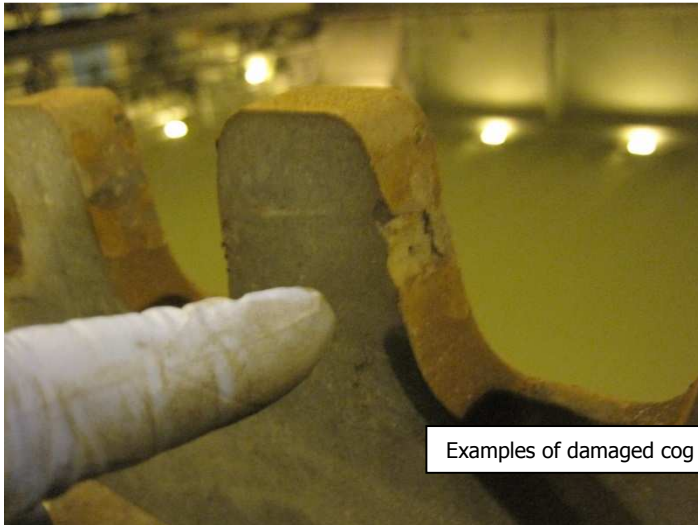
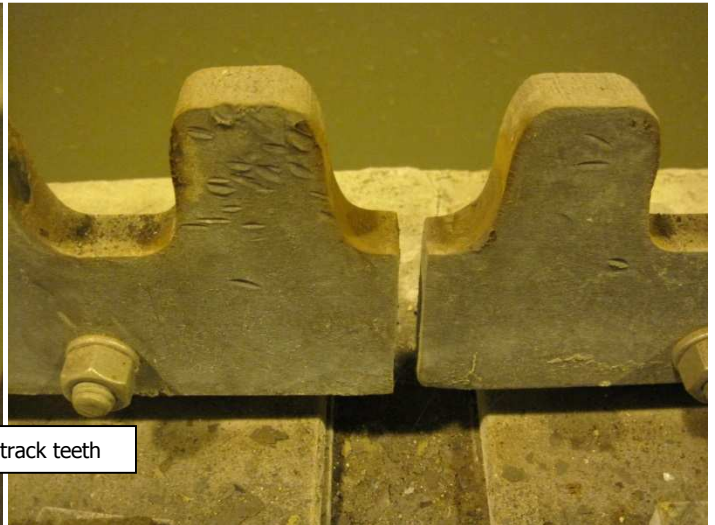
- A small number of the cog track teeth show minor signs of damage, such as pitting or chipping.
- On nearly all of the cog track teeth, the faces and flanks of the teeth show varying degrees of wear, on either side of each tooth.

Examples of damaged cog track teeth

- While the cog track appears that it may be salvageable (in particular the South cog track), to ensure correction of the jerky action of the bridge as it travels, both the North and South cog tracks should be replaced.

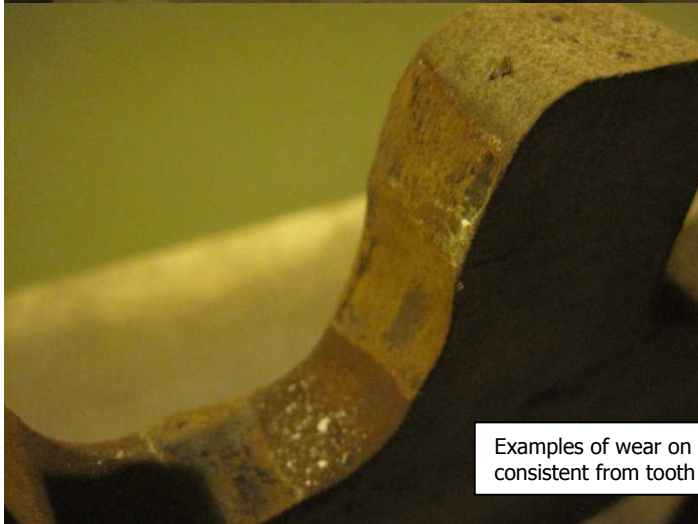
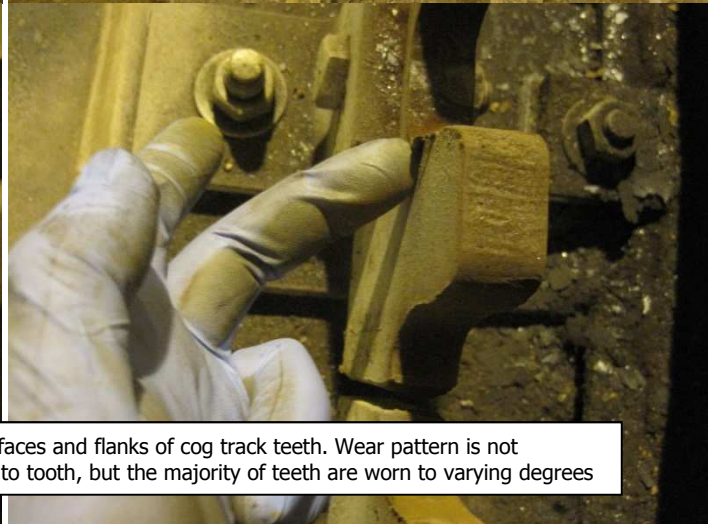
- On a few of the teeth, the tooth thickness was measured, and compared to unworn teeth near the ends of the rail. Differences in thickness of over 30 thousandths of an inch were found between some teeth and the reference teeth. As a result of this varying degree of wear on the cog track teeth, the effective length of the pitch of the cog track's tooth pattern has changed significantly, which likely is the cause for the jerky, rocky action of the bridge as it travels.

Examples of wear on faces and flanks of cog track teeth. Wear pattern is not consistent from tooth to tooth, but the majority of teeth are worn to varying degrees

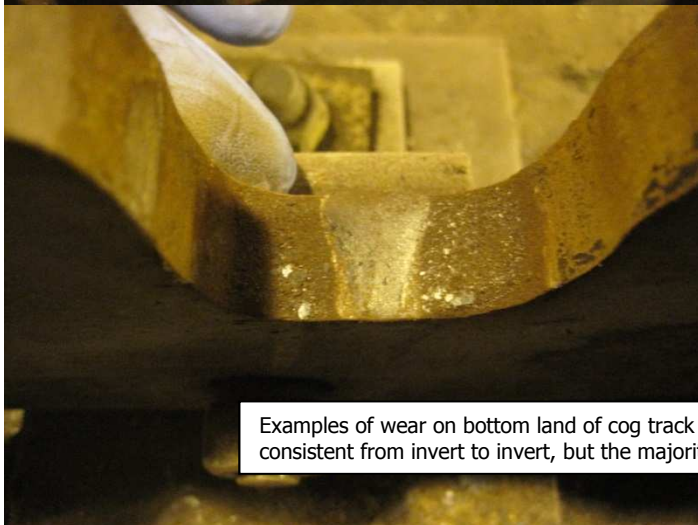
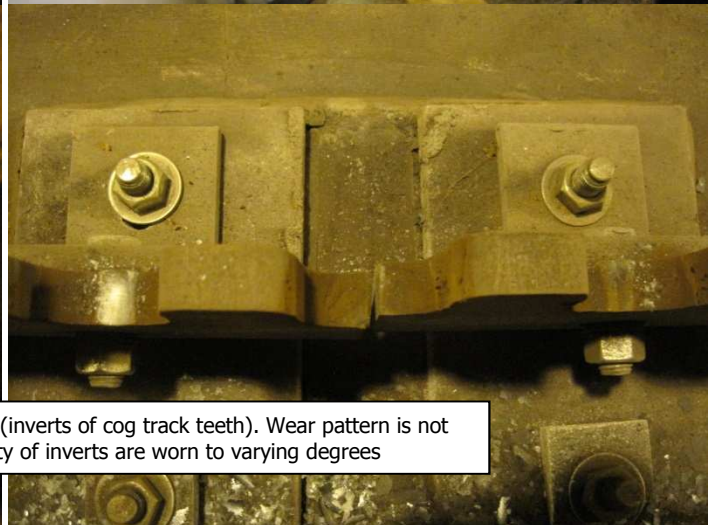
- In addition to the wear found on the faces and flanks of the teeth, significant wear was found on the bottom land of the cog track as well (on the inverts of the teeth). With the bridge travelling at its design elevation, there should be a small gap between the cog rollers and these inverts, and the rollers should not make contact with these inverts. Wear on this invert again indicates that the North truck of the bridge has dropped and is riding lower to the floor.

Examples of wear on bottom land of cog track (inverts of cog track teeth). Wear pattern is not consistent from invert to invert, but the majority of inverts are worn to varying degrees

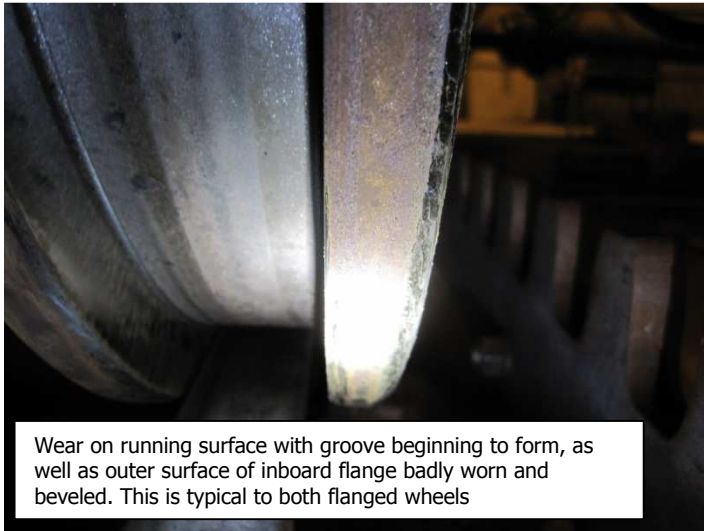
- Both of the flanged wheels appear to be significantly worn on the running surface, to the point where a groove is beginning to form.
- On both wheels, the outer surface of the inboard flange is badly beveled and worn at the rim, and appears to be making contact with the upper edge of the splice plates, the heads of the splice bolts, and the rail clip mounting hardware, in certain locations.
- On both wheels, the inner surface of both the inboard and outboard flange is significantly worn. At the rim, it is flat and sharp, with no bevel whatsoever. At the inner rim of the flange, there is no fillet left between the inner surface of the flange and the running surface.

Wear on running surface with groove beginning to form, as well as outer surface of inboard flange badly worn and beveled. This is typical to both flanged wheels

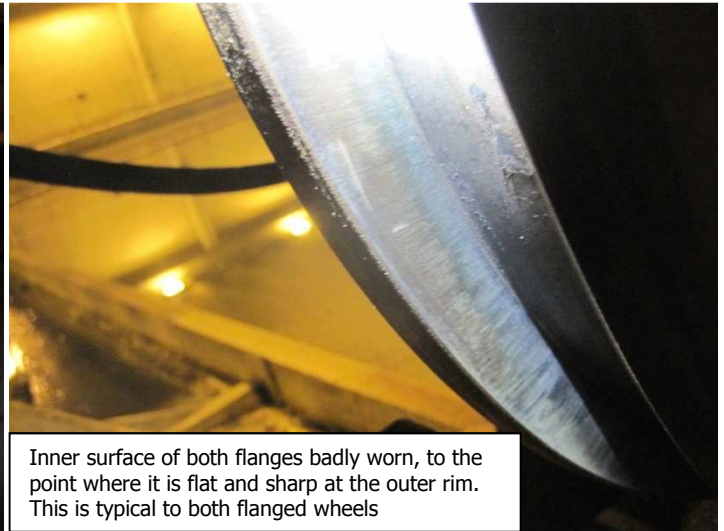
Inner surface of both flanges badly worn, to the point where it is flat and sharp at the outer rim. This is typical to both flanged wheels

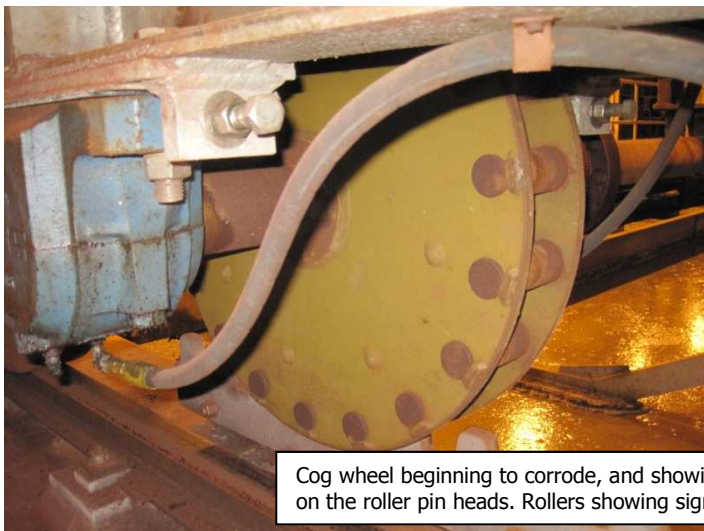
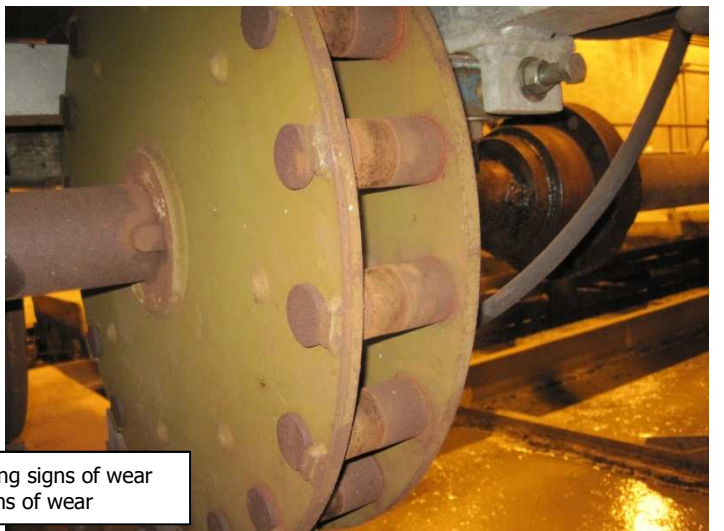
- The cog wheel has begun to corrode.
- The rollers on the cog wheel are showing some wear.
- Most still spin freely, but some appeared to be bound up. We were unable to access them all to test them for binding.

Cog wheel beginning to corrode, and showing signs of wear on the roller pin heads. Rollers showing signs of wear

- Both North and South cog wheels should be replaced. Once again, Ovivo recommends replacement of these as complete assemblies – wheels, axles and bearings. At an absolute minimum, the cog wheel pins and rollers should be replaced.

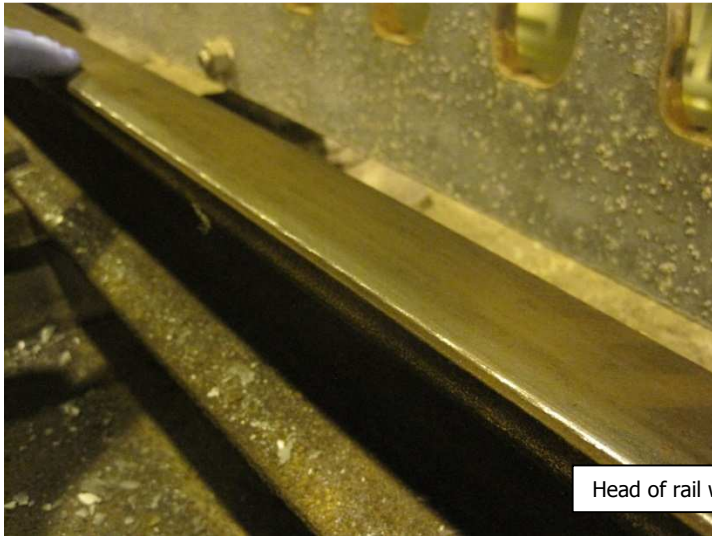
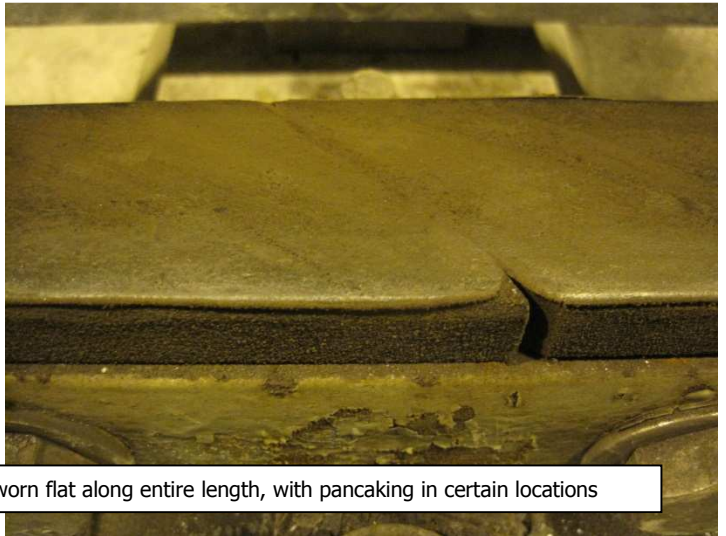
- Similar to the North rail, the head of the rail is worn flat along nearly its entire length.
- In a number of sections, the head of the rail has pancaked and the overlay has begun to delaminate.
- The rail splice plates and heads of the splice bolts are not worn, nor is any of the rail clip mounting hardware. This is as-expected, as the wheel on the South truck is not flanged.

Head of rail worn flat along entire length, with pancaking in certain locations

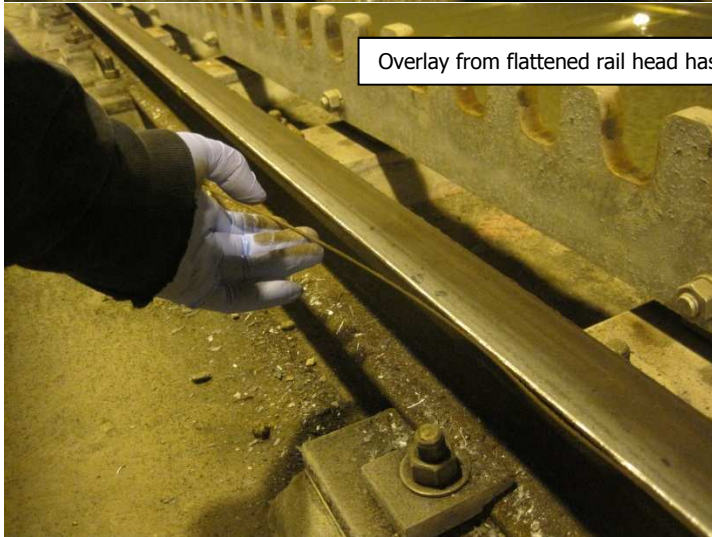
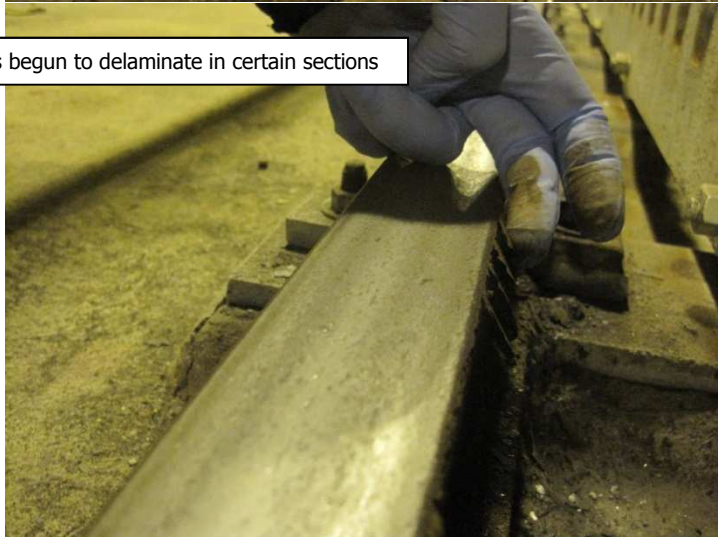
Overlay from flattened rail head has begun to delaminate in certain sections

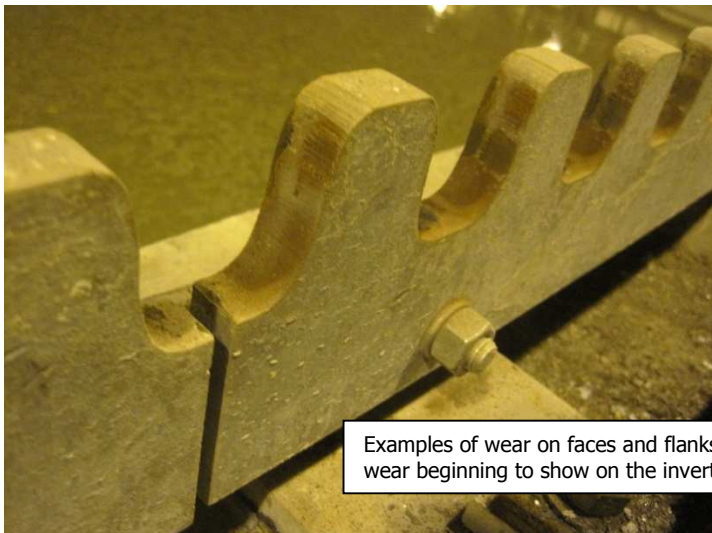
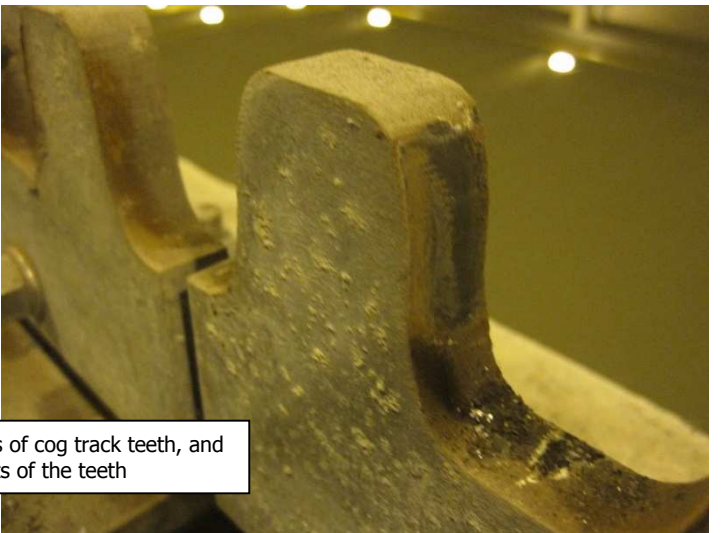
- The South cog track is in similar condition to the North cog track, but the extent of wear does not appear to be quite as bad.
- The majority of the cog track teeth have begun to show minor wear on the tooth faces and flanks.
- In some locations, wear was noticed on the bottom land of the cog track (on inverts of the teeth).

Once again, the flattened nature of the head of the rail, and the wear showing on the inverts of the teeth on the cog track, indicate that the South truck has also 'dropped', and is now riding closer to the floor, though maybe not to the same extent as the North truck.

Examples of wear on faces and flanks of cog track teeth, and wear beginning to show on the inverts of the teeth

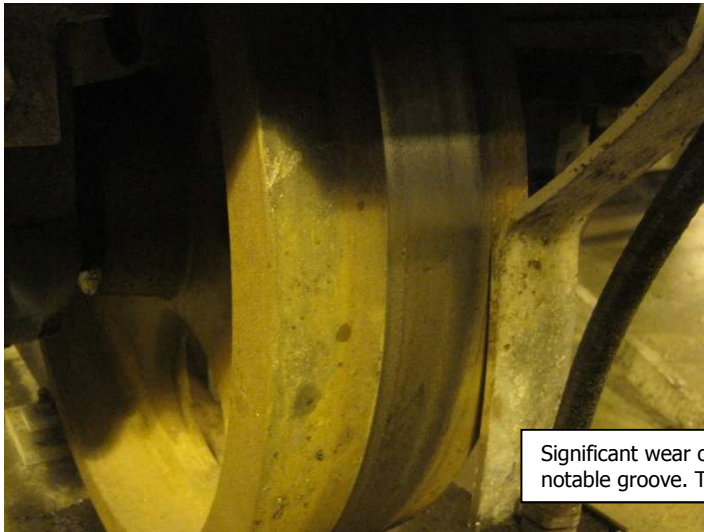
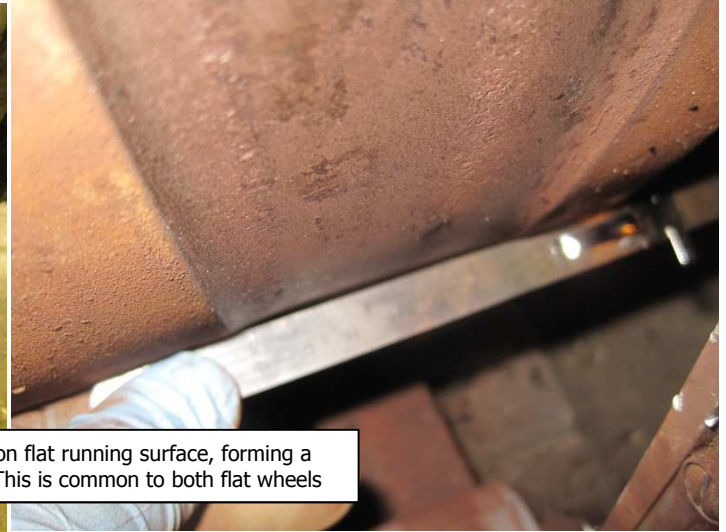
- Both of the flat running wheels on the South truck are worn badly on the flat running surface. On each wheel, a significant groove has formed.
- The wear does not appear to be travelling side-to-side along the running surface of the wheel, indicating that the bridge is travelling relatively straight (no alignment issues).

Significant wear on flat running surface, forming a notable groove. This is common to both flat wheels

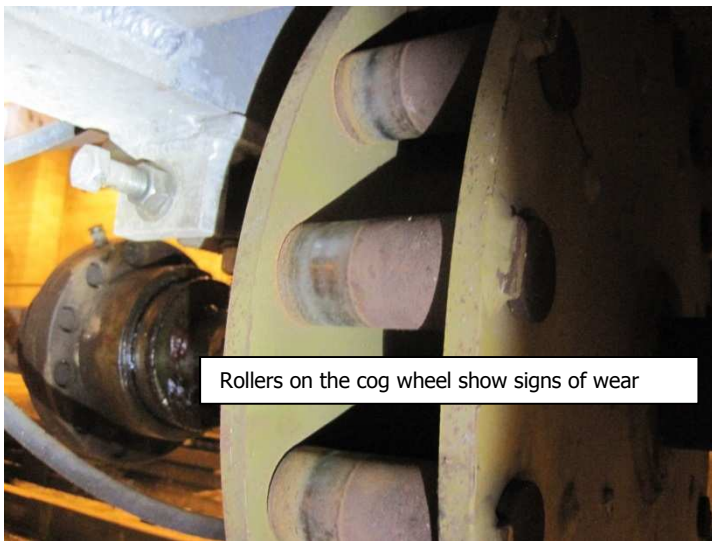
- The rollers on the cog wheel are showing some wear.
- Most still spin freely, but we were unable to access them all to test them for binding.

Rollers on the cog wheel show signs of wear

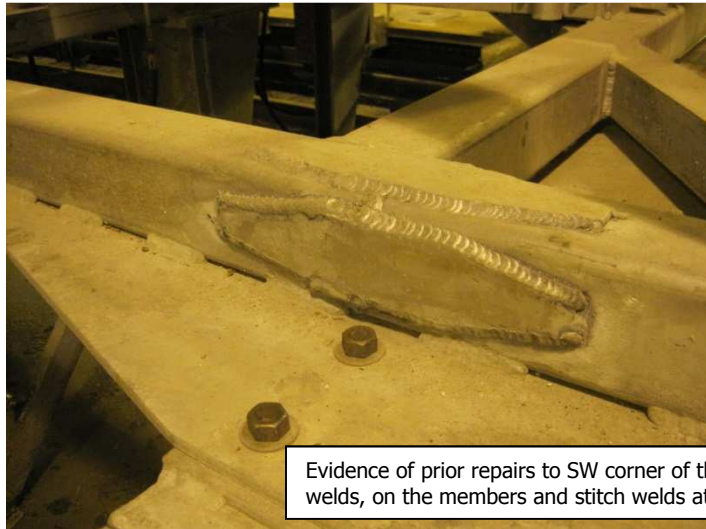
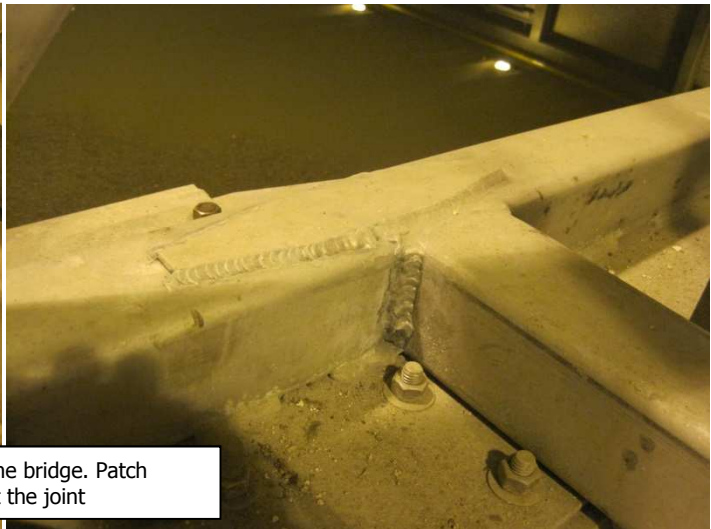
- It is evident that the south-west corner of the bridge has had some prior repair. Structural members have been patch-welded in this area, and stitch welded at the joint. This south-west corner appears to be only location with patch welds.

Evidence of prior repairs to SW corner of the bridge. Patch welds, on the members and stitch welds at the joint

- NDT testing should be performed on the bridge structure by a third party, to confirm its structural integrity.

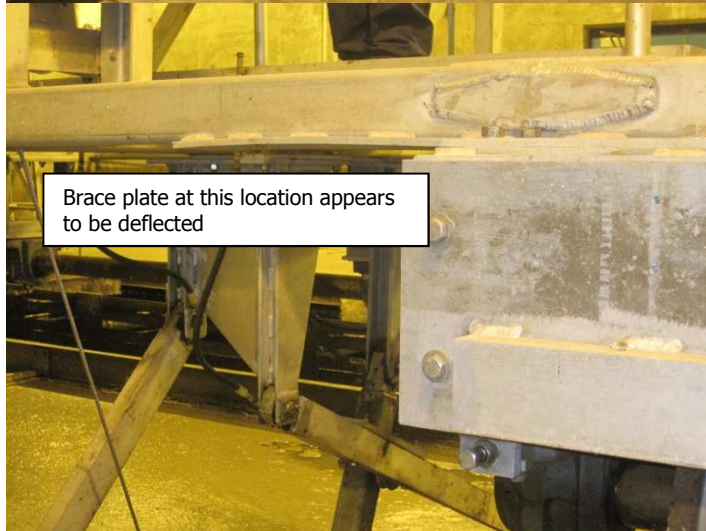
- In the same south-west corner of the bridge, the brace plate (where the bridge structure bolts to the South truck) appears to be showing some deflection.

Brace plate at this location appears to be deflected

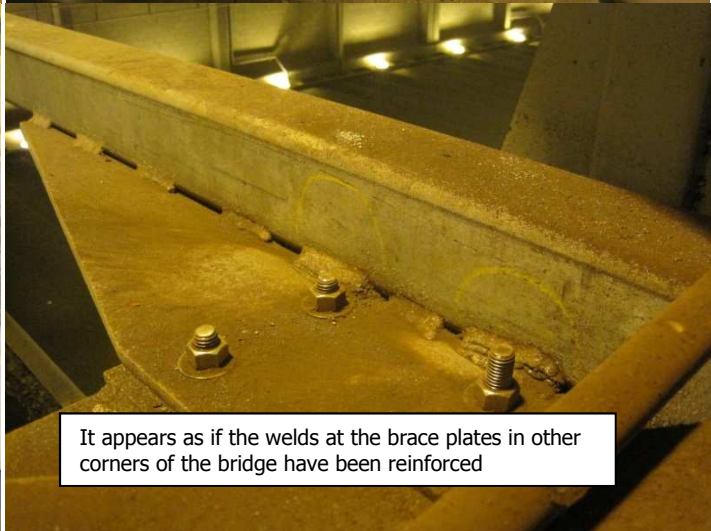
- In some other locations, it appears as if some welded joints have been re-welded, and that the brace plate welds in other corners of the bridge have been reinforced.

It appears as if the welds at the brace plates in other corners of the bridge have been reinforced

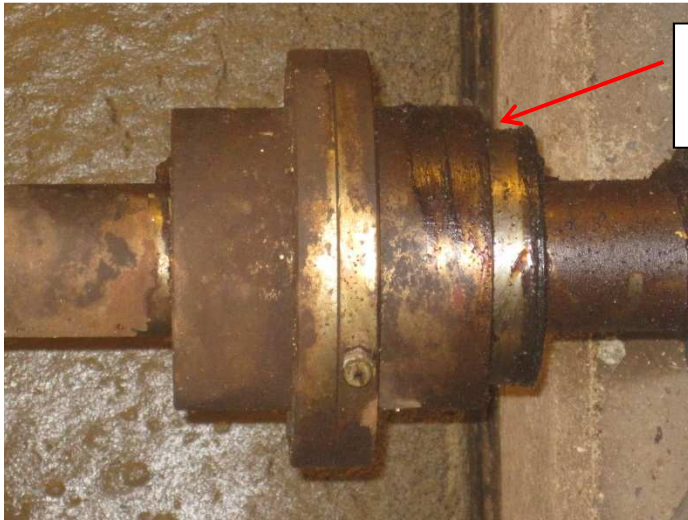
Wally informed me that they grease the pillow block bearings monthly as part of their PM regime. From the bridge above, on two or three of the drive line shaft couplings, it appears as if the coupling cover has moved on the coupling body, but that may not indeed be the case – the coupling halves may be machined differently. It does not appear as if the couplings are walking on the shaft, as the telltale sign of a shiny exposed surface on the shaft where the coupling has walked from does not appear to be present when viewed from the bridge above.

Example of drive line shaft coupling where the coupling cover appears to have moved on the coupling body. This appears to be typical to two or three of the couplings along the length of the line shaft.

Regarding the line shaft couplings in question, the couplings in question should be taken apart for an inspection of the internals. If the customer’s O&M manual has a coupling data sheet, this should be referred to, in order to identify any discrepancies between couplings.
