## **AJP Engineering Services**

**Subject: *Structural Condition Assessment of Primary Clarifier Travelling Bridge Collector No. 3 at the South End Sewage Treatment Plant, Revision 0***

## INSPECTION REPORT

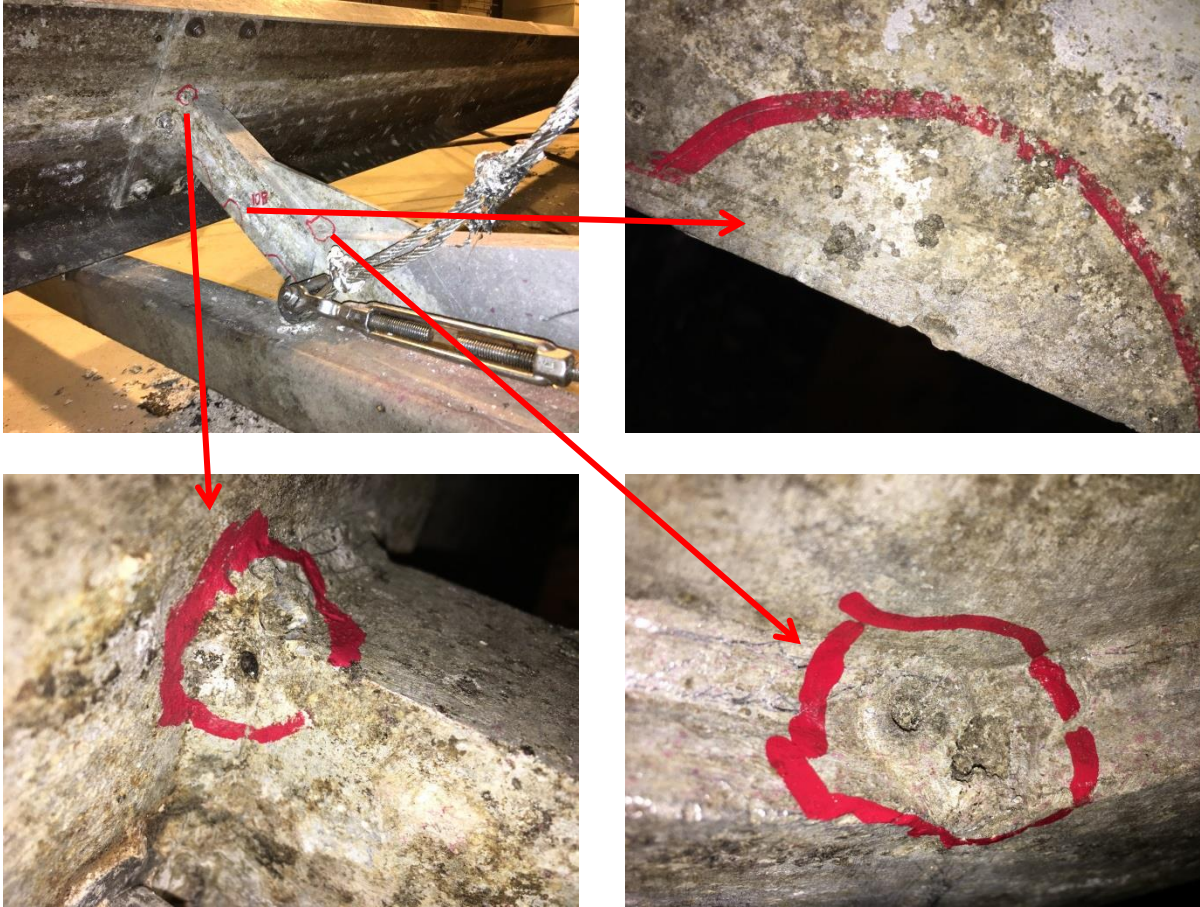
Figure 2: Skimmer Arm Corrosion

The front and rear skimmer arms have undergone extensive corrosion, affecting the main members and the welds at the elbow joint and the connection to the skimmer blade (Figure 2).

Due to the extensive corrosion, both front and rear skimmer arms should be replaced. This is not an immediate concern, but should be addressed within the next 3-5 years.

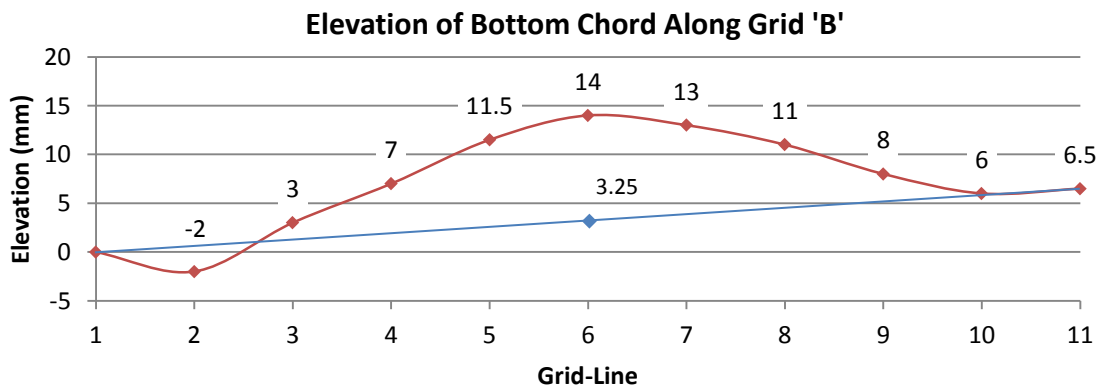
Figure 3: Bottom Chord Elevation

The elevation of the bottom chord along grid-line 'B' was taken using a self-levelling laser. The measurements are plotted in Figure 3

There is an elevation difference of 6.5mm (1/4") between the north and south sides of the bridge collector. The center of the bridge has deformed upwards approximately 10.75mm (7/16") relative to the theoretical straight line between the north and south end.

The 6.5mm difference in elevation between the north and south end-trucks probably did not contribute to the excessive wear or jerky motion, as this measurement was taken from the top of the end-trucks and not the rail. This may be an effect of the wear, rather than a cause.

After the rails are replaced, the top elevation of the end-trucks should be measured again to ensure that they are an equivalent height from their respective tracks and that they are level with respect to the horizontal plane. If they are not, then the wheels should be shimmed accordingly.

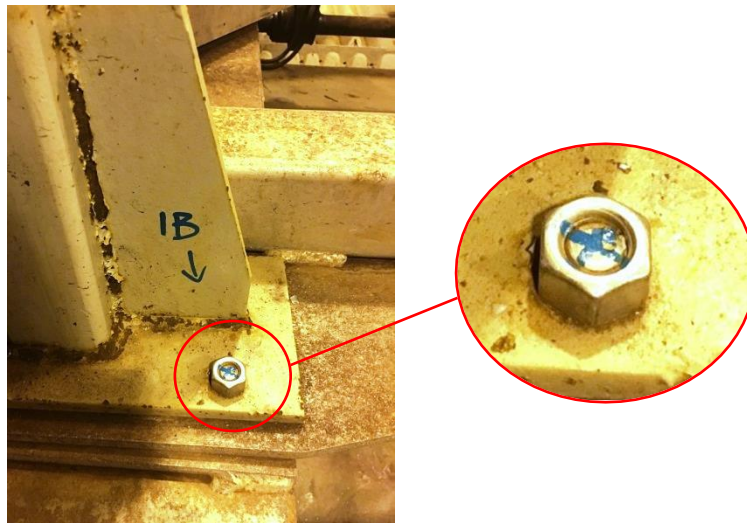
**Figure 4: Bolt with Inadequate Length**

A few of the bolts that connect the collector bridge to the end trucks were not long enough to bring the ends flush with the nut (Figure 4). This is a minimum requirement for structural bolts.

All bolts that are not long enough to be flush with outside face of the nut should be replaced with longer bolts of the same diameter and grade.

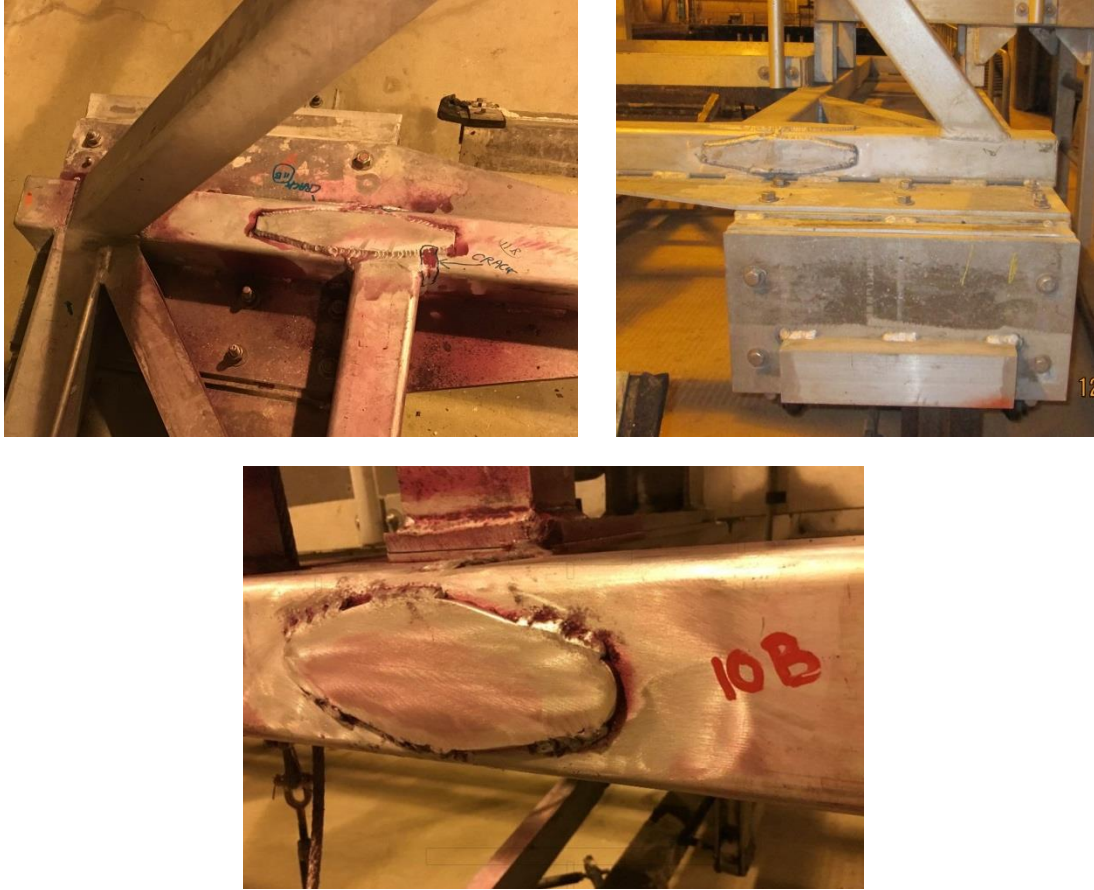
Figure 5: Field-Welded Plates

Three plates were field-welded to the bottom chord along grid 'B' on the south side of the bridge collector (Figure 5). Two were welded on the vertical and horizontal faces of the chord near grid 11. The other one was welded on the vertical face near grid 10.

The field-welded plates on the bottom chord along grid 'b' (Figure 5) should be removed and re-inspected to determine the reason that they were installed. Based on this information, an appropriate solution for reinforcement should be determined by a qualified professional engineer.

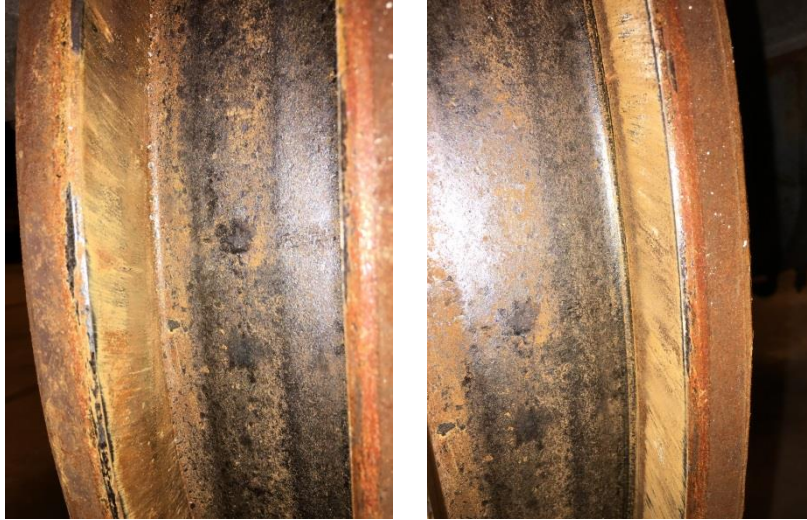
Figure 6: Wear on North End-Truck Wheels

On the north end-truck wheels, significant wear was observed on the interior radii where the flanges meet the bearing surface (Figure 6). One side had substantially more wear than the other. Significant wear was also noticed on the interior side of the top flange on the north rail, starting at the bridge collector's in-service position on the west side of the clarifier (Figure 7). On the south end-truck, approximately 2mm of wear was measured on the non-flanged wheels.

Dan Carriere also posited that the groove on the south end-truck wheels (caused by the wear) may be preventing the wheels from floating. These wheels do not have a flange and are intended to move freely in order to relieve horizontal forces from the rail. The groove may be causing friction and additional stresses on the south rail.

The City of Winnipeg has indicated that it intends to replace the rails, wheels cog-track and cog-wheels in the near future. Installation of the new rails should conform to tolerances specified in the original construction drawings.

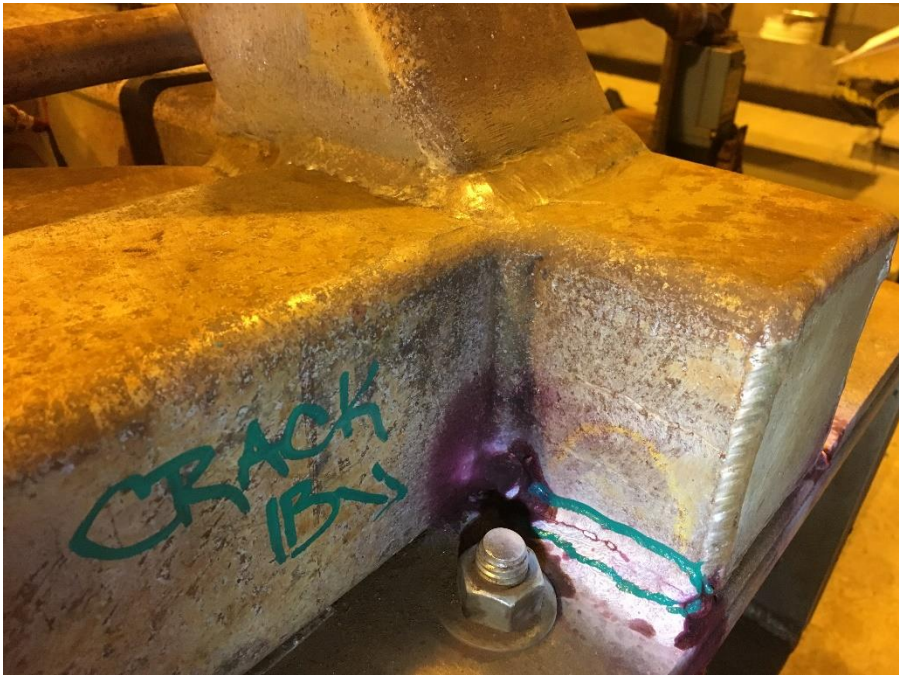
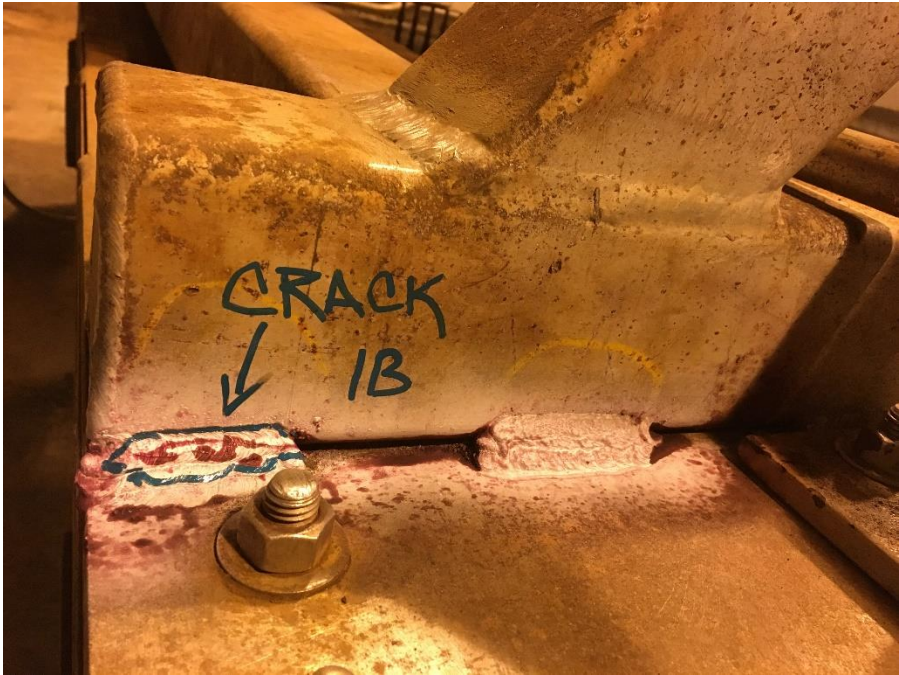
- 1. Location 1B – Cracked weld on both sides of lower horizontal tube.*
  - 2. Location 1B – Cracked weld on end truck bearing mount weld.*
  - 3. Location 1B – Lack of fusion on reinforcement plate weld.*

Crack at location 1B

All issues identified in the CQI report should be addressed. Welds should be repaired by a CWB certified welder with appropriate credentials for aluminum welding. The missing weld on grid 9A on the upper tube should be added.

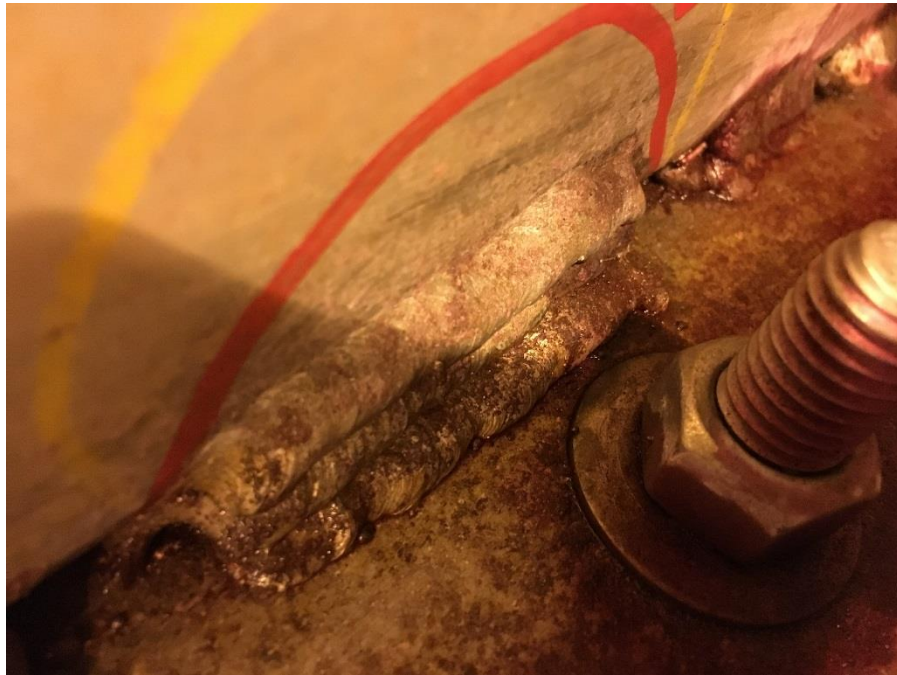
*Lack of weld fusion on repair weld at location 1B*

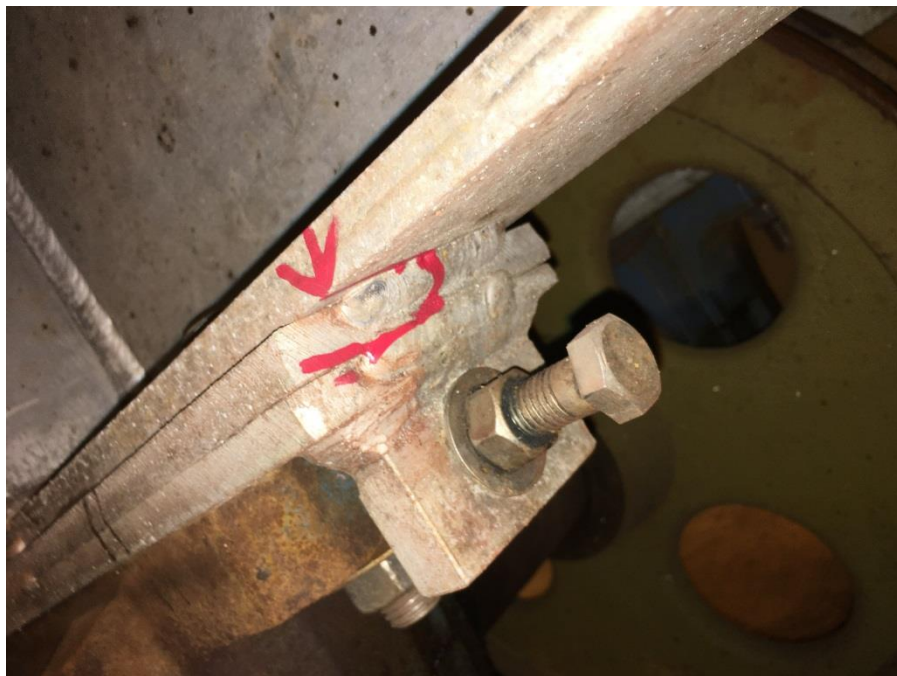
*Cracked bearing mount  
plate weld at location 1B*

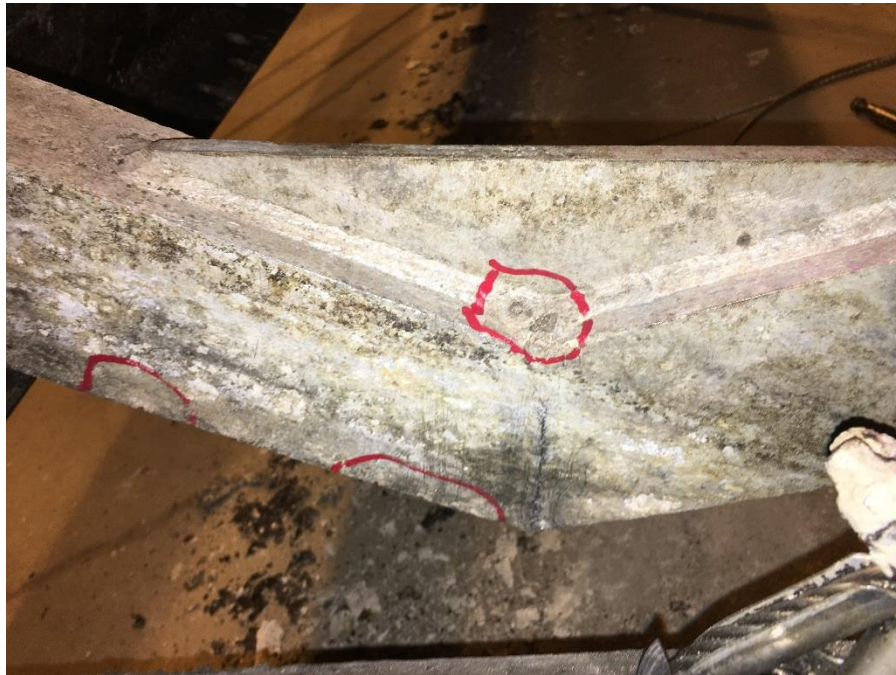
- 4. Location 1A – Cracked weld on lower horizontal weld.*
  - 5. Location 2B, 4B, 6B, 8B, 10B – Aluminum skimmer arm weld and material is corroded and pitted.*

*Photo showing pitted corrosion in scum paddle arm  
This is typical to all below water line aluminum members*

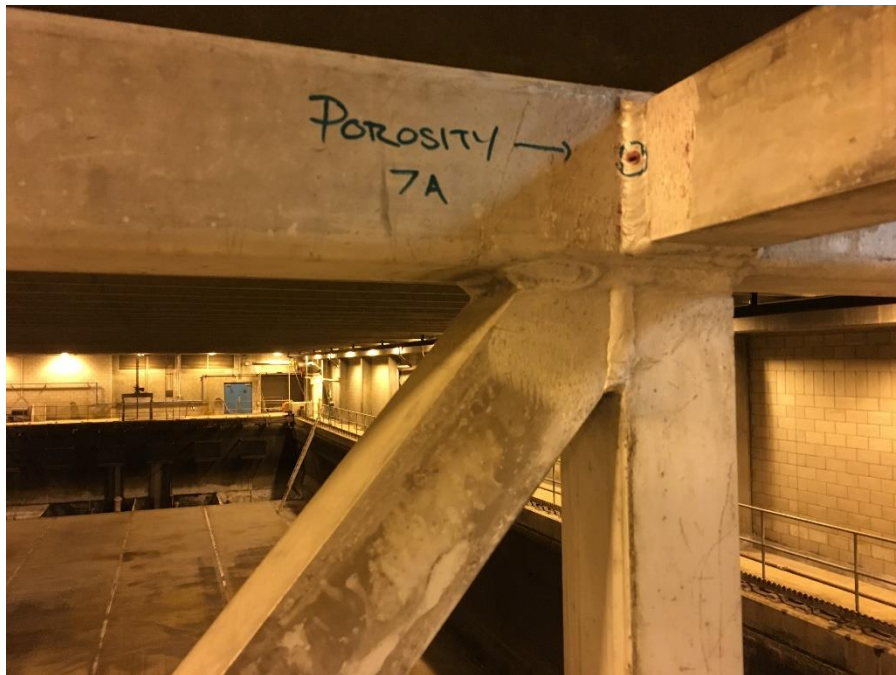
- 6. Location 7A – Porosity on upper horizontal tube weld, see photos.*
  - 7. Location 9A – Missing weld on upper horizontal tube, see photos.*
  - 8. Location 10A – Cracked welds on lower diagonal and horizontal tube.*

Porosity at location 7A

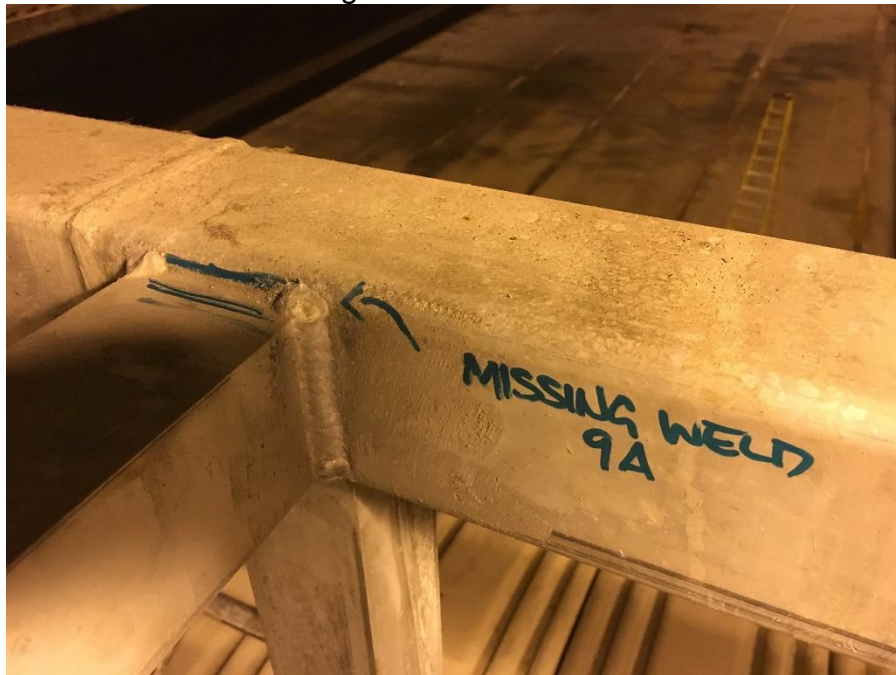
Missing Weld at location 9A

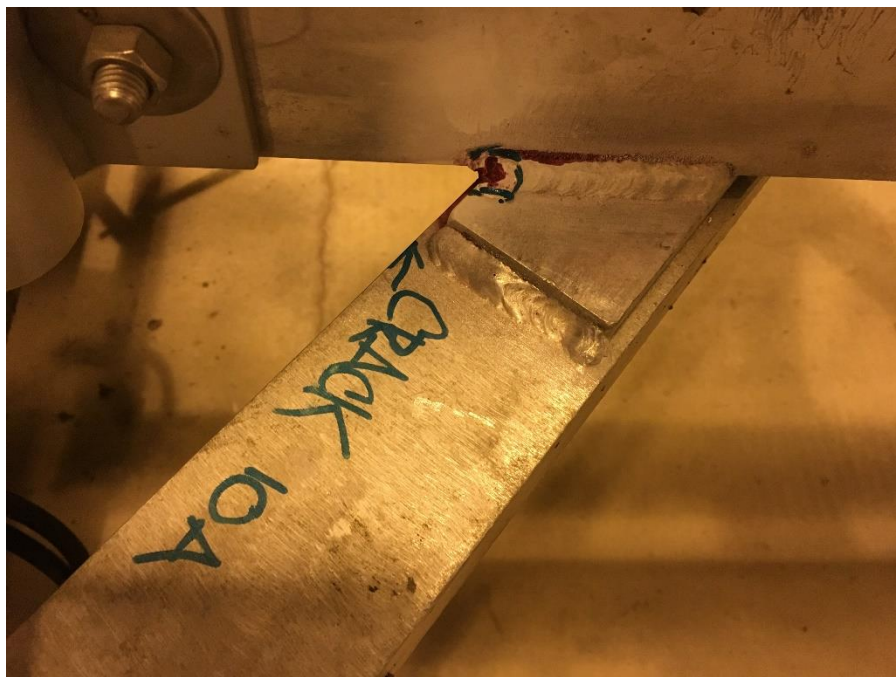
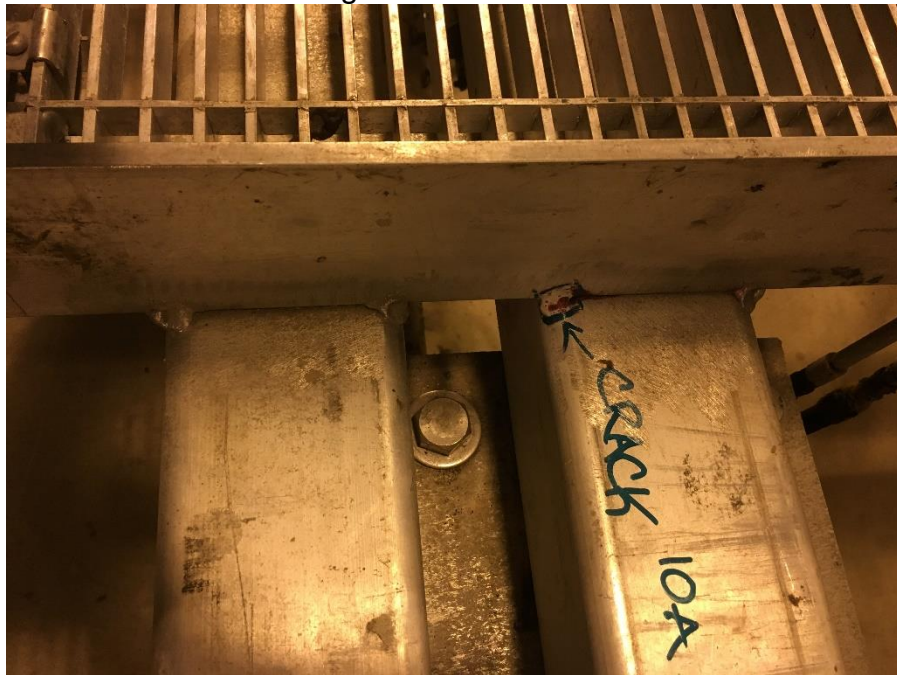
Crack at location 10A

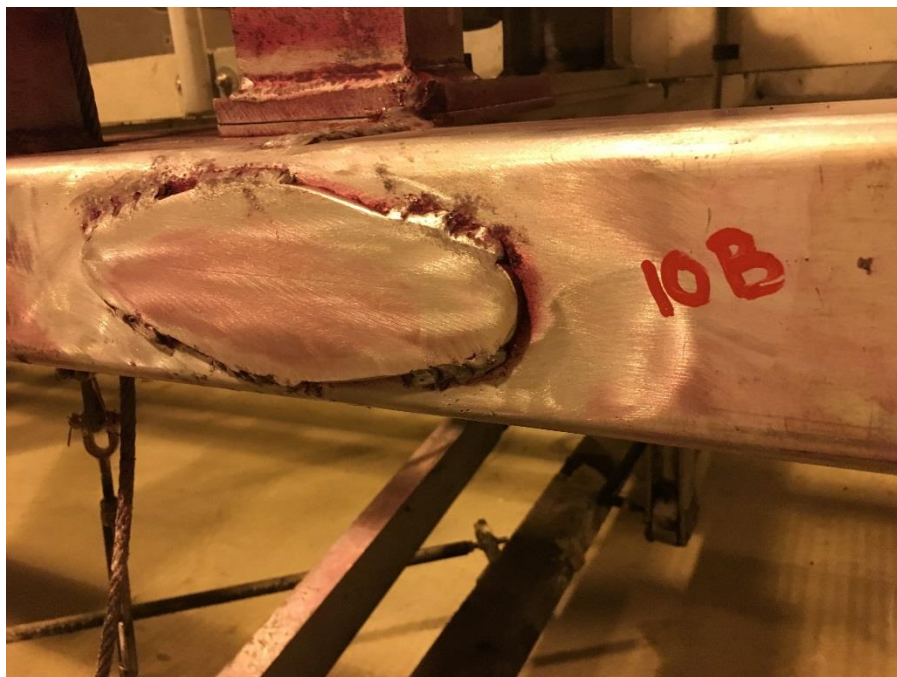
- 9. Location 10B – Fish plate weld quality is unacceptable*
  - 10. Location 11B -- Crack in parent material penetrating from fish plate.*
  - 11. Location 11B – Lack of fusion on fish plate weld.*

Photo of fish plate at location 10B. Poor weld quality

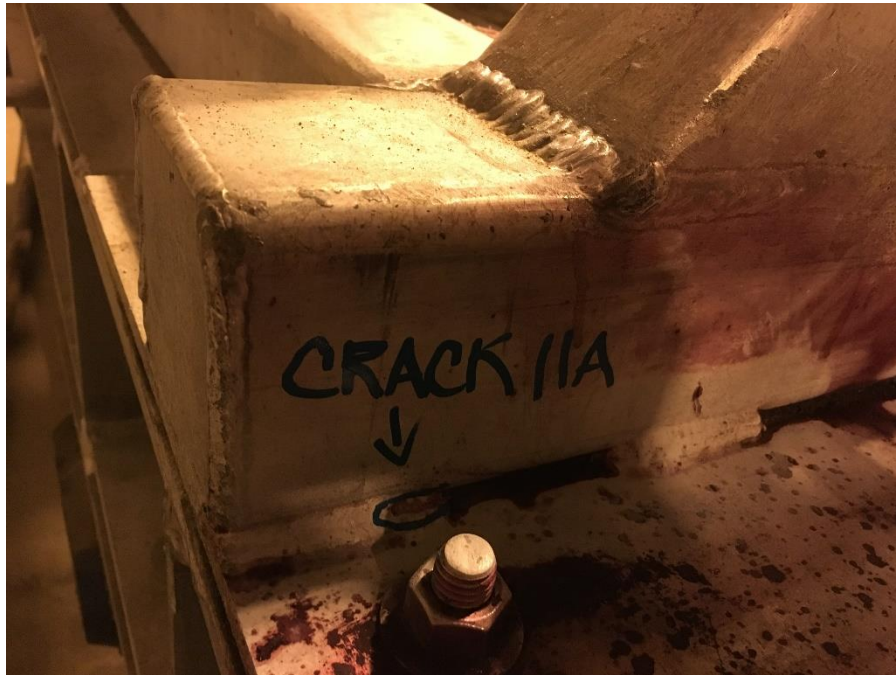
- 12. Location 11B – Cracked weld on lower horizontal tube.*
  - 13. Location 11A – Cracked weld on lower horizontal tube.*
-

Crack at location 11A

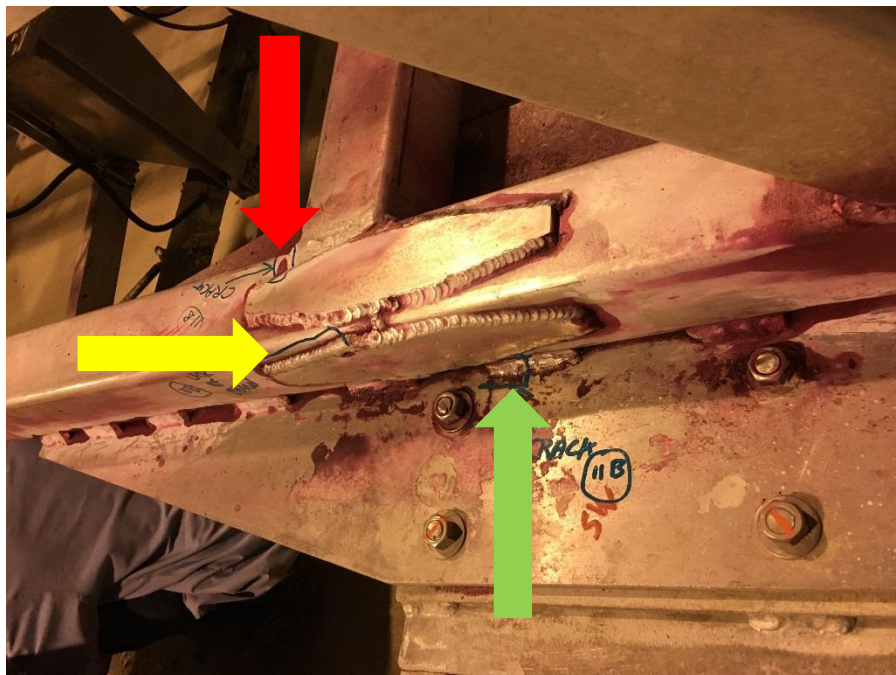
Photo of area 11B Red arrow shows location of crack in parent material yellow arrow shows lack of fusion on fish plate weld and green arrow shows crack on stitch weld. All at location 11B

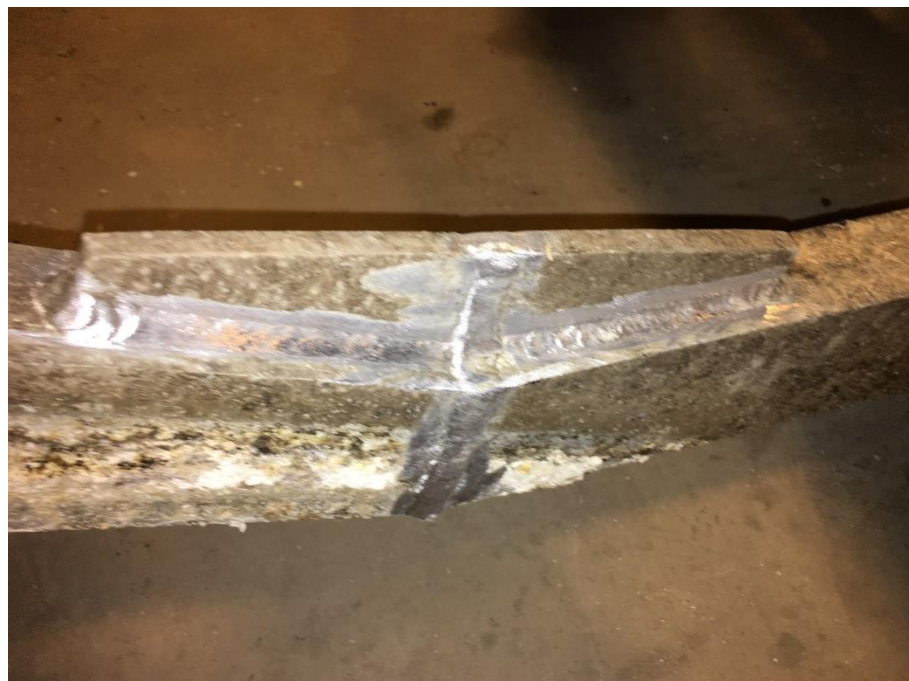
- *All welding was found to be acceptable.*
- *No damage or deformation was found on the above noted items and locations.*

**Photo showing general condition of welds on Skimmer Arms**
