GEOTECHNICAL REPORT

Regional Streets Renewal Projects – 2018 Program Geotechnical Report

0022-061-00

November 2, 2017

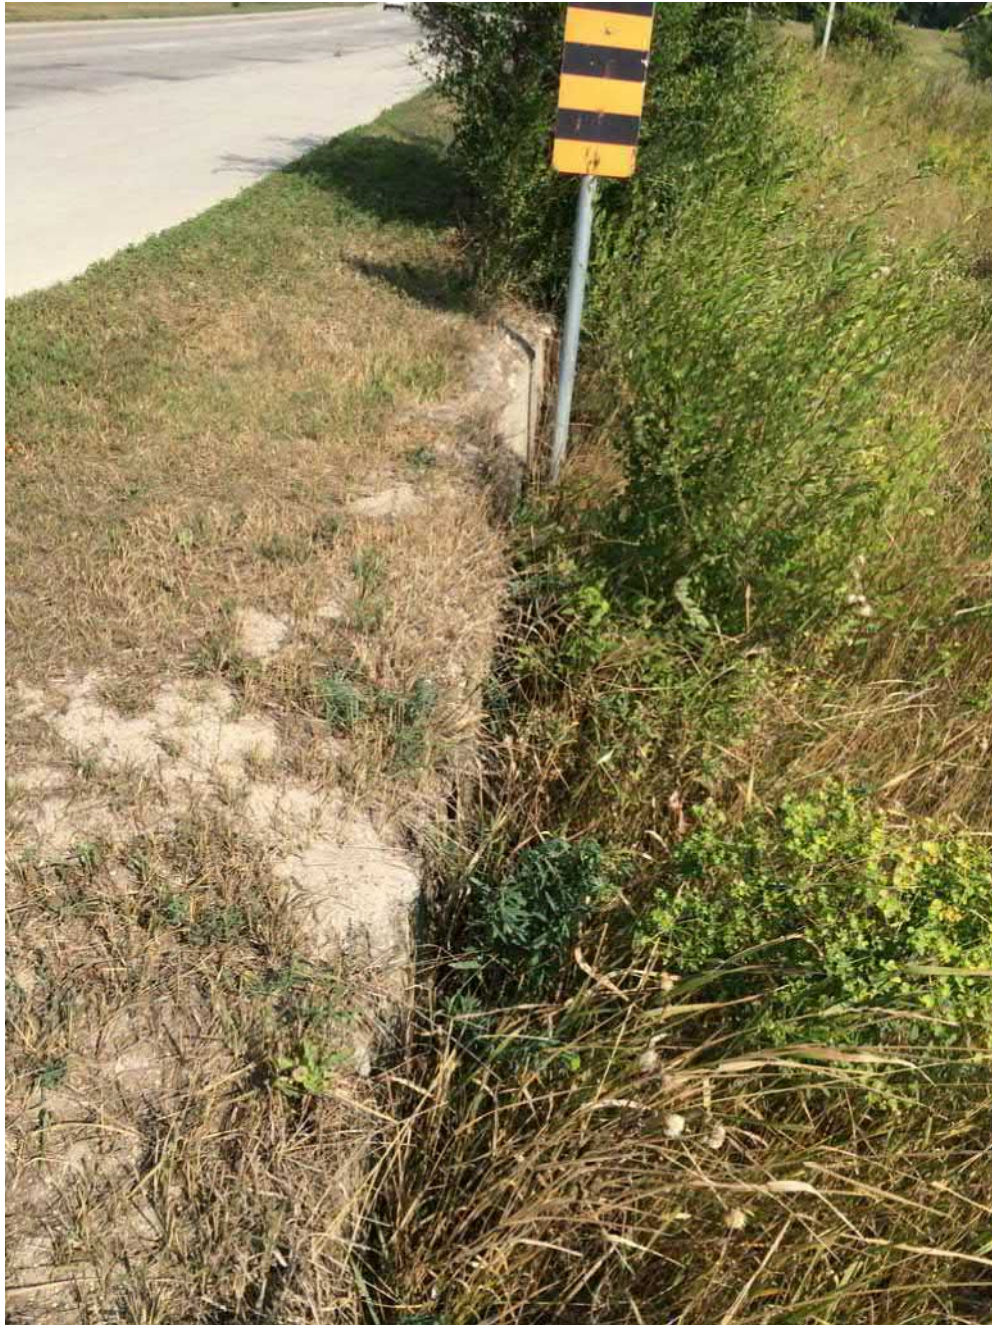
The top of the retaining wall is exposed along a short section of the upper bank where the soil in front of the wall has subsided by about 0.5 m (Photo attached); this is within the area where regrading was carried out following installation of the rockfill columns. The wall consists of H-Piles spaced at approximately 1.5 m and horizontal treated timber lagging. Based on available information, we believe the wall to be approximately 35 m long and 10 m deep. Although the tops of several piles are damaged and in some cases twisted, the lagging is intact and appears to be in good condition. The damage to the piles can likely be attributed to installation methods rather than slope movements. Aside from the noted subsidence, there is no visual evidence of active slope movements such as tension cracks, scarps or bulging downslope of the retaining wall or in the immediate upstream and downstream vicinity. Additionally, there was no indication of movements such as cracking or slumping of the ground behind the wall. It should be noted that vegetation on the site prevented a detailed examination. The current riverbank topography (based on a recent site survey by Dillon) is generally consistent with the final grading completed during riverbank stabilization works.

Subsidence of soil in front of retaining wall

The existing level of stability for the proposed pathway alignment is considered acceptable, and any change in FS associated with its construction is inconsequential to bank stability. However, placement of clay fill in front of the retaining wall to the sidewalk level will result in a 4% reduction in stability in an area where previous failures have occurred (Cross-section B) and where some continued horizontal ground displacements are continuing to occur farther downslope. For these reasons, it is recommended that light weight fill, such as wood chips, be used to restore grades in front of the retaining wall, or that no fill be placed and a guard rail installed for safety reasons along the top of the wall where the subsidence has occurred. In consideration of the overall geometry of the potential slip surface, the small additional load associated with this amount of fill is not considered to be of any consequence in overall bank stability. If any additional future subsidence occurs, it may be necessary to place additional light weight fill to re-establish grades.

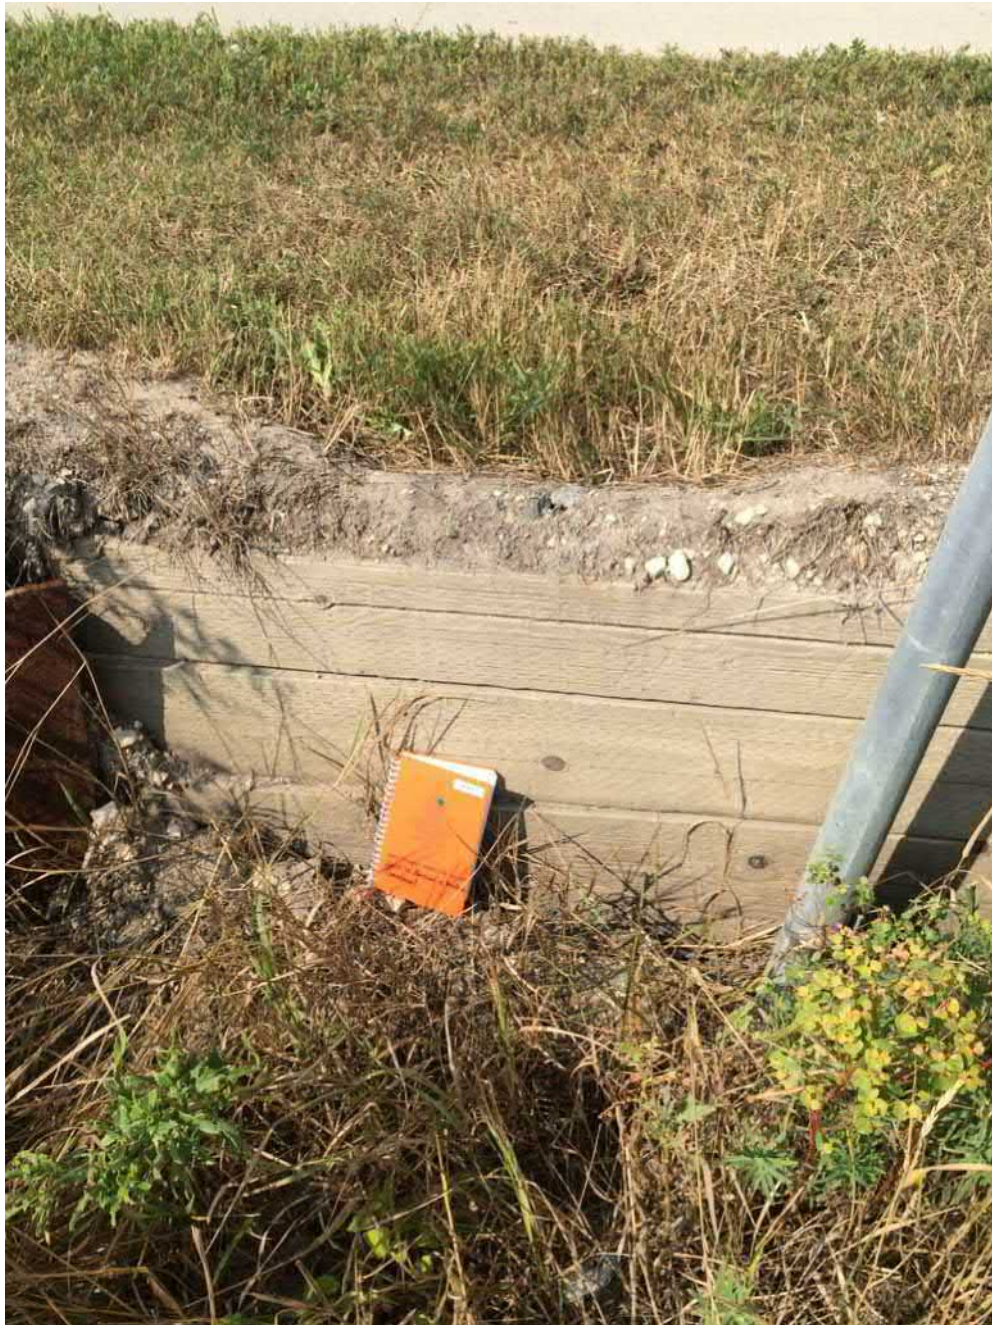
Subsidence of soil in front of retaining wall

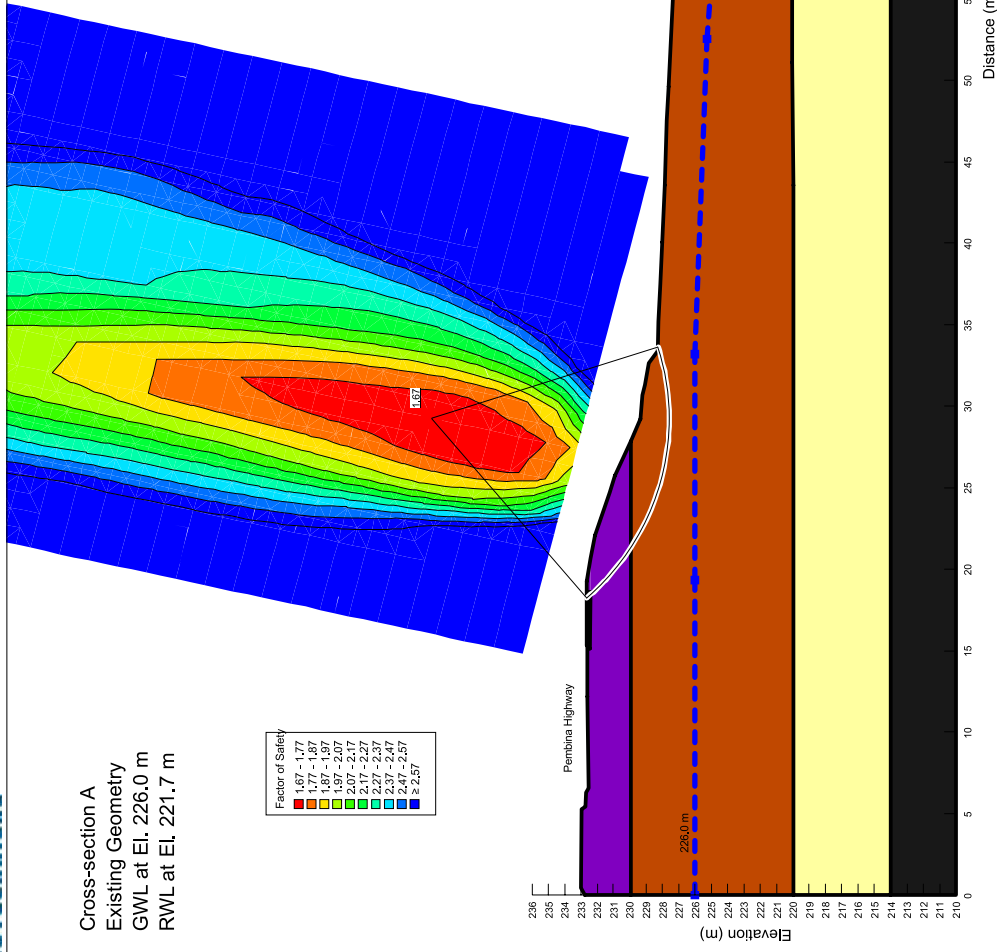
Cross-section A
 Existing Geometry
 GWL at El. 226.0 m
 RWL at El. 221.7 m

| Location | Calculated Factor of Safety | | |
|---|---|---|---|
| Cross-Section A | 1.67 | 1.65 | Not Applicable |

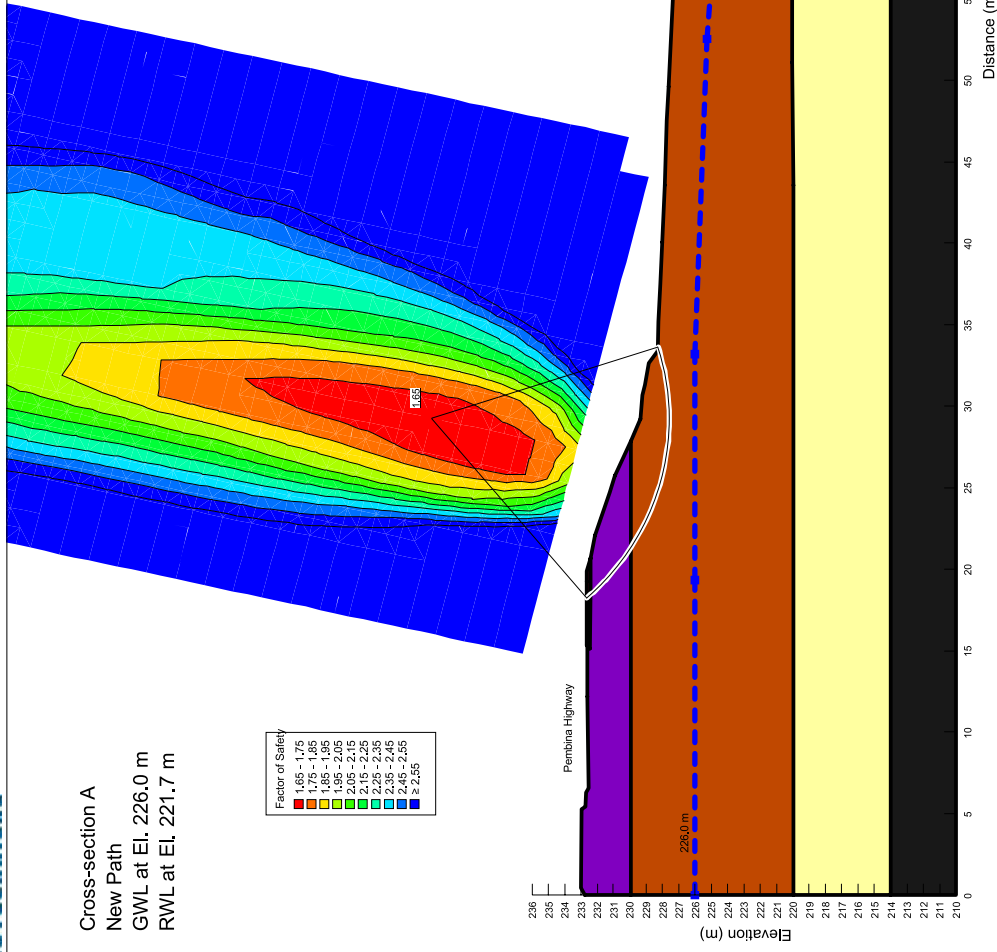
Cross-section A
 New Path
 GWL at El. 226.0 m
 RWL at El. 221.7 m

The placement of the pathway at all cross-sections results in a negligible reduction of FS. Clay fill placement at Cross-section B, results in a 4% reduction of FS.

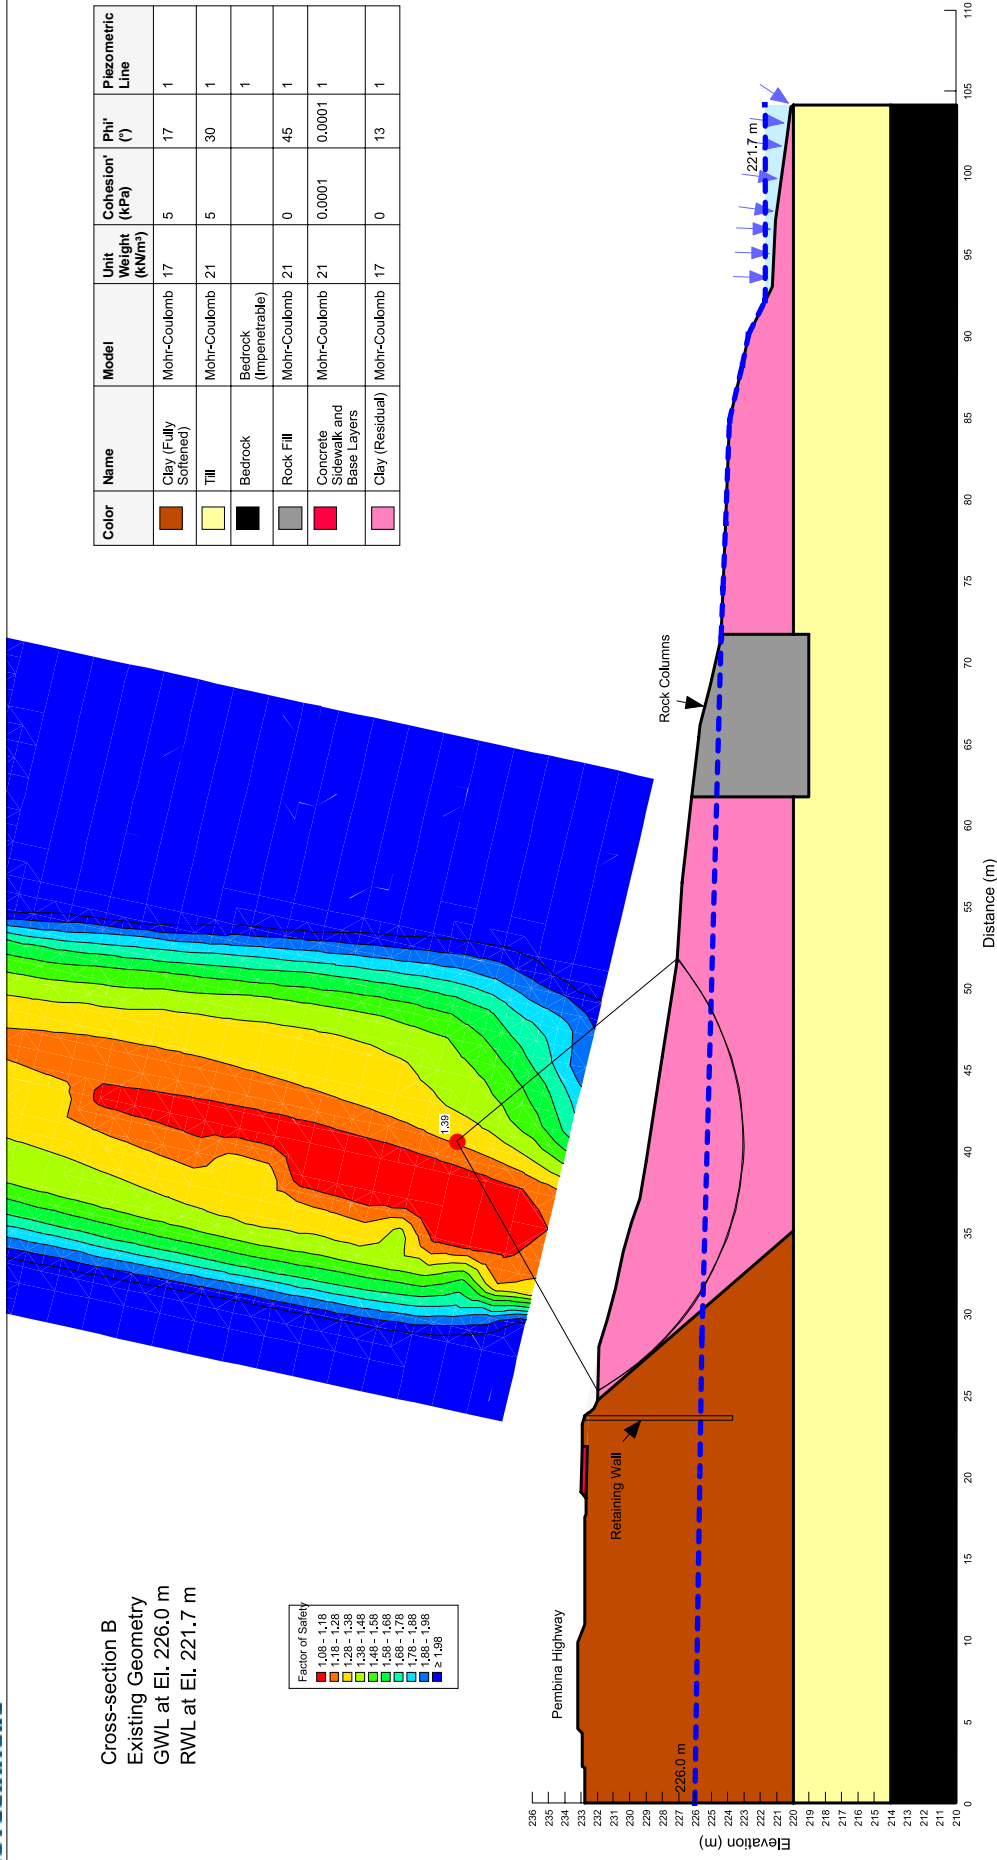
Cross-section B
Existing Geometry
GWL at El. 226.0 m
RWL at El. 221.7 m

| Location | Calculated Factor of Safety | | |
|---|---|---|---|
| Cross-Section B (downslope of retaining wall) | 1.39 | 1.39 | 1.35 |

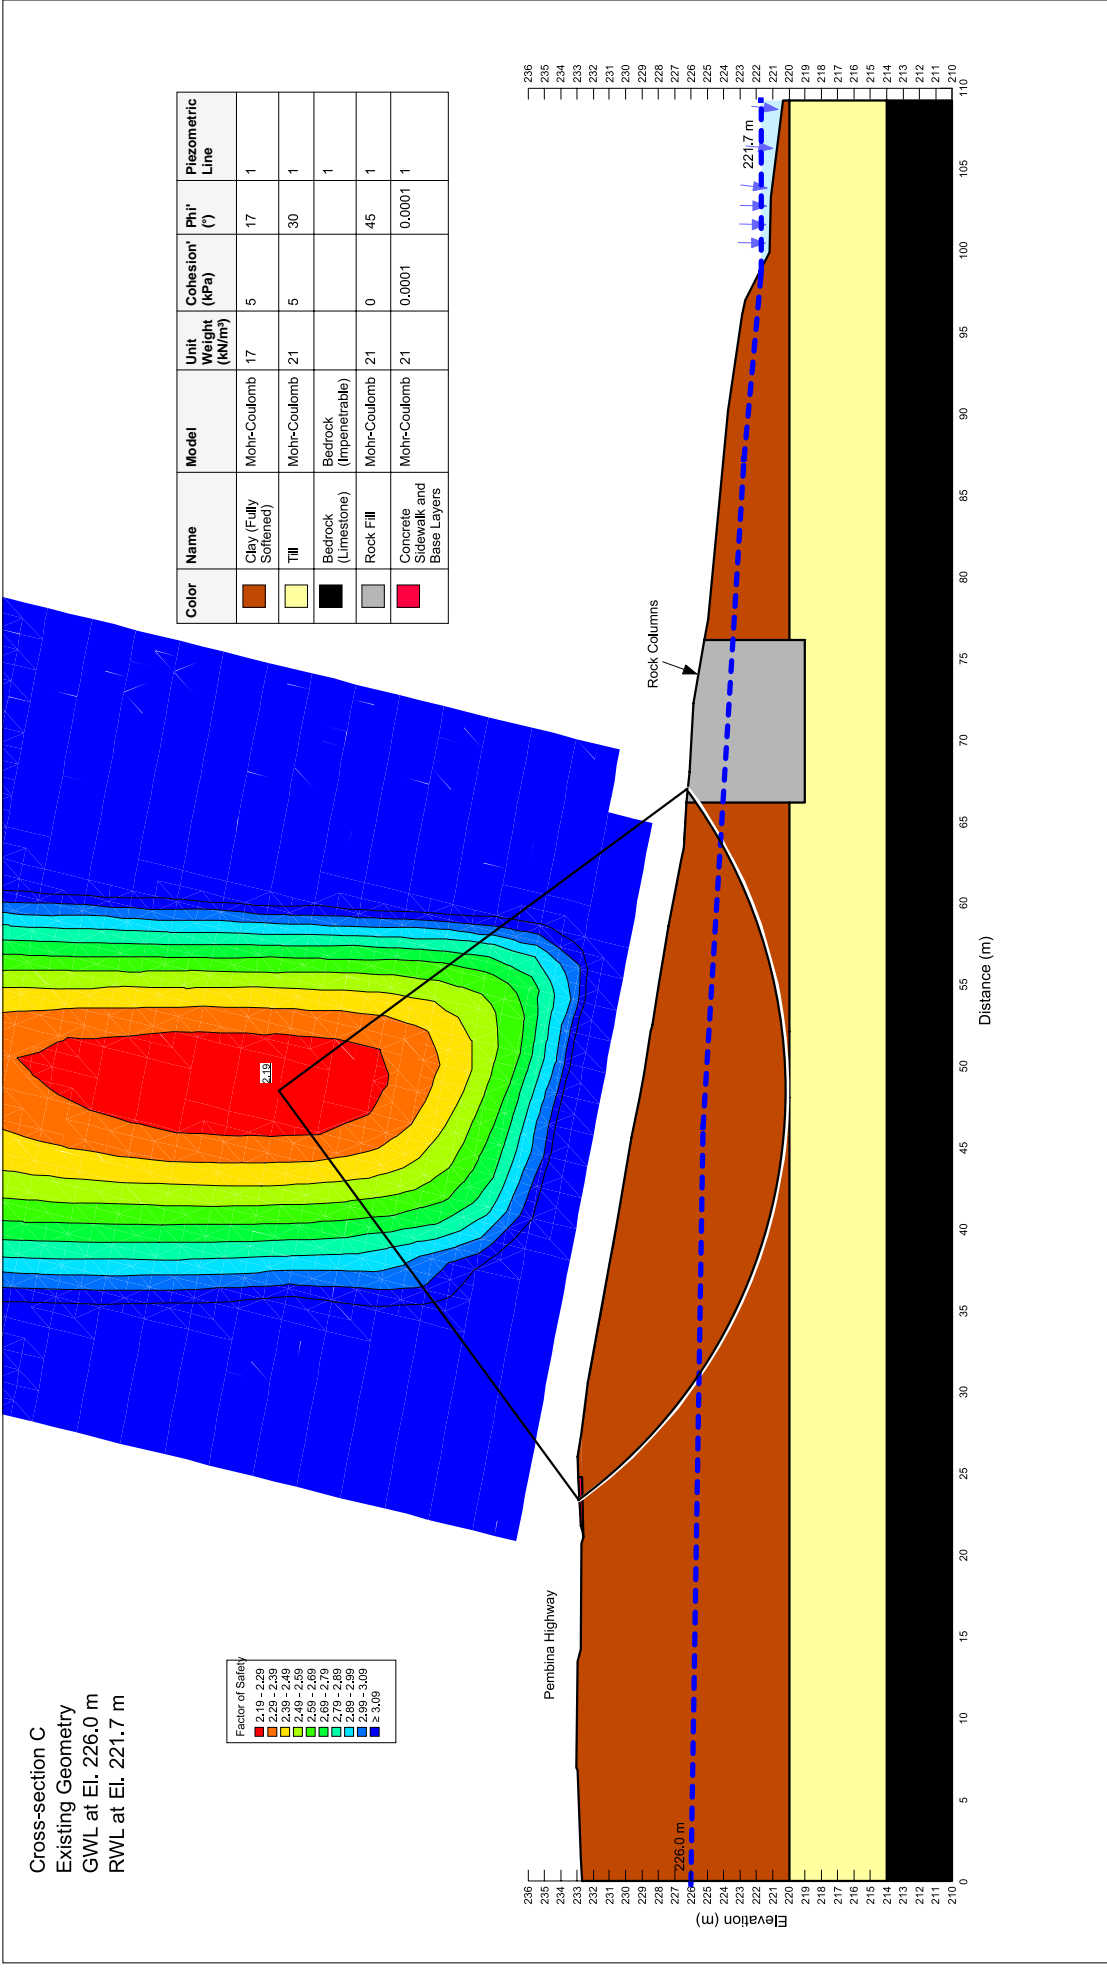
Cross-section C
 Existing Geometry
 GWL at El. 226.0 m
 RWL at El. 221.7 m

| Location | Calculated Factor of Safety | | |
|---|---|---|---|
| Cross-Section C | 2.19 | 2.19 | Not Applicable |
