ASBESTOS INVENTORY CONTROL

Building Name:	Canada Post Tower	Inspection Date:	June 28, 2018
Building Code:	LO-11	Inspected By:	Will Deller & Ryan Matthews
Building Address:	266 Graham Avenue	Construction Date:	1965

ASBESTOS LOCATIONS			
BUILDING:	LO-11 CANADA POST TOWER 266 GRAHAM AVENUE WINNIPEG, MANITOBA		
REVISED BY:	DATE:	SCALE:	SHEET #:
REM	JUNE 11, 2018	N.T.S.	1/2

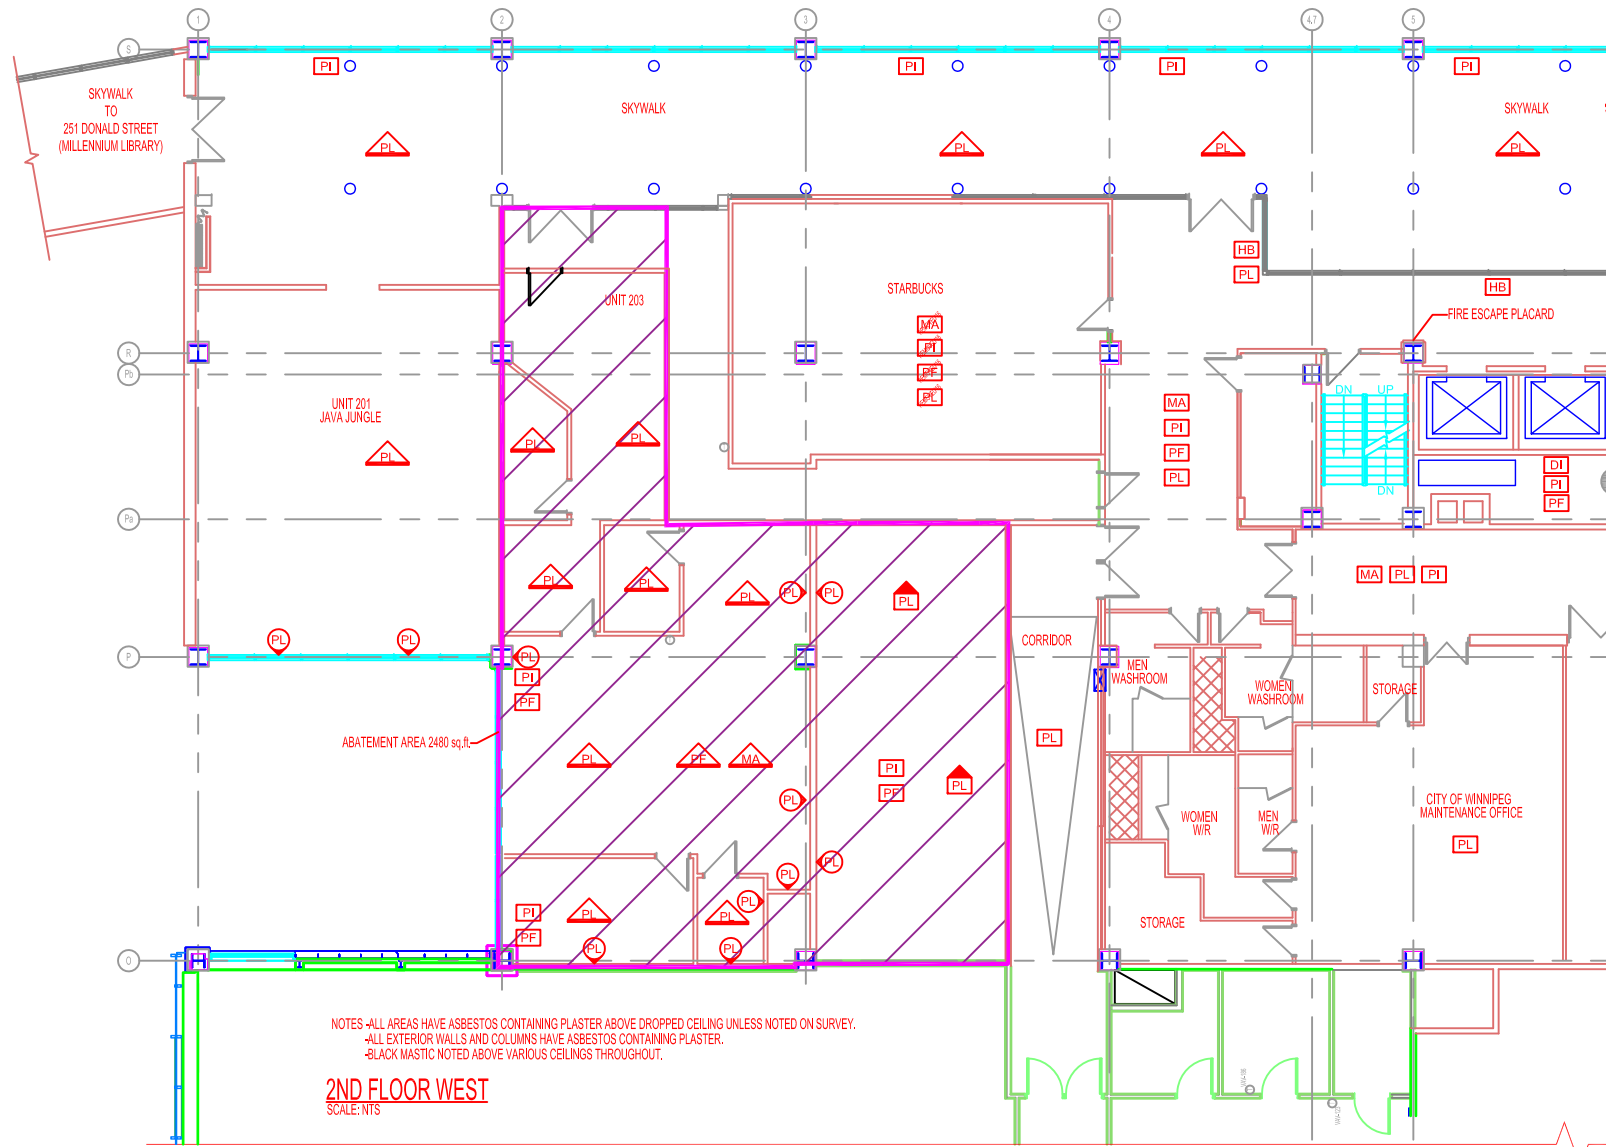
2ND FLOOR WEST
 SCALE: NTS

NOTES -ALL AREAS HAVE ASBESTOS CONTAINING PLASTER ABOVE DROPPED CEILING UNLESS NOTED ON SURVEY.
 -ALL EXTERIOR WALLS AND COLUMNS HAVE ASBESTOS CONTAINING PLASTER.
 -BLACK MASTIC NOTED ABOVE VARIOUS CEILINGS THROUGHOUT.

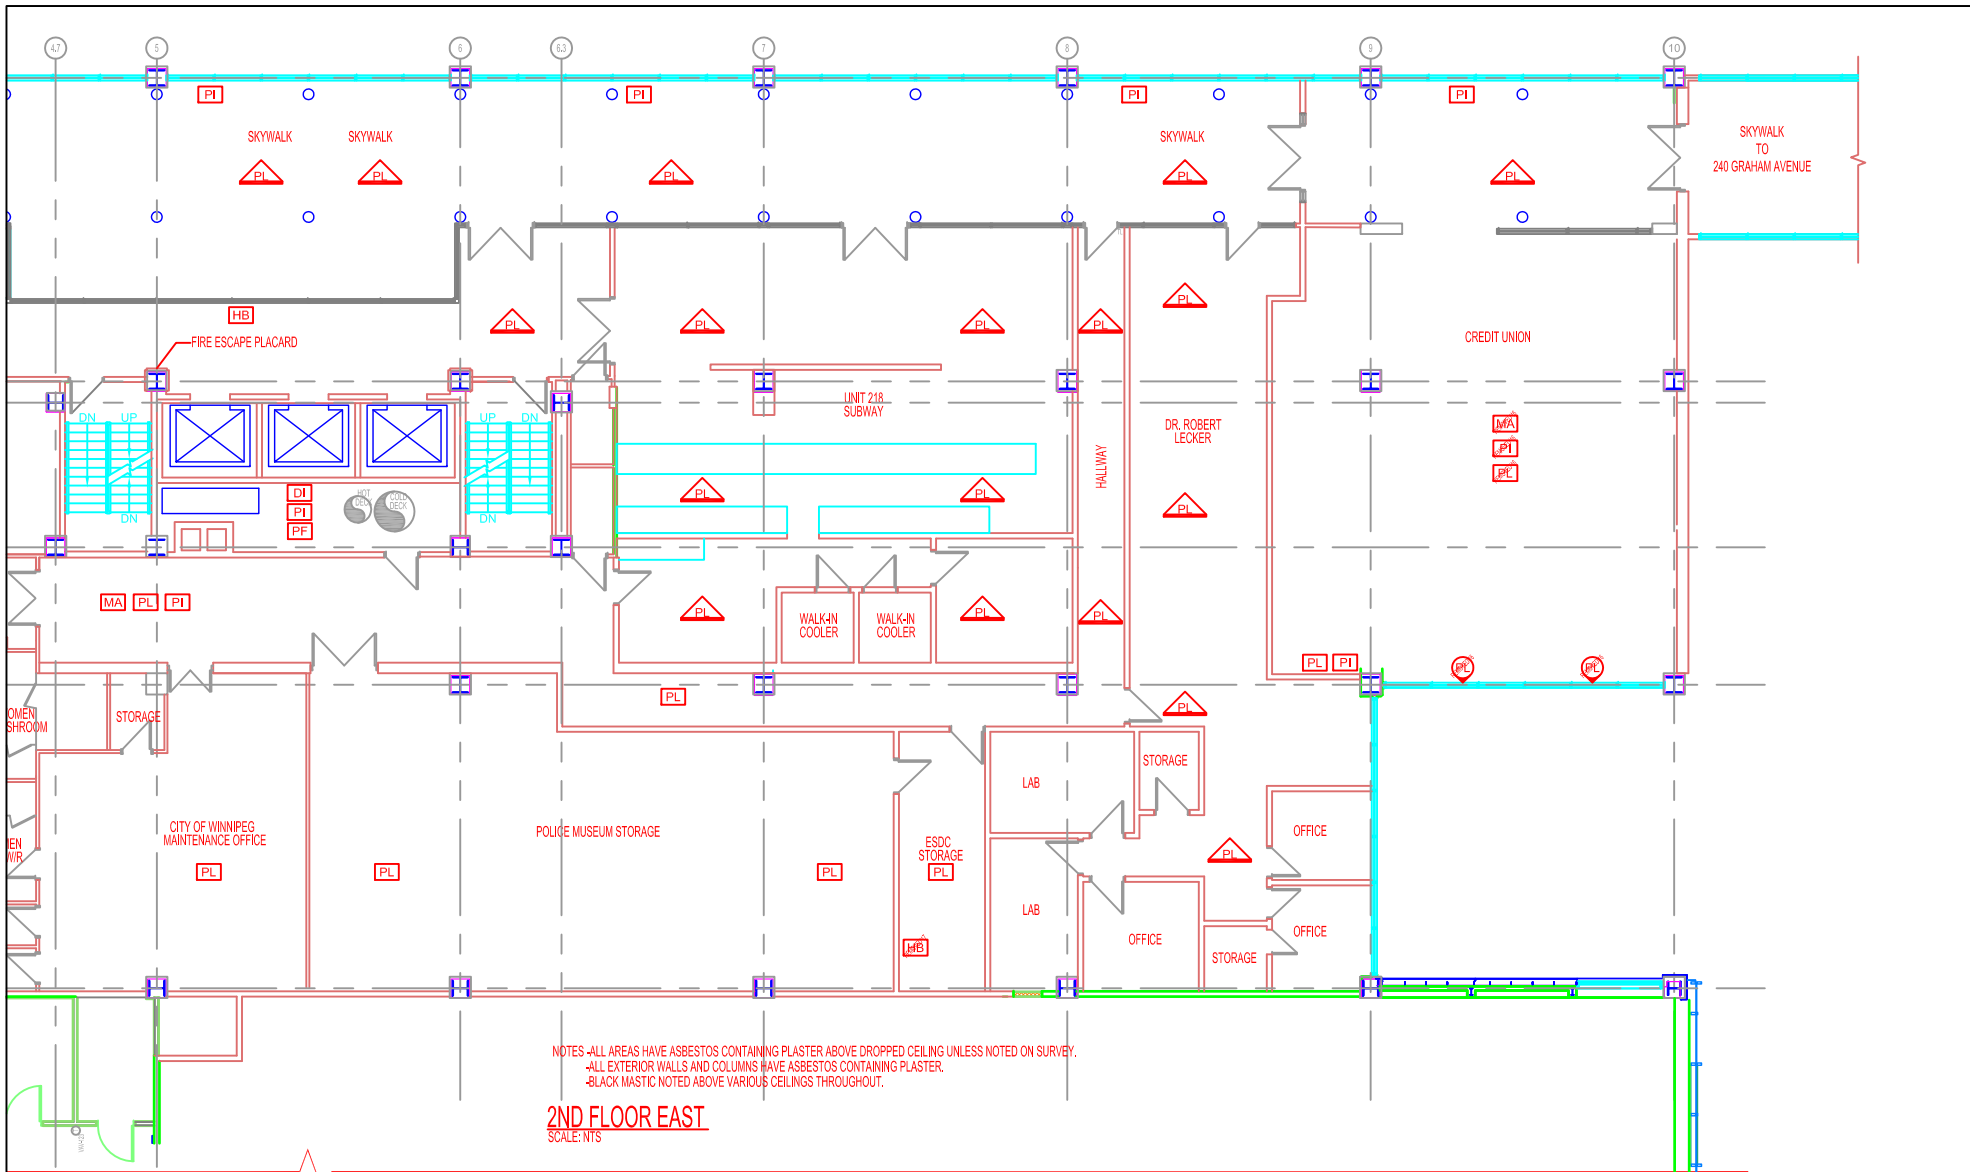
2ND FLOOR EAST
 SCALE: N.T.S.

NOTES - ALL AREAS HAVE ASBESTOS CONTAINING PLASTER ABOVE DROPPED CEILING UNLESS NOTED ON SURVEY.
 - ALL EXTERIOR WALLS AND COLUMNS HAVE ASBESTOS CONTAINING PLASTER.
 - BLACK MASTIC NOTED ABOVE VARIOUS CEILINGS THROUGHOUT.
