Sodium Hypochlorite Tank, TK-J520A Inspection

Inspection Date: **November 22, 2017**

Prepared by: **Structural Composite Technologies Ltd.**

Inspector: **Bon Bacani, CCT-C, C.Tech.**

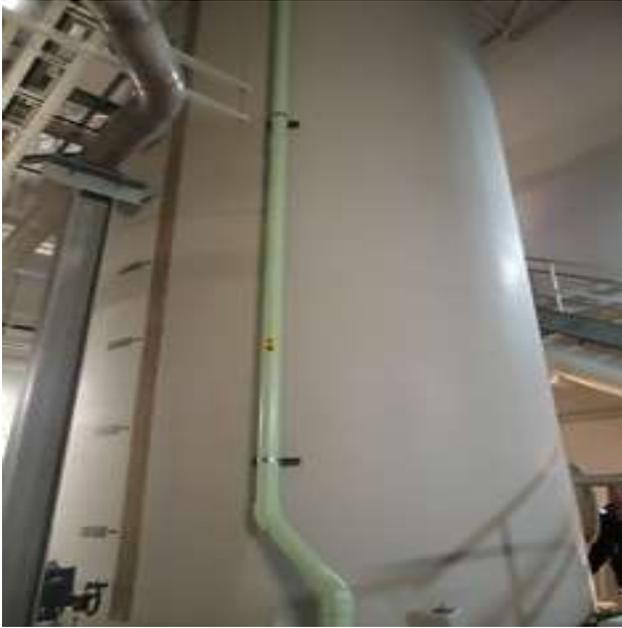
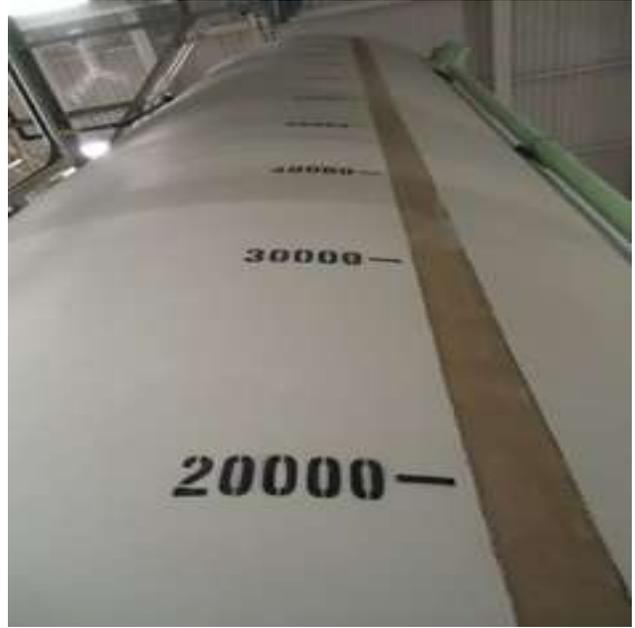
Photo Set 1: View of the outside of the tank showing external piping and sight strip

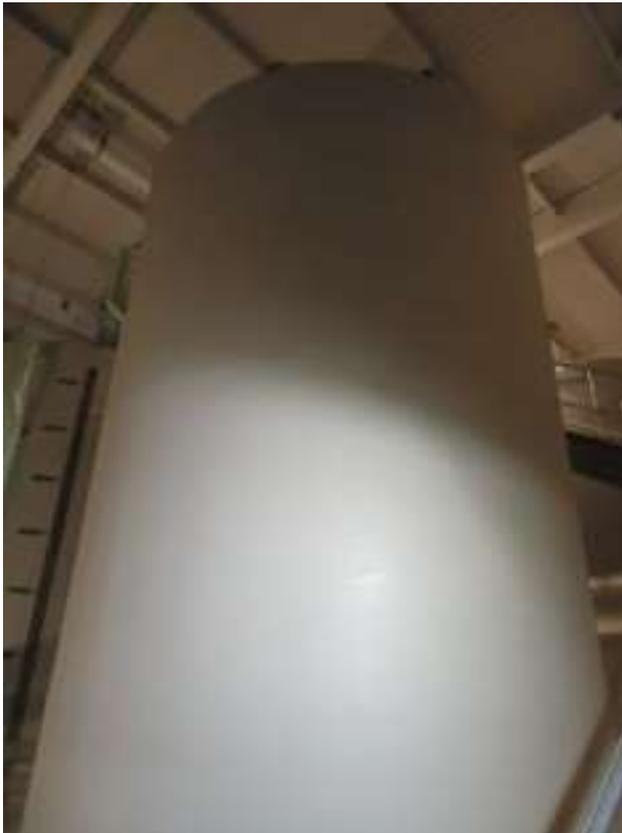
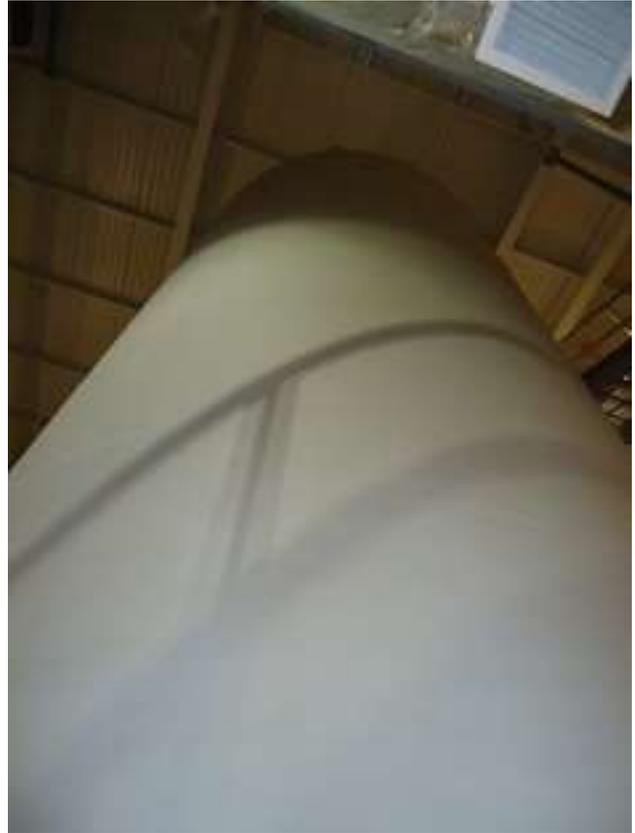
Photo Set 2: Views of the outside of tank

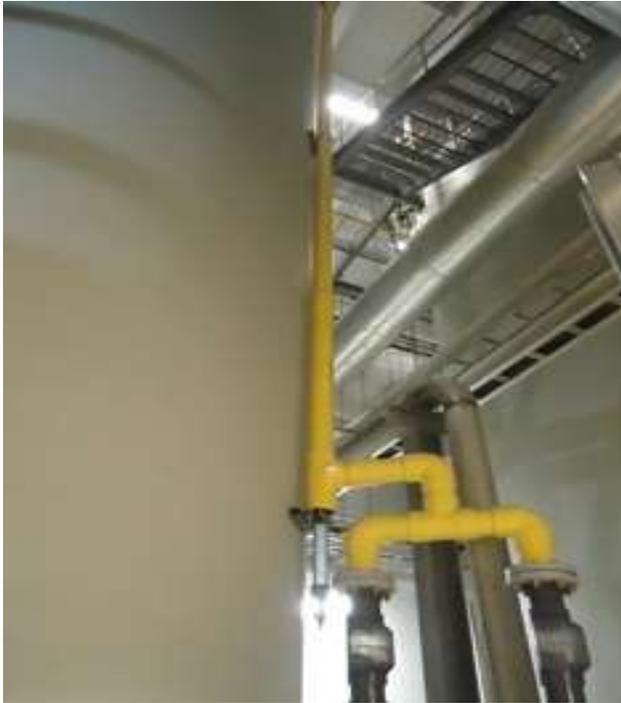
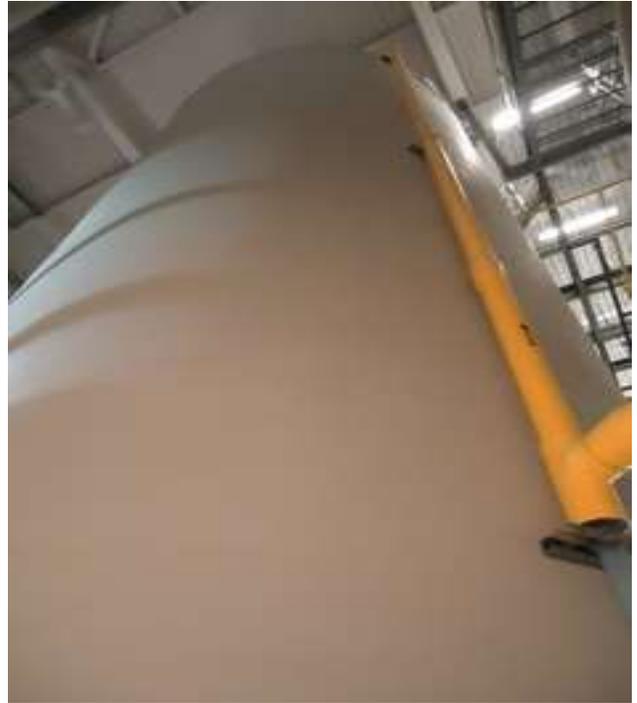
Photo Set 3: Additional views of the outside of tank showing external piping

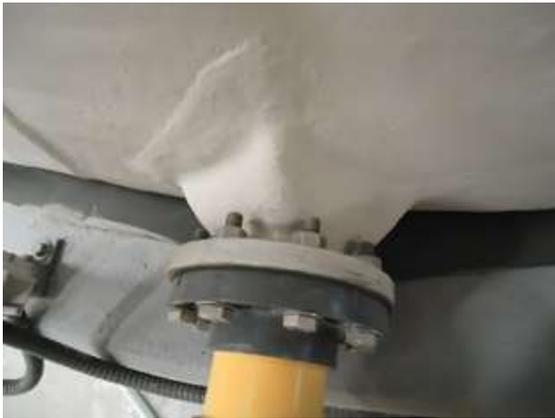
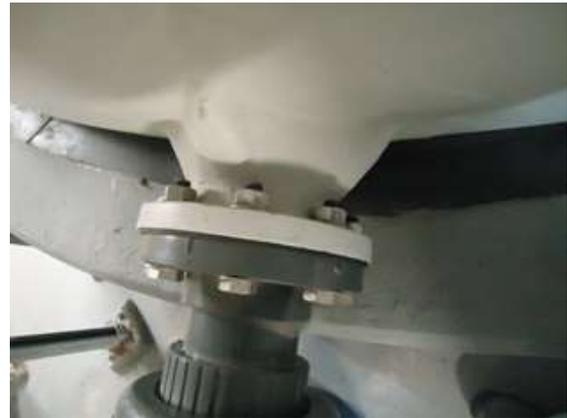
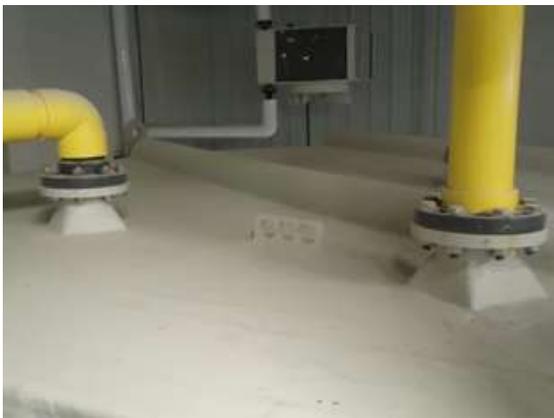
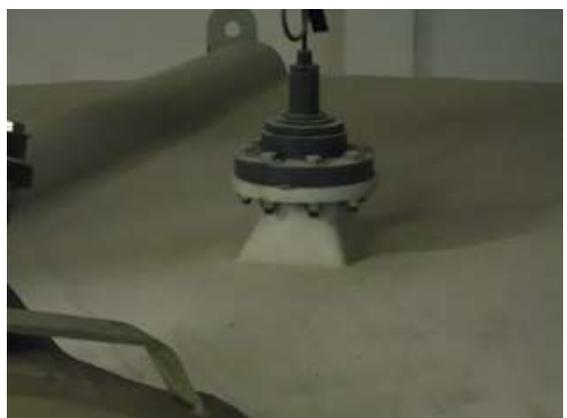
1. There was no sign of leaking nor cracks from the tank;
2. Flanges don't have any sign of cracks nor leaks;
3. No significant corrosion observed on the flange fasteners, lugs and other metal parts on the tank.

Photo Set 4: Tank Appurtenances – Flanged Nozzles (outside view)

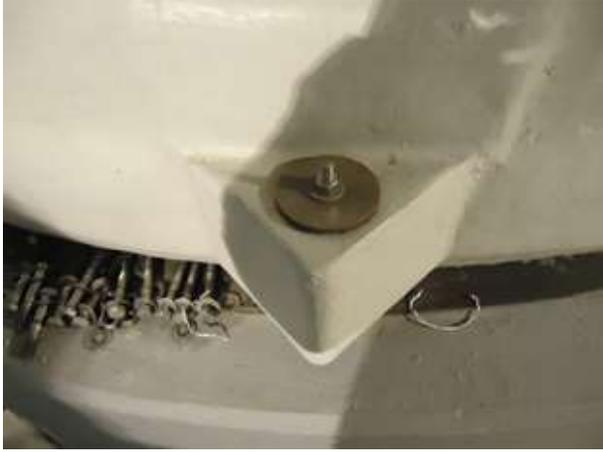
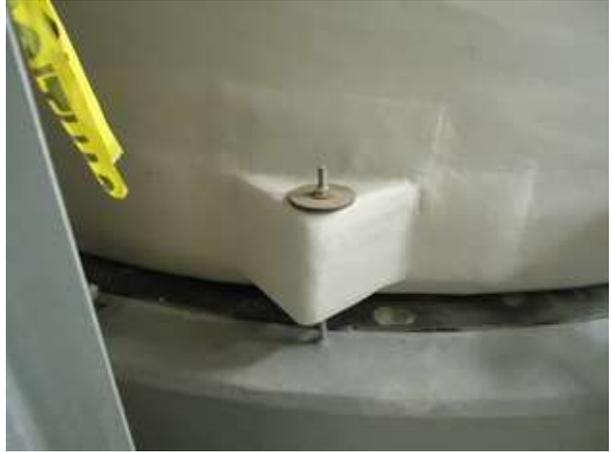
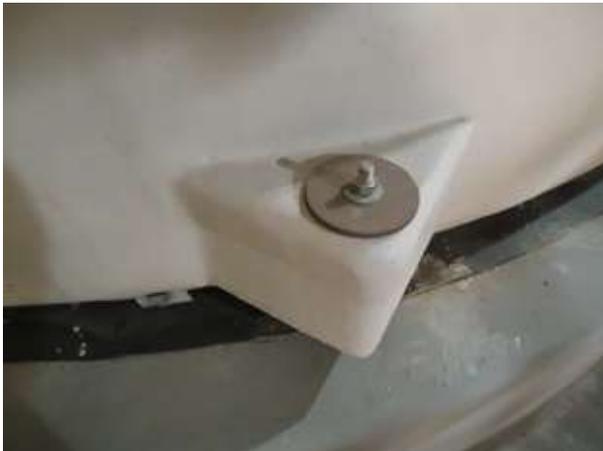
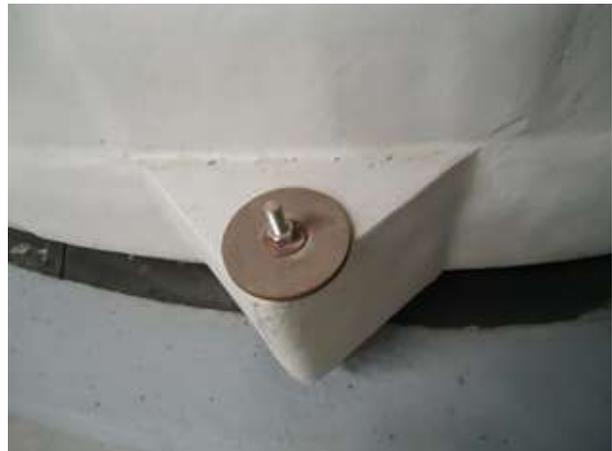
Photo Set 7: Appurtenances – Hold Down Lugs

Overall on the outside surface of tank, there was no issues found that requires fixing.

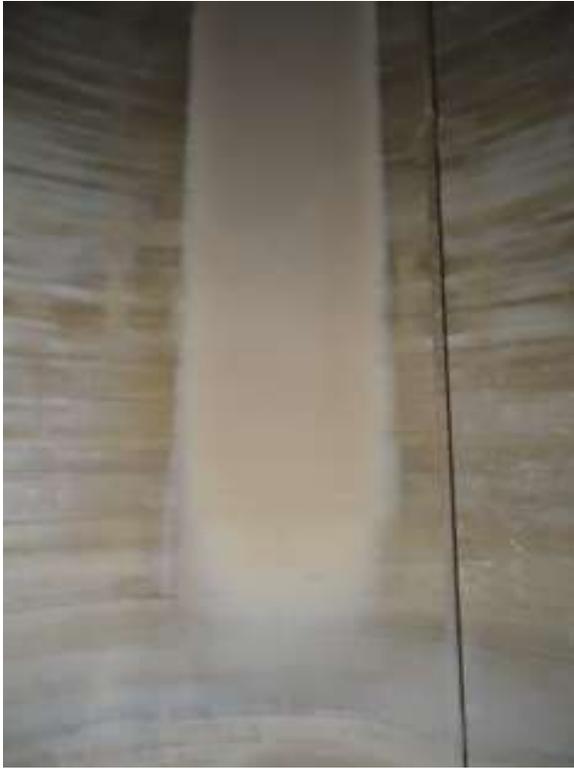
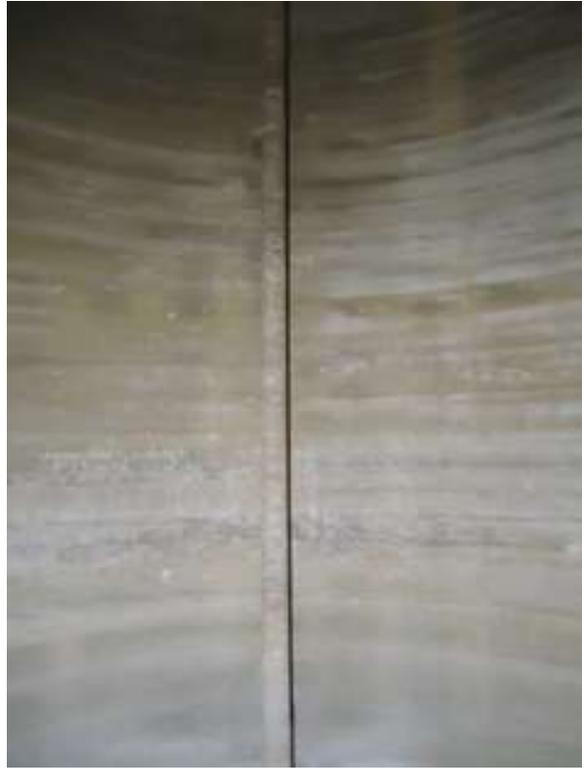
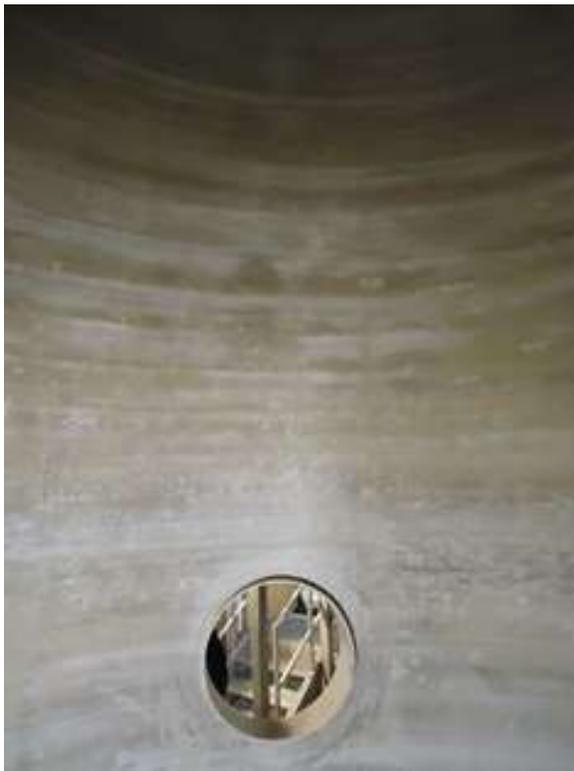
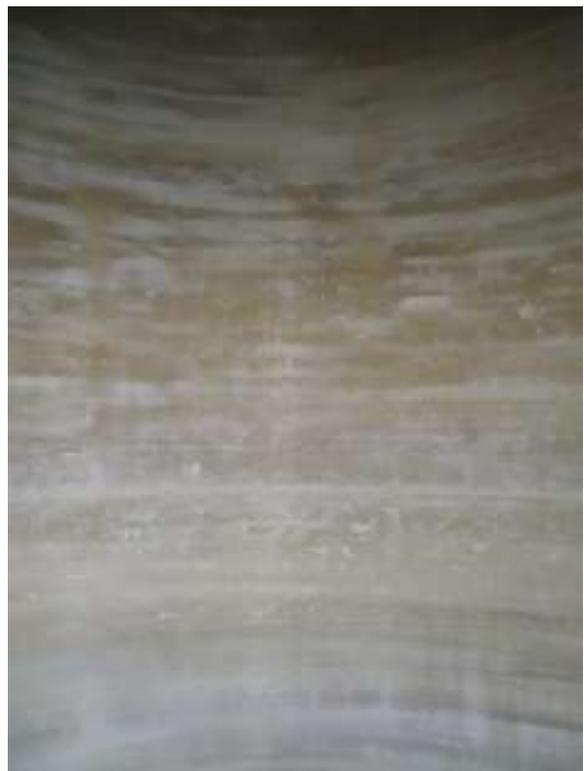
Tank Wall (inside) – appears to have been **compromised** which is characterized by the dryness and roughness of the wall surface (see photos).

Photo Set 8: View of the compromised tank liner (inside)

1. **Tank wall and floor (inside)** - Sandblast to remove compromised liner;
2. **Nozzles and Appurtenances (inside)** - Repair or replace nozzles on bottom half of tank; manway needs to be relined as well;

4. **Tank wall and floor (inside)** - Reline the whole tank inside wall and floor after sandblasting, recommended laminate construction is 2 plies of 1.5 oz mat and 2 plies of Nexus synthetic veil using Vipel K022-ACA vinyl ester resin which is suitable for the 12% Sodium Hypochlorite service;

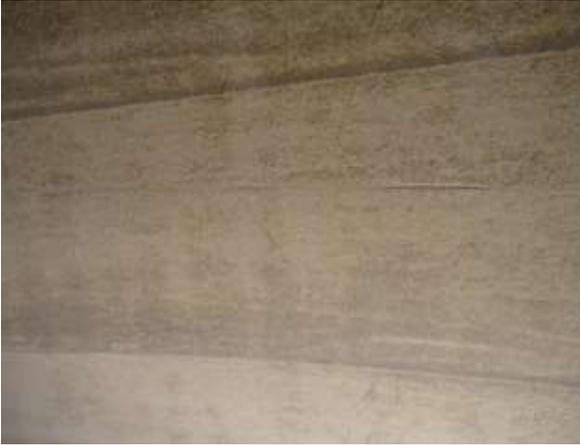
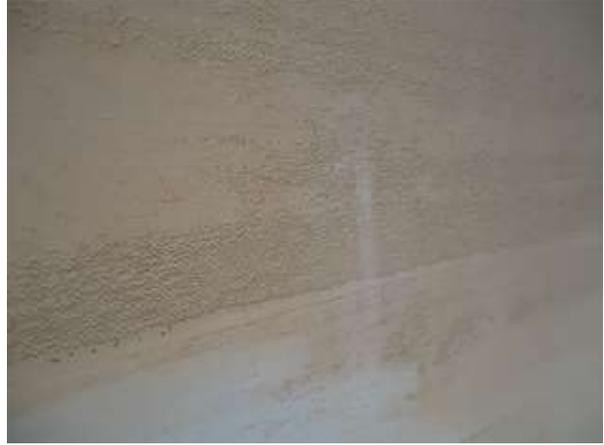
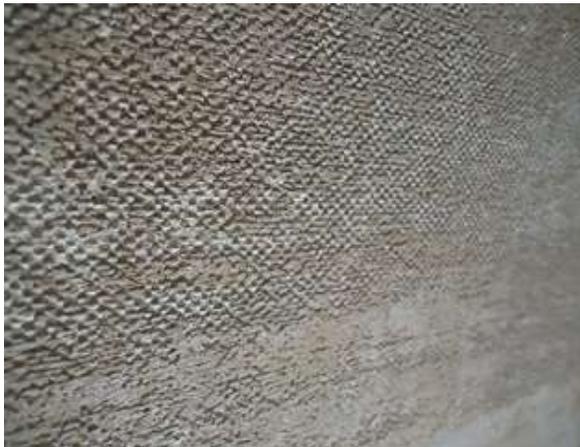
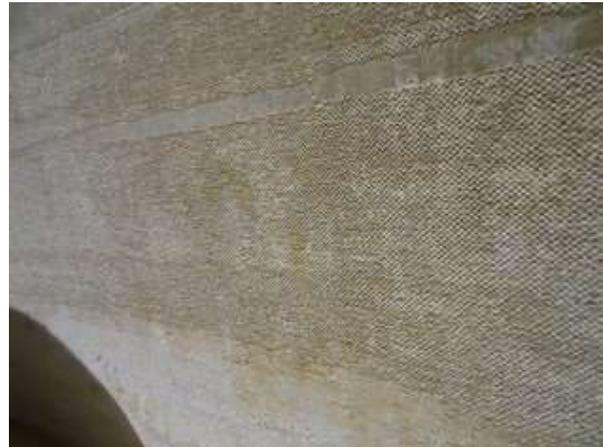
Photo Set 9: Close up view of the dryness and roughness of the compromised tank liner

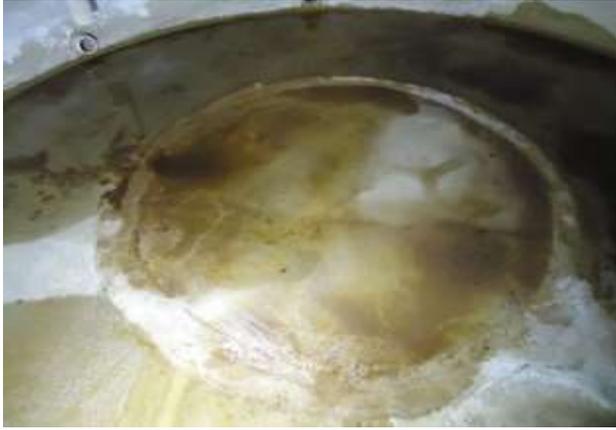
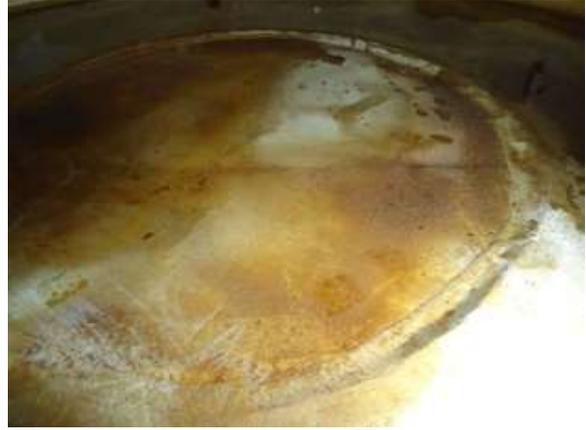
Tank Floor (inside) – appears to have been **compromised** which is characterized by the roughness of the surface. There was also significant delamination (lifting) observed on the floor seam which suggests that it has been chemically attacked (see photos).

Photo Set 11: Overall view of the tank floor (inside)

3. **Tank floor (inside)** - Remove the delaminated bond on the floor seam and laminate alternating plies of 3 – 1.5 oz mat and 2 – 24 oz woven roving before doing the whole tank reline (refer to Photo Sets 11 & 12);

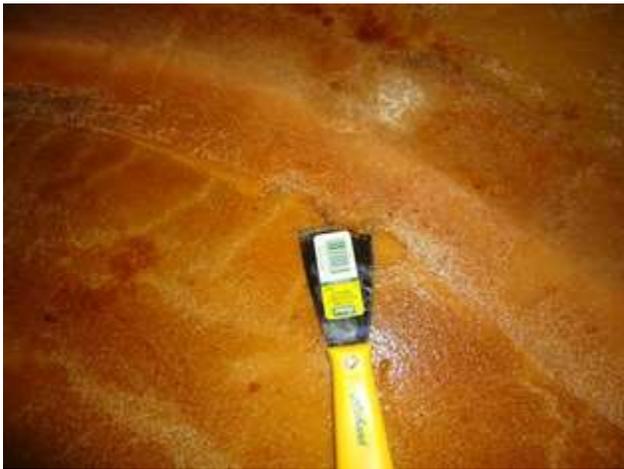
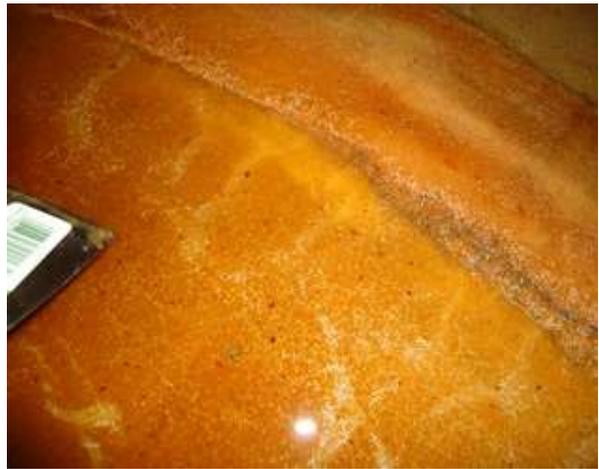
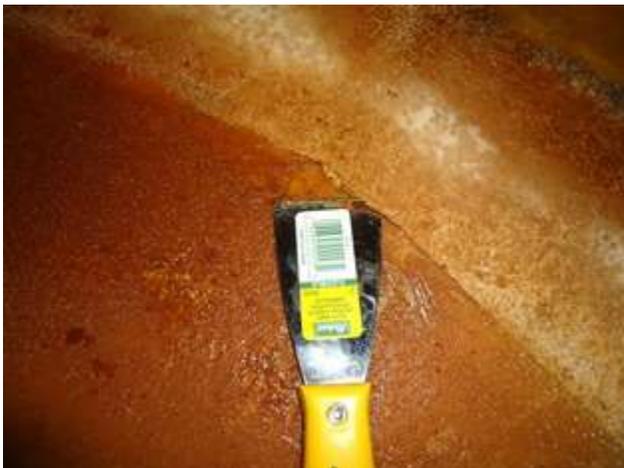
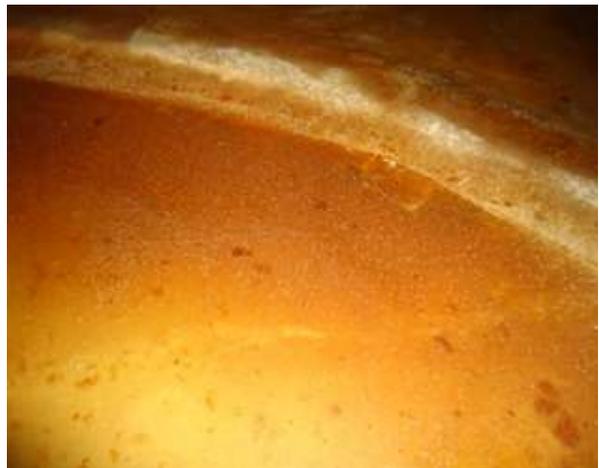
Photo Set 12: Tank floor seam bonding – delamination (lifting)

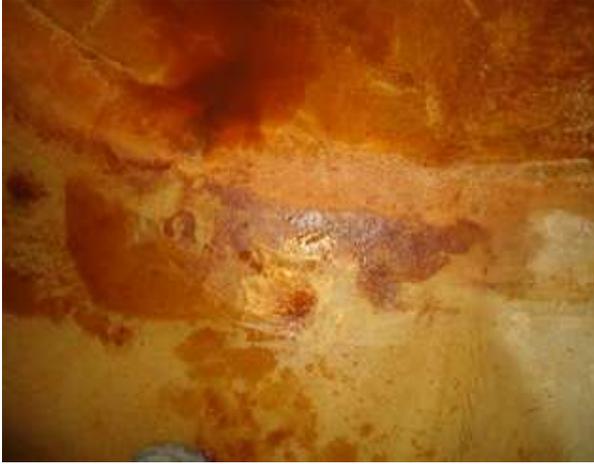
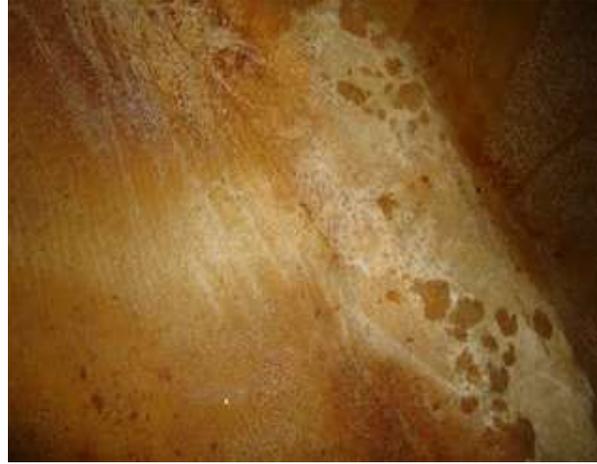
Photo Set 13: Tank floor roughness (compromised)

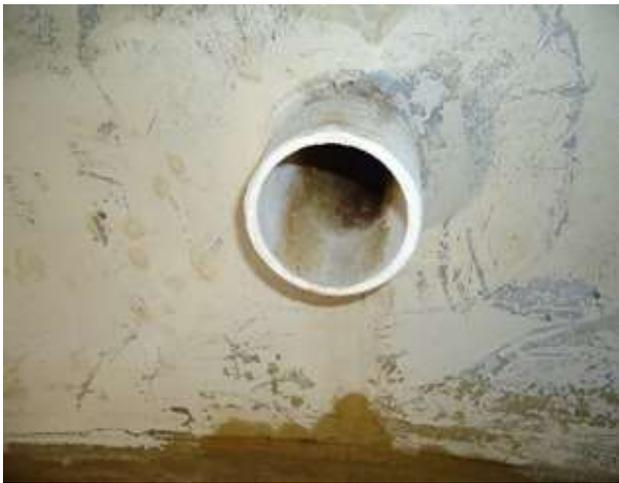
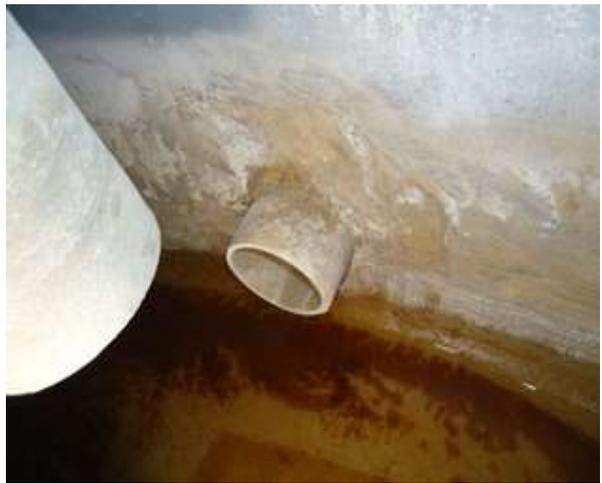
Tank Appurtenances (inside) – there are a few piping and flanges on the tank which appeared to have been **compromised** (the areas that have contact with the contents of the tank) - Downpipe with brackets and a few nozzles.

Photo Set 16: Appurtenances – Nozzles (inside)

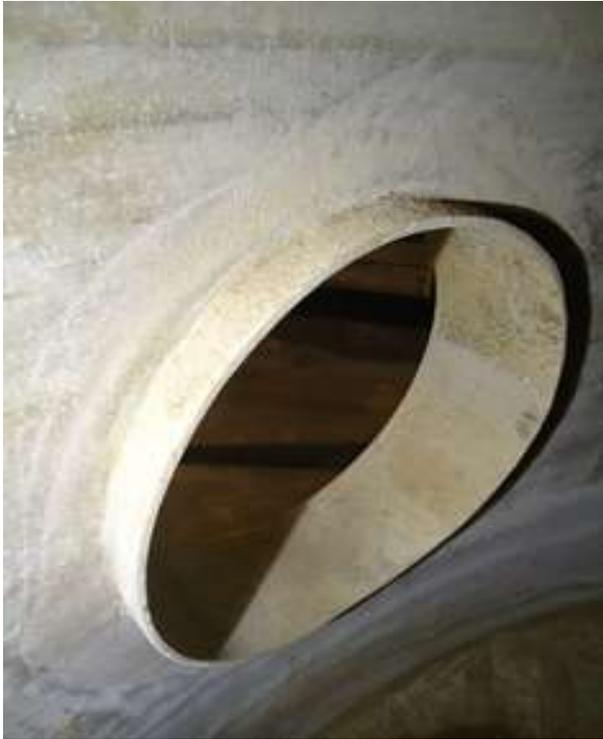
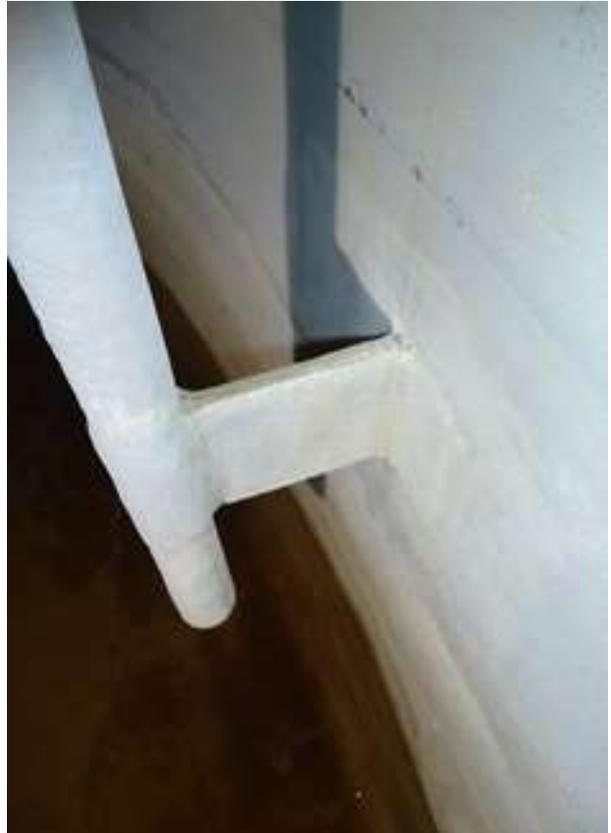
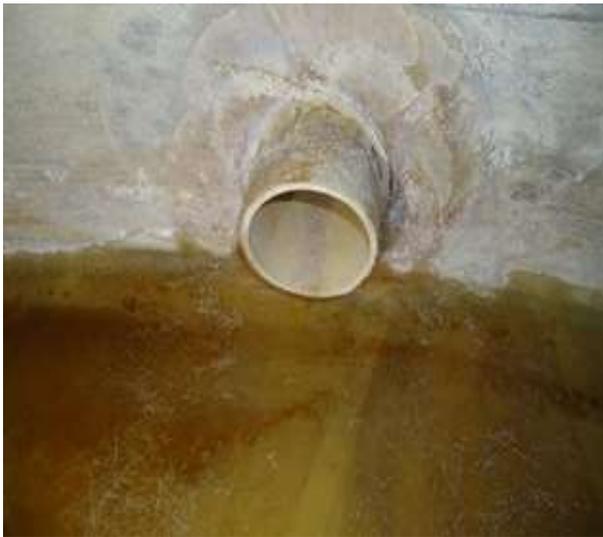
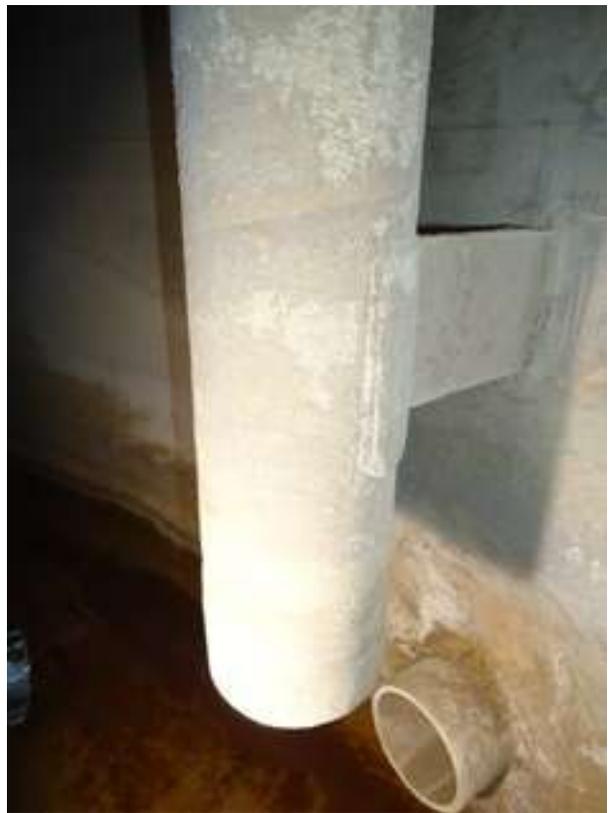
Photo Set 17: Appurtenances –
Access Manway and Down
pipes (inside)
