## **APPENDIX B – MMM GROUP LTD. CONCEPTUAL GATE CHAMBER DESIGN EXISTING CONDITION ASSESSMENTS REPORT**

**Re: RFP No. 818-2014 - Professional Consulting Services for Developing Conceptual Concepts for Gate Chamber Designs for Storm Relief Sewer Systems**

# CONCEPTUAL GATE CHAMBER DESIGN EXISTING CONDITION ASSESSMENTS

Prepared for:  
**The City of Winnipeg**

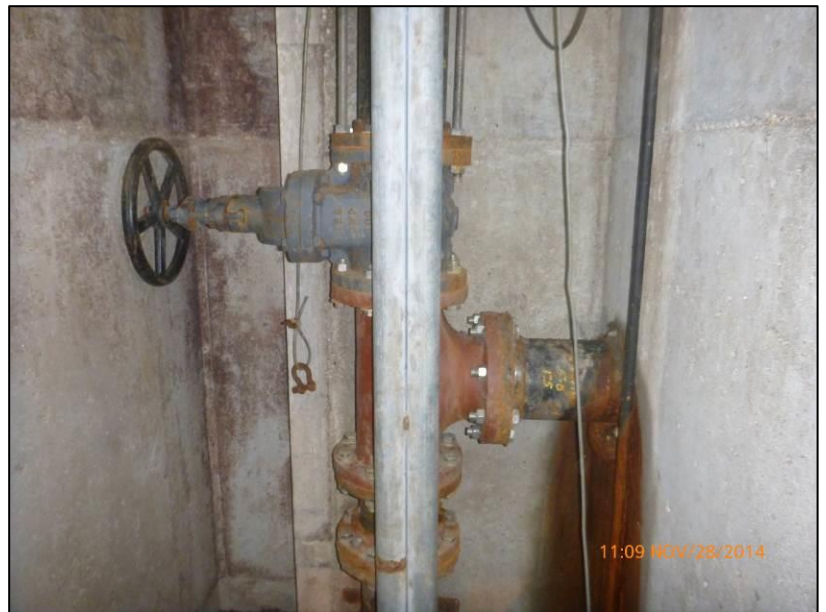
**Photograph No. 4**

Valve in upstream chamber and piping from submersible pump

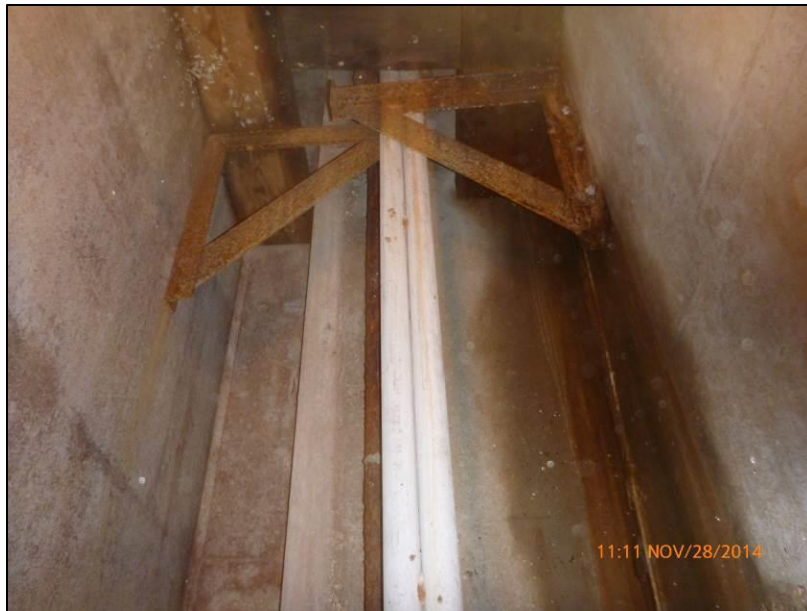
**Photograph No. 5**

Support for platform in upstream chamber, staining on concrete walls

The parts of the chamber that were visible and accessible were in overall good condition. Steel brackets supporting a timber platform in the upstream cell should be replaced with galvanized brackets if the platform is to be maintained. The condition below the waterline at the time of inspection is unknown and it is possible that there may be maintenance repairs required.

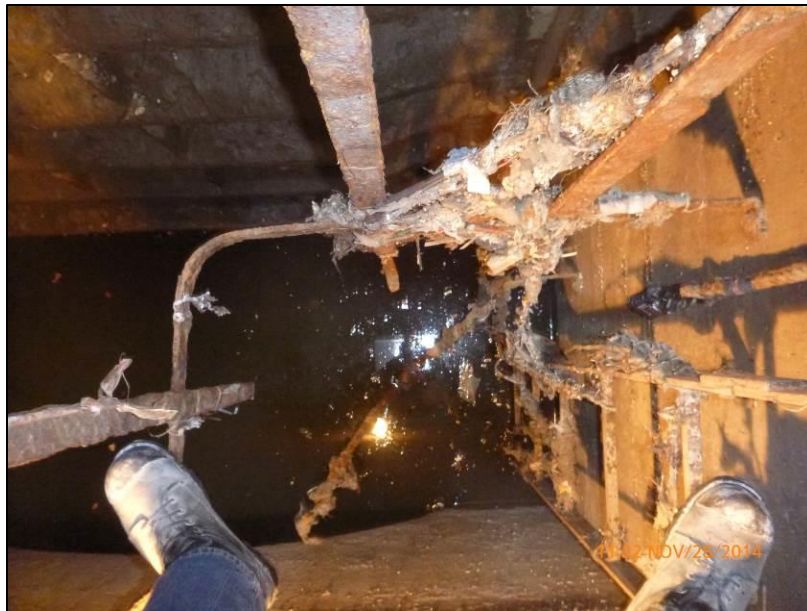
**Photograph No. 7**

Corrosion on ladder cage, downstream chamber

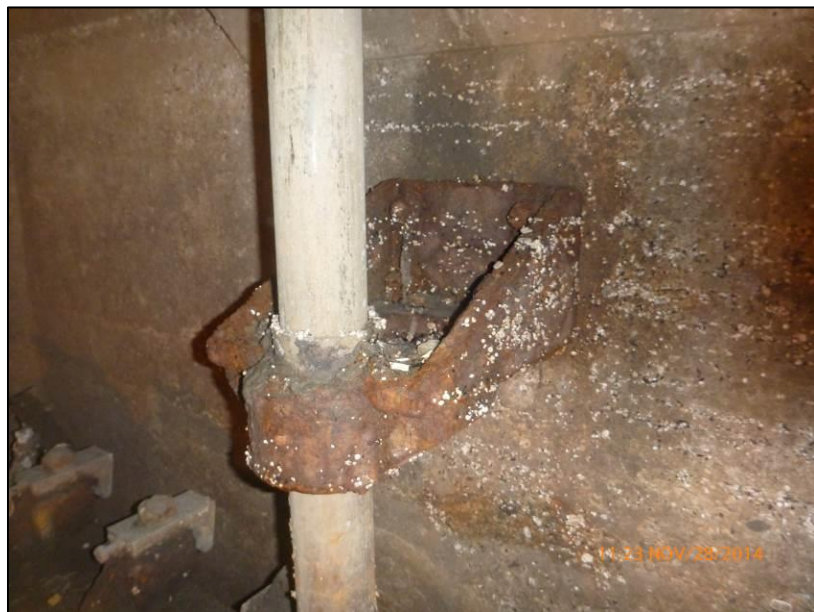
**Photograph No. 8**

Corrosion on gate stem guide

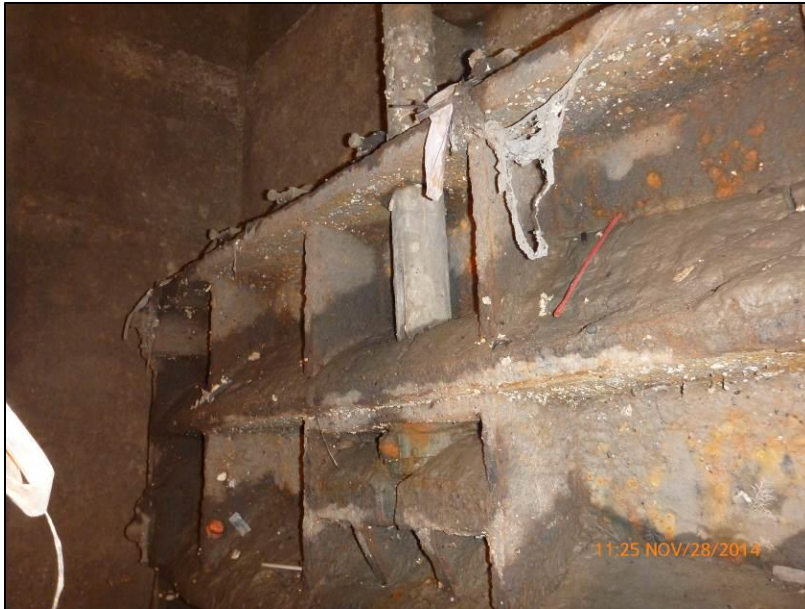
**Photograph No. 9**  
Positive sluice gate

The existing chamber is functional, although there is visible corrosion to several gate components and it is understood that the existing sluice gate leaks when closed. Because of site constraints, in order to install a flap gate it is preferable to locate it in a new cell downstream of the existing positive gate. This would result in abandoning the existing positive gate and installing a new positive gate further downstream in a second new cell.

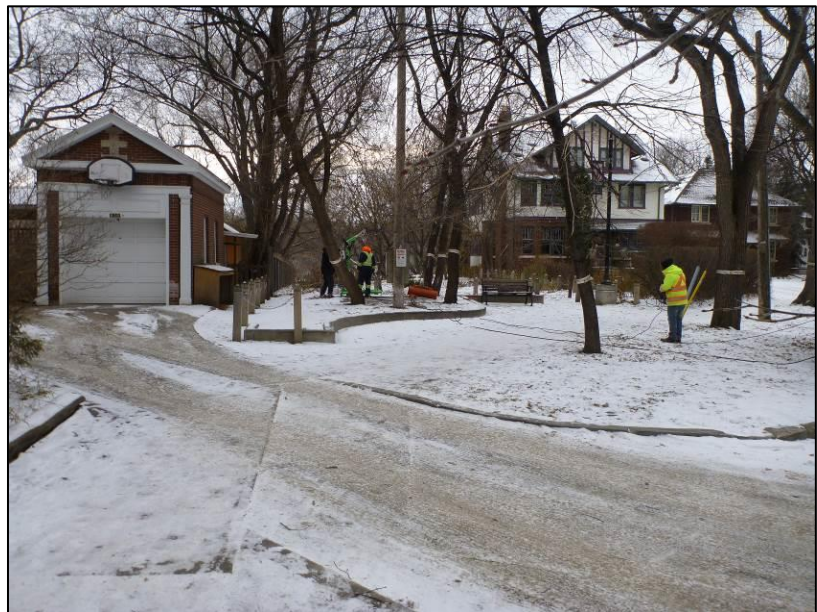
**Photograph No. 2**

Existing site looking south (towards outfall)

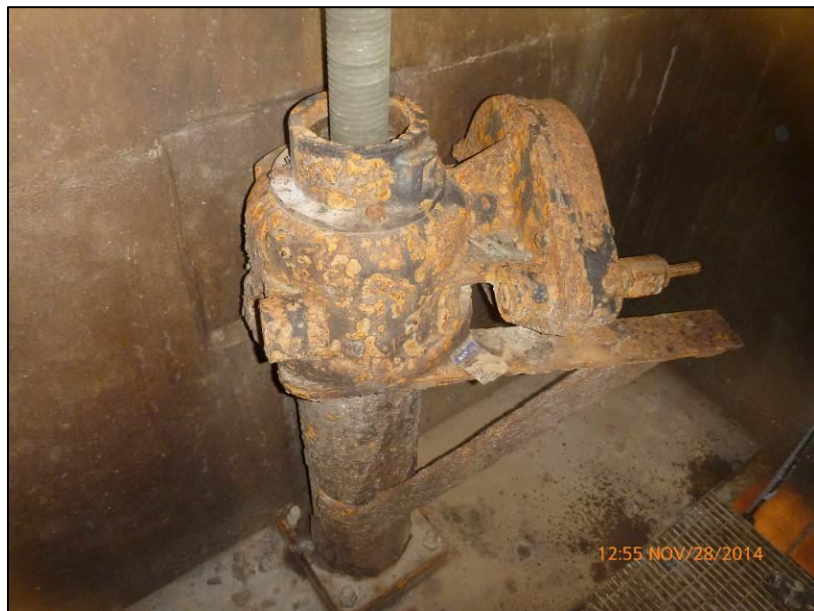
**Photograph No. 4**

Positive gate lift, operating shaft not present

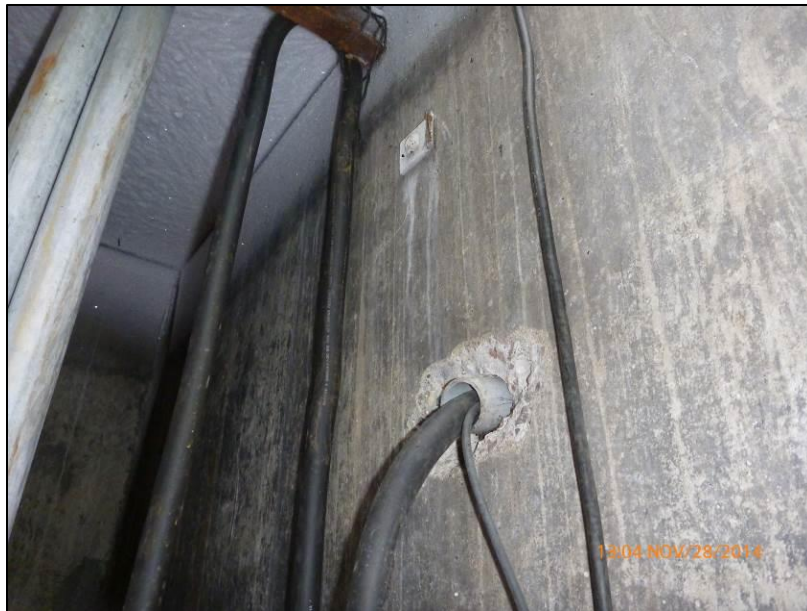
**Photograph No. 7**

Spalling around openings for conduits in existing concrete wall

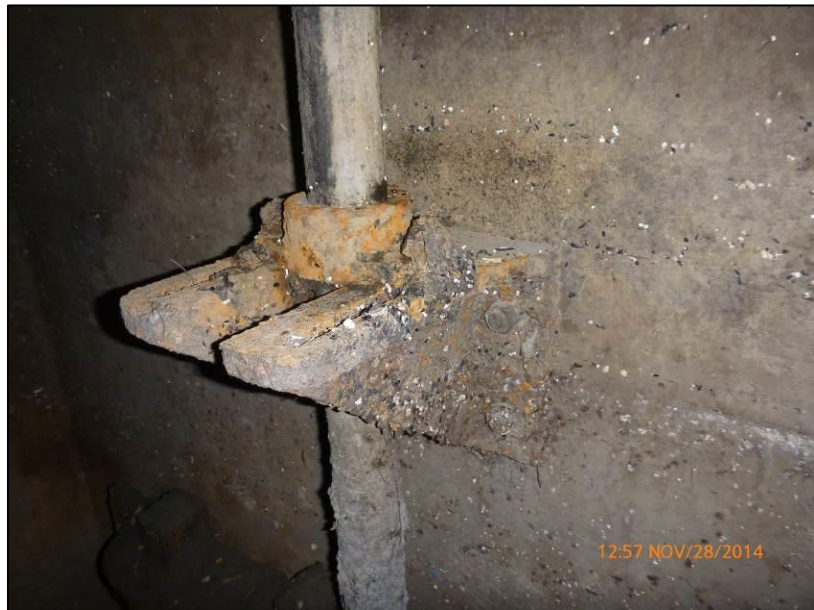
**Photograph No. 8**

Corrosion on gate stem guide

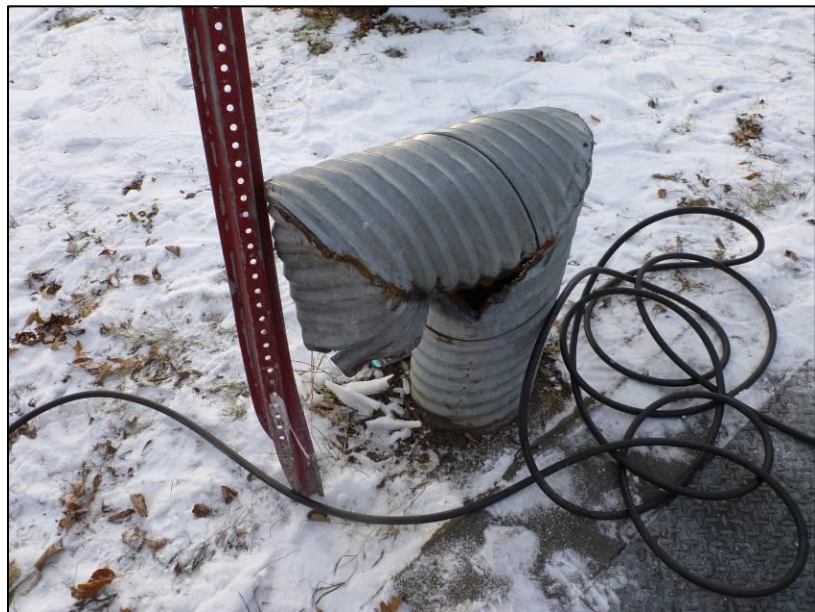
**Photograph No. 2**

Damaged air vent

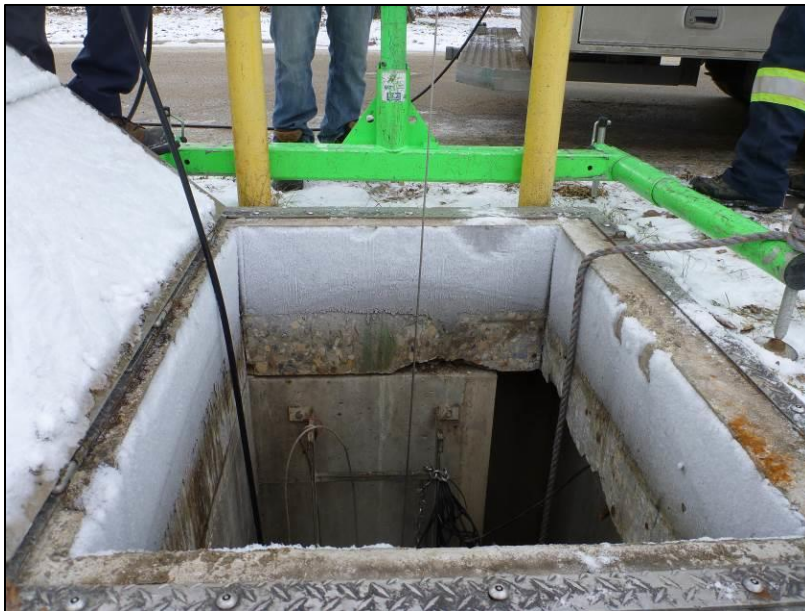
**Photograph No. 3**

Opening to upstream chamber, spalls and exposed reinforcing

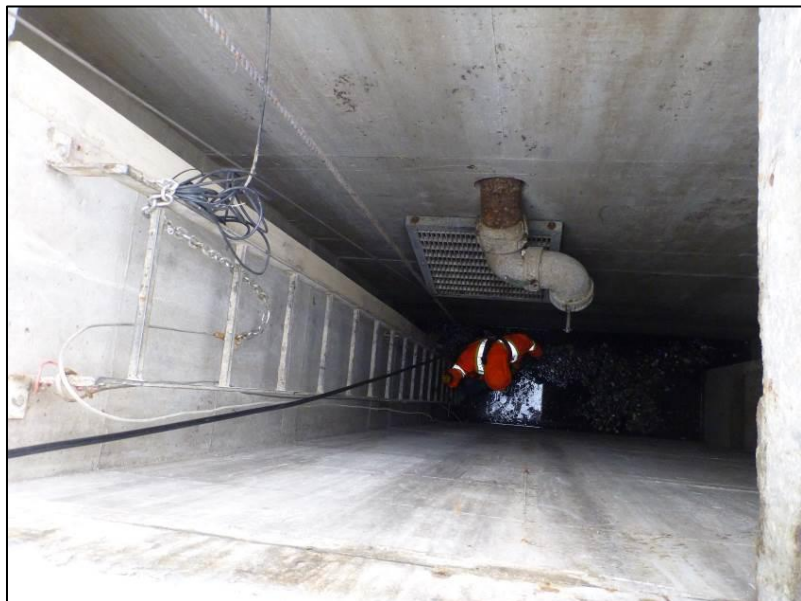
**Photograph No. 4**

Upstream chamber, ladder safety cage removed

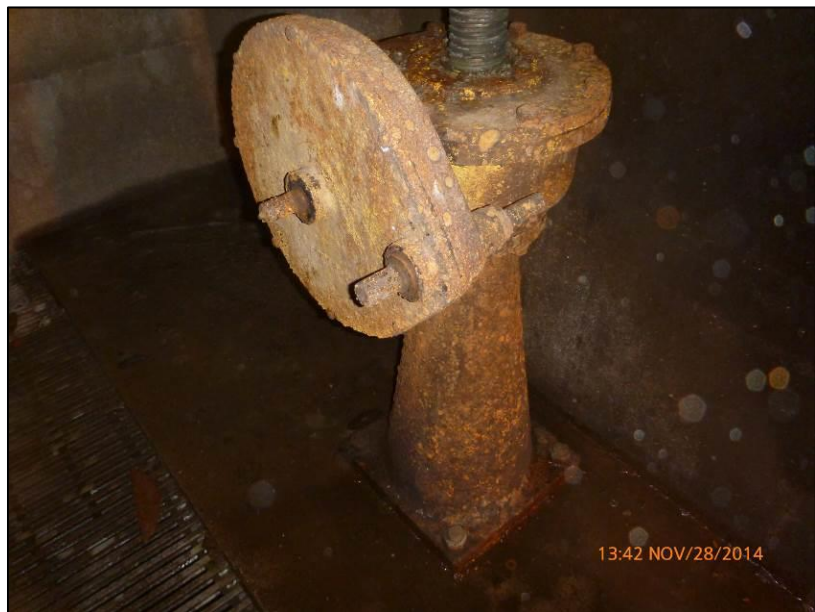
**Photograph No. 6**

Gate lift, operating shaft not present

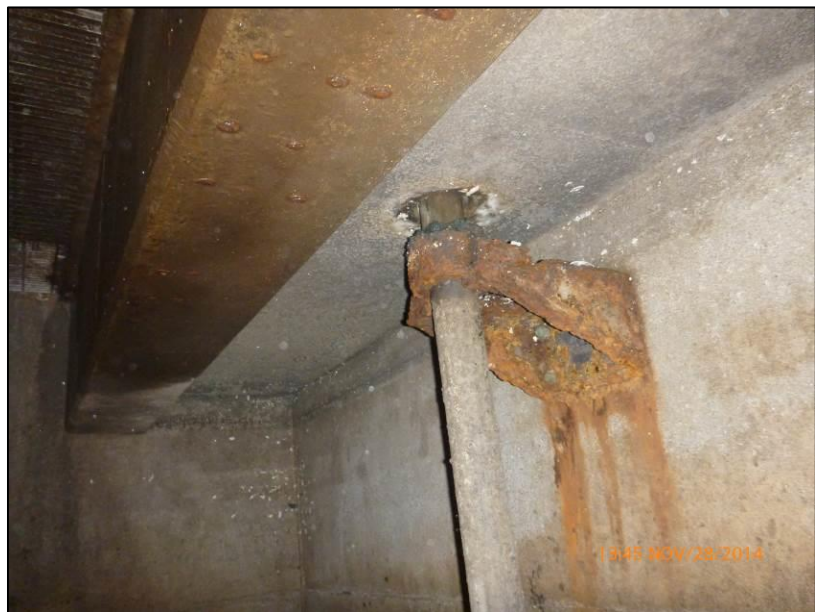
**Photograph No. 8**

Severe corrosion on gate stem guide

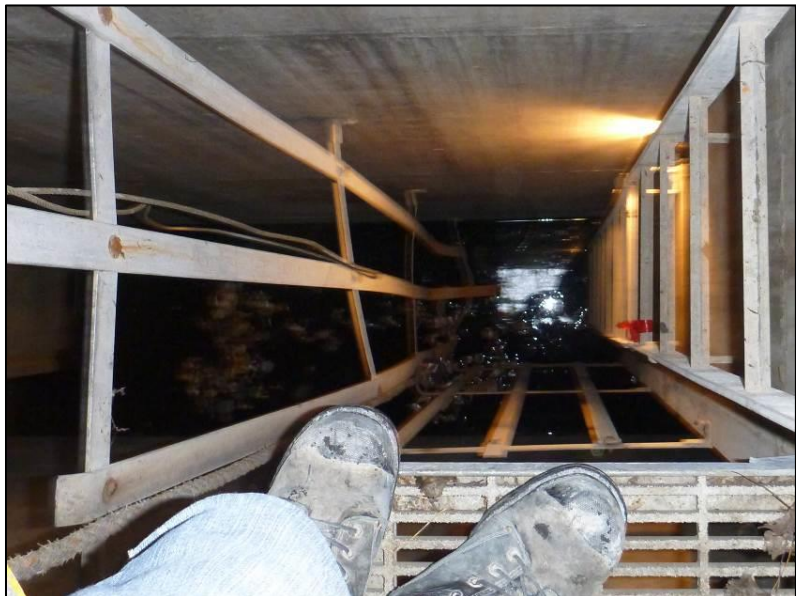
**Photograph No. 4**

Upstream chamber cell, damage to safety cage near bottom of chamber

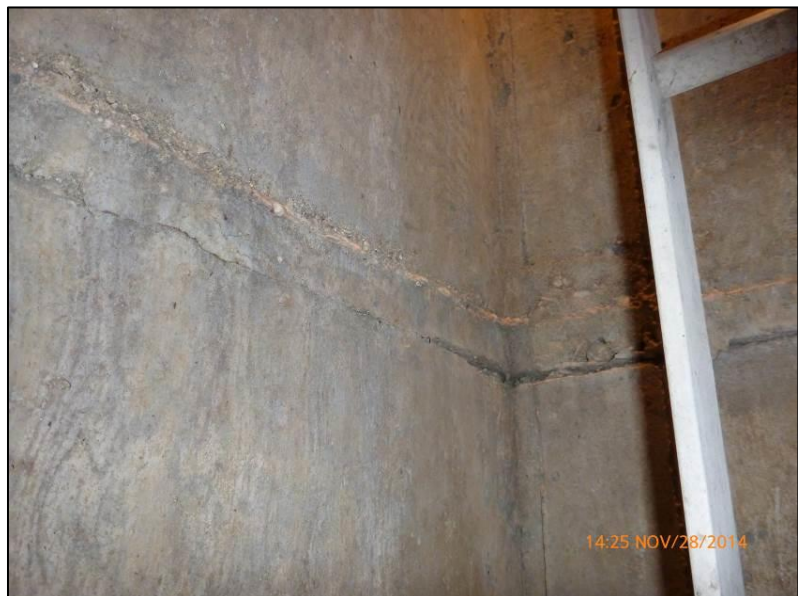
**Photograph No. 6**

Cracks in construction joint in upstream chamber cell

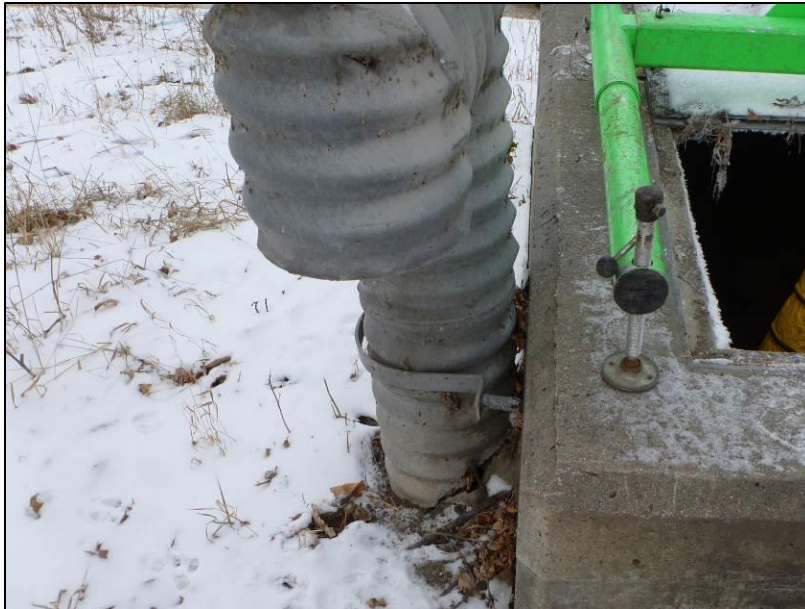
**Photograph No. 3**  
Damage to air vent and anchor

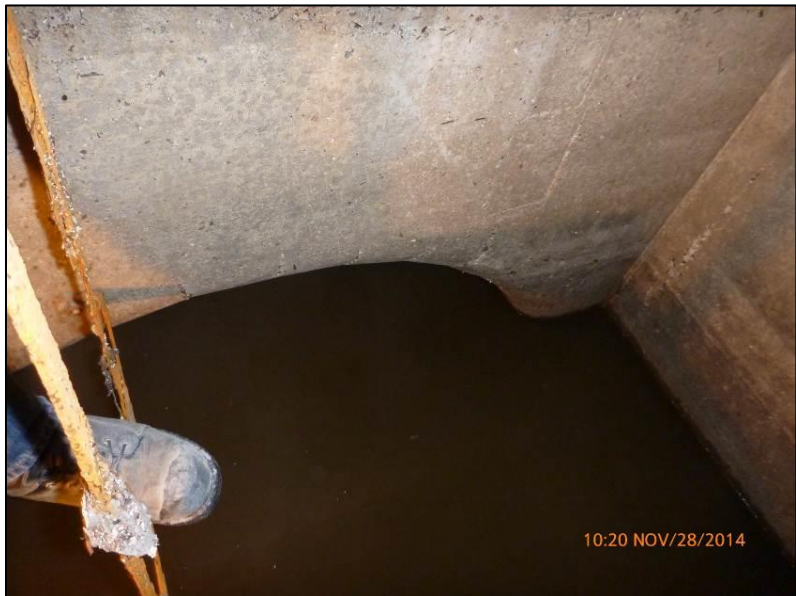
**Photograph No. 4**  
Corrosion and section loss to ladder safety cage

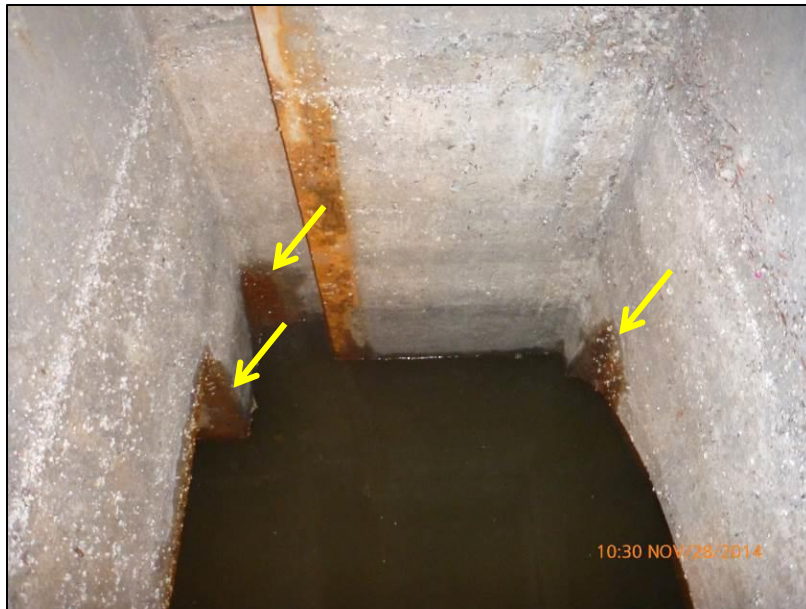
**Photograph No. 5**

Rust stains in concrete in upstream chamber

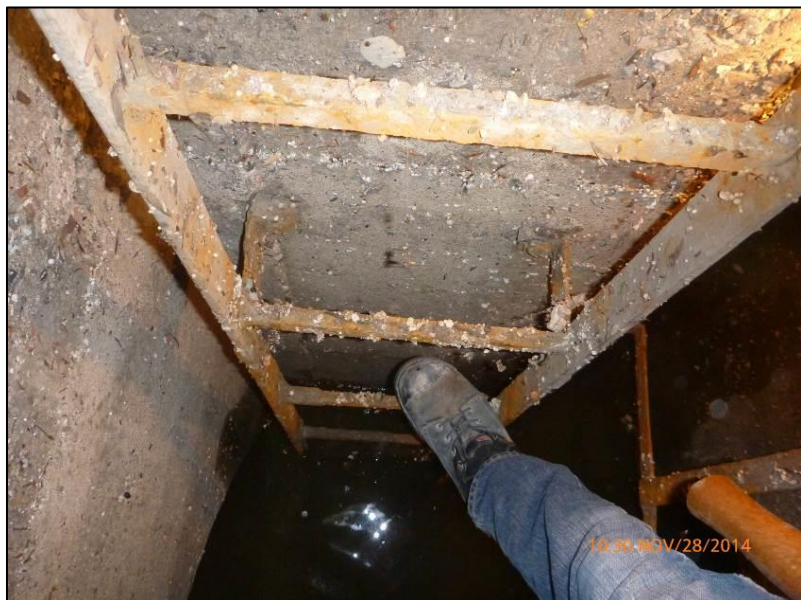
**Photograph No. 6**

Loss of galvanizing and corrosion on ladder

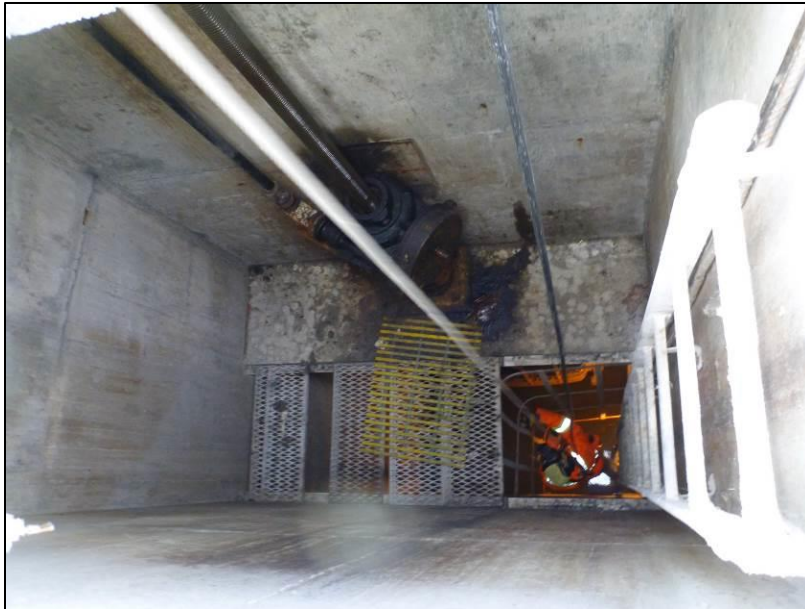
**Photograph No. 7**

Grease staining on floor and wall around gate lift
