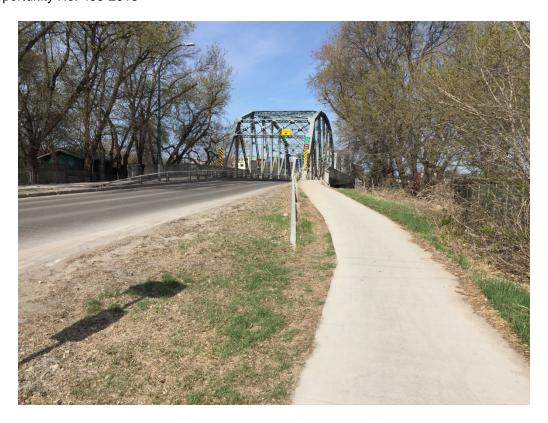
Site 1 – East site looking west towards bridge and chamber site

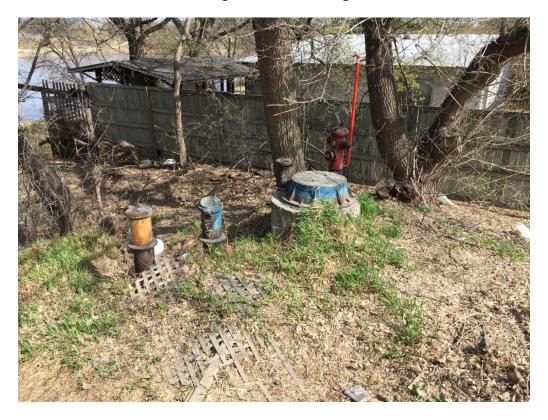
Site 1 – East chamber site looking north

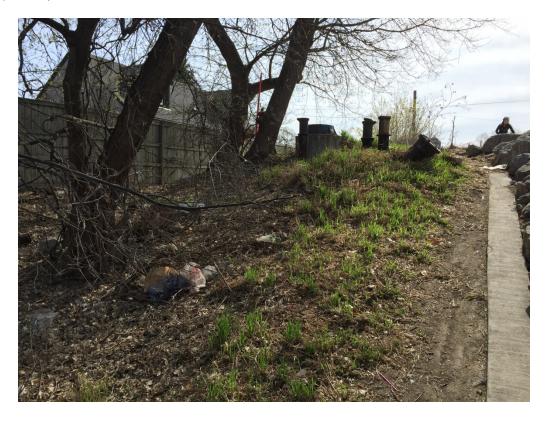
Site 1 – East chamber site looking east from bottom of bridge

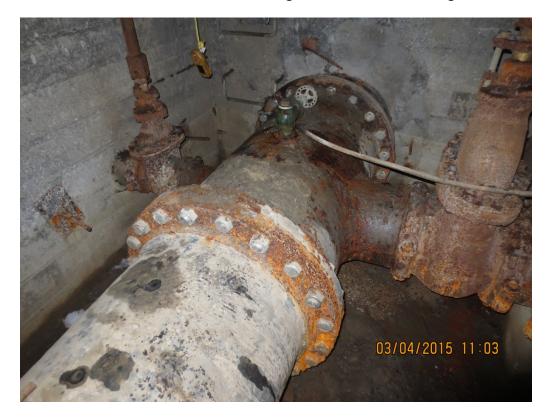
Site 1 – East chamber interior - existing cross and 300 mm offtake

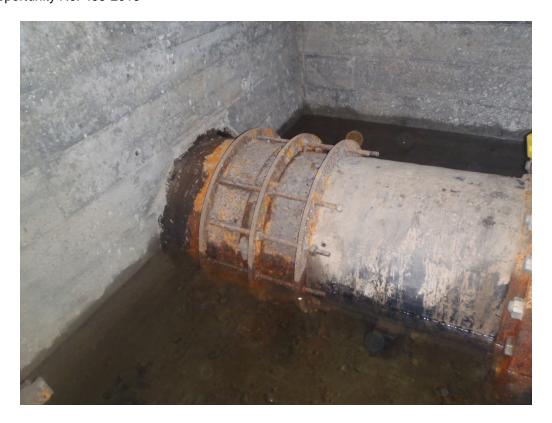
Site 1 – East chamber interior - 600 feeder main

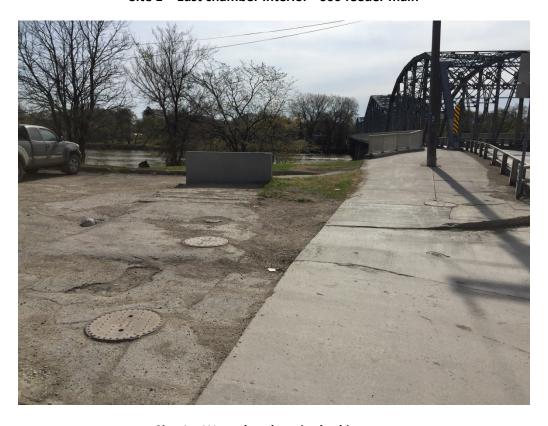
Site 1 – West chamber site looking east

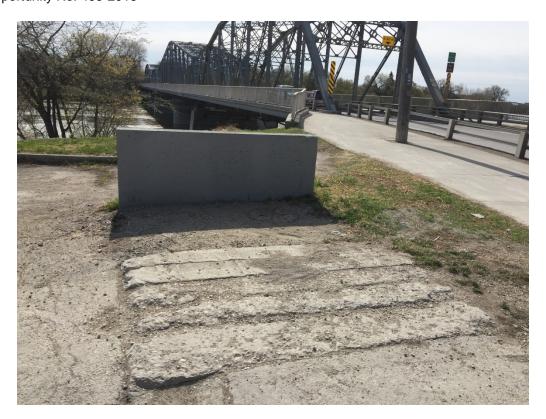
Site 1 – West chamber site top of crossing chamber

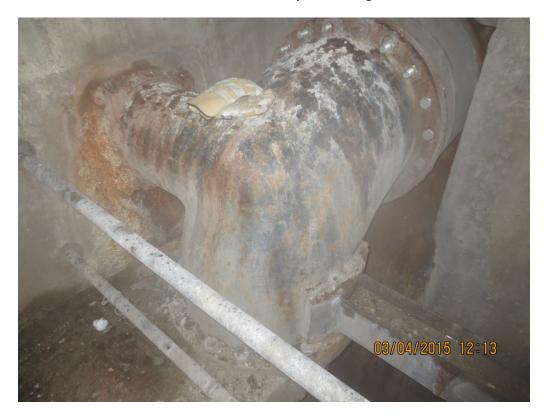
Site 1 – West chamber interior - existing side-outlet elbow with welded brace

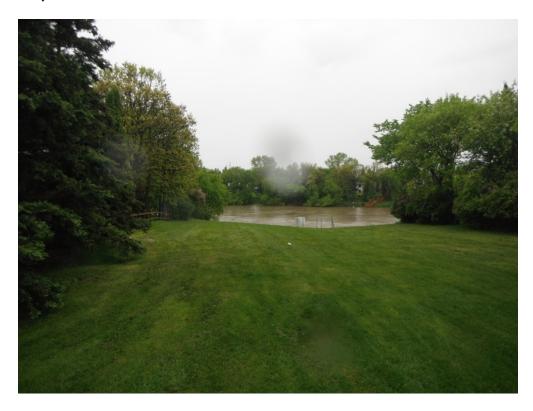
Site 2 – North chamber site looking south

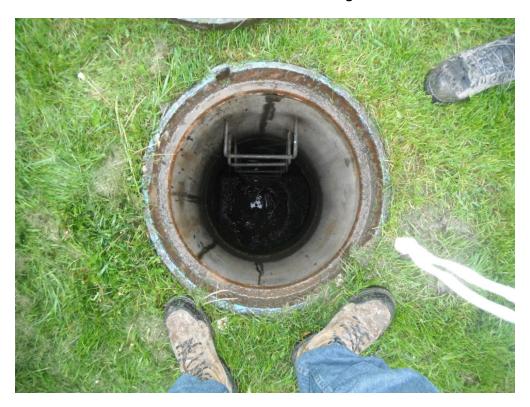
Site 2 – North chamber access.

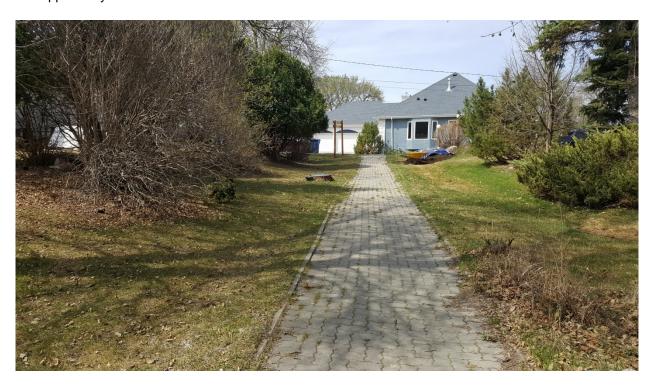
Site 2 – South chamber site looking south

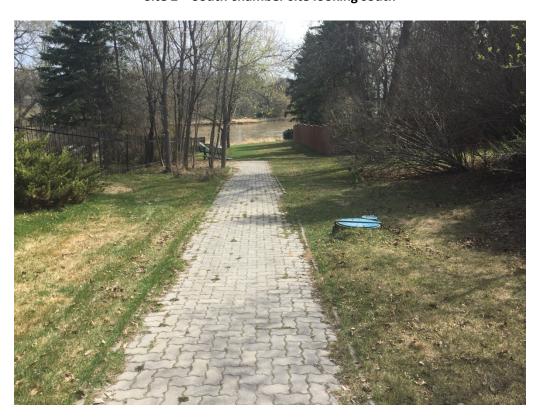
Site 2 – South chamber site looking north

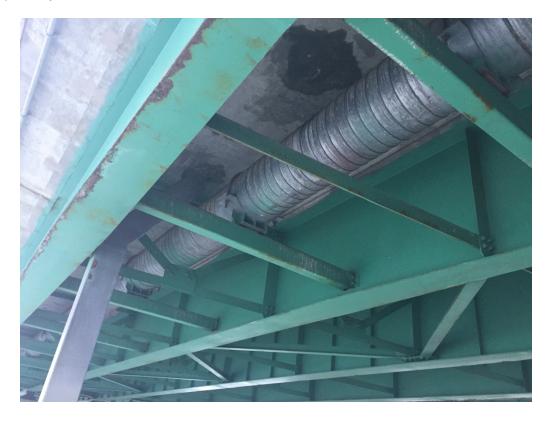
Site 3 – Force Main at underside of bridge

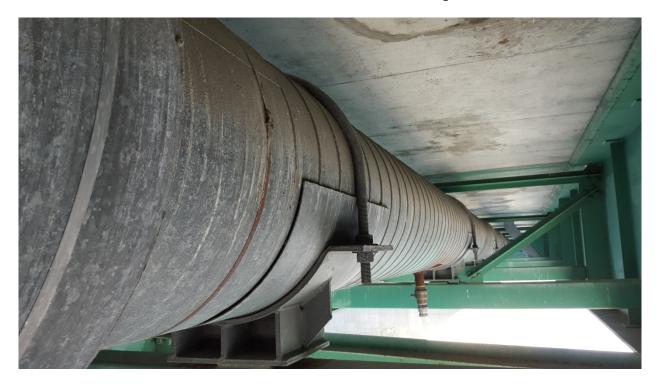
Site 3 – Force main at underside of bridge
