APPENDIX B – PORTAGE AND MAIN UNDERGROUND CONCOURSE ESCALATOR STUDY - JANUARY 2018

Subject: Winnipeg Square Escalators and Lifts

We have completed audits of the 8 escalators, 1 handicap elevator and 4 handicap lifts at the above captioned location. The results of our audits are as follows:

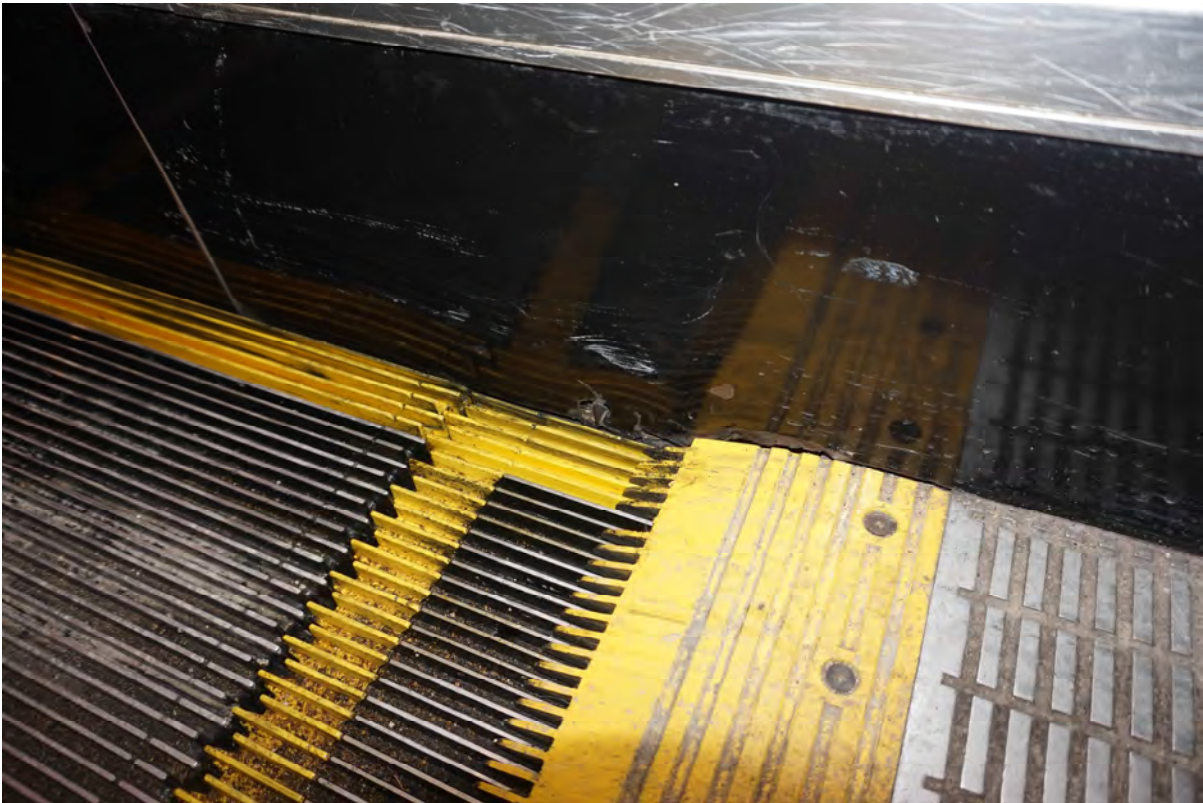
- Down escalator, skirt panel on one side is damaged and actually has a small hole in it. That skirt panel is loose and wearing on the sides of the steps, and needs to be replaced.

This skirt plate needs to be removed and replaced. It has a hole in it, and it is wearing on the steps.

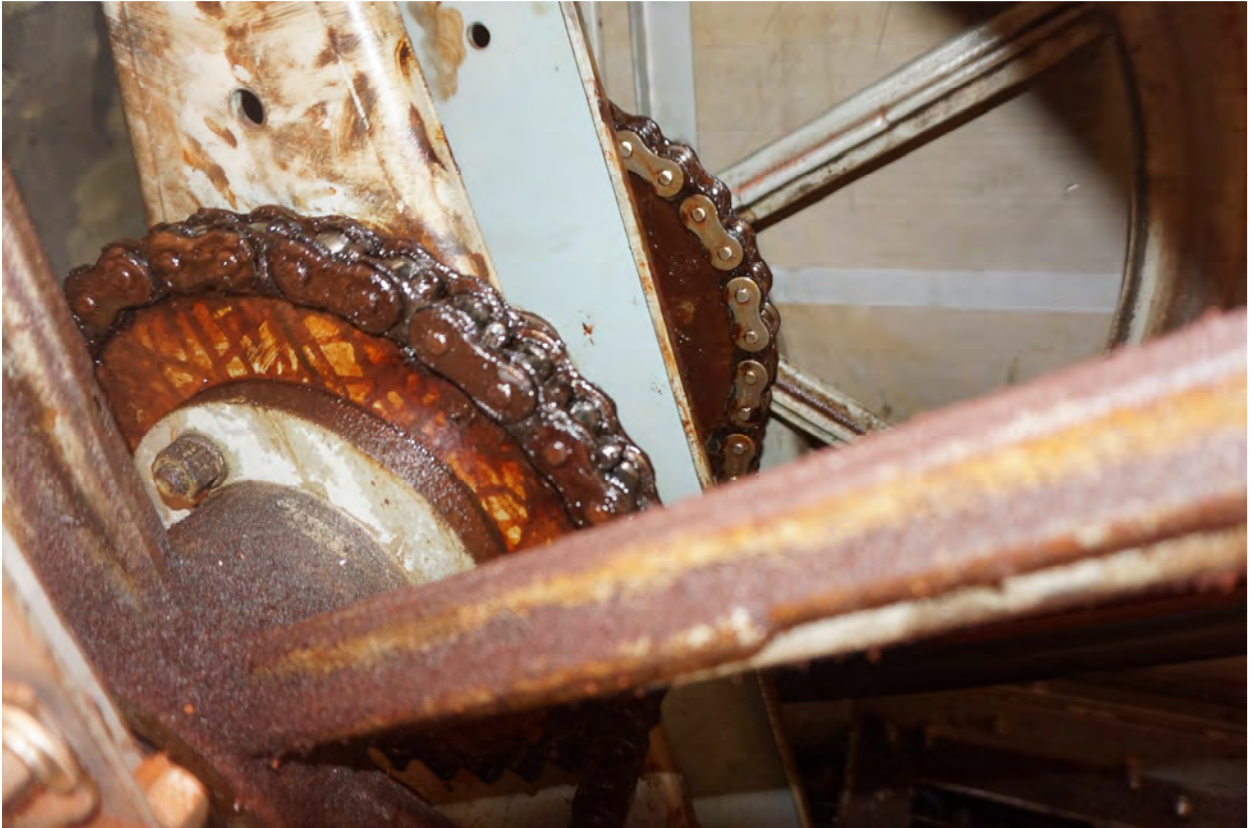
The handrail drive chain in the foreground is worn out (down escalator).
Chain in background is up escalator handrail drive chain (newer).

- Down escalator handrail drive chain should be replaced. The up escalator drive chain is newer.
- All balustrade fastening bolts should be removed, larger holes drilled and tapped, and new fastening bolts installed. Some screws are different, some holes are stripped, a couple of holes have broken bolts stuck in them.

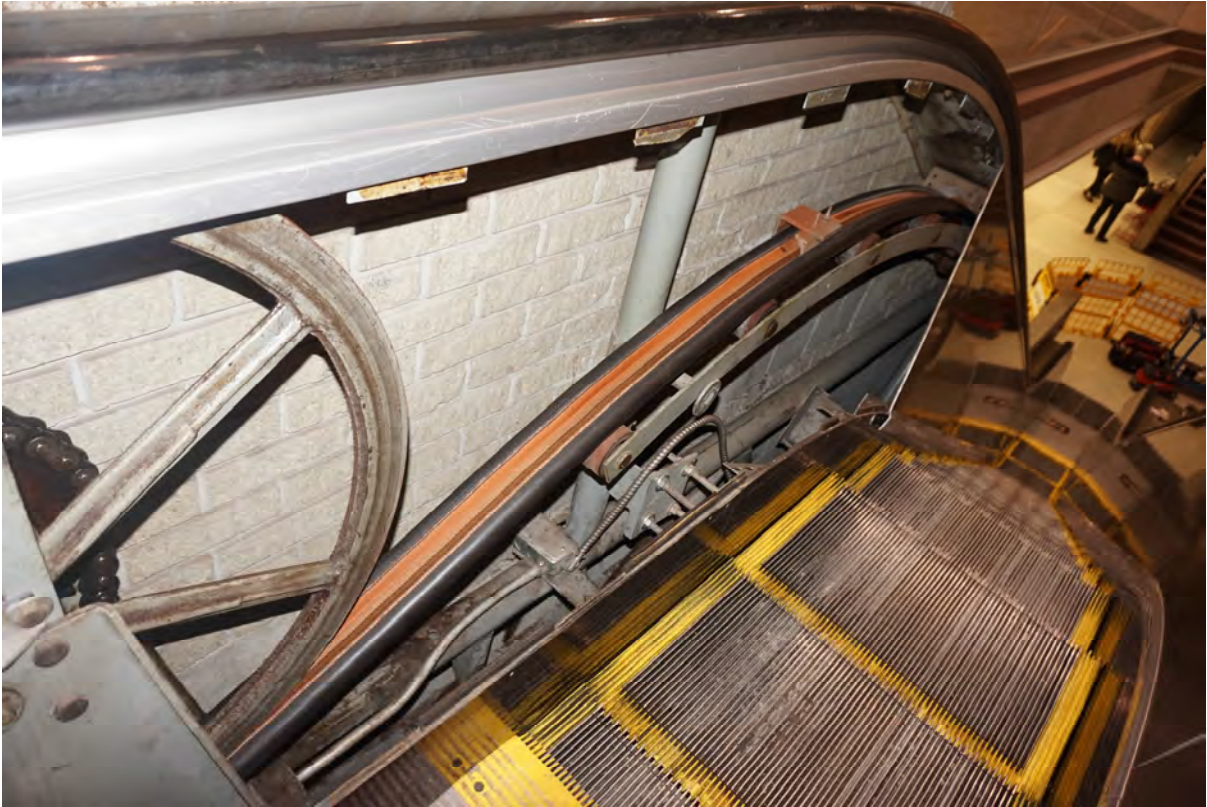
Handrails are in good shape on both escalators. Drives are working properly.

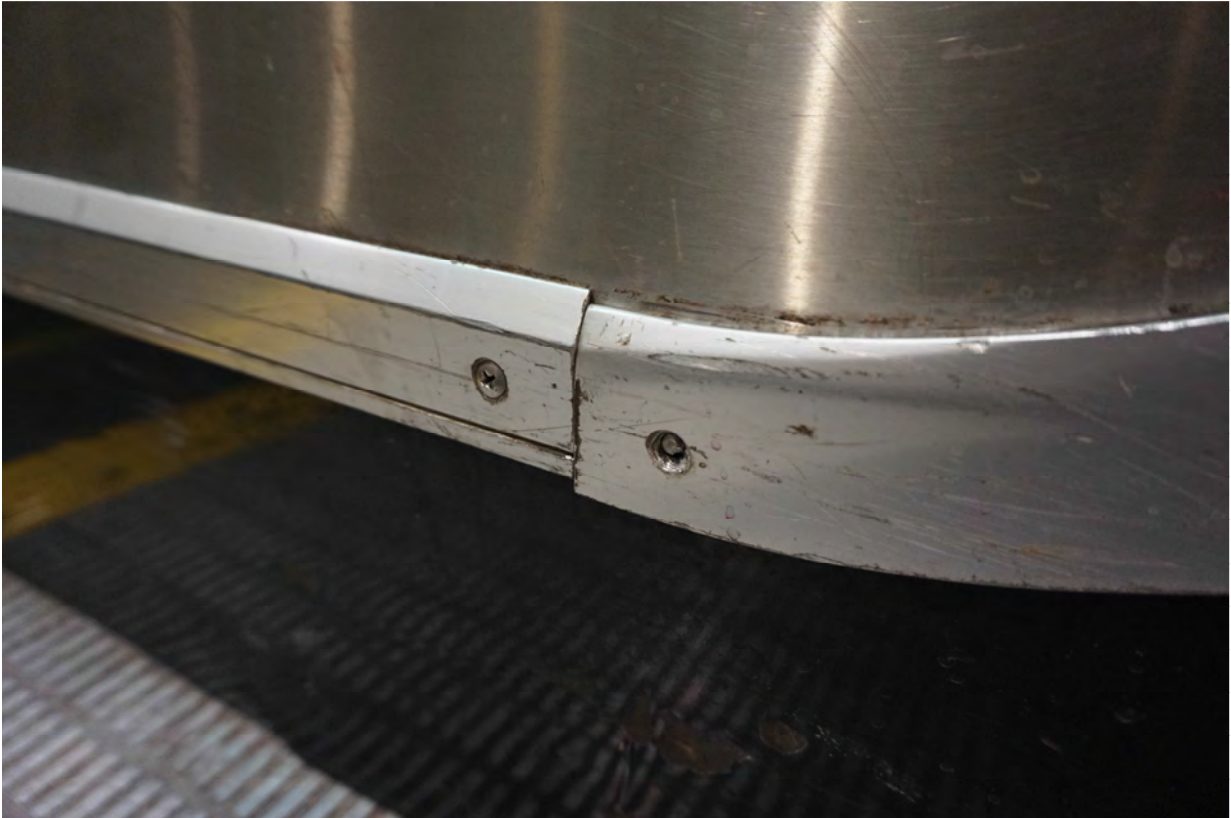
Broken off bolts in the trim holding balustrades in place. All these should be drilled out, re tapped, for new fastenings.

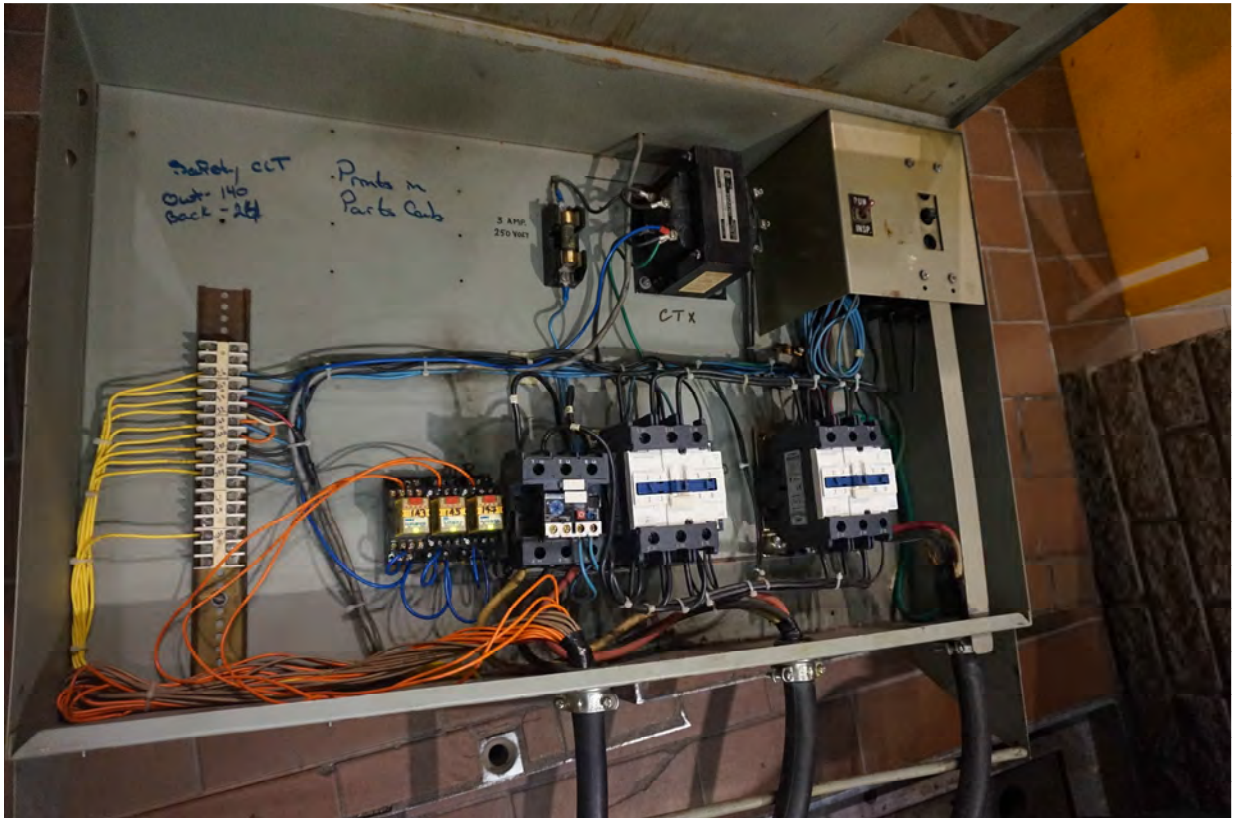
Controllers are clean. Additional relays have been installed to facilitate troubleshooting.

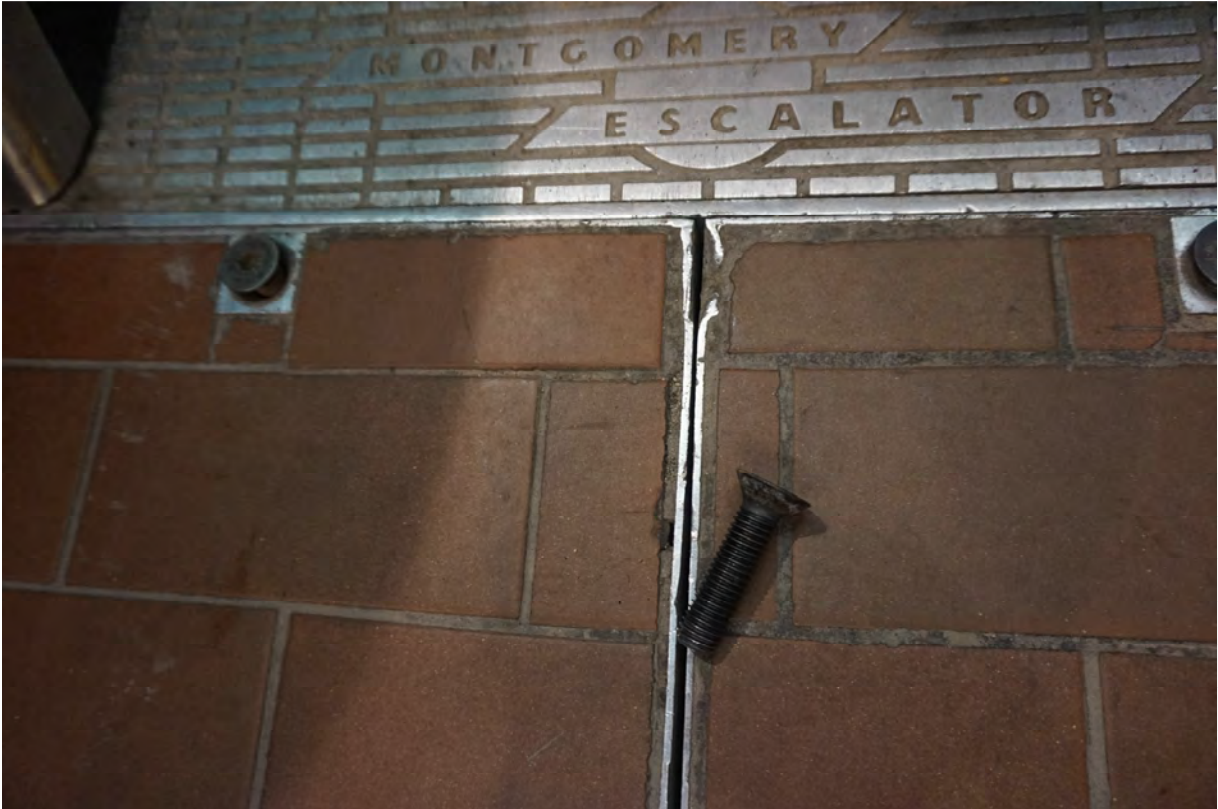
Floor plates damaged due to improper removal means.

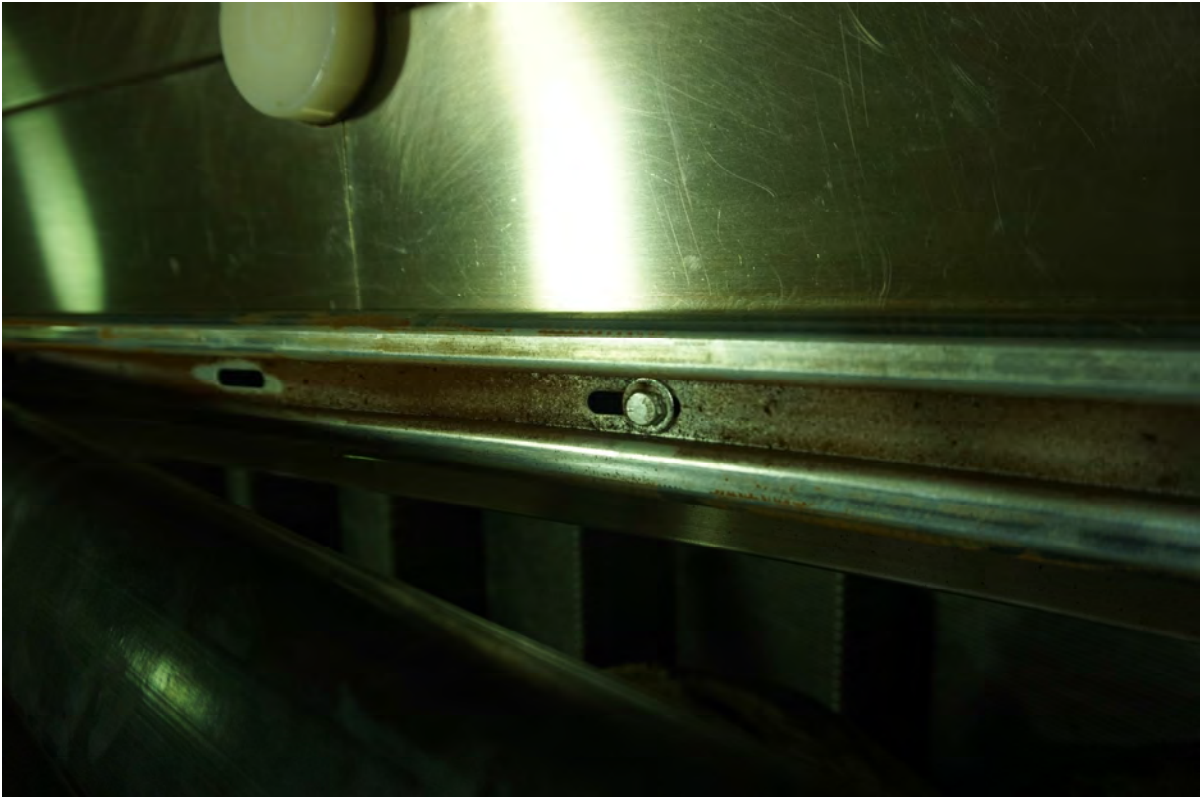
This is the fastenings under the handrail. Some are missing. If these get loose, they wear on the underside of the handrail. The handrails should be removed, and all hardware should be checked, replaced as necessary and fastened with lock tite.

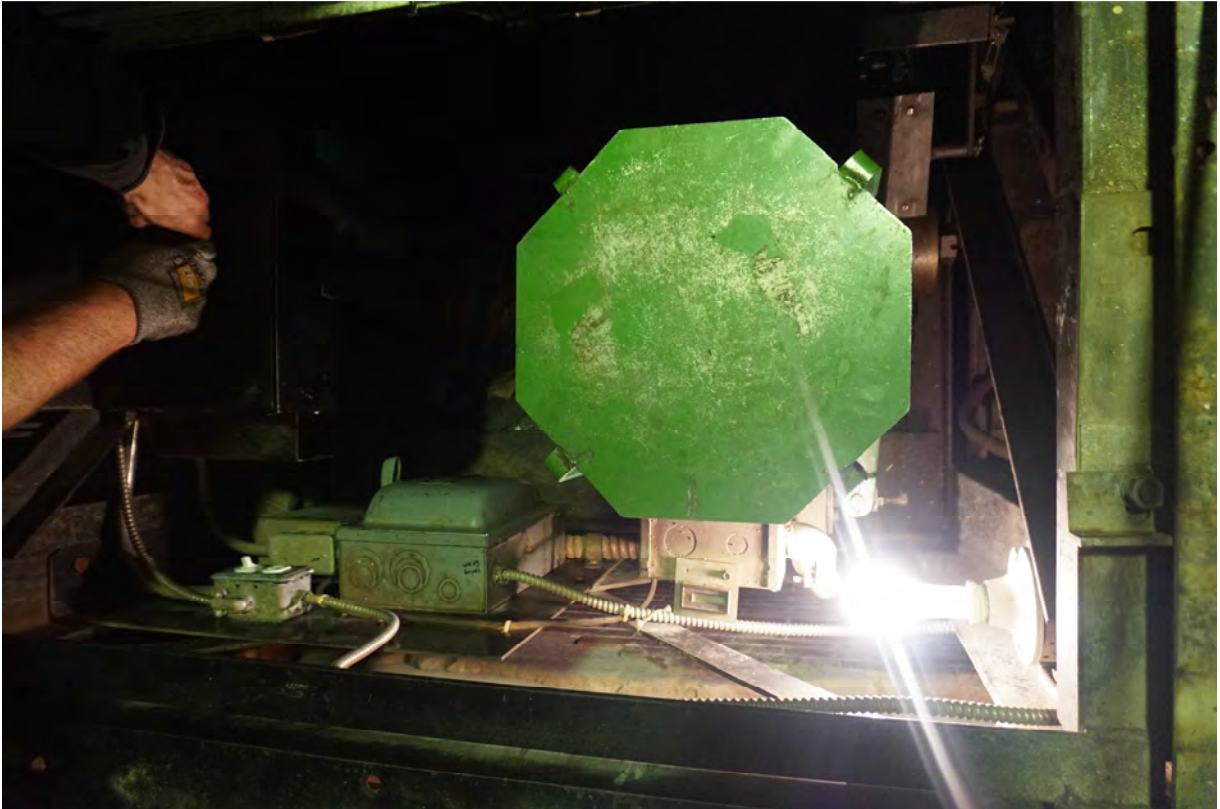
This is the upper pit of the down escalator. The light is really bright and singular, and reduces night vision, and casts a shadow on the other side of the machine, making it really difficult to see anything. All escalator pits should get lighting improvements to facilitate maintenance and safety.

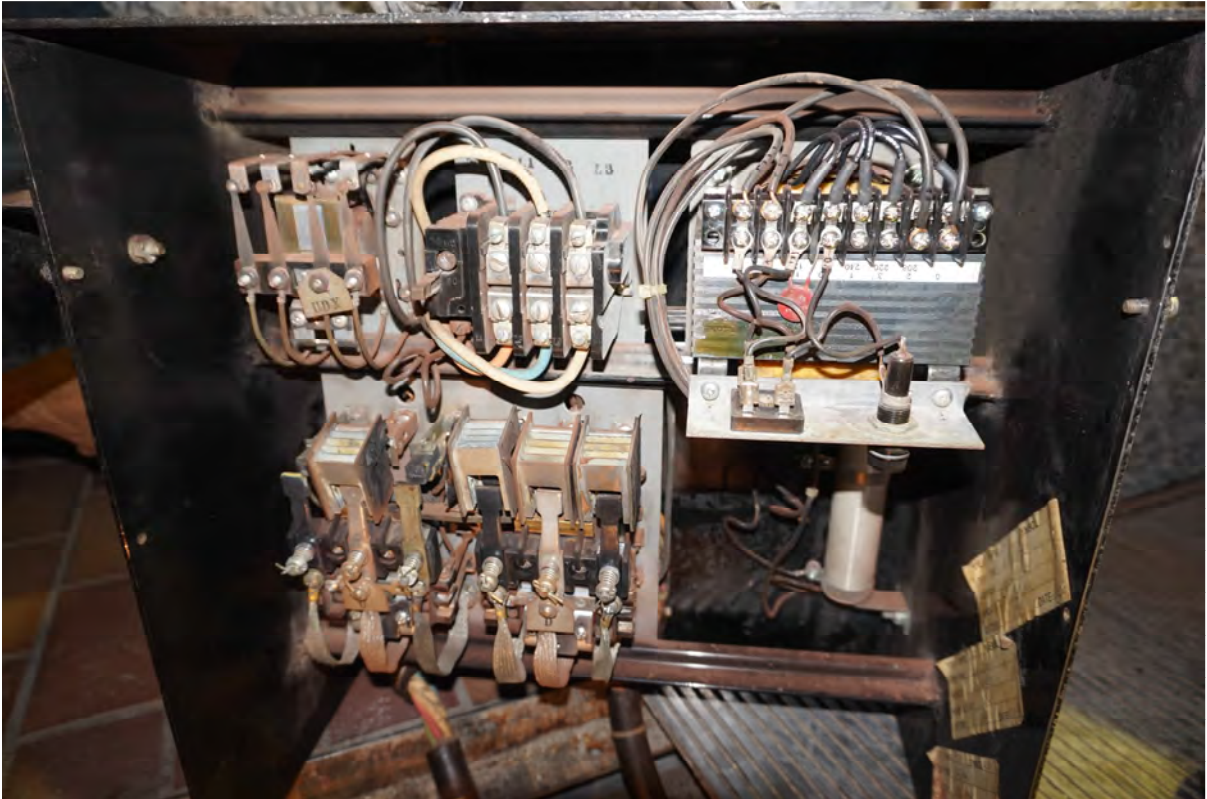
This is the up escalator controller. Some arc deflectors are missing which should be done under maintenance. These contactors are really heavy and they don't turn off sometimes when the controller is laid down. This is a safety concern. Emergency stop switch should be installed in the upper pits of both escalators.

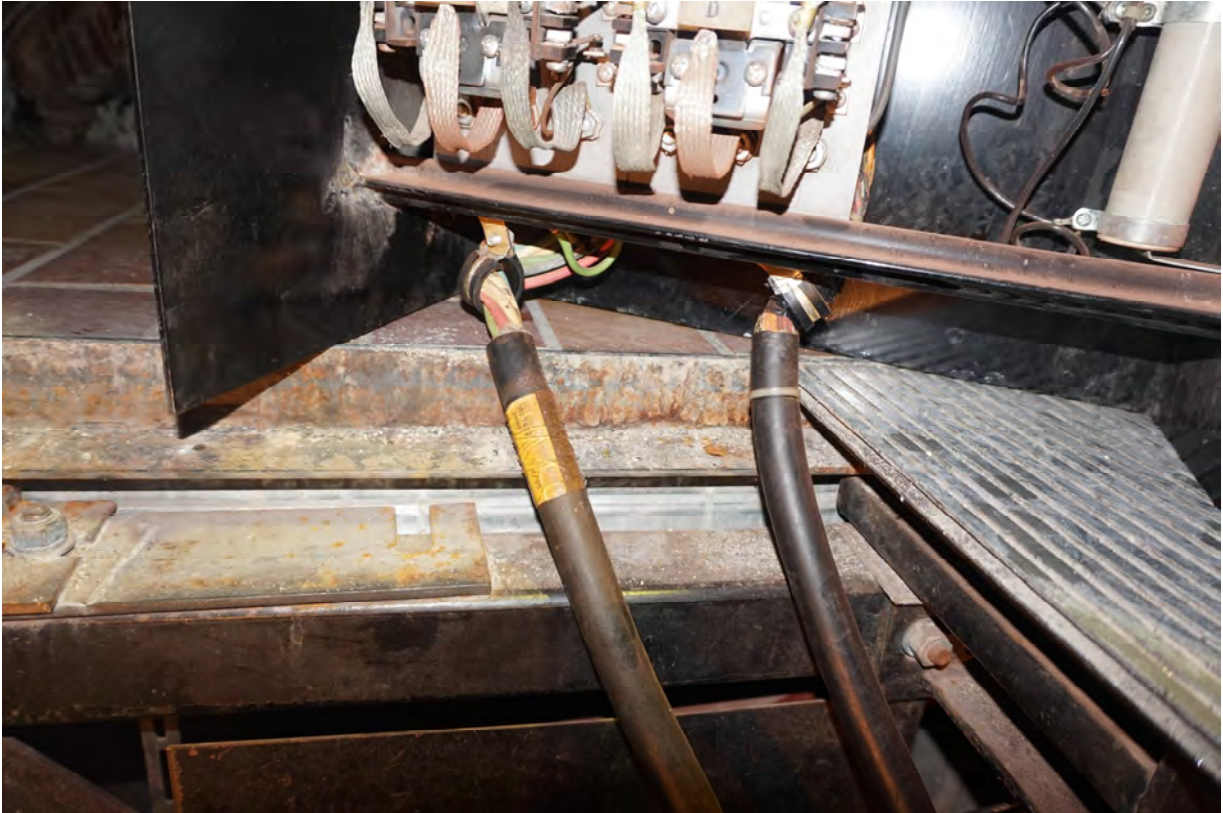
- There are some missing arc deflectors in the controller. Central will replace these under maintenance.
- The control cable to the controller is also coming off its' fastening. This should be repaired under maintenance.

These connectors should be repaired to avoid damage to the cables.

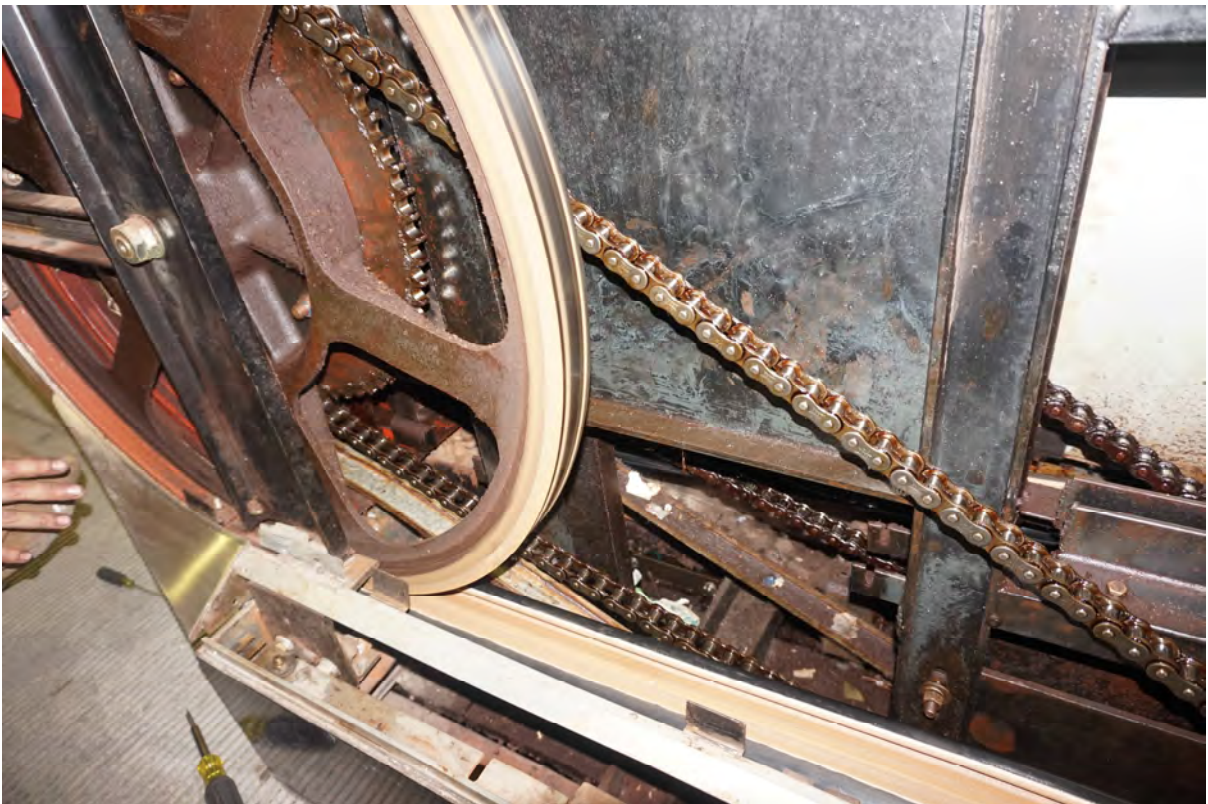
Up escalator handrail drive chain is in the background. It should be done within 5 years.

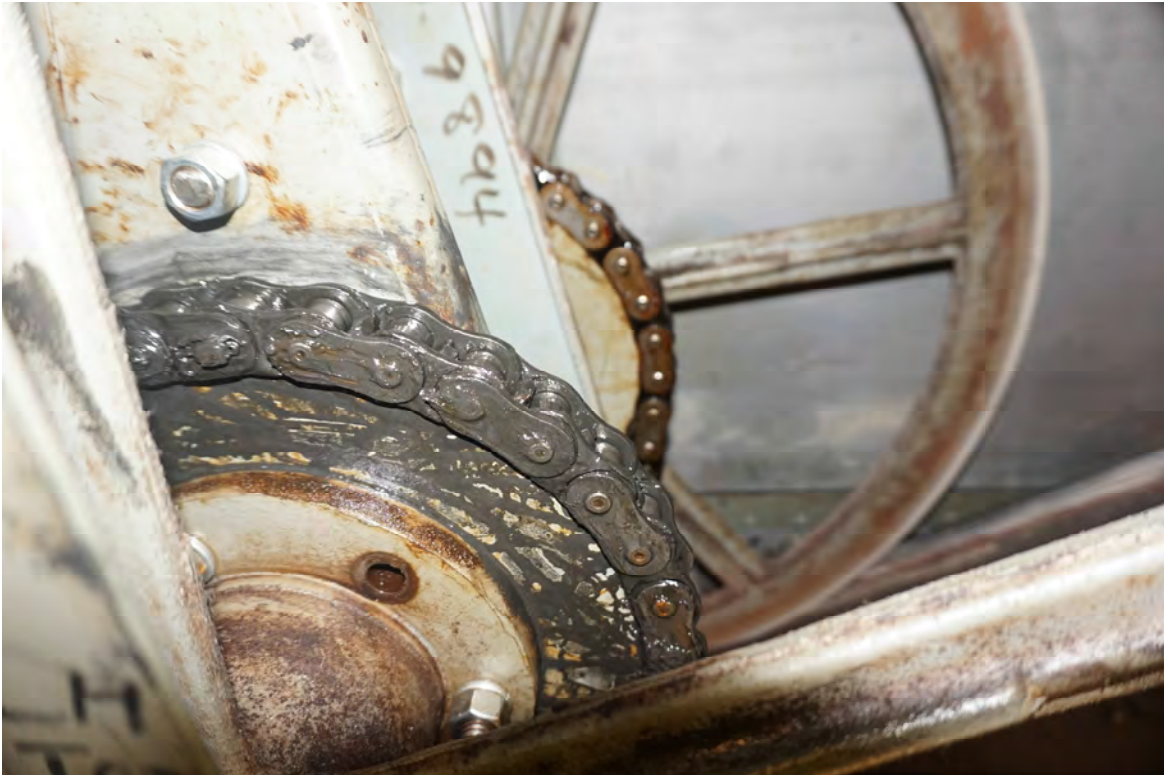
- These escalators have skirt panel brushes.
- Down escalator handrail drive sprocket right hand side was recently replaced.
- Down escalator handrail drive chain is damaged. Aluminum from a disintegrating tensioner has contaminated the lubrication and caused undue wear. It should be replaced within a year.

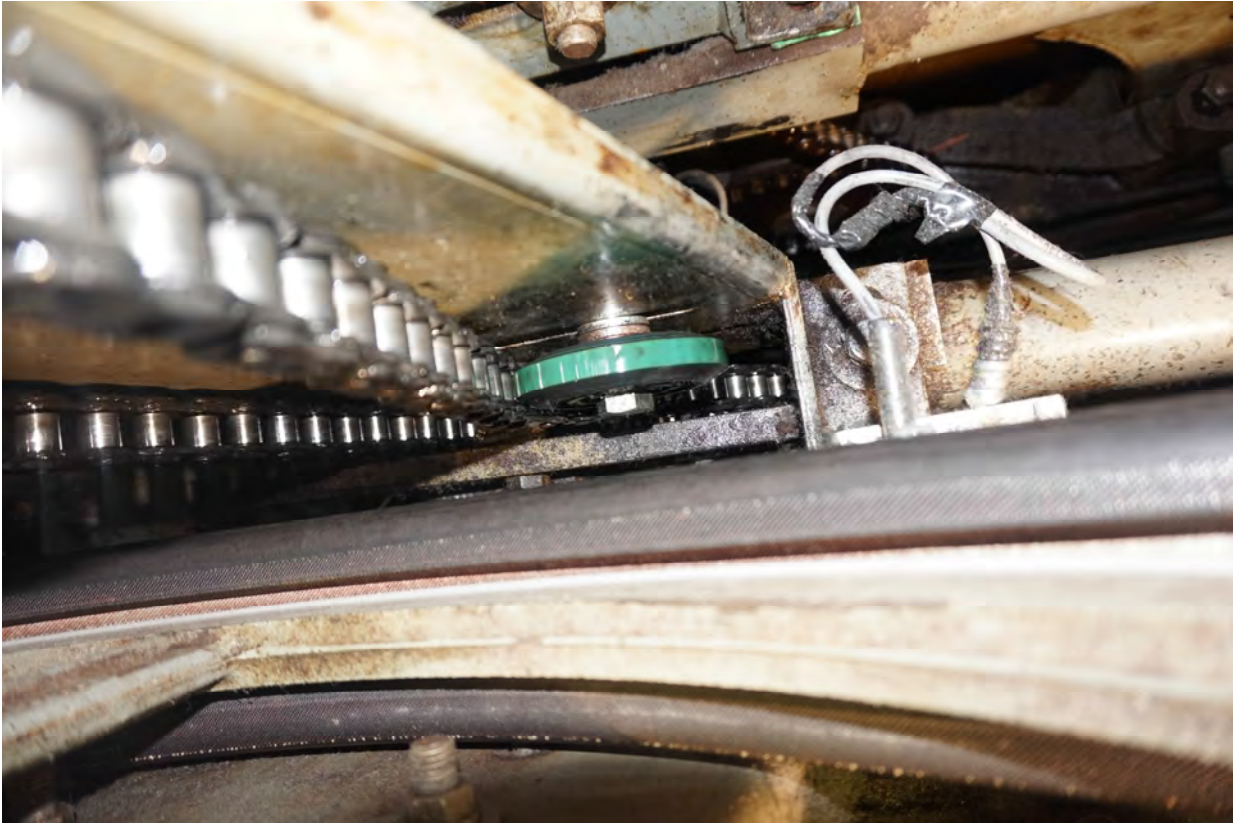
This is the new, non-aluminium, handrail drive chain tensioner.

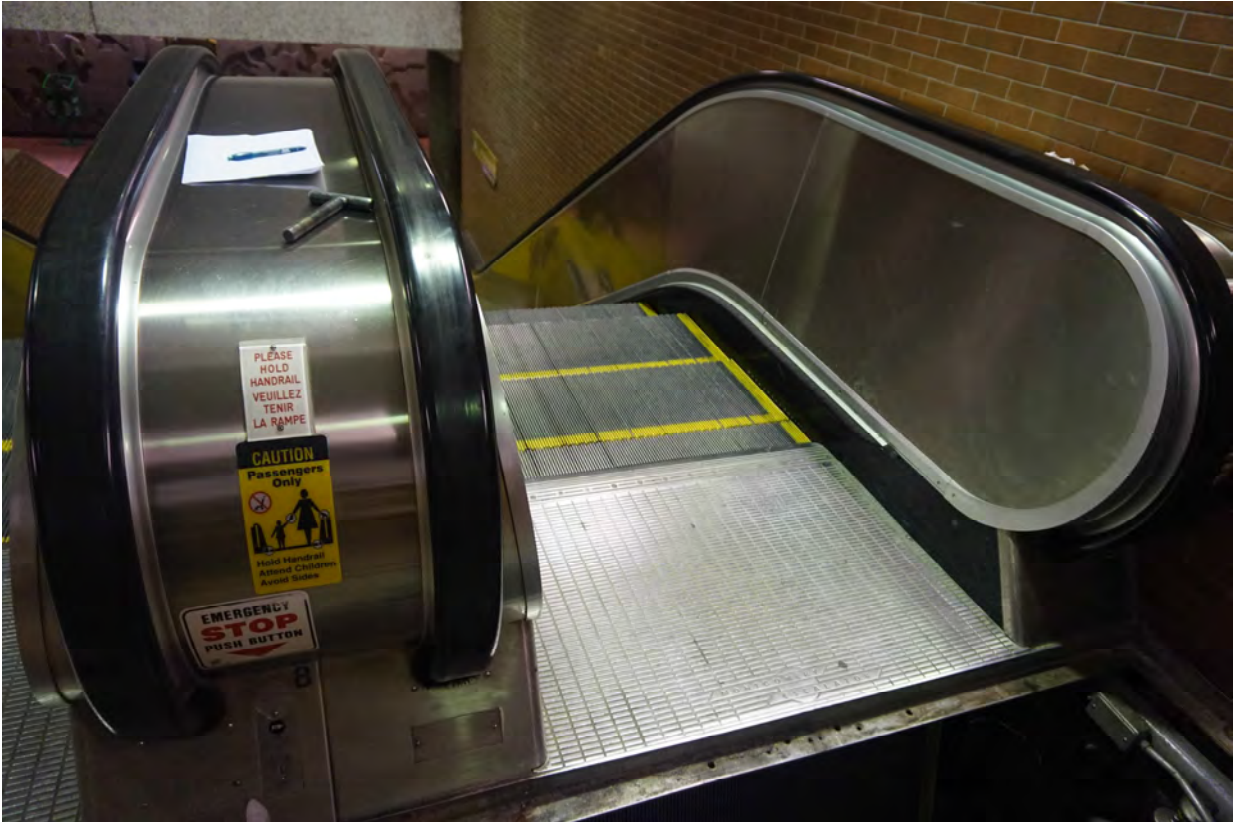
These escalators have the skirt brushes. Skirt brushes are installed just above the steps on the top of the skirt panels, which discourages pedestrians from getting their feet right at the step / skirt panel intersection. That intersection is the cause of most escalator entrapments, where clothing and rubber boots get drawn into the escalator. These should be installed on all escalators that don't have them (#1, #2, #3, #4, #5, #6)

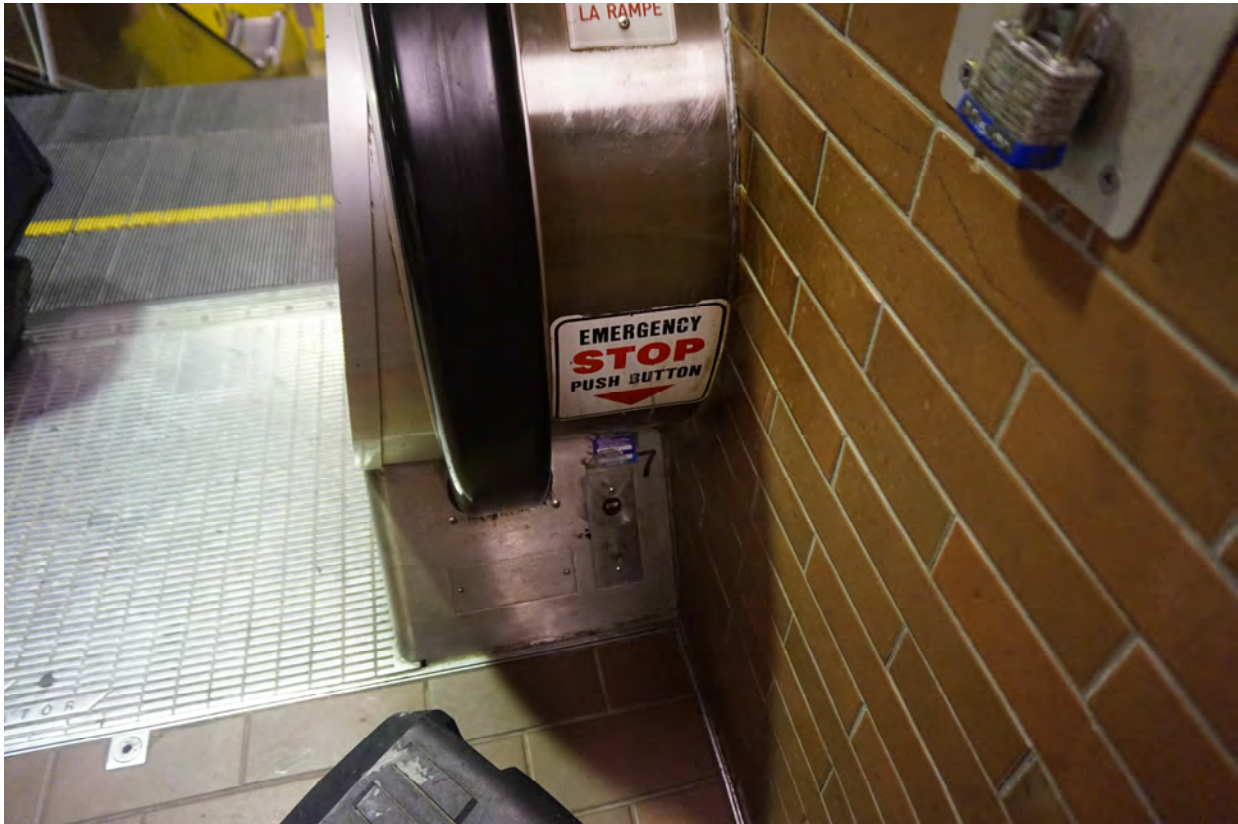
This is the emergency stop switch. Modern ones are located on a pedestal between the escalators at upper and lower landings and are highly visible and accessible.

- Emergency stop buttons are hidden away and hard to access. We recommend stop switches on pedestals with alarming covers be installed at upper and lower landing of all escalators. This is a non retroactive code requirement. However if something were to

happen such as an entrapment, modern style stop switches would facilitate a pedestrian being able to quickly stop an escalator. This applies to all escalator groups.

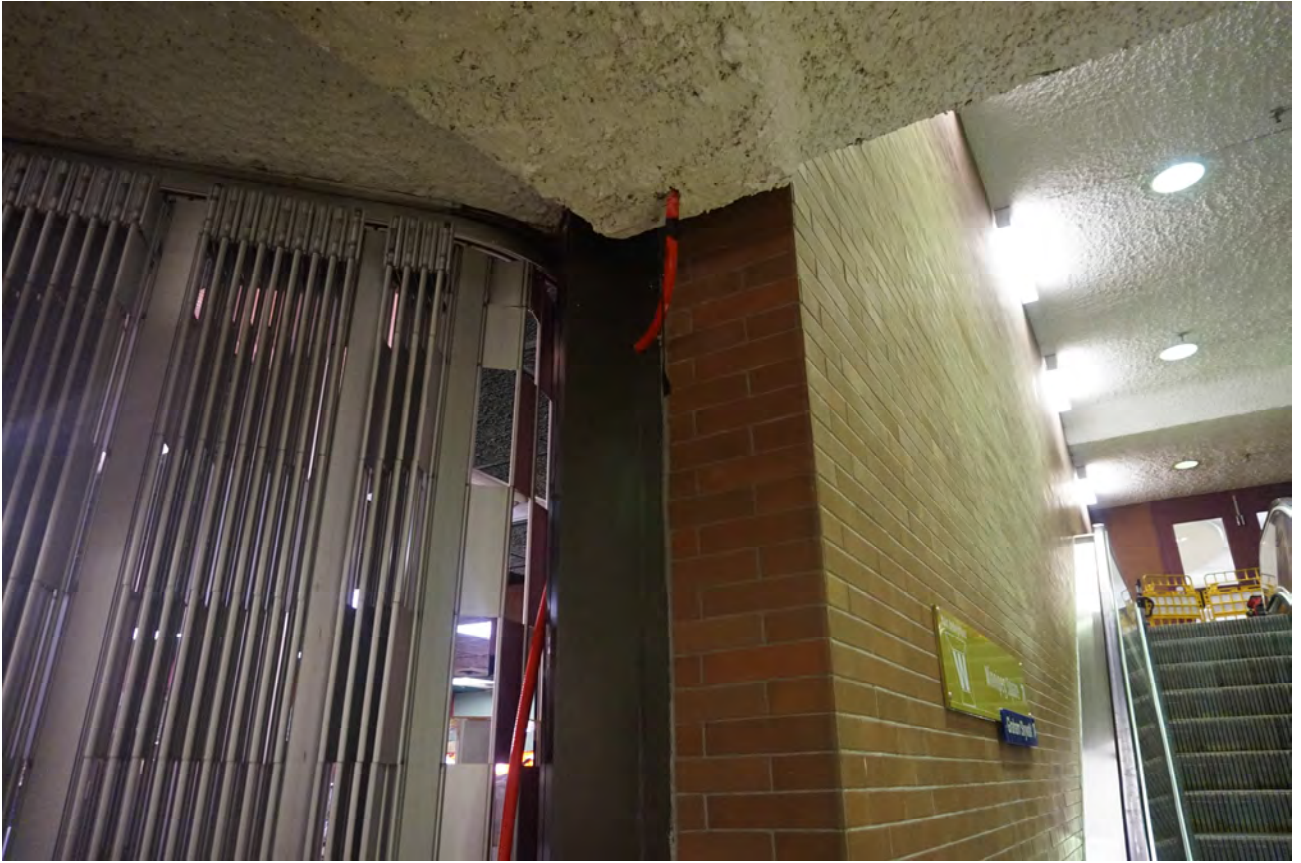
- Plumbing needs to be fixed! At the bottom of the escalators, there is a red hose that leaks water from some unknown source above. This occasionally gets on the escalator floor plate. If it leaks badly it could wash the lubrication off the step chain, and then step chains would have to be replaced, which would be very costly (\$60,000.00).

This is the red hose from which water from above comes. It is directed into a bucket, but has been known to overflow, or come out of the bucket and cause water to be deposit on the down escalator lower landing floor plate. This risks very expensive damage to the escalator. We strongly recommend that a permanent solution should be found to redirect this moisture.

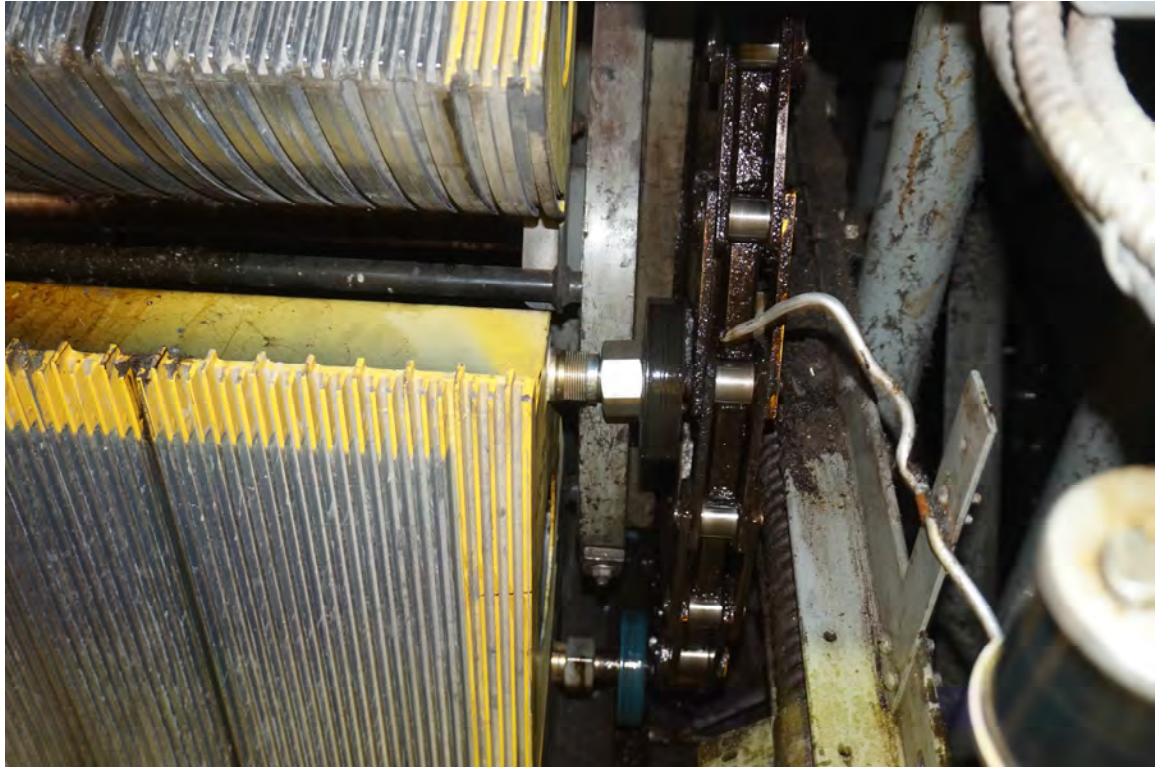
This nut has been removed from the step axle. These nuts were excessively tightened, so that when trying to remove them, the seal between the axle and the step sides were broken, now the axle spins within the step. When it spins, it moves from the position it needs to be in to facilitate step removal.

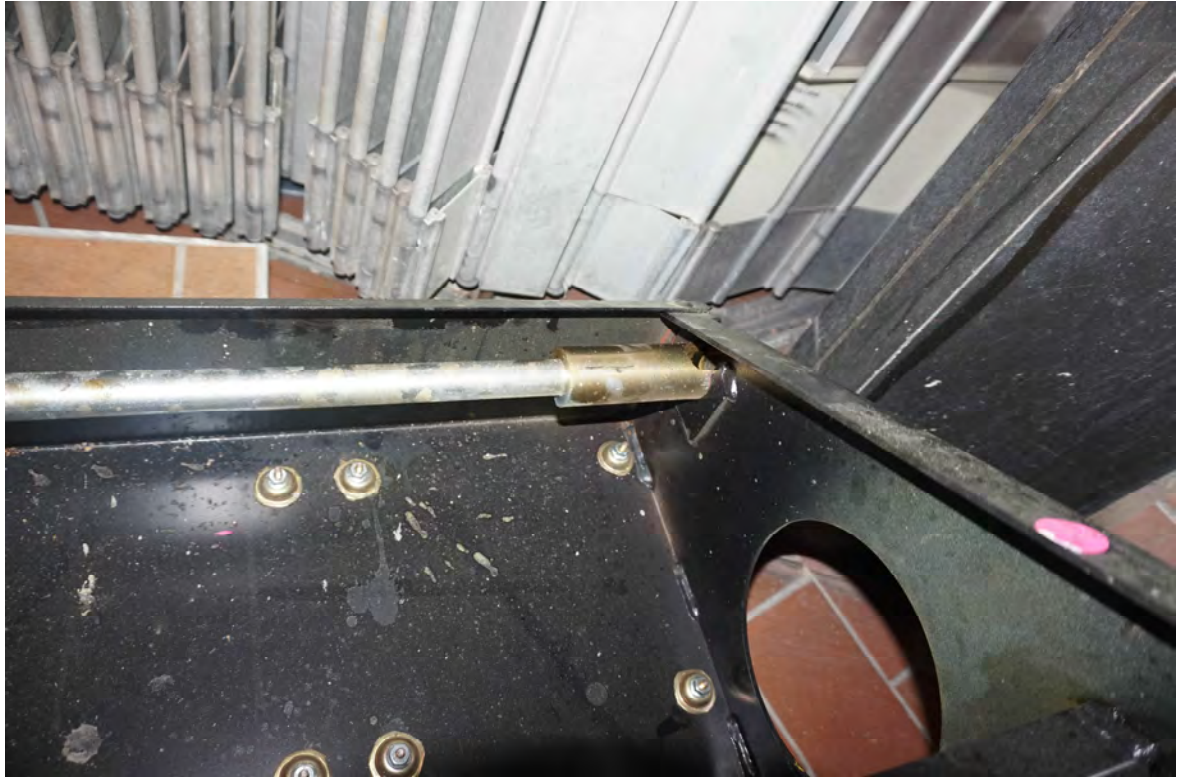
The step axle is horizontal, the inside of the step is black. Where the axle passes through the side of the step it is a negative interference fit. On many steps this rigid fit has been broken free, allowing the axle to spin when trying to remove the nut. If the axle spins, the nut can't be removed. Once the axle spins, it moves out of the position it needs to be in, to remove the steps.

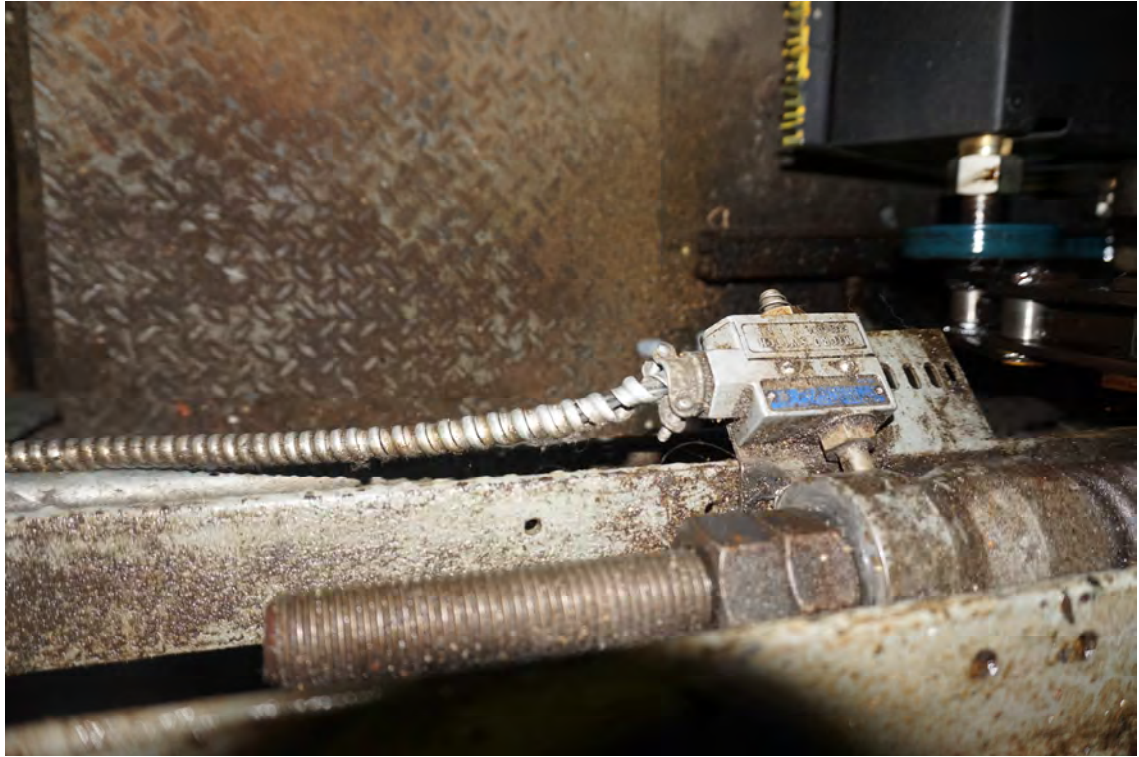
- Flex needs to be replaced at one step chain tension safety switch. This will be done by the service provider.

This flex will be replaced under maintenance.

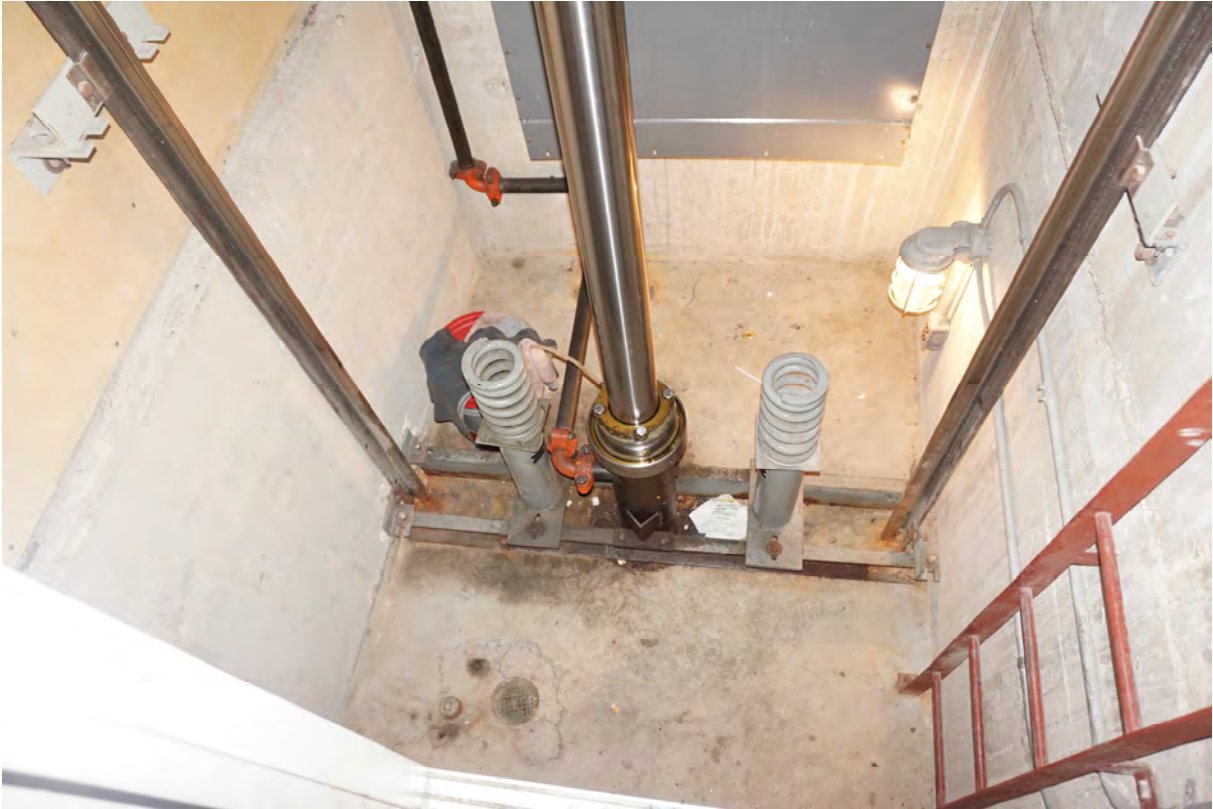
This photo shows the in ground hydraulic cylinder for the handicap elevator.

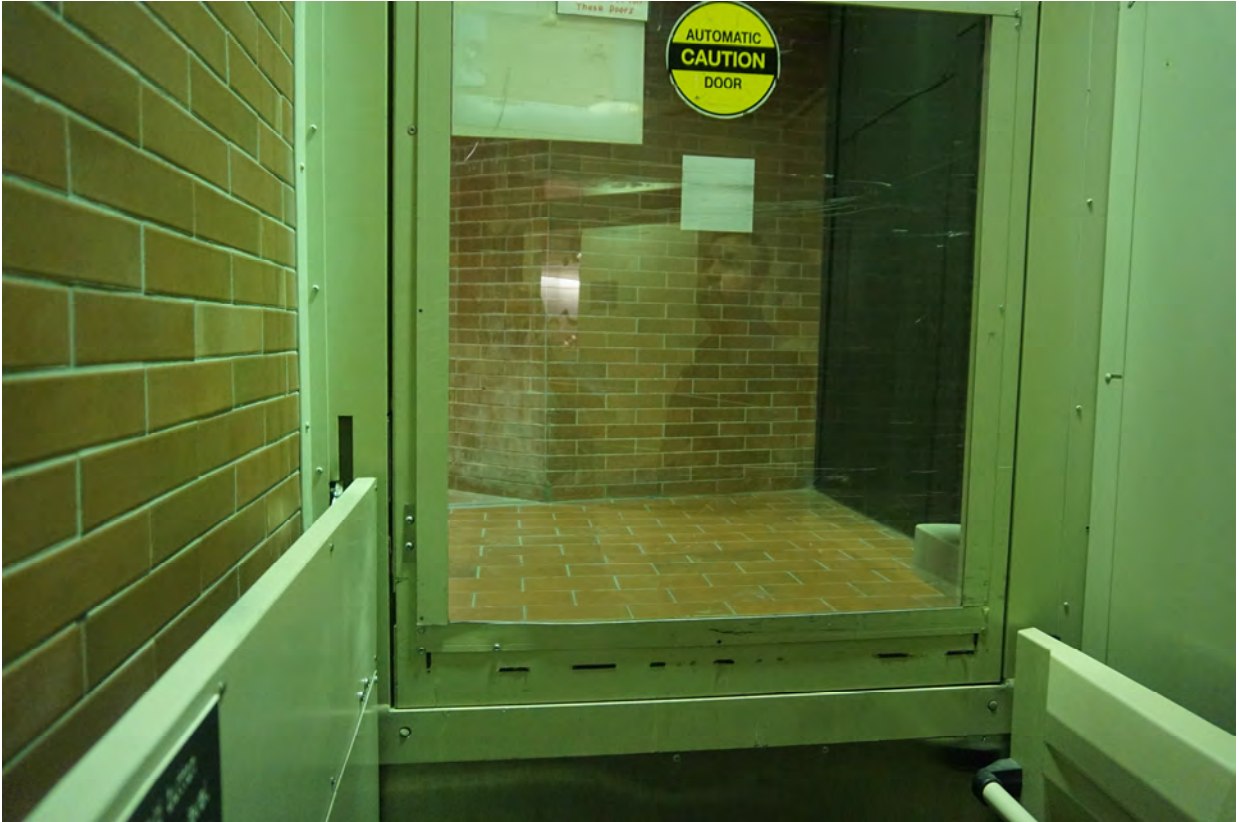
- Lower door is full height, power operated.
- Upper door is a half door, also power operated.
- Upper door is badly damaged. It opens with the speed and force that it is designed for, but it is too slow for some users of the lift. It has been repeatedly smashed from the inside. This door should be changed, and a floor stop should be installed so that it can't be over extended at the upper landing.

Upper door is damaged and should be replaced.
