APPENDIX B – PORTAGE AND MAIN UNDERGROUND CONCOURSE ESCALATOR STUDY - JANUARY 2018

Subject: Winnipeg Square Escalators and Lifts

We have completed audits of the 8 escalators, 1 handicap elevator and 4 handicap lifts at the above captioned location. The results of our audits are as follows:

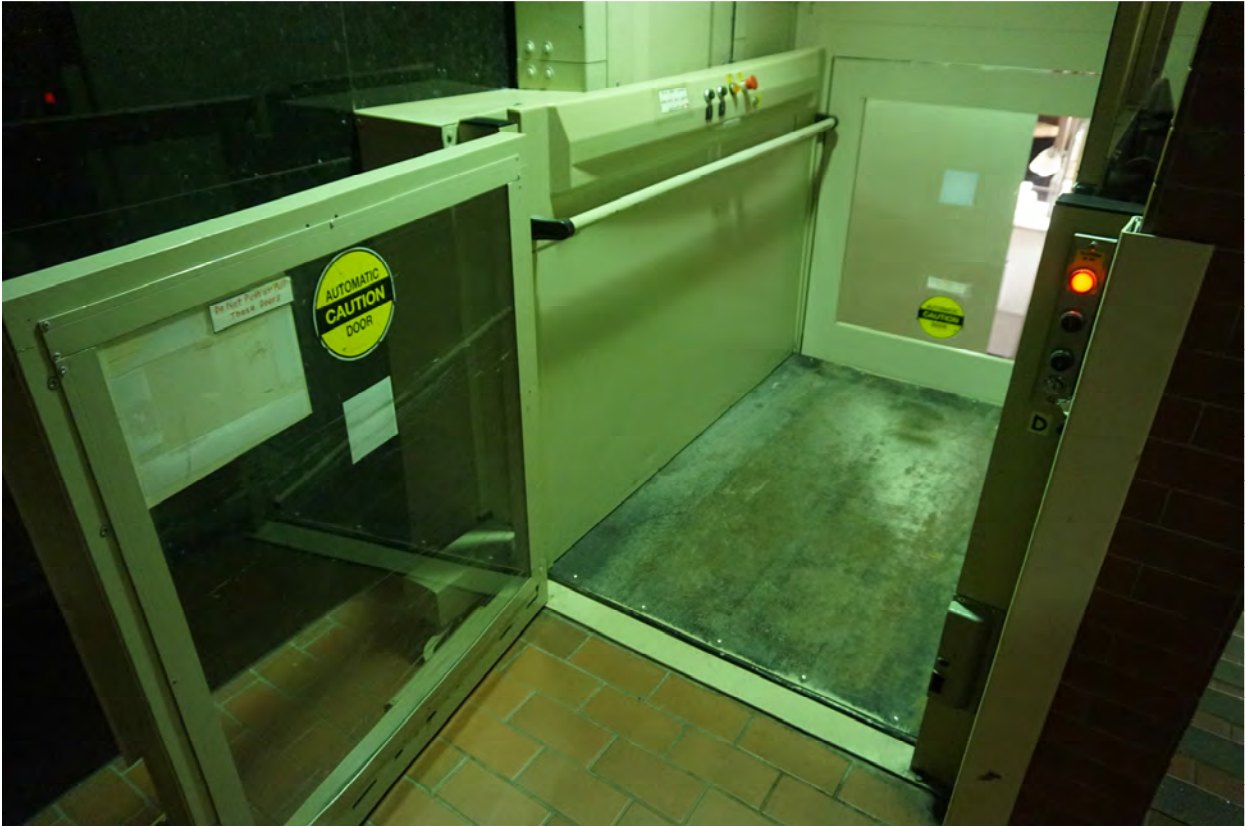
- The flooring in the unit has been removed, revealing a bare steel floor surface. This does not meet the requirements for barrier free design for a slip resistant, colour contrasted lift floor surface, and new flooring should be installed.

This lift requires new flooring to be installed.
