# ASBESTOS INVENTORY CONTROL (R1)

<b>Building Name:</b>	Cornish Library	<b>Inspection Date:</b>	September 24, 2018
<b>Building Code:</b>	LB-02	<b>Inspected By:</b>	Ryan Matthews & Will Deller
<b>Building Address:</b>	20 WestGate	<b>Construction Date:</b>	1914

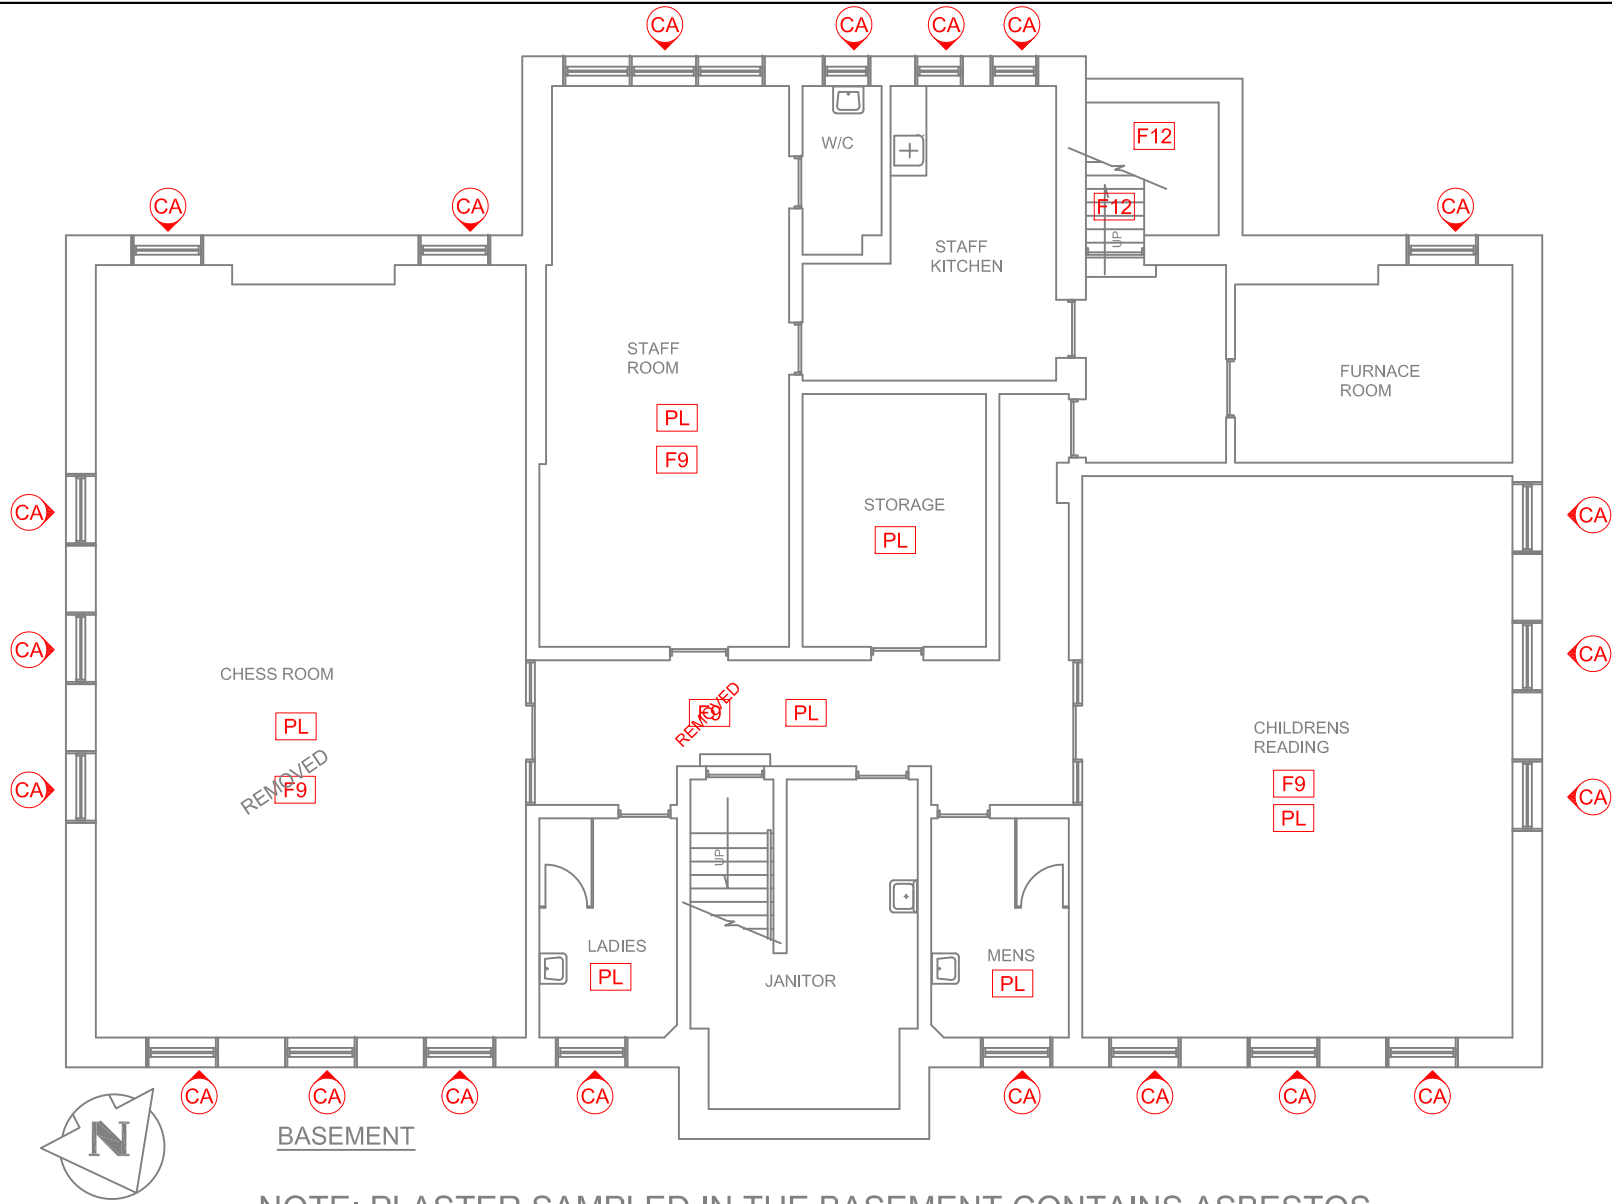
NOTE: PLASTER SAMPLED IN THE BASEMENT CONTAINS ASBESTOS.

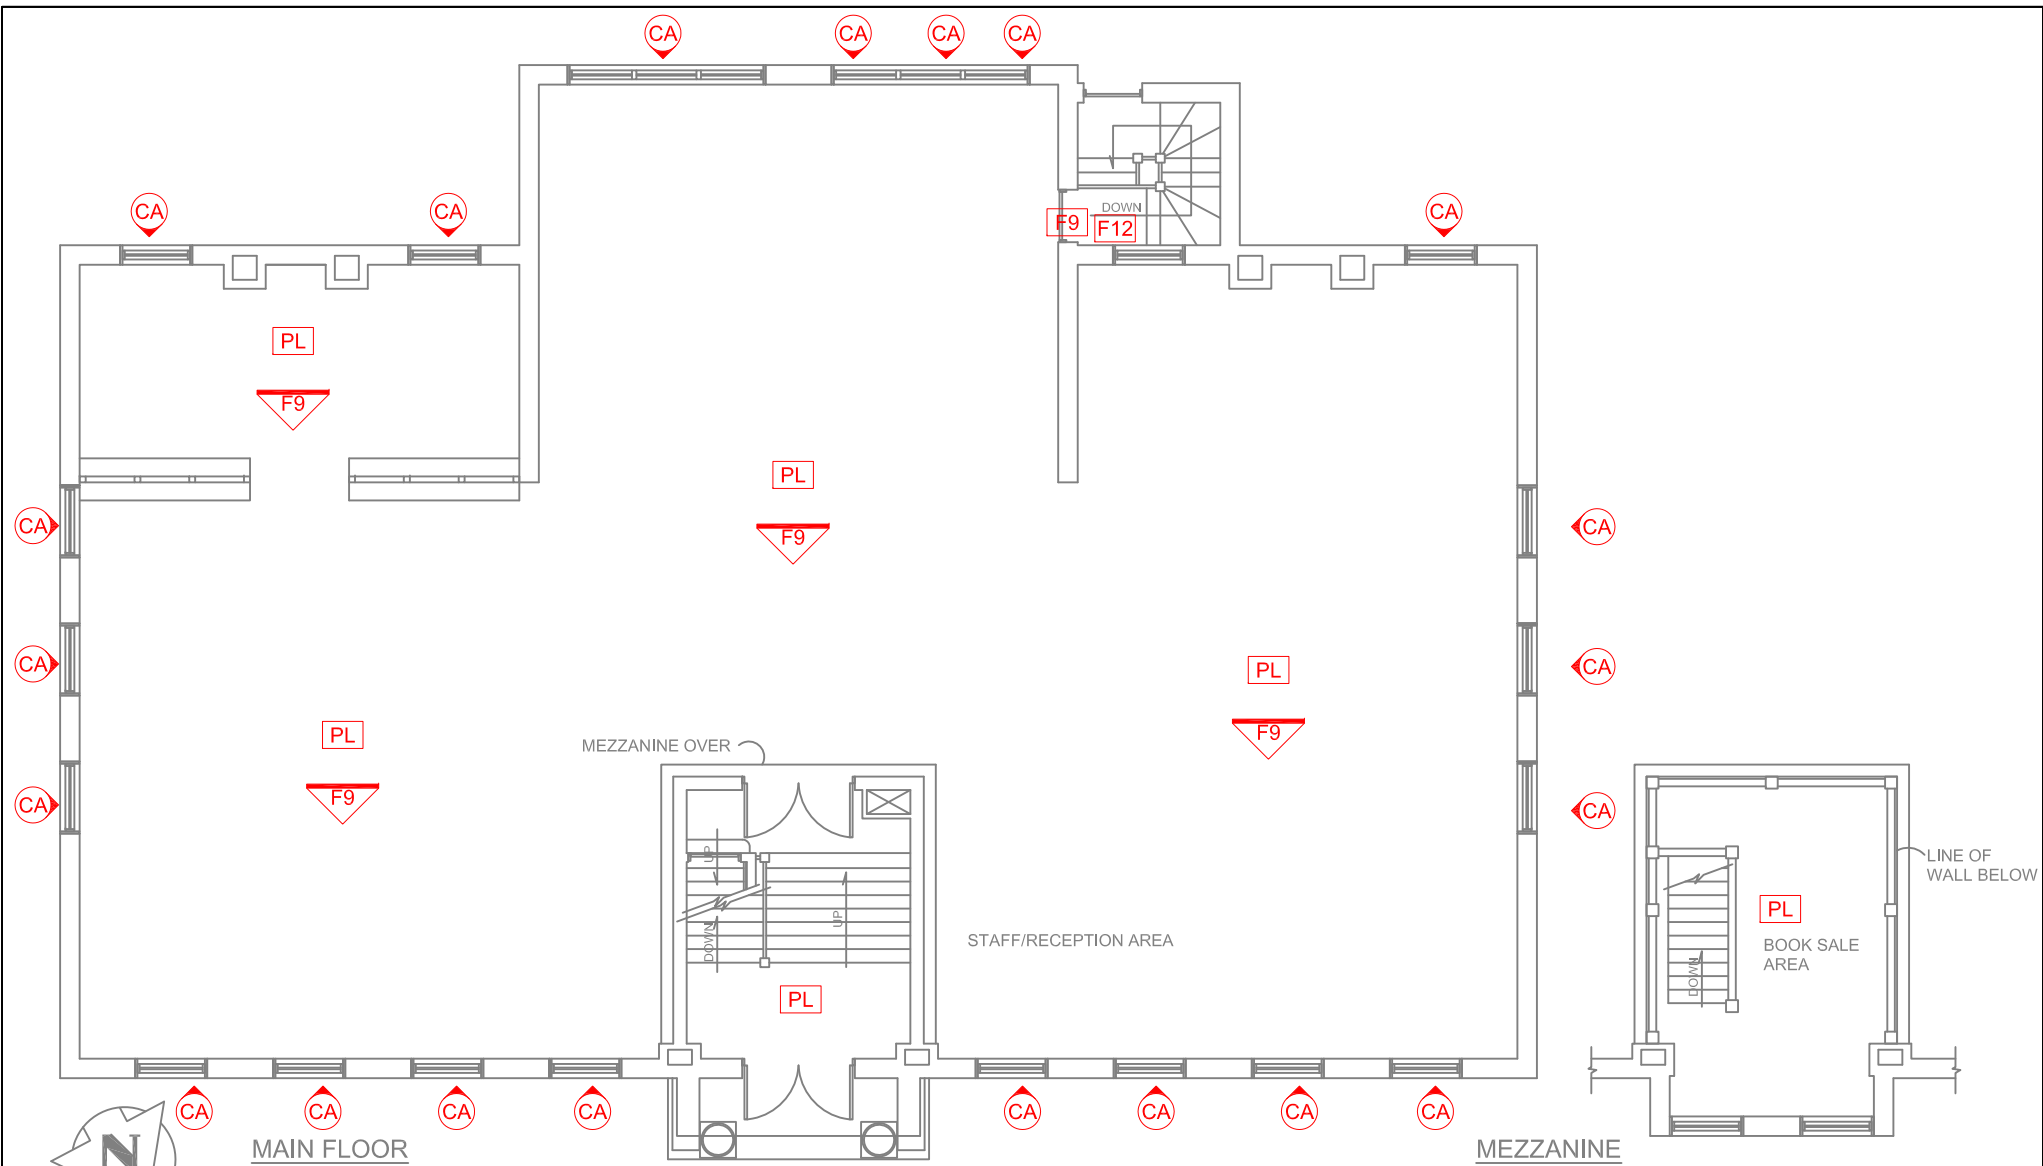
NOTE: PLASTER SAMPLED ON THE MAIN FLOOR DOES NOT CONTAIN ASBESTOS.
