CONCEPTUAL GATE CHAMBER DESIGN EXISTING CONDITION ASSESSMENTS

Prepared for:
The City of Winnipeg

Submitted by:
MMM Group Limited

March 2015

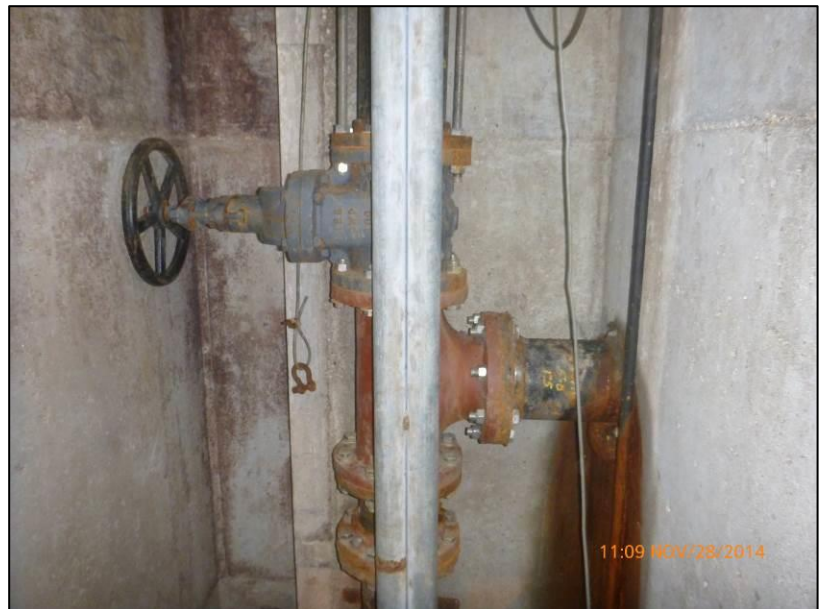
Photograph No. 3

Piping in upstream chamber to downstream chamber,
float switches not in use

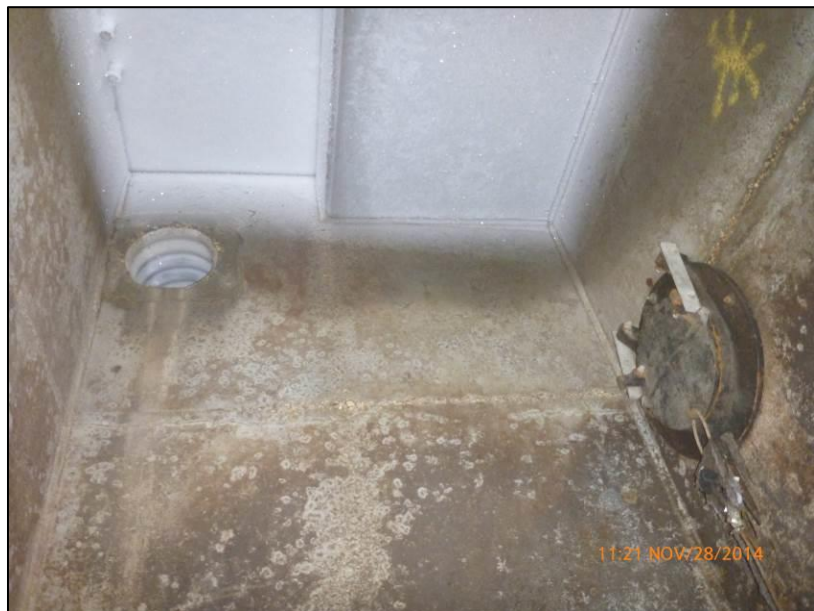
Photograph No. 5

Support for platform in upstream chamber, staining on concrete walls

The parts of the chamber that were visible and accessible were in overall good condition. Steel brackets supporting a timber platform in the upstream cell should be replaced with galvanized brackets if the platform is to be maintained. The condition below the waterline at the time of inspection is unknown and it is possible that there may be maintenance repairs required.

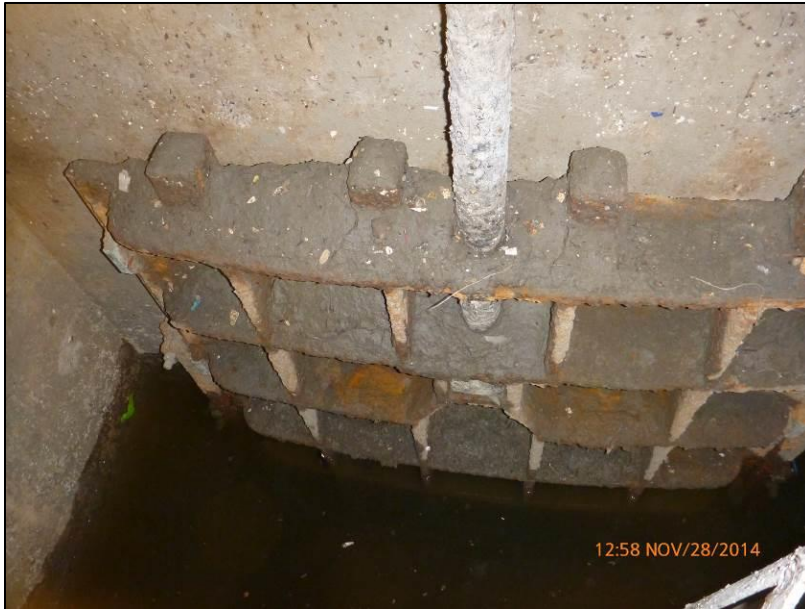
Photograph No. 8

Corrosion on gate stem guide

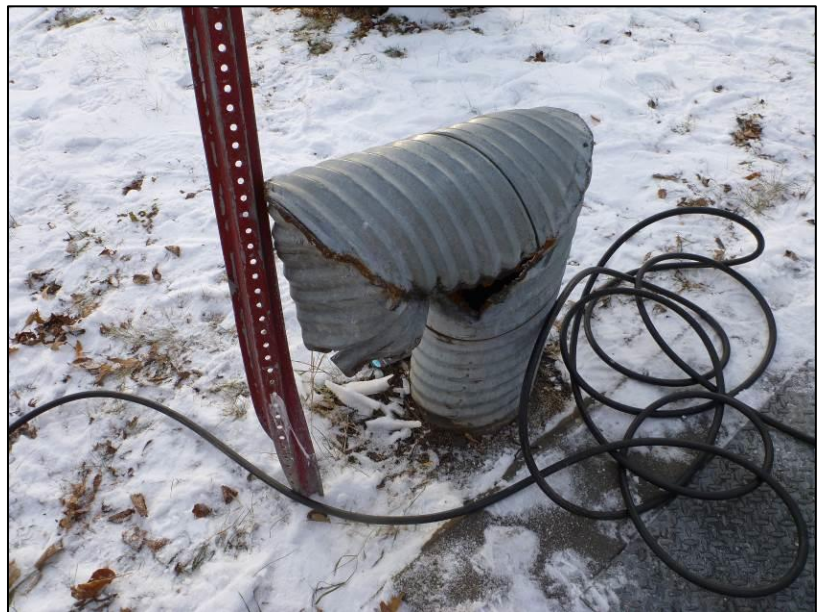
Photograph No. 2

Damaged air vent

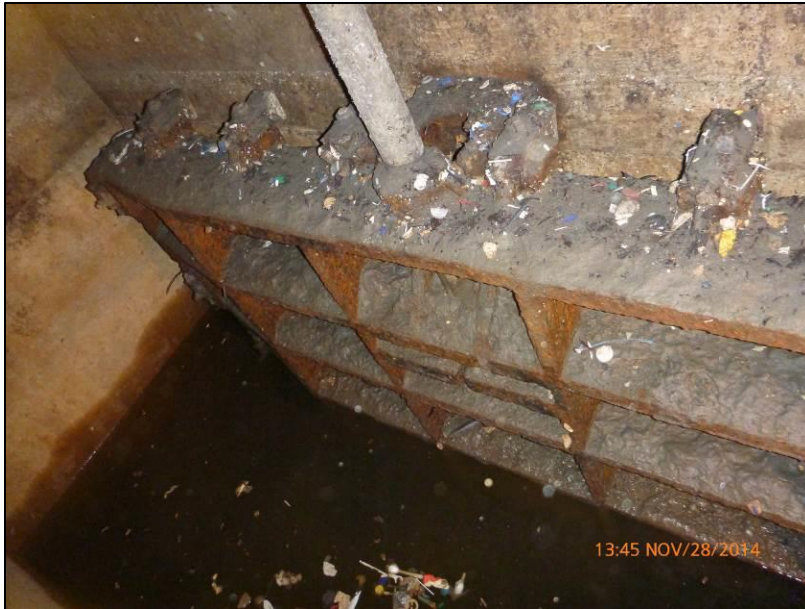
Photograph No. 8

Severe corrosion on gate stem guide

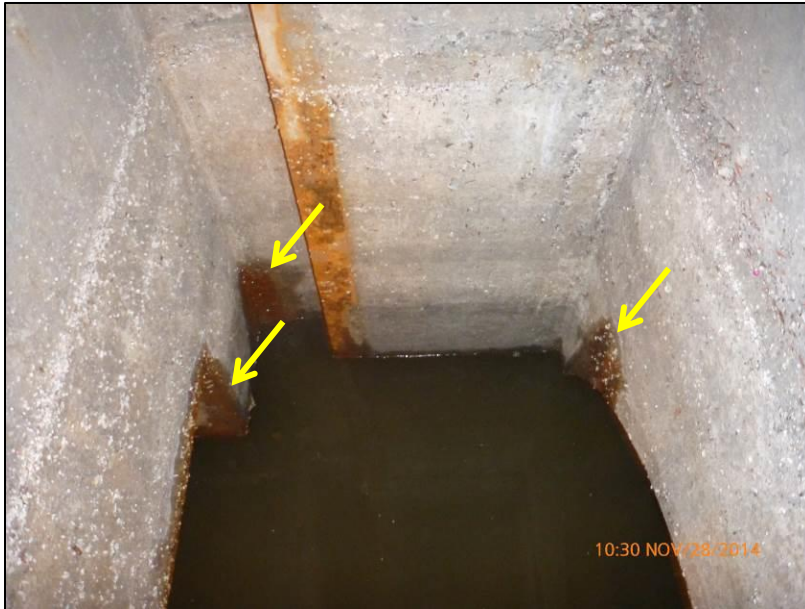
Photograph No. 5

Rust stains in concrete in upstream chamber

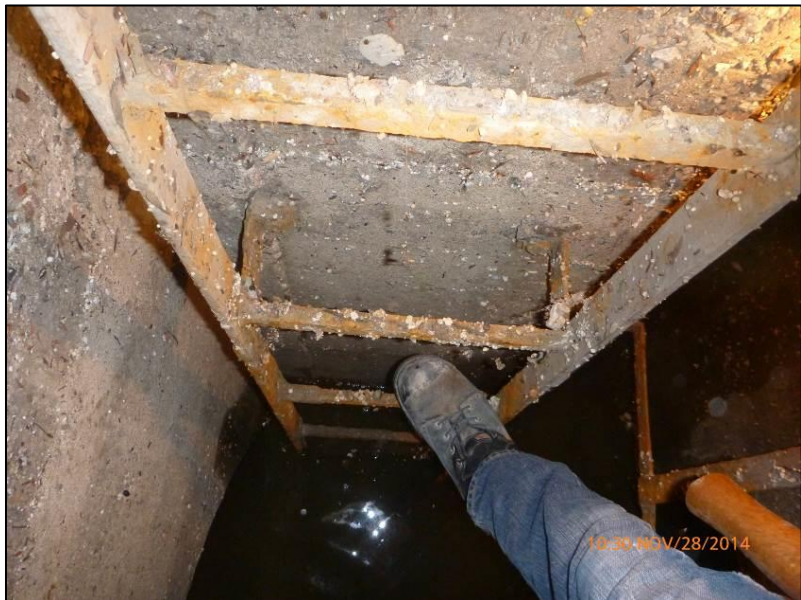
Photograph No. 6

Loss of galvanizing and corrosion on ladder
