ASBESTOS INVENTORY CONTROL

Building Name:	Civic Centre Car Park	Inspection Date:	April 9, 2018
Building Code:	PK-03	Inspected By:	Ryan Matthews & Will Deller
Building Address:	171 Princess Street	Construction Date:	1966

Building Name:	Public Safety Building	Inspection Date:	April 9, 2018
Building Code:	PS-01	Inspected By:	Will Deller & Ryan Matthews
Building Address:	151 Princess Street	Construction Date:	1965

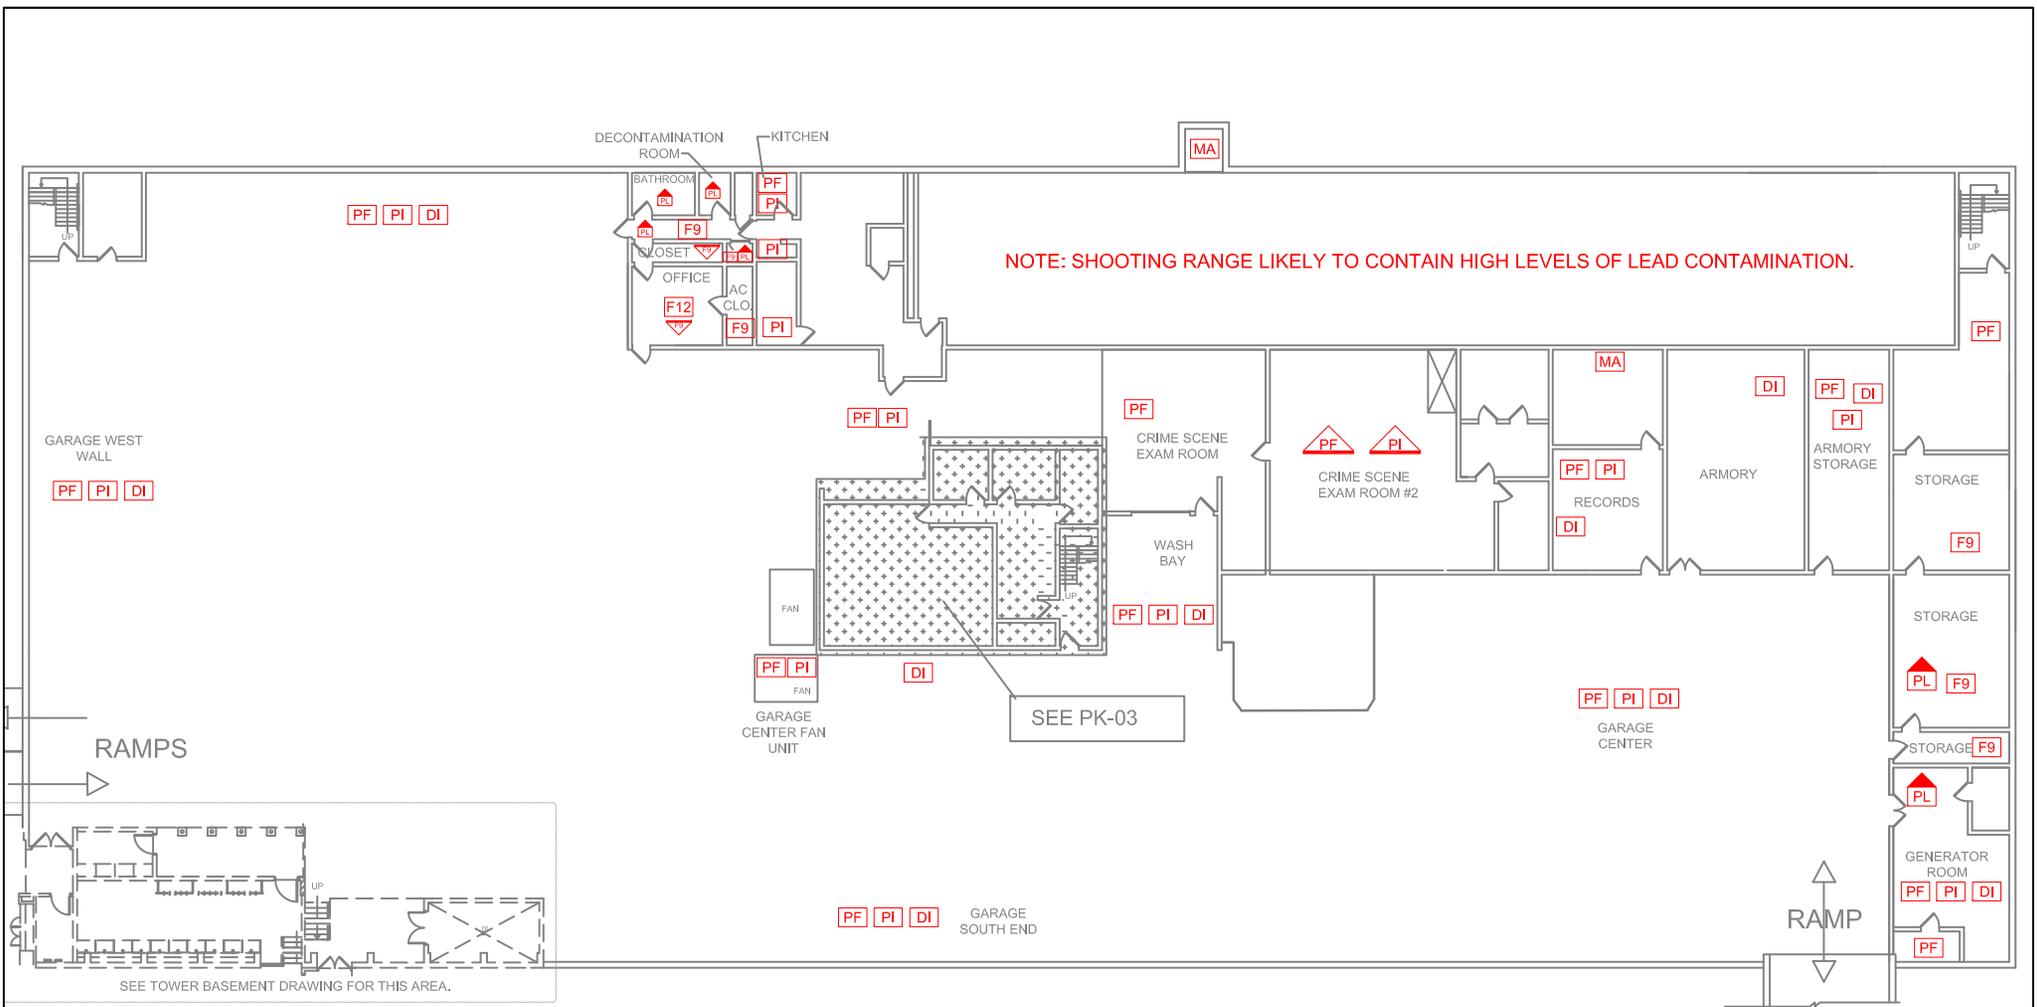
PARKADE BASEMENT

NOTES: -BROWN DUCT MASTIC ON METAL DUCTWORK THROUGHOUT MAY CONTAIN ASBESTOS.
 -BLACK MASTIC ON FIBREGLASS PIPE INSULATION THROUGHOUT MAY CONTAIN ASBESTOS.
 -PLASTER THROUGHOUT MAY CONTAIN ASBESTOS.

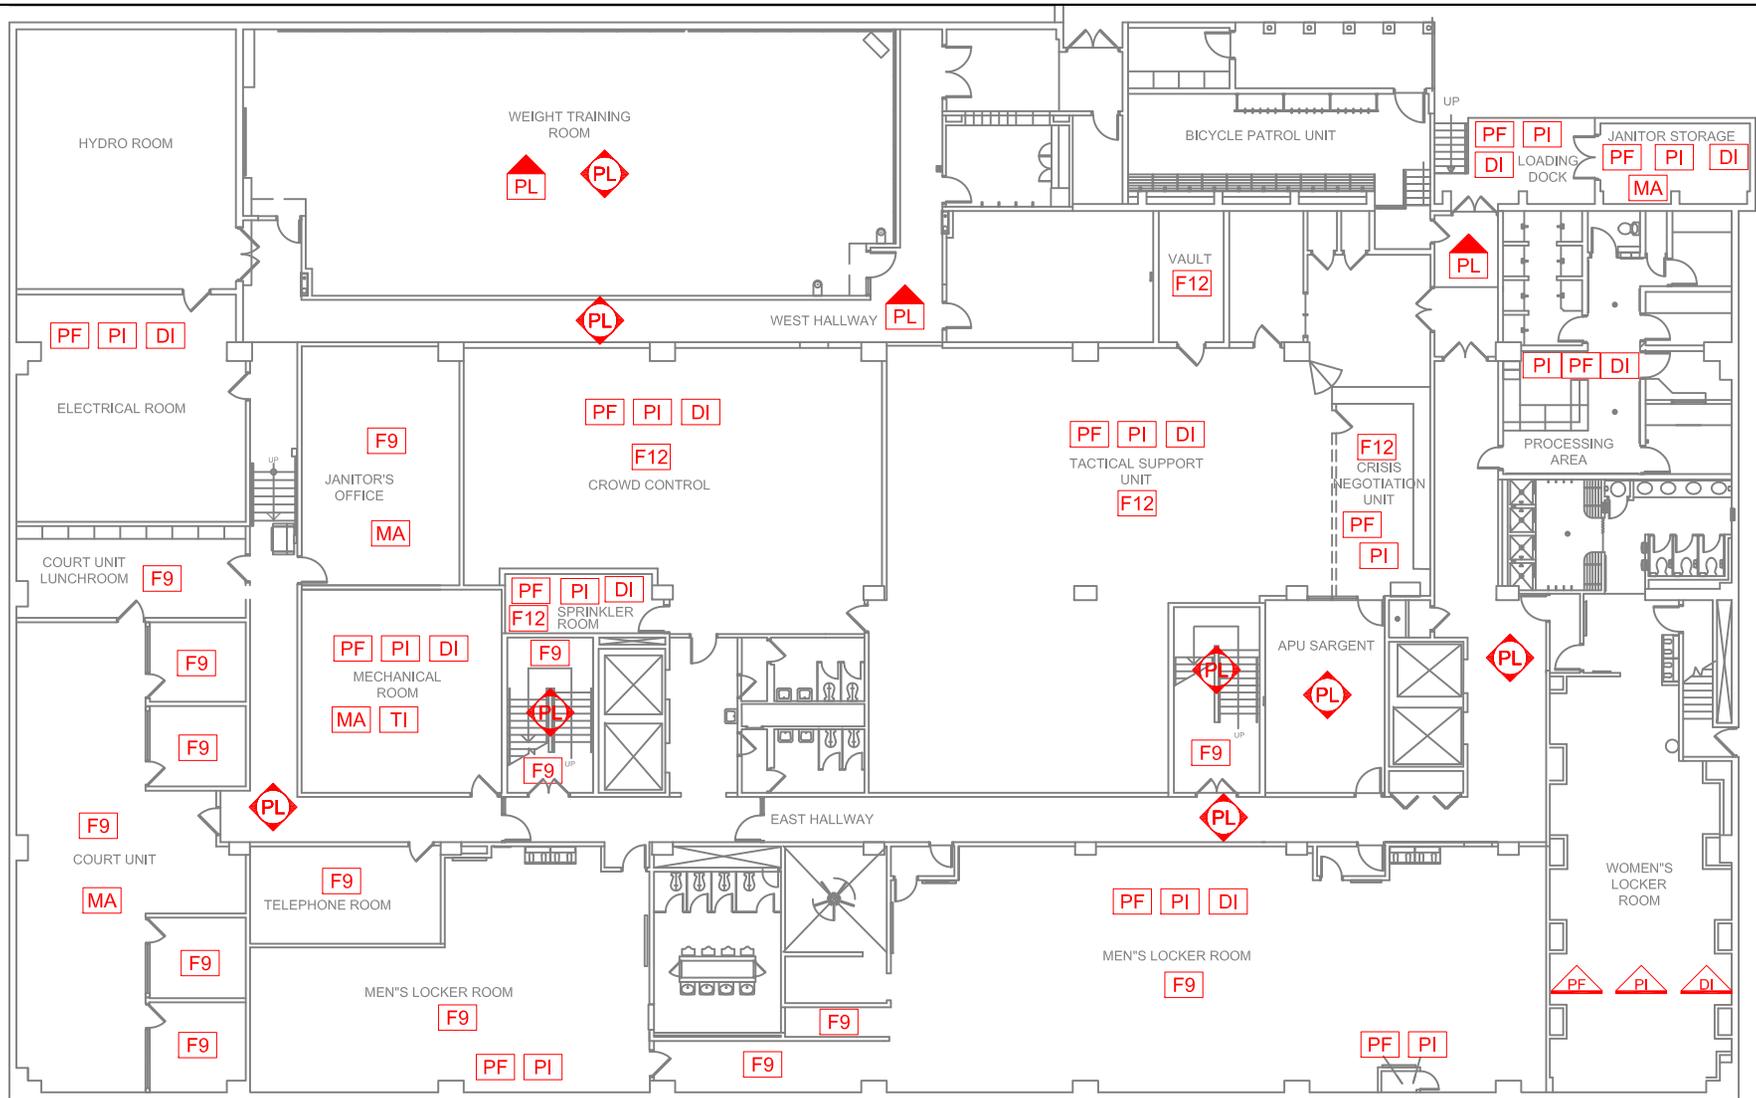
TOWER BASEMENT

NOTES: -BROWN DUCT MASTIC ON METAL DUCTWORK THROUGHOUT MAY CONTAIN ASBESTOS.
 -BLACK MASTIC ON FIBREGLASS PIPE INSULATION THROUGHOUT MAY CONTAIN ASBESTOS.
 -PLASTER THROUGHOUT MAY CONTAIN ASBESTOS.

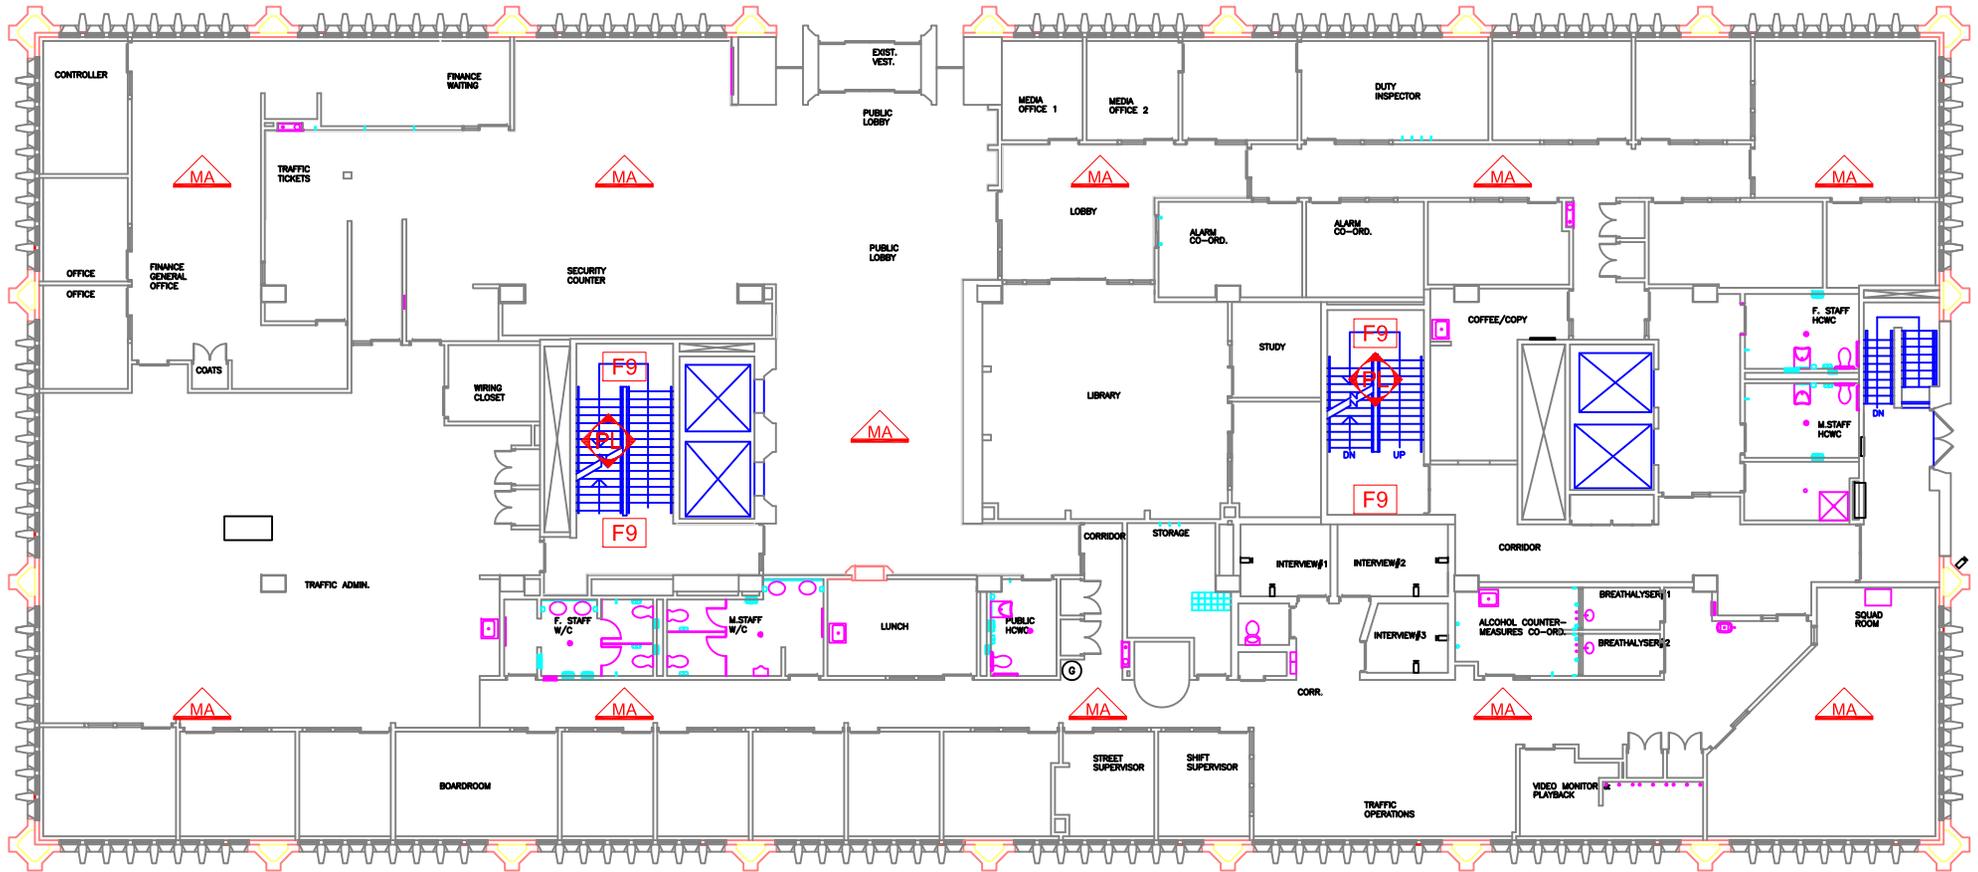
FIRST FLOOR

**NOTES: -BROWN DUCT MASTIC ON METAL DUCTWORK THROUGHOUT MAY CONTAIN ASBESTOS.
 -BLACK MASTIC ON FIBREGLASS PIPE INSULATION THROUGHOUT MAY CONTAIN ASBESTOS.
 -PLASTER THROUGHOUT MAY CONTAIN ASBESTOS.**

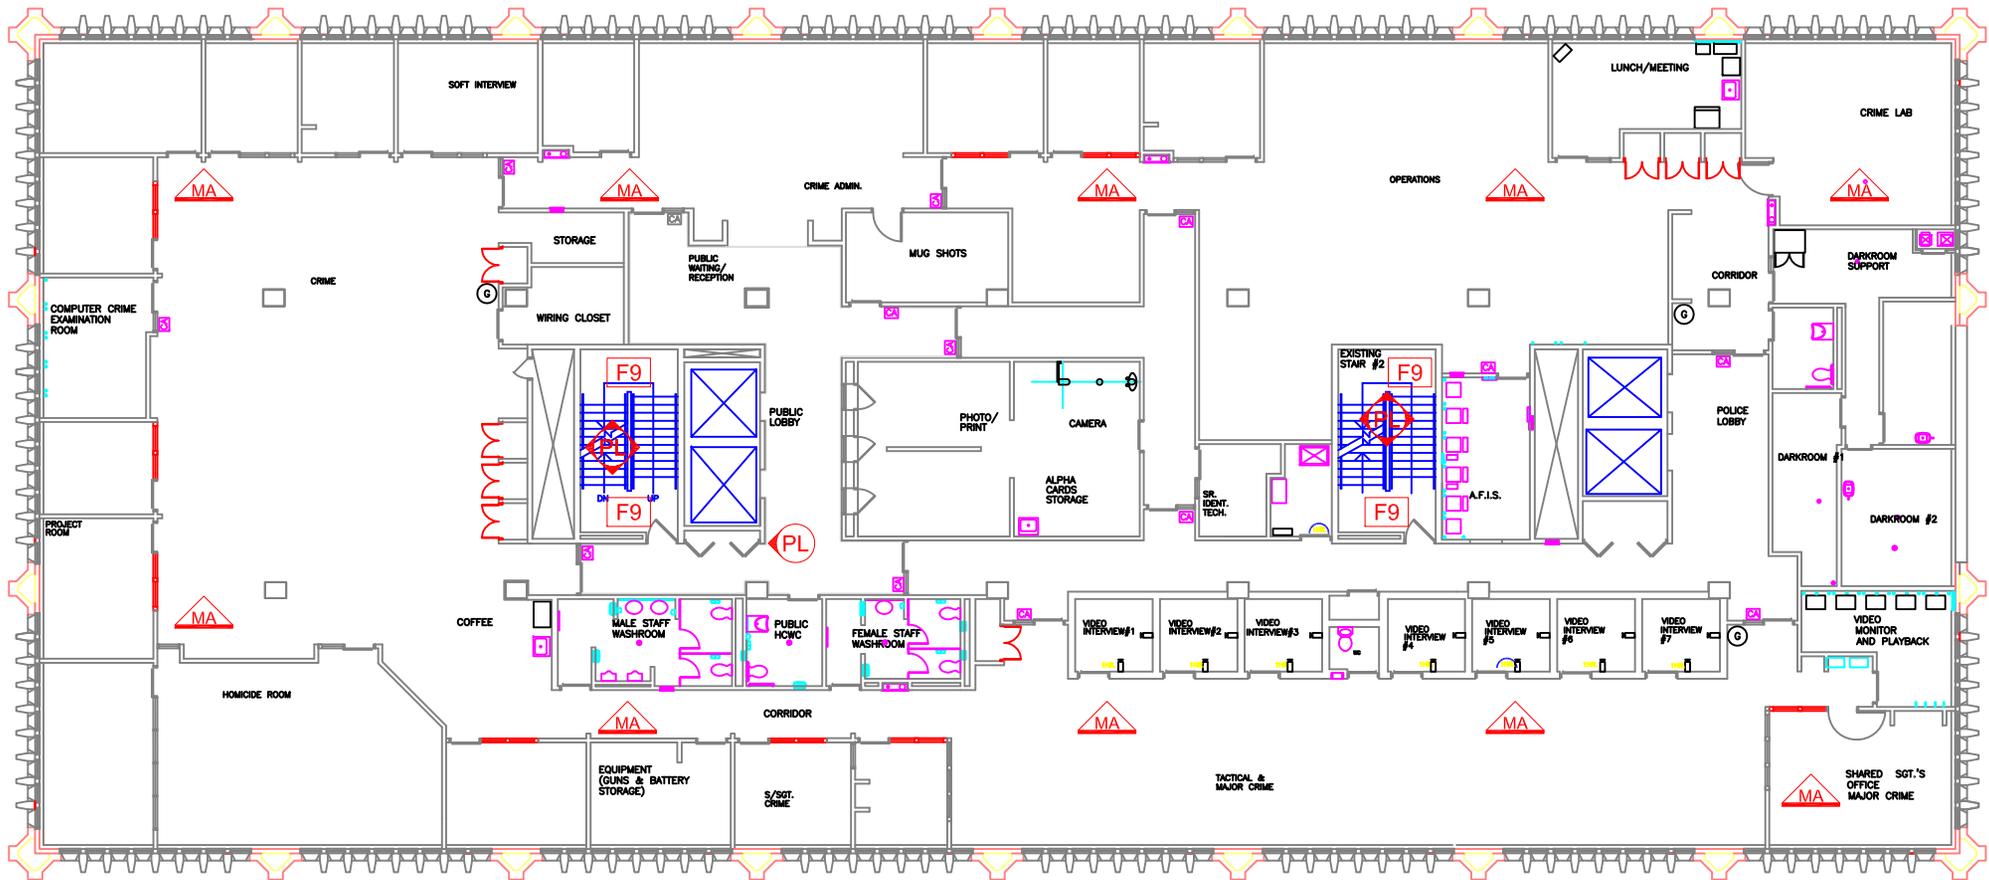
SECOND FLOOR

NOTES: -BROWN DUCT MASTIC ON METAL DUCTWORK THROUGHOUT MAY CONTAIN ASBESTOS.
 -BLACK MASTIC ON FIBREGLASS PIPE INSULATION THROUGHOUT MAY CONTAIN ASBESTOS.
 -PLASTER THROUGHOUT MAY CONTAIN ASBESTOS.

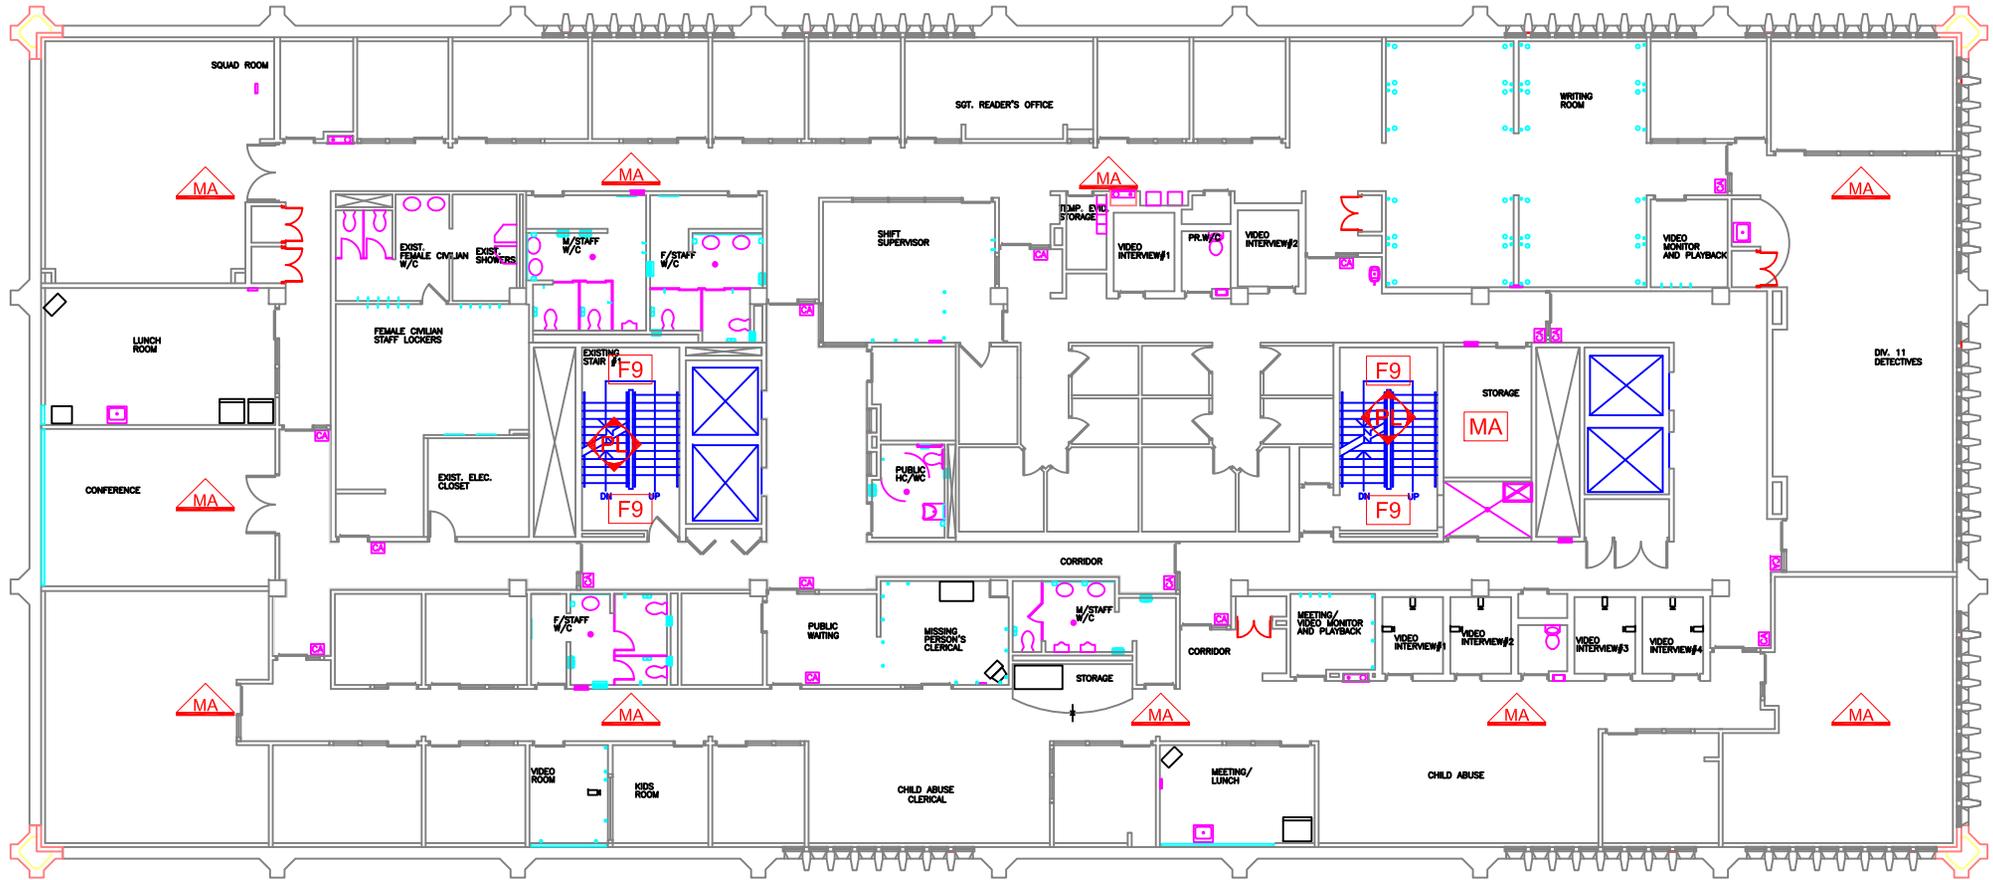
THIRD FLOOR

NOTES: -BROWN DUCT MASTIC ON METAL DUCTWORK THROUGHOUT MAY CONTAIN ASBESTOS.
 -BLACK MASTIC ON FIBREGLASS PIPE INSULATION THROUGHOUT MAY CONTAIN ASBESTOS.
 -PLASTER THROUGHOUT MAY CONTAIN ASBESTOS.

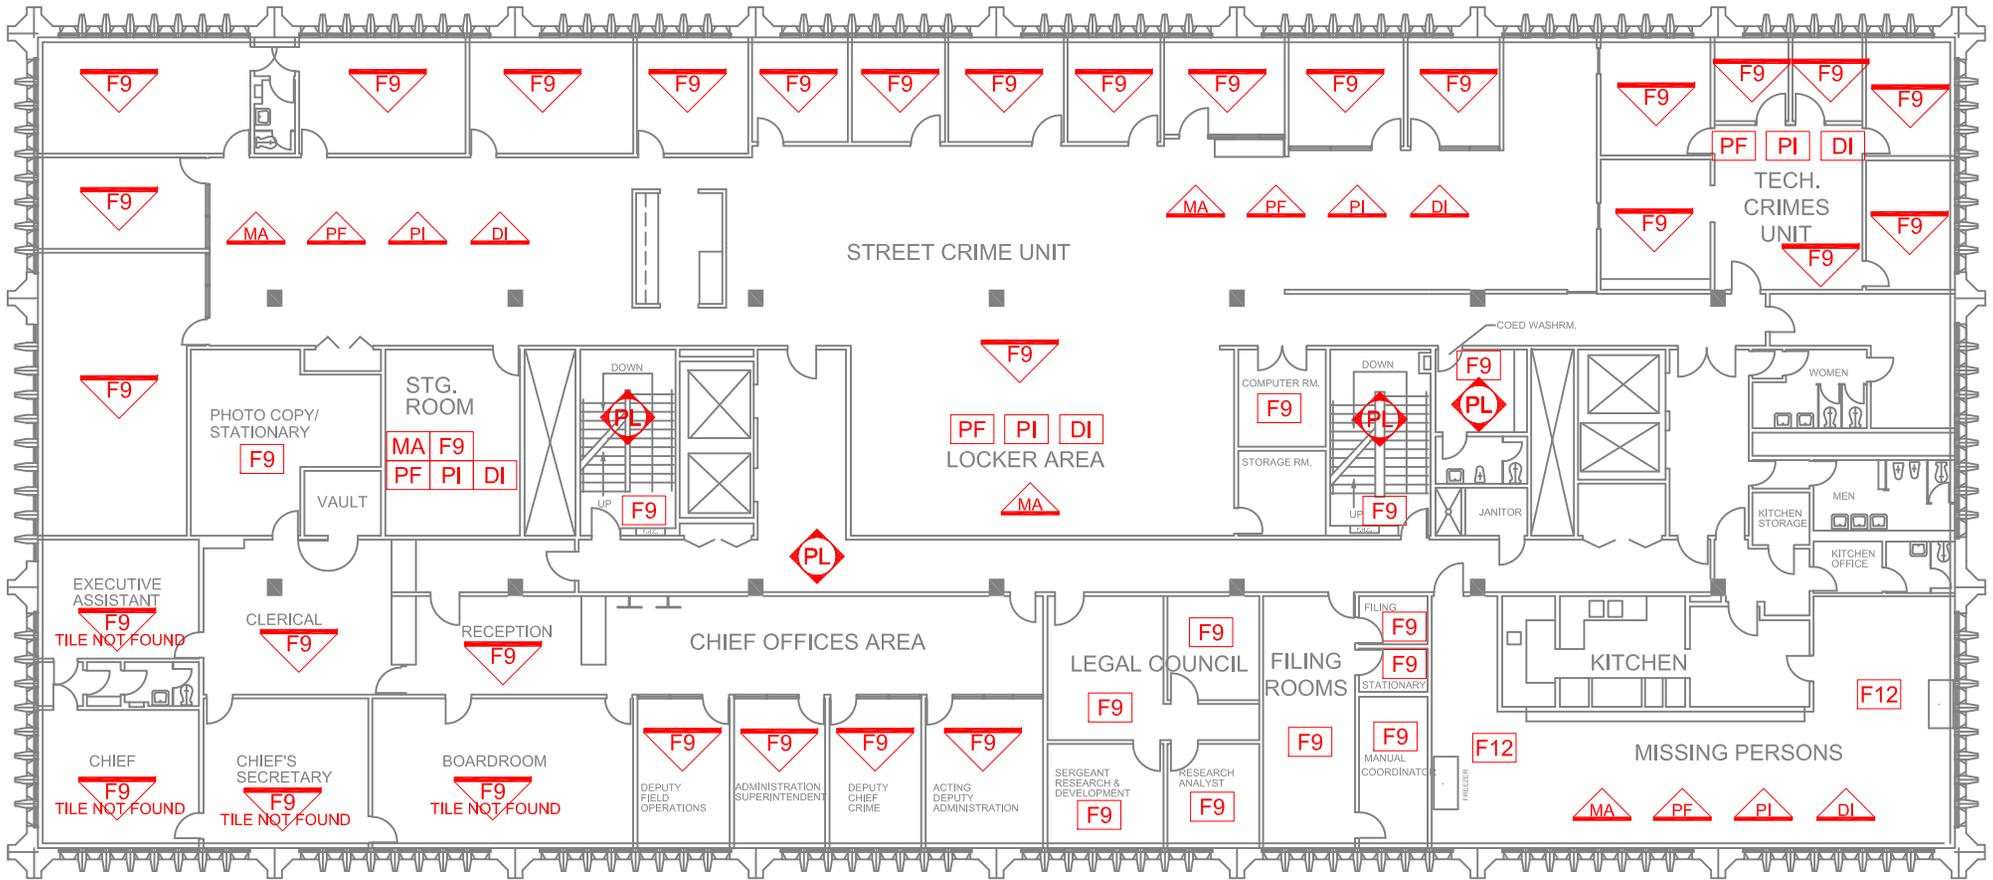
FIFTH FLOOR

NOTES: -BROWN DUCT MASTIC ON METAL DUCTWORK THROUGHOUT MAY CONTAIN ASBESTOS.
 -BLACK MASTIC ON FIBREGLASS PIPE INSULATION THROUGHOUT MAY CONTAIN ASBESTOS.
 -PLASTER THROUGHOUT MAY CONTAIN ASBESTOS.

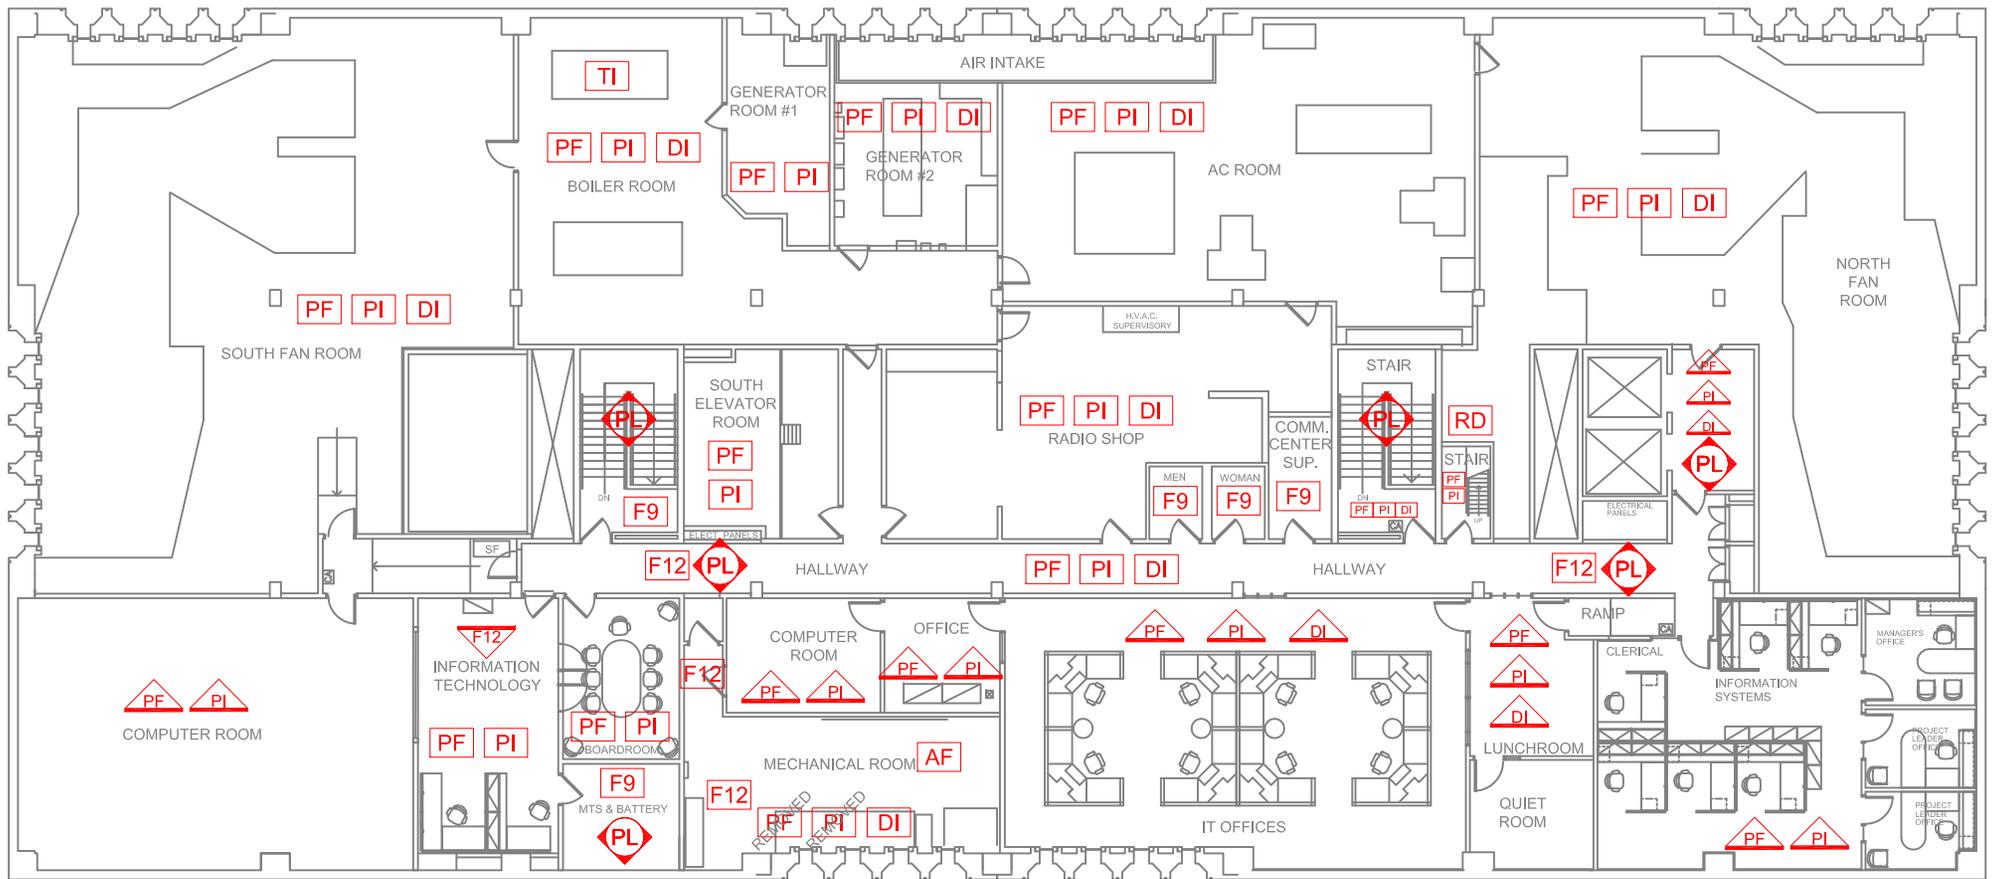
SIXTH FLOOR

NOTES: -BROWN DUCT MASTIC ON METAL DUCTWORK THROUGHOUT MAY CONTAIN ASBESTOS.
 -BLACK MASTIC ON FIBREGLASS PIPE INSULATION THROUGHOUT MAY CONTAIN ASBESTOS.
 -PLASTER THROUGHOUT MAY CONTAIN ASBESTOS.
