ASBESTOS INVENTORY CONTROL

| Building Name: | Public Safety Building | Inspection Date: | April 9, 2018 |
| Building Code: | PS-01 | Inspected By: | Will Deller & Ryan Matthews |
| Building Address: | 151 Princess Street | Construction Date: | 1965 |

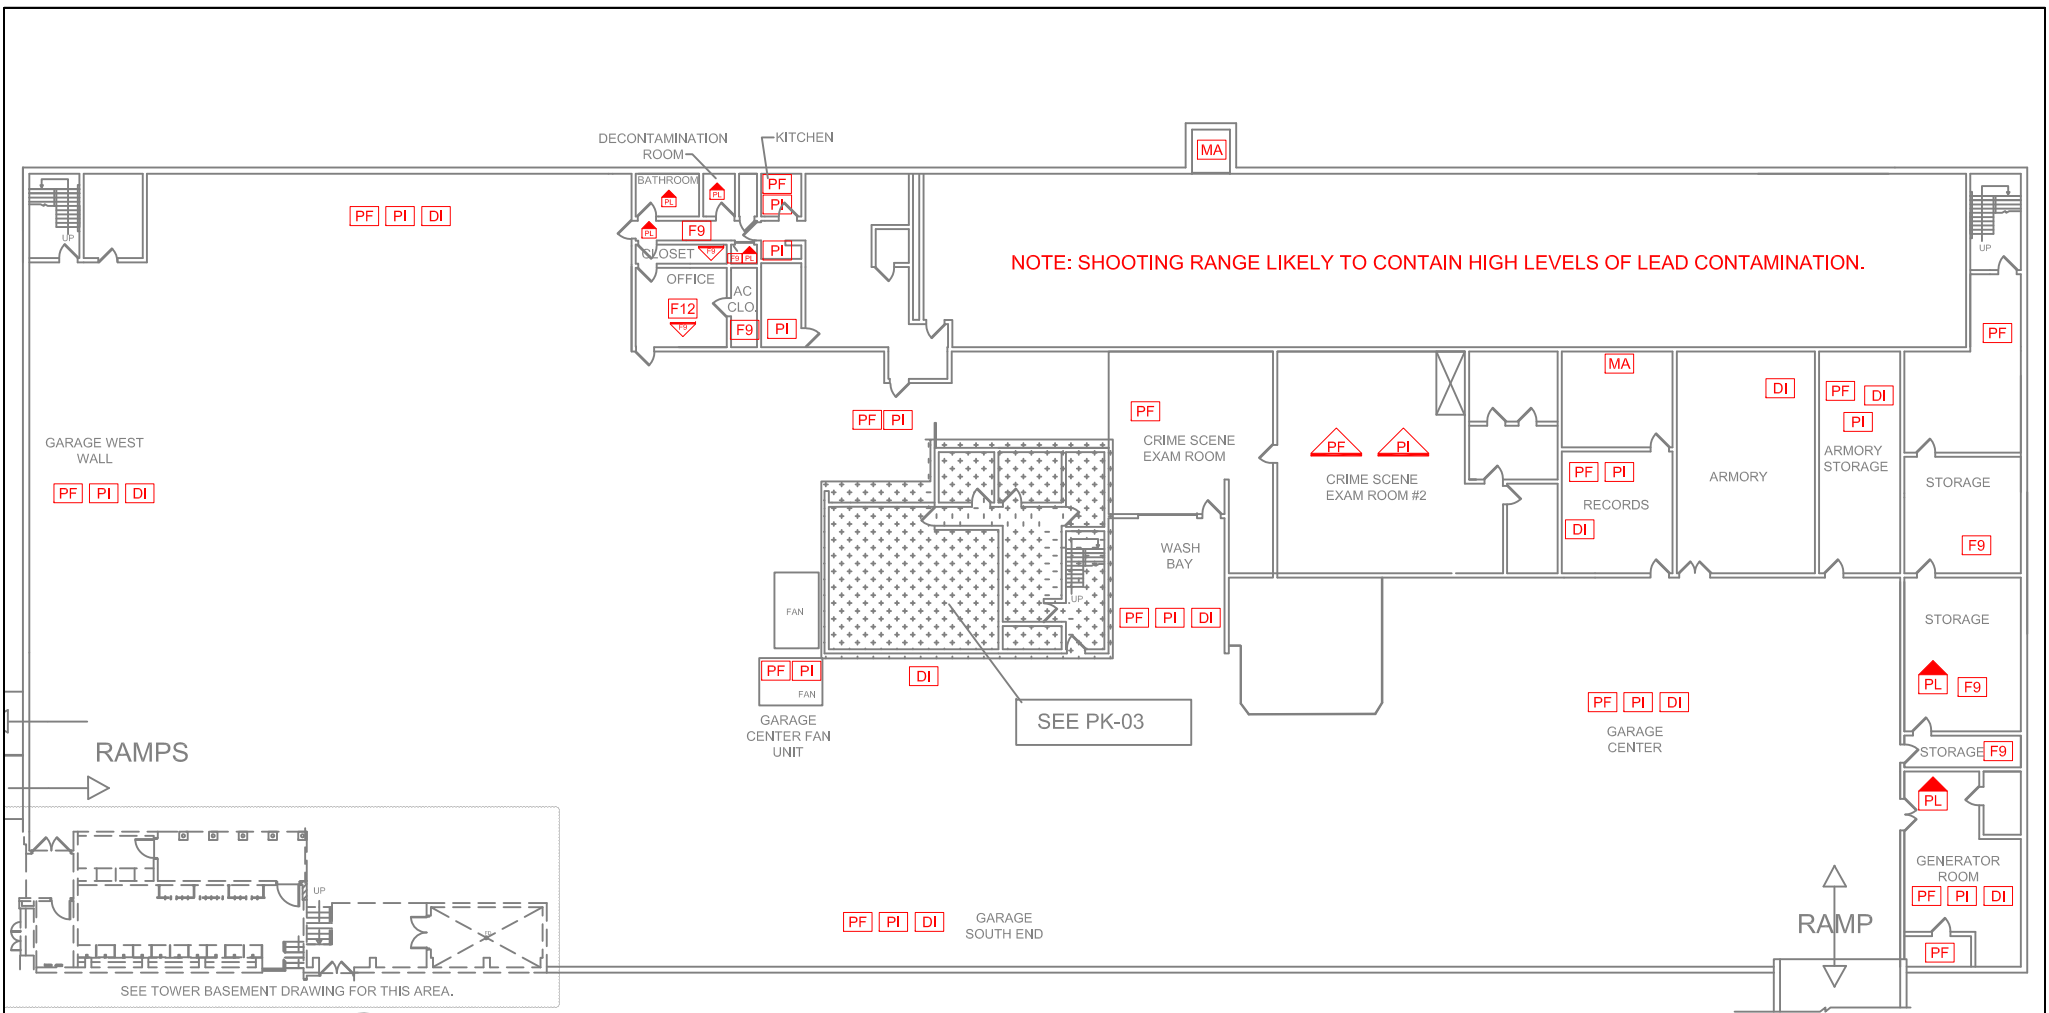
PARKADE BASEMENT

NOTES: -BROWN DUCT MASTIC ON METAL DUCTWORK THROUGHOUT MAY CONTAIN ASBESTOS.
 -BLACK MASTIC ON FIBREGLASS PIPE INSULATION THROUGHOUT MAY CONTAIN ASBESTOS.
 -PLASTER THROUGHOUT MAY CONTAIN ASBESTOS.

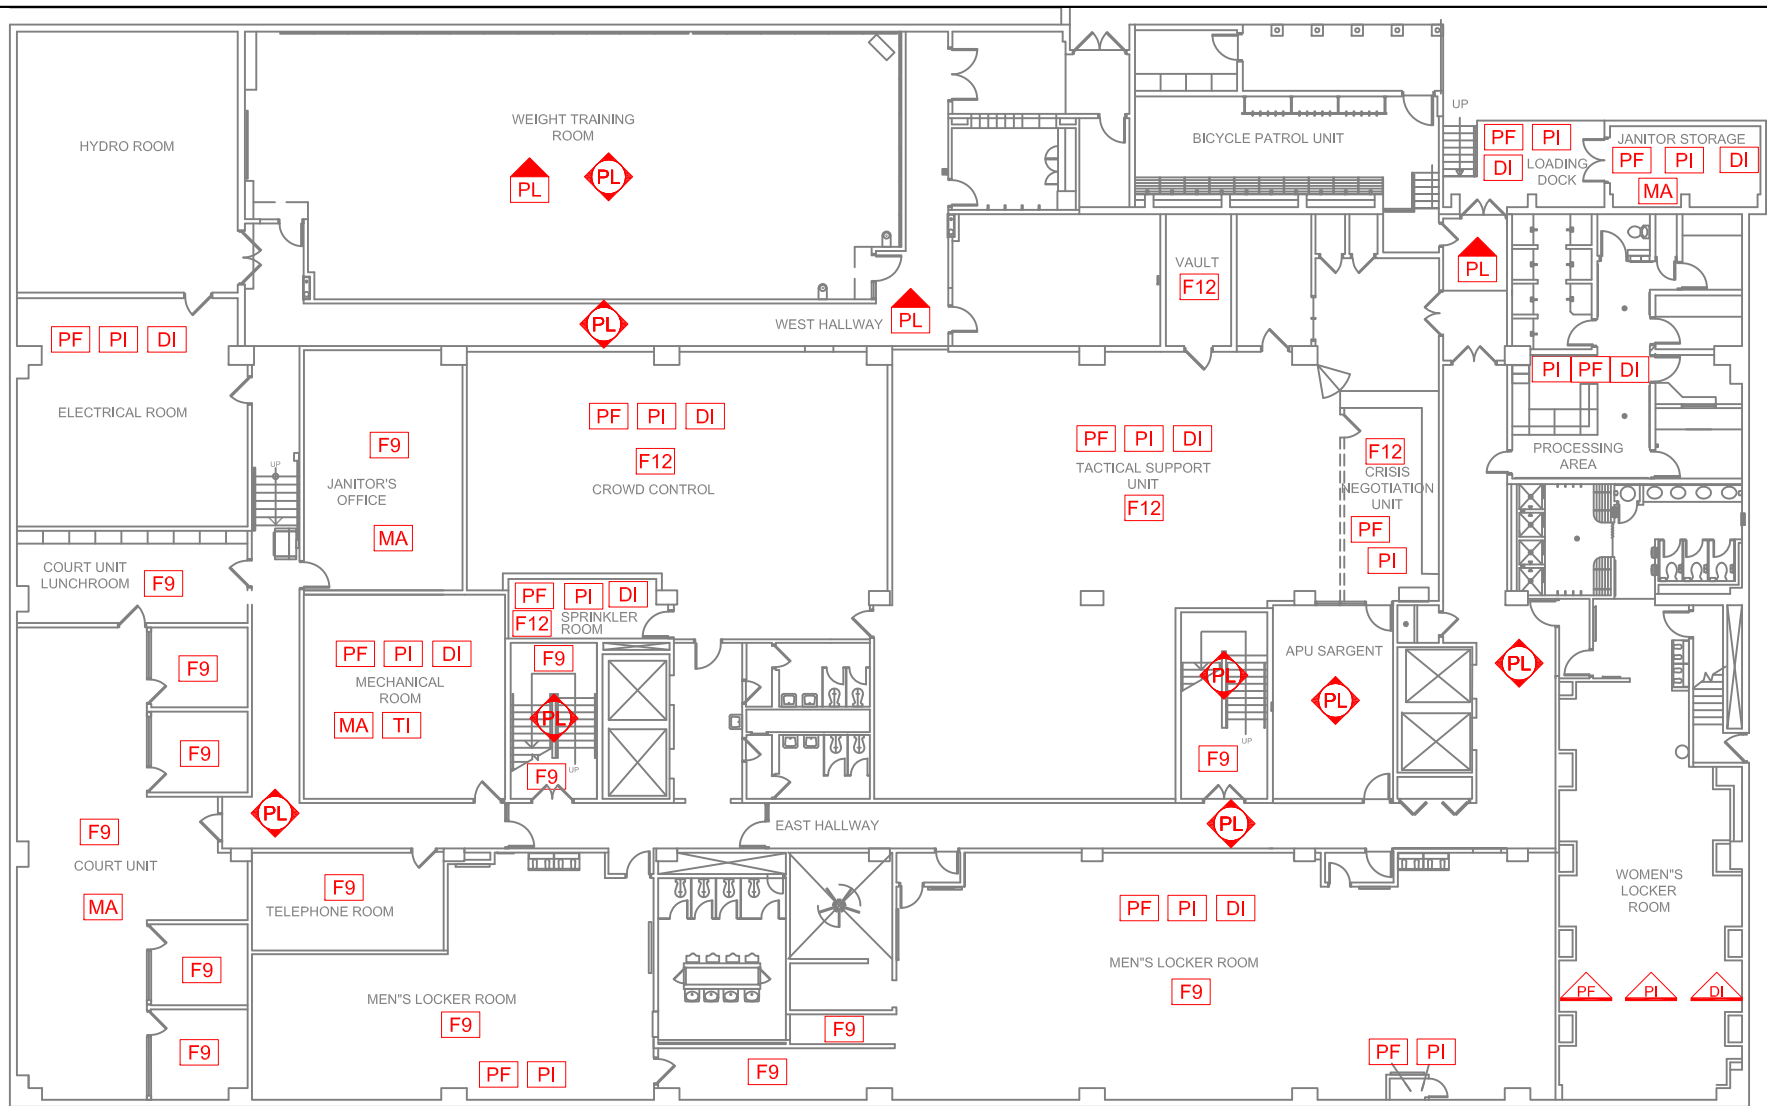
TOWER BASEMENT

NOTES: -BROWN DUCT MASTIC ON METAL DUCTWORK THROUGHOUT MAY CONTAIN ASBESTOS.
 -BLACK MASTIC ON FIBREGLASS PIPE INSULATION THROUGHOUT MAY CONTAIN ASBESTOS.
 -PLASTER THROUGHOUT MAY CONTAIN ASBESTOS.

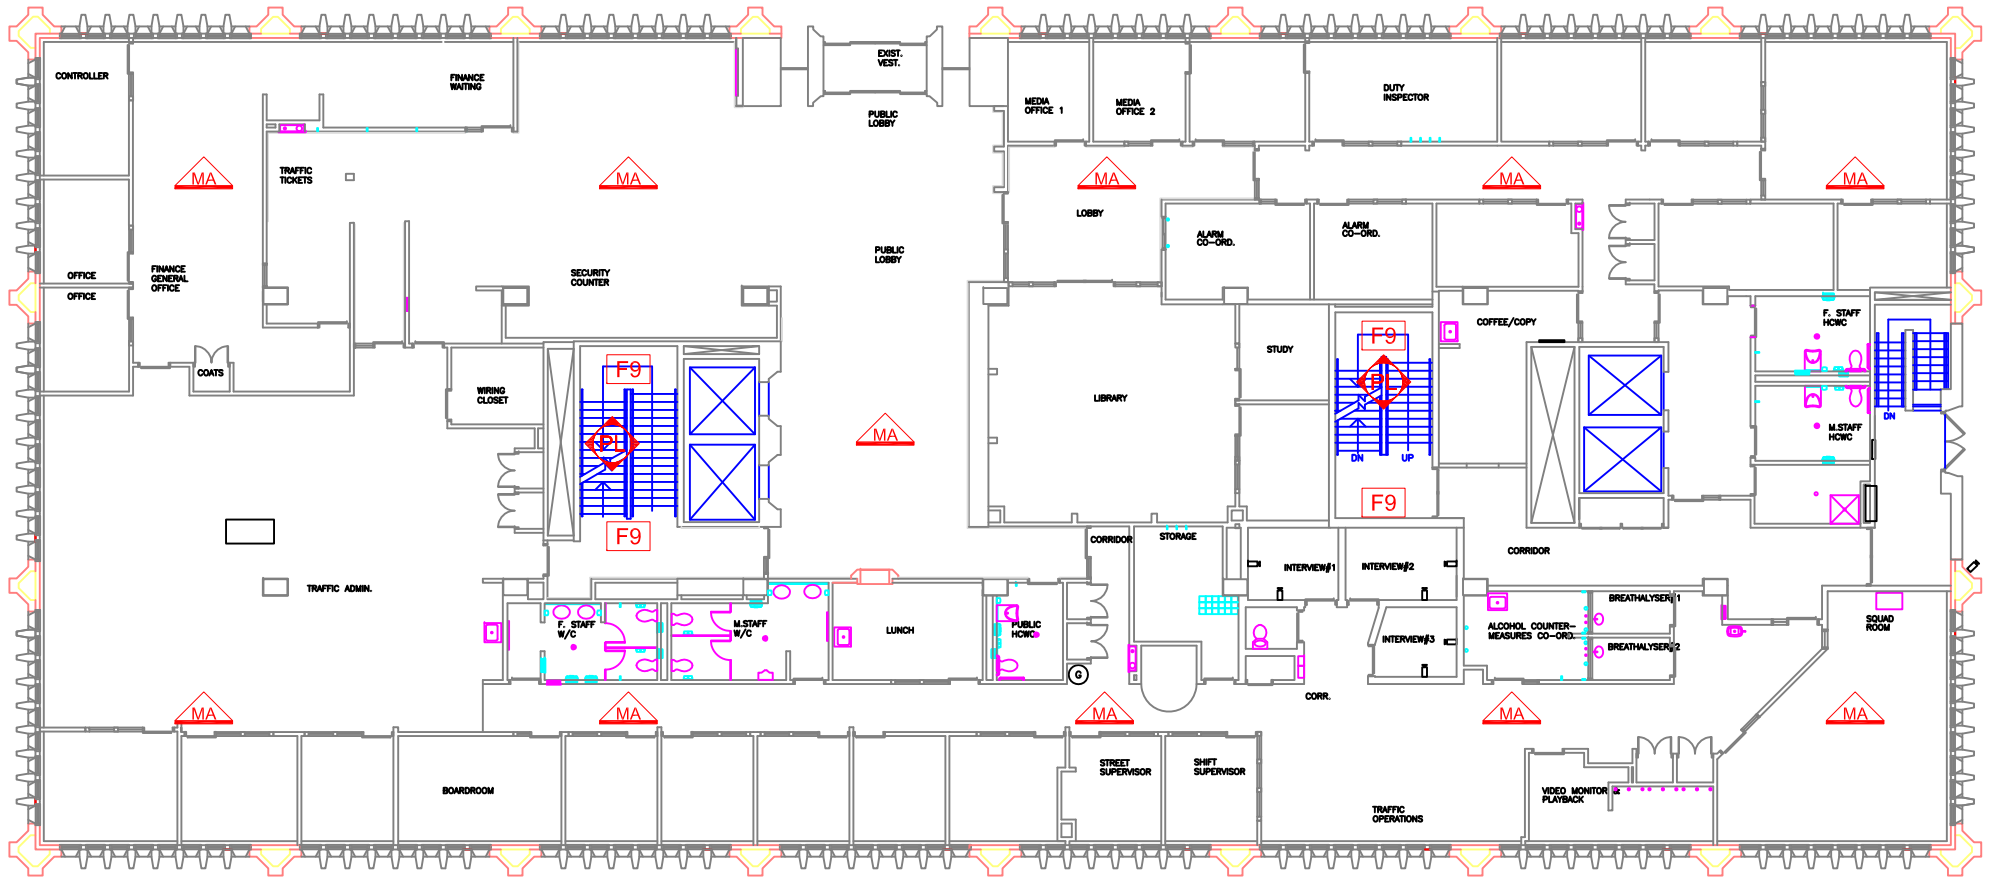
FIRST FLOOR

| Material Location | Material Description | Drawing Label | Material Condition | Testing Status | Date M/Y | Test % | Est. % |
|---|---|---|---|---|---|---|---|
| | Plaster - Walls | PL | Needs Repair | | | | <1 |

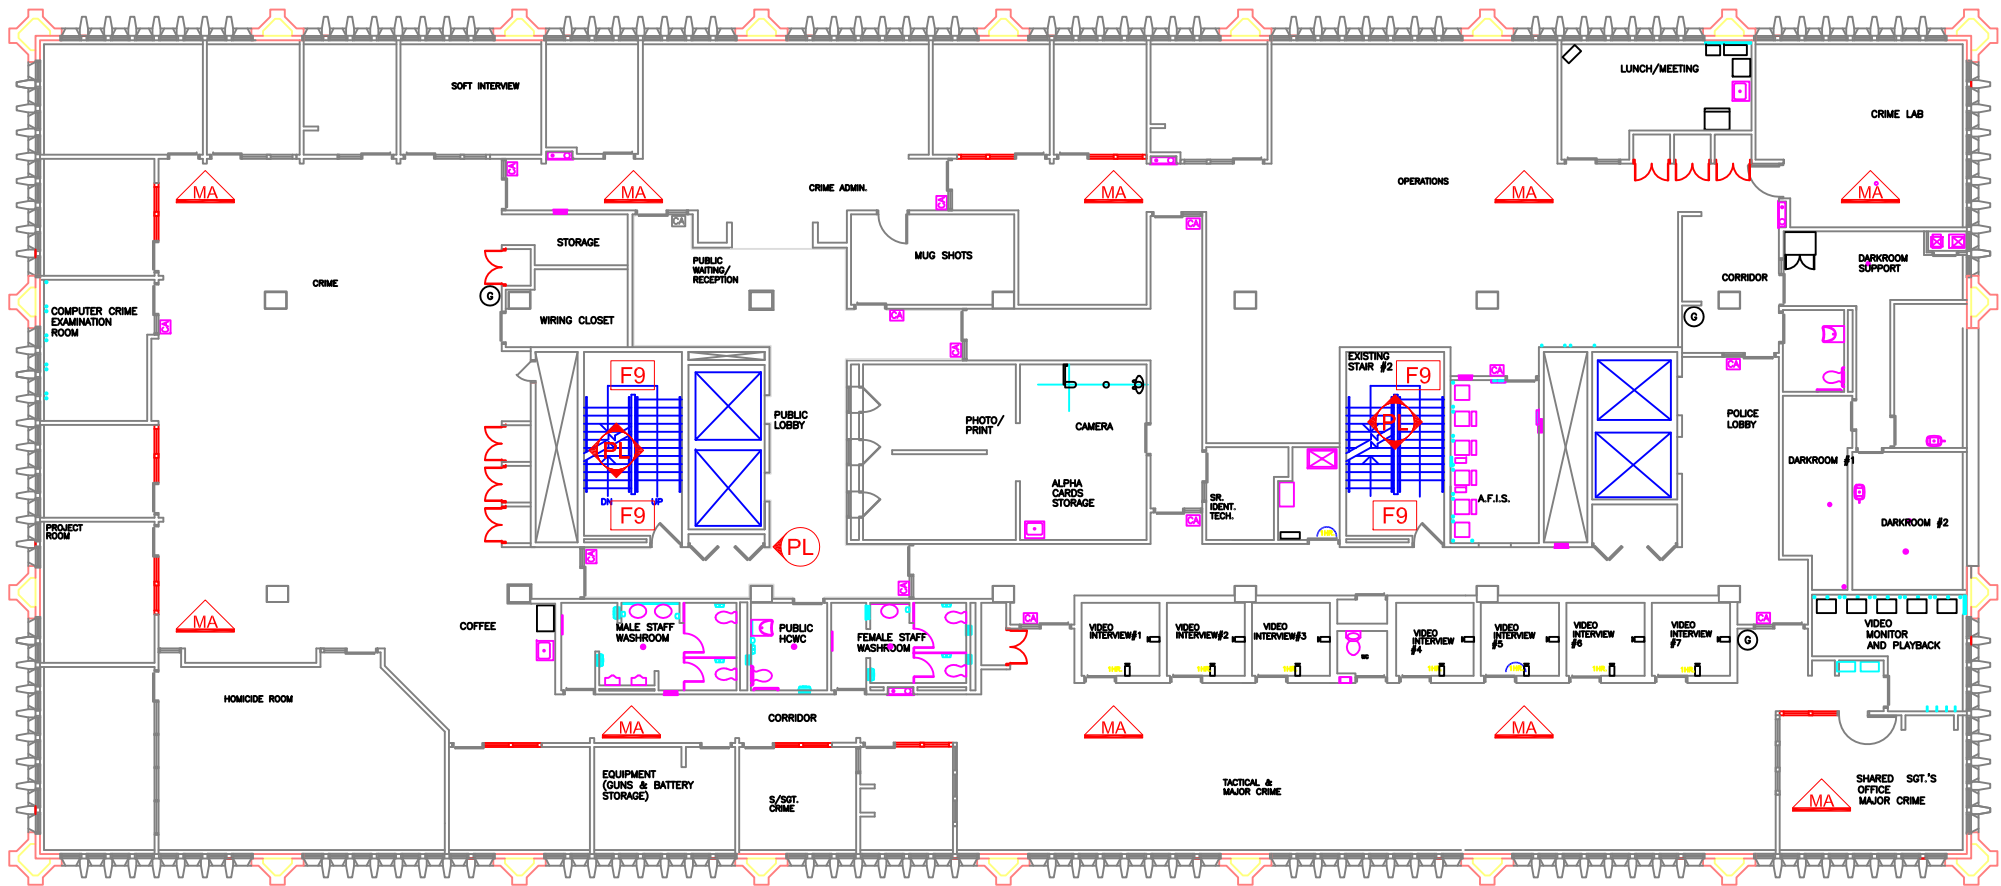
SECOND FLOOR

| Material Location | Material Description | Drawing Label | Material Condition | Testing Status | Date M/Y | Test % | Est. % |
|---|---|---|---|---|---|---|---|
| | Plaster - Walls | PL | Needs Repair | | | | <1 |

NOTES: -BROWN DUCT MASTIC ON METAL DUCTWORK THROUGHOUT MAY CONTAIN ASBESTOS.
 -BLACK MASTIC ON FIBREGLASS PIPE INSULATION THROUGHOUT MAY CONTAIN ASBESTOS.
 -PLASTER THROUGHOUT MAY CONTAIN ASBESTOS.

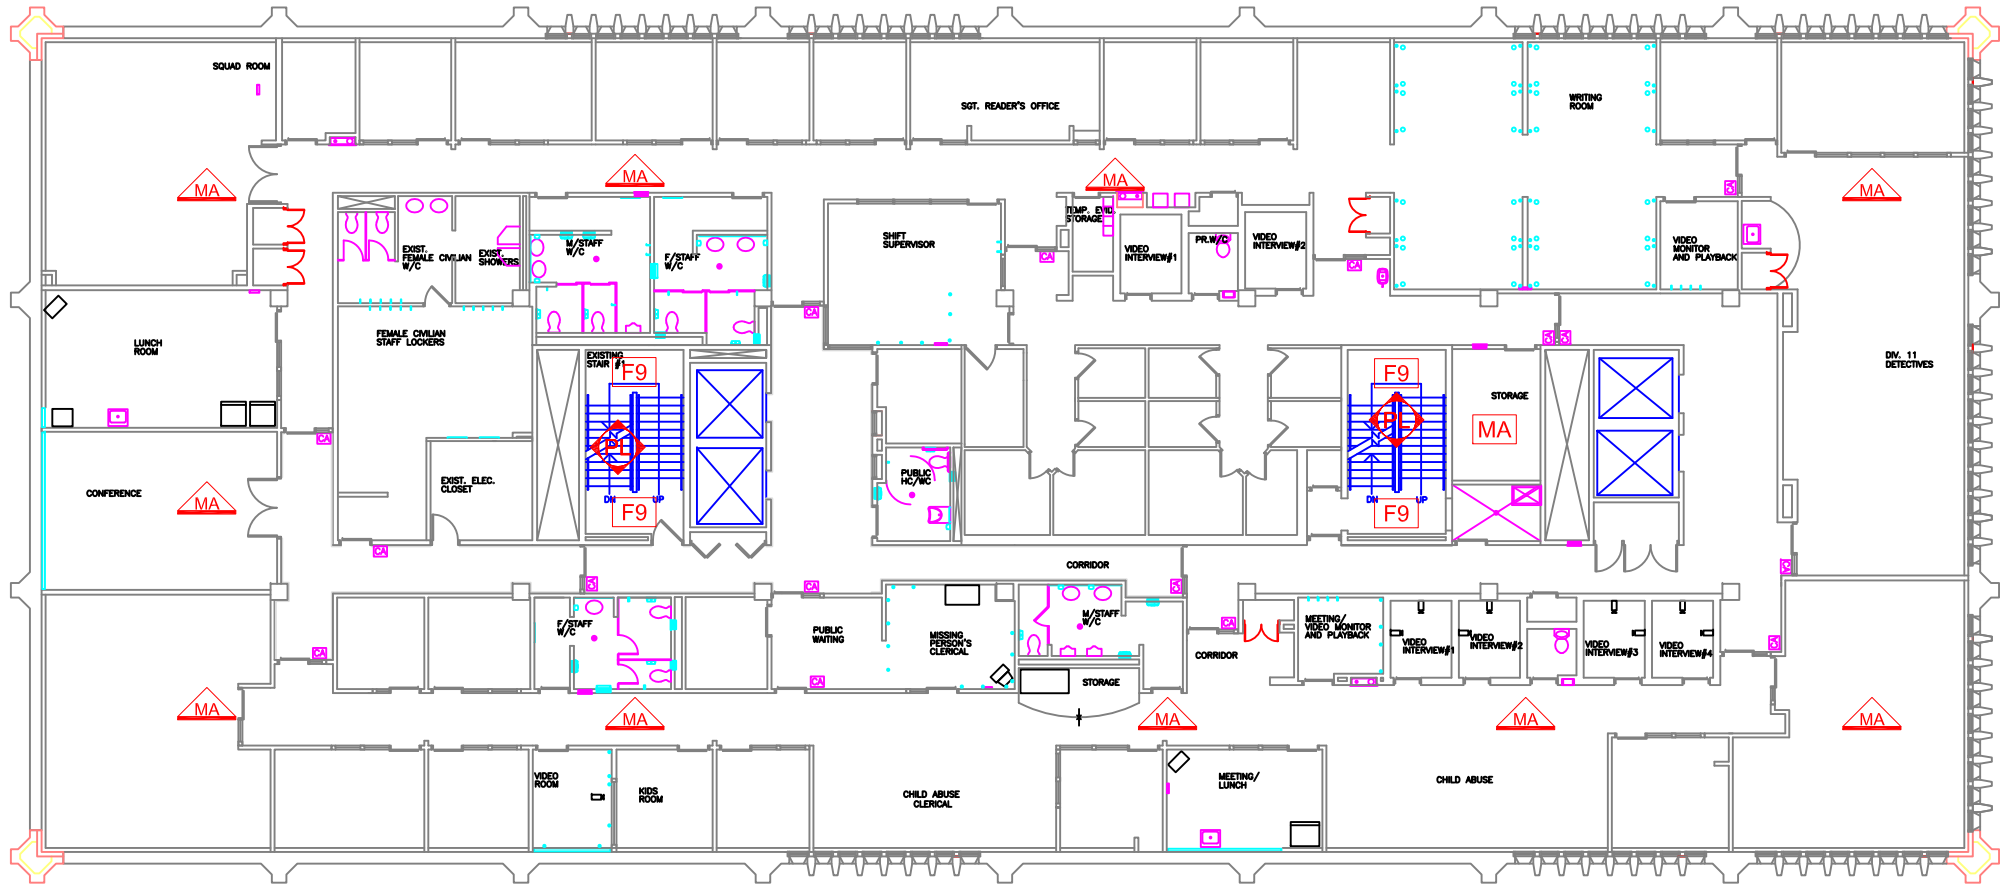
THIRD FLOOR

| Material Location | Material Description | Drawing Label | Material Condition | Testing Status | Date M/Y | Test % | Est. % |
|---|---|---|---|---|---|---|---|
| | Plaster - Walls | PL | Needs Repair | | | | <1 |

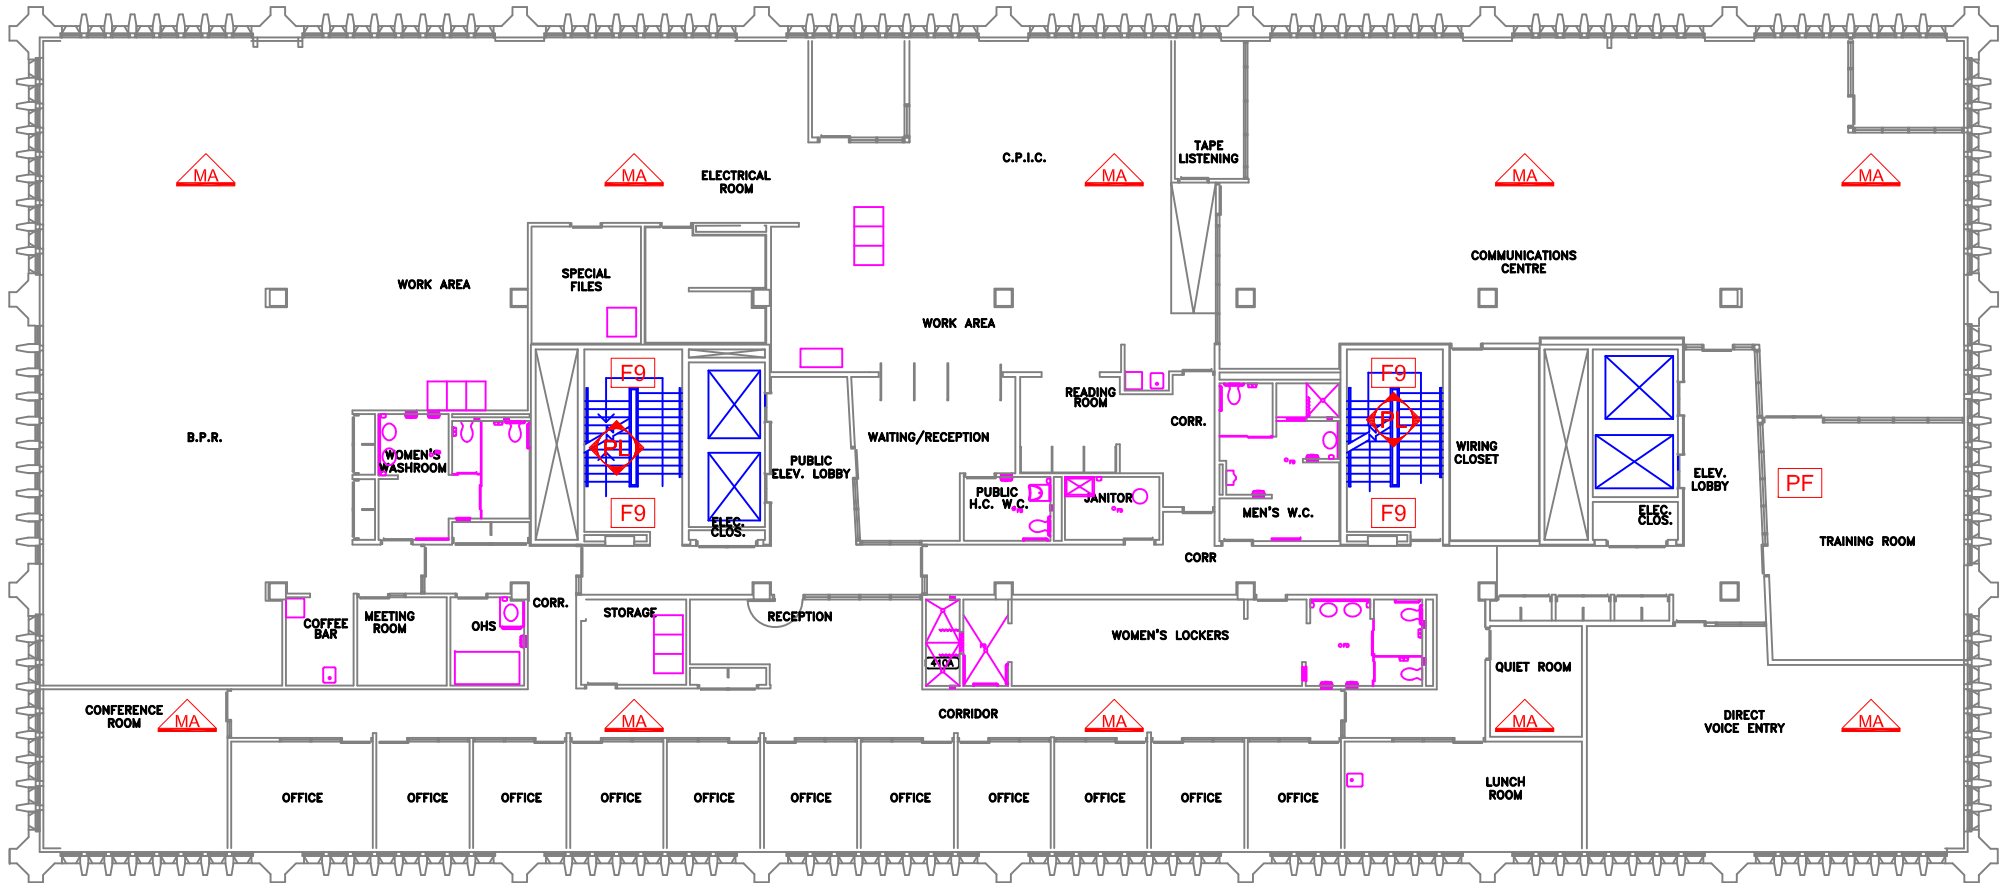
FOURTH FLOOR

| Material Location | Material Description | Drawing Label | Material Condition | Testing Status | Date M/Y | Test % | Est. % |
|---|---|---|---|---|---|---|---|
| | Plaster - Walls | PL | Needs Repair | | | | <1 |

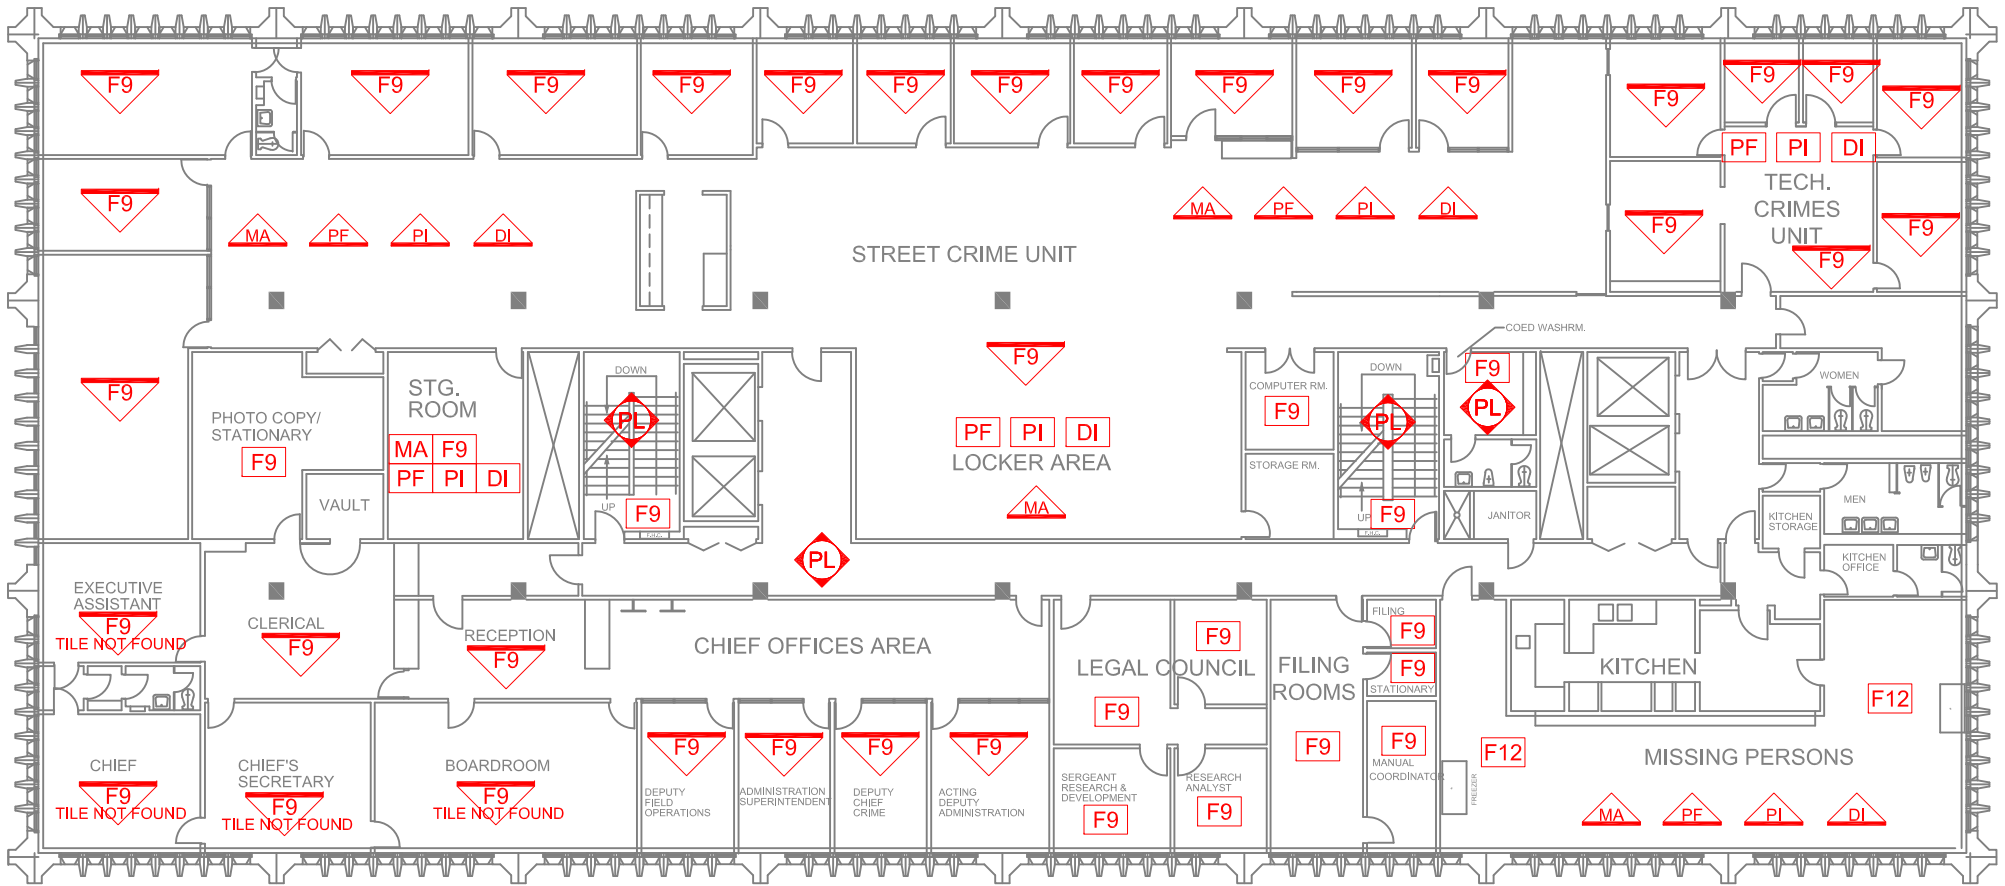
FIFTH FLOOR

| Material Location | Material Description | Drawing Label | Material Condition | Testing Status | Date M/Y | Test % | Est. % |
|---|---|---|---|---|---|---|---|
| | Plaster - Walls | PL | Needs Repair | | | | <1 |

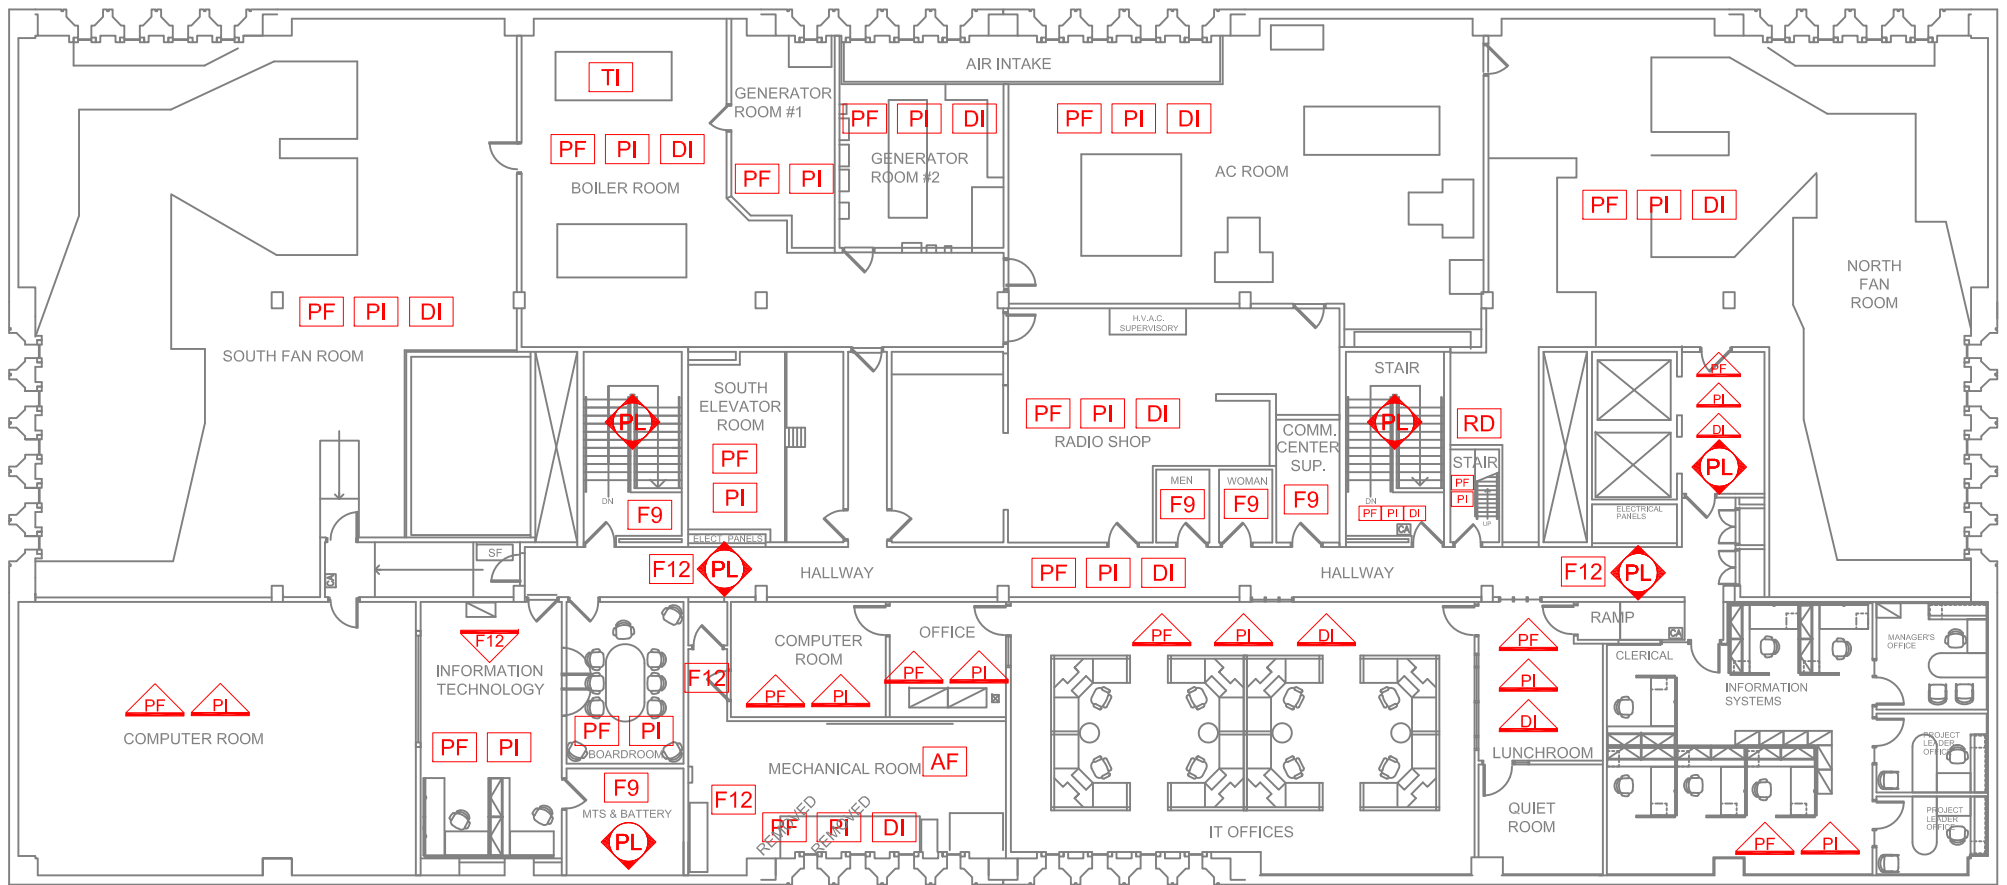
SIXTH FLOOR

| Material Location | Material Description | Drawing Label | Material Condition | Testing Status | Date M/Y | Test % | Est. % |
|---|--|---|---|---|---|---|---|
| | Plaster - Walls | PL | Needs Repair | | | | <1 |
