“Asbestos Inventory Control” for the Public Safety Building (inspection date April 9, 2018, and associated drawings).

“Asbestos Inventory Control” for the Civic Centre Car Park (inspection date April 9, 2018, and associated drawings).

HAZARDOUS BUILDING MATERIALS REVIEW AND ASSESSMENT

Readying the Lands of the Former Public Safety Building and Civic Centre Car Park for
 Redevelopment - 151 & 171 Princess Street
 Hazardous Building Materials Review and Assessment

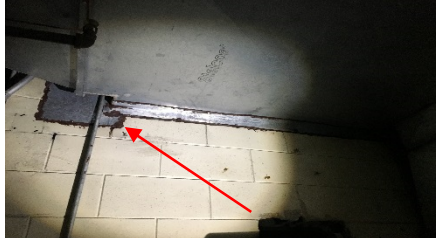
Location	Hazardous Building Material Observations	Condition	Photo
Throughout	Previously identified ACM brown duct mastic on metal duct work	Remains on ducting throughout and observed in good condition

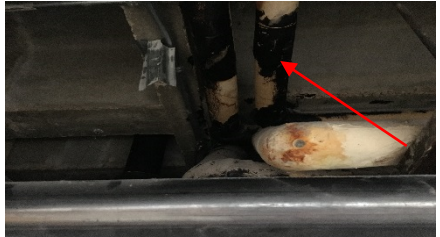
Throughout	Previously identified ACM black mastic on fiberglass pipe insulation	Remains on fiberglass pipe insulation throughout and observed in good condition

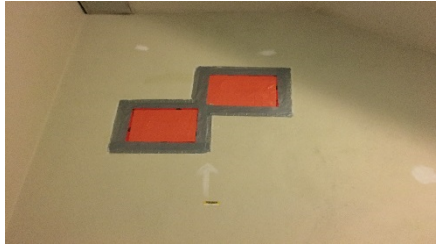
Throughout	Previously identified ACM plaster walls and ceilings Note – representatives of the City of Winnipeg were reportedly unsure as to whether asbestos is present in all plaster, or only in wall and ceiling materials with a textured finish. As this wasn't confirmed, both items are discussed as ACM herein.	Small areas throughout the PSB had damaged plaster which had been previously addressed (covered with poly) by City staff

- Patch and repair areas of damaged ACM wall plaster (each area requiring repair is less than one square foot).
 - Patch and repair (or remove and dispose of) insulation on pipe fittings with small, localized areas of damage.

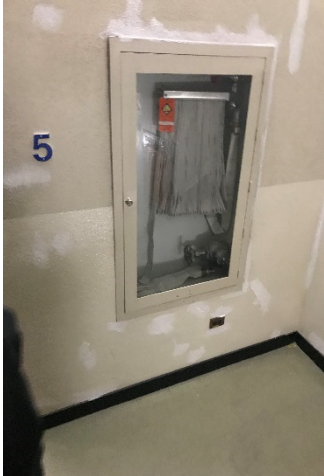
Throughout	Previously identified ACM texture coat on plaster walls and ceiling. Note – representatives of the City of Winnipeg were reportedly unsure as to whether or not asbestos is present in all plaster, or only in wall and ceiling materials with a textured finish. As this wasn't confirmed, both items are discussed as ACM herein.	Small areas throughout the PSB had damaged plaster which had been previously addressed by City staff

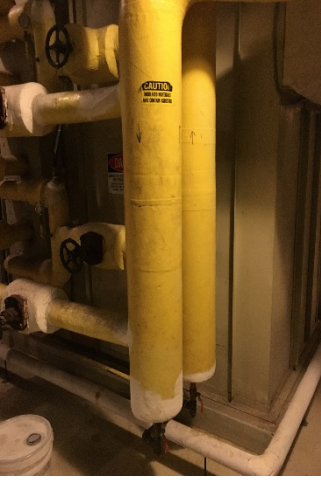
Location	Hazardous Building Material Observations	Condition	Photo
Throughout	Previously identified ACM insulation on mechanical pipe straights	Remains on pipe straights throughout and observed in good condition

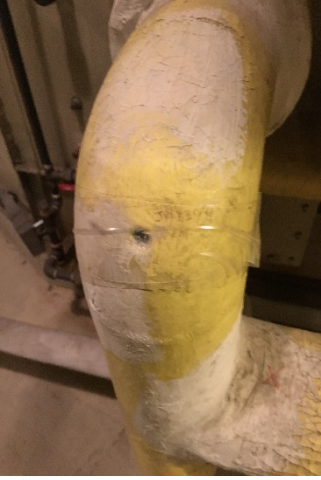
Throughout	Previously identified ACM insulation on mechanical pipe fittings	Remains on pipe fittings throughout and observed to generally be in good condition; minor damage observed on approximately 10 mechanical pipe elbows

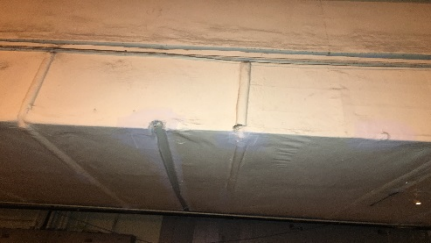
Throughout	Previously identified ACM insulation on ducts	Remains on ducts and observed to generally be in good condition; small areas of insulation in basement need repair

- Patch and repair areas of damaged ACM duct insulation (each area requiring repair is less than one square foot).
 - Patch and repair areas of damaged ACM tank insulation (each area requiring repair is less than one square foot).

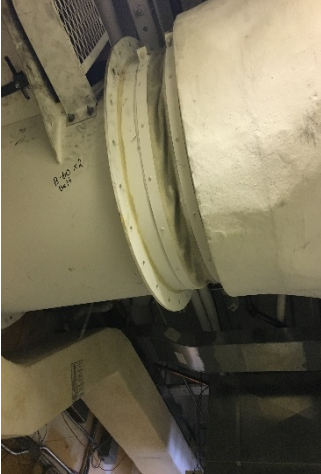
Location	Hazardous Building Material Observations	Condition	Photo
Throughout	Previously identified ACM gaskets in flanges of mechanical pipes and systems throughout	Remains and observed in good condition

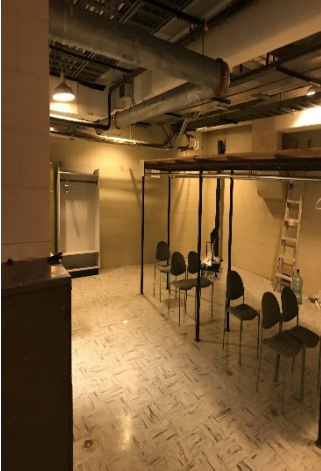
Electrical room	Previously identified ACM gold mastic	Remains and observed in good condition	No photo
Multiple locations	Previously identified ACM 9" x 9" vinyl floor tiles (various colours and patterns) and associated mastics	Remains and observed in good condition

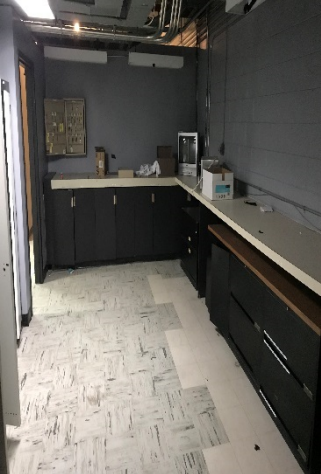
Location	Hazardous Building Material Observations	Condition	Photo
Multiple locations	Previously identified ACM 12" x 12" vinyl floor tiles (various colours and patterns) and associated mastics	Remains and observed in good condition

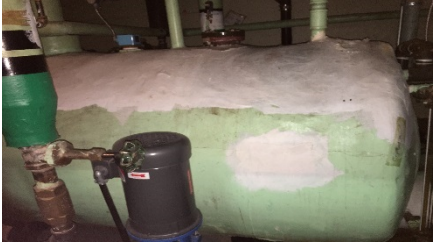
Mechanical room and boiler room	Previously identified ACM tank insulation	Remains; some areas of mechanical room and boiler room tanks observed to need repair

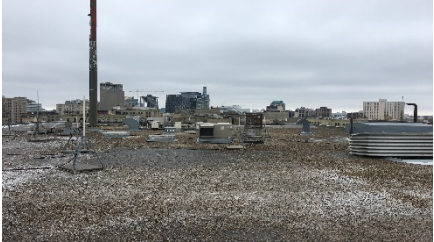
Roof	Previously identified ACM drains and sealants	Not observed	No photo
Roof	Presumed ACM roofing material (asphalt; mastics)	Remains and observed in good condition

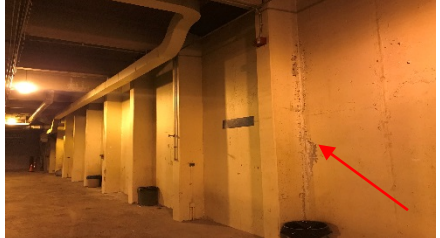
Location	Hazardous Building Material Observations	Condition	Photo
Throughout	All paint presumed to be lead-containing	Peeling paint observed throughout basement; small damaged areas noted throughout remainder of building

- Paints in poor condition should be addressed. This would include removal of loose/flaking paint from surfaces. In general, consideration should be given to re-painting surfaces where paints are delaminating, to mitigate the potential for additional delamination and distribution of LCP waste within the area.

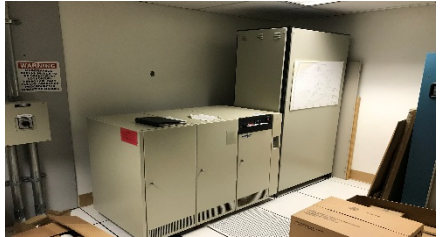
IT Room	Two lead-acid batteries observed	Good condition

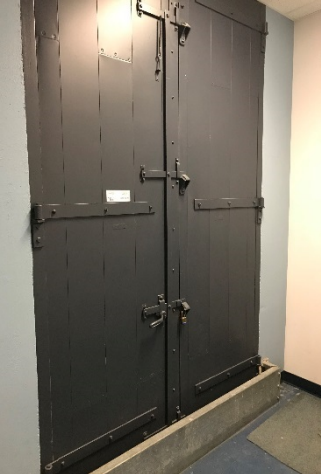
Location	Hazardous Building Material Observations	Condition	Photo
PSB vault	Potential PCB-containing transformers noted to be Manitoba Hydro-owned	N/A

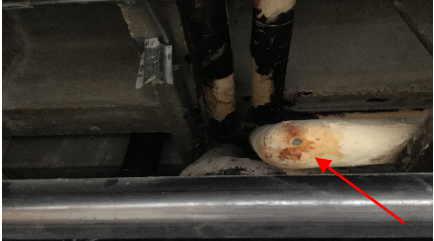
Tower basement; 1 st floor washrooms; 6 th floor	Few moisture-stained ceiling tiles; small areas of moisture-damaged pipe wrap	Moisture may provide conditions conducive to mould growth. No suspect mould growth observed currently.

- Remove and replace moisture-stained ceiling tiles with new tiles. If staining re-appears on the new tiles, the source of moisture should be identified and corrected.

- This work can be conducted by regular facility maintenance staff, if conducted prior to the onset of mould growth.
 - Replacement of ceiling tile may be unnecessary, given the scenarios currently being considered by the City of Winnipeg. However,

consideration must be given to the materials beneath water-stained ceiling tiles – as if tiles are not replaced, additional materials beneath them (e.g., carpet, drywall) may become water impacted (if moisture sources remain active) and may provide suitable conditions for mould growth.

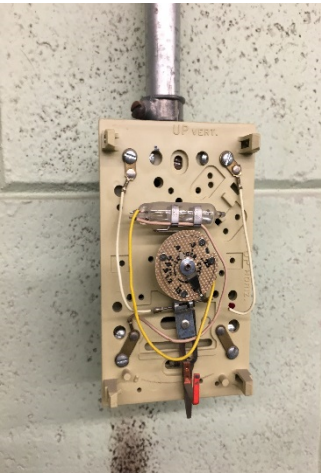
Throughout	Fluorescent light tubes and high-intensity discharge bulbs contain mercury vapour	N/A	No photo
Throughout – various locations	Approximately 100 mercury-containing thermostats observed	N/A

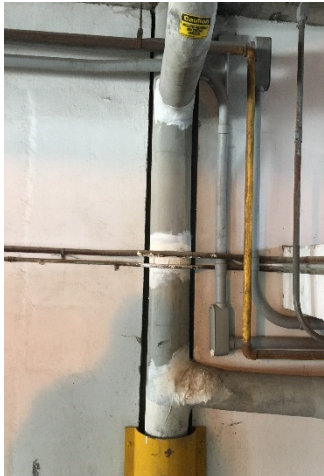
Location	Hazardous Building Material Observations	Condition	Photo
Throughout	Previously identified ACM insulation on mechanical pipe straights	Remains and observed in good condition

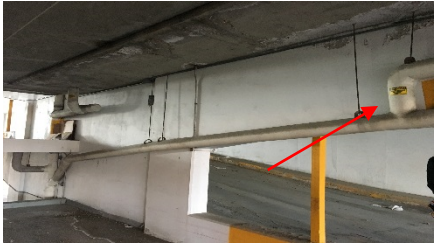
Throughout	Previously identified ACM insulation on mechanical pipe fittings	Remains and observed in good condition

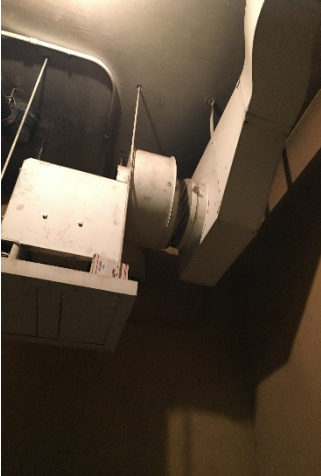
Location	Hazardous Building Material Observations	Condition	Photo
Basement	Previously identified ACM gaskets in flanges of mechanical pipes and systems in the basement	Remains and observed in good condition

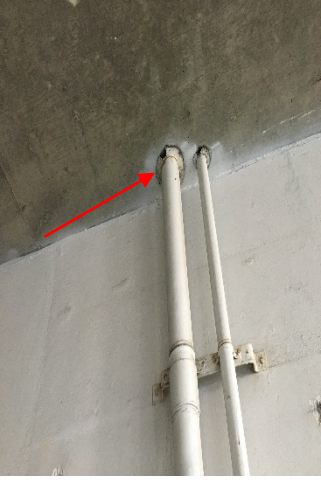
Location	Hazardous Building Material Observations	Condition	Photo
P4 North	Previously identified ACM white caulking at pipe penetrations	Remains and observed in good condition

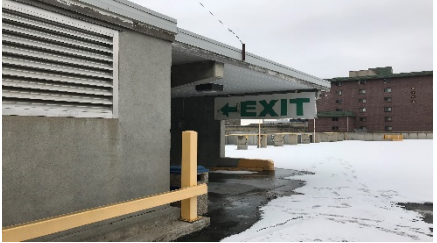
Exterior; P8	Presumed ACM sealant on fascia	Good condition

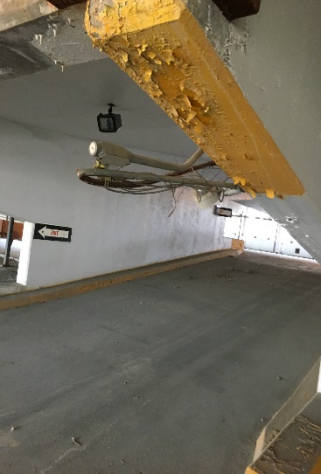
Throughout	Presumed ACM insulation in fire-rated doors	Good condition	No photo
Rooftop	Presumed ACM roofing material	Not observed	N/A
Throughout	All paint presumed to be lead-containing	Peeling paint observed on various surfaces throughout

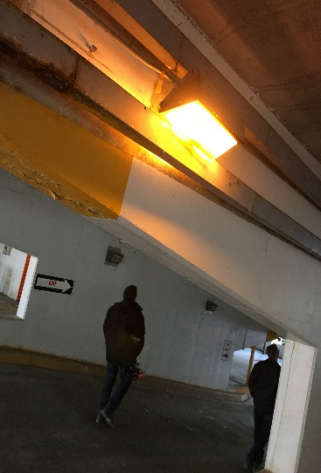
Location	Hazardous Building Material Observations	Condition	Photo
Throughout	Lead is expected to be present in the following: <ul style="list-style-type: none"> • Lead-acid batteries used in emergency lighting • Older electrical wiring materials and sheathing • Solder used in bell fittings for cast iron pipes and in electrical equipment • Vent and pipe flashings 	Those items observed were noted to be in good condition	No photo
Boiler room and basement	Fluorescent light fixtures reportedly all replaced with high-efficiency fixtures – ballasts not suspected to contain PCBs	N/A	No photo
Throughout	Fluorescent light tubes and high-intensity discharge bulbs contain mercury vapour	N/A
