Bonivital Pool; 1215 Archibald Street Building Condition Assessment

Submitted to: City of Winnipeg
Planning, Property, and Development Department
Accommodation Services

Date: April 4, 2019

Submitted by: Crosier Kilgour & Partners Ltd.
300-275 Carlton Street
Winnipeg, Manitoba R3C 5R6
Phone: 204.943.7501 Fax: 204.943.7507
Website: www.ckpeng.com

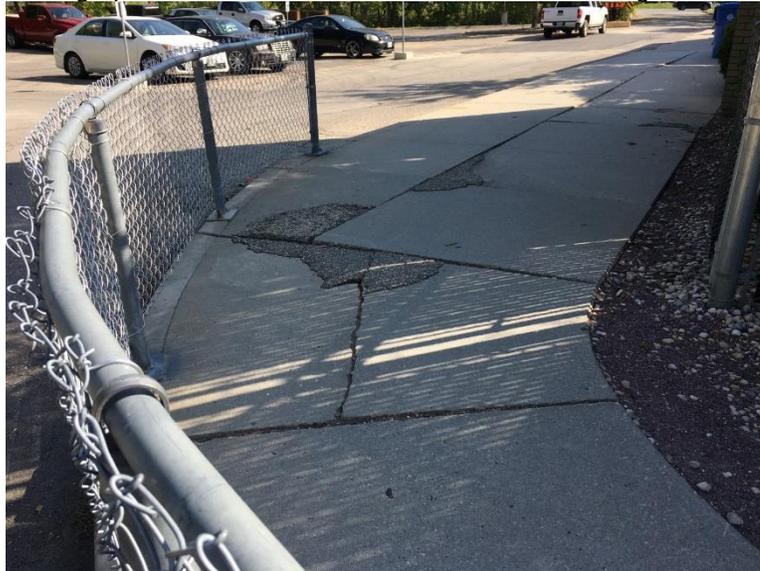
- .1 Varying degrees of cracking and movement in the concrete sidewalks and deterioration of concrete curbs was observed. Localized repairs are required to address tripping hazards and existing deficiencies.

Photograph 3.1.1.1-1: Partial view of sidewalk cracking and movement.

Recommendation 3.1.1.1-1: Complete localized repairs to existing sidewalks and curbs to address potential tripping hazards and deterioration. Repairs will range from localized patches to full depth replacement.

Priority: Short Term, recommended within 1 year.

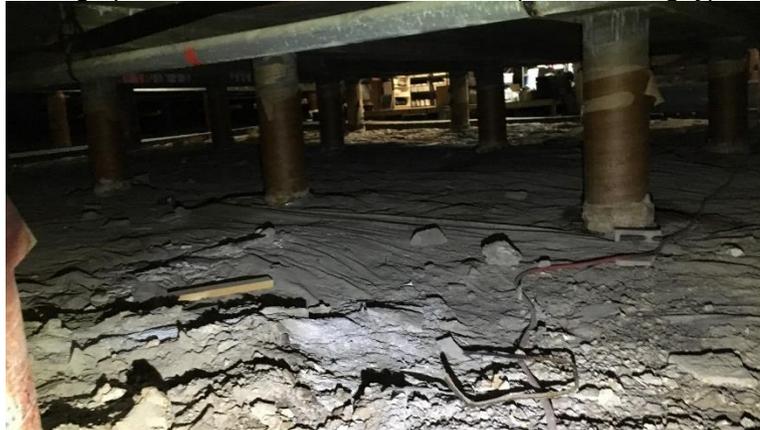
- .1 A crawlspace is located below the pool deck. Access to the crawlspace is provided by way of a man door off the mechanical room. The existing vapour retarder is discontinuous and in poor condition (Photograph 3.2.2.1-1). A wood walkway is provided as a walking surface in select areas (Photograph 3.2.2.1-2). The walkway is in good condition.

Photograph 3.2.1.1-1: Partial view of crawlspace showing typical ground cover.

Recommendation 3.2.1.1-1: The crawlspace does not have a functioning vapour barrier. Remediation of the crawlspace is required including grading of the existing soil to direct water away from structural members, installation of a new drainage system and sump pits (if required, see mechanical), and installation of a vapour retarder and sand cover. Installation of new sub-surface drainage, vapour barrier, and sand cover is recommended within 5 years.

Priority: Medium Term, recommended within 1 to 5 years.

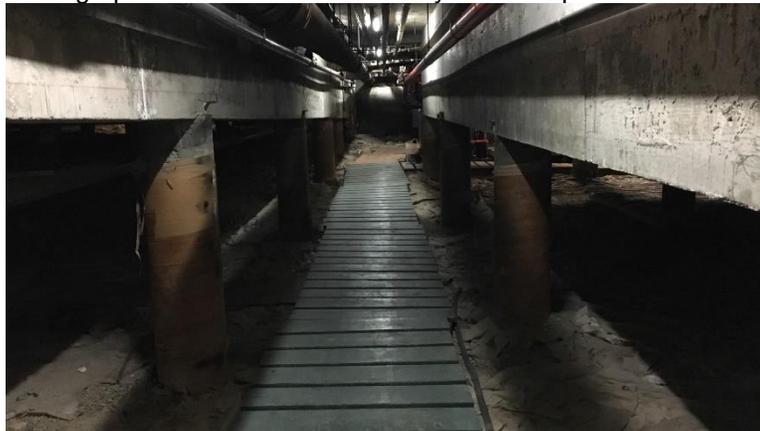
Photograph 3.2.1.1-2: Wood walkway between pool basins.

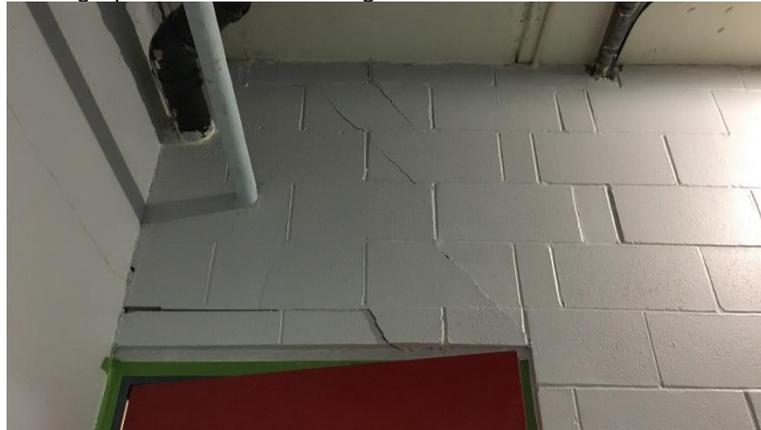
- .2 There is evidence of heaving of the basement floor slab in the mechanical room. Cracking is occurring as a result of the heaving and site personnel indicated that the conditions have been present for some time. Since the slab is grade-supported, the cracking is considered a functional/aesthetics issue rather than a structural problem.

Movement in the slab-on-grade is causing cracking in the concrete masonry unit (CMU) wall above the electrical room door (Photograph 3.2.1.2-1). The conditions are likely caused by heaving of the slab-on-grade. Repairs to the CMU wall is recommended in the short term.

Photograph 3.2.1.2-1: Cracking in CMU wall.

Recommendation 3.2.1.2-1: To address cracking in the CMU wall, localized removal and rebuilding of the wall will be required. Installation of a soft joint at the top of the wall and around penetrations is also recommended to allow for future movement.

Priority: Short Term, recommended within 1 year.

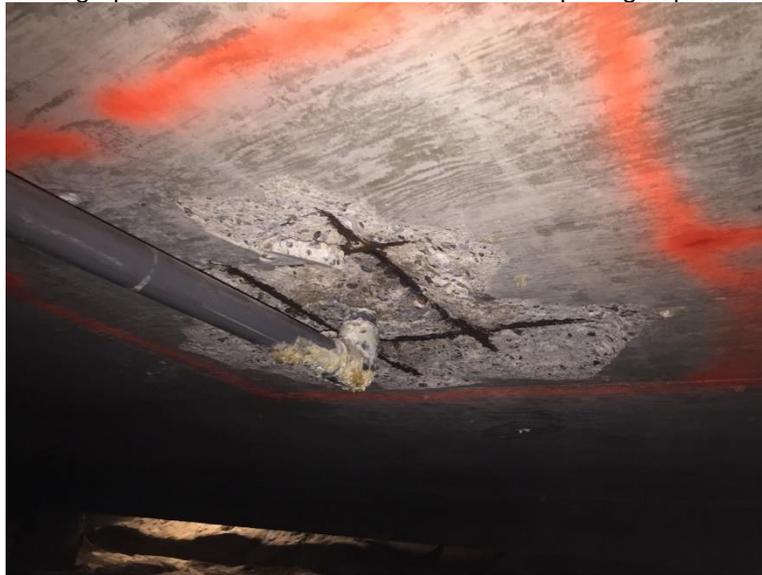
- .1 Delamination of the underside of the concrete pool tanks was observed at numerous locations from within the crawlspace. Photographs 3.2.2.1-1 and 3.2.2.1-2 show typical delamination of the slab soffit. The delamination is a result of corrosion of the embedded reinforcing steel. Efflorescence is also visible which is caused by water seepage through cracks in the concrete.

Photograph 3.2.2.1-1: Soffit delamination and spalling at pool tank drain.

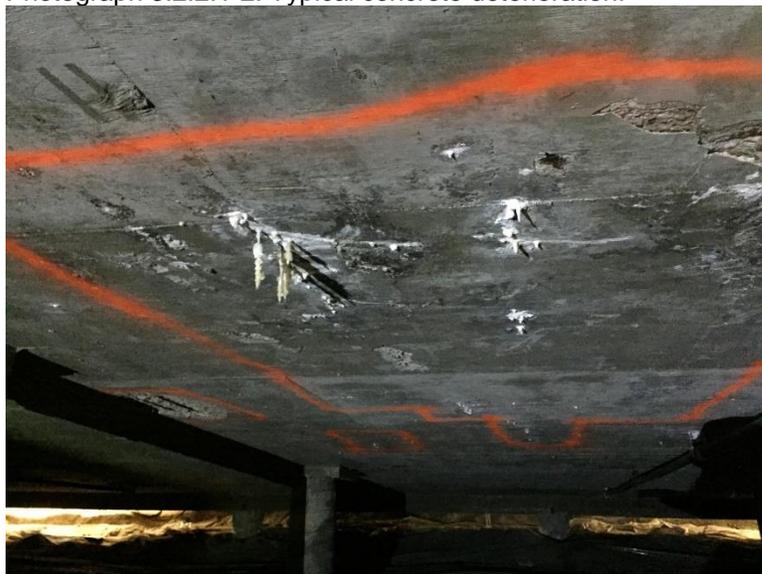
Photograph 3.2.2.1-2: Typical concrete deterioration.

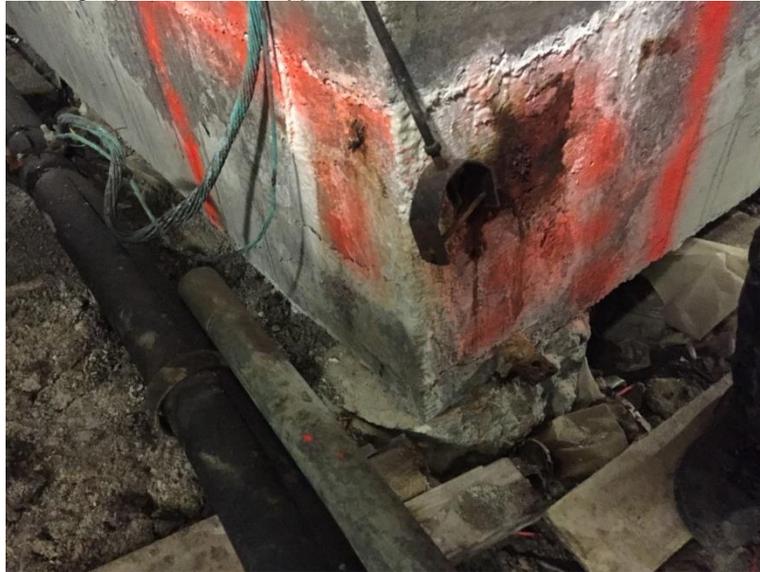
Efflorescence and corrosion staining were observed along the existing construction joints in the pool walls (Photograph to 3.2.2.1-3). The conditions are caused by water seepage through the joint.

Photograph 3.2.2.1-3: Typical concrete deterioration.

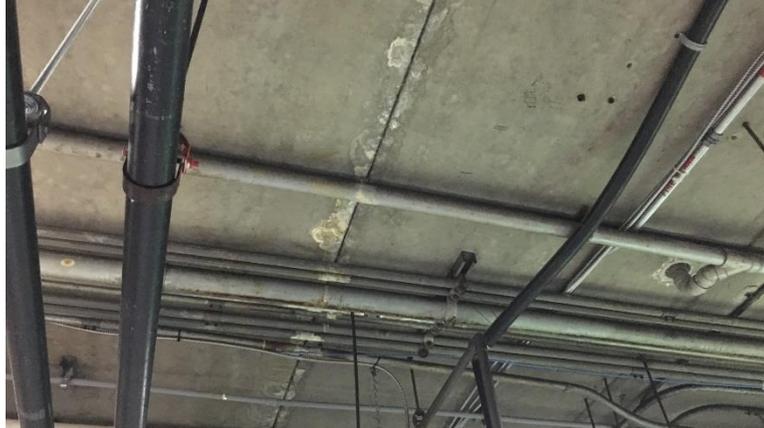
Photograph 3.2.3.1-1: Leakage along main floor hollowcore joints.

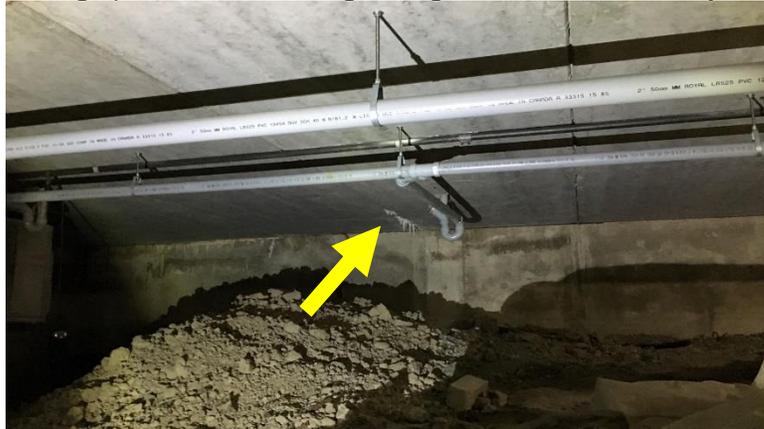
Photograph 3.2.3.1-2: Leakage along main floor hollowcore joints.

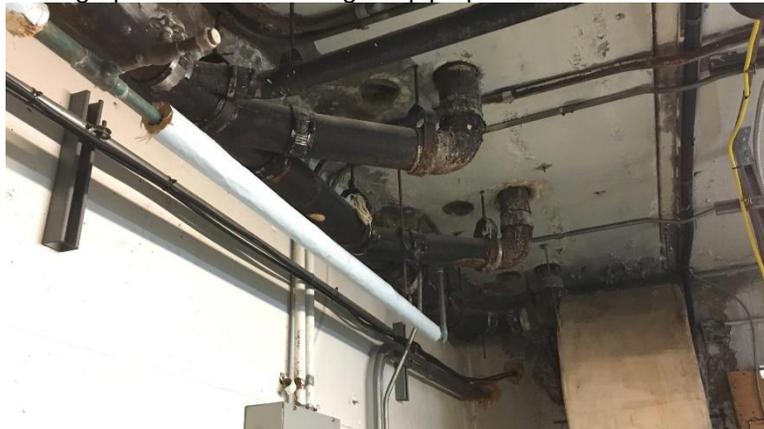
Photograph 3.2.3.1-3: Leakage at pipe penetrations.

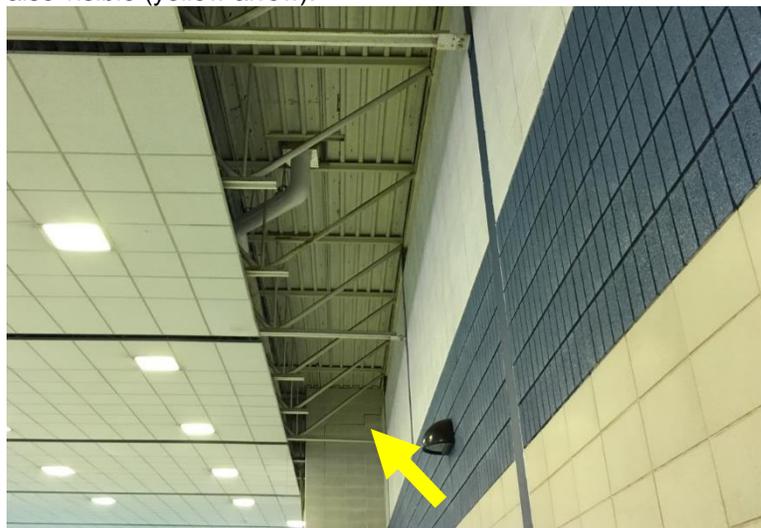
Photograph 3.2.4.1-1: Partial view of roof framing. Step cracking in northwest corner also visible (yellow arrow).

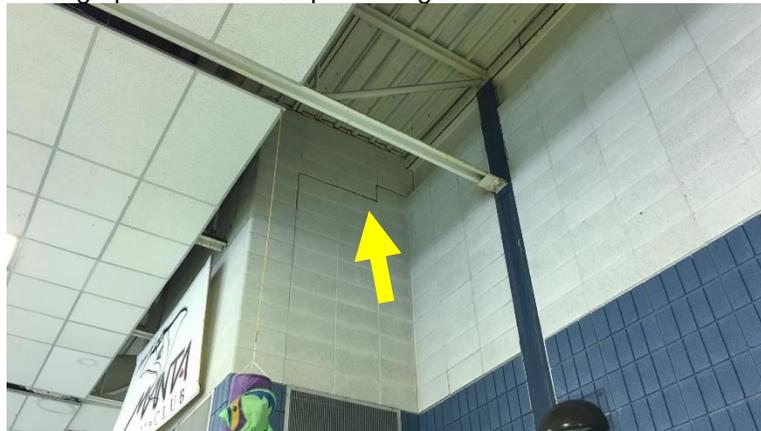
Photograph 3.2.4.2-1: Step cracking in south wall.

Recommendation 3.2.4.2-1: Localized masonry joint repairs are recommended to address cracks in the mortar joints.

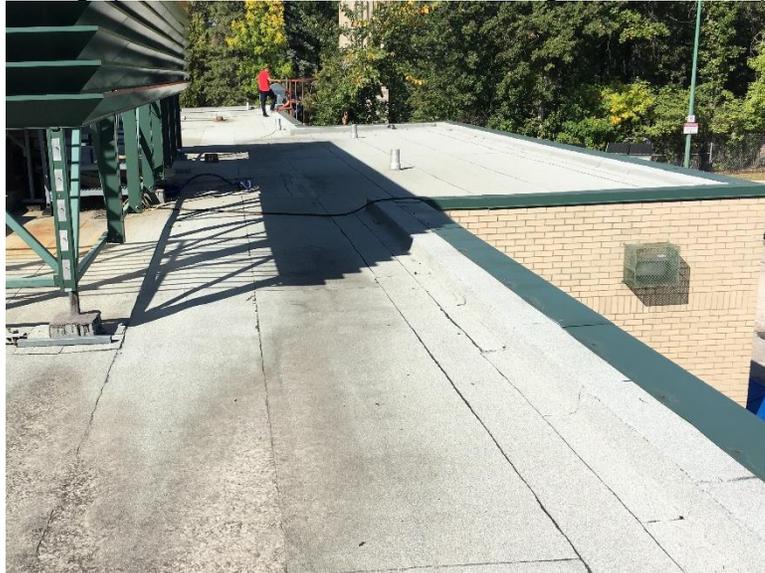
Photograph 3.2.5.2-1: North Low Roof showing area without fall protection.

Recommendation 3.2.5.2-1: Install fall protection consisting of a surface mounted, non-penetrating guardrail along portions of north elevation roof edge.

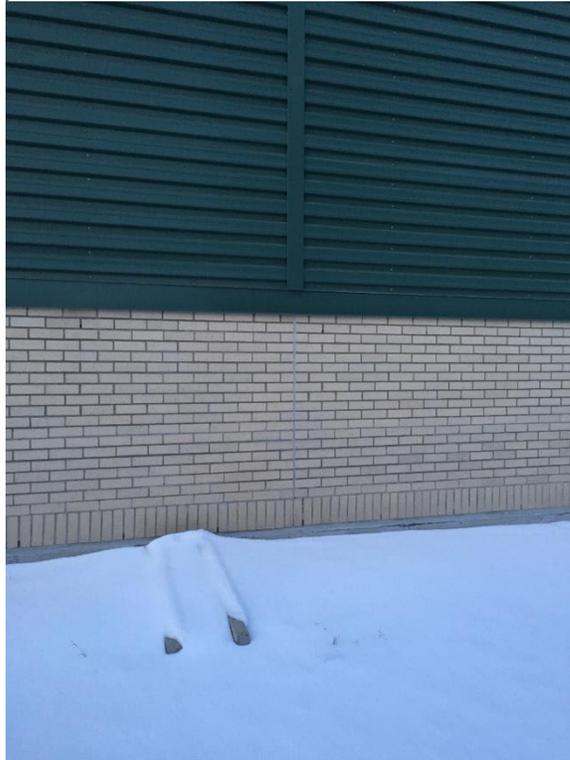
Photograph 3.3.1.4-1: General view of existing metal cladding and brick masonry control joint where thermal anomalies were observed during thermographic scanning.

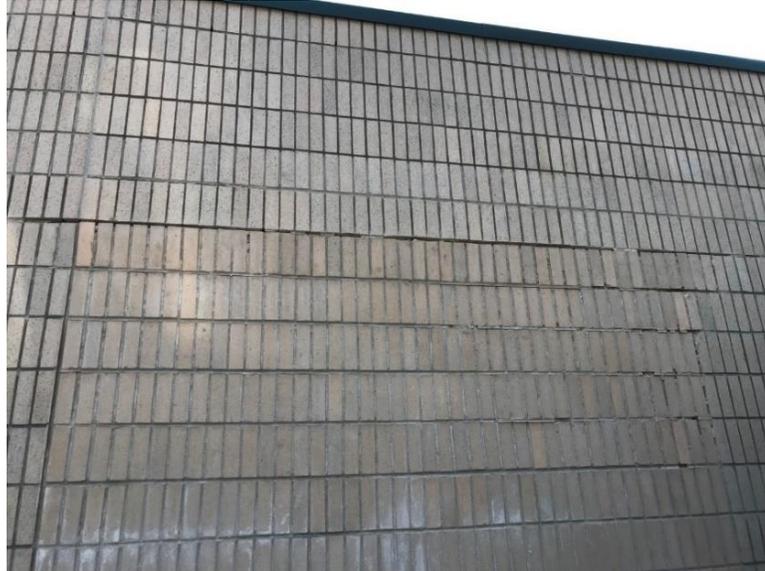
Photograph 3.3.1.4-2: Localized brick mortar joint deterioration with efflorescence build-up at brick cladding (West Elevation).

Recommendation 3.3.1.1-1: Repointing of localized deteriorated/cracked brick and granite mortar joint is anticipated as original mortar joint work becomes aged and breaks down due to exposure to the elements. Assume 20% of the existing mortar joint.

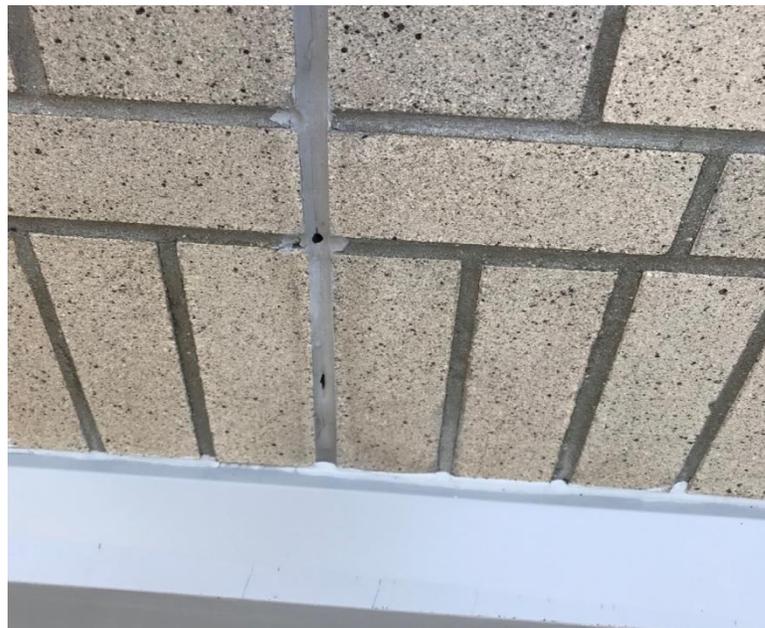
Photograph 3.3.1.4-3: Typical cracking and debonding of existing sealant at brick masonry control joint where thermal anomaly was observed during thermographic scanning.

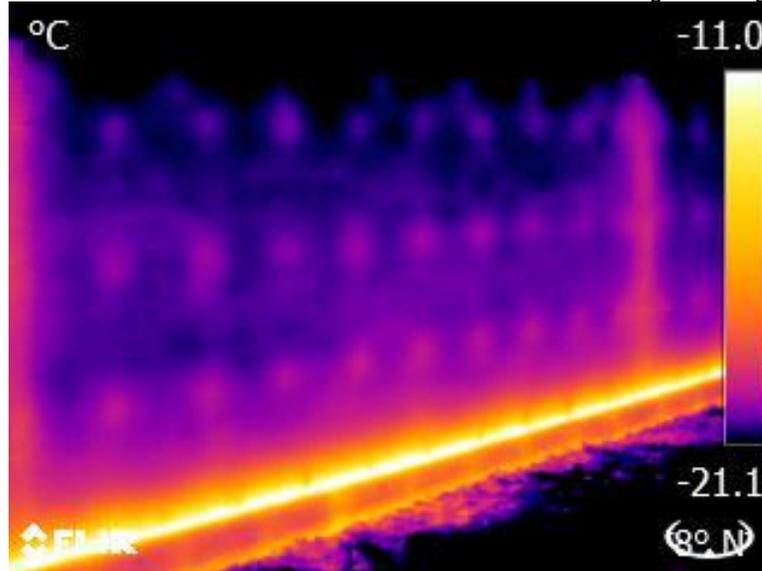
Photograph 3.3.1.4-4: Heat transfer at brick masonry ties, at control joints and along the foundation wall/brick wall interface was observed during thermographic scanning.

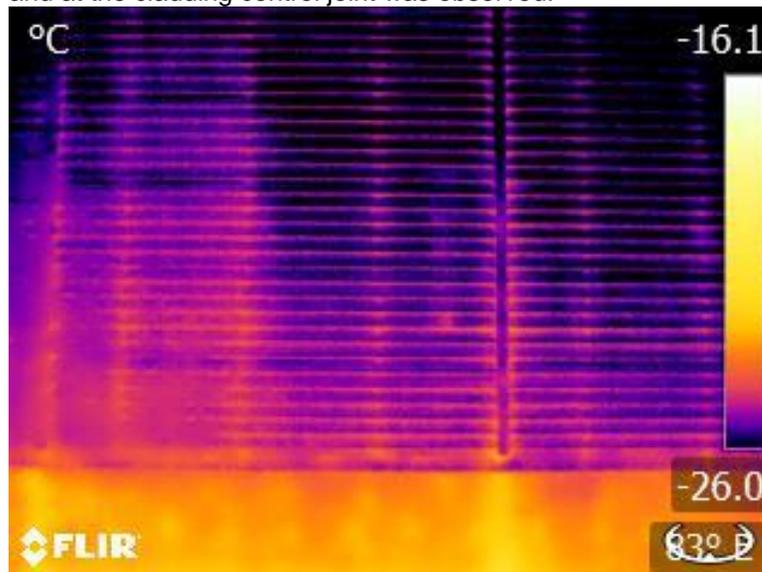
Photograph 3.3.1.4-5: Heat transfer through steel girts supporting the metal cladding and at the cladding control joint was observed.

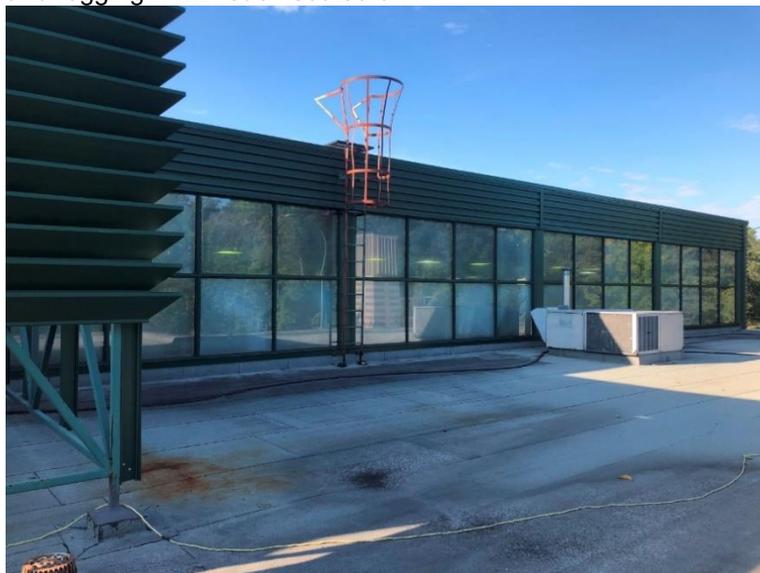
All sealed units exhibited evidence of seal failure including fogging, condensation, streaking, and accumulation of desiccant residue on interior surfaces of lites. Four of the 62 sealed clerestory units underwent frost point testing, which confirmed failed seals in all instances.

Photograph 3.3.2.1-3: Partial view of west end of north elevation showing condensation and fogging within each sealed unit.

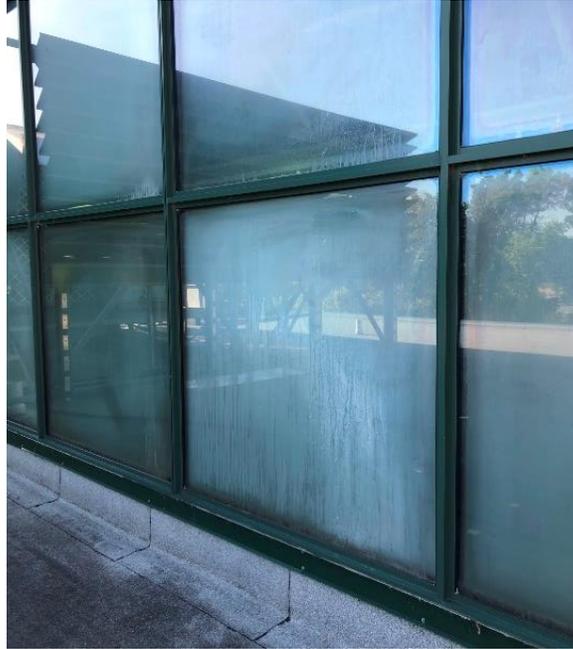
Photograph 3.3.2.1-4: Typical example of a failed sealed glazing unit, exhibiting condensation between the lites.

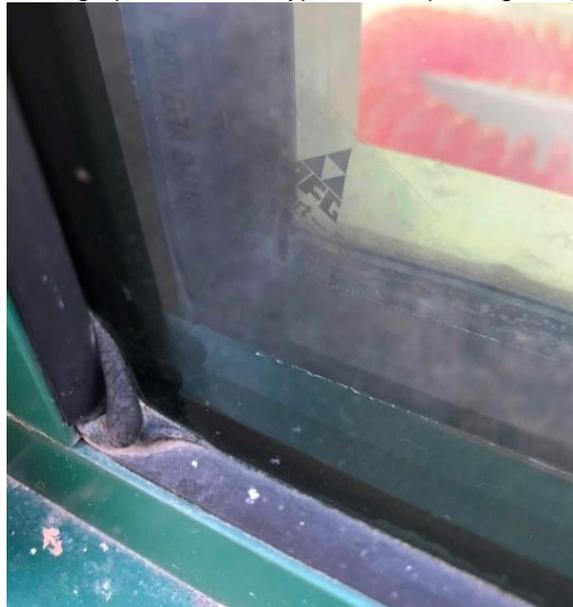
No visible cracks were observed in any of the sealed units. Generally, the exterior gaskets were intact; however, environmental exposure degradation, such as minor cracking and stiffening of the gasket, was observed. Displacement of glazing sealant from behind the gaskets was noted, generally at horizontal to vertical frame connection points.

Photograph 3.3.2.1-5: Typical example of glazing sealant displacement.

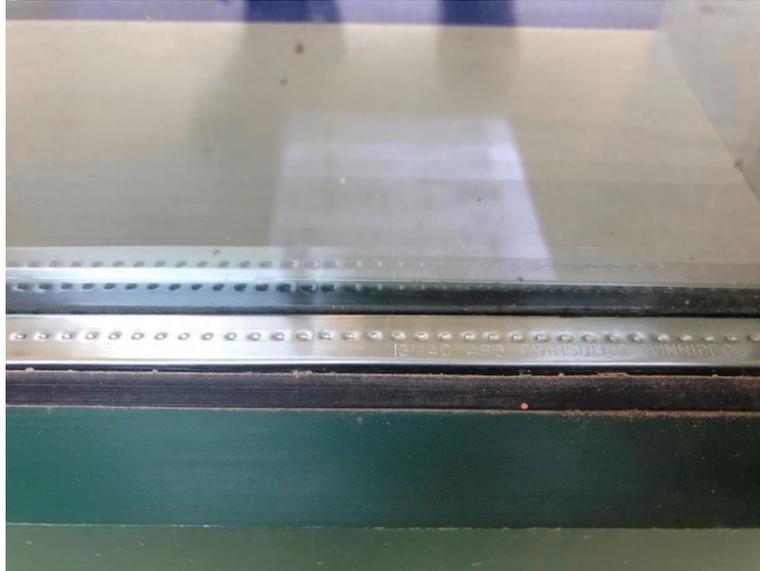
Though the sealed units did not exhibit visible evidence of seal failure, frost point testing of one of the five window units revealed seal failure.

Photograph 3.3.2.2-2: Typical example of north elevation entrance window exterior gasket and metal spacer.

Recommendation 3.2.2.2-1: Existing aluminum doors and associated curtain wall framed entrance windows are near the end of their expected service life and exhibiting sealed unit failure. Short term replacement is recommended to increase thermal performance, visibility, and occupant comfort. It is recommended that associated flashing and sealant replacement and repairs be conducted simultaneously to increase the performance and durability of the window tie in to the overall envelope system.

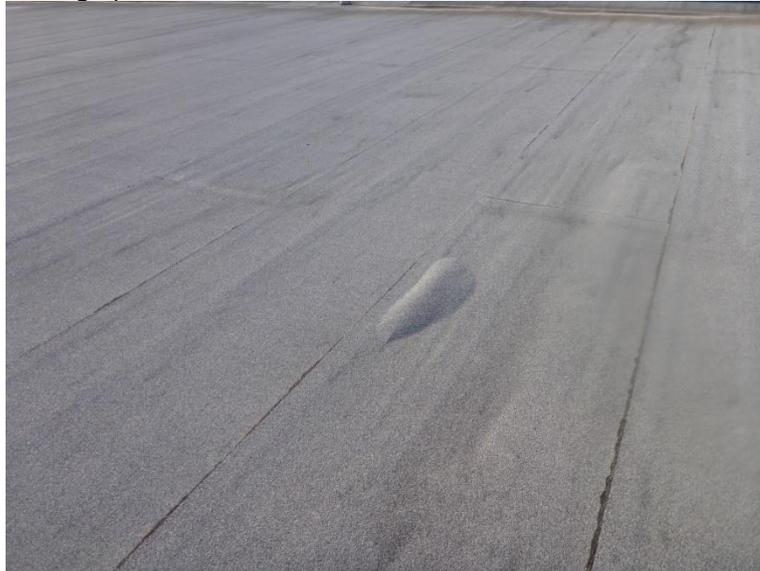
Photograph 3.3.3.1-2: View of minor blister.

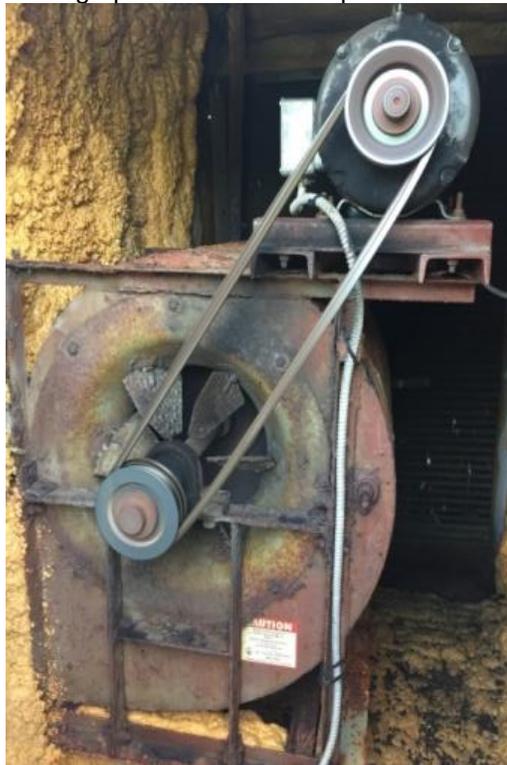
Photograph 3.4.1.1-1 Rooftop HRV Fan deterioration

Recommendation 3.4.1.1-1: Replace pool area heat recovery unit with heat recovery unit suitable for use pool environment, installed in in same roof top location as the existing unit. The new unit shall be capable of providing minimum ventilation and exhaust requirements to comply with current code. Proposed unit does not include mechanical cooling or dehumidification. Consideration should be given during design to requirement or benefits to adding mechanical dehumidification to manage humidity levels within the pool deck area.

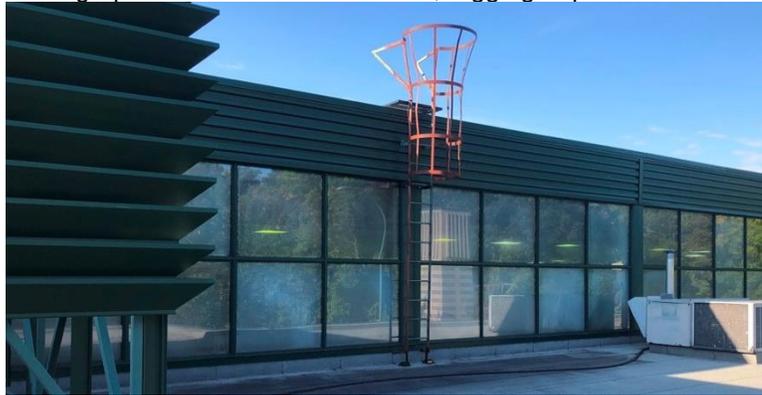
Photograph 3.4.1.2-1: Condensation, fogging of pool north side windows

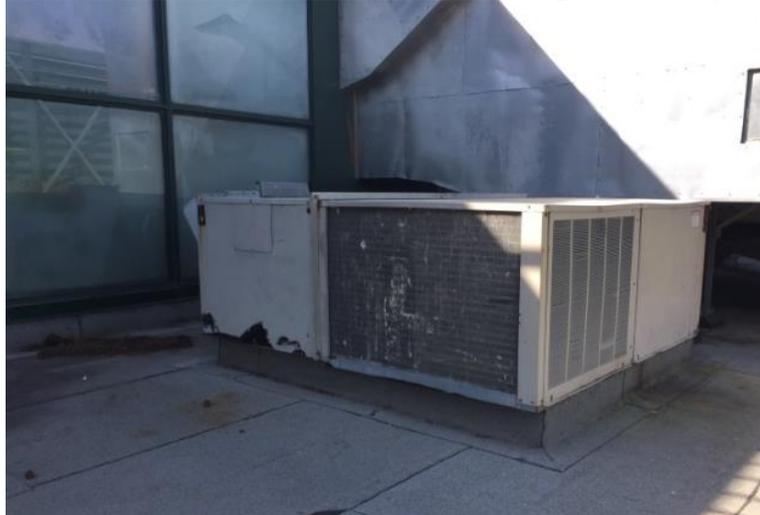
Photograph 3.4.3.1.5-2: D/X rooftop unit serving observation area - west side

Recommendation 3.4.1.5-1: The units should be replaced with alternatives that are capable of conditioning the outside air during the winter months so as to provide adequate fresh air ventilation to the spaces served throughout the entire year.

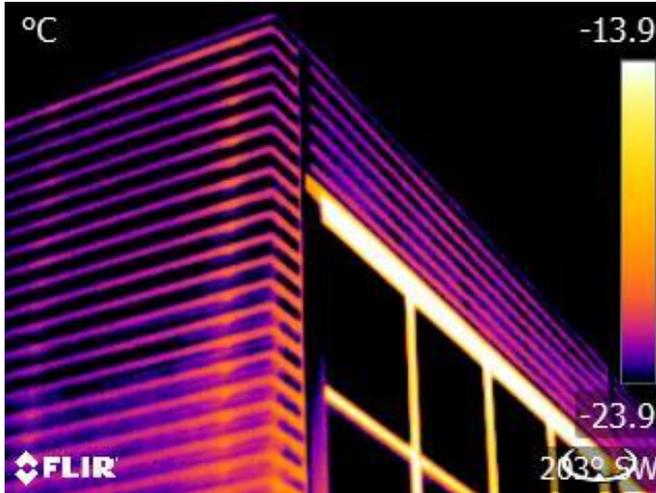
Figure 6: Thermal bridge at window frames at North elevation (refer to Photograph #65).

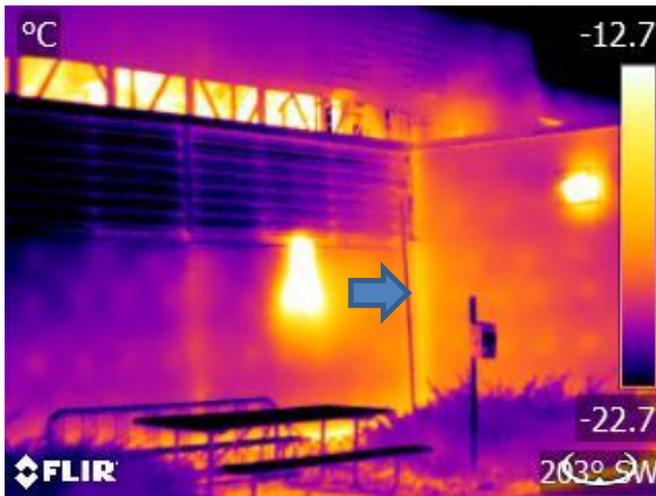
Figure 7: Thermal bridge at inside corner of North elevation wall intersection at entrance (refer to Photograph #5). Direct path for heat flow from mass of masonry at the corner causes elevated temperatures on the exterior surface during colder weather.

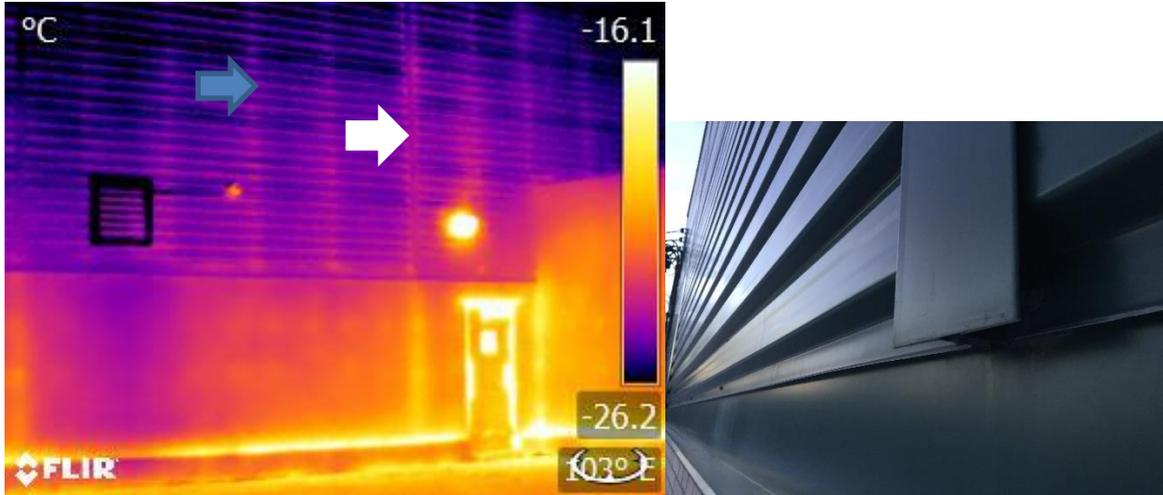
Figure 8: Metal siding control joints and supporting girts at West elevation (refer to Photograph #27). Heat transfer through steel girts supporting the siding (blue arrow) and at siding control joints (white arrow) and photograph to right).

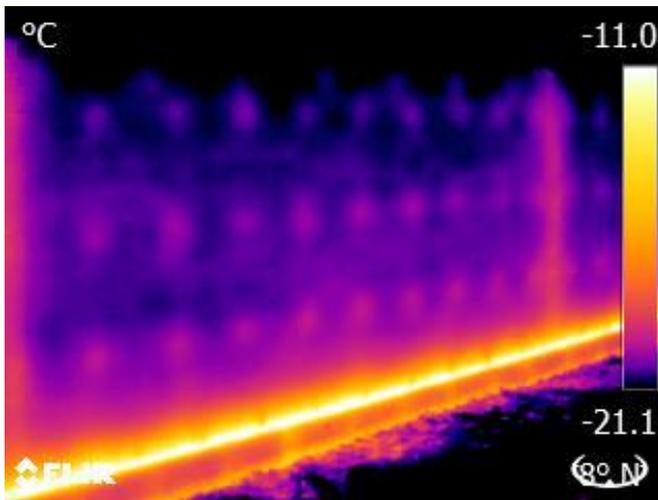
Figure 9: Masonry wall ties and foundation wall at grade at East elevation (refer to Photograph #57). Heat transfer through wall at ties supporting the clay brick veneer. Also, heat transfer through the foundation wall at grade.

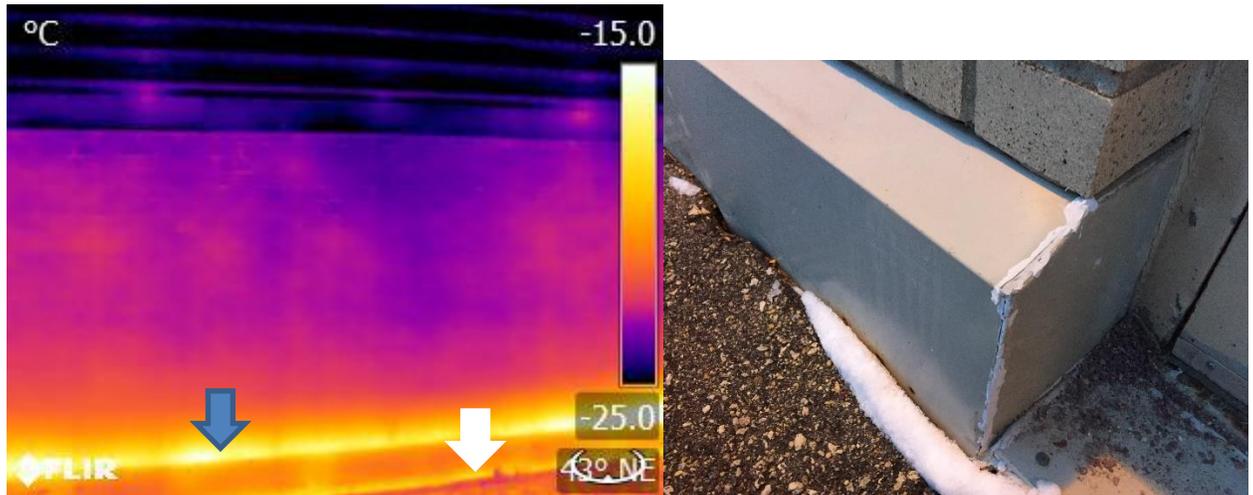
required to review the condition of the foundation wall. Further review is recommended to assess if air leakage is occurring at this location.

Figure 10: Thermal anomaly at the intersection of the brick cladding and foundation wall (blue arrow). Note that this thermal anomaly is located at the intersection of the top of the foundation wall and brick cladding and not at the intersection of the foundation wall and grade (white arrow). Also note that insulation and metal flashing is installed outboard of the foundation wall below the brick cladding.
