Carlton Street Skywalks
Structural and Cladding Investigation
City of Winnipeg Project No. 2013-139

Submitted to: City of Winnipeg
Planning Property and Development Department

Date: April 5, 2016

CKP File No. 2015-1231

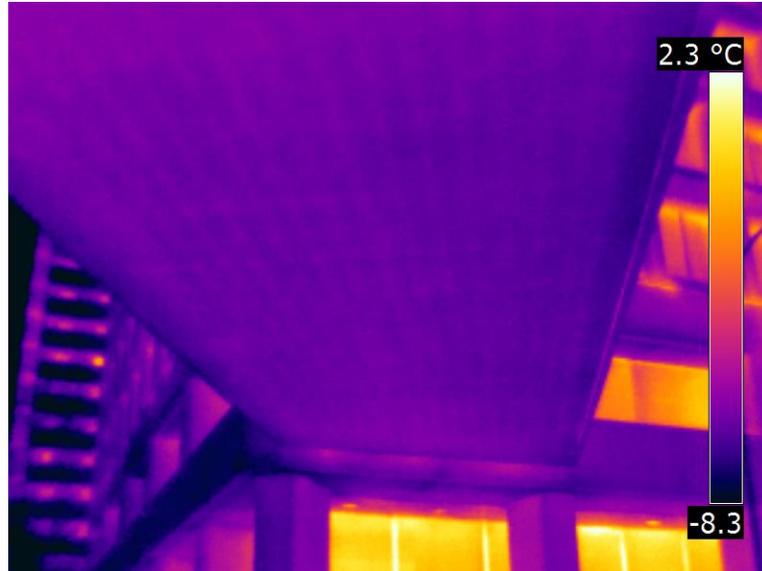
Figure 2: Image showing a typical example of thermal bridging at soffit supports below the skywalk.

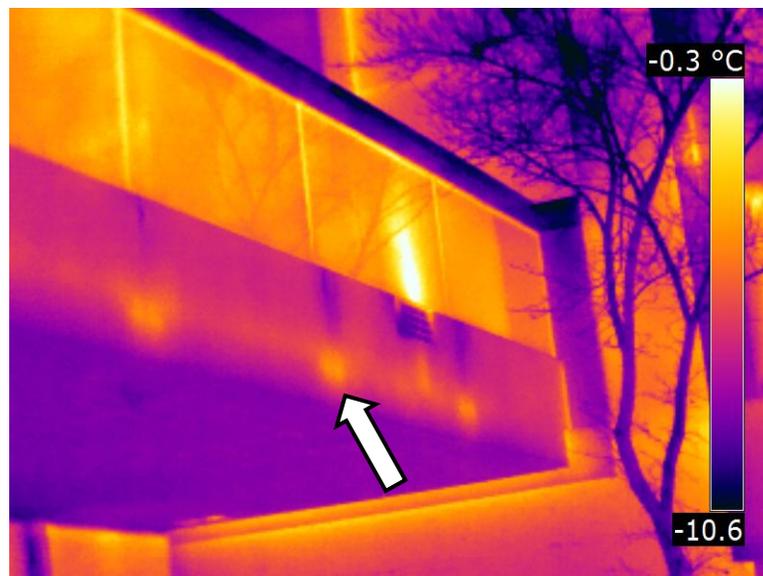
Figure 3: Image showing a typical example of thermal bridging at precast panel weld plate connections.

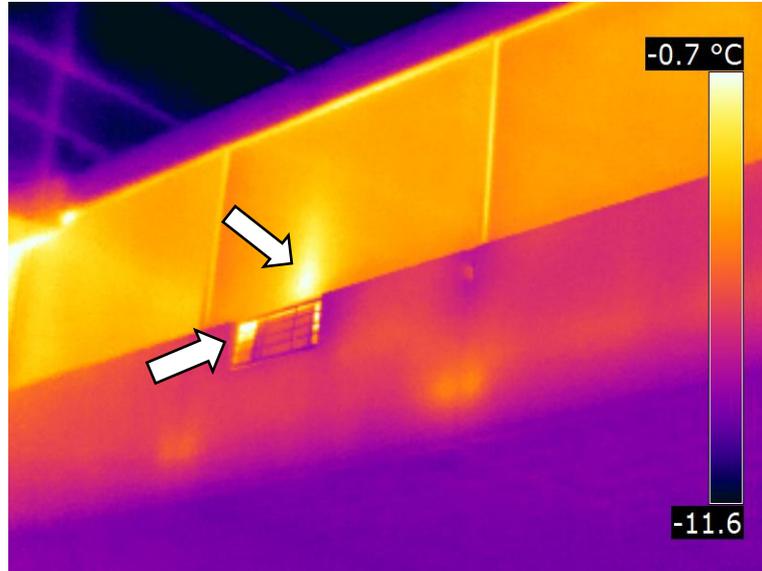
Figure 4: Image showing air leakage at the mechanical heating unit. Examples of both direct and indirect (disbursed) air leakage patterns can be seen.

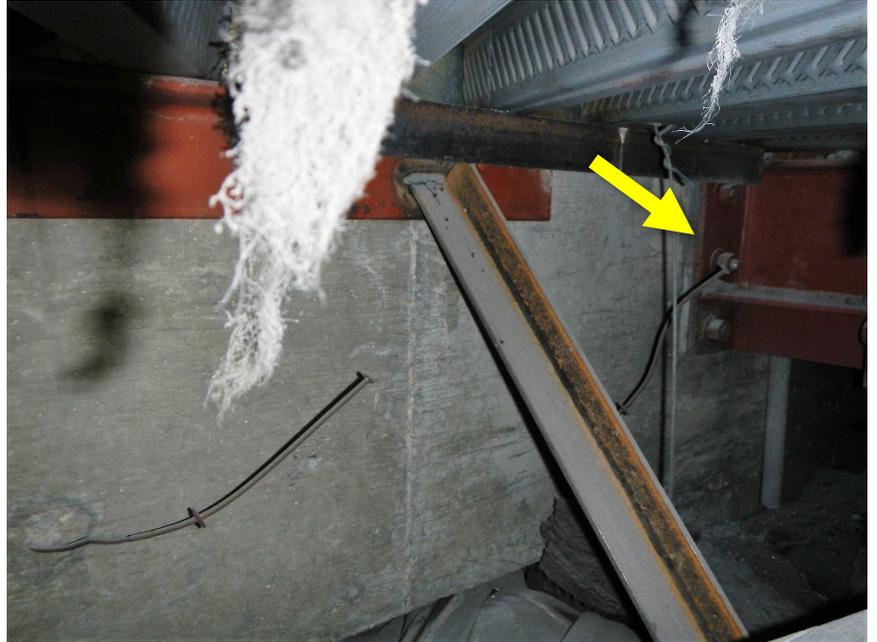
Photograph #5:

An inspection recess was created through the existing cementitious stucco soffits to allow visual assessment of the bridge connections at 155 Carlton. Photograph #5 shows the connection of the steel bridge beam to the concrete beam of 155 Carlton. The connection appears to be in good condition with no evidence of deterioration or structural duress.

South skywalk, southeast bearing connection at 155 Carlton Street.

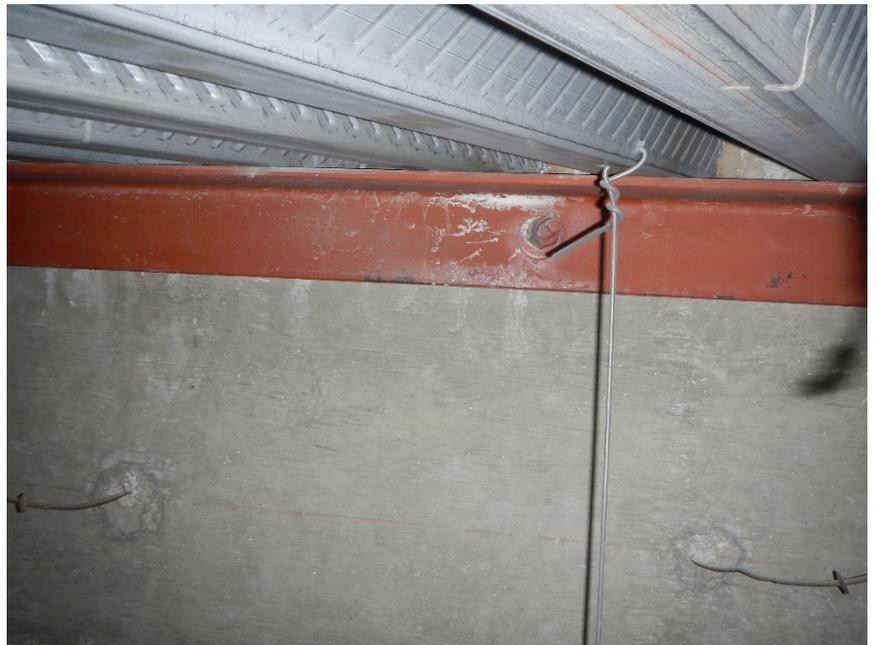
Photograph #6:

Photograph #6 shows the steel angle supporting the edge of the steel floor deck. The steel angle is in good condition with no evidence of deterioration or structural duress.

South skywalk, shelf angle supporting the steel floor decking at 155 Carlton Street.

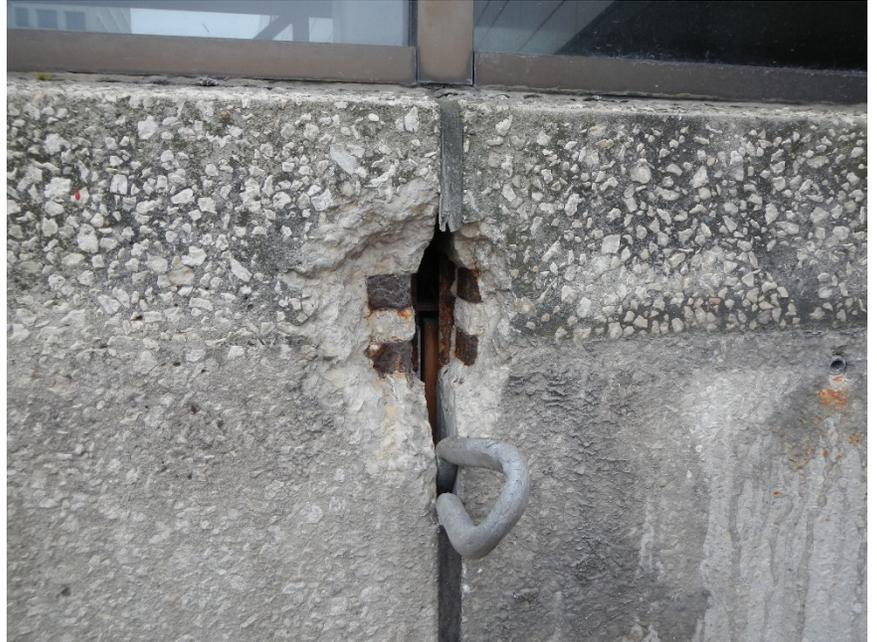
Delamination and spalling at the cladding anchorages.

Deterioration of the precast joint sealants and window rough opening sealants.

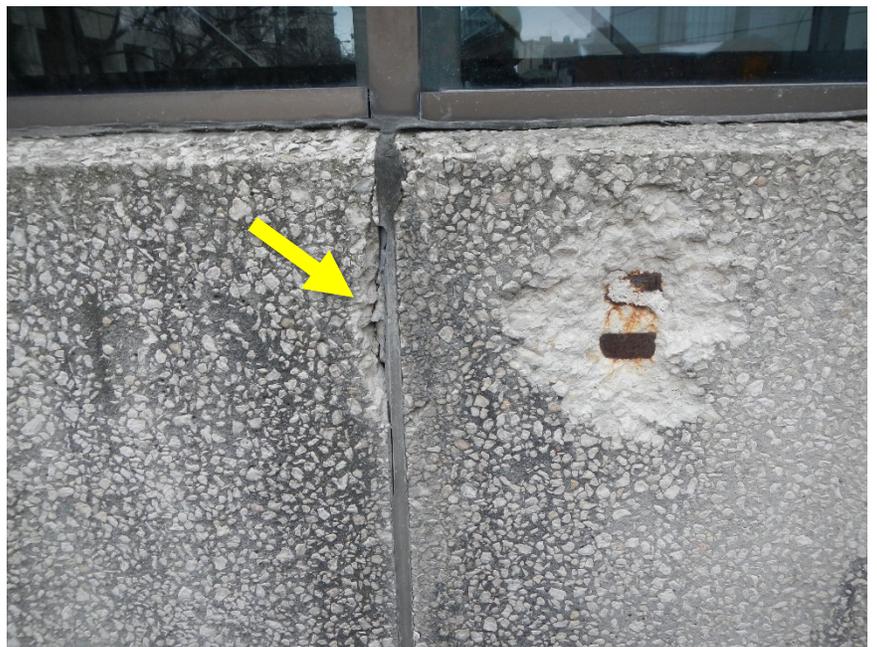
Photograph #8:

North Skywalk – North Elevation

Freeze-thaw deterioration at panel joints.

Deterioration of the precast joint sealants and window rough opening sealants.

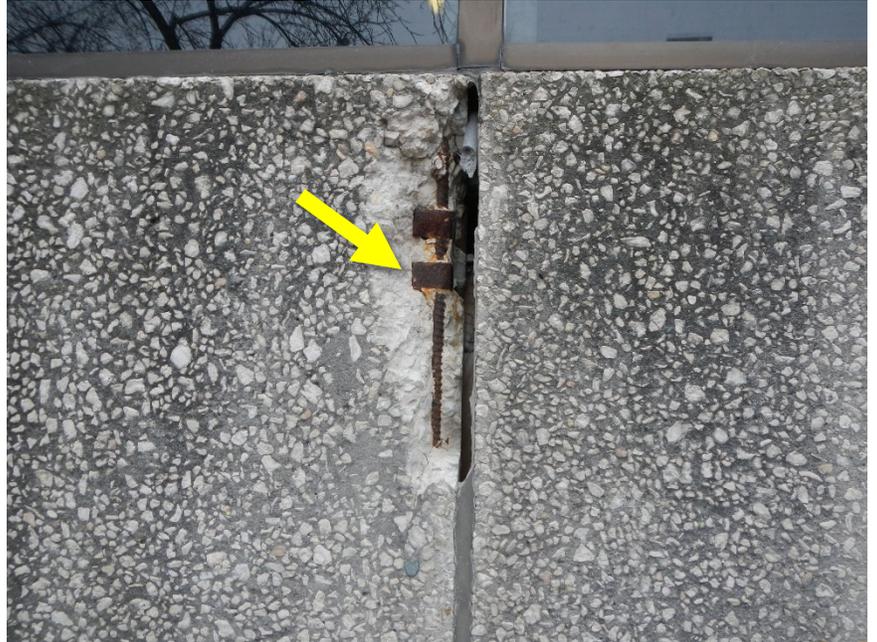
North Skywalk – North Elevation

Delamination and spalling at the
cladding anchorages with
exposed reinforcing steel.

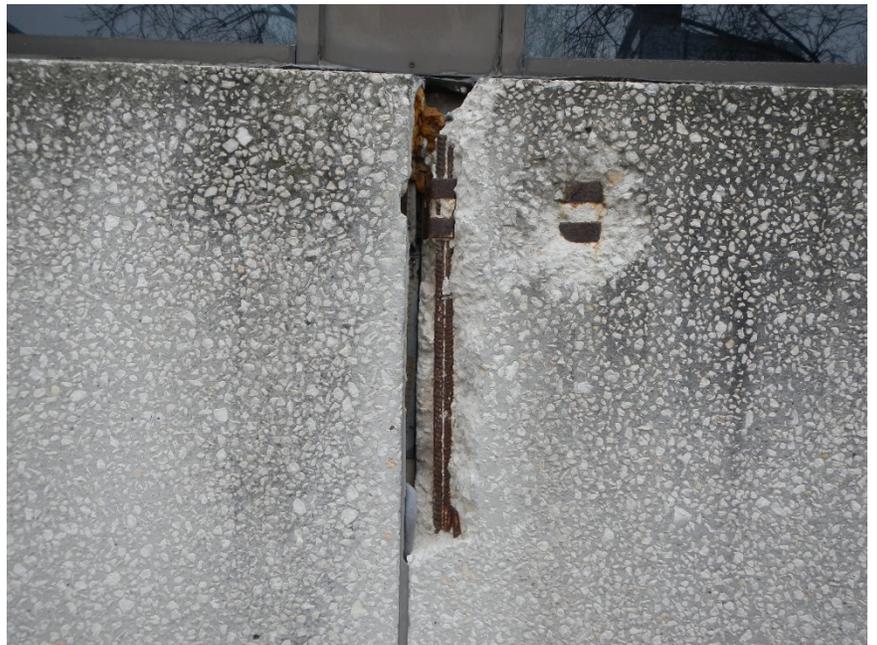
Photograph #10:

North Skywalk – North Elevation

Delamination and spalling at the
cladding anchorages with
exposed reinforcing steel.

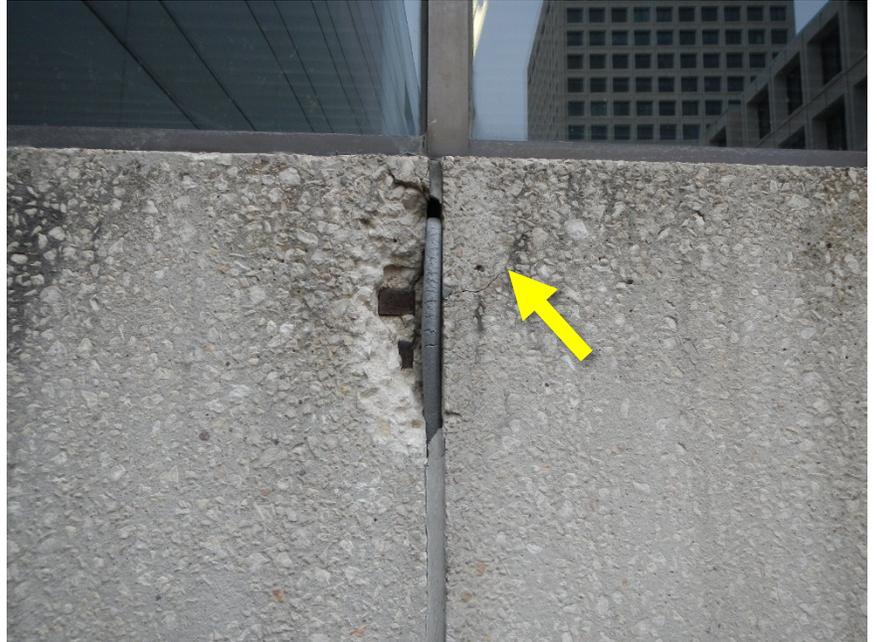
Delamination and spalling at the
cladding anchorages.

Cracking along face of panel.

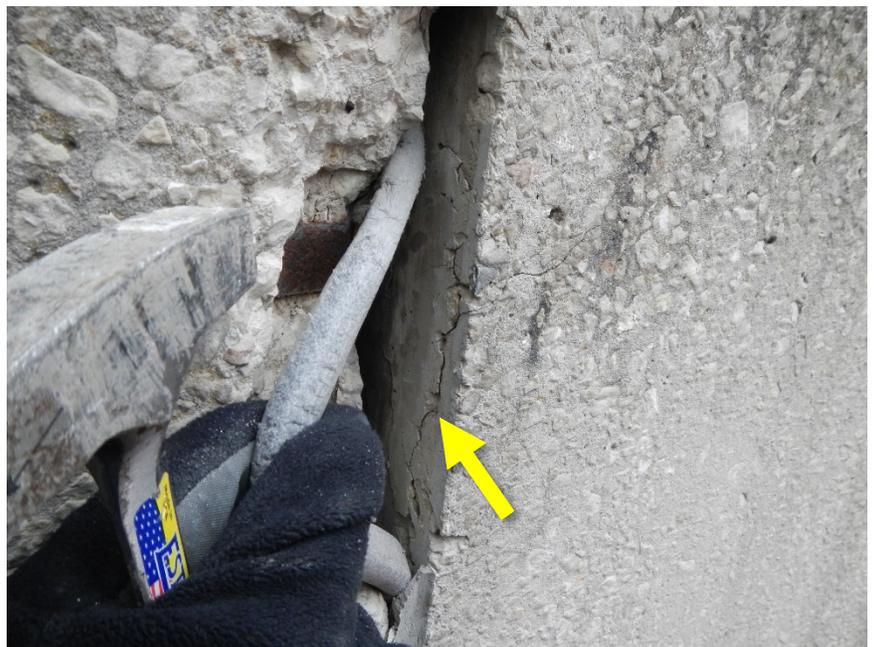
Photograph #12:

North Skywalk – South Elevation

Close-up of precast panel shown
in Photograph #11.

Cracking visible along the side of
the precast panel consistent with
delamination.

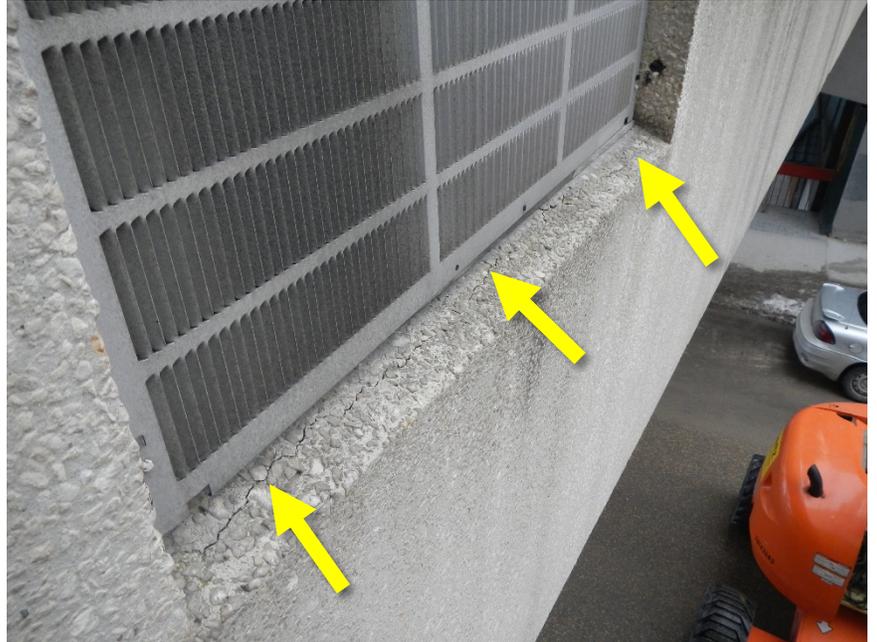
North Skywalk – South Elevation

Cracking visible along edge of precast opening.

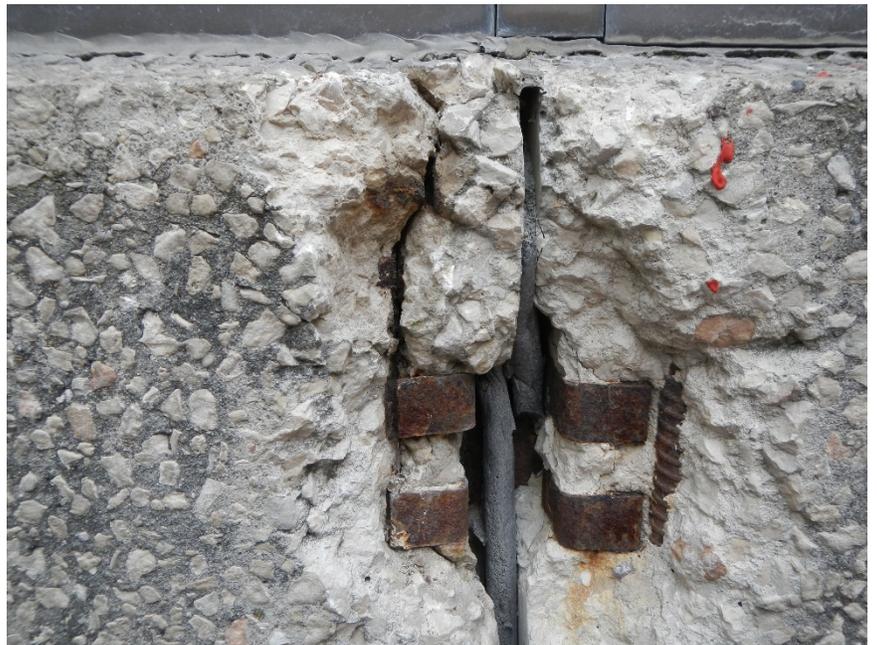
Photograph #14:

North Skywalk – South Elevation

Delamination and spalling at the cladding anchorages.

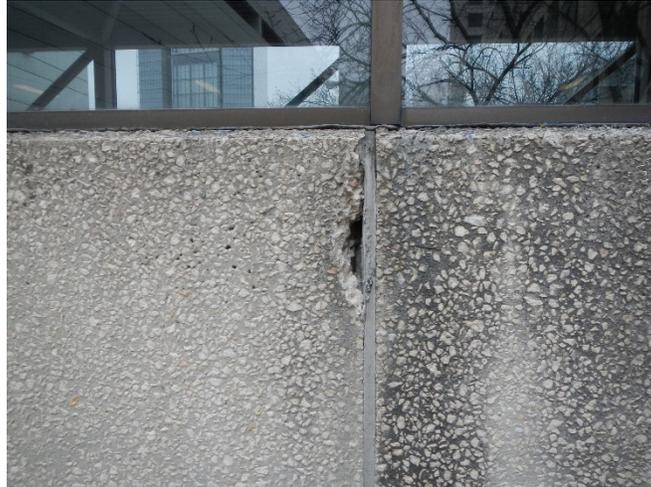
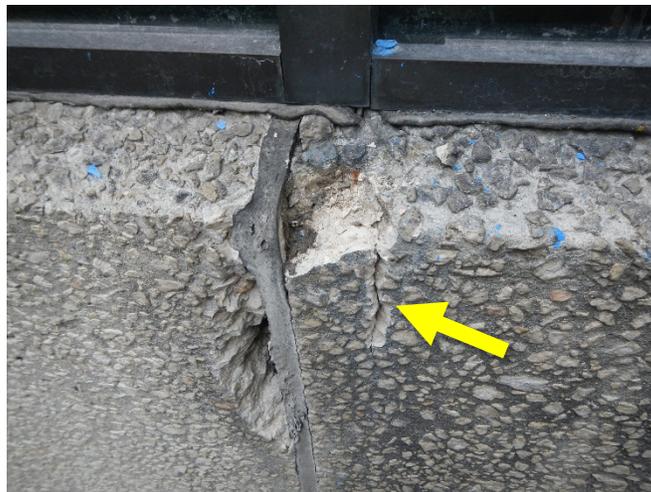
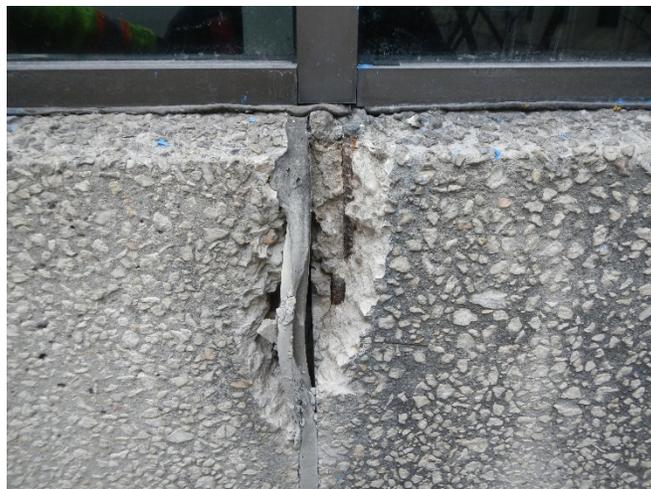
- Loose concrete was observed at several locations that was able to be easily removed with a hand hammer. Photograph #15 shows the progression of one location where loose concrete was removed.

Middle: Cracking and spalling on right side of joint.

Bottom: After removal of loose concrete. Corroded reinforcing visible.

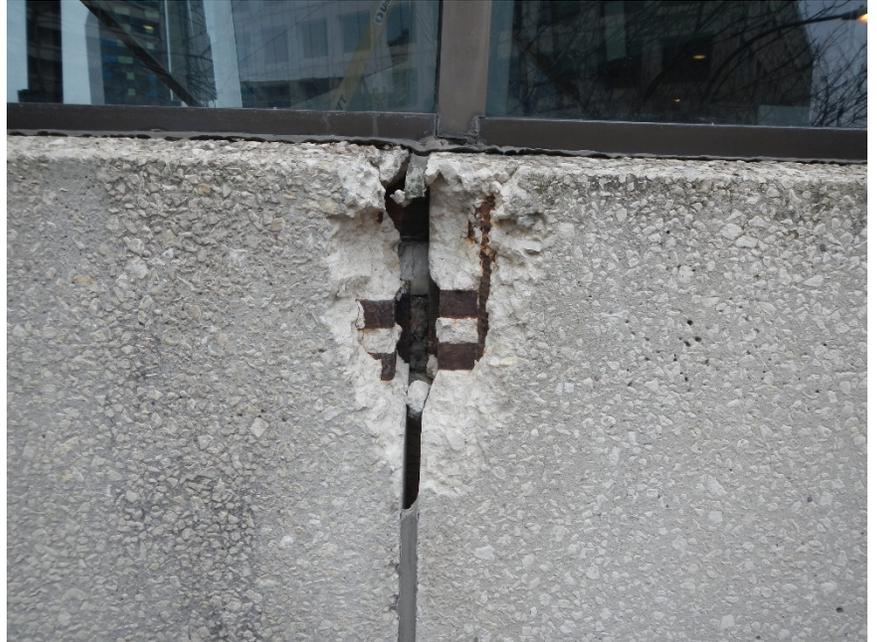
Delamination and spalling at the cladding anchorages.

Deterioration of the precast joint sealants and window rough opening sealants.

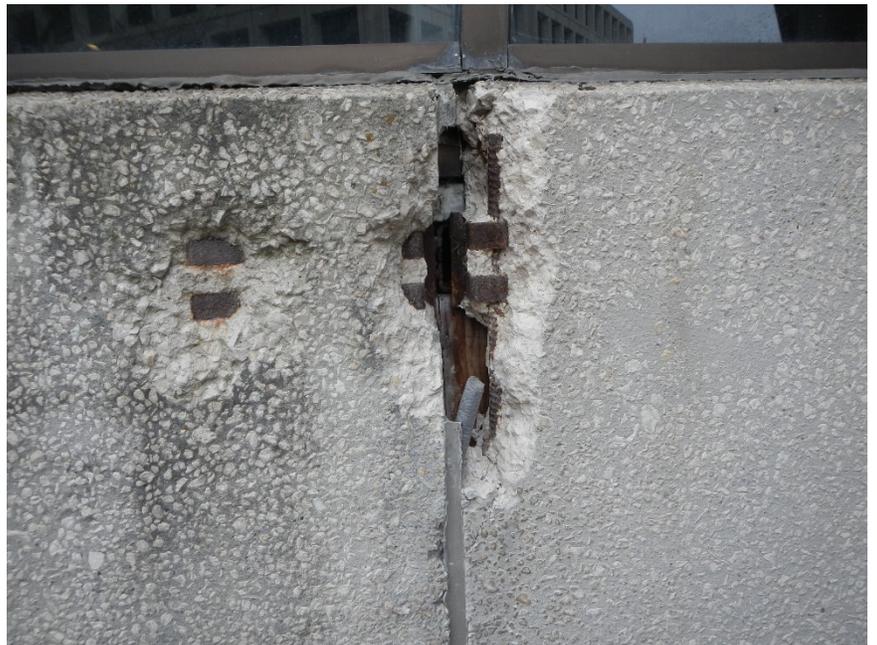
Photograph #17:

South Skywalk – North Elevation

Delamination and spalling at the cladding anchorages.

Deterioration of the window rough opening sealants.

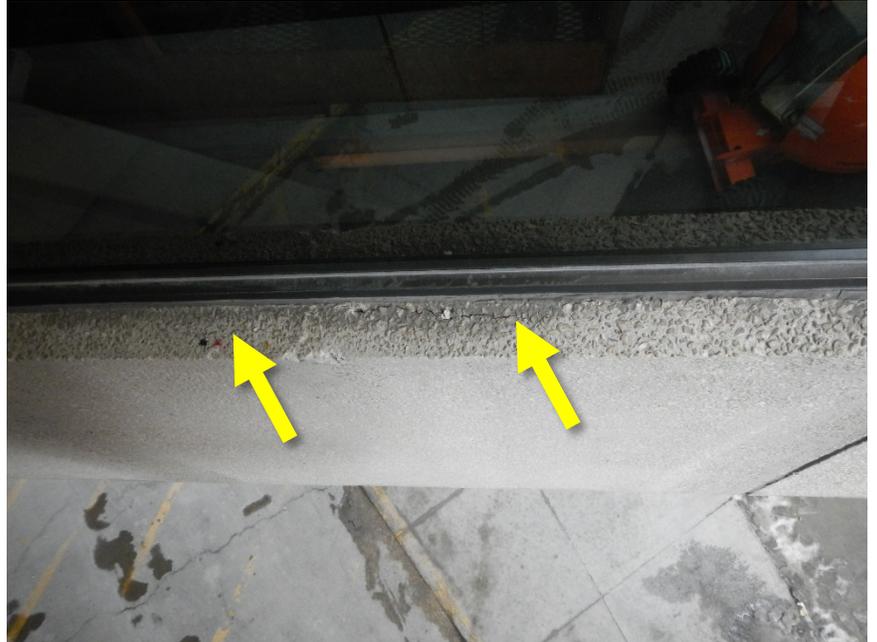
South Skywalk – South Elevation

Cracking on top surface of the precast panel.

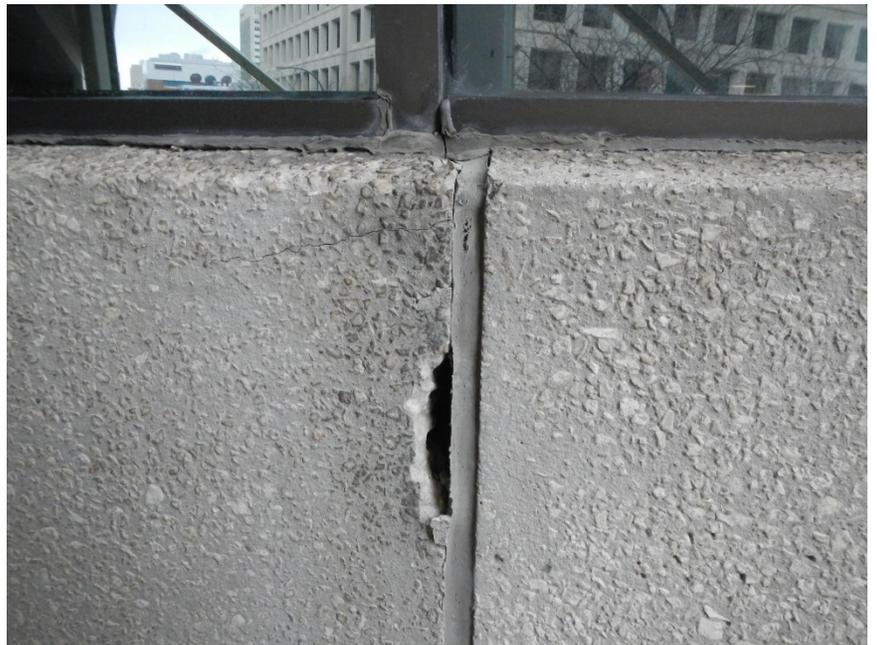
Photograph #19:

South Skywalk – South Elevation

Freeze-thaw deterioration at panel joints.

Cracking along face of panel.

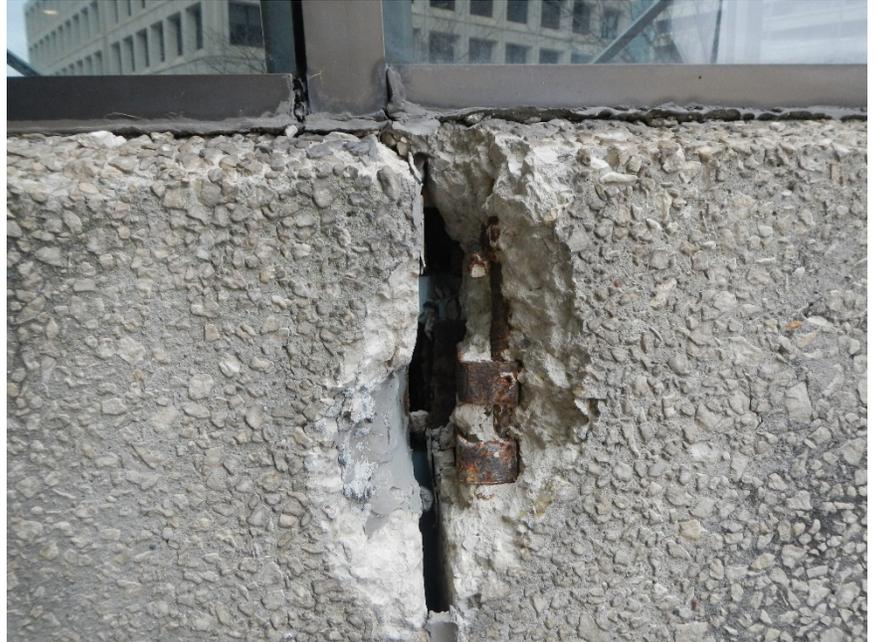
Delamination and spalling at the
cladding anchorages.

Deterioration of the window rough
opening sealants.

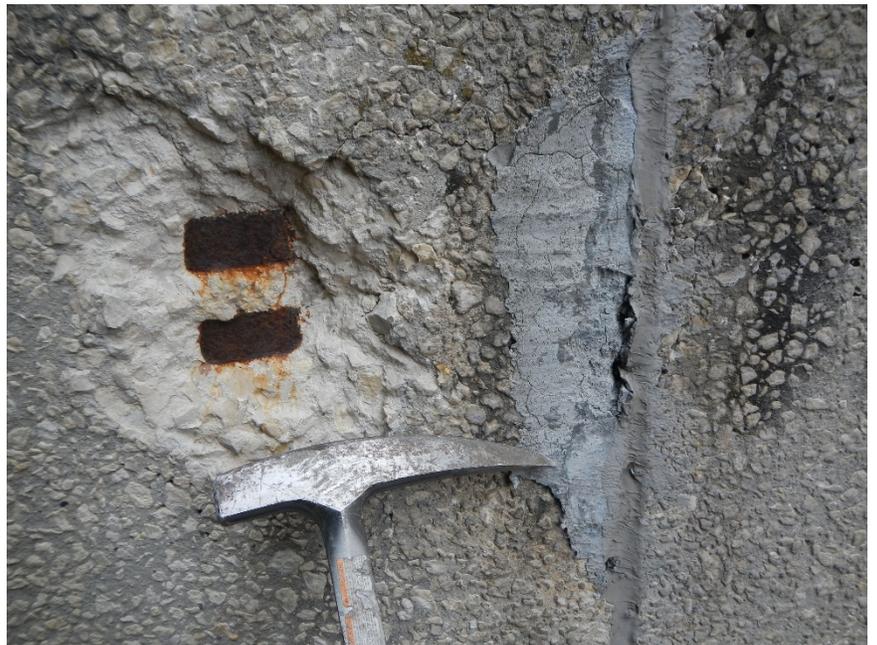
Photograph #21:

- Evidence of a previous repair was observed at one location on the south elevation of the south skywalk (Photograph #21). The patch was debonded and in poor condition. Several existing spalls had been coated with an epoxy resin.

South Skywalk – South Elevation

Delamination and spalling at the
cladding anchorages.

Existing debonded patch.

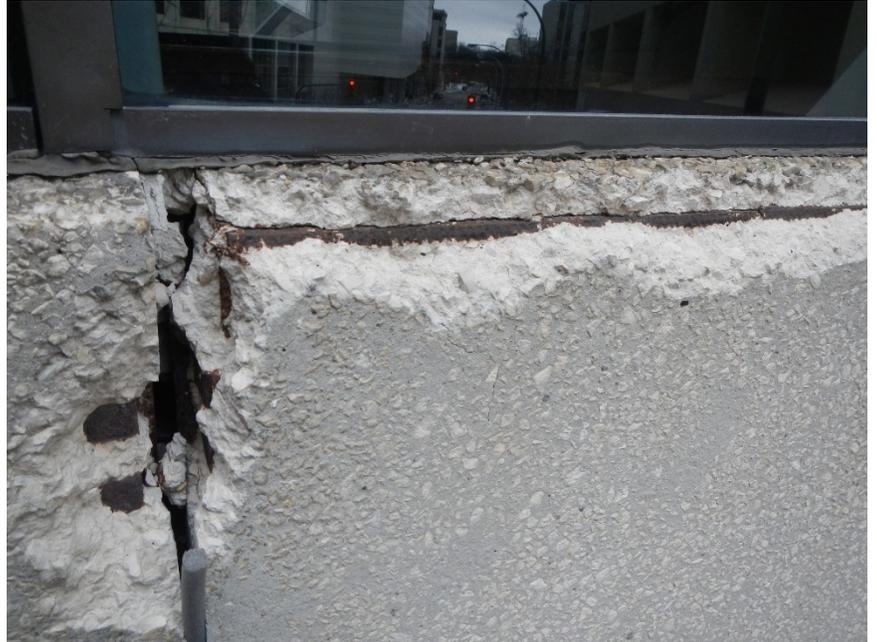
South Skywalk – South Elevation

Delamination and spalling at the
cladding anchorages and
reinforcing steel.

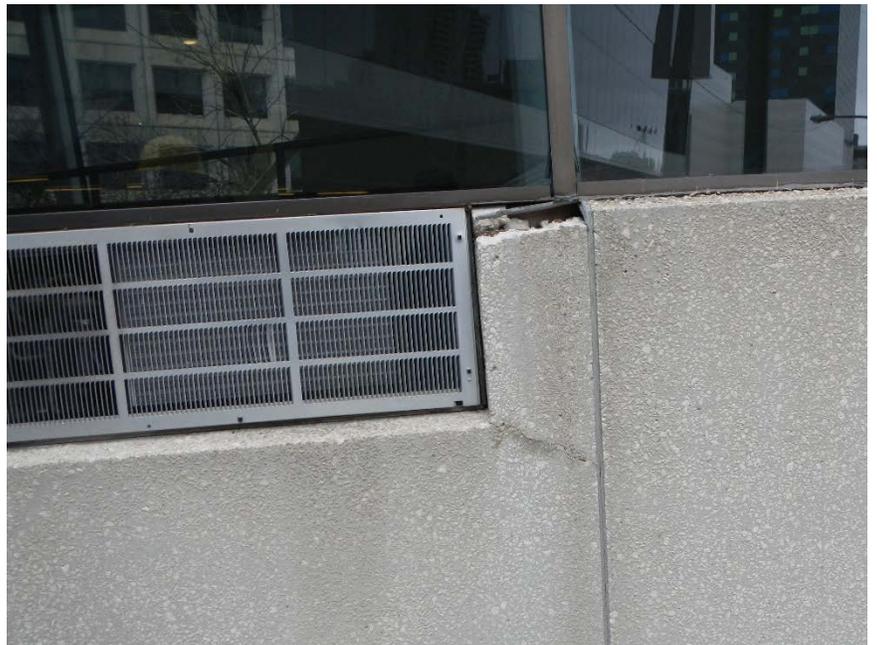
Photograph #23:

South Skywalk – South Elevation

Large concrete spall adjacent to
mechanical opening.

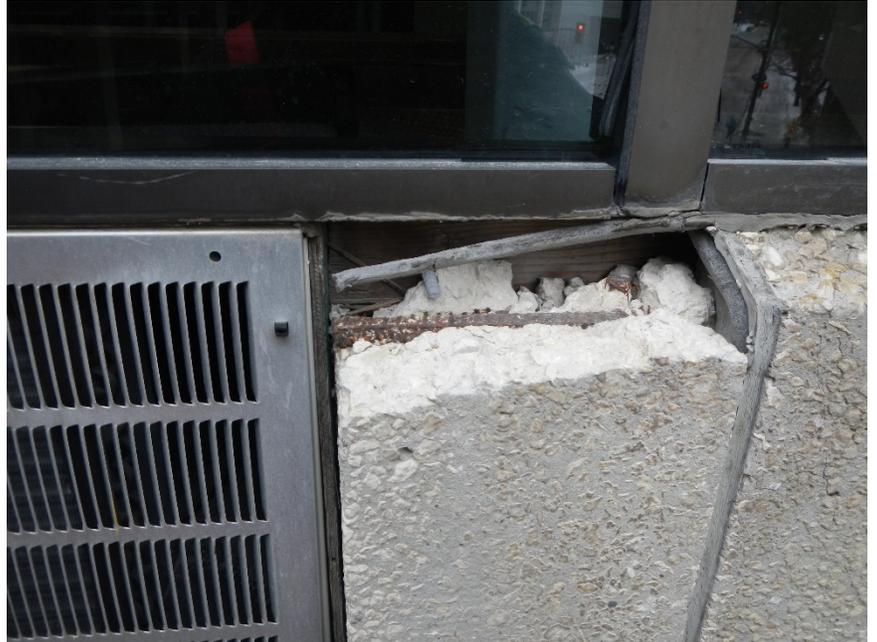
South Skywalk – South Elevation

Close-up view of concrete spall shown in Photograph #23.

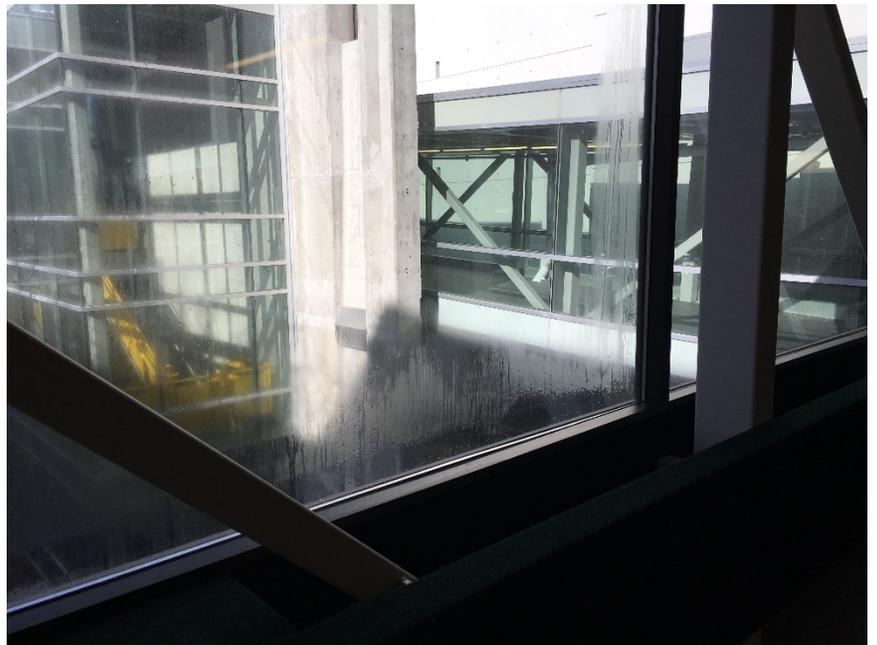
Photograph #25:

- Three (3) IGUs in the north skywalk have failed glazing seals resulting in fogging of the unit (Photograph #25). No evidence of failed IGUs in the south skywalk was noted. Replacement of the failed IGUs is required.

North Skywalk – North Elevation

Failed insulated glass unit.

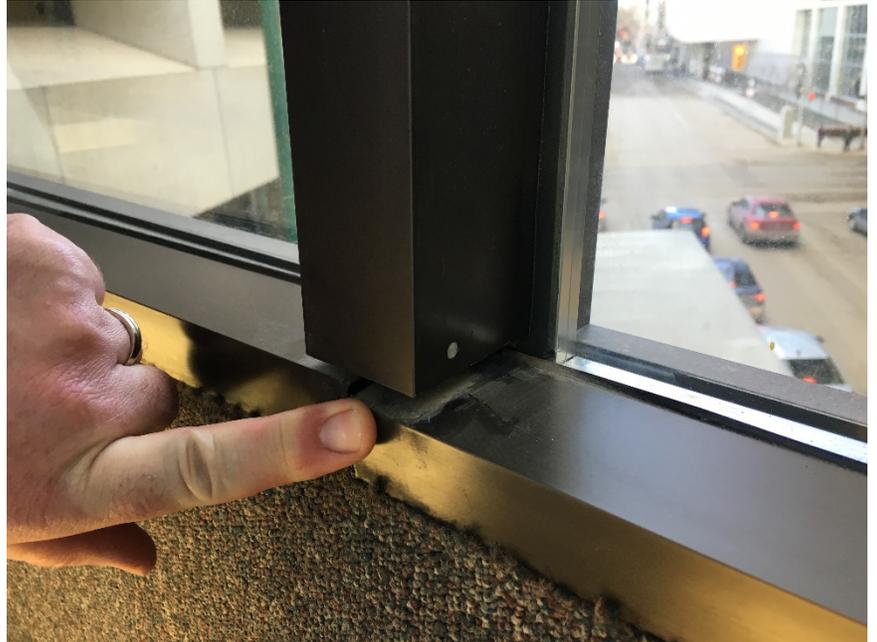
Photograph #26:

- Large gaps were observed at several joints between the vertical mullions and sill/head (Photograph #26). The large gaps are contributing to air leakage.

South Skywalk – South Elevation
Open joint in window framing.

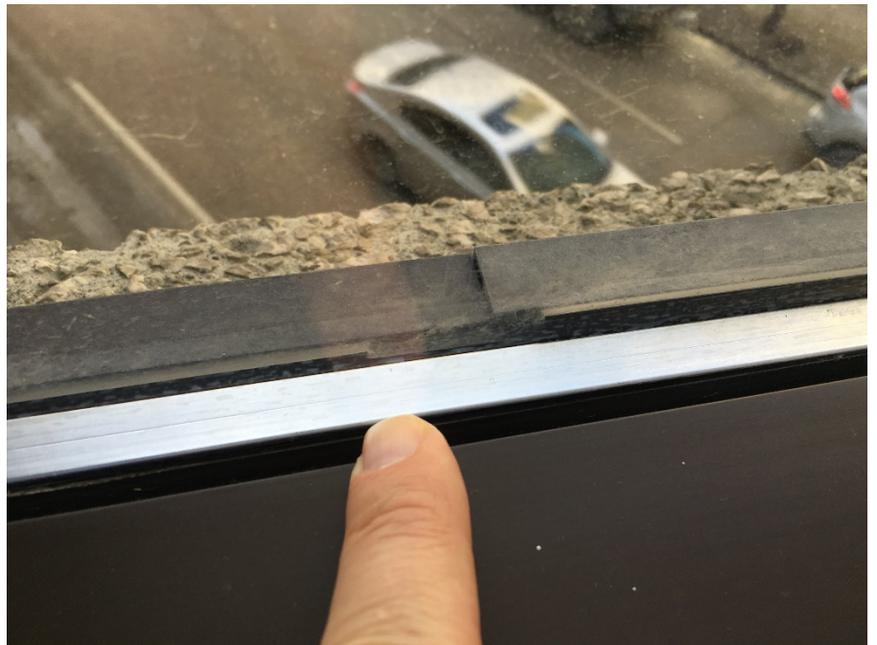
Photograph #27:

- The exterior glazing seals show evidence of shrinkage related to long term aging. Shrinkage of the exterior glazing seals (Photograph #27) will allow a direct path for moisture infiltration.

South Skywalk – South Elevation
Deteriorated exterior glazing seal.

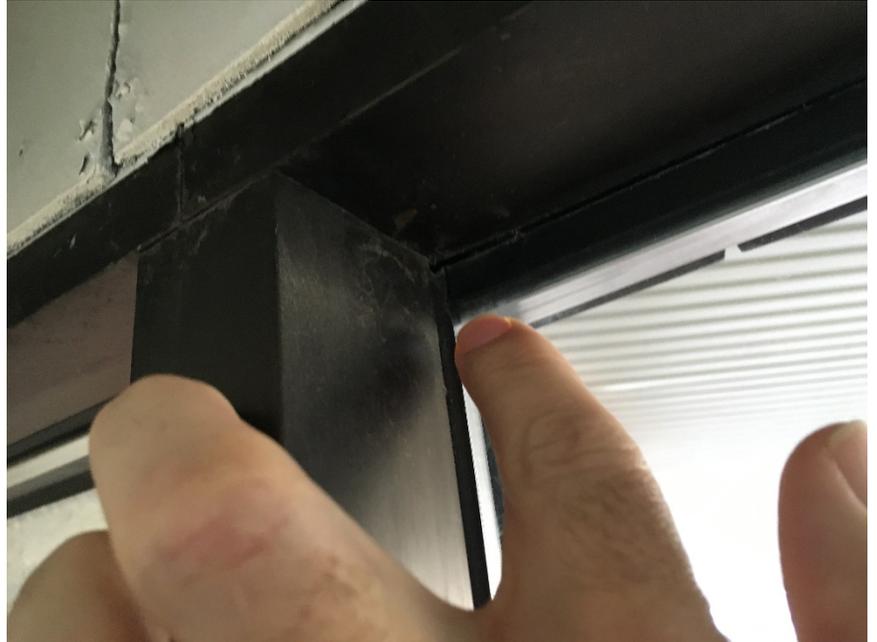
- Several IGUs on the north elevation of the south skywalk had evidence of movement. In one location a gap between the glazing edge and aluminum framing was visible on the upper west corner (Photograph #28). The cause of the movement could not be confirmed but may be related to the slope of the framing which caused the IGUs to creep to the west over time. Further investigation beyond the scope of this work would be required to confirm the cause(s).

South Skywalk – North Elevation

Gap visible between glazing and window frame.

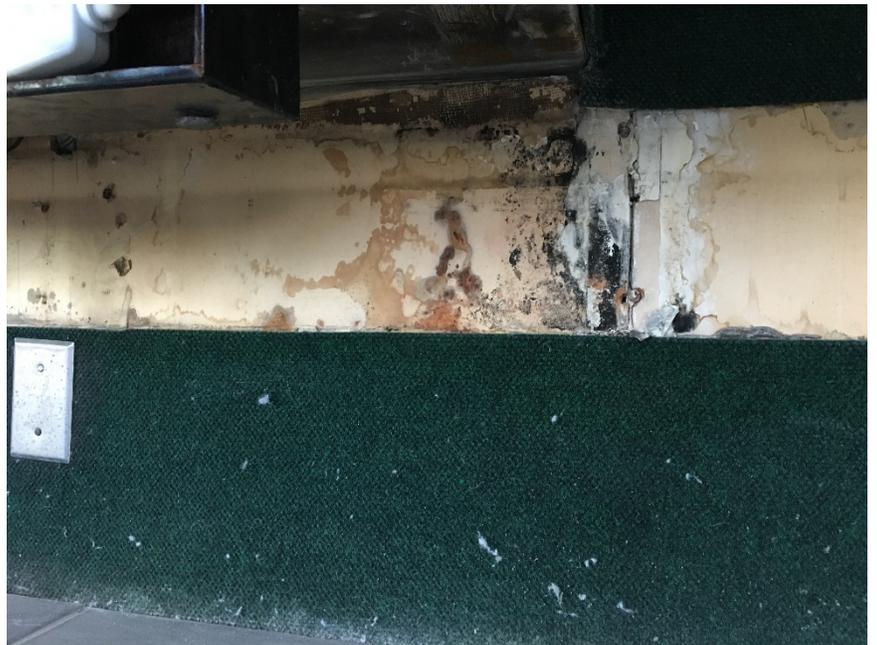
Photograph #29:

- Moisture staining, deterioration, and suspected biological growth was observed on the interior surfaces of the drywall on the north skywalk (Photograph #29)

North Skywalk – South Elevation

Water damage with suspected biological growth on interior face of drywall.

Thermal anomalies consistent with air leakage were observed at various locations around both skywalks. Transitions between the skywalks and the adjacent buildings were also noted. Additionally, we also observed air leakage at the mechanical units and windows which is contributing to deterioration of the precast cladding panels and building enclosure components. In addition, moisture leakage either from wind driven rain penetration or condensation from air leakage is damaging interior finishes or resulting in suspected biological growth. Further investigation of the suspected biological growth by an environmental consultant is recommended.

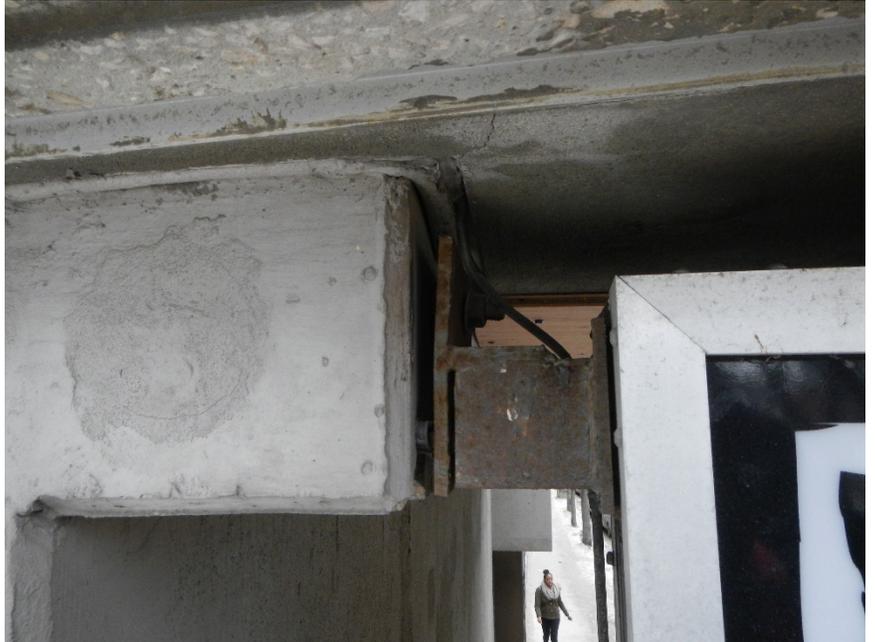
Photograph #30:

- Photographs #31 and #32 shows the connection between the existing sign at the east end of the north skywalk to the concrete beam. The connection plate has pulled away from the beam. Three of the four bolts have been removed from the holes and the fourth bolt has pulled out. A review of the top connection indicates that the sign has been hit multiple times. The top connection to the skywalk appears to be welded to the skywalk frame and has been repaired previously. Repair of the sign connection is required to address a potential safety hazard.

North Skywalk – East End
Sign connection to beam.

The existing sign at the east end of the north sidewalk is in poor condition and the lower connection to the concrete beam has been severely compromised. The conditions represent a potential safety concern. Removal, repair, or replacement of the sign is therefore required as soon as reasonably possible.

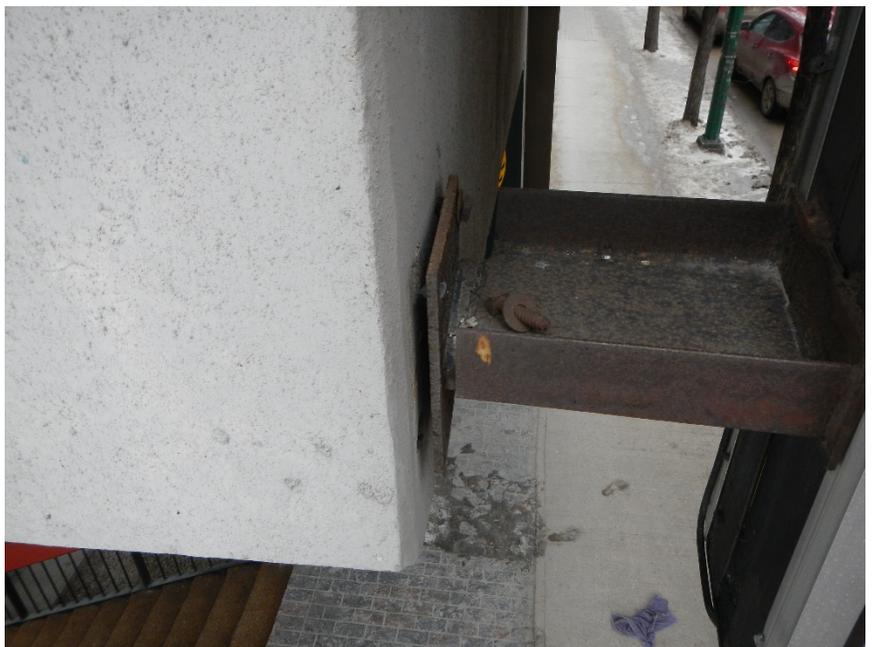
Photograph #31:

North Skywalk – East End
Close-up of sign connection to beam showing missing and displacement bolts.

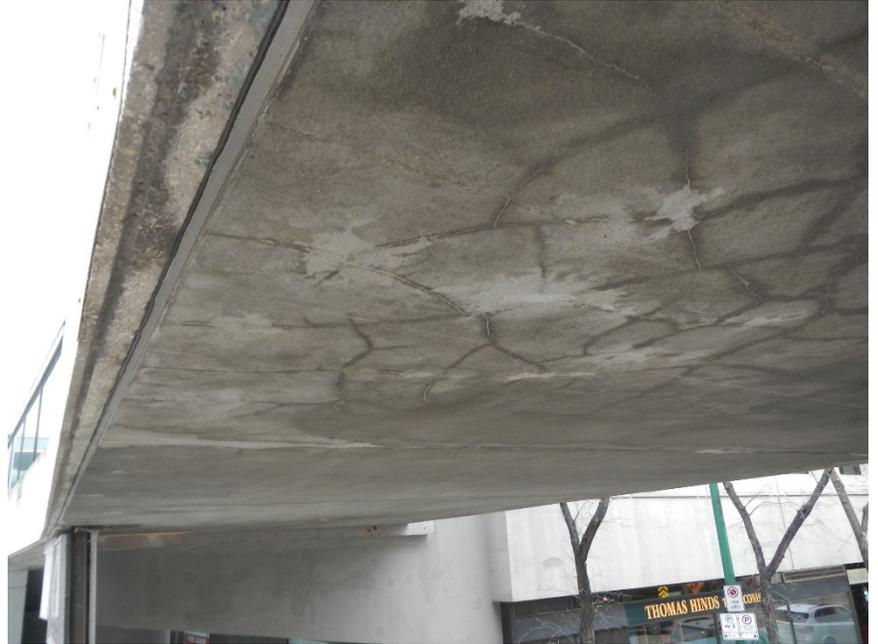
- Cracking of the stucco soffit was observed near the east end of the north skywalk (Photograph #32). Localized hammer soundings did not reveal any evidence that the stucco was loose or in danger of falling.

North Skywalk

Soffit stucco.

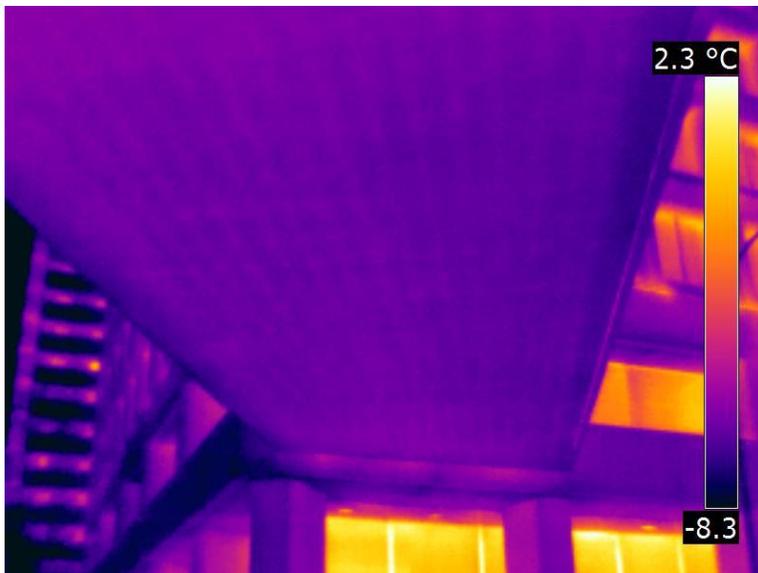
Figure 1: Image showing a typical example of thermal bridging at soffit supports below the skywalk.

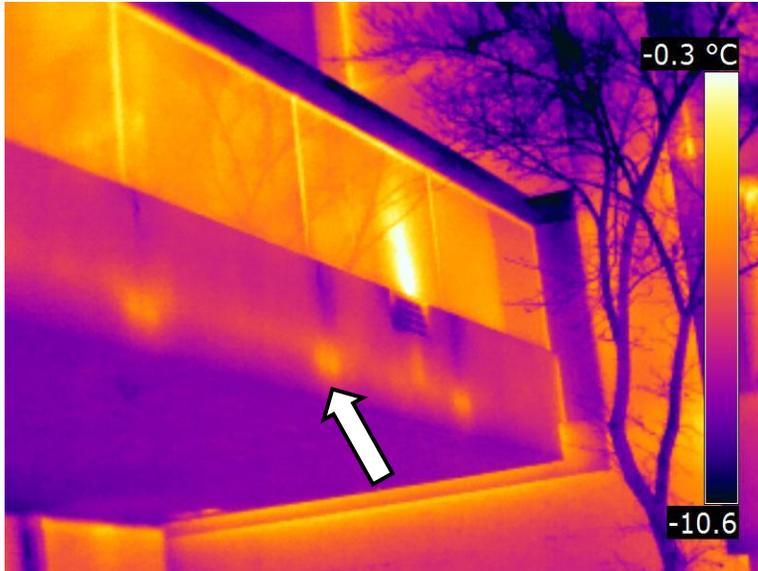
Figure 2: Image showing a typical example of thermal bridging at precast panel weld plate connections.

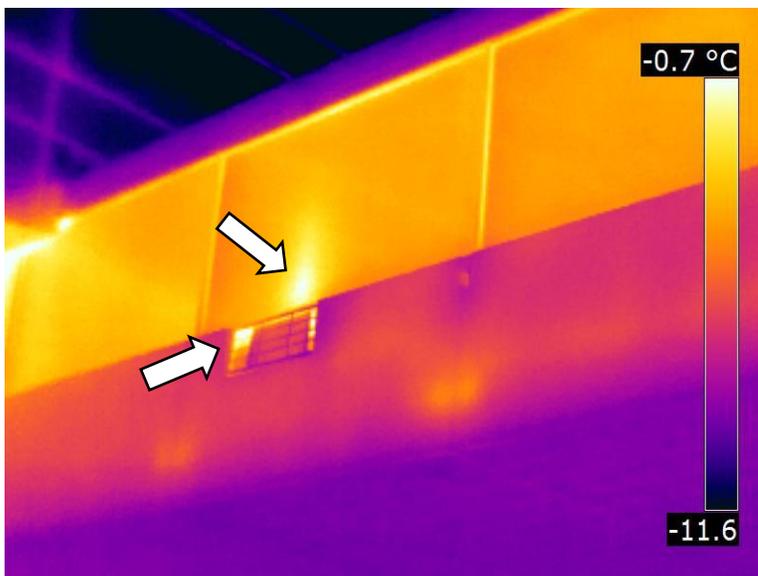
Figure 3: Image showing air leakage at the mechanical heating unit. Examples of both direct and indirect (disbursed) air leakage patterns can be seen.

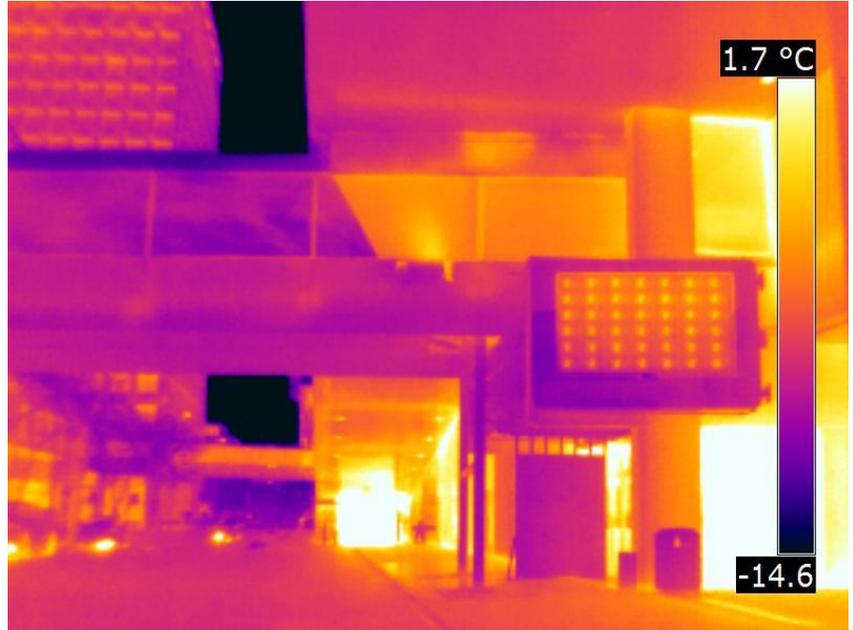
Photograph #1:
Partial north elevation. Note
air leakage at mechanical
unit.

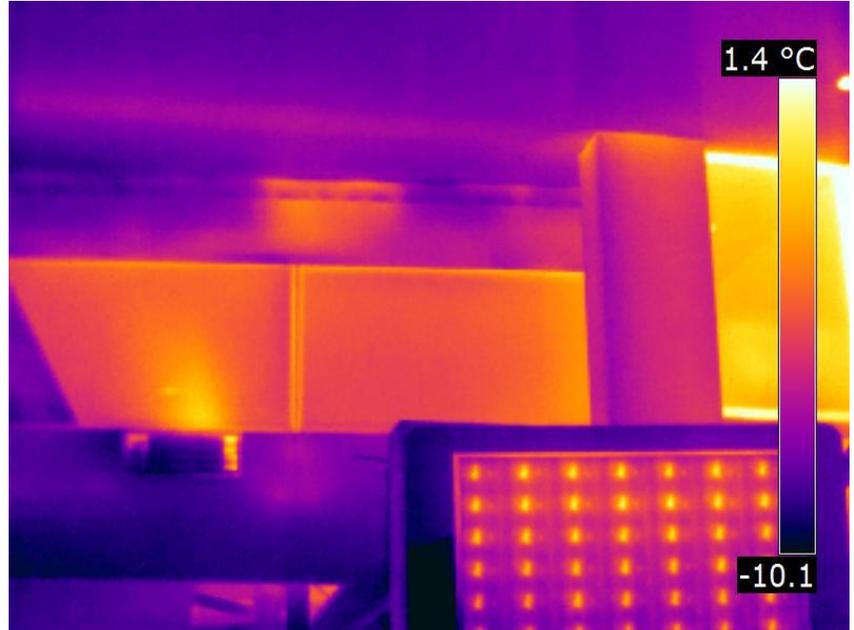
Photograph #7:

Detail view of north elevation showing air leakage at mechanical unit. Also note probable air leakage above and below vertical window mullion.

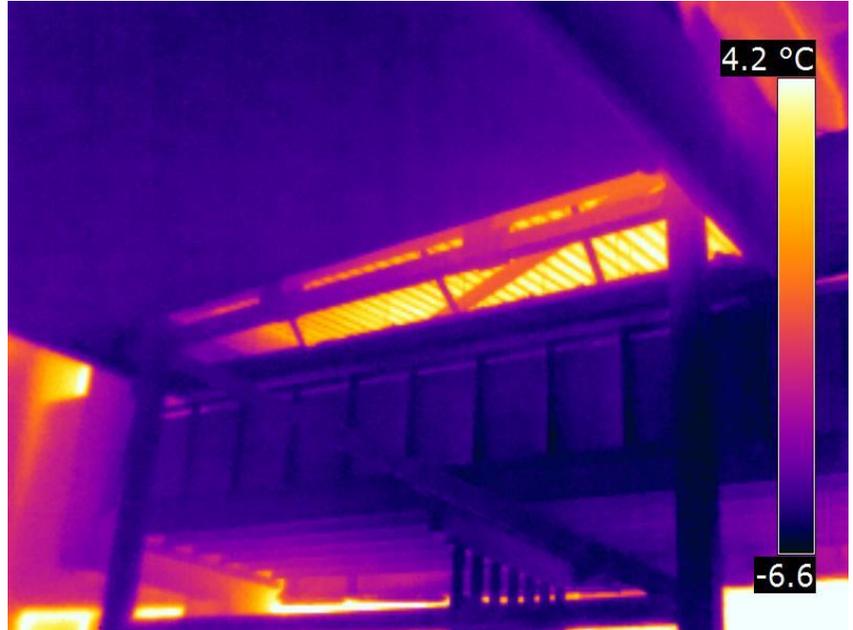
Photograph #17:

Detail view of open soffit at west end of skywalk. Note elevated temperature within soffit area likely caused by a combination of thermal bridging and air leakage.
