Carlton Street Skywalks
Structural and Cladding Investigation
City of Winnipeg Project No. 2013-139

Submitted to: City of Winnipeg
Planning Property and Development Department

Date: April 5, 2016

CKP File No. 2015-1231

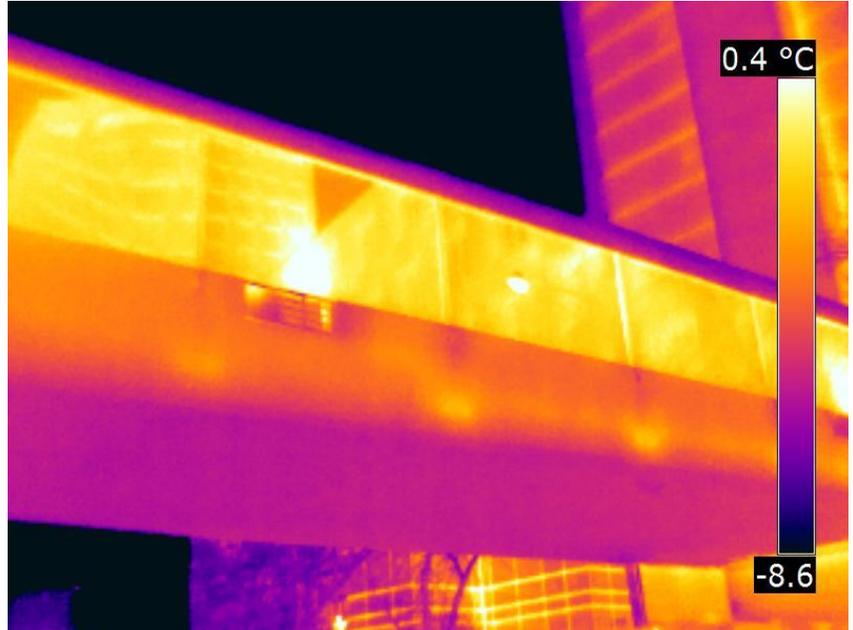
Photograph #23:

Partial south elevation. Note air leakage and thermal bridging.

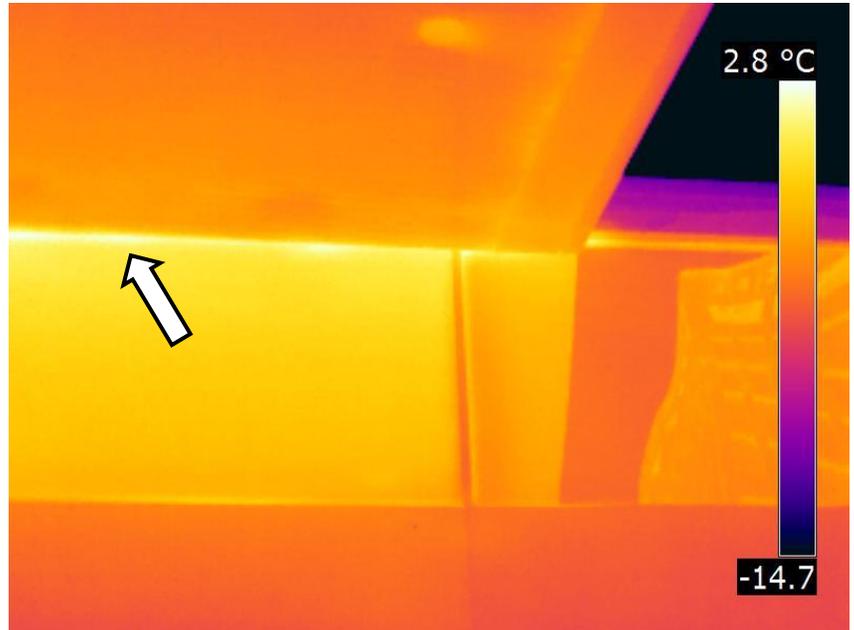
Photograph #29:

Detail view at west end of skylight. Note apparent air leakage at connection to soffit above.

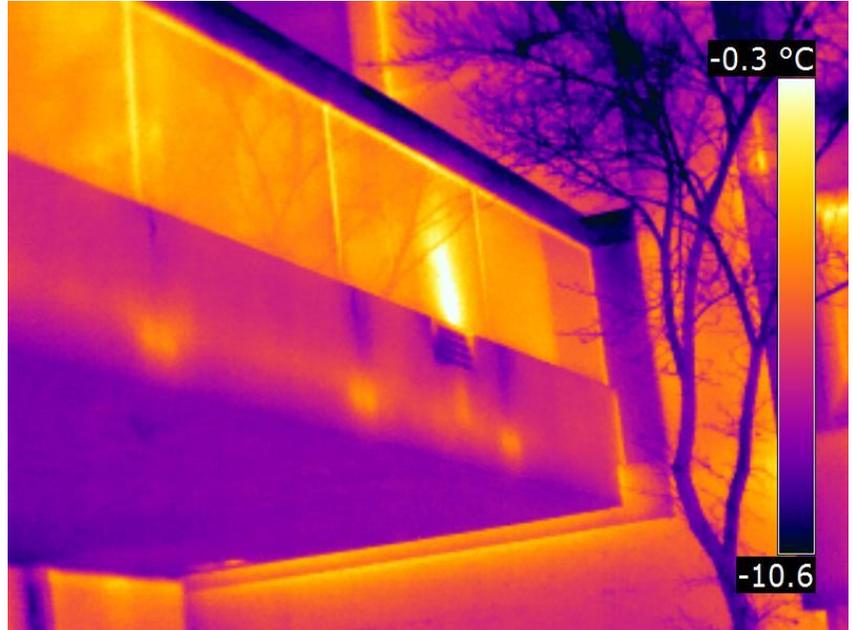
Photograph #33:

Partial south elevation. Note significant air leakage from mechanical unit.

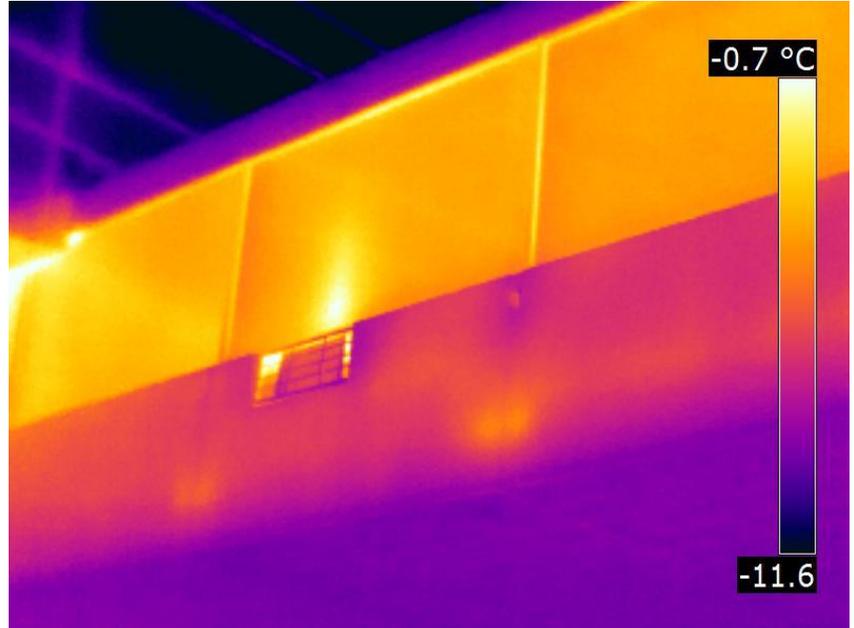
Photograph #53:

Detail view of south elevation showing air leakage and thermal bridging.

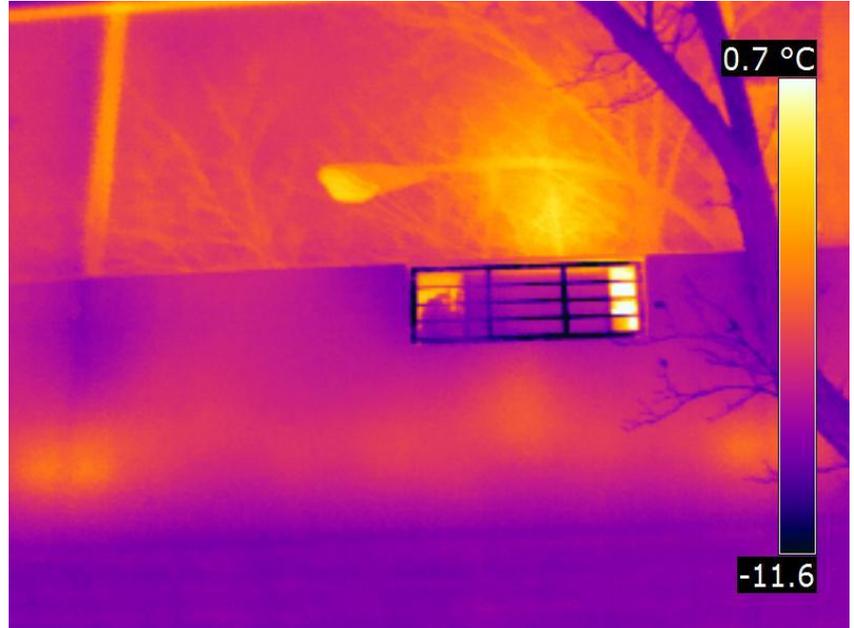
Photograph #55:

Detail view of mechanical unit showing air leakage.

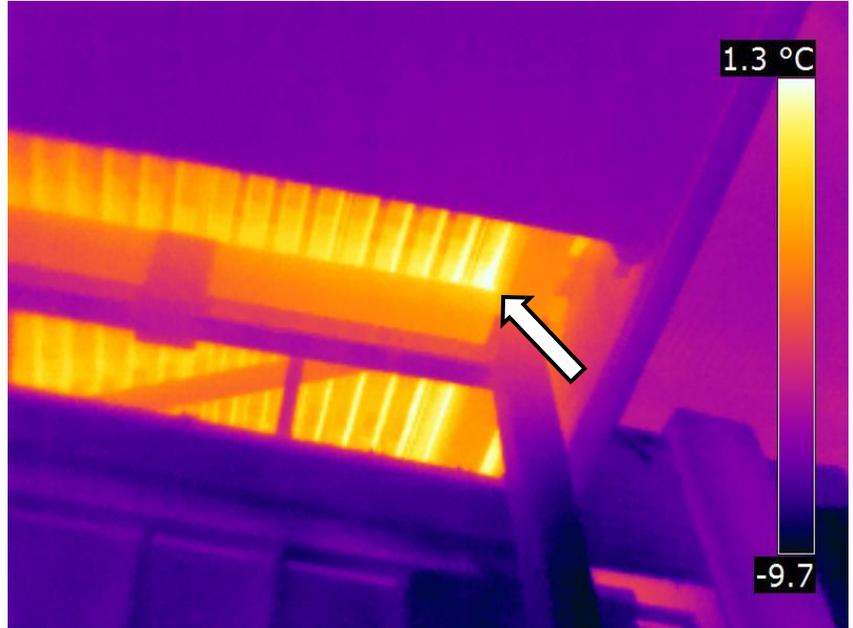
Photograph #67:

Detail view of open soffit at west end. Note elevated temperature and probable air leakage location.

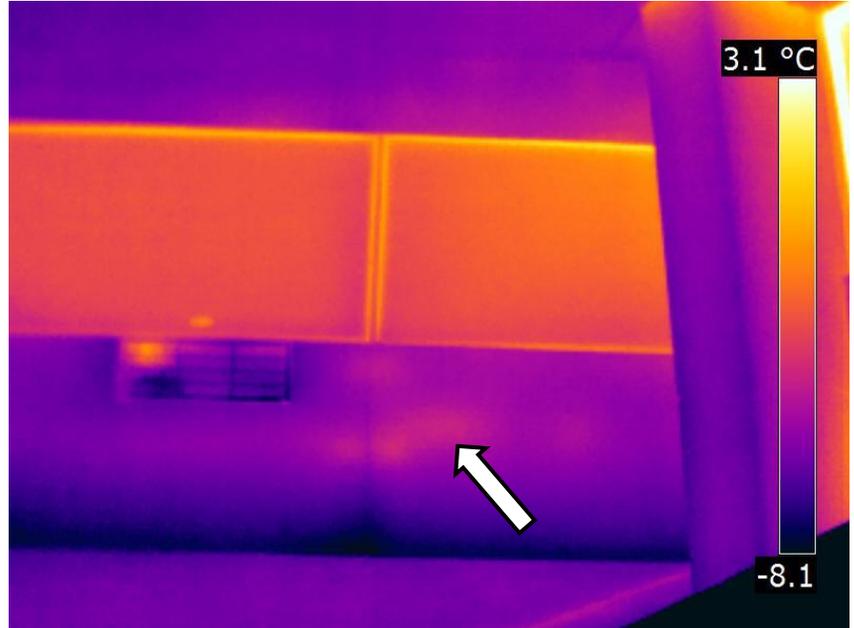
Photograph #79:

Detailed view of north elevation. Note thermal anomaly likely caused by air leakage into the wall assembly.

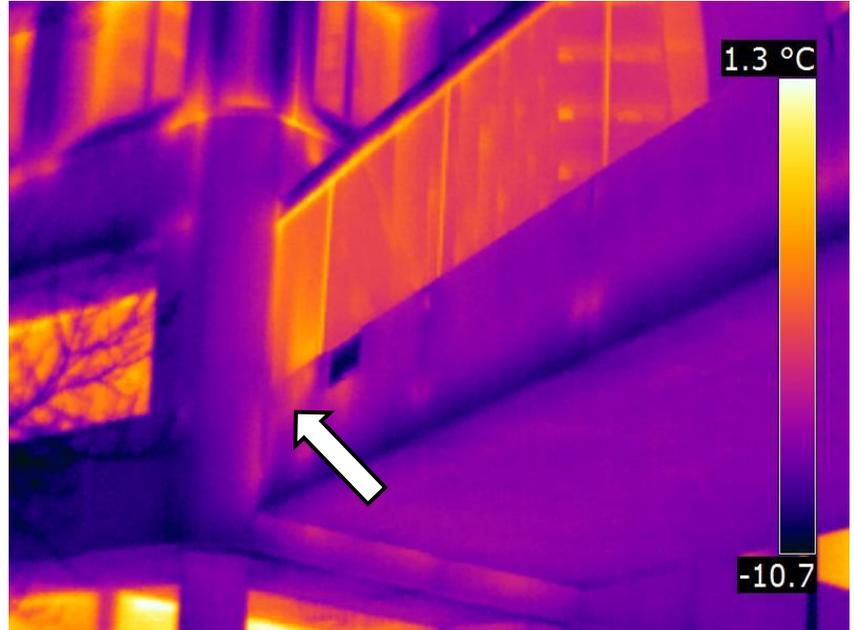
Photograph #87:

Detailed view of north elevation. Note apparent air leakage at sill of first window.

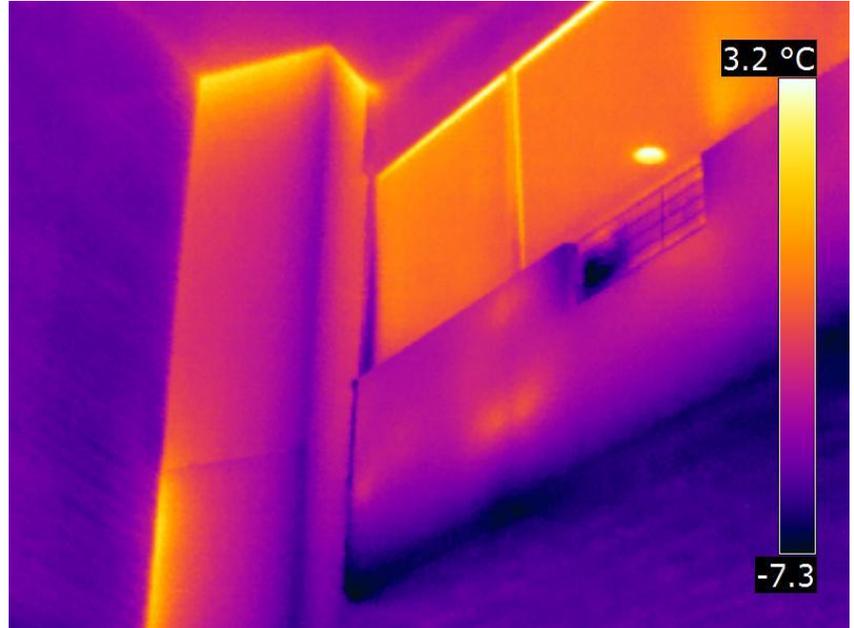
Photograph #91:

Detail view of south elevation. Note apparent air leakage at column.

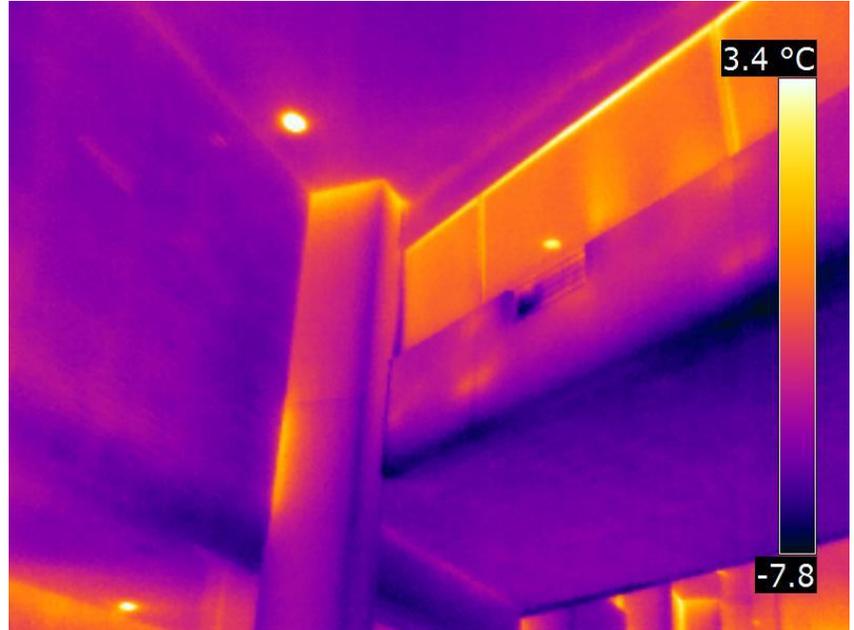
Photograph #93:

Detail view of south elevation. Note apparent air leakage at column.

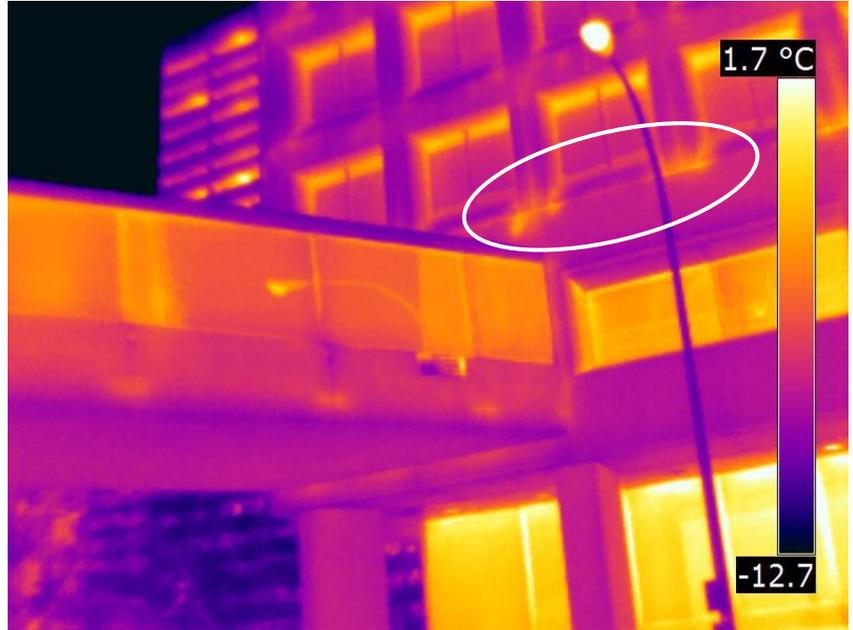
Photograph #97:

Partial south elevation. Note air leakage at precast cladding elements of adjacent building.
