## **APPENDIX C – 2018 OUTFALL RENEWAL AND REHABILITATION CONDITION ASSESSMENT - LODGE AVENUE OUTFALL**

**2018 OUTFALL RENEWAL AND REHABILITATION  
CONDITION ASSESSMENT  
LODGE AVENUE OUTFALL**

KGS Group 17-0107-020  
February 2019

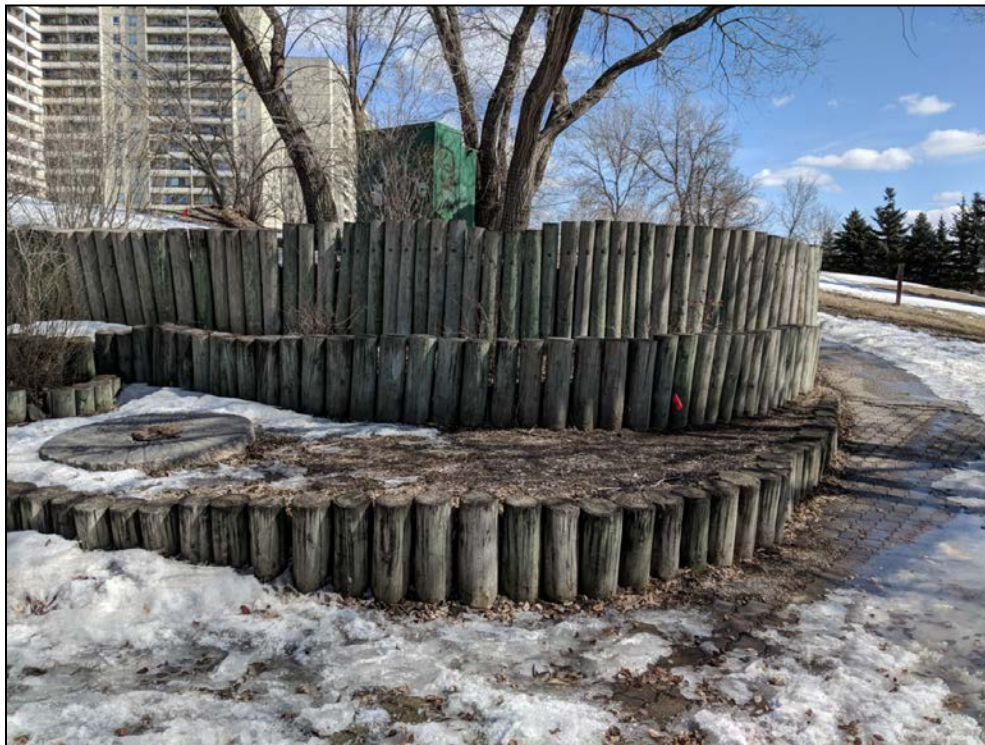
The outfall exists within a park area dedicated to the replica 1829 flour mill operated by Metis Leader Cuthbert Grant. A multi-level timber retaining wall structure exists above the pipe in close proximity to the alignment (consisting of vertical timber poles). The vertical timbers show evidence of movement and have been restrained using metal cable running through eyelets bolted into each timber pole. The metal cable is temporarily supported to the base of the existing hydro transformer pad.

**PHOTO 1**  
**LODGE AVENUE OUTFALL – EXISTING RETAINING WALL STRUCTURE**

The future design and construction must address these site issues.

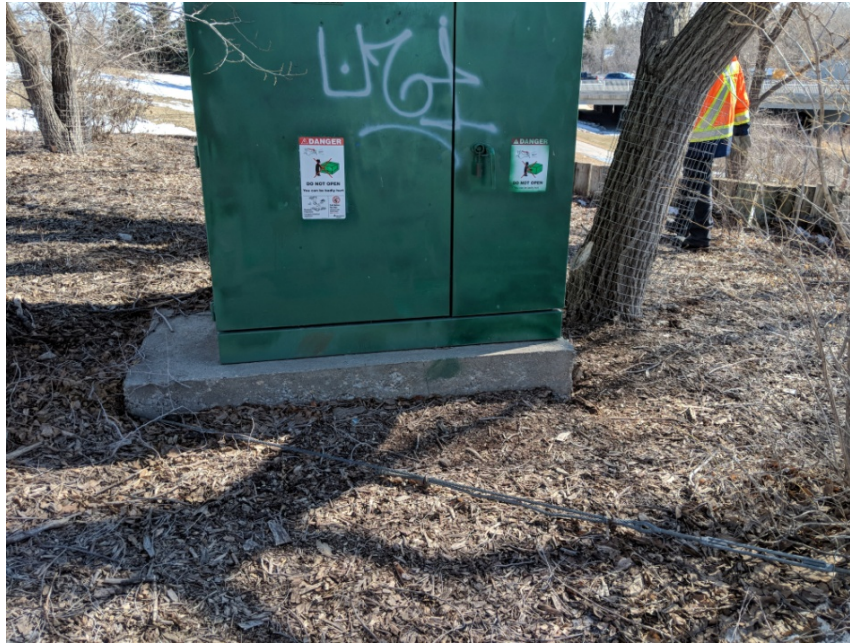
**PHOTO 2**  
**CABLE INSTALLED AROUND TRANSFORMER CONCRETE PAD TO SUPPORT TIMBER STRUCTURE**

For budgeting purposes a cost estimate was prepared with the following assumptions: Replacement of the CMP pipe; lining of the first 3 sections of concrete pipe; concrete repairs to pipe invert of approximately 15m cast in place outfall; relocation of the hydro transformer; landscaping (included in Site Development and Restorations); and geotechnical stabilization for the site.

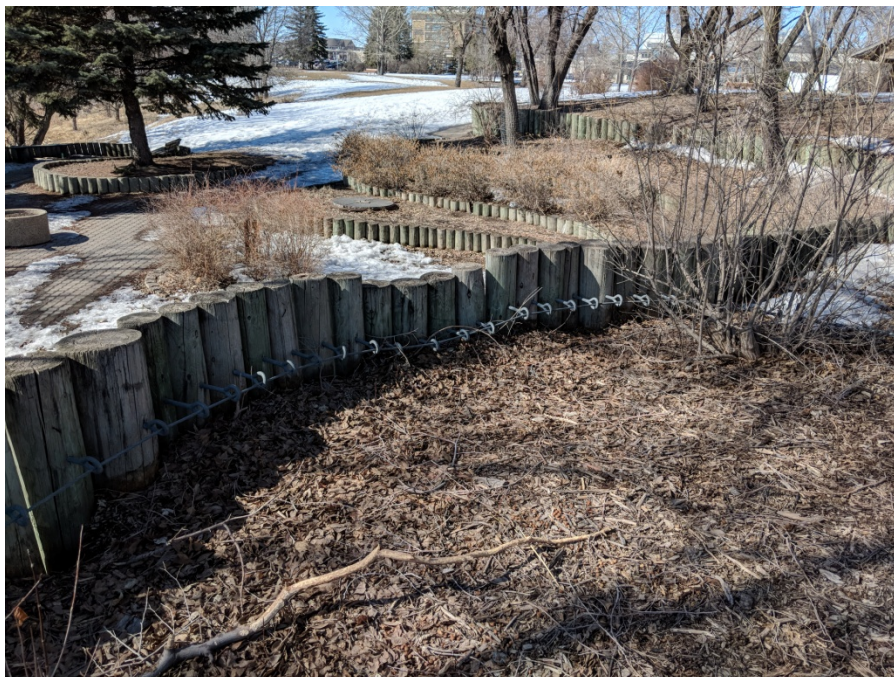
**PHOTO 3**  
**CABLE CONNECTED TO TIMBER STRUCTURE**

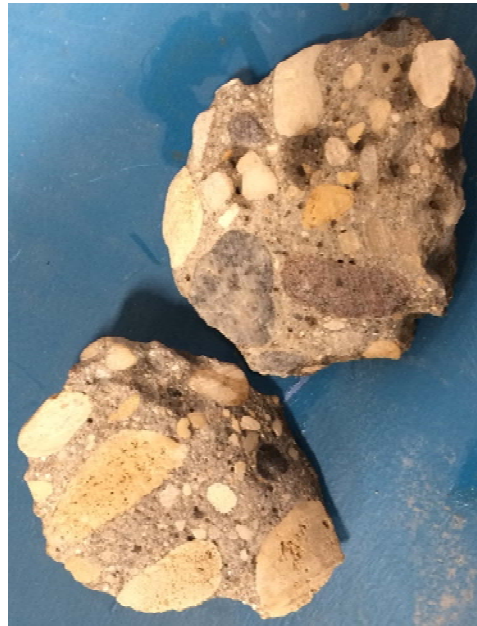
The compressive strength results presented above demonstrate that the core samples taken at 5:00 and 4:00 are sound competent concrete. A core at 1+78.3 was taken at the invert (6:00), in an area showing major deterioration. A competent sample was not retrieved at this location (only concrete rubble). Therefore is assumed negligible compressive strength exists at the invert in this location. The second core was taken at the same stationing but was moved over slightly across the pipe invert to an area where deterioration appeared slightly less (approximately 5:00 position), the invert appears sound for the first 80 mm, but then indicates fracturing and deterioration.

Figure 2 - Core no. 2 (pieces)

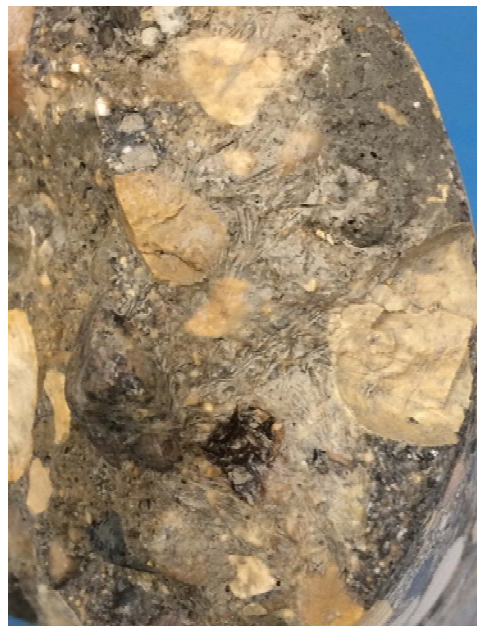
Figure 4 - Core no. 3 (frost/rootlets)
