ASBESTOS INVENTORY CONTROL

Building Name:	Dakota C.C.	Inspection Date:	July 26, 2018
Building Code:	CC-020	Inspected By:	Will Deller
Building Address:	1188 Dakota Street	Construction Date:	1984/1987

ASBESTOS LOCATIONS

BUILDING:	Dakota Community Center CC - 020 1188 Dakota Street Winnipeg, Manitoba
REVISED BY:	REM
DATE:	October 26, 2012
SCALE:	N.T.S.
SHEET #:	2/2

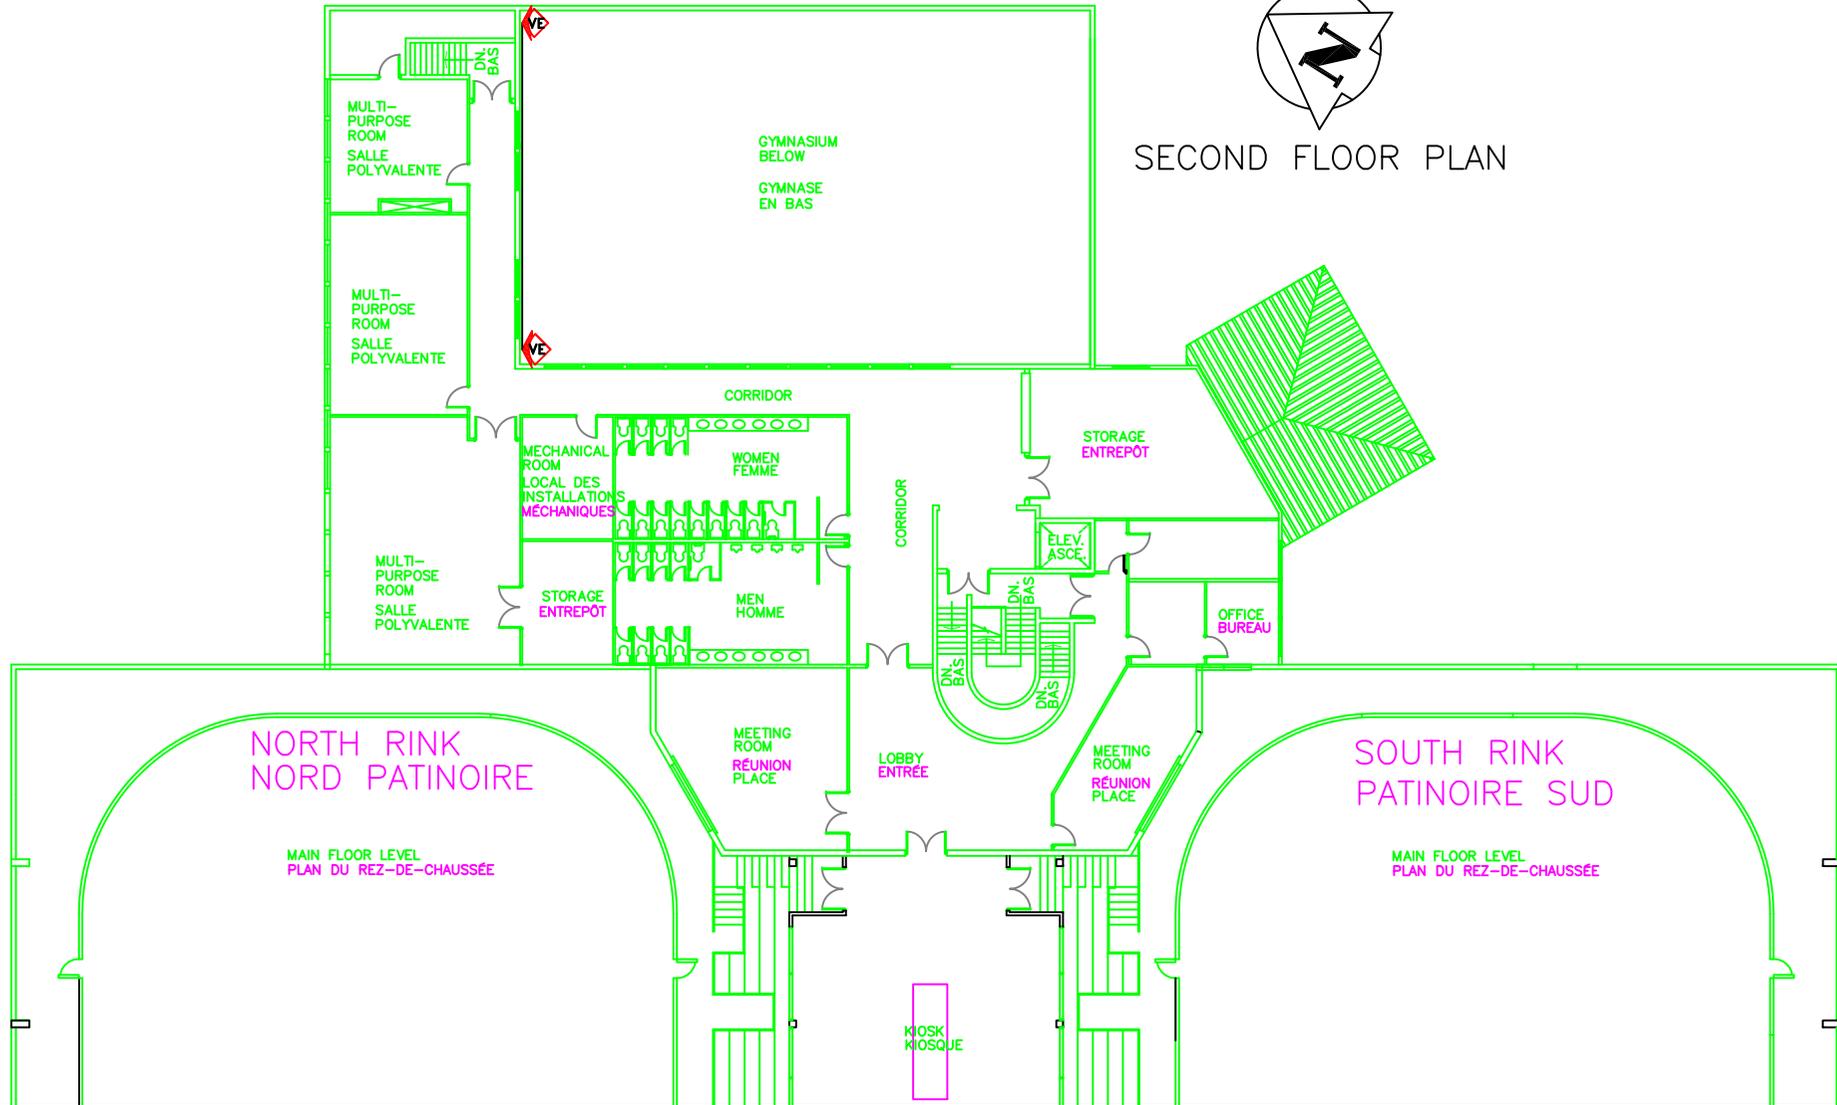
SECOND FLOOR PLAN

Storage Room (Southside) (Now Office Area)	Drywall Compound (3 Wall Samples)		Good	TESTED	Oct/'16	0	
	Mortor (Exposed Rock Siding)		Good	TESTED	Oct/'16	0	
Meeting Room	Drywall Compound (3 Wall Samples)		Good	TESTED	Jan/'18	0	
	12x12 Floor Tile		Good	TESTED	Jan/'18	0	
Sairwell	Wall Plaster/ Stucco		Good				
Exterior	Stucco	ST	Good				
Basement							
Hot Water Tank	Insulation Wrap (3 Samples)		Good	TESTED	Apr/'18	0	
North & South Indoor Arenas (CC-021)	Built in 1997 -No Asbestos Materials Located

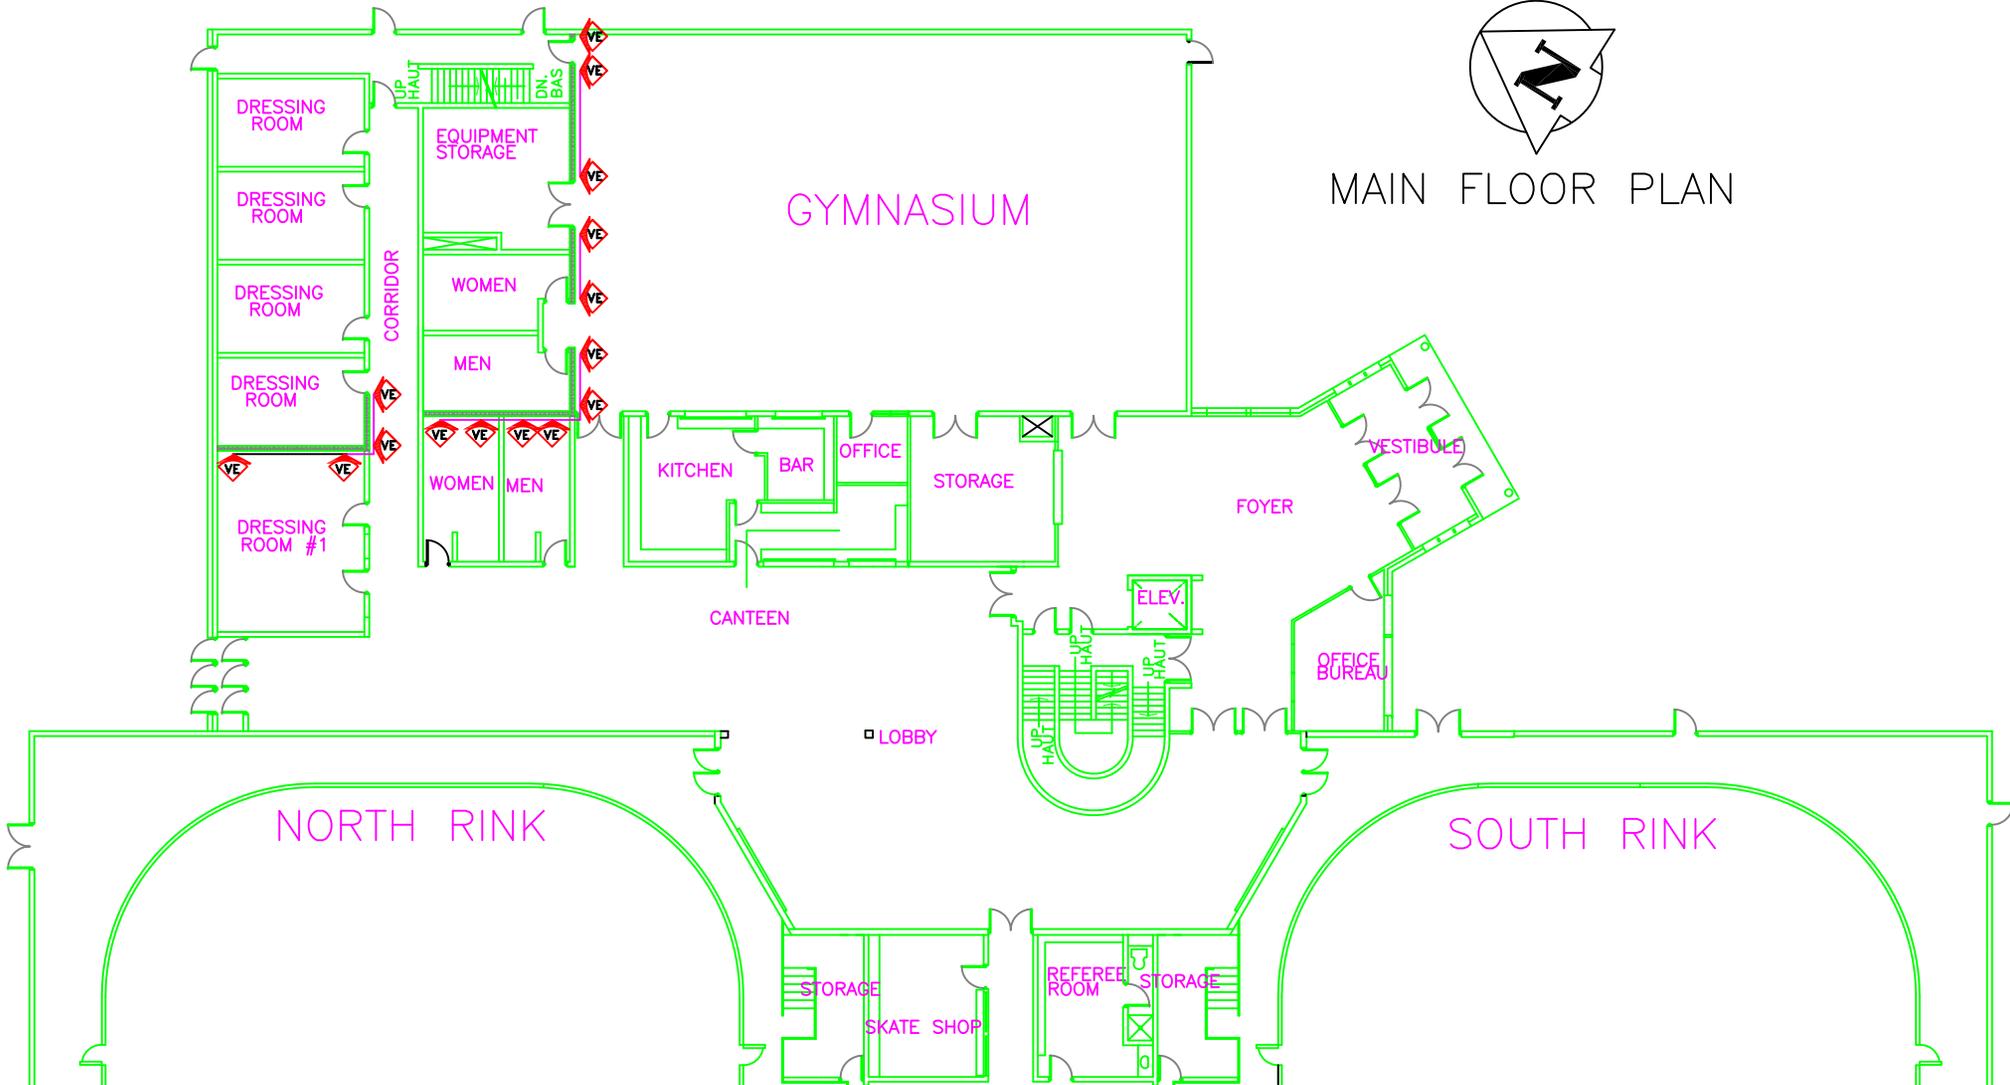
MAIN FLOOR PLAN

Material Location	Material Description	Drawing Label	Material Condition	Testing Status	Date M/Y	Test %	Est. %
Main Floor							
Block Walls of Old Portion of Bldg (North Section)	Contain Vermiculite Insulation (Which May Contain Asbestos)	VE	Good				
Dressing Room No.1` (north side side) (Seniors)	Asphalt Plank Flooring (1 x 4 Planks - 3 samples)		Good	TESTED	Jul/'17	0	
Lobby	Asphalt Plank Flooring (4 Samples taken) (1x4 and 1x2)	APF	Good	TESTED	Mar/'19	0	
Gymnasium	Southeast Wall - Drywall Compound			TESTED	May'19	0	
Foyer (under East Window)	Drywall Compound			TESTED	May'19	0	
Storage Room (off Gym)	Drywall Compound			TESTED	May'19	0	
2nd Floor							
Wall Between North Hallway & Gymnasium	Contains Vermiculite Insulation (Which May Contain Asbestos)	VE	Good				
North East Hall Way	12x12 Floor Tile	F12	Removed/18	TESTED	Aug/'18		
	Drywall Compound	DC	Good	TESTED	Aug/'18		
Multipurpose Room	12x12 Floor Tile	F12	Removed/18	TESTED	Aug/'18
