19-B-01 Fermor Reconstruction

Project Number:
0035 075 00

Date:
December 20, 2018
Final Report

**RE: Sub-Surface Investigation Report for
19-B-01 Fermor Reconstruction**

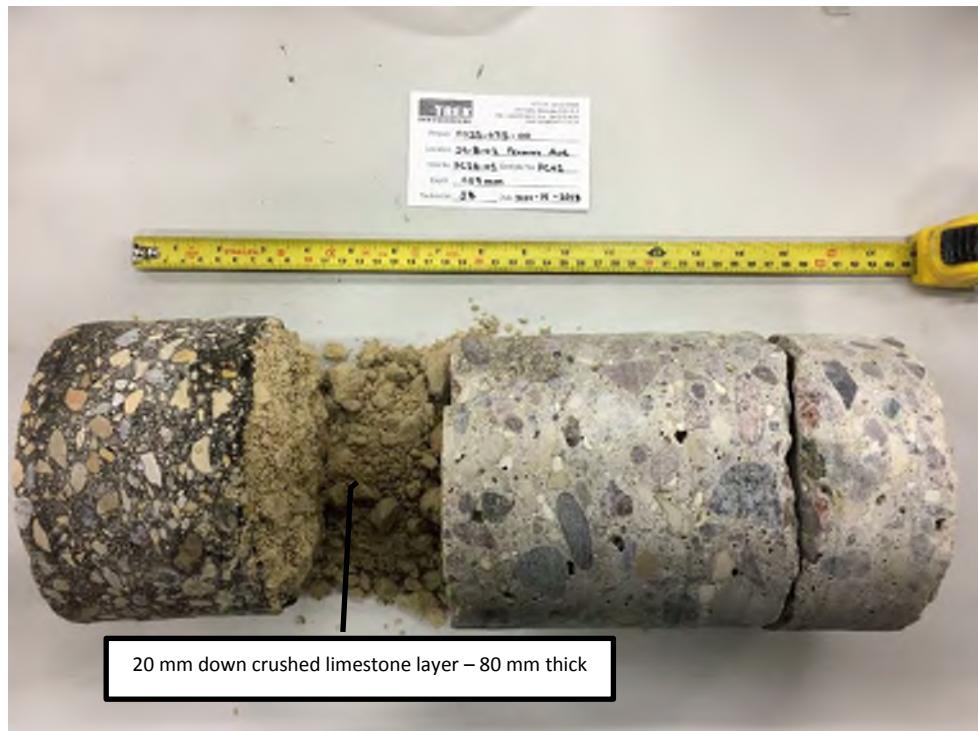
Photo 1: Pavement Core Sample at Test Hole TH18-01

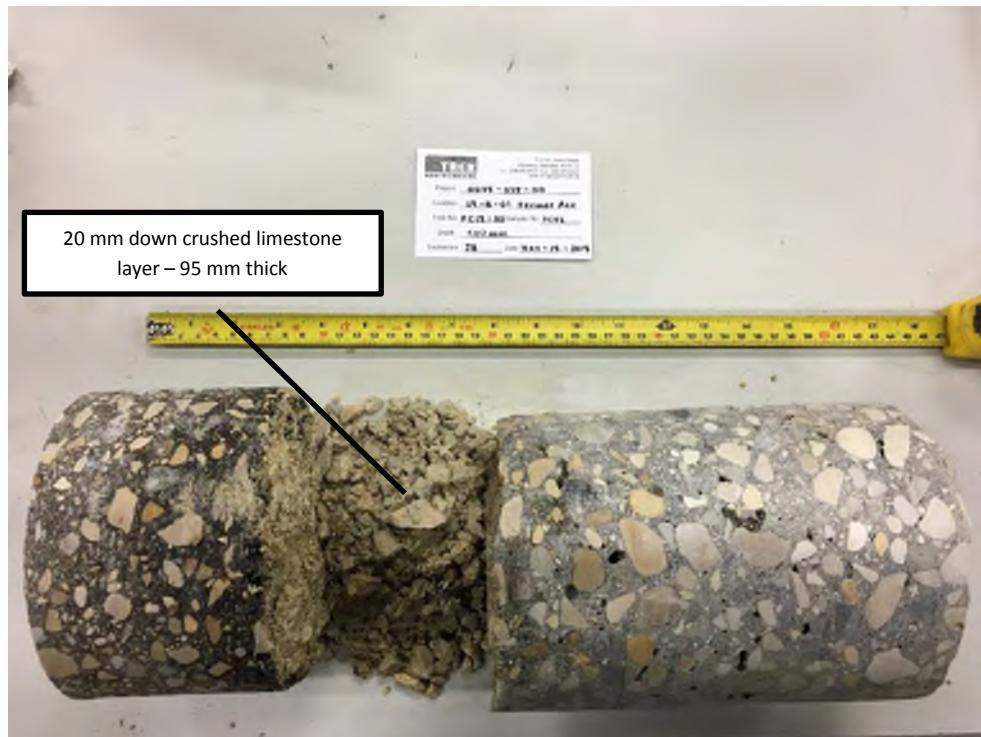
Photo 2: Pavement Core Sample at Test Hole TH18-02

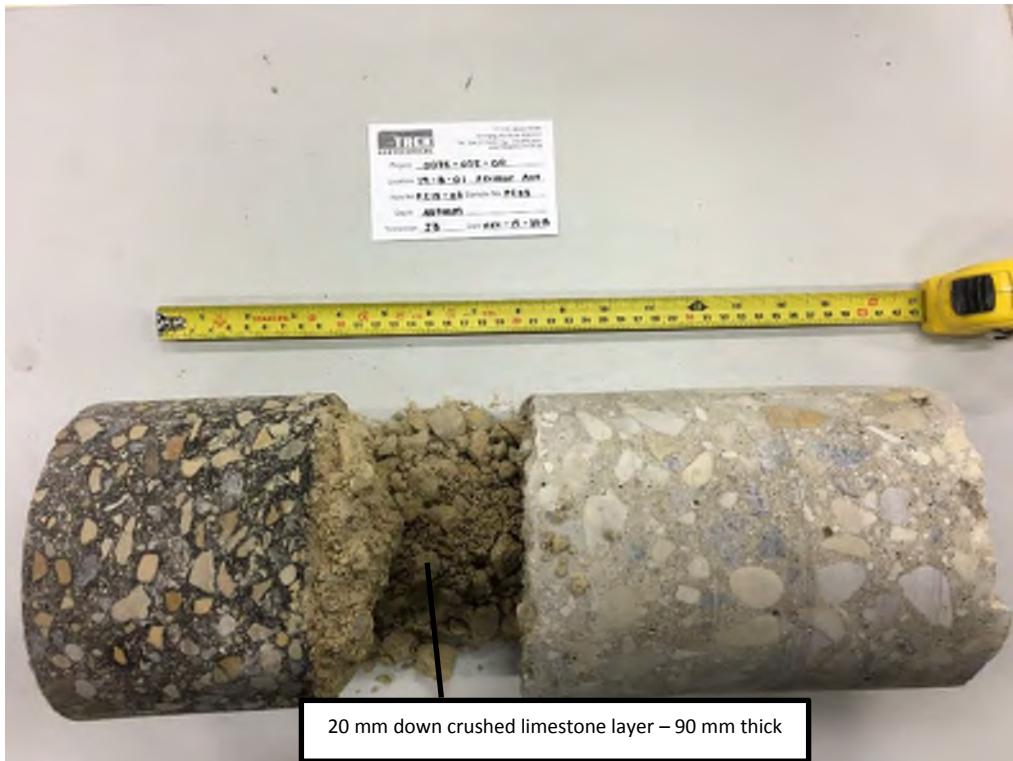
Photo 3: Pavement Core Sample at Test Hole TH18-03

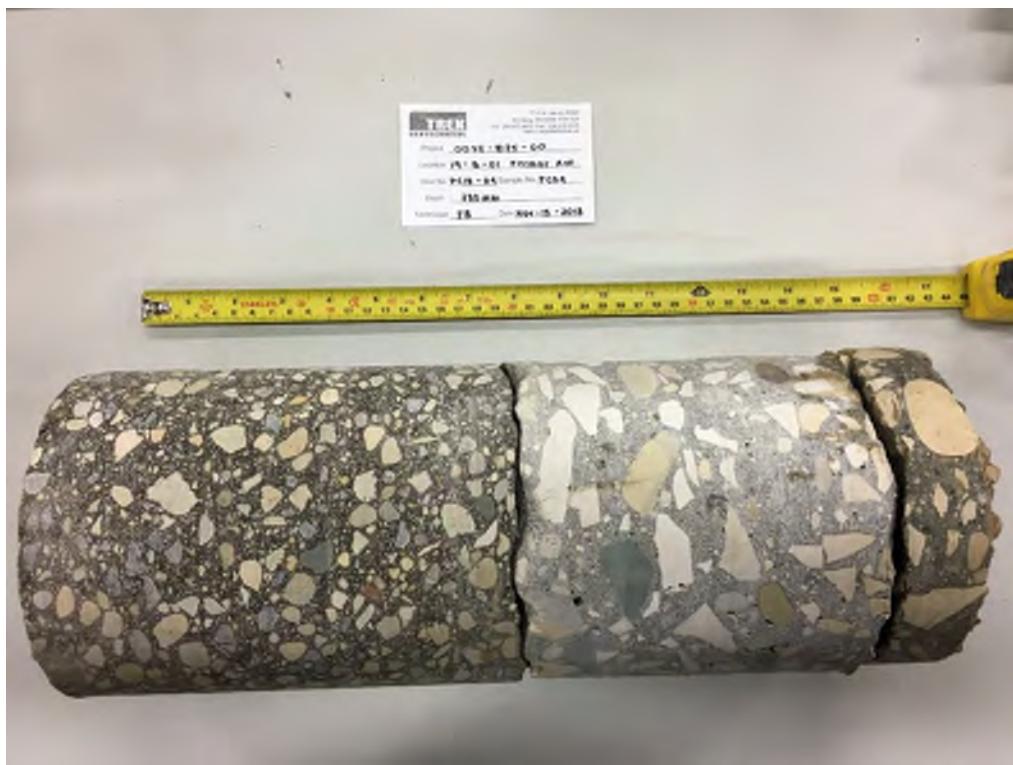
Photo 4: Pavement Core Sample at Test Hole TH18-04

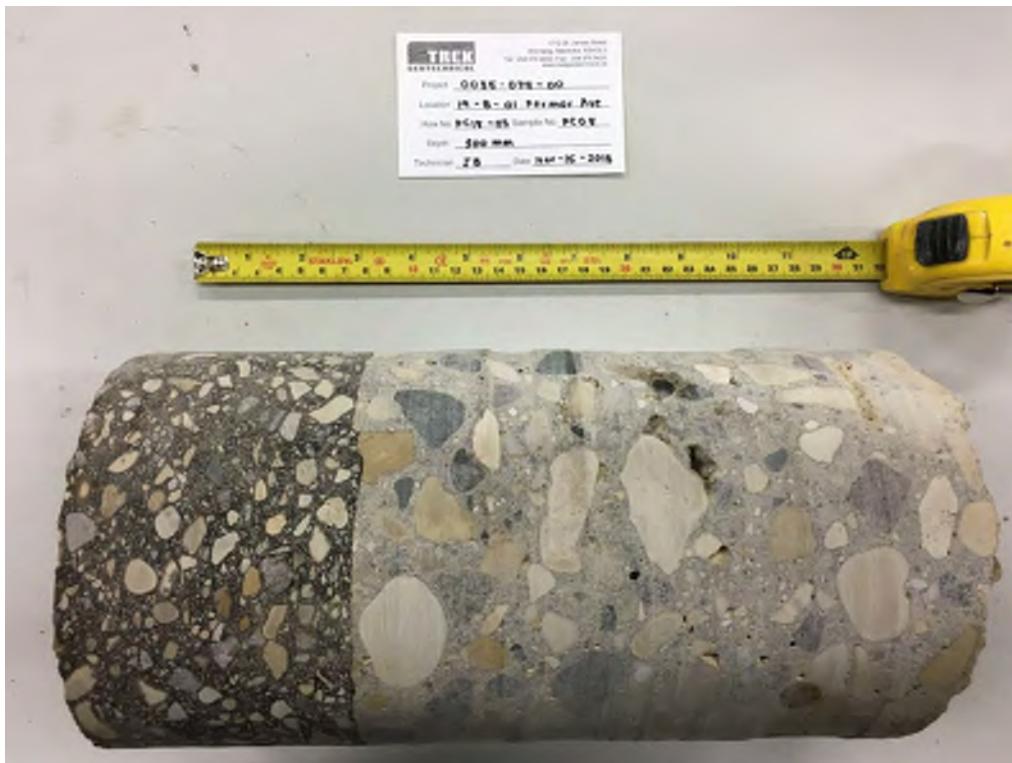
Photo 5: Pavement Core Sample at Test Hole TH18-05

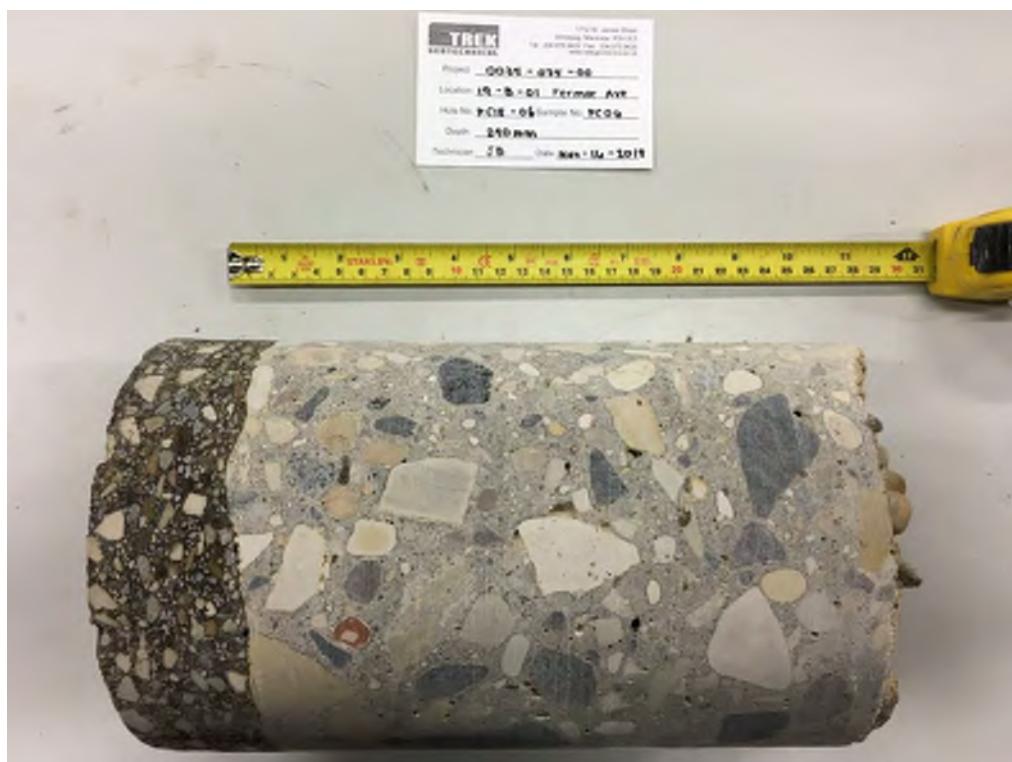
Photo 6: Pavement Core Sample at Test Hole TH18-06

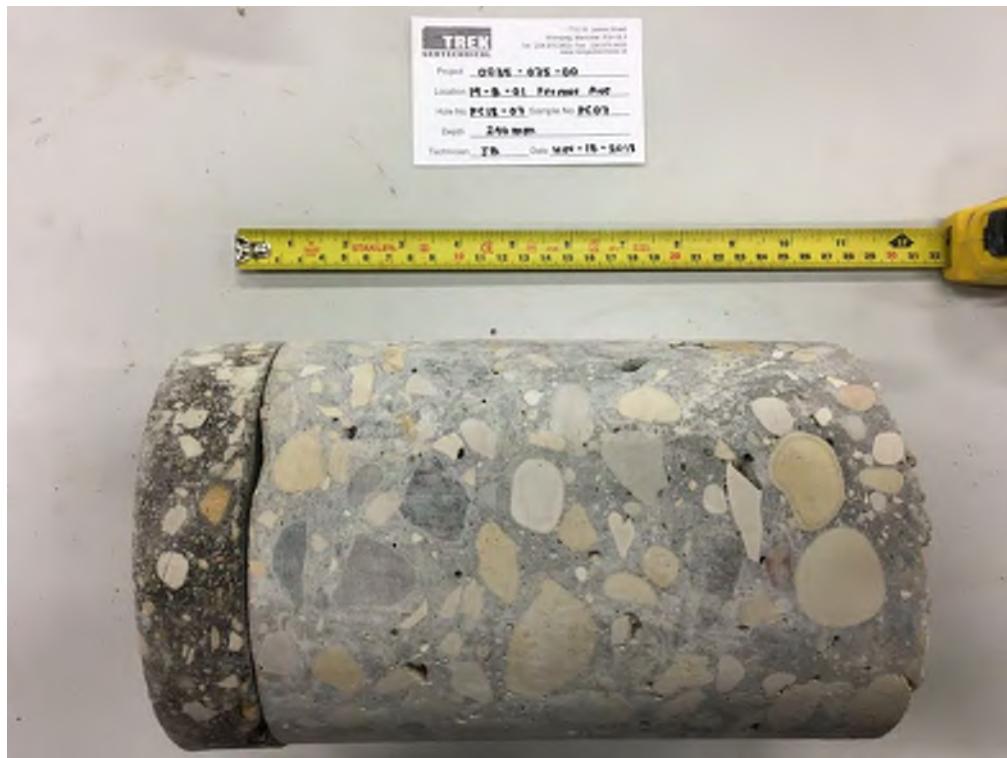
Photo 7: Pavement Core Sample at Test Hole TH18-07

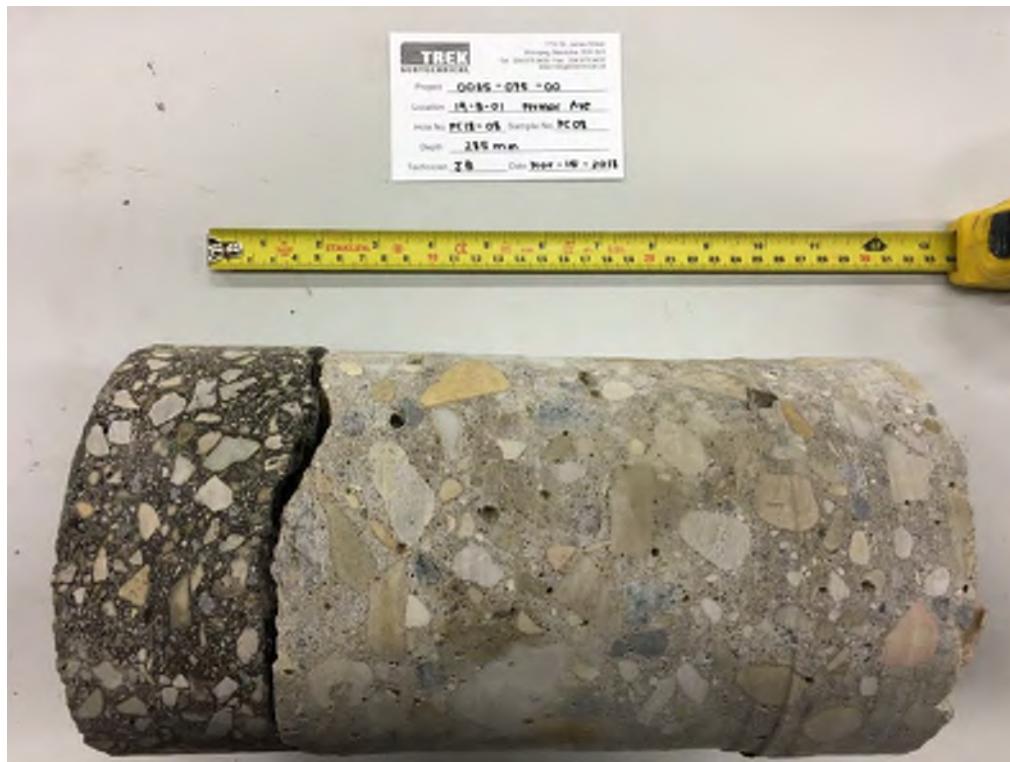
Photo 8: Pavement Core Sample at Test Hole TH18-08

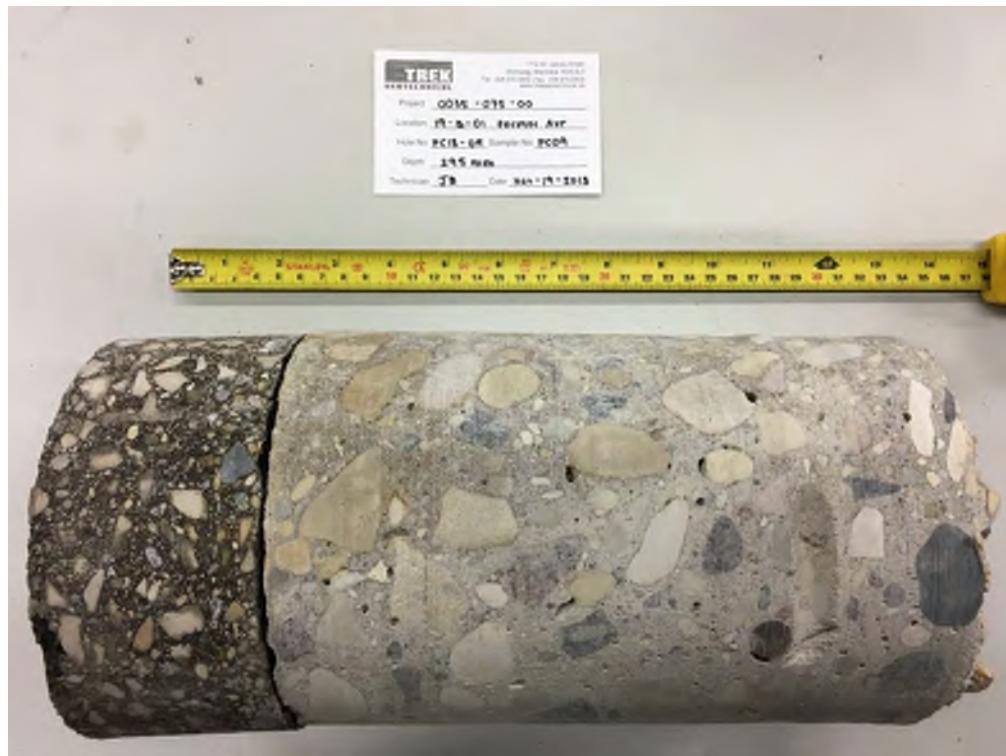
Photo 9: Pavement Core Sample at Test Hole TH18-09

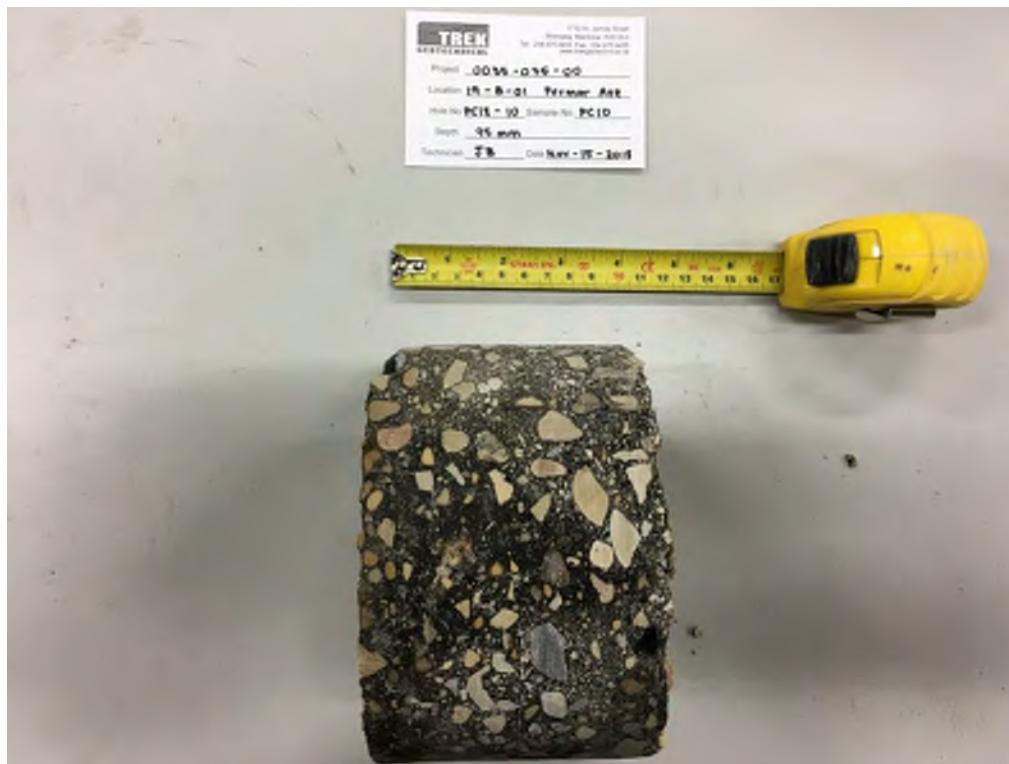
Photo 10: Pavement Core Sample at Test Hole TH18-10

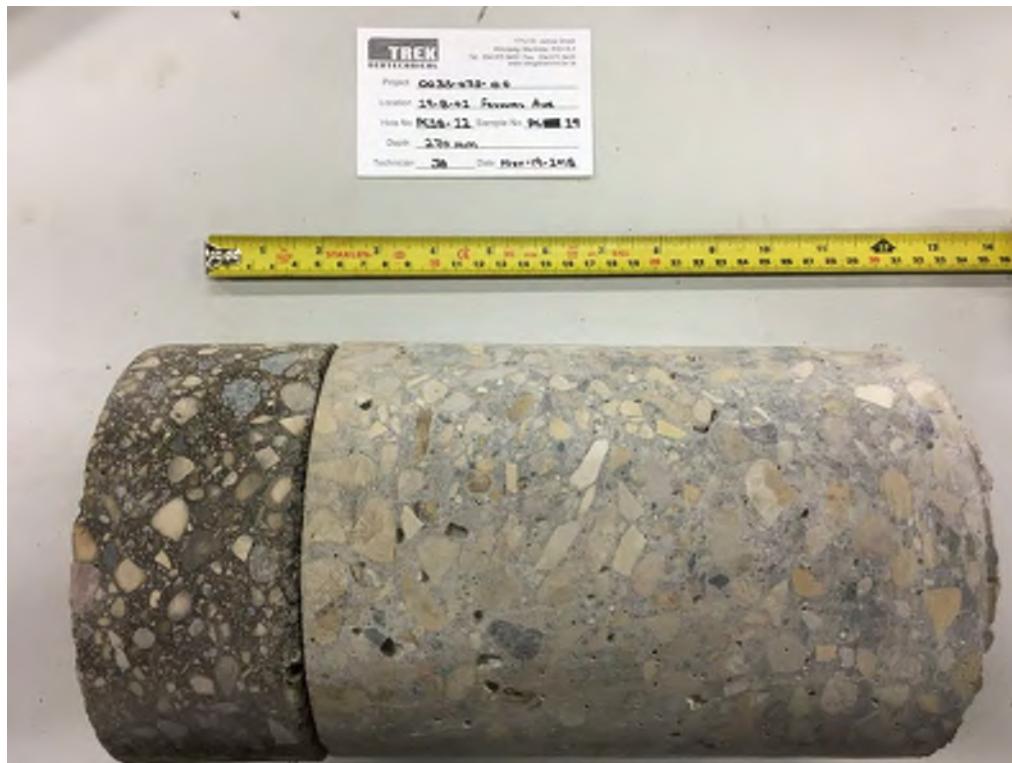
Photo 11: Pavement Core Sample at Test Hole TH18-12

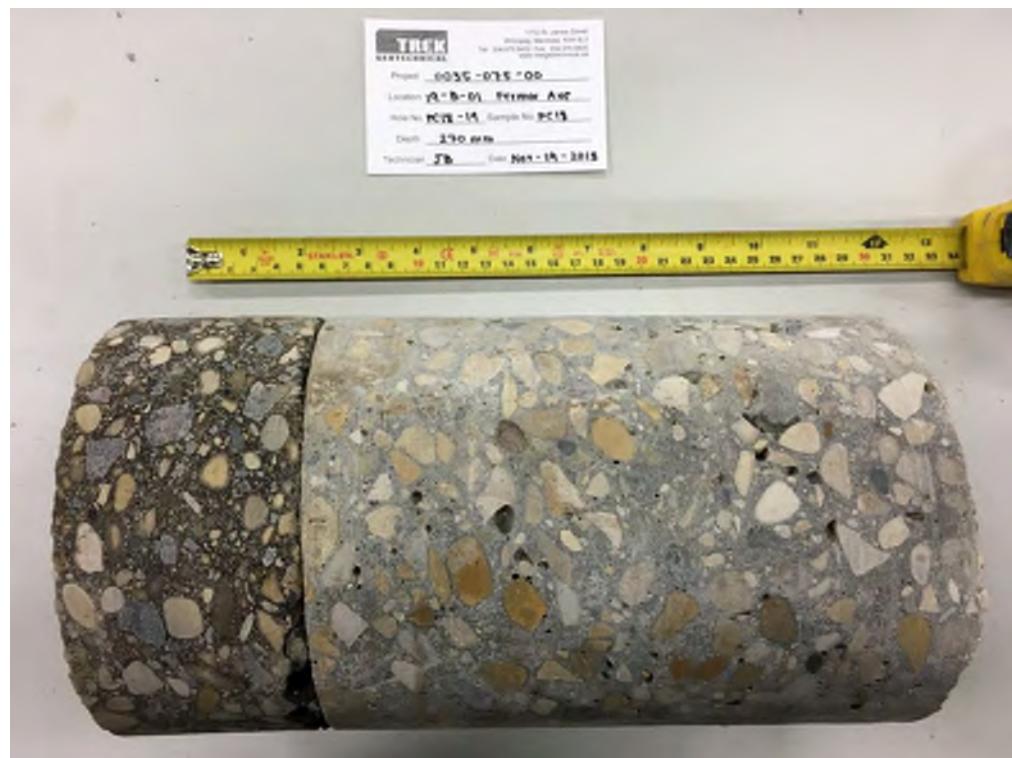
Photo 12: Pavement Core Sample at Test Hole TH18-14

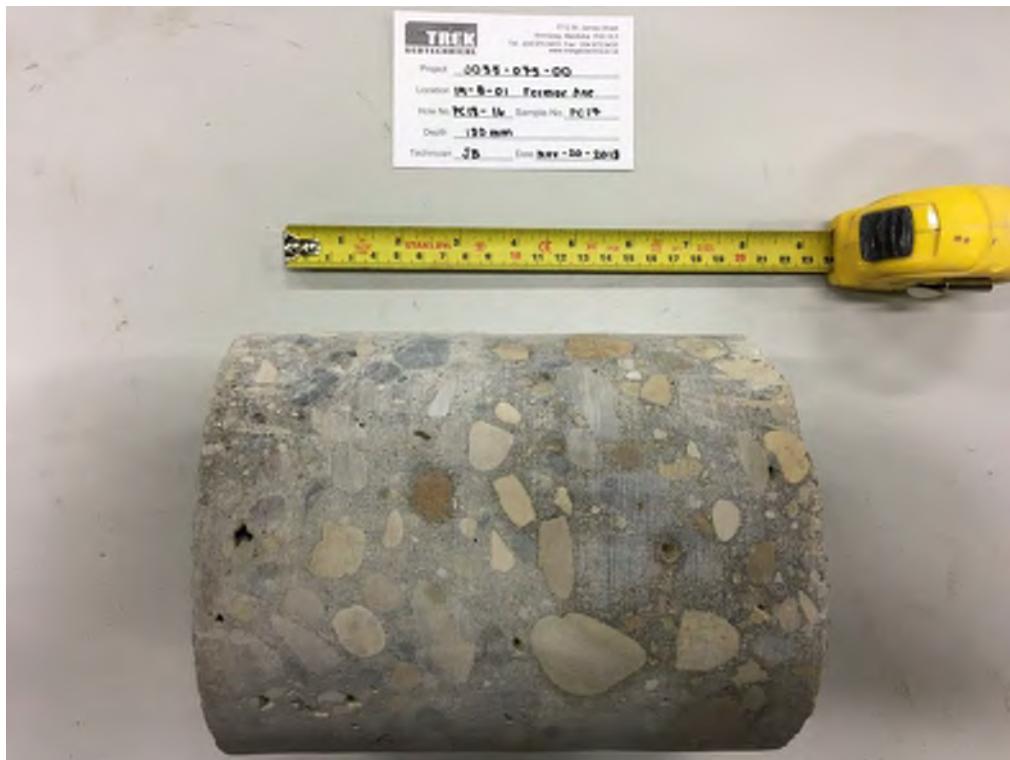
Photo 13: Pavement Core Sample at Test Hole TH18-16

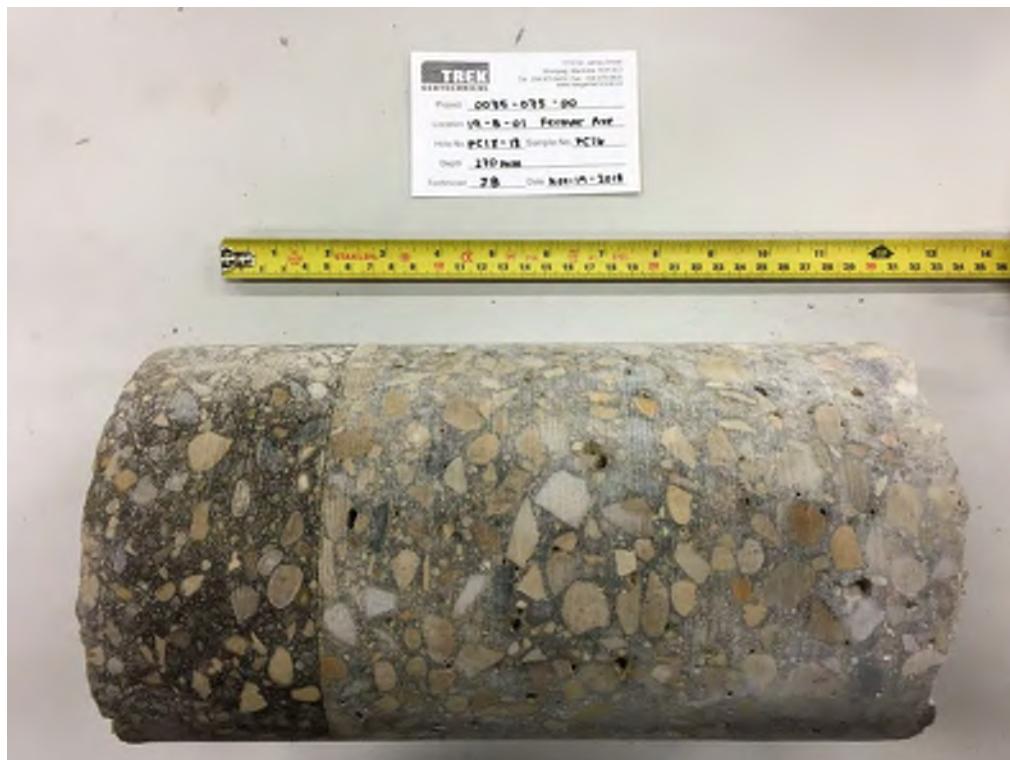
Photo 14: Pavement Core Sample at Test Hole TH18-18

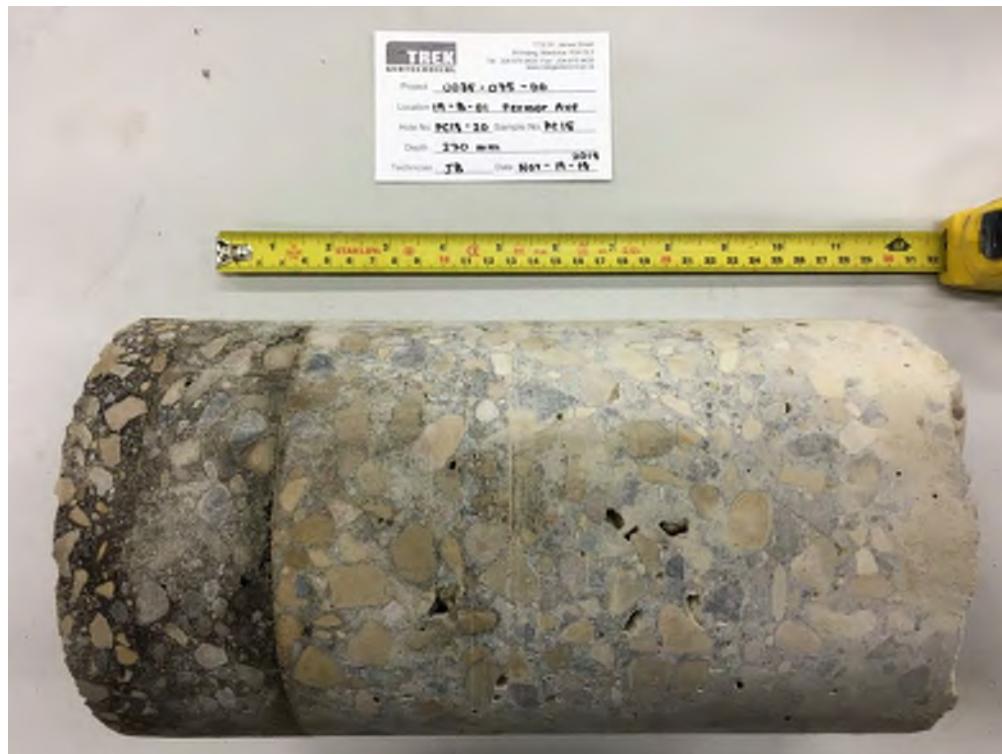
Photo 15: Pavement Core Sample at Test Hole TH18-20

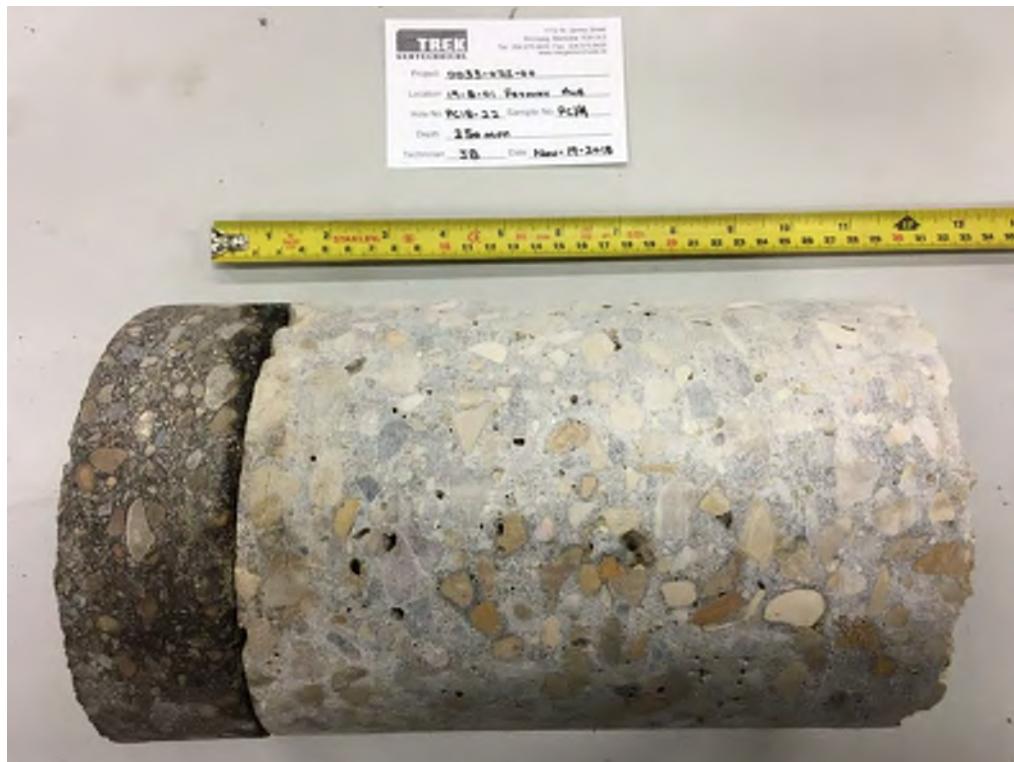
Photo 16: Pavement Core Sample at Test Hole TH18-22

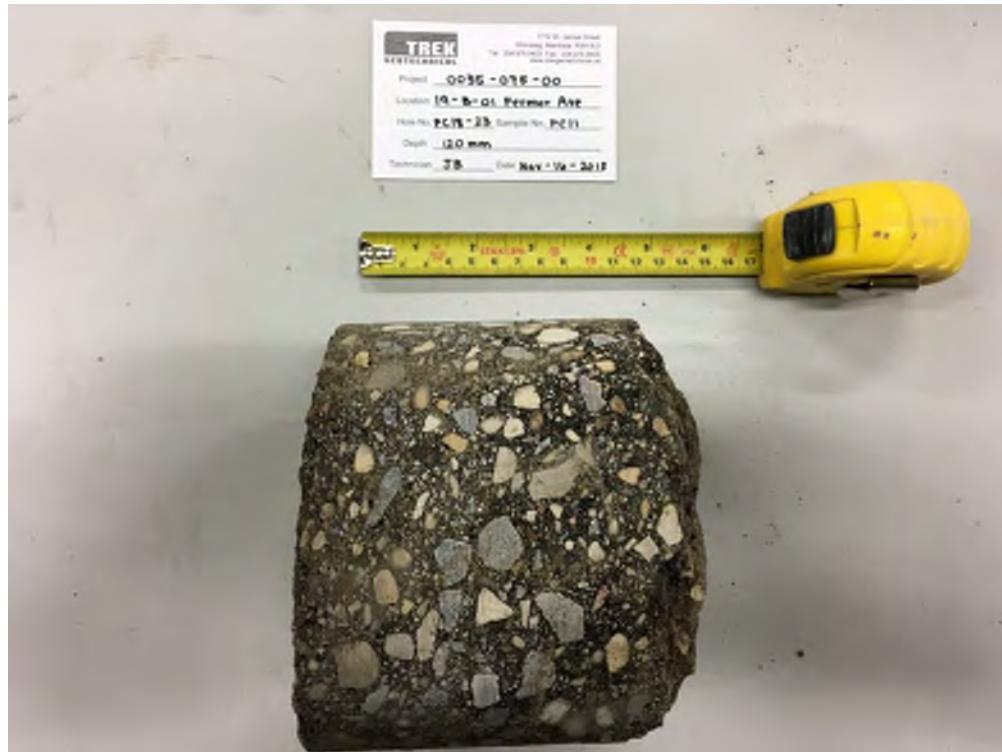
Photo 17: Pavement Core Sample at Test Hole TH18-23

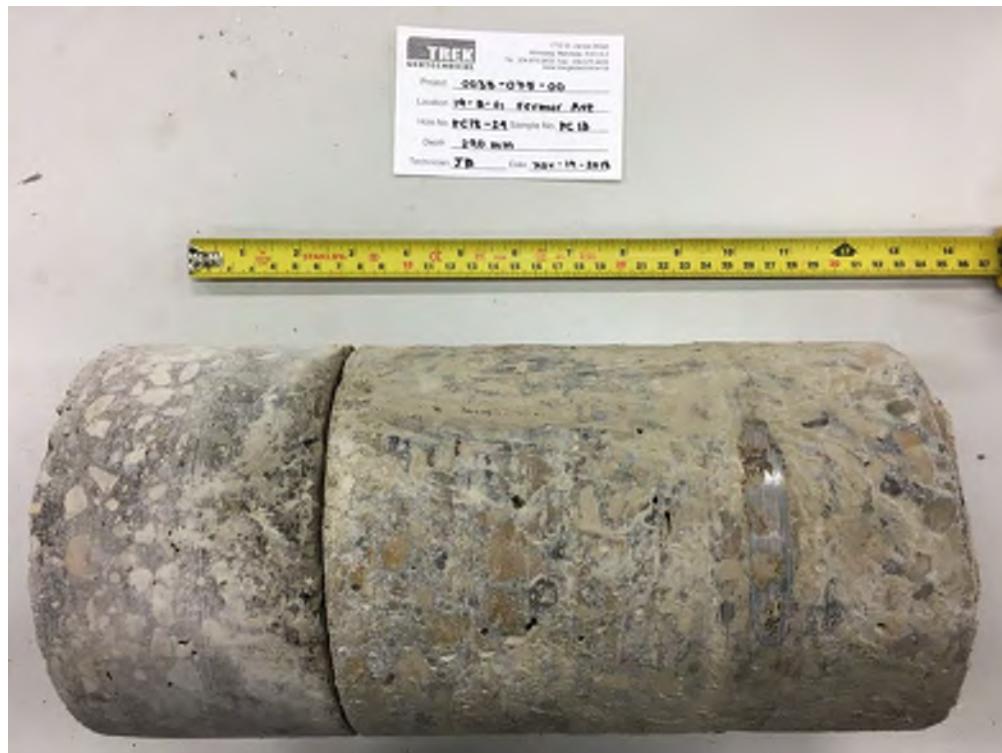
Photo 18: Pavement Core Sample at Test Hole TH18-24

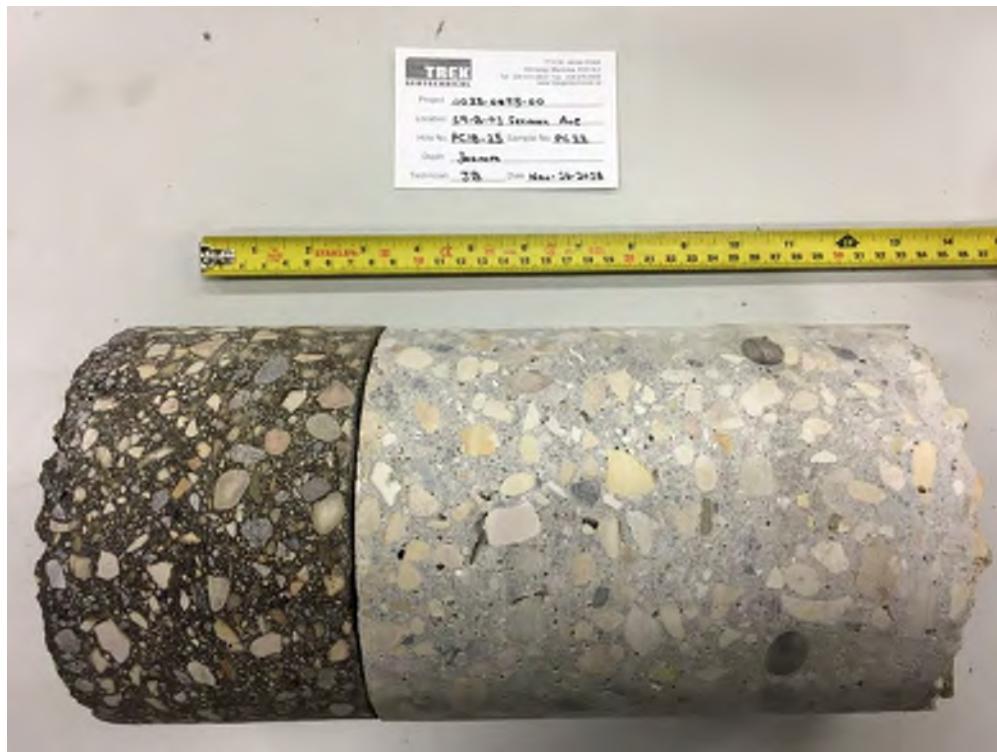
Photo 19: Pavement Core Sample at Test Hole TH18-25

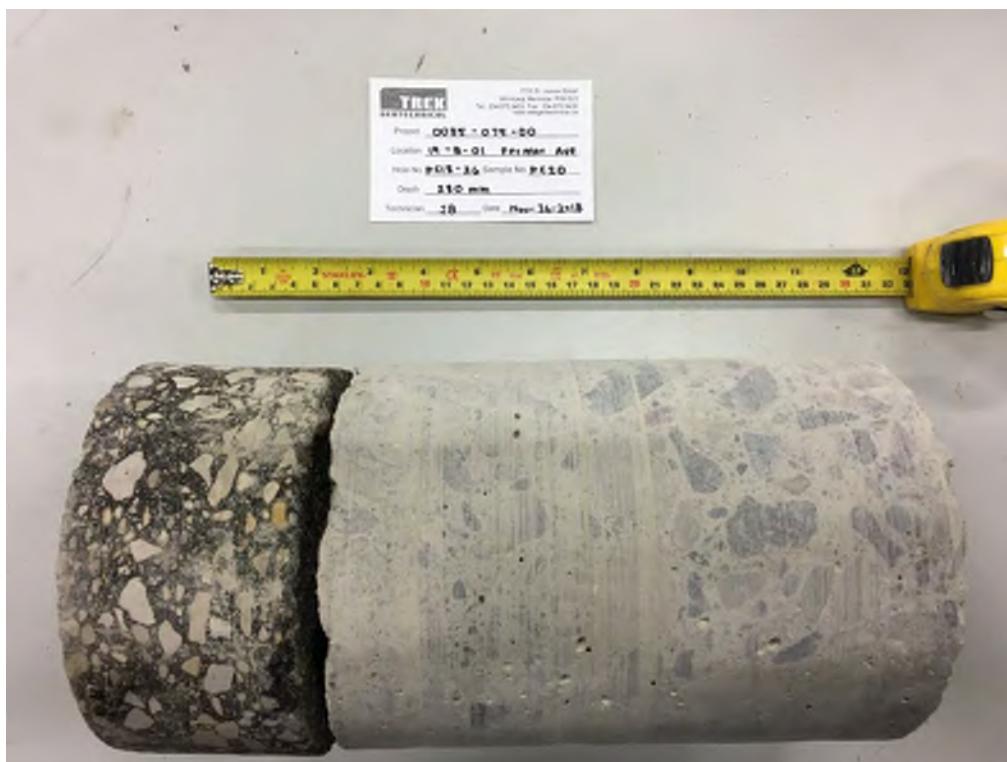
Photo 20: Pavement Core Sample at Test Hole TH18-26

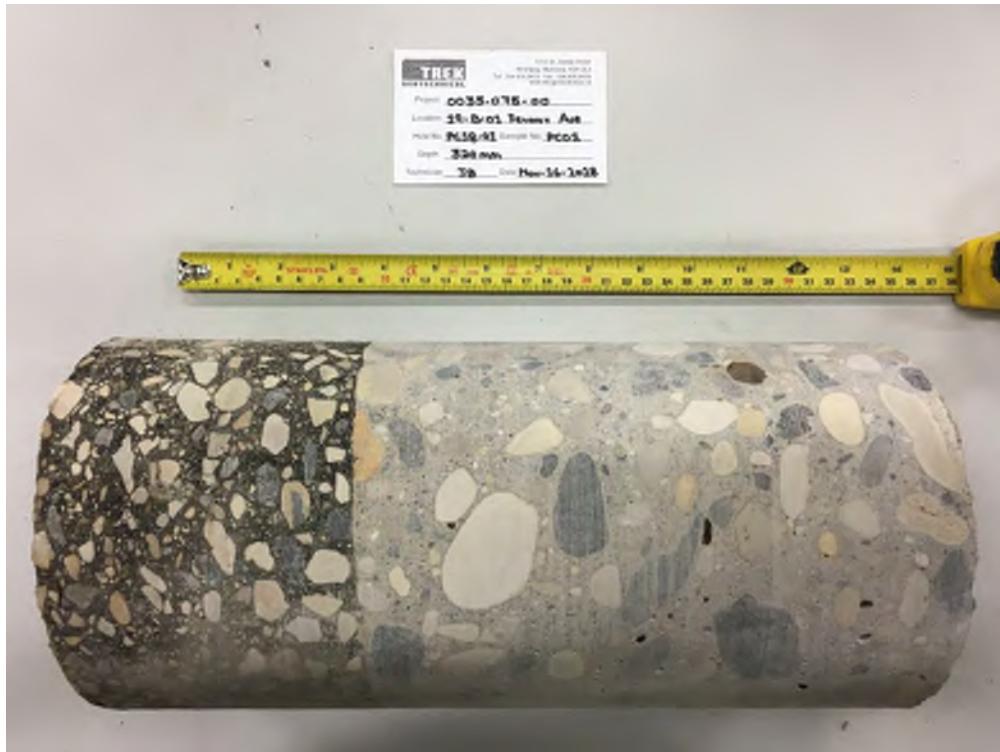
Photo 1: Pavement Core Sample at Test Hole PC18-01

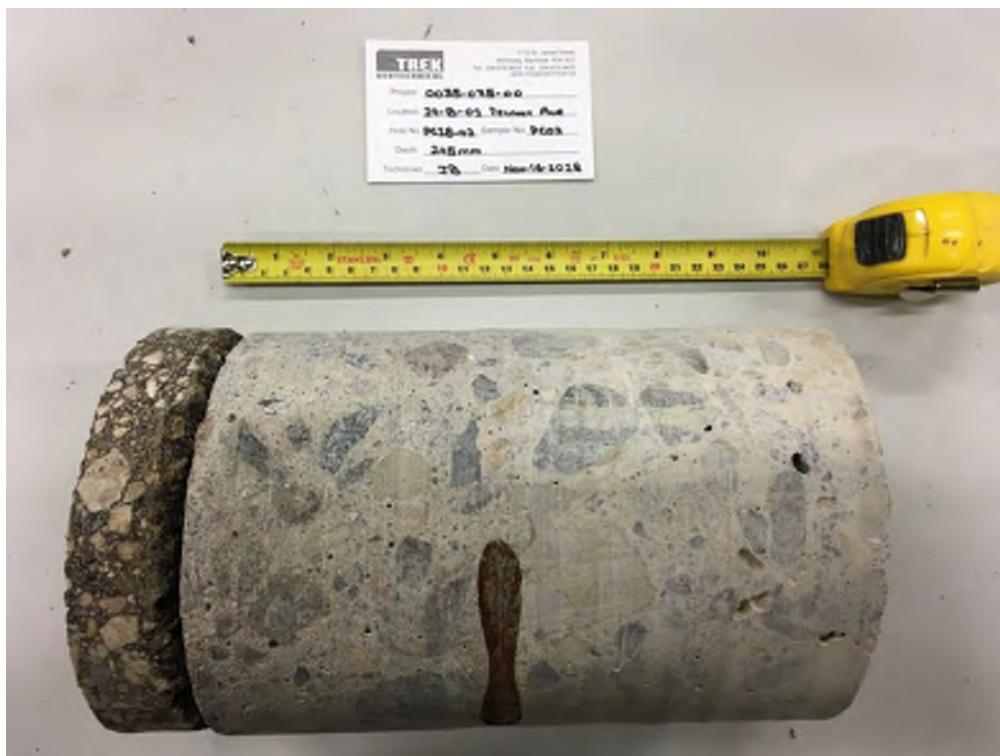
Photo 2: Pavement Core Sample at Test Hole PC18-02
