APPENDIX F – 2019 CRANE INSPECTION REPORT
Hurst Pumping Station

A19-153 - COW - Pump Station Inspections

R.S.I.-A (Regulatory Safety Inspection - ANNUAL)

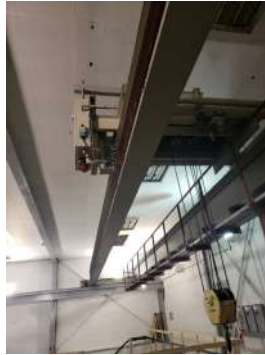
Defect/Adjustment/Repair Image

1- No directional sign on Bridge . Crane requires directional sign on bottom of bridge girder that corresponds to remote controller.

Greased all bridge drive line shaft bearings and drive wheel bearings. Checked oil level in gearbox, level is good.
*could not grease southeast bridge wheel bearings, inaccessible

1- No directional sign on Bridge . Crane requires directional sign on bottom of bridge girder that corresponds to remote controller.

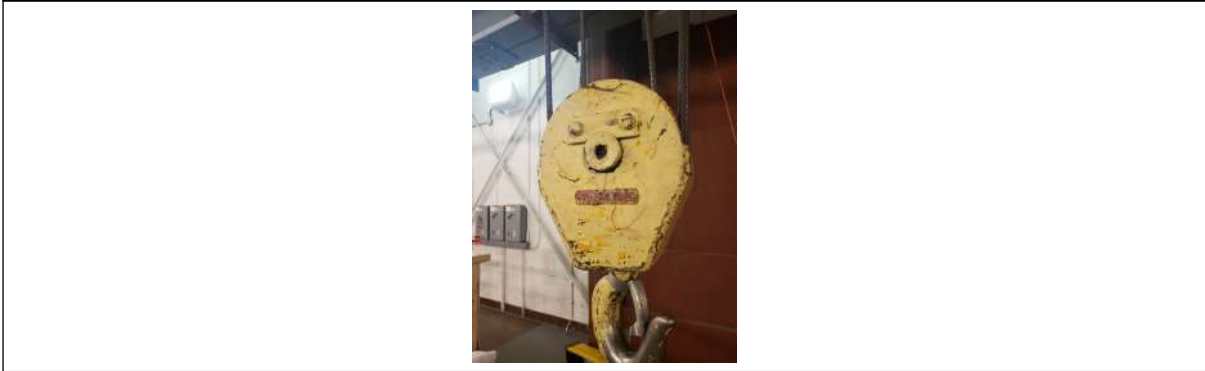
Defect/Adjustment/Repair Image

1- load capacity on hook block is not clear . Hook block requires clear load capacity sign. (7.5 tons)

Greased hook block and upper sheaves. Checked oil level in hoist gearbox, level is good.

1- load capacity on hook block is not clear . Hook block requires clear load capacity sign. (7.5 tons) 1 tech/1hr for all repairs
