| Project: | <u>Kildonan-Redwood Feeder Main Pipe Inspection</u> | Date: | <u>March 29, 2019</u> |
| Contractor: | <u>J-Con Civil Ltd.</u> | Project #: | <u>60549028</u> |
| Owner: | <u>City of Winnipeg</u> | Weather: | <u>Snow, Blustery, -5° C</u> |

# Inspection Report

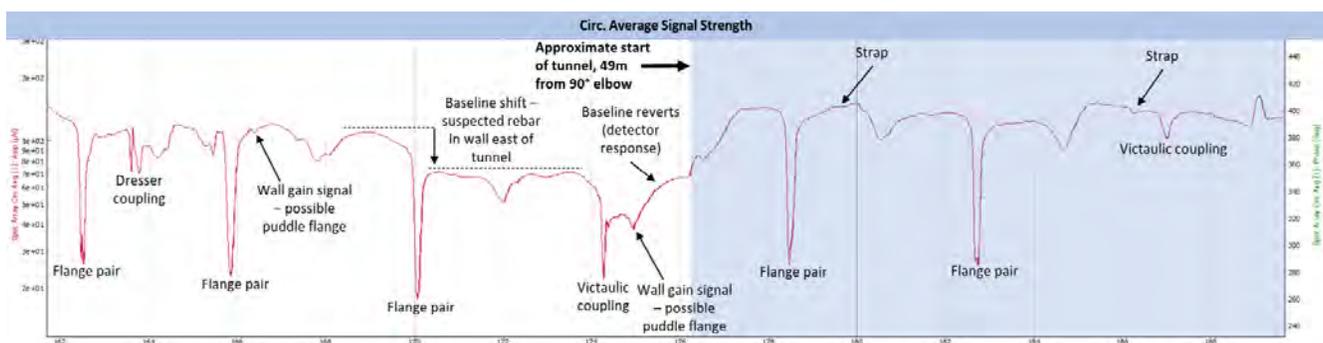
- The data shows what potentially are two welds associated with each of the 30° flanged bends. At each bend there is a single 30° deflection at the weld furthest away from the flange. Drawing 12531 depicts this construction accurately.

- The apparent increase in wall thickness for the pipe at 170 to 174 m (shown with a dashed black line) may be due to rebar within the concrete encasement.

- Regarding the water stop shown within the east tunnel wall on drawing 12531, two wall-gain signals associated with possible water stop locations were identified. However, the signals are quite different from each other so if they are both puddle flanges, the actual flange make-up is different for each.

- In the EM data, PICA can distinguish between flanged and Victaulic connections. The connection just beyond the east tunnel wall appears to be a Victaulic, as is shown on drawing 12531. However, the pipe strap and pedestal shown further east does not appear to be present, though it is possible that the wall gain signal marked as a possible puddle flange is in fact the strap support at a relocated position.

**Figure 1 - Electromagnetic Inspection Data for the Feeder Main at the East Tunnel Wall. (East is left; vertical bends are on left side; tunnel area is shown grey)**

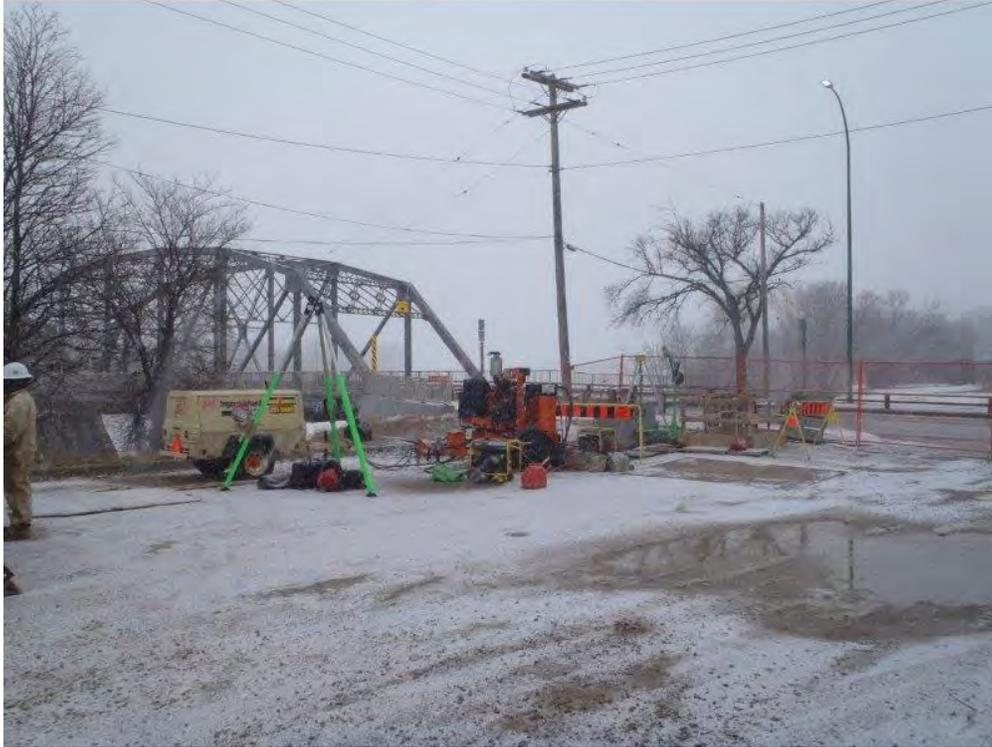
**Figure A 3 – Contractor's Equipment at Top of Shaft on Redwood Avenue.**

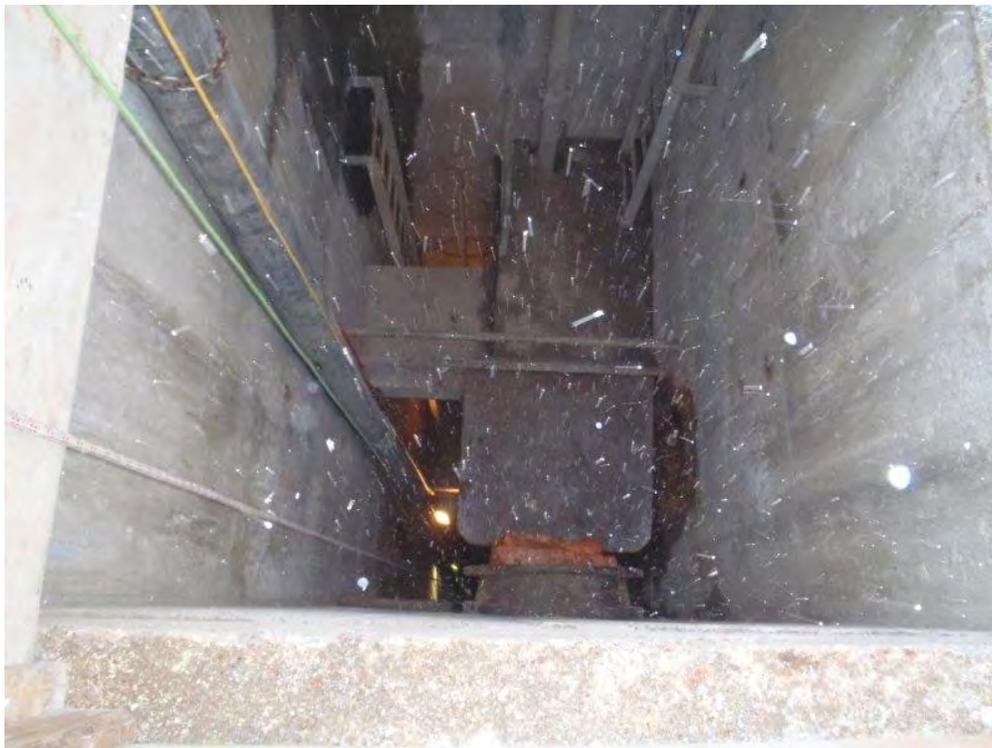
**Figure A 4 – View Into Shaft on Redwood Avenue.**

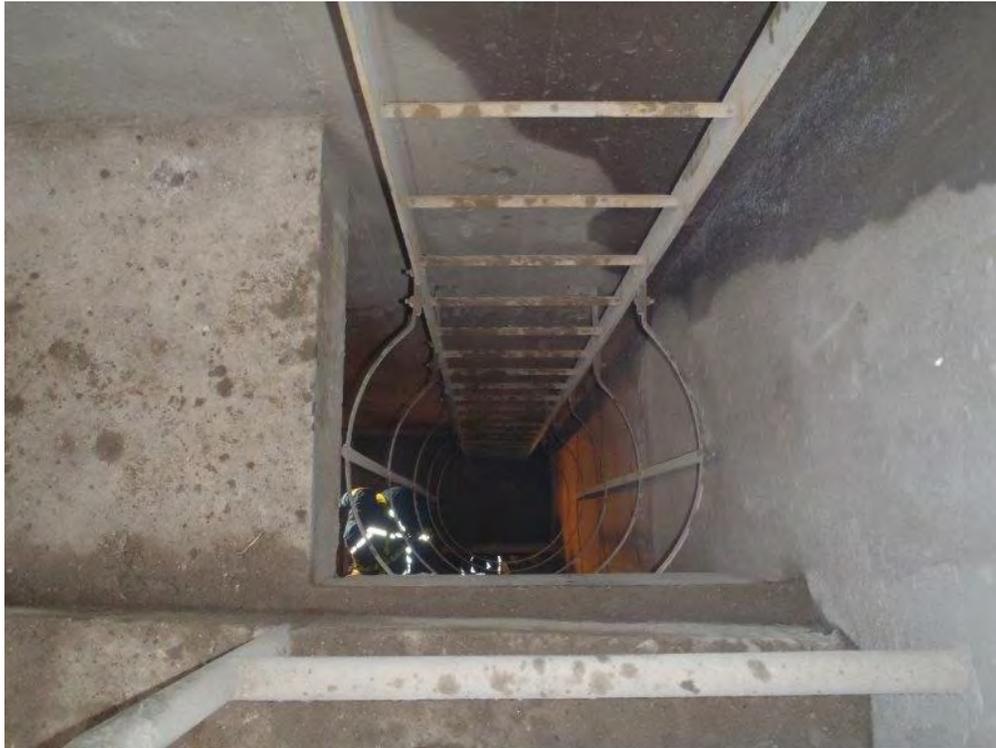
**Figure A 5 – View Into Base of Shaft Showing Condition of Galvanized Ladder.**

- Monitor the condition of the ladders in the tunnel shaft.
- Seal cracks and / or joints in the tunnel structure from water infiltration by injecting them with hydrophilic polyurethane grout. Similar repairs have been made throughout the Shoal Lake Aqueduct.

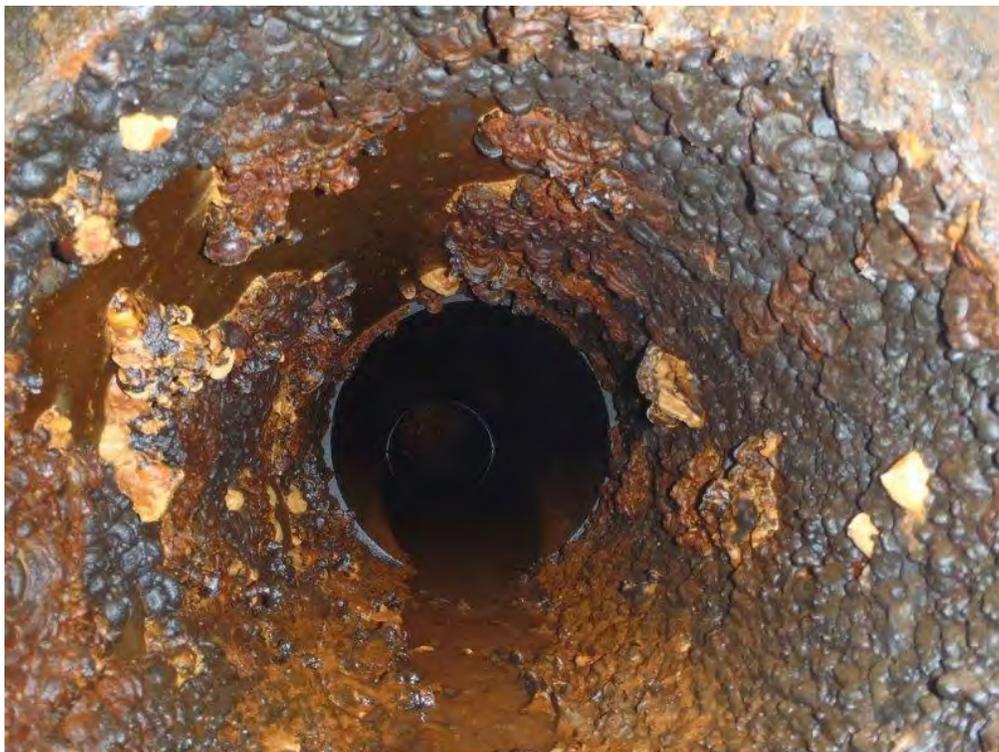
**Figure A 6 – View Into 350 mm Water Main Through West Wall of Shaft.**

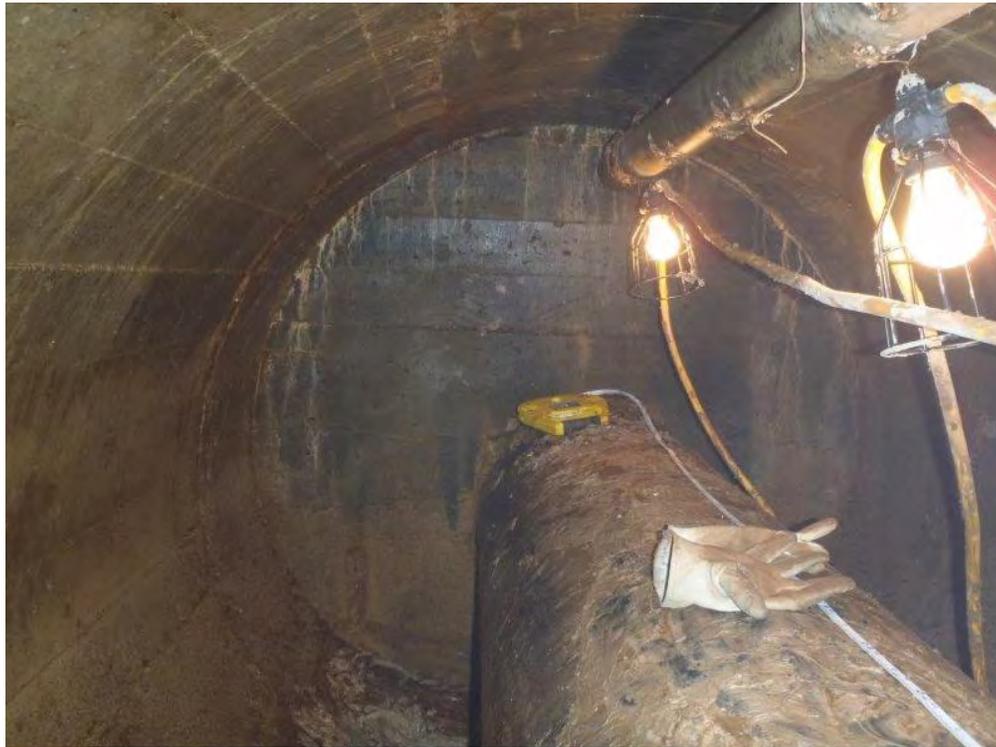
- The finished tunnel length is 49.02 m (160.83 feet), not 57.3 m (188 feet) as shown on historic drawing WA-12531. The water industry publication discussed numerous difficulties that were encountered while constructing the east end of the tunnel.
- Tunnel was in good condition, but water was observed seeping (dripping to slow running) from some of the concrete cold-pour joints that were spaced at 4 or 6 feet along the tunnel.
- The original Universal cast iron air piping had been replaced with aluminum pipe, which has suffered galvanic corrosion due to direct contact with the steel or iron pipe hanger assemblies. Condition of the aluminum piping ranged from being relatively uncorroded to being completely perforated.
- The built-in air piping system was effective in ventilating the tunnel.

**Figure A 7 – East End of Tunnel, 49.0 m From Shaft.**

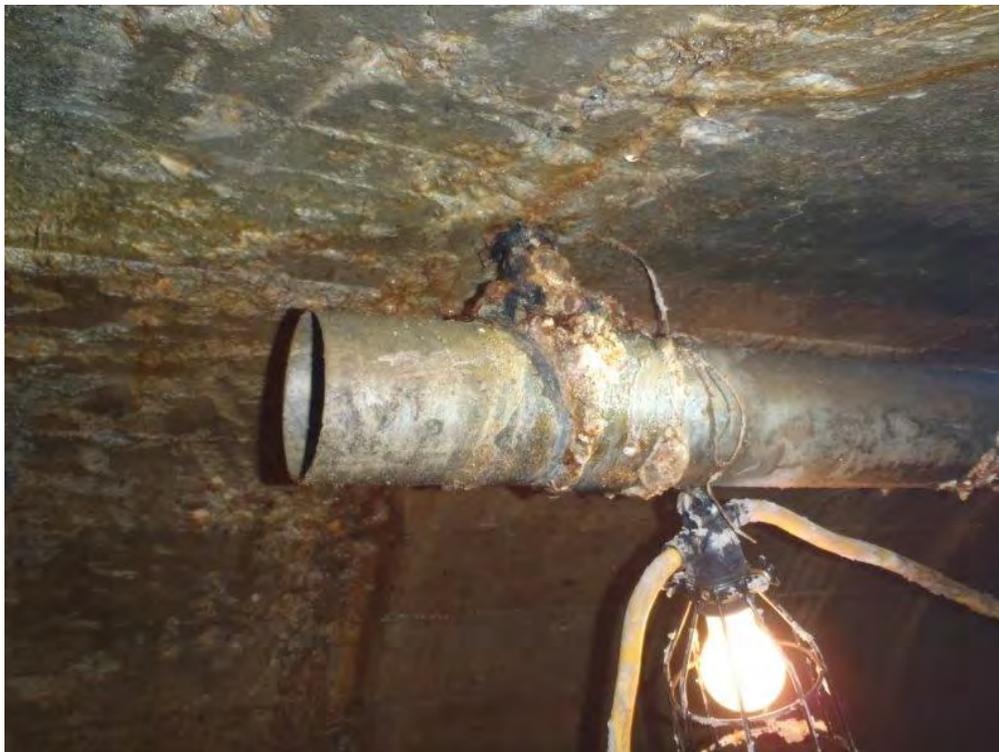
**Figure A 8 – End of Aluminum Air Pipe at East End of Tunnel.**

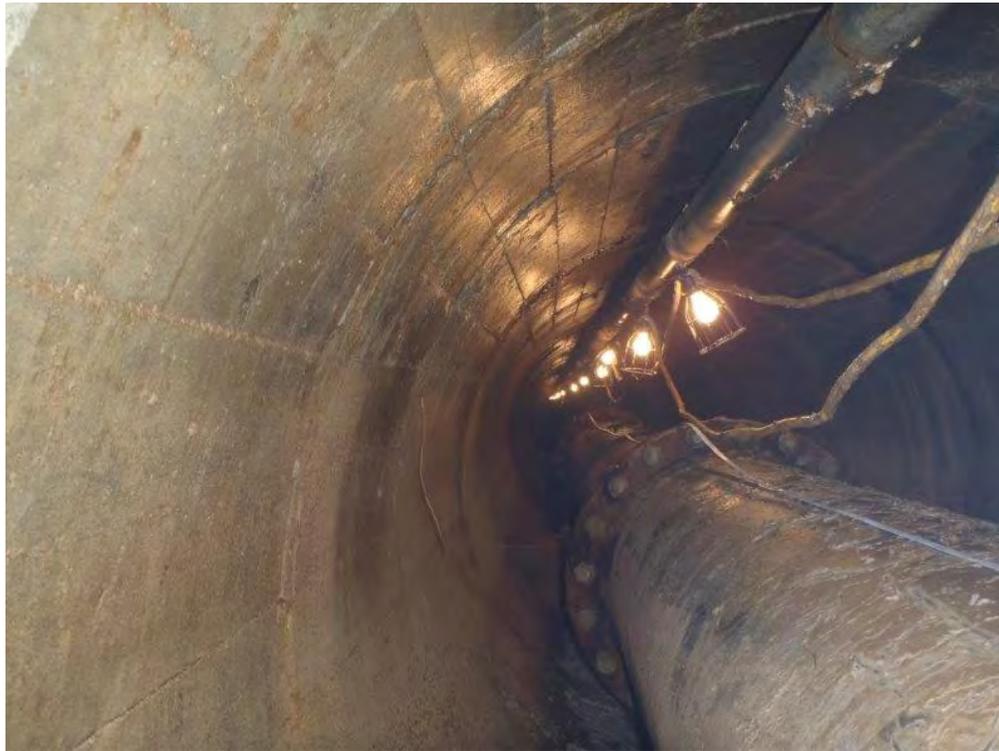
**Figure A 9 – View of Tunnel, Looking Westward From East End.**

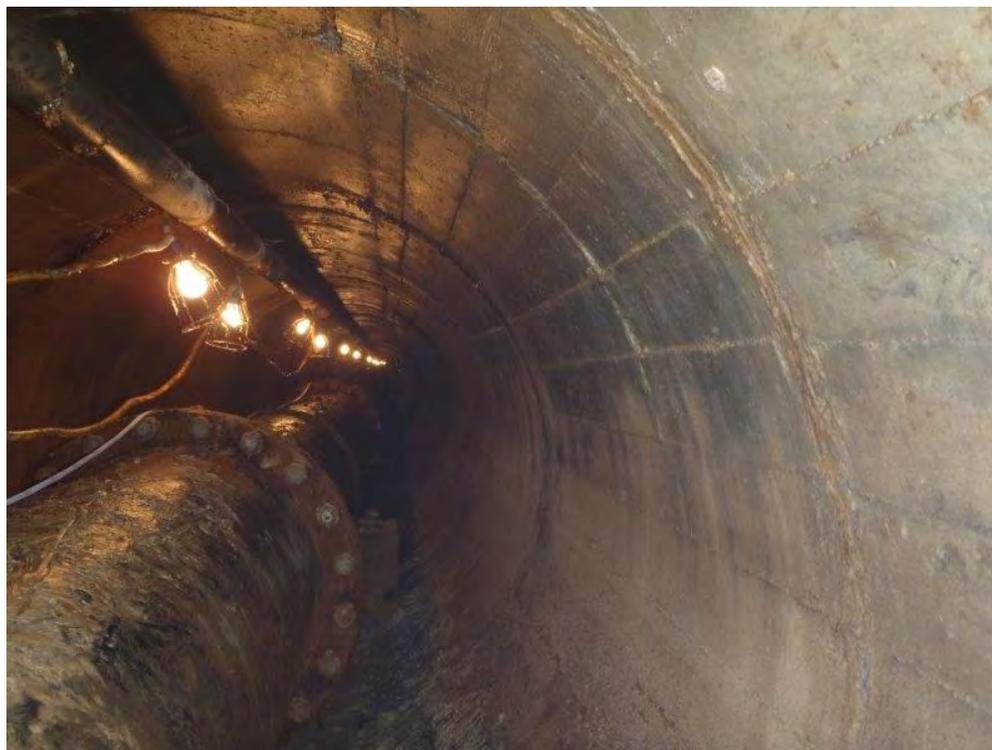
**Figure A 10 – View of Tunnel, Looking Westward From East End.**

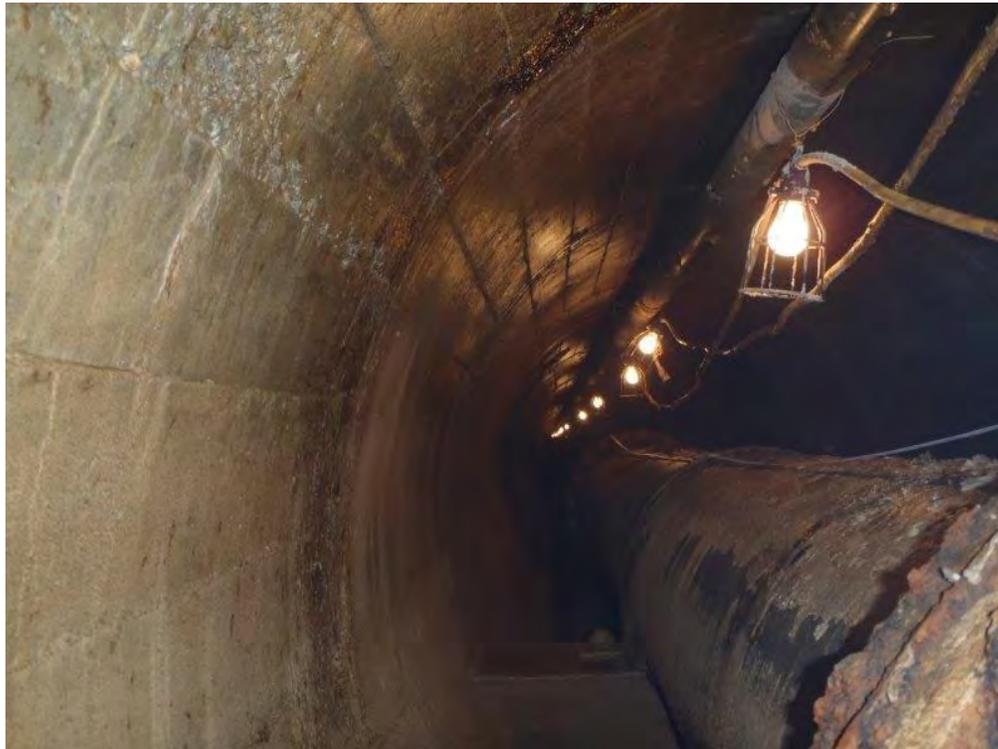
**Figure A 11 – Water Infiltrating at Concrete Cold Pour Joint 4.5 m from Tunnel End.**

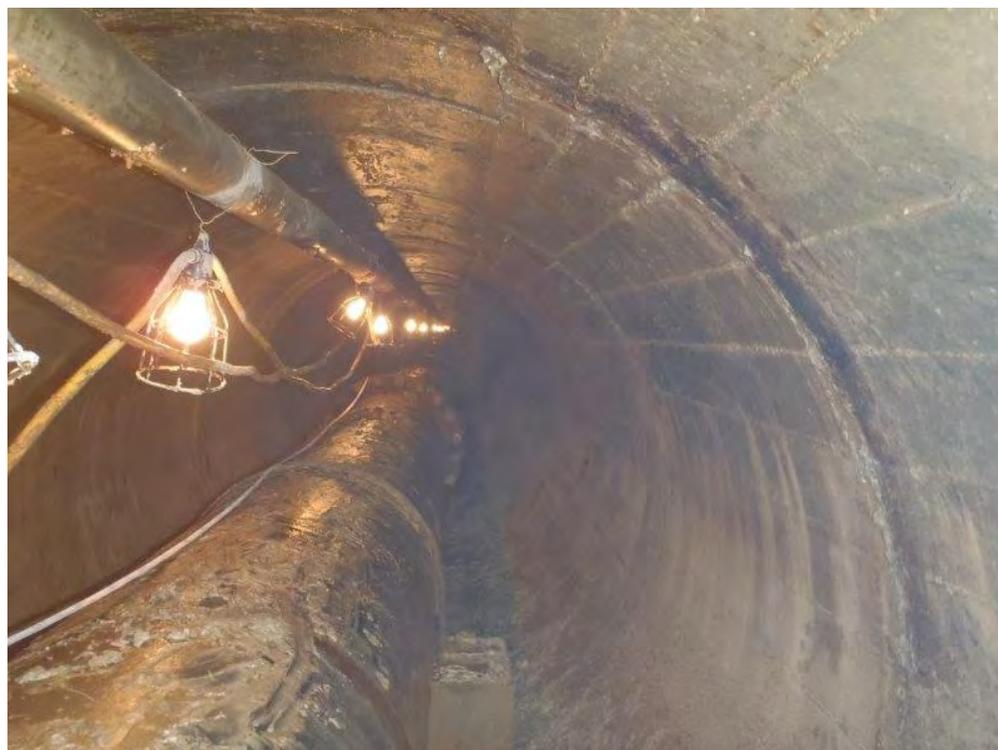
**Figure A 12 – Water Infiltrating at Concrete Cold Pour Joint 4.5 m from Tunnel End.**

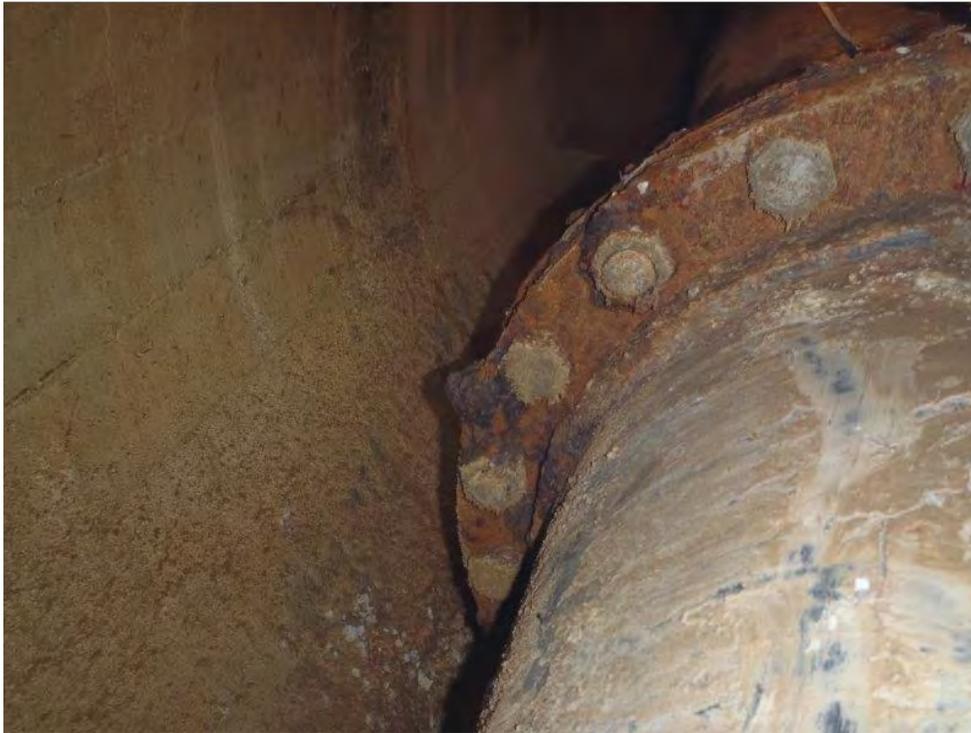
- Flanged connections were in good condition, exhibiting only slight general corrosion. Fasteners, which appeared to be galvanized or stainless steel, also were in good condition.

**Figure A 13 – Flange Connection at 10:00 o'clock, 46.78 m from Shaft.  
Note Corrosion Tubercle Between Bolt Heads at 9:30 o'clock.**

- Install petrolatum tape coating system over all flanged connections. Clean dirt and corrosion from flanges prior to coating and use profiling mastic to fill irregular spaces between flange fasteners, creating a smooth surface for tape wrapping.

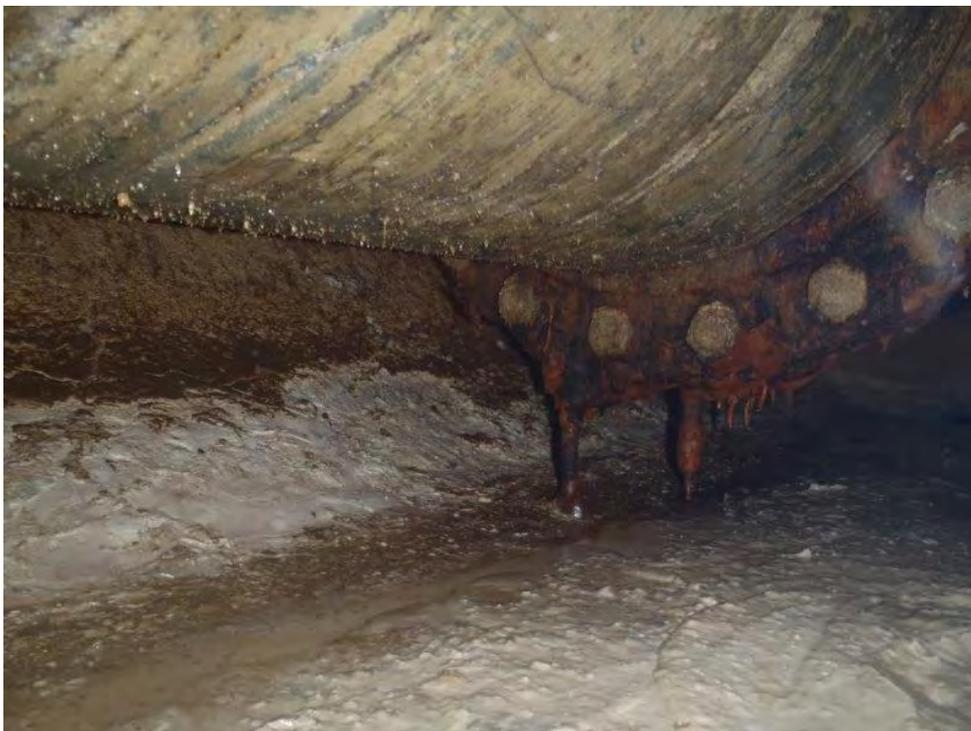
**Figure A 14 – Flange Connection at 6:00 o'clock, 46.78 m from Shaft.**

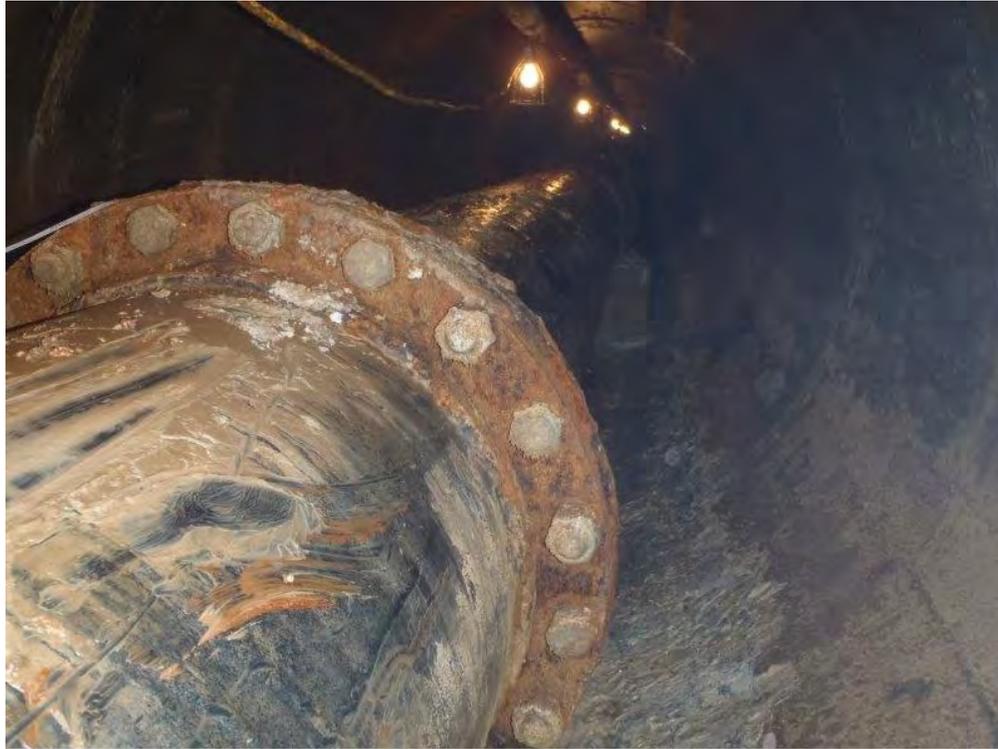
**Figure A 19 – Flange Connection at 2:00 o'clock, 42.50 m from Shaft.**

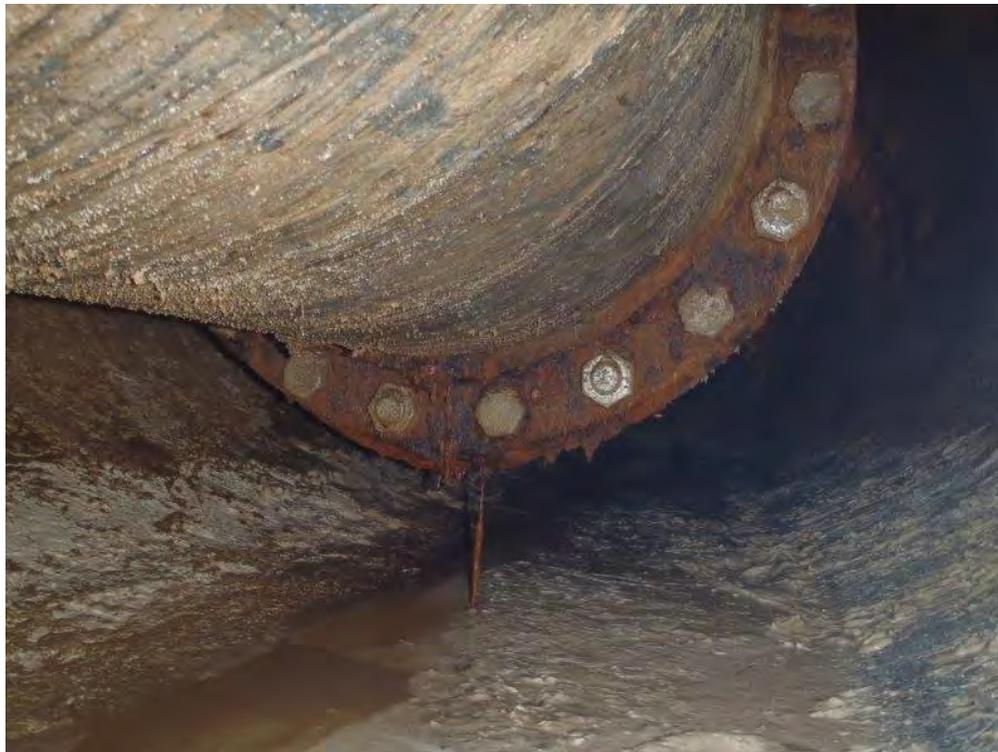
**Figure A 20 – Flange Connection at 6:00 o'clock, 42.50 m from Shaft.**

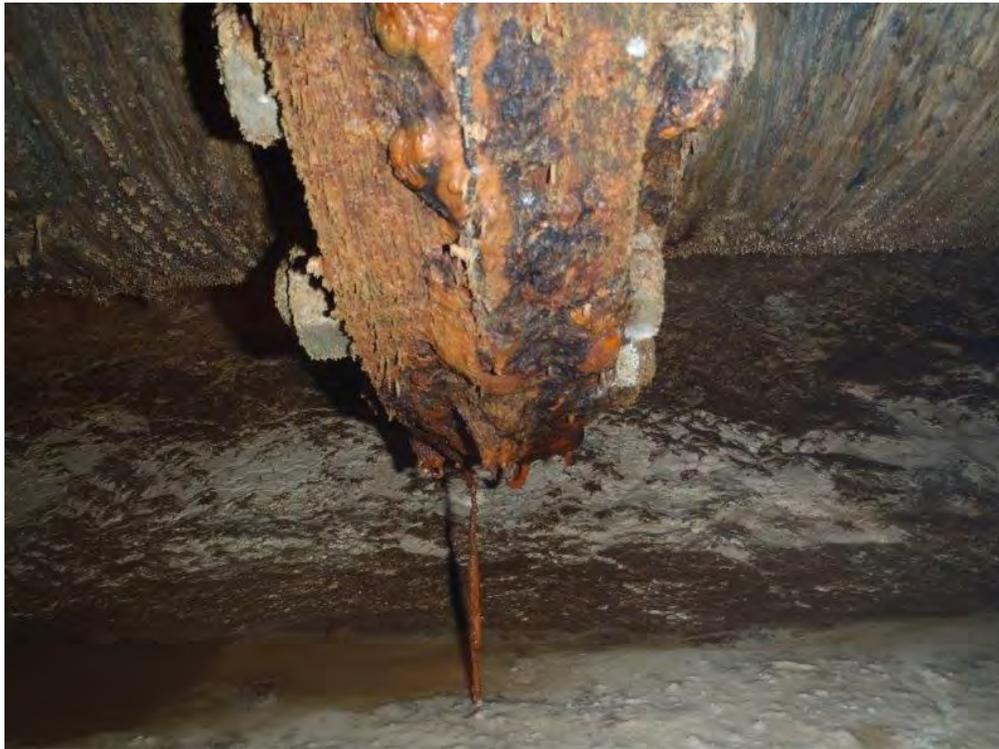
**Figure A 21 – Underside of Flange Connection at 42.50 m from Shaft.**

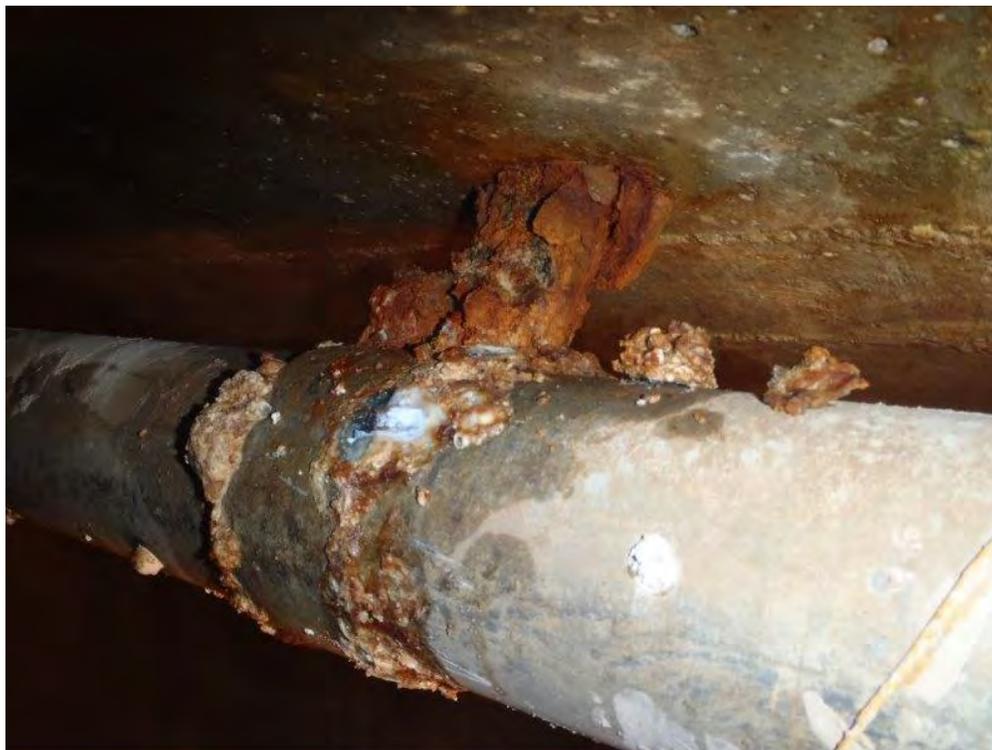
**Figure A 22 – Typical Corrosion of Aluminum Air Pipe at Anchor Point, ~40.0m From Shaft.**

- Repair or replace the deteriorated tunnel ventilation pipe. Options include:
  - Replace the existing aluminum piping with plastic piping (PVC or CPVC) that will not undergo galvanic corrosion on contact with the ferrous metal pipe anchors and will not corrode in the humid tunnel environment. Piping could be socketed for joining by solvent welding.

- Wrap a neoprene sheet gasket around the air pipe at the hanger points to isolate the aluminum from the steel / iron hangers (eliminate galvanic corrosion) and seal the perforations through the pipe. Gaskets may be held in place by plastic zip ties.

- Repair or replace the corroded aluminum piping at the anchor locations and secure the piping to the hangers with non-metallic anchors (for example, FRP anchor system).

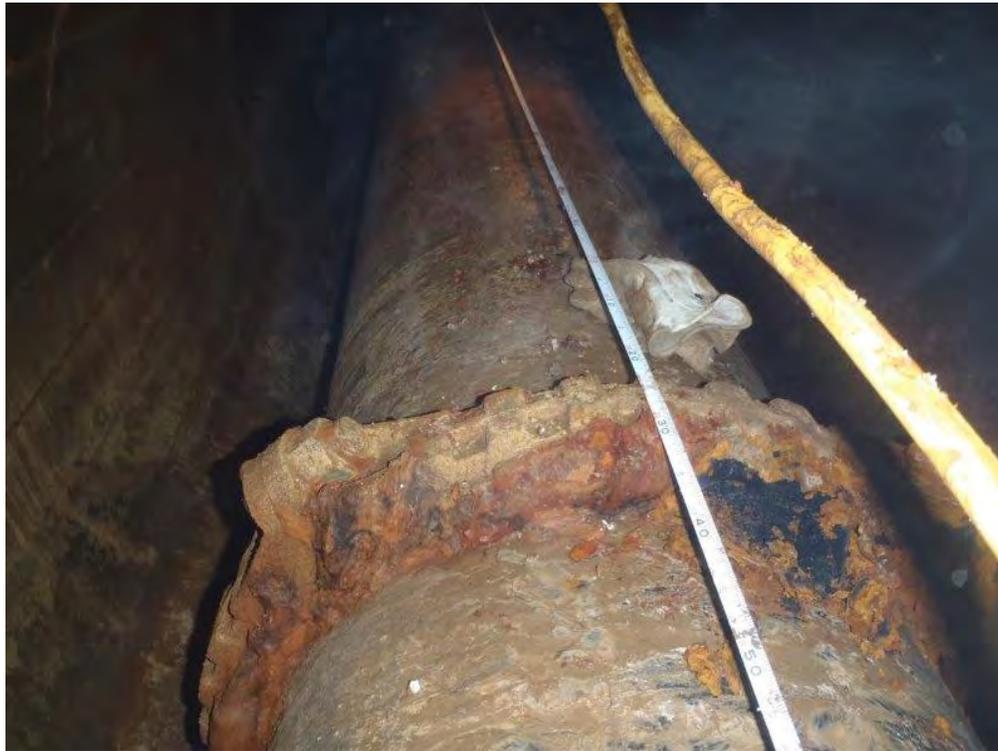
- Galvanized pipe straps at pedestals were in very good condition.
- Victaulic couplings were severely corroded and should be replaced. The bodies of the couplings were unevenly corroded with the appearance of grey cast iron, a brittle material. The underlying restraining rings

**Figure A 23 – Victaulic Connection at 12:00 o'clock, 38.24 m from Shaft.**

- Replace the Victaulic couplings.
- Install a petrolatum tape coating repair (mastic and tape wrap) around the feeder main pipe at the coating break near the east tunnel wall. The repair should extend from the wall to 0.2 m from the wall.

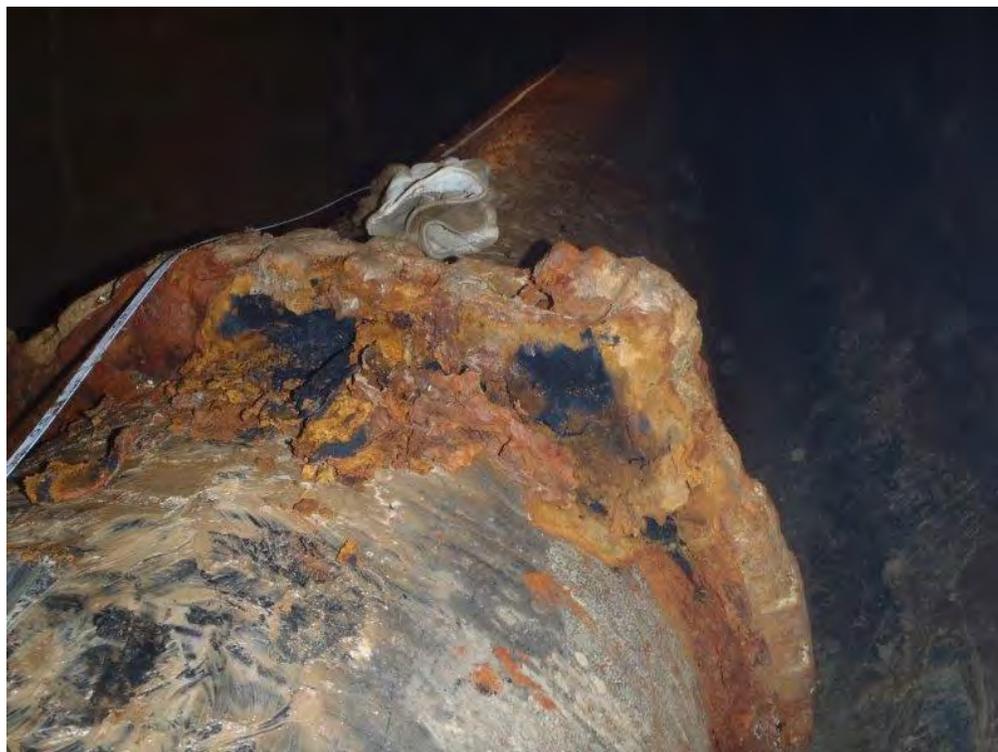
**Figure A 24 – Victaulic Connection at 2:00 o'clock, 38.24 m from Shaft.**

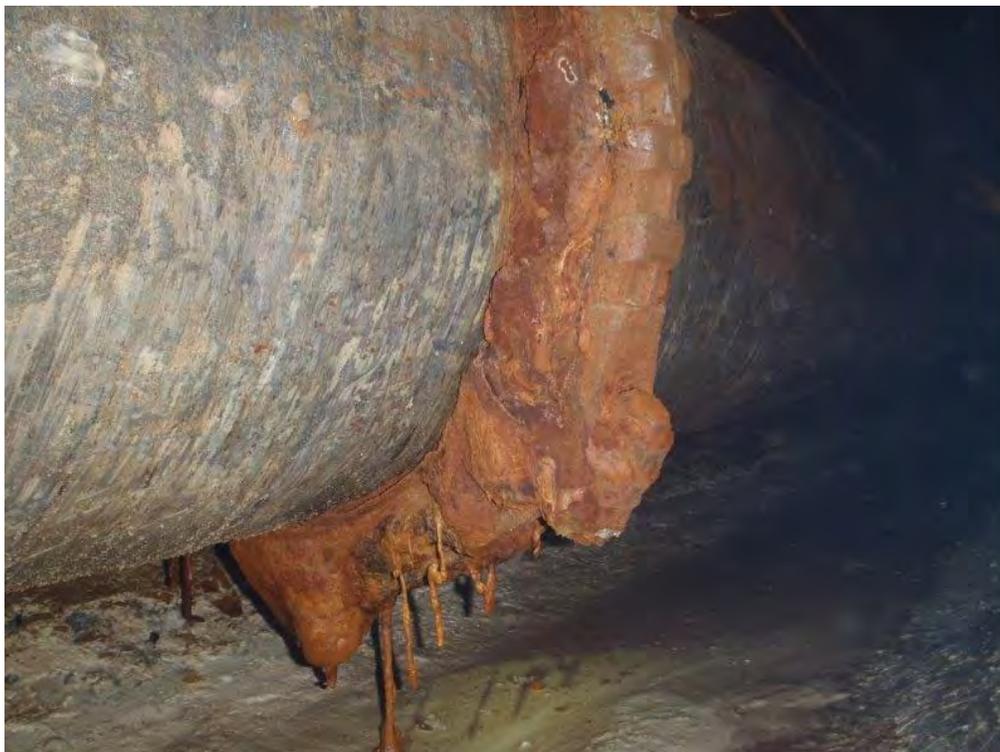
**Figure A 26 – Underside of Victaulic Connection at 4:00 o'clock, 38.24 m from Shaft.**

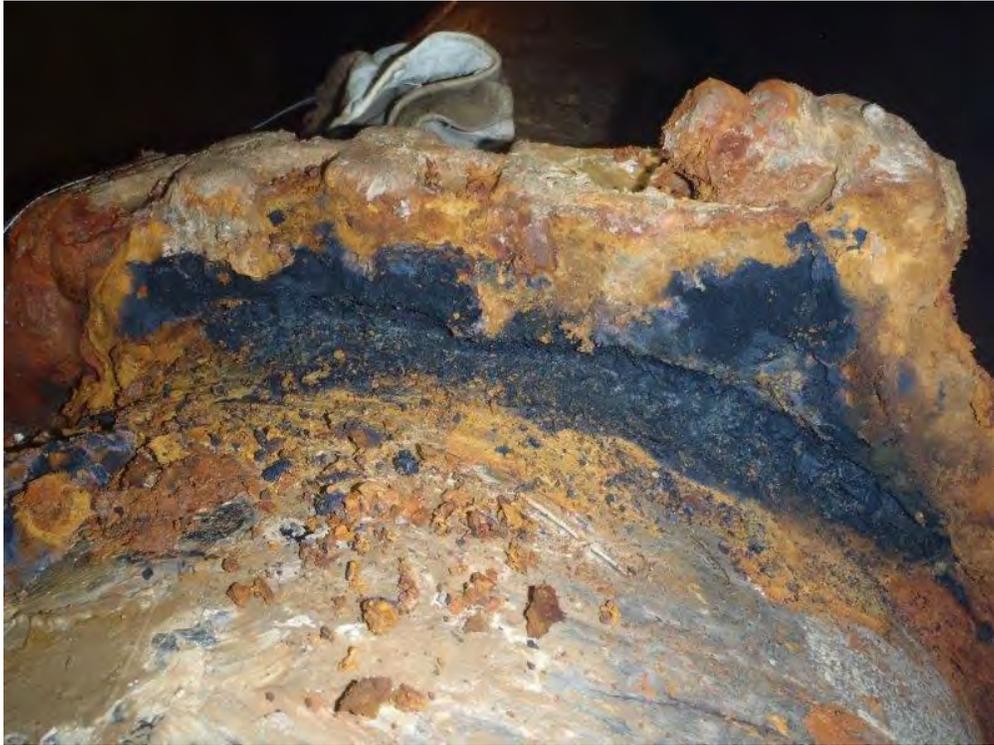
**Figure A 27 – Corroded Body of Victaulic Connection at 1:00 o'clock, 38.24 m from Shaft.**

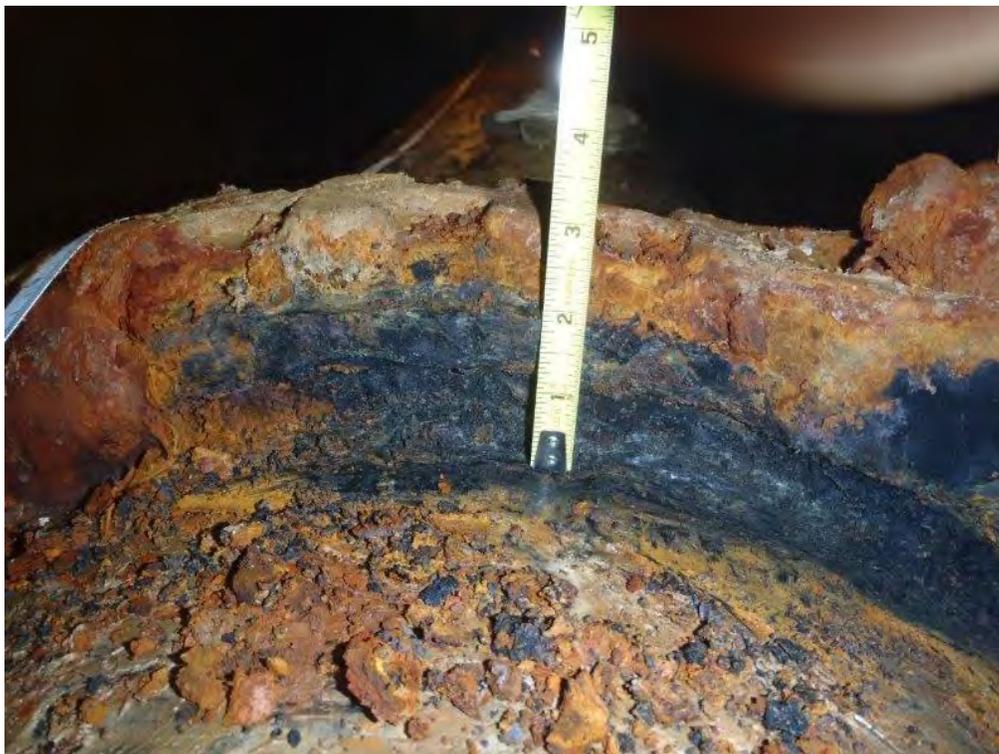
**Figure A 28 – Corroded Body of Victaulic Connection at 1:00 o'clock, 38.24 m from Shaft.**

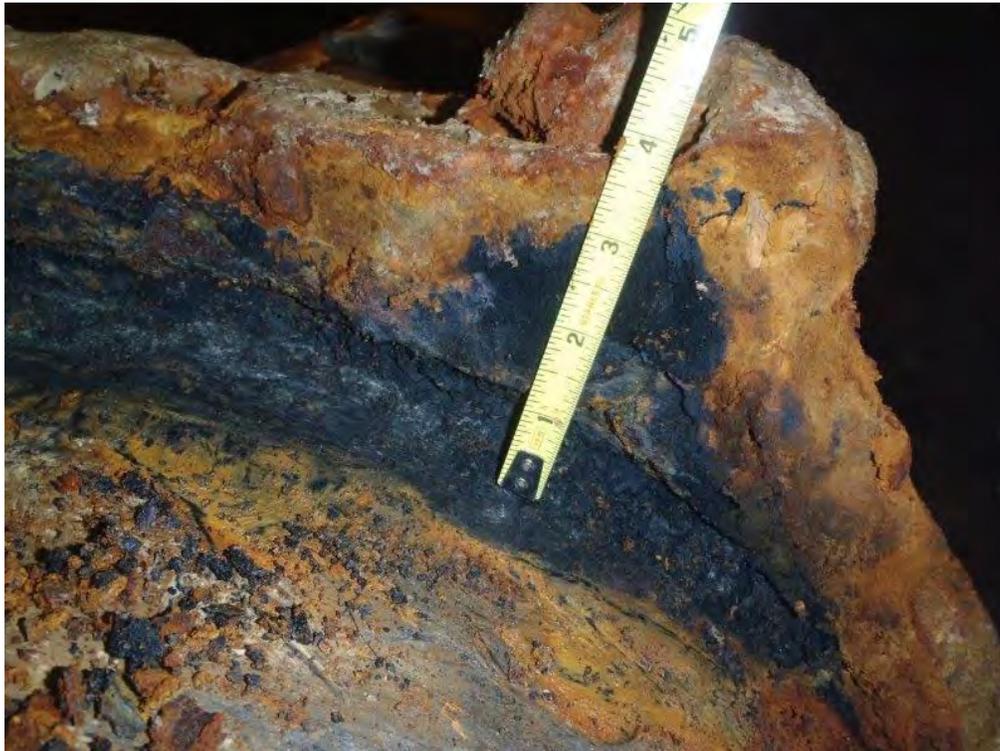
**Figure A 29 – Corroded Body of Victaulic Connection at 1:30 o'clock, 38.24 m from Shaft.**

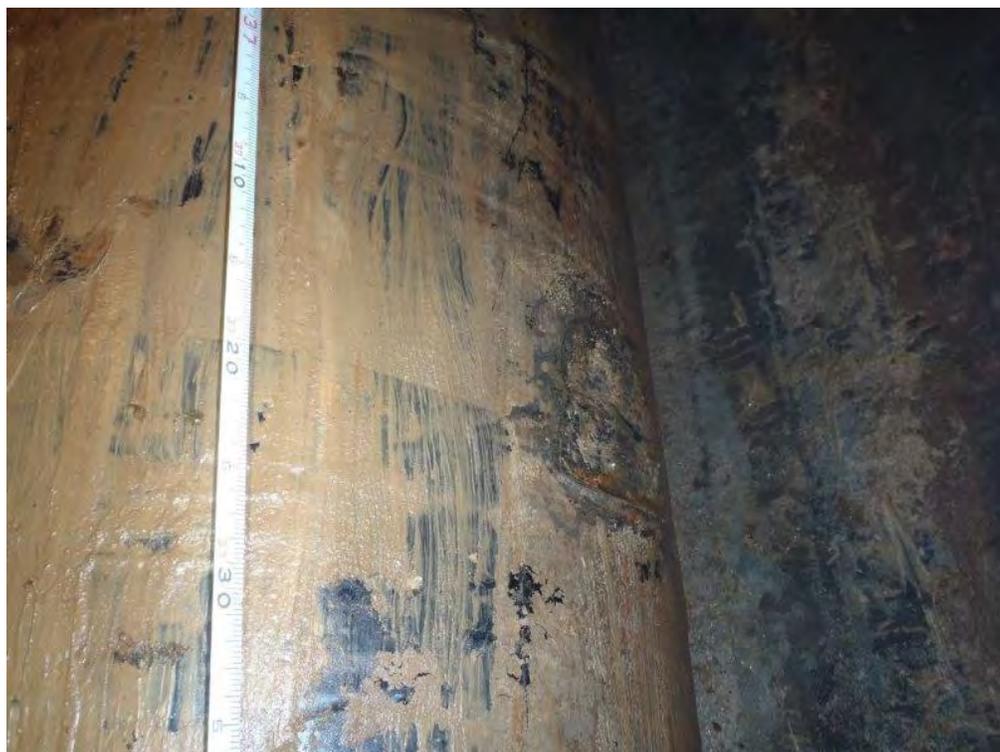
- Several blemishes in the coating as may be caused by lifting the pipe with straps or forks while the coating was soft.
  - Dents or gouges in the steel pipe and coating caused by mechanical forces, which required the coatings to be repaired. PICA advised that such damage may be detected by their EM tool because it causes stress-related changes in the steel.

**Figure A 30 – 125 mm-square Dimple in Coating at 2:30 o'clock, 37.20 m From Shaft.**

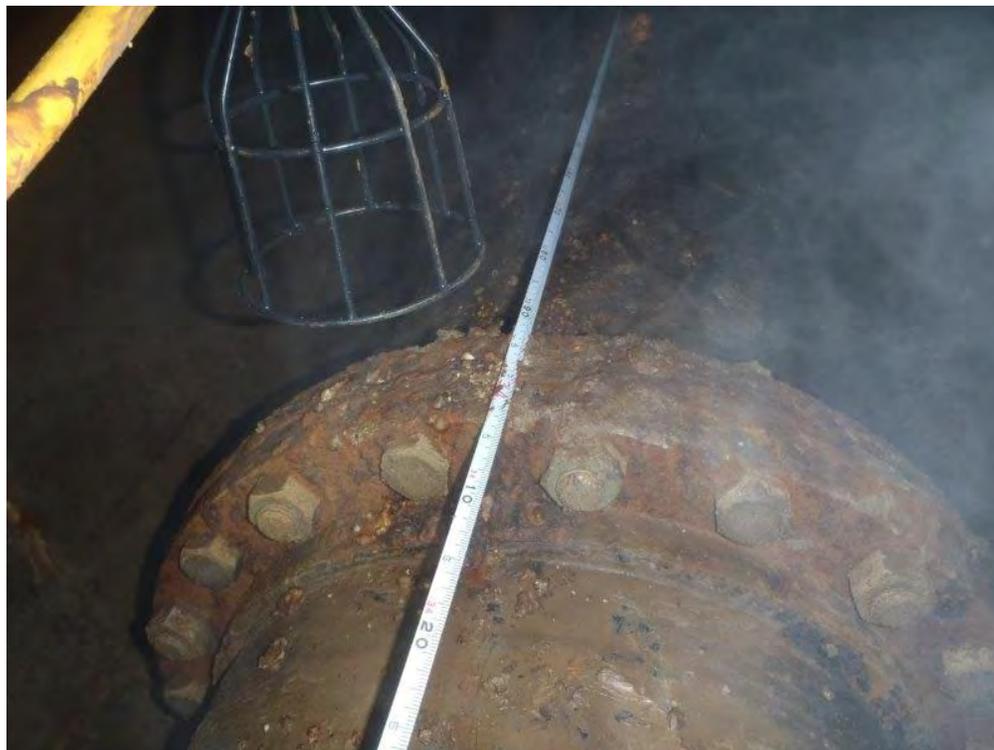
**Figure A 32 – Flange Connection at 12:00 o'clock, 33.96 m from Shaft.**

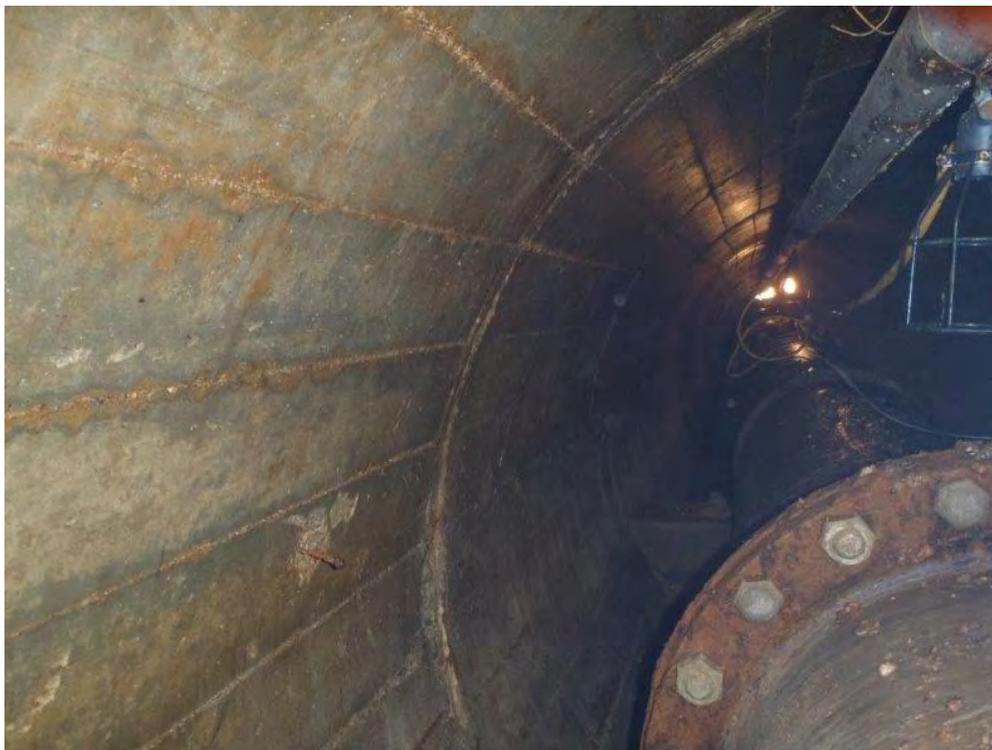
**Figure A 34 – View of Tunnel, Looking Westward at 33.96 m From Shaft.**

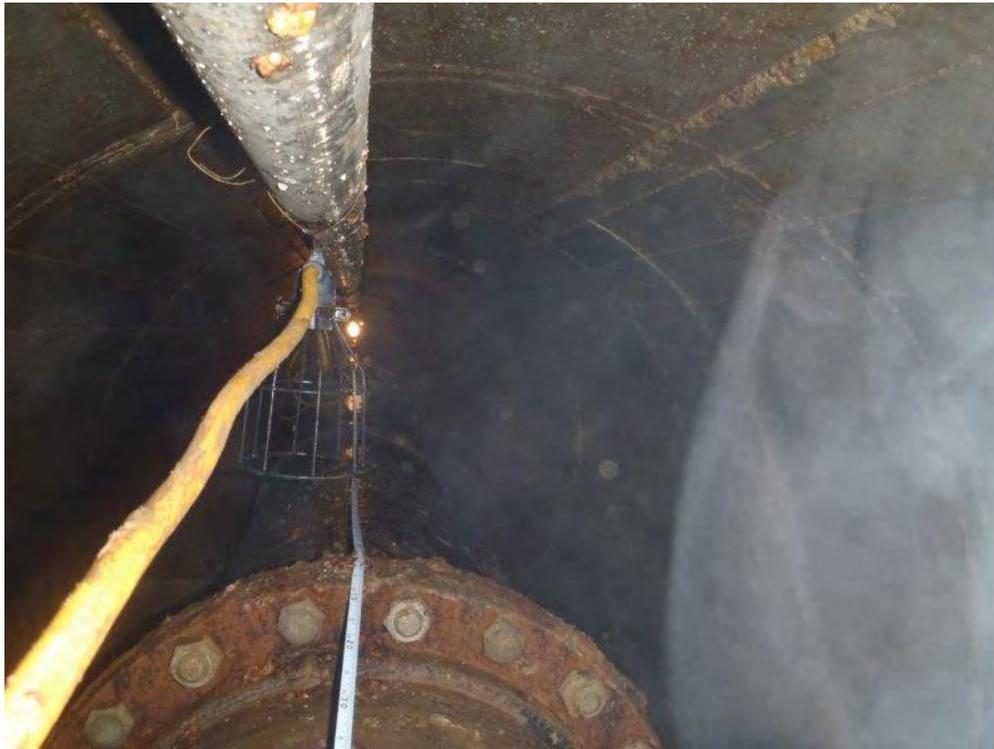
**Figure A 35 – View of Tunnel, Looking Westward at 33.96 m From Shaft.**

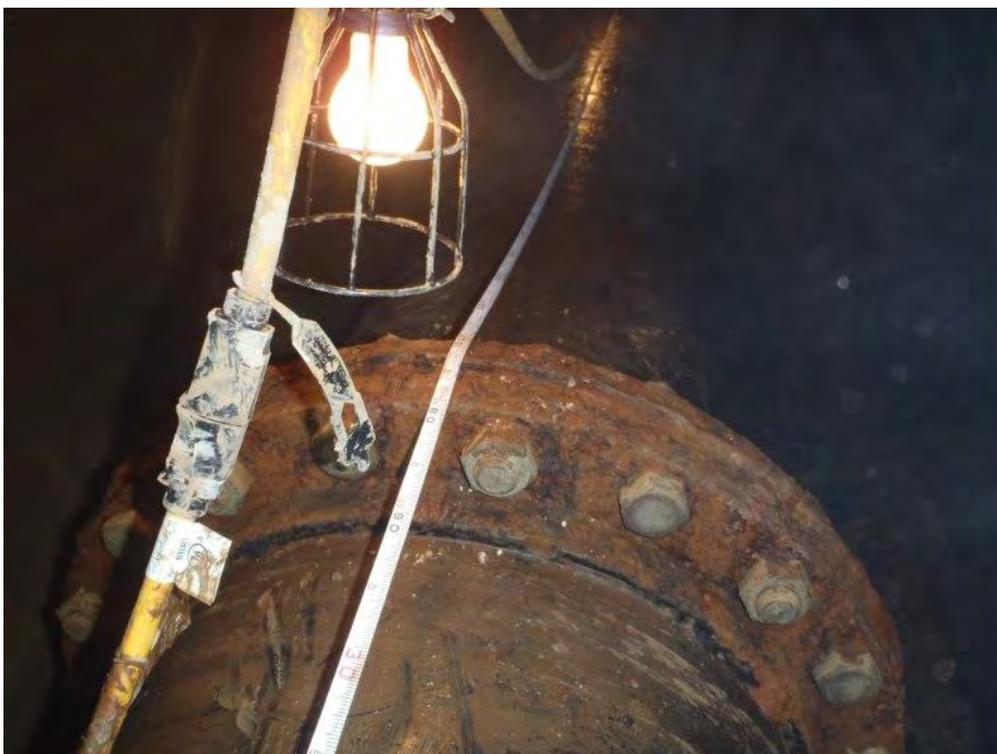
**Figure A 36 – Flange Connection at 12:00 o'clock, 29.68 m from Shaft.**
