| Project: | <u>Kildonan-Redwood Feeder Main Pipe Inspection</u> | Date: | <u>March 29, 2019</u> |
| Contractor: | <u>J-Con Civil Ltd.</u> | Project #: | <u>60549028</u> |
| Owner: | <u>City of Winnipeg</u> | Weather: | <u>Snow, Blustery, -5° C</u> |

# Inspection Report

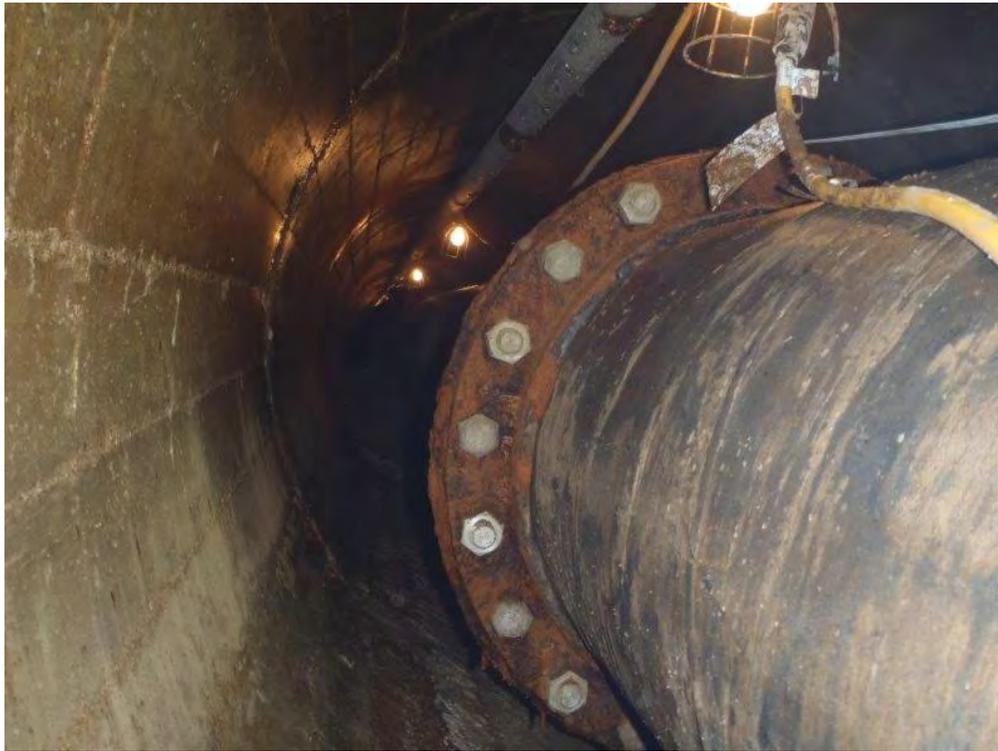
**Figure A 37 – Flange Connection at 9:00 o'clock, 29.68 m from Shaft.**

- Install petrolatum tape coating system over all flanged connections. Clean dirt and corrosion from flanges prior to coating and use profiling mastic to fill irregular spaces between flange fasteners, creating a smooth surface for tape wrapping.

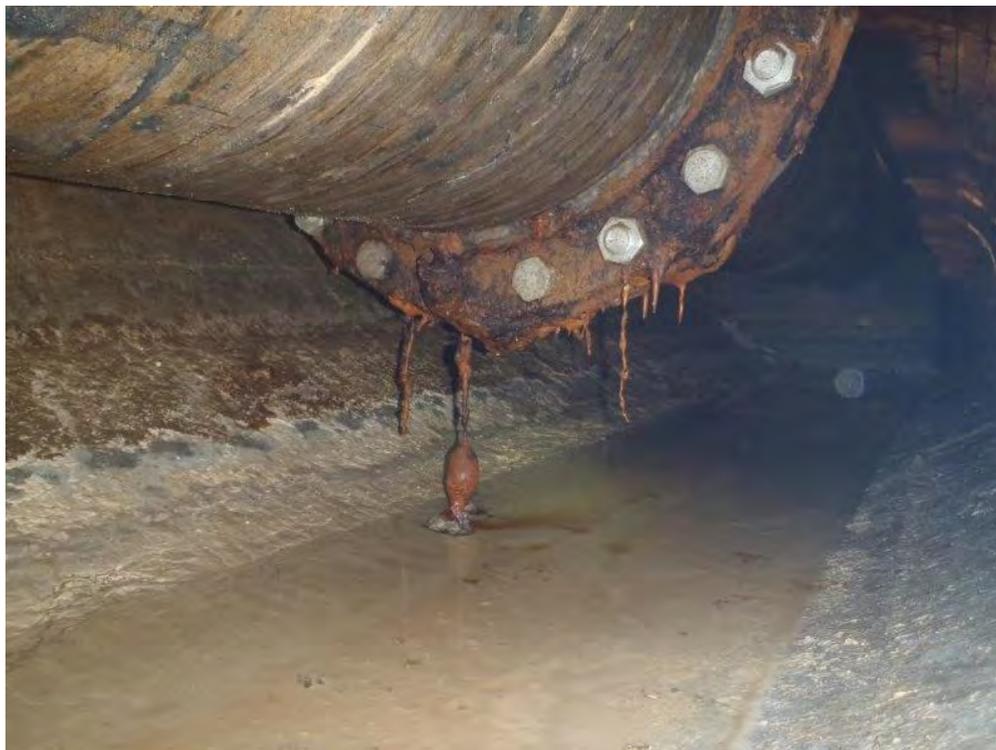
**Figure A 38 – Flange Connection at 6:00 o'clock, 29.68 m from Shaft.**

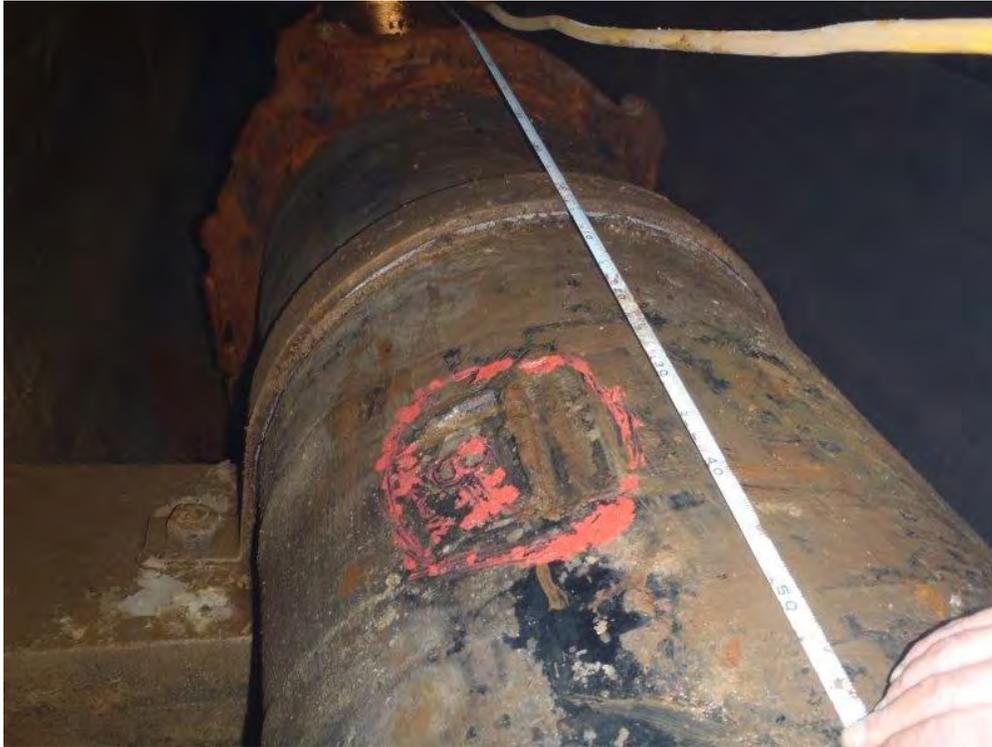
- Several blemishes in the coating as may be caused by lifting the pipe with straps or forks while the coating was soft.
  - Dents or gouges in the steel pipe and coating caused by mechanical forces, which required the coatings to be repaired. PICA advised that such damage may be detected by their EM tool because it causes stress-related changes in the steel.

**Figure A 39 – Coating Dimple at 11:00 o'clock, 26.30 m From Shaft.  
Possible Dent in Pipe.**

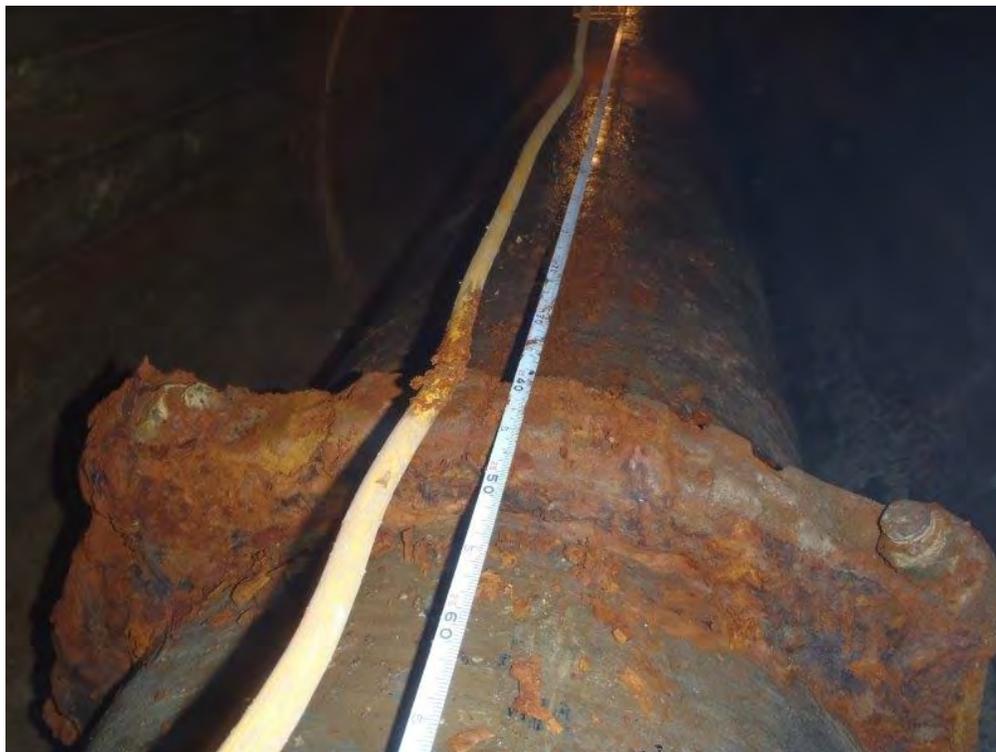
**Figure A 40 – Victaulic Connection at 12:30 o'clock, 25.42 m from Shaft.**

- Replace the Victaulic couplings.
- Install a petrolatum tape coating repair (mastic and tape wrap) around the feeder main pipe at the coating break near the east tunnel wall. The repair should extend from the wall to 0.2 m from the wall.

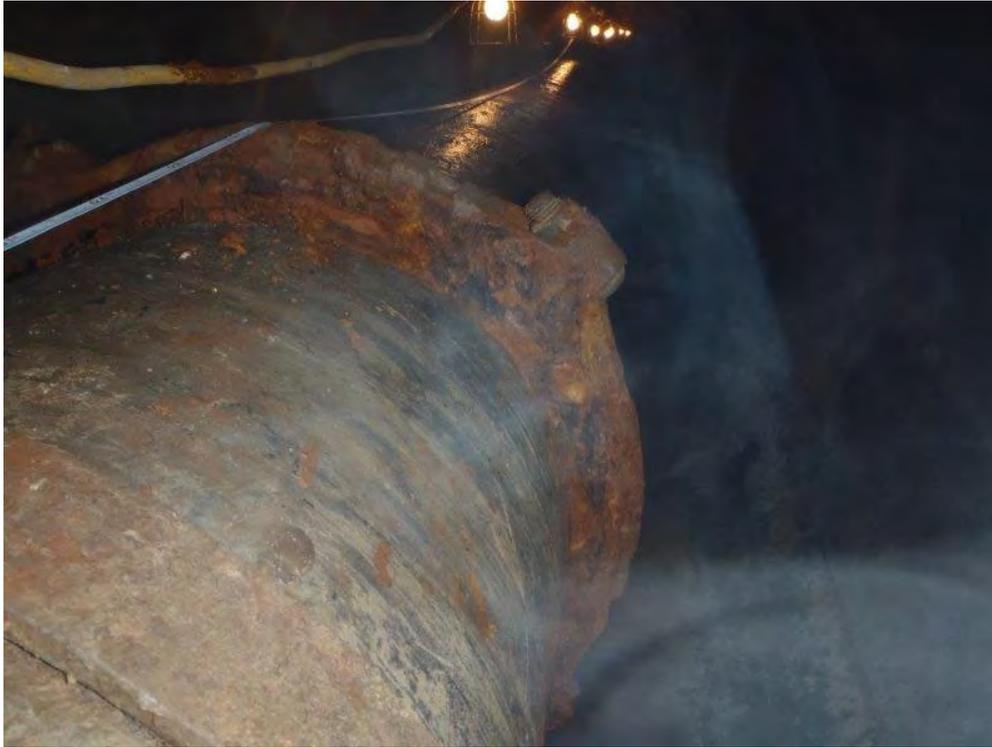
**Figure A 41 – Victaulic Connection at 2:00 o'clock, 25.42 m from Shaft.**

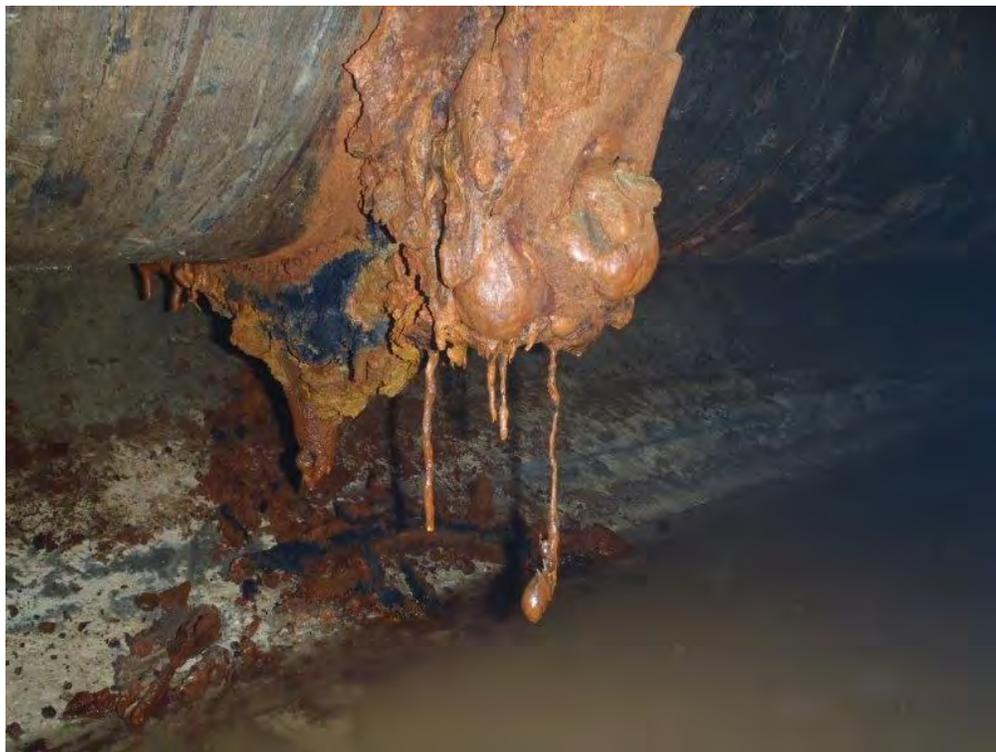
**Figure A 42 – Victaulic Connection at 6:00 o'clock, 25.42 m from Shaft.**

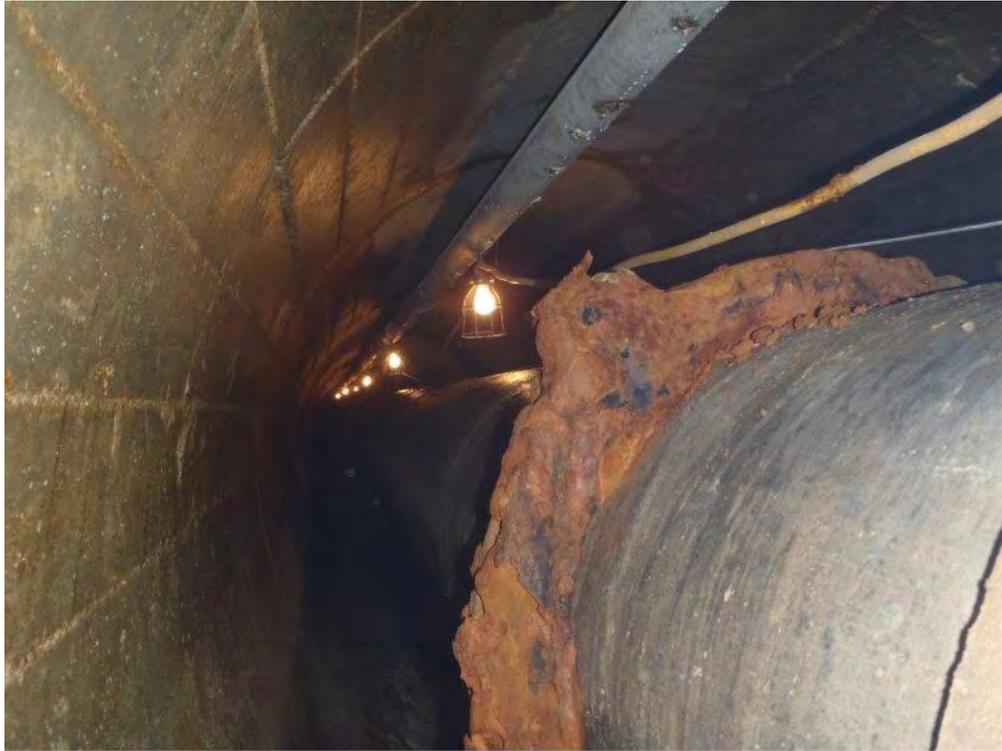
**Figure A 43 –Victaulic Connection at 10:00 o'clock, 25.42 m from Shaft.**

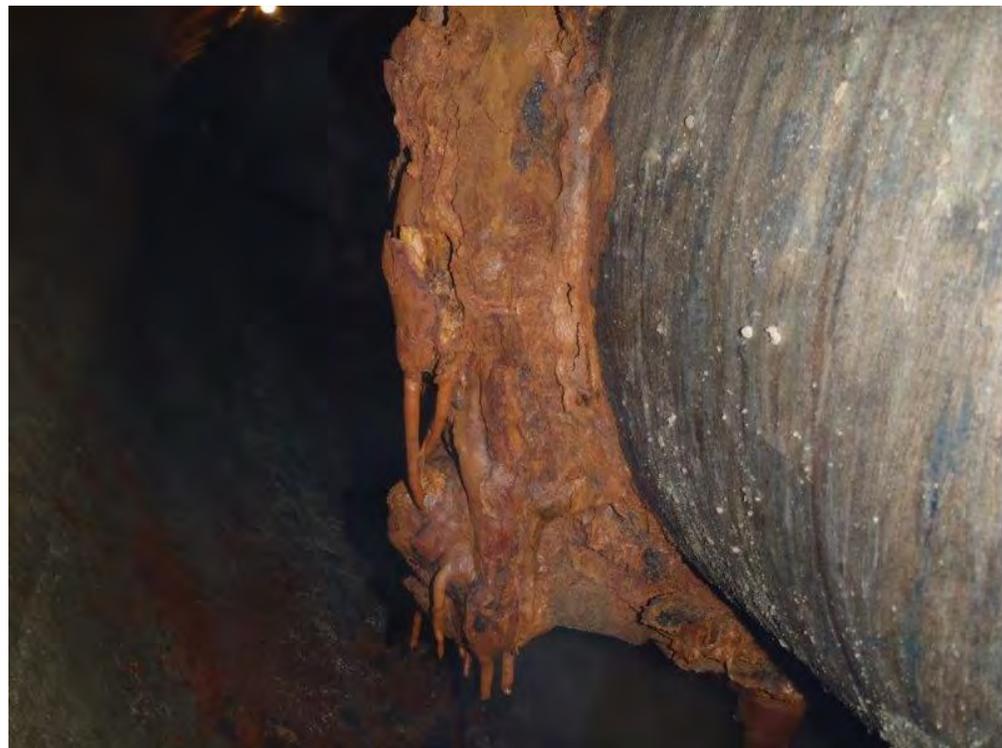
**Figure A 44 – Underside of Victaulic Connection at 8:00 o'clock, 25.42 m from Shaft.**

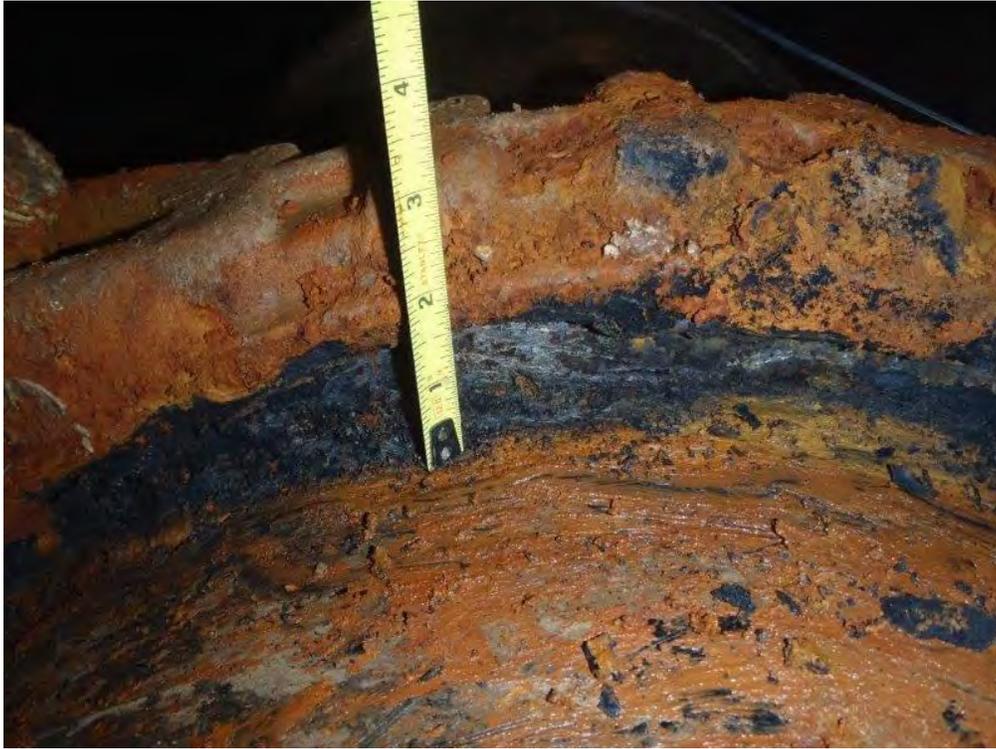
- Galvanized pipe straps at pedestals were in very good condition.
- Victaulic couplings were severely corroded and should be replaced. The bodies of the couplings were unevenly corroded with the appearance of grey cast iron, a brittle material. The underlying restraining rings

**Figure A 45 – Corroded Body of Victaulic Connection at 1:00 o'clock, 25.42 m from Shaft.**

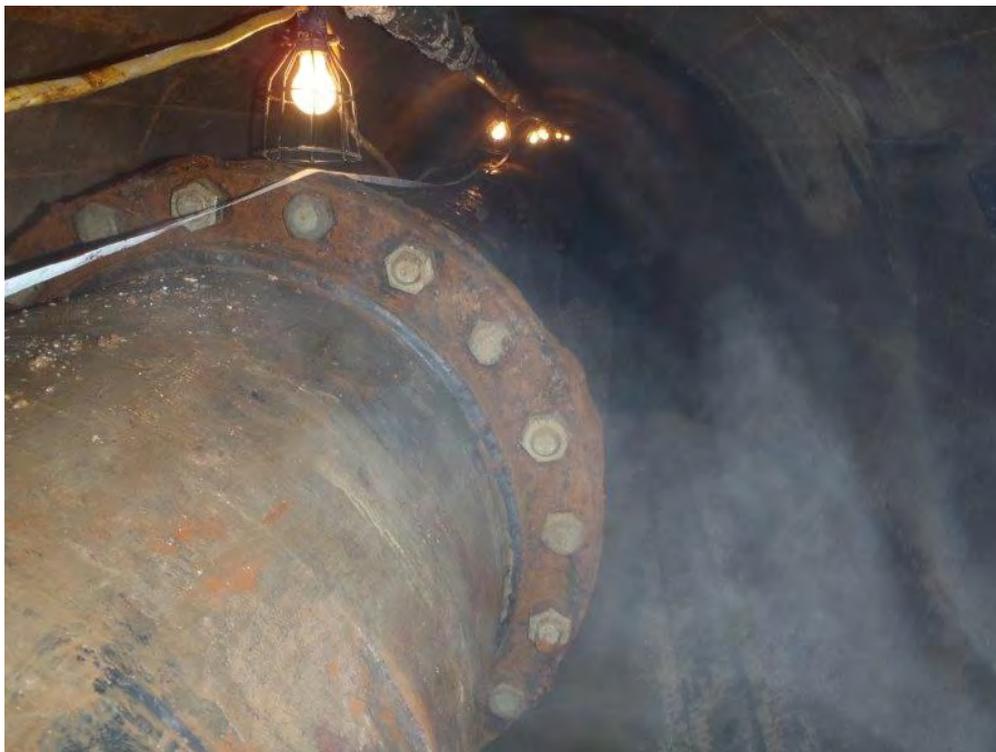
**Figure A 46 – Flange Connection at 2:00 o'clock, 21.14 m from Shaft.**

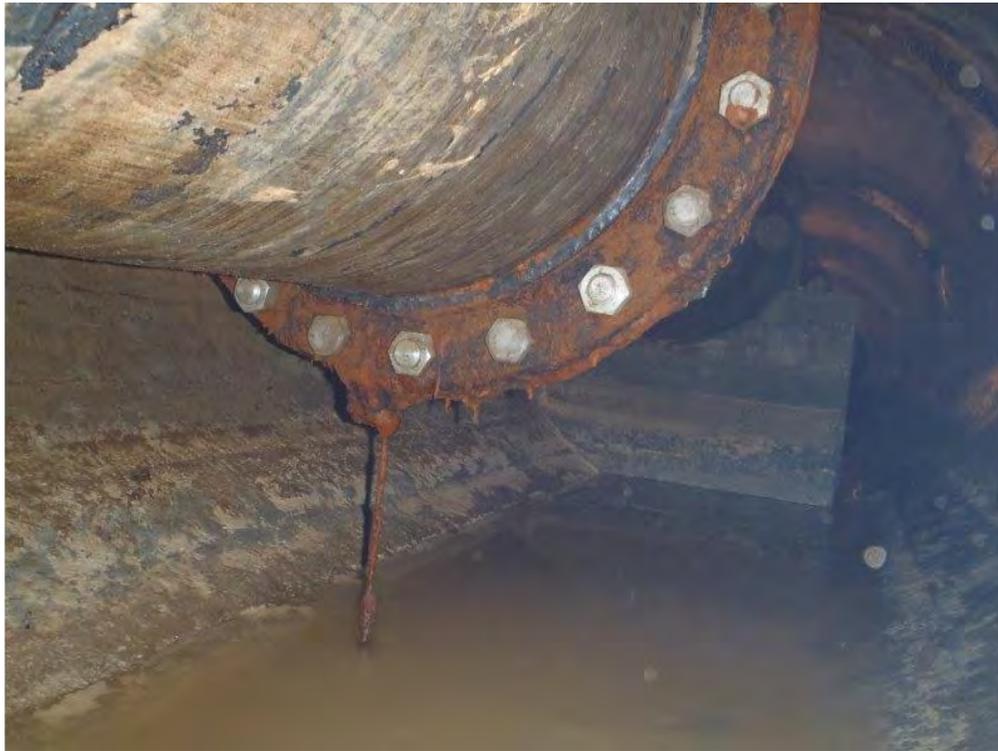
**Figure A 47 – Flange Connection at 5:00 o'clock, 21.14 m from Shaft.**

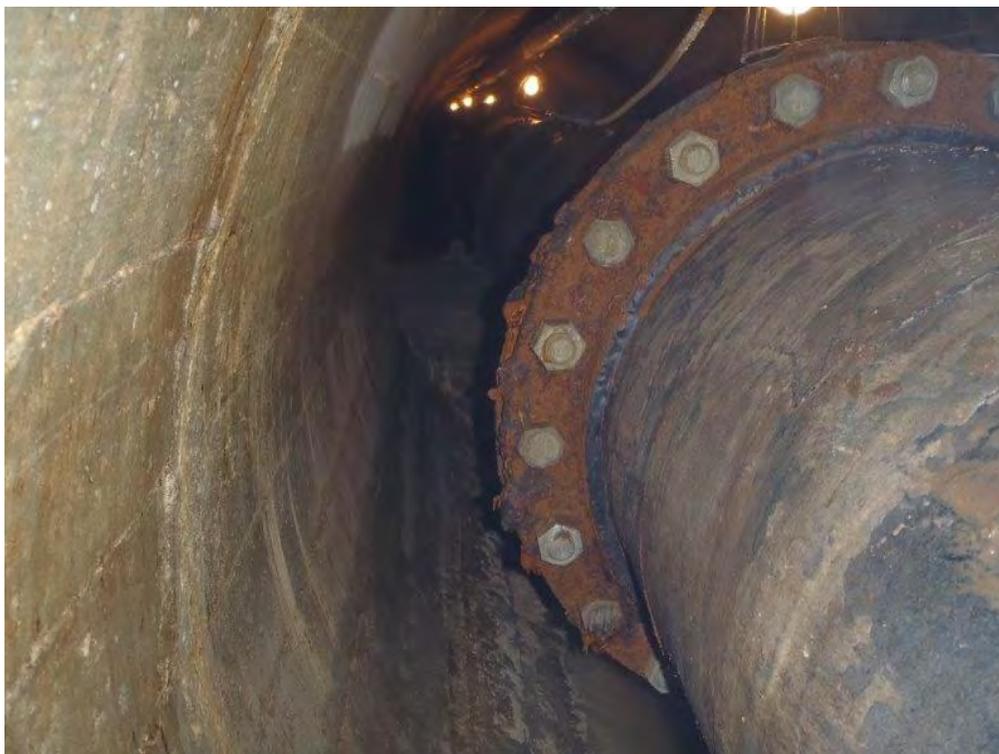
**Figure A 48 – Flange Connection at 5:00 o'clock, 21.14 m from Shaft.**

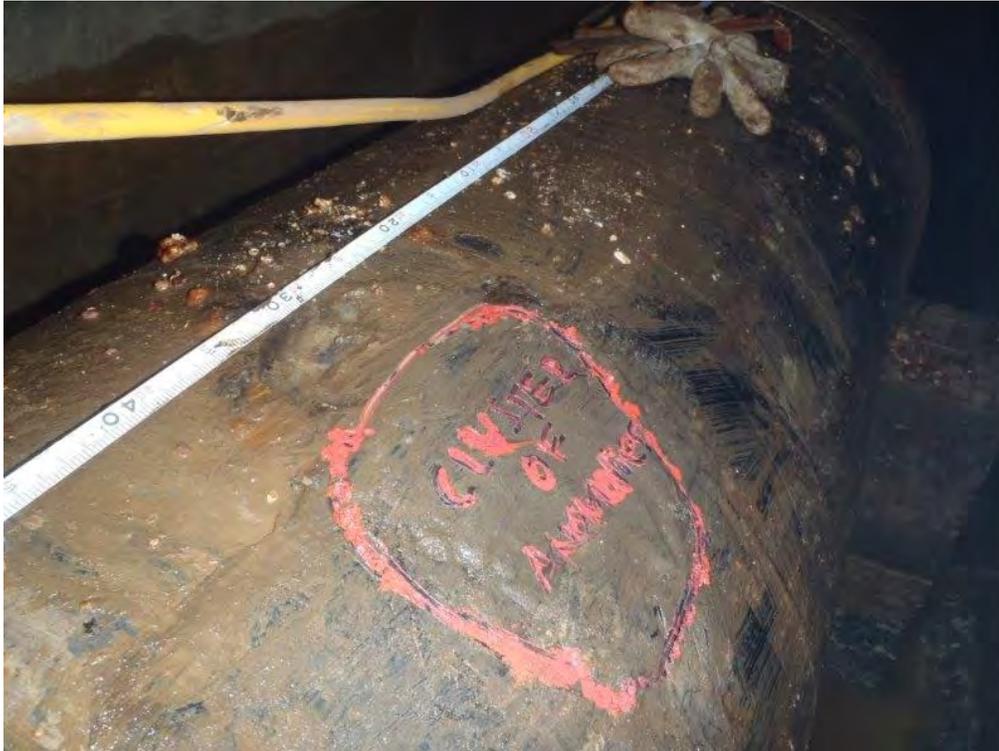
**Figure A 49 – Coating Dimple at 12:30 to 2:30 o'clock, 20.30 m From Shaft.  
Possible Dent in Pipe.**

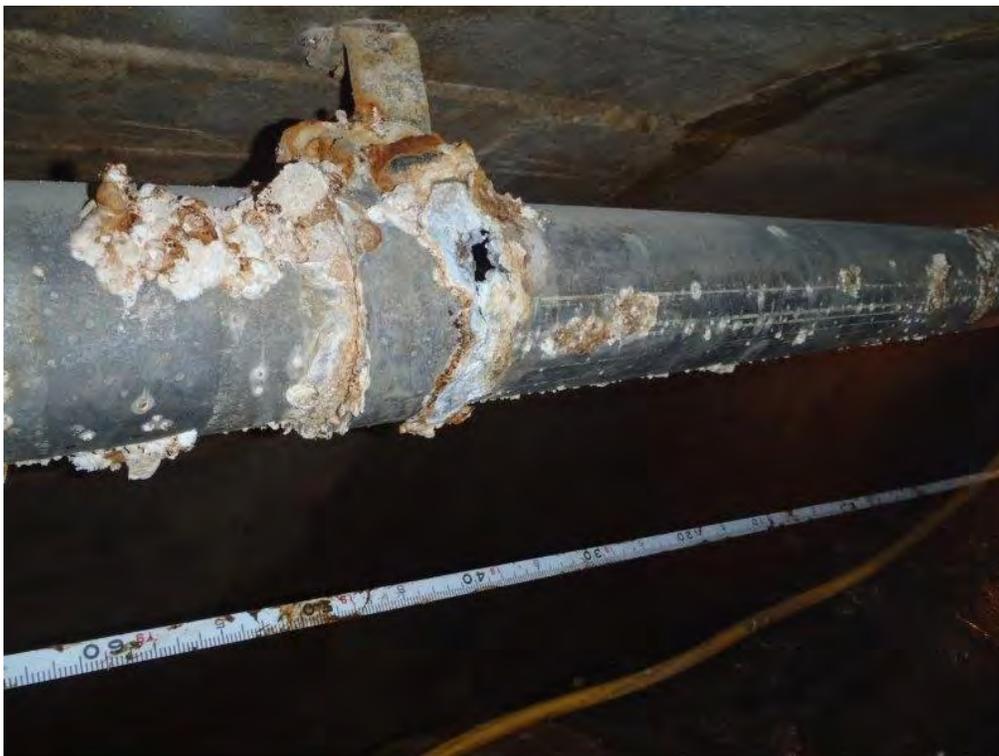
**Figure A 50 – Corrosion / Perforation of Aluminum Air Pipe, 19.50 m From Shaft.**

- Repair or replace the deteriorated tunnel ventilation pipe. Options include:
  - Replace the existing aluminum piping with plastic piping (PVC or CPVC) that will not undergo galvanic corrosion on contact with the ferrous metal pipe anchors and will not corrode in the humid tunnel environment. Piping could be socketed for joining by solvent welding.

- Wrap a neoprene sheet gasket around the air pipe at the hanger points to isolate the aluminum from the steel / iron hangers (eliminate galvanic corrosion) and seal the perforations through the pipe. Gaskets may be held in place by plastic zip ties.

- Repair or replace the corroded aluminum piping at the anchor locations and secure the piping to the hangers with non-metallic anchors (for example, FRP anchor system).

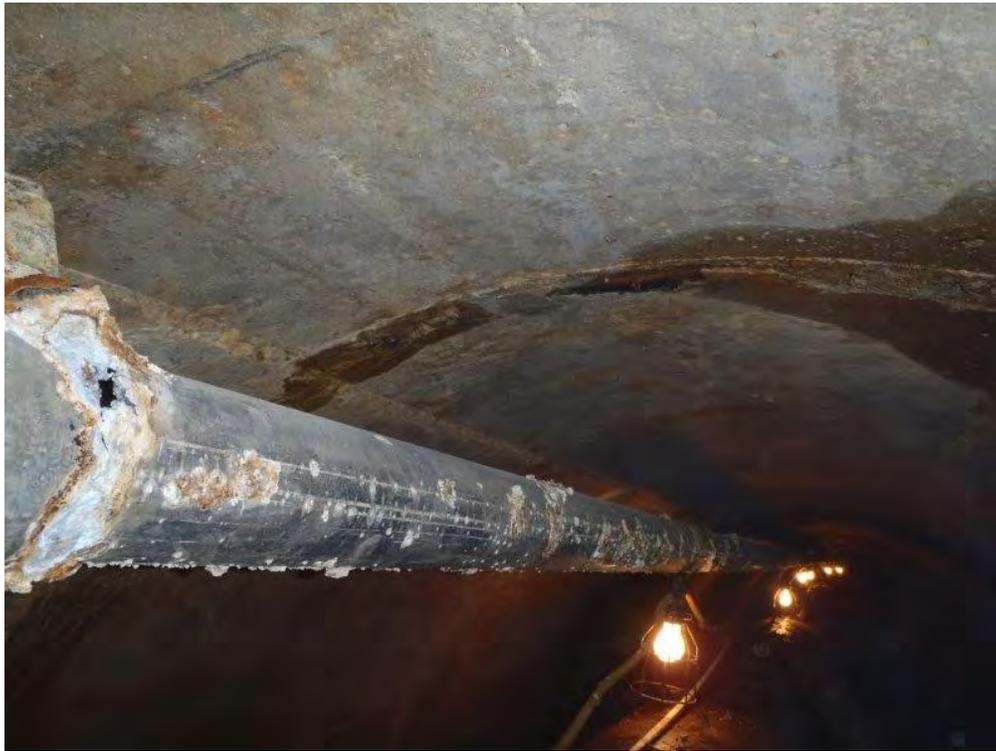
**Figure A 51 – Water Infiltrating (Slow Run) at Concrete Pour Joint, 19.10 m From Shaft.**

- Monitor the condition of the ladders in the tunnel shaft.
- Seal cracks and / or joints in the tunnel structure from water infiltration by injecting them with hydrophilic polyurethane grout. Similar repairs have been made throughout the Shoal Lake Aqueduct.

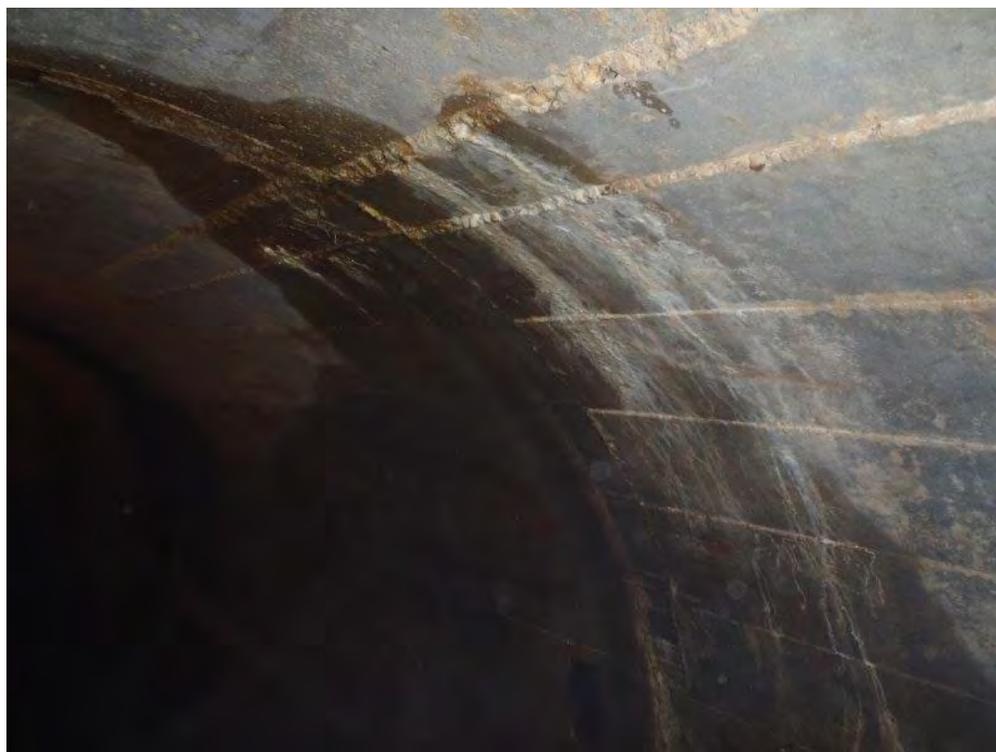
**Figure A 52 – Water Infiltrating (Slow Run) at Concrete Pour Joint, and at 100 mm-diameter honeycomb pocket at 1:00 o'clock, 19.10 m From Shaft.**

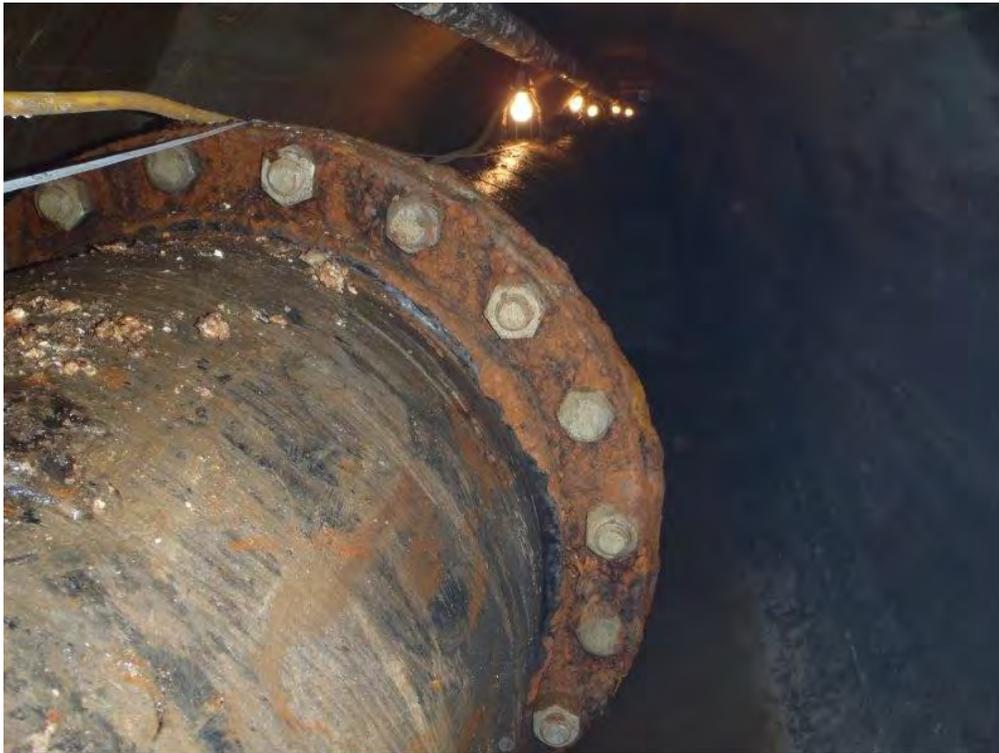
**Figure A 53 – Flange Connection at 1:30 o'clock, 16.86 m from Shaft.**

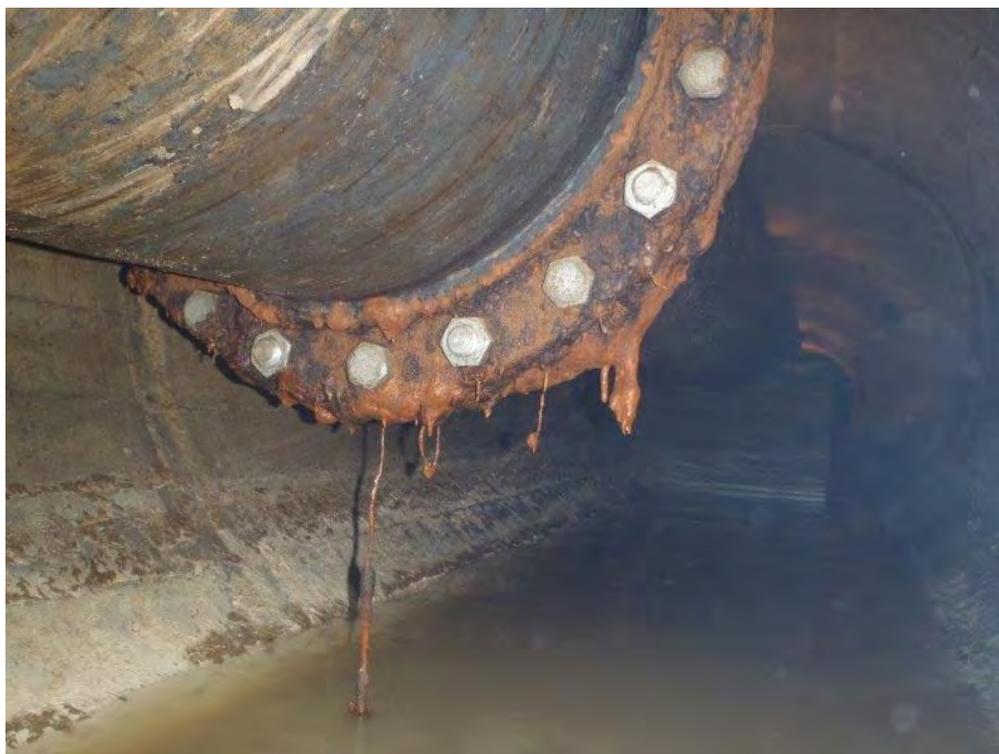
**Figure A 54 – Flange Connection at 9:00 o'clock, 16.86 m from Shaft.**

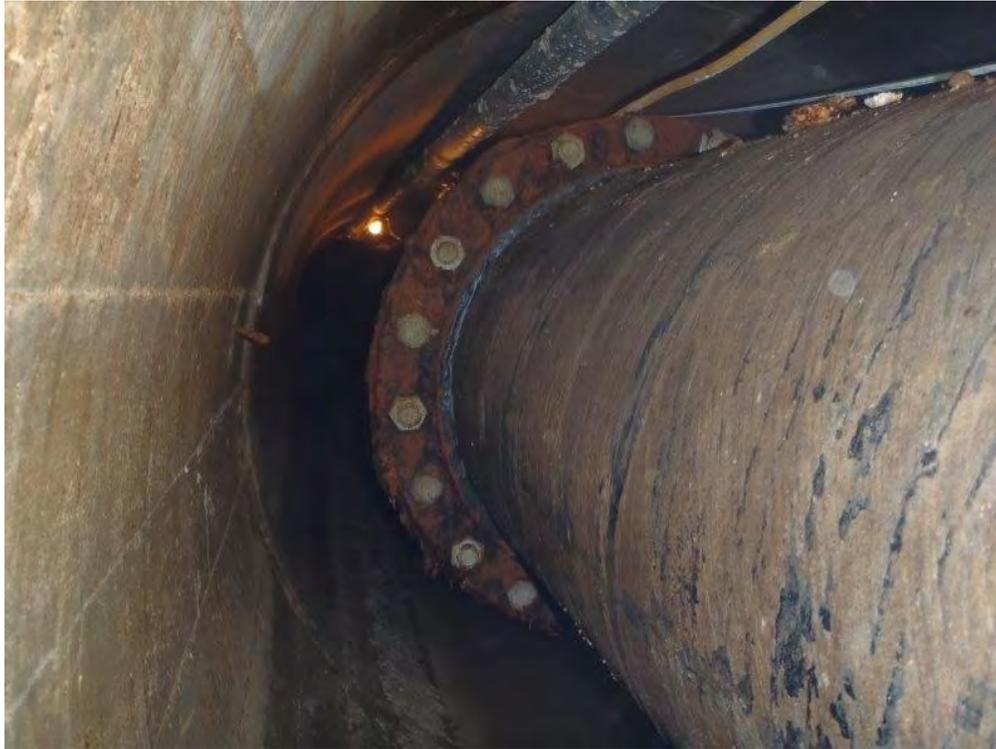
**Figure A 55 –Flange Connection at 9:00 o'clock, 16.86 m from Shaft.**

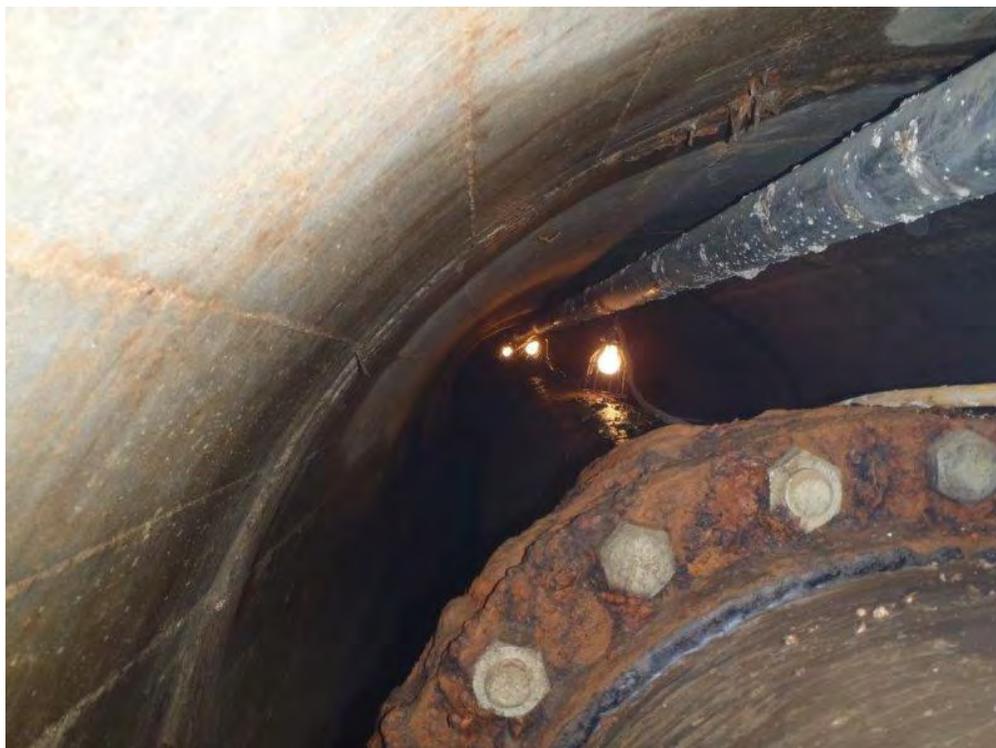
**Figure A 56 – View of Tunnel, Looking Westward, 16.86 m From Shaft.**

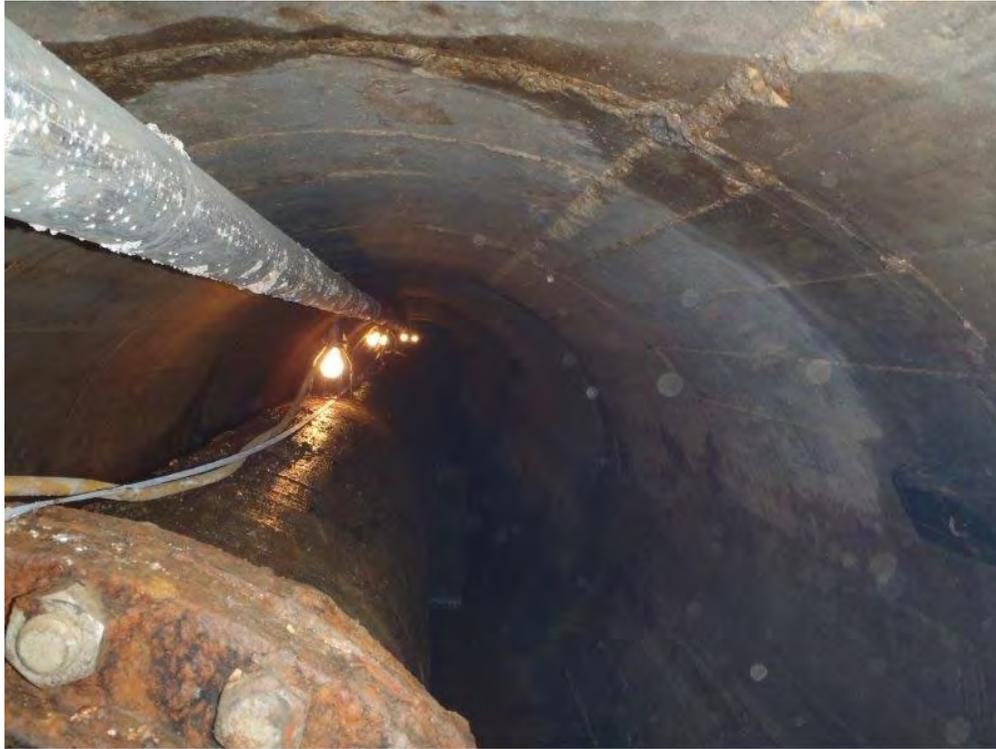
**Figure A 57 – View of Tunnel, Looking Westward, 16.86 m From Shaft.**

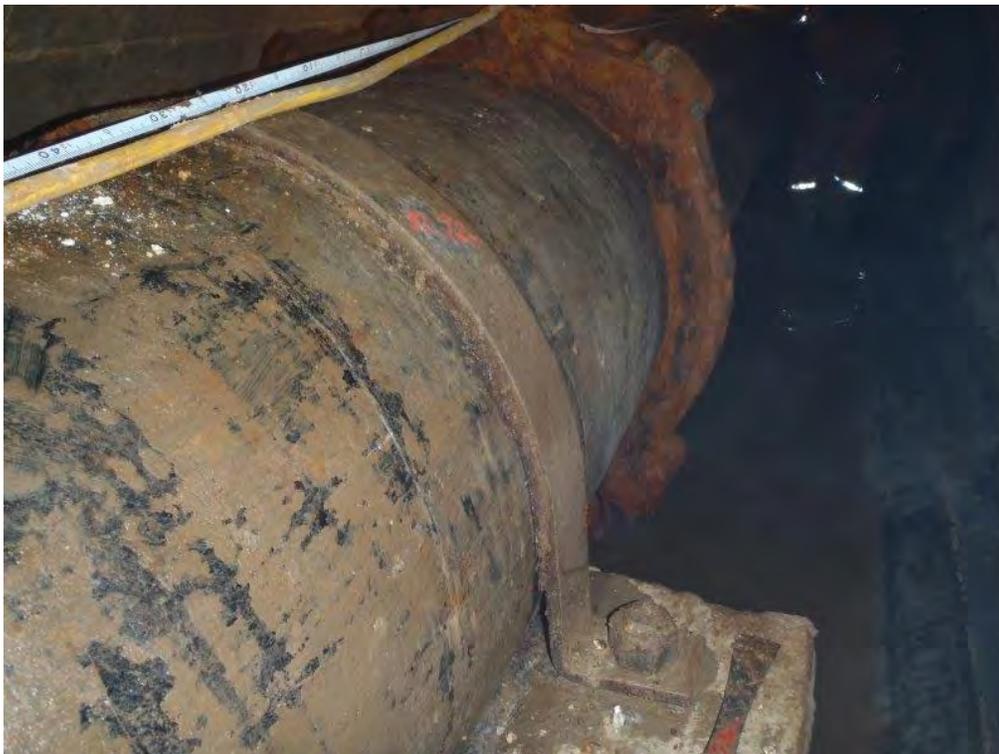
**Figure A 58 – Galvanized Pipe Strap and Pedestal, 13.58 m From Shaft.**

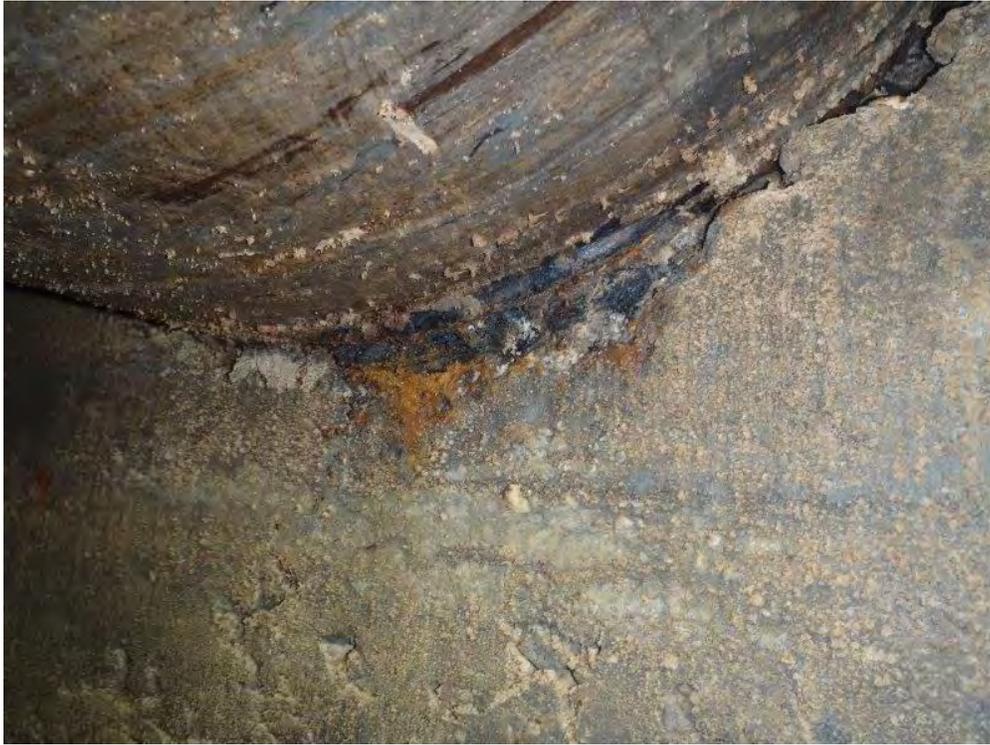
**Figure A 59 – Feeder Main Pipe on Pedestal, 13.58 m From Shaft.  
Suspect rust staining is from pedestal reinforcing.**

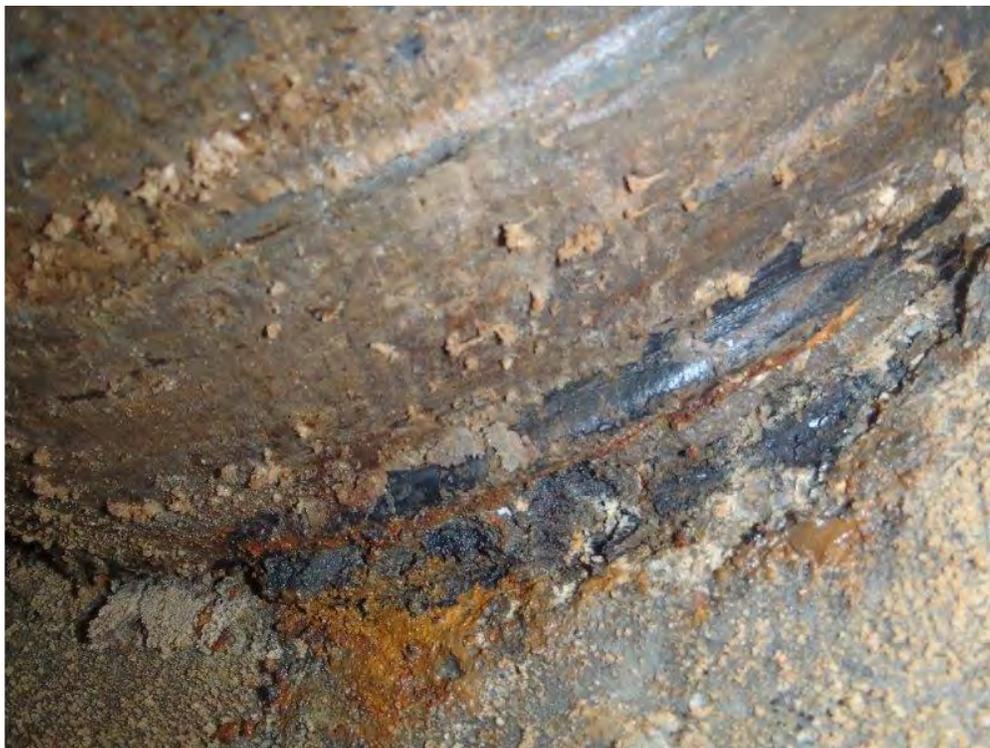
**Figure A 60 – Feeder Main Pipe on Pedestal, 13.58 m From Shaft.  
Note graphite paste pipe cushion along surface of coating.**

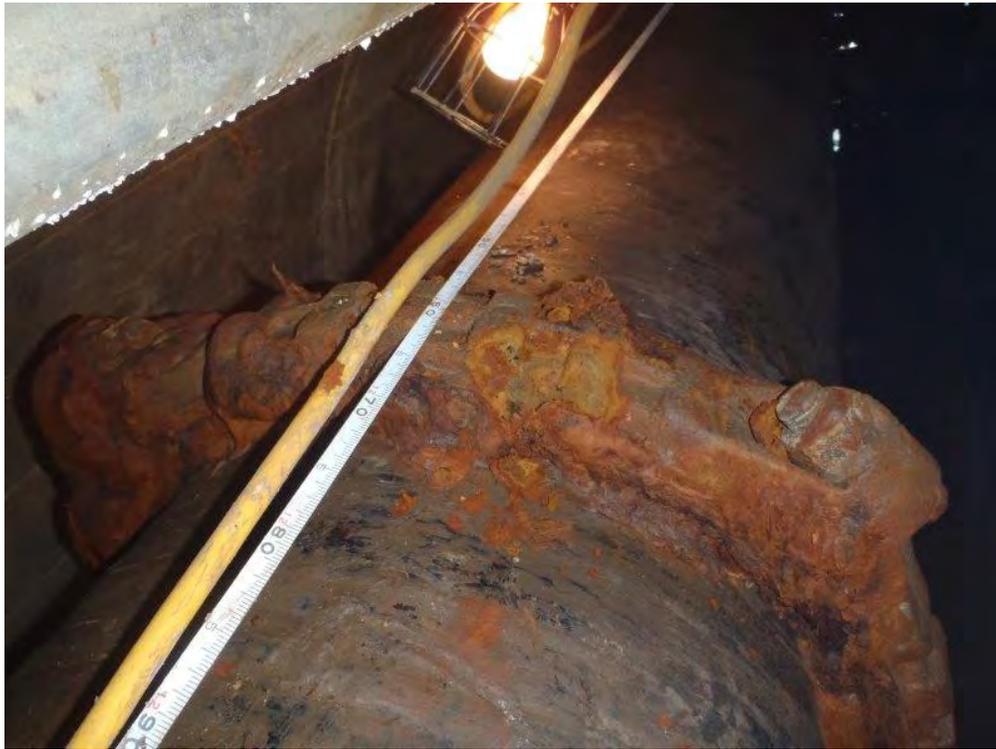
**Figure A 61 – Victaulic Connection at 12:30 o'clock, 12.59 m from Shaft.**

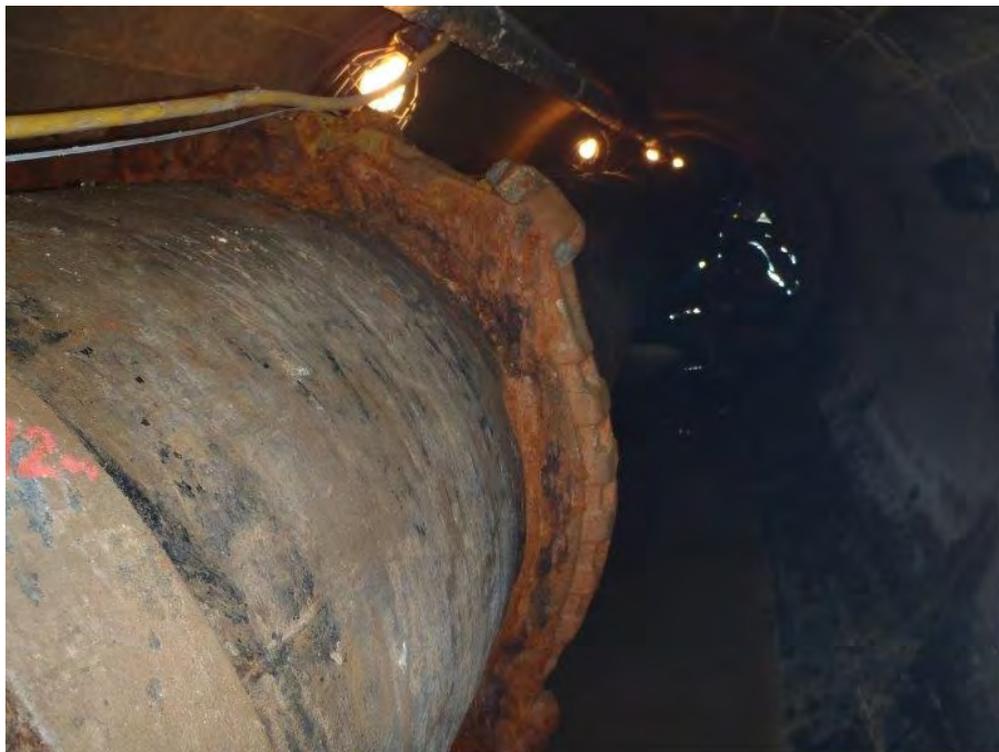
**Figure A 62 – Victaulic Connection at 2:00 o'clock, 12.59 m from Shaft.**

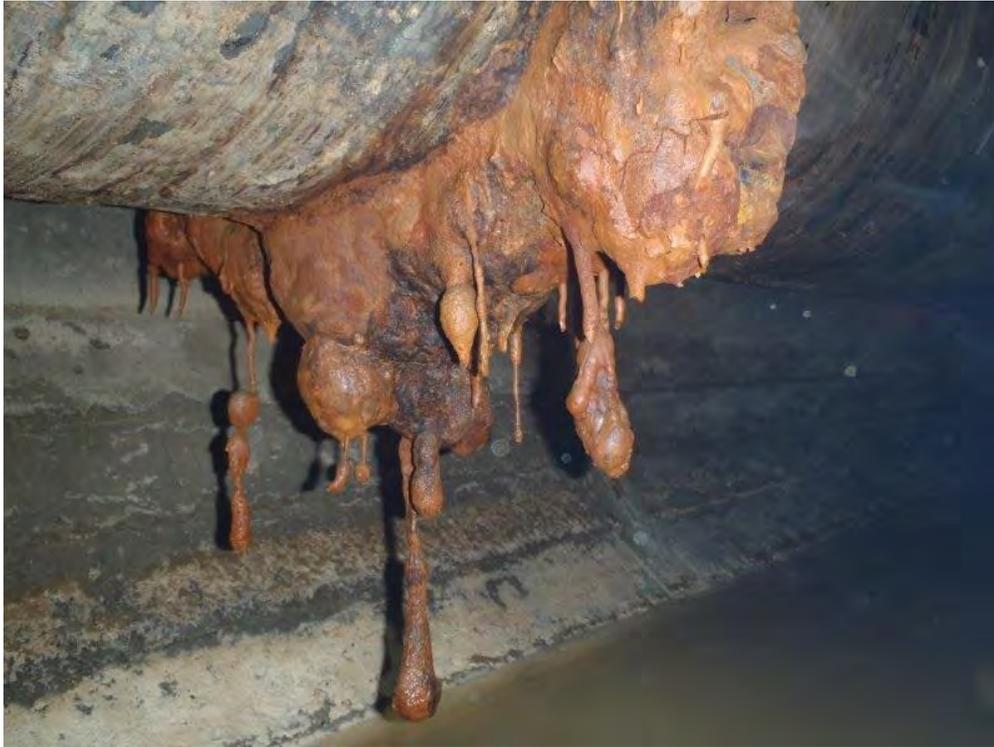
**Figure A 63 –Victaulic Connection at 6:00 o'clock, 12.59 m from Shaft.**

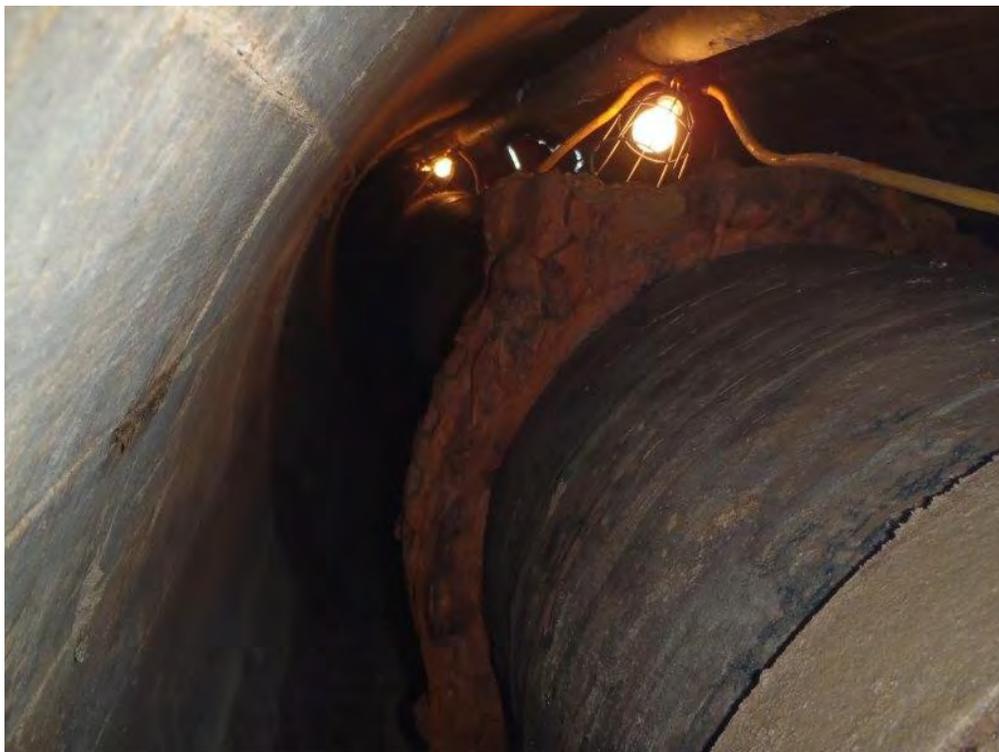
**Figure A 64 –Victaulic Connection at 10:00 o'clock, 12.59 m from Shaft.**

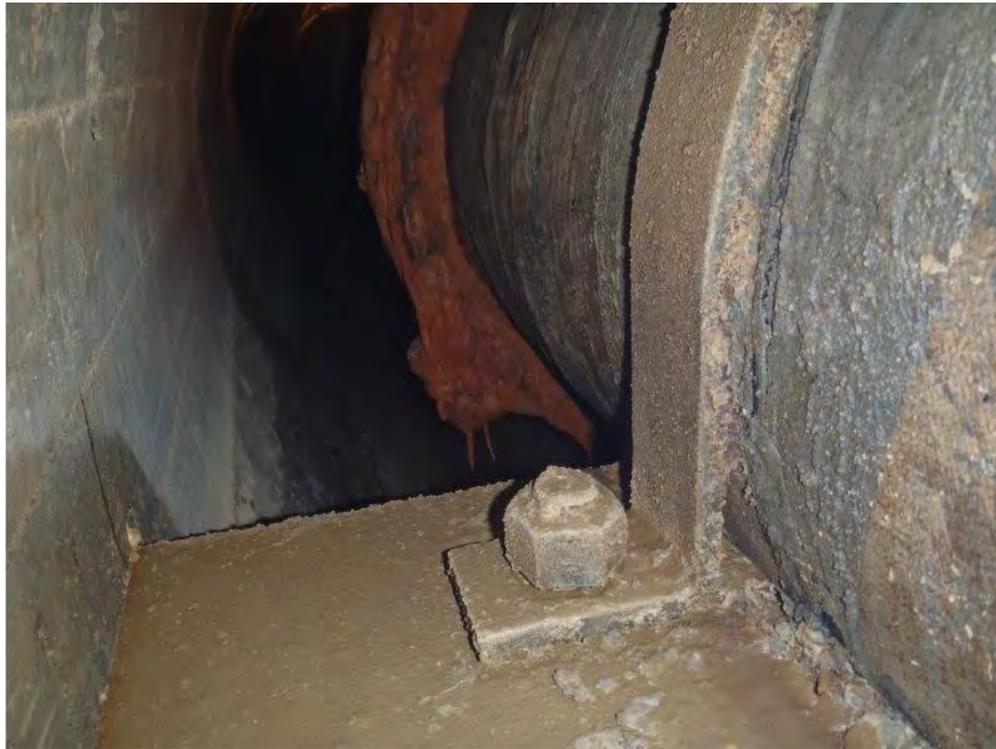
**Figure A 65 –Victaulic Connection at 8:00 o'clock, 12.59 m from Shaft.**
