| Project: | <u>Kildonan-Redwood Feeder Main Pipe Inspection</u> | Date: | <u>March 29, 2019</u> |
| Contractor: | <u>J-Con Civil Ltd.</u> | Project #: | <u>60549028</u> |
| Owner: | <u>City of Winnipeg</u> | Weather: | <u>Snow, Blustery, -5° C</u> |

# Inspection Report

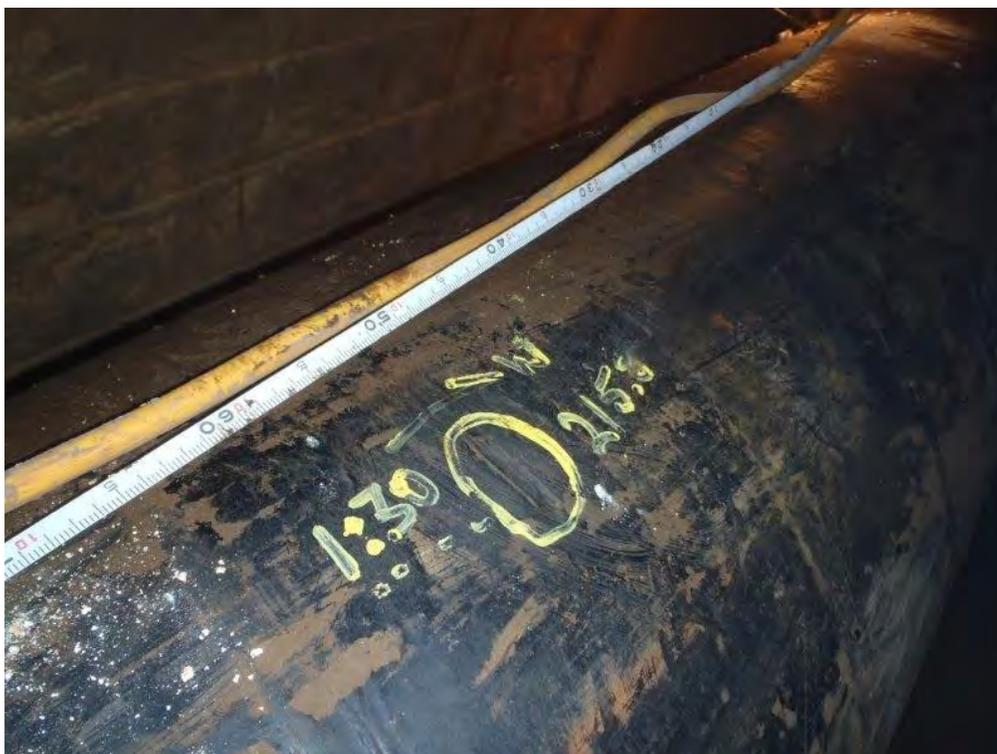
- Several blemishes in the coating as may be caused by lifting the pipe with straps or forks while the coating was soft.
  - Dents or gouges in the steel pipe and coating caused by mechanical forces, which required the coatings to be repaired. PICA advised that such damage may be detected by their EM tool because it causes stress-related changes in the steel.

**Figure A 66 – Coating Dimple at 1:00 o'clock, 10.50 m From Shaft.  
Possible dent in pipe.**

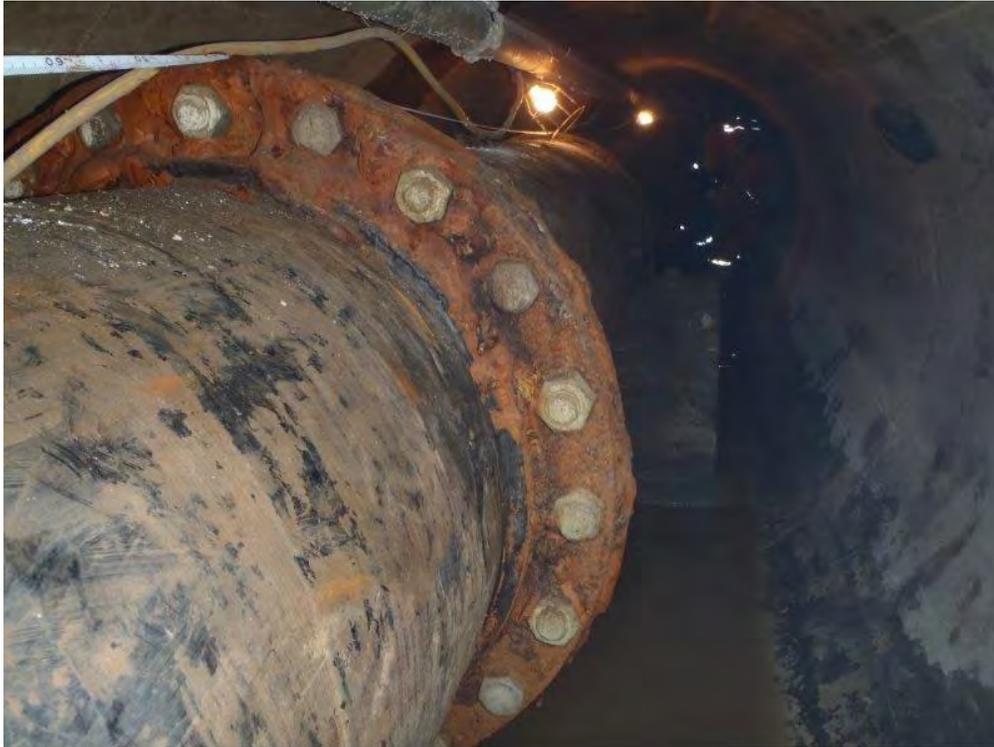
**Figure A 67 – Flange Connection at 2:00 o'clock, 8.32 m from Shaft.**

- Install petrolatum tape coating system over all flanged connections. Clean dirt and corrosion from flanges prior to coating and use profiling mastic to fill irregular spaces between flange fasteners, creating a smooth surface for tape wrapping.

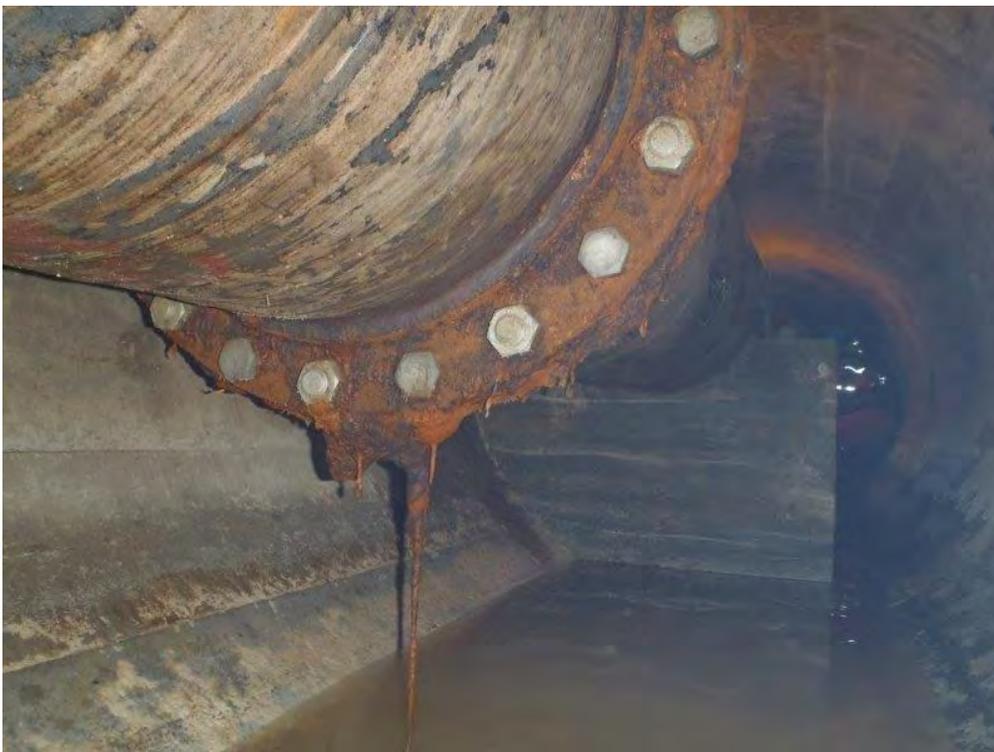
**Figure A 68 – Flange Connection at 5:00 o'clock, 8.32 m from Shaft.**

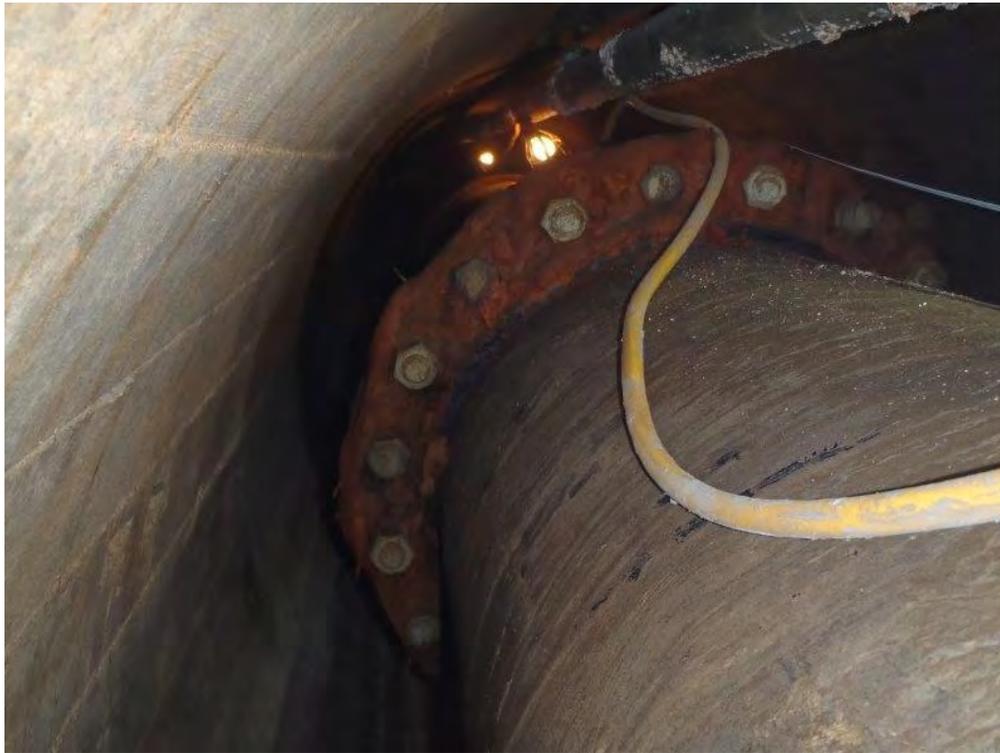
**Figure A 69 –Flange Connection at 10:00 o'clock, 8.32 m from Shaft.**

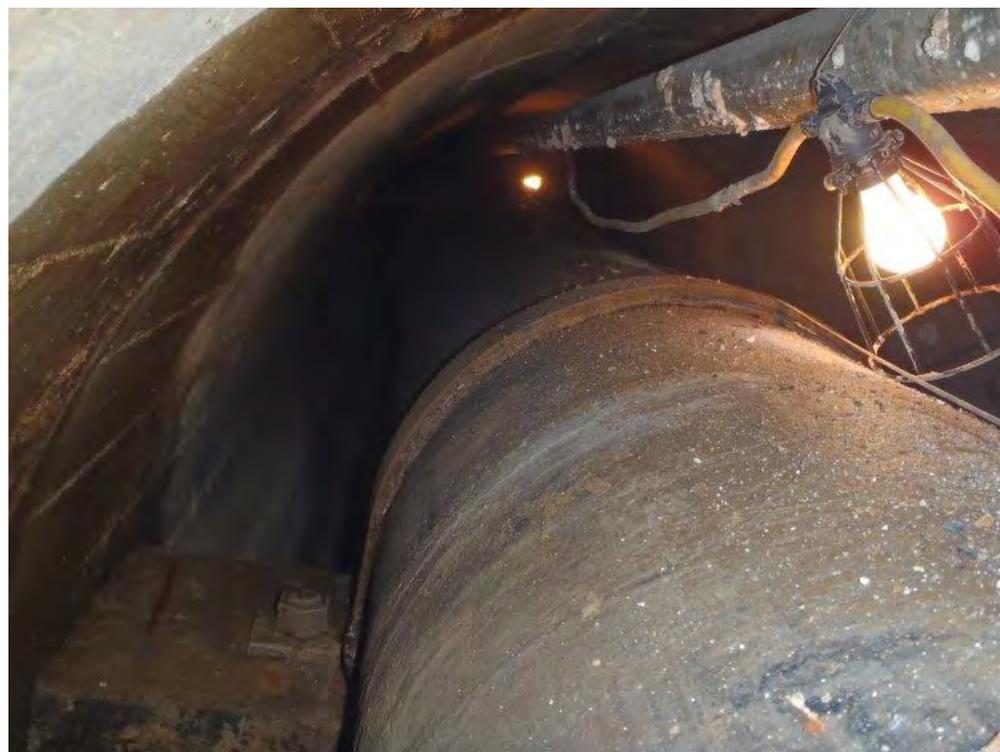
**Figure A 70 – Galvanized Pipe Strap and Pedestal, 6.48 m From Shaft.**

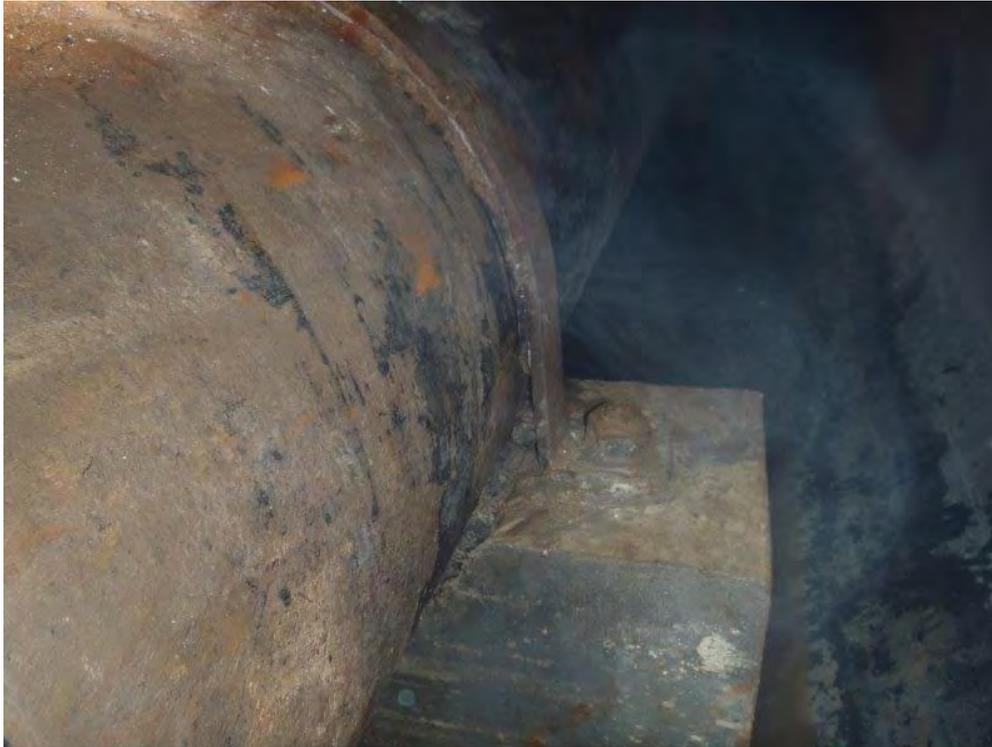
**Figure A 71 – Galvanized Pipe Strap and Pedestal, 6.48 m From Shaft.**

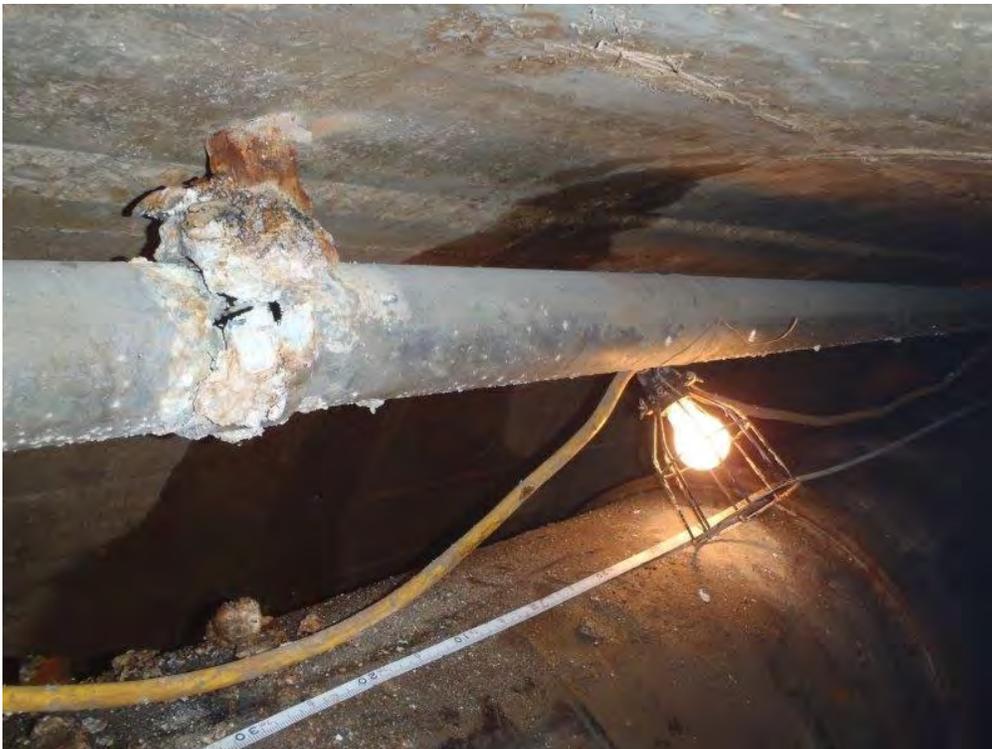
**Figure A 72 – Corrosion / Perforation of Aluminum Air Pipe, 7.30 m From Shaft.  
Water infiltrating tunnel at concrete pour joint near 6.48m from shaft.**

- Repair or replace the deteriorated tunnel ventilation pipe. Options include:
  - Replace the existing aluminum piping with plastic piping (PVC or CPVC) that will not undergo galvanic corrosion on contact with the ferrous metal pipe anchors and will not corrode in the humid tunnel environment. Piping could be socketed for joining by solvent welding.

- Wrap a neoprene sheet gasket around the air pipe at the hanger points to isolate the aluminum from the steel / iron hangers (eliminate galvanic corrosion) and seal the perforations through the pipe. Gaskets may be held in place by plastic zip ties.

- Repair or replace the corroded aluminum piping at the anchor locations and secure the piping to the hangers with non-metallic anchors (for example, FRP anchor system).

- Monitor the condition of the ladders in the tunnel shaft.
- Seal cracks and / or joints in the tunnel structure from water infiltration by injecting them with hydrophilic polyurethane grout. Similar repairs have been made throughout the Shoal Lake Aqueduct.

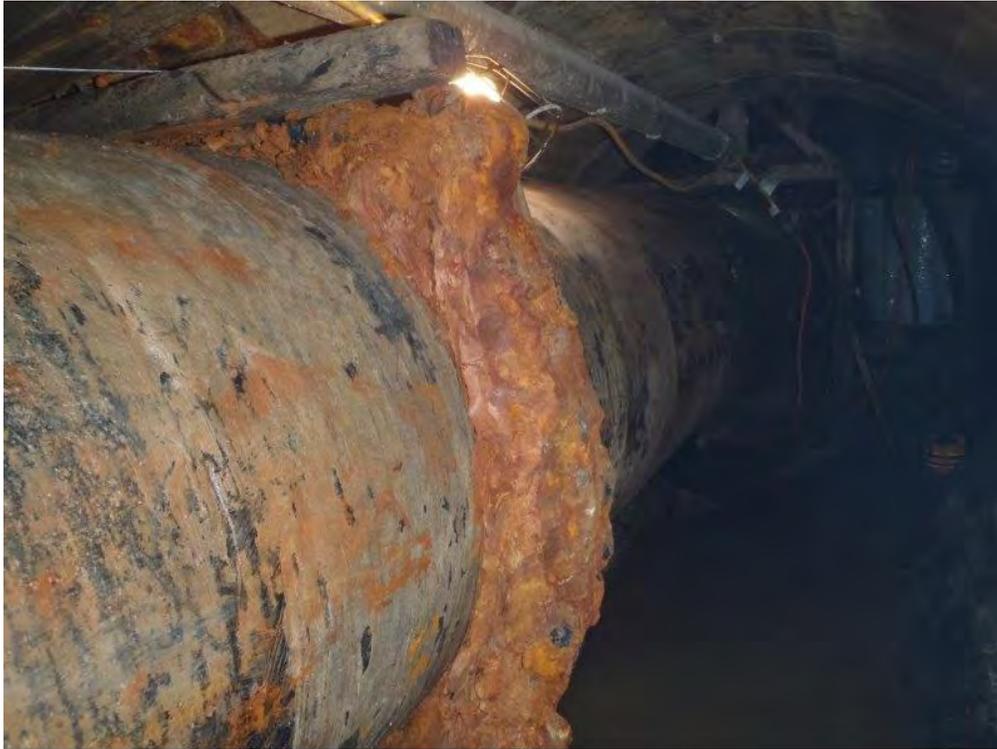
**Figure A 73 – Victaulic Connection at 2:30 o'clock, 4.60 m from Shaft.**

- Replace the Victaulic couplings.
- Install a petrolatum tape coating repair (mastic and tape wrap) around the feeder main pipe at the coating break near the east tunnel wall. The repair should extend from the wall to 0.2 m from the wall.

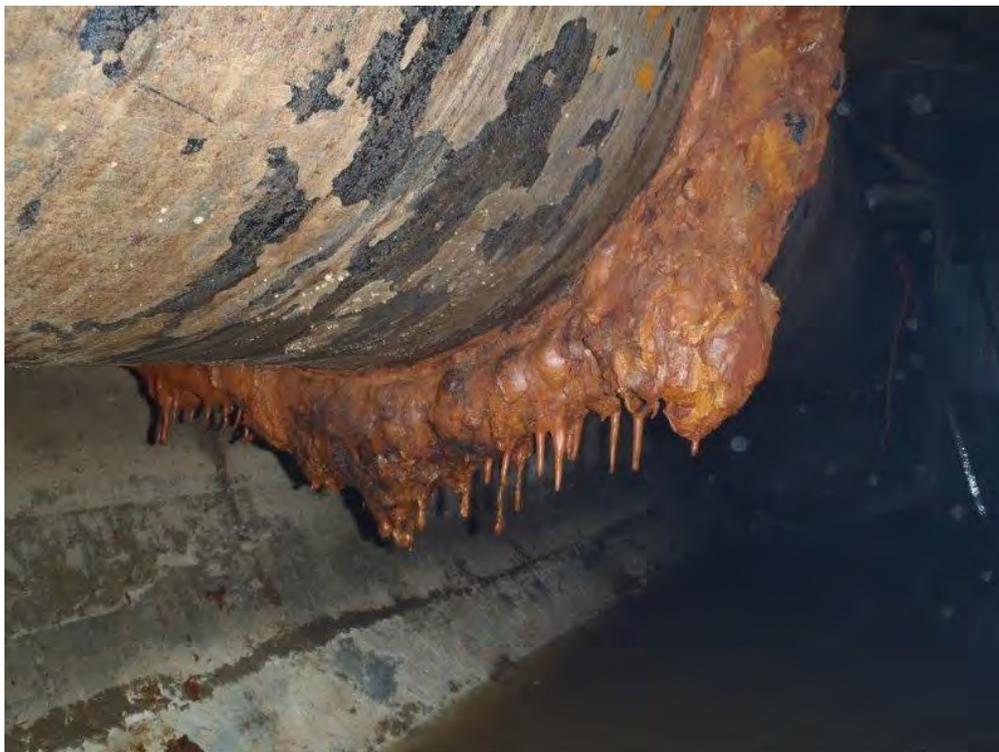
**Figure A 74 – Victaulic Connection at 5:30 o'clock, 4.60 m from Shaft.**

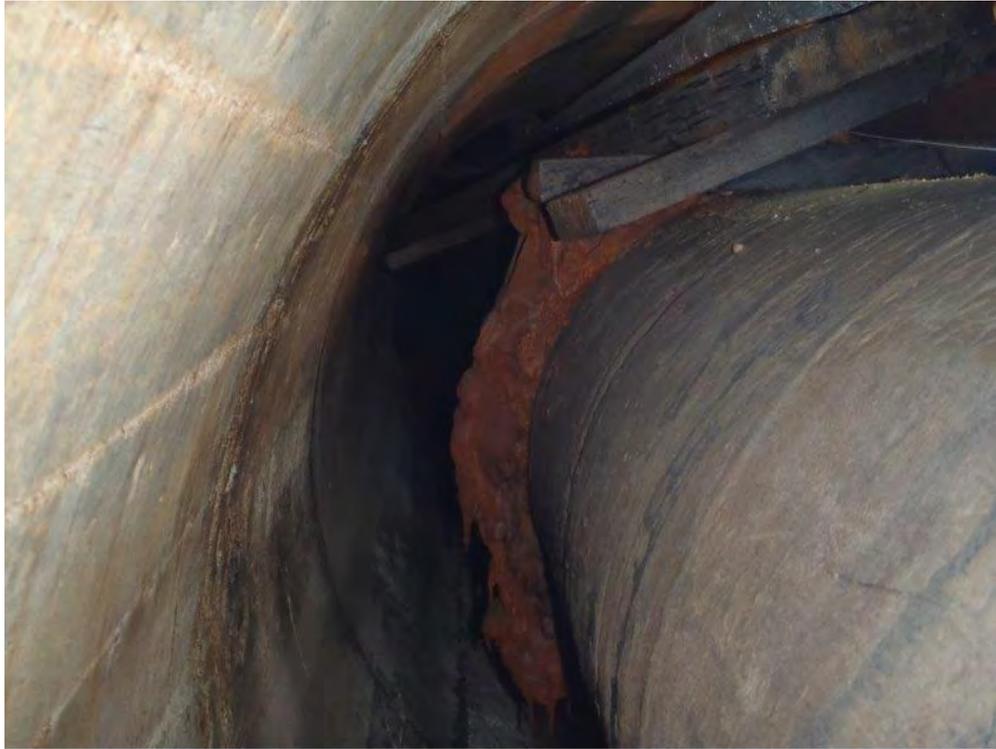
**Figure A 75 –Victaulic Connection at 9:30 o'clock, 4.60 m from Shaft.**

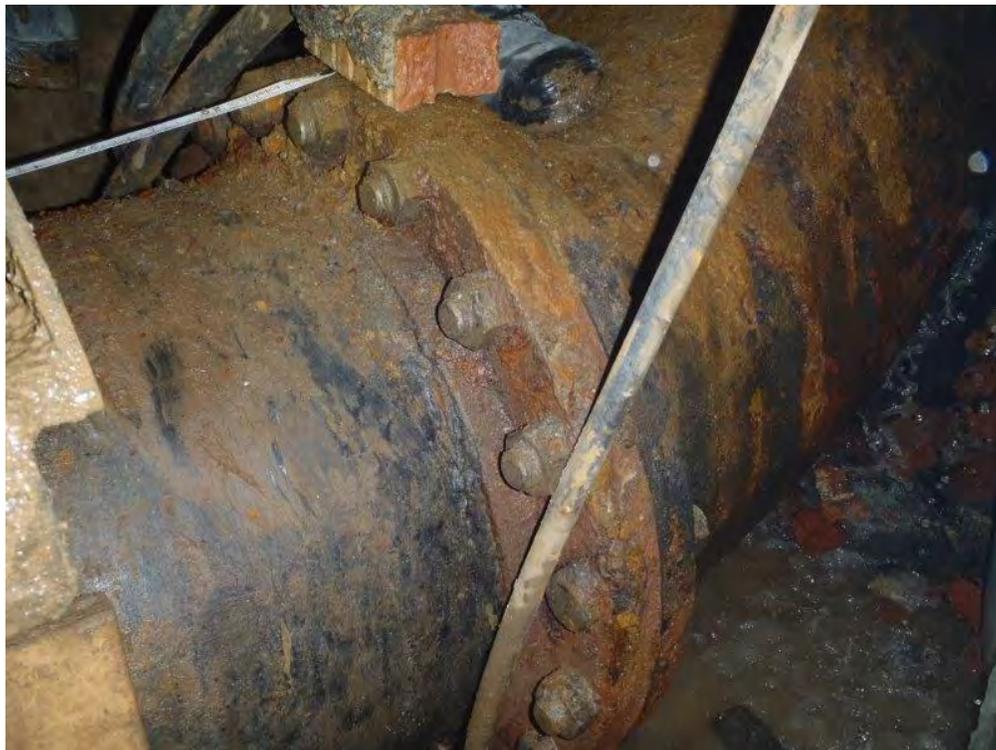
**Figure A 76 – Base Elbow at Shaft, 2:00 o'clock.**

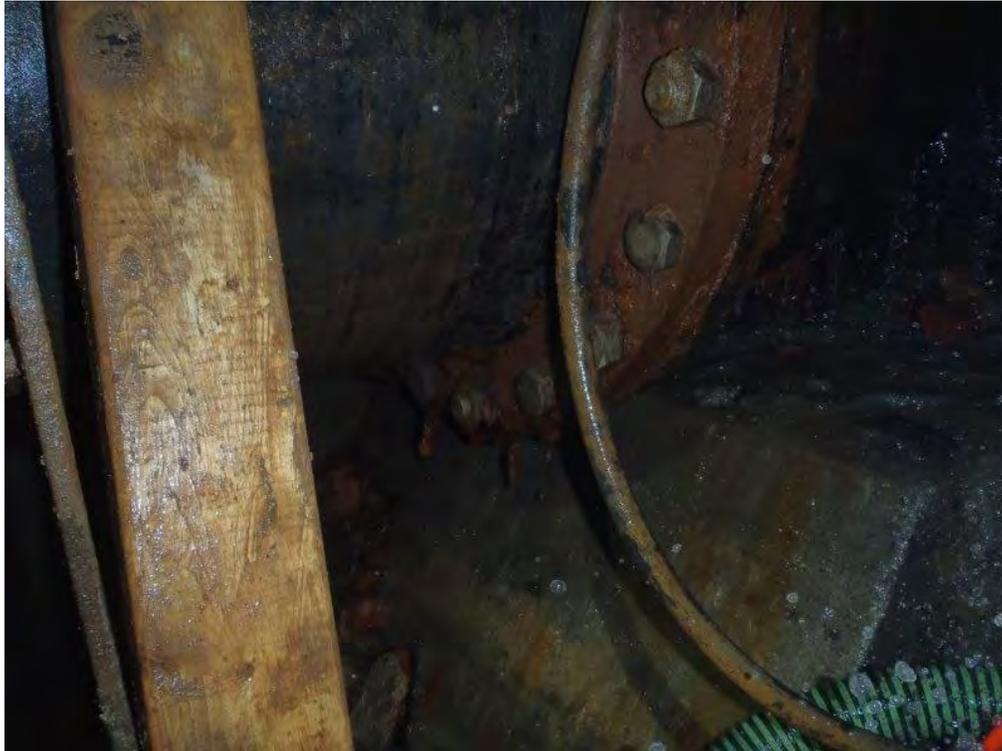
**Figure A 77 – Underside of Lower Flange Connection on Base Elbow at Shaft, 4:00 o'clock.**

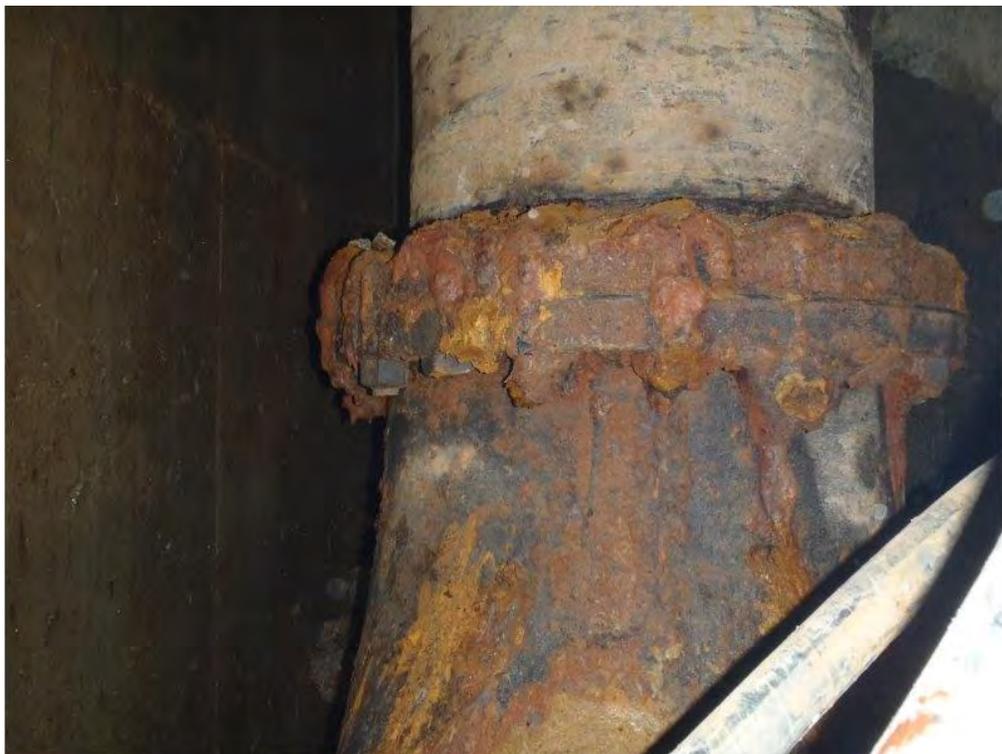
**Figure A 78 – Upper Flange Connection on Base Elbow at Shaft, 4:00 o'clock.**
