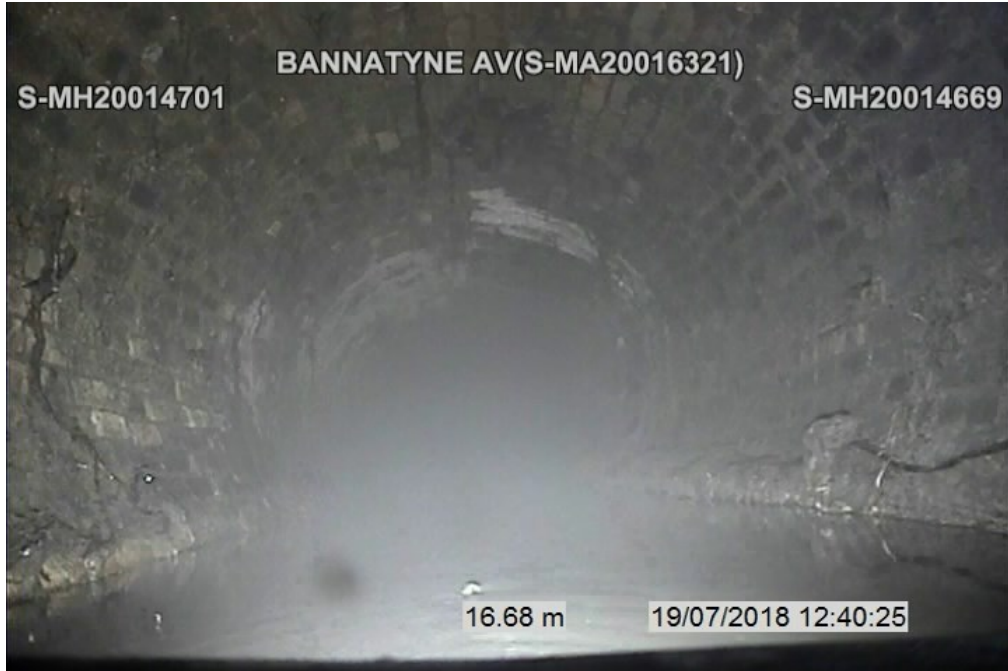
Figure 1 - Site 1: Bannatyne S-MA20016321 - General Conditions

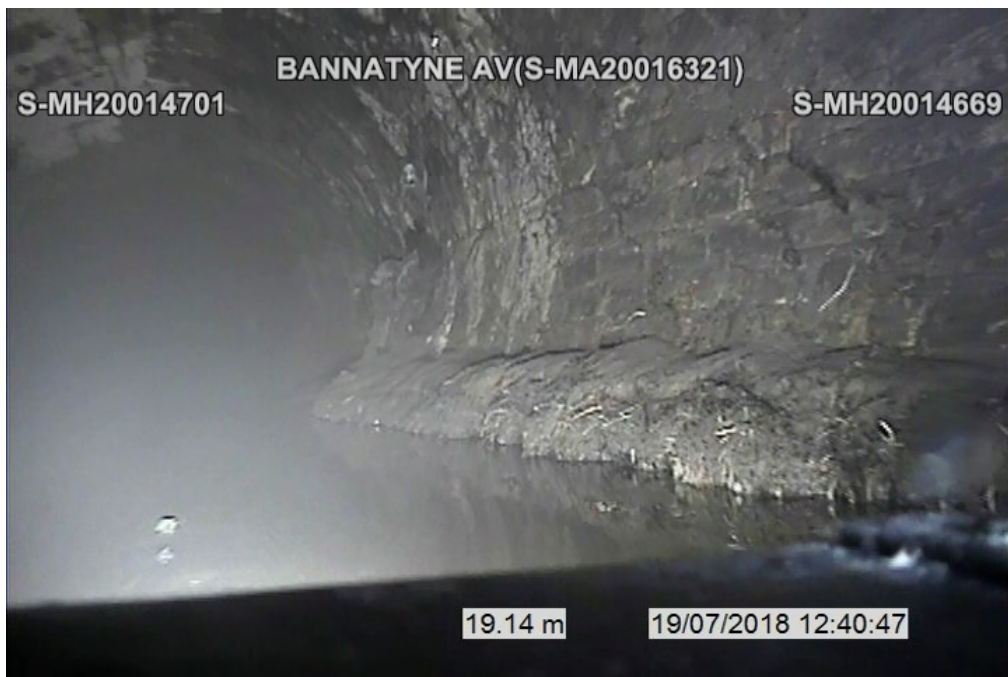
Figure 2 - Site 1: Bannatyne S-MA20016321 – Encrustation and Roots

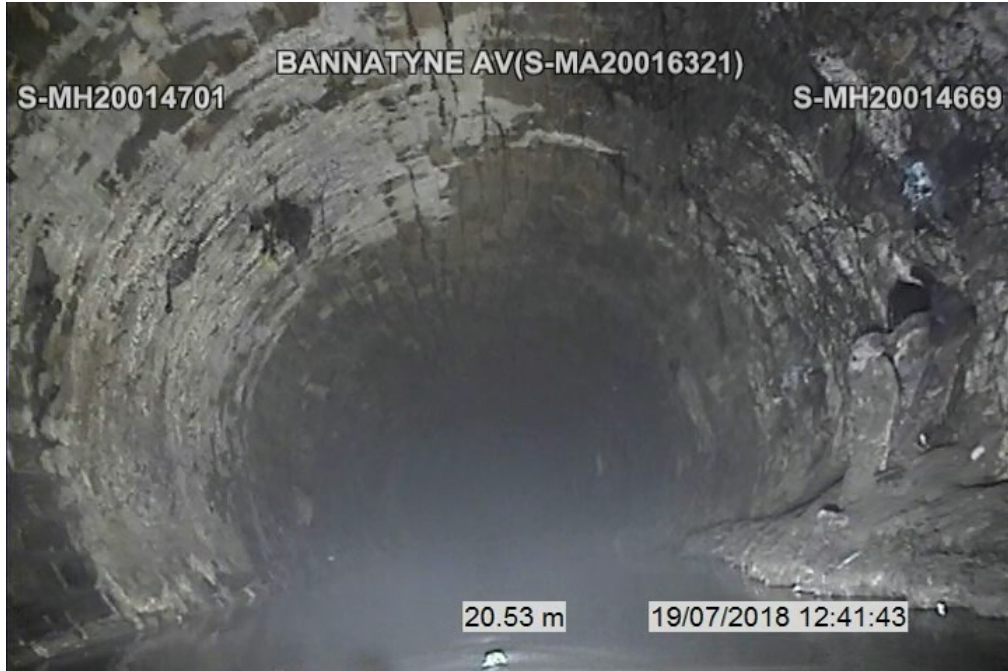
Figure 3 - Site 1: Bannatyne S-MA20016321 – General Condition

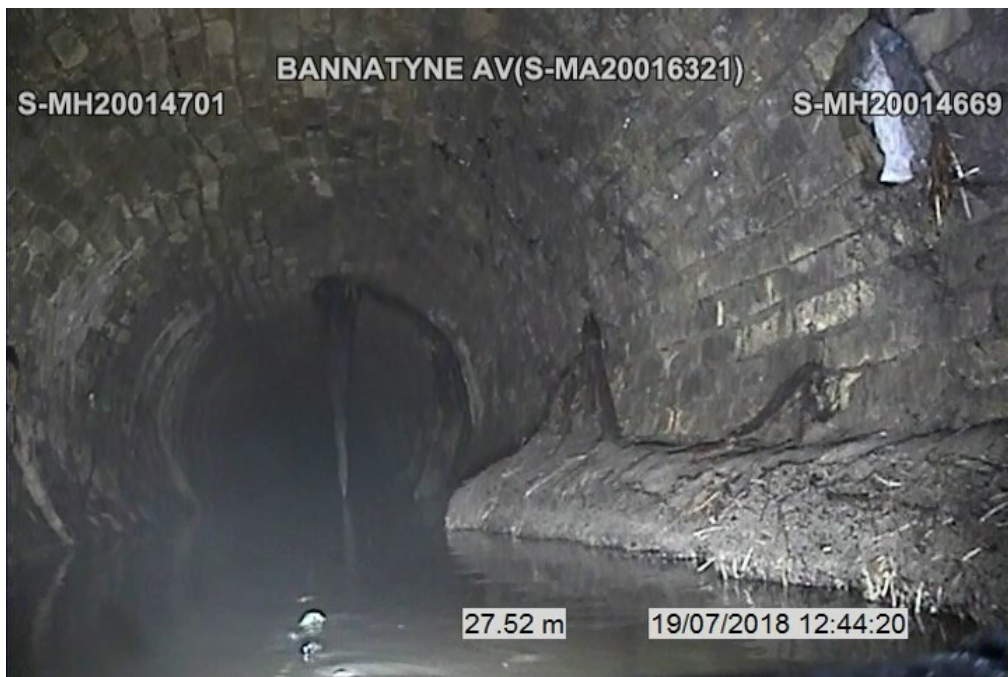
Figure 4 - Site 1: Bannatyne S-MA20016321 – Encrustation and Roots

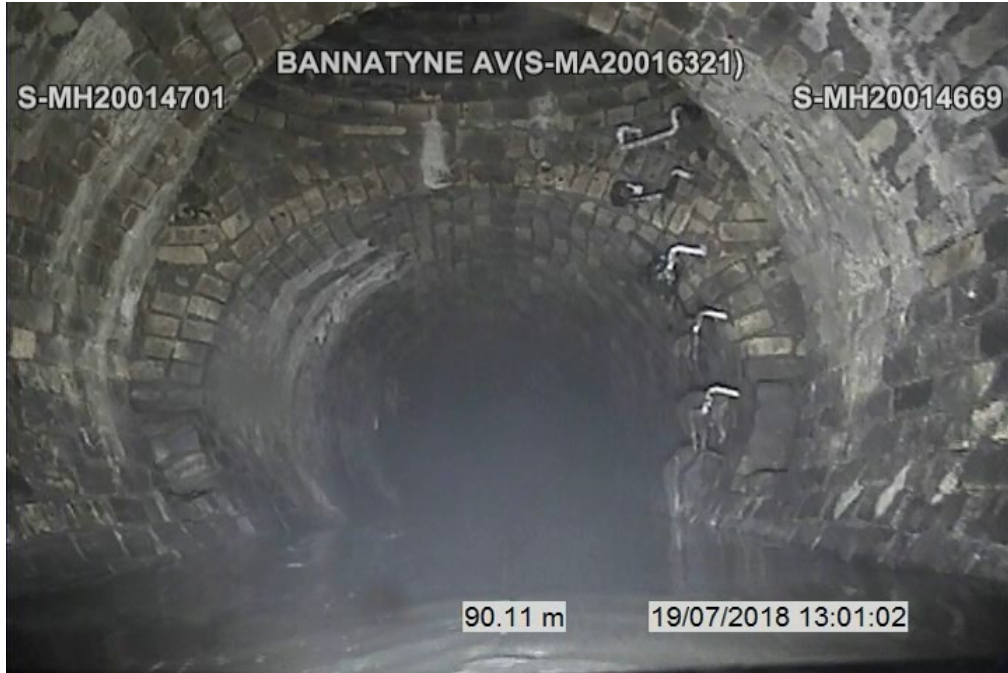
Figure 5 - Site 1: Bannatyne S-MA20016321 – Downstream Manhole

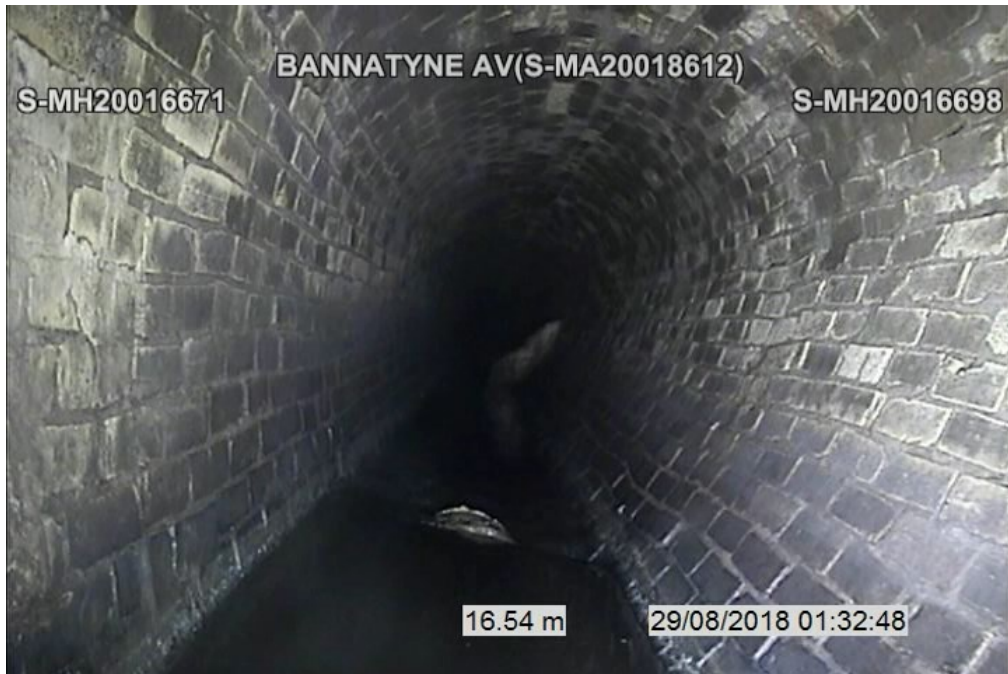
Figure 6 - Site 2: Bannatyne S-MA20018612 - General Condition

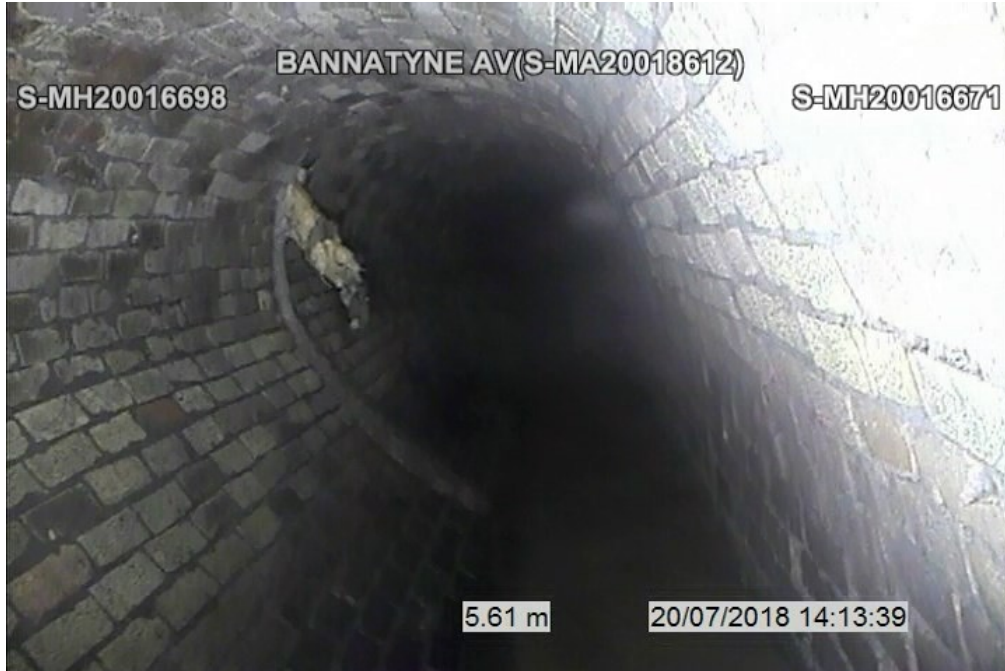
Figure 7 - Site 2: Bannatyne S-MA20018612 - General Condition w/ encrusted service

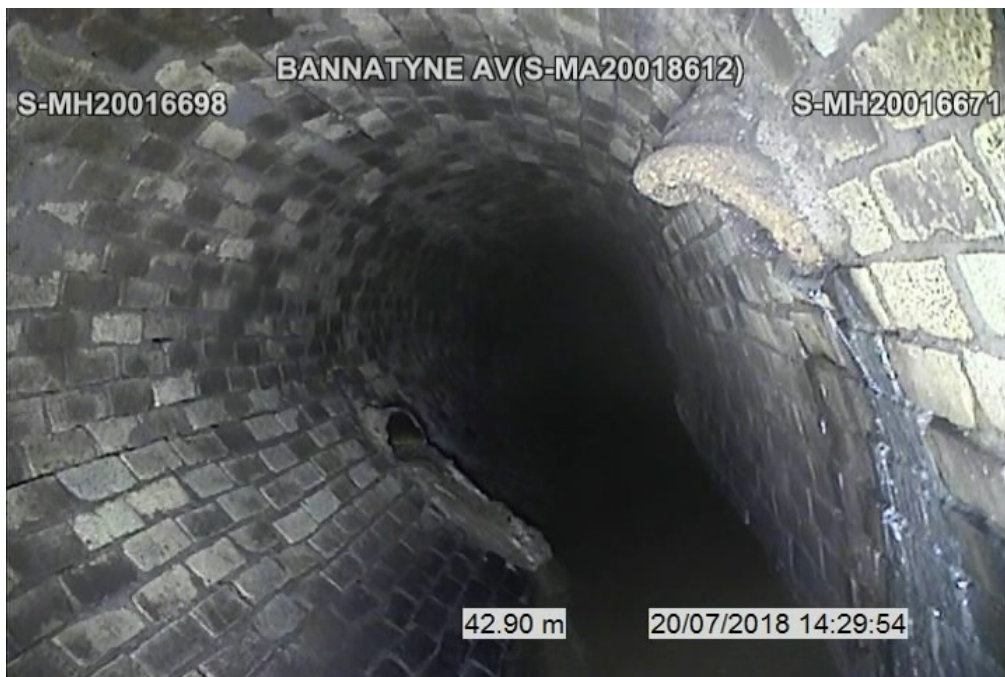
Figure 8 - Site 2: Bannatyne S-MA20018612 - General Condition w/ intruding service and encrustation

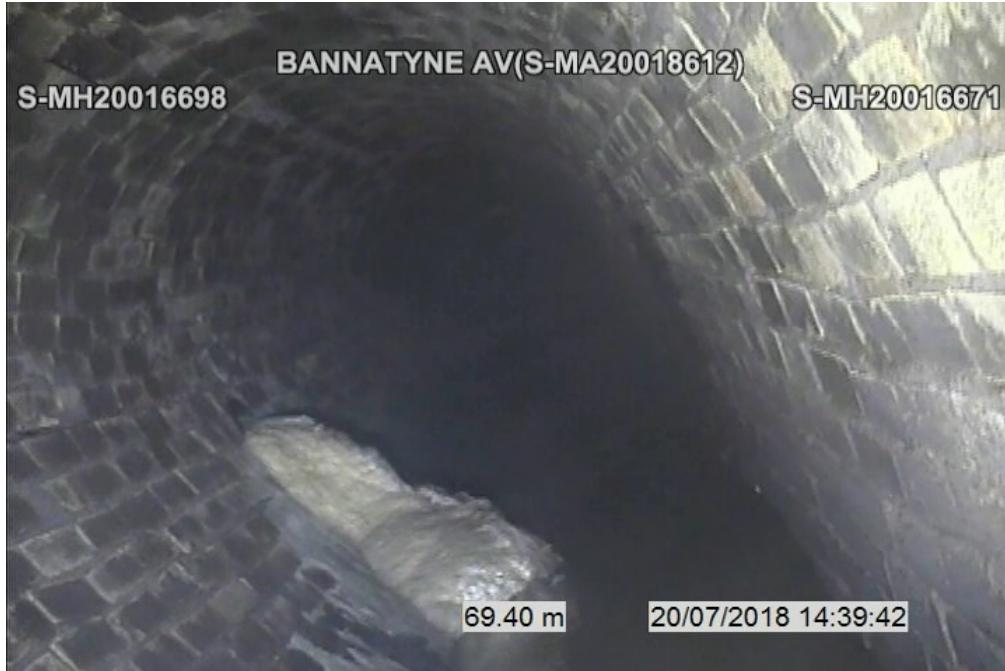
Figure 9 - Site 2: Bannatyne S-MA20018612 - General Condition w/ encrusted service

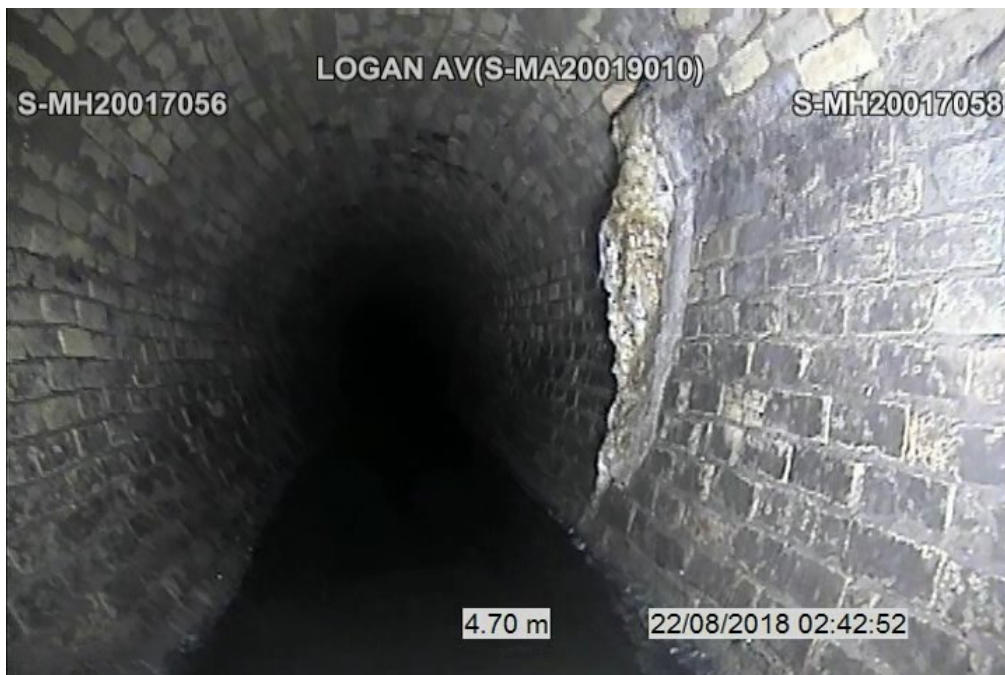
Figure 10 - Site 3: Logan Av S-MA20019010 - General Conditions

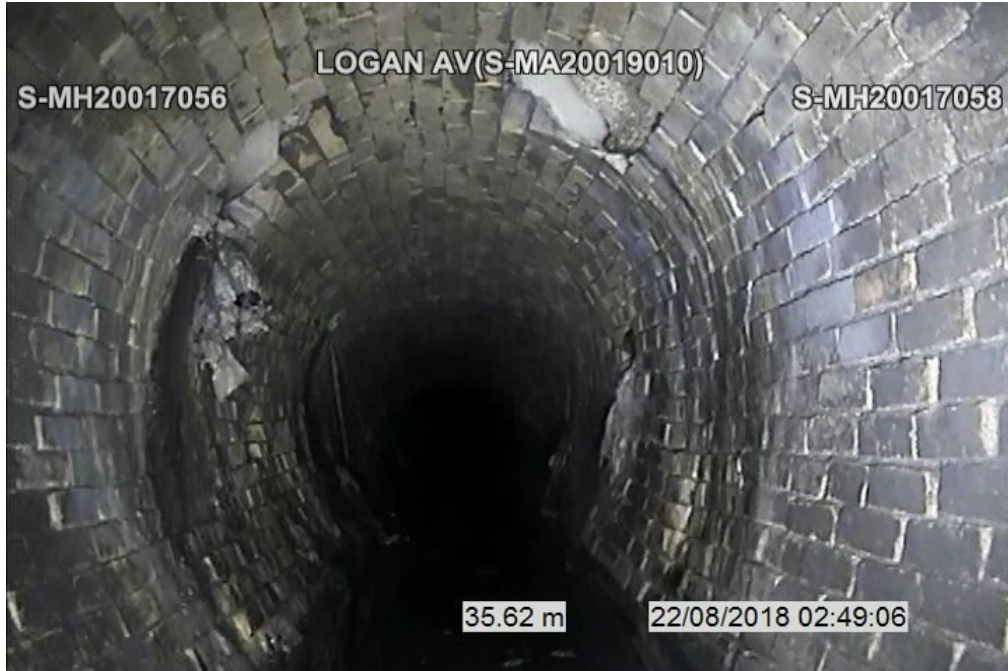
Figure 11 - Site 3: Logan Av S-MA20019010 - General Conditions w/ missing grout

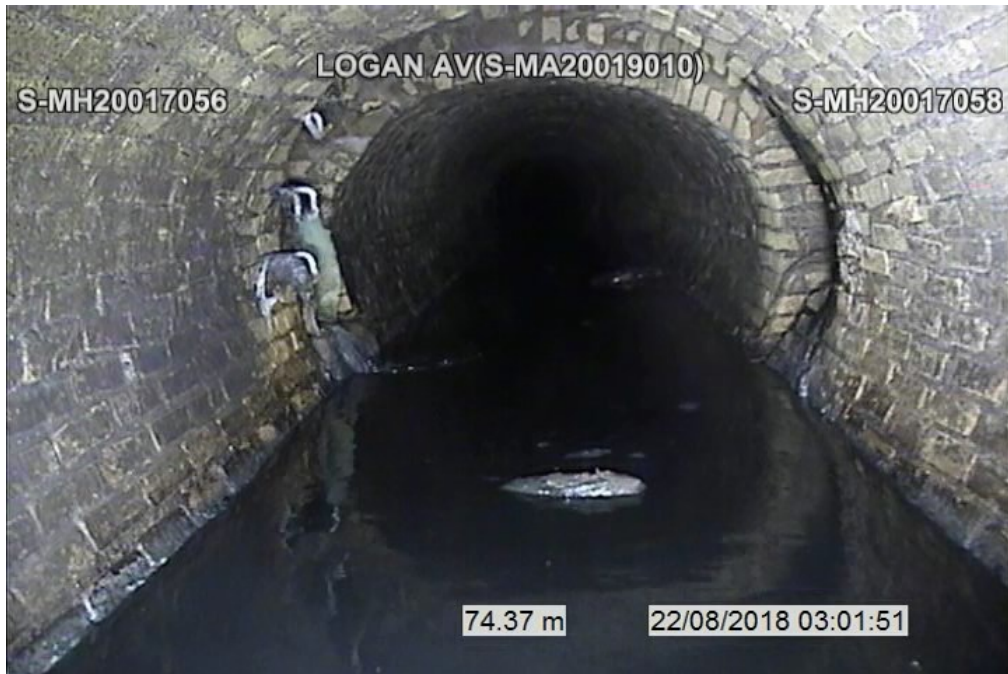
Figure 12 - Site 3: Logan Av S-MA20019010 - General Conditions @ DS Manhole

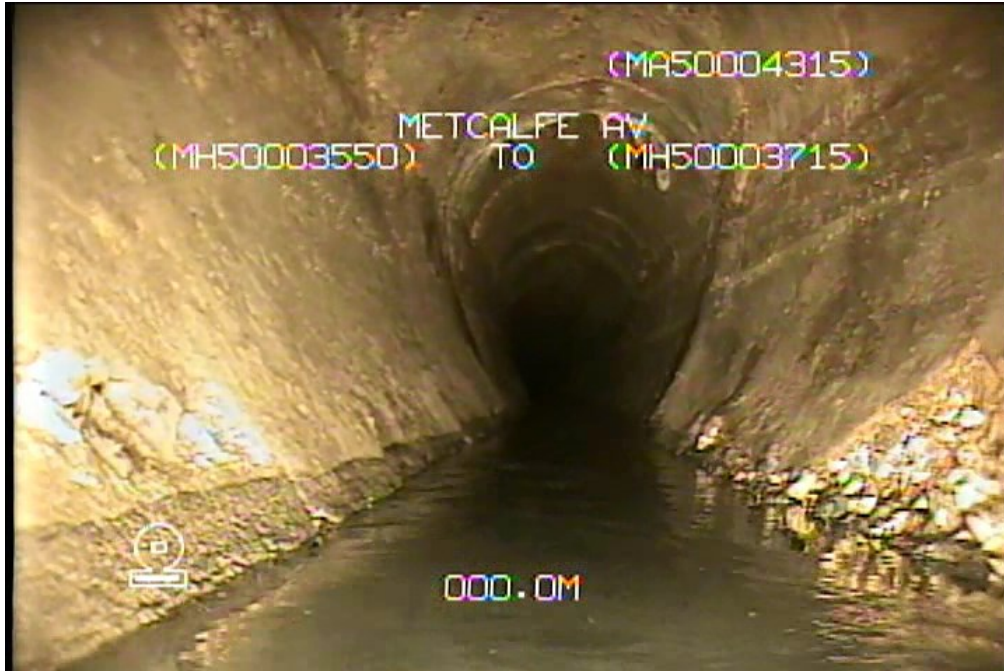
Figure 13 - Site 4: Metcalfe Av S-MA50004315 - General Conditions w/ Surface Spalling

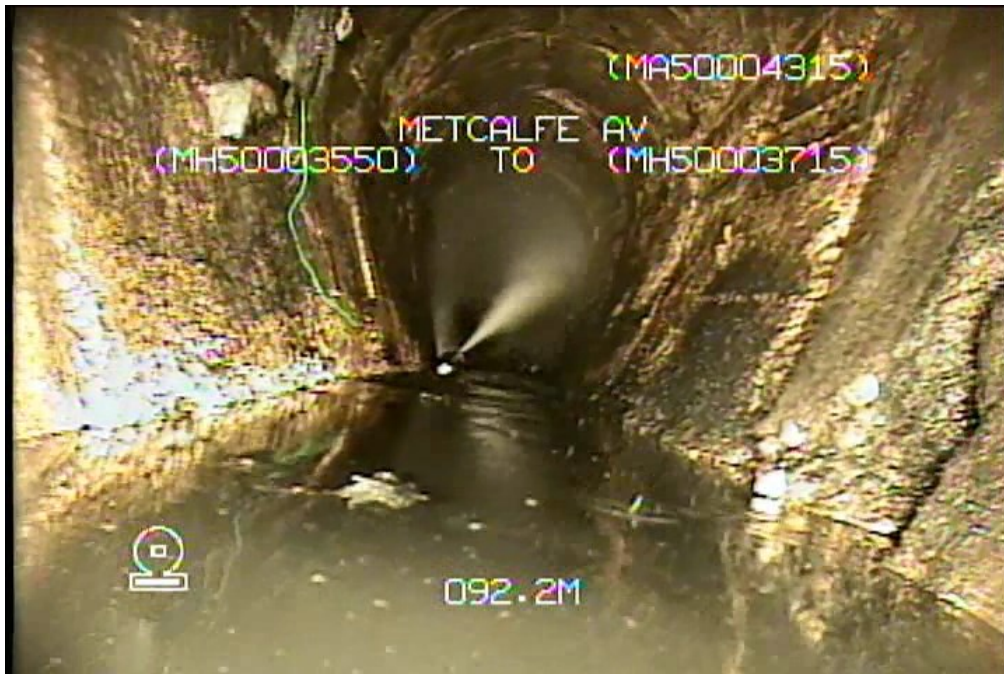
Figure 14 - Site 4: Metcalfe Av S-MA50004315 - General Conditions w/ Surface Spalling

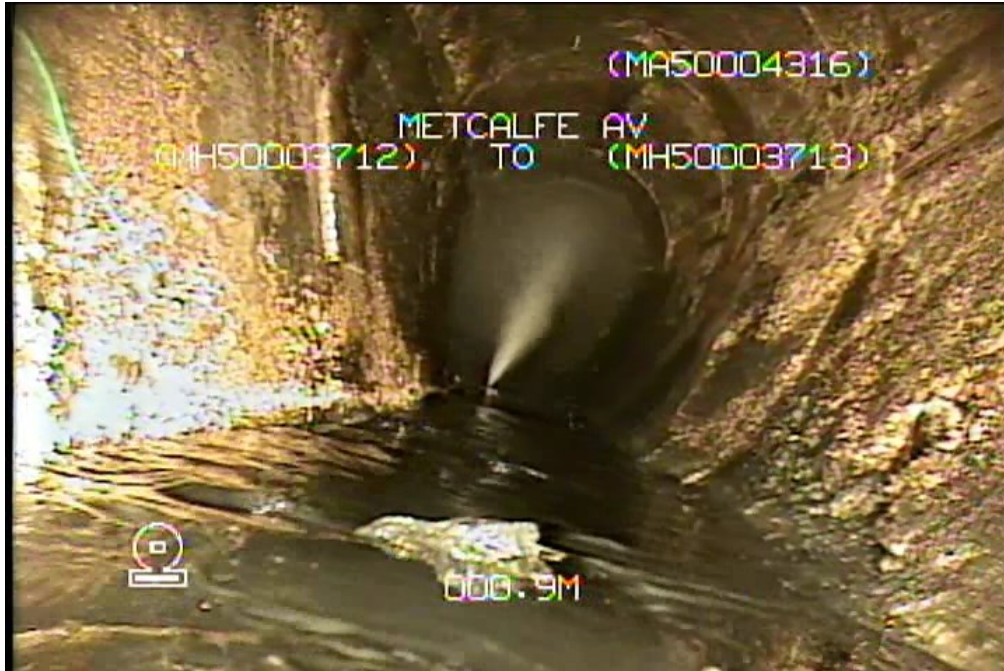
Figure 15 - Site 4: Metcalfe Av S-MA50004316 - General Conditions w/ Surface Spalling

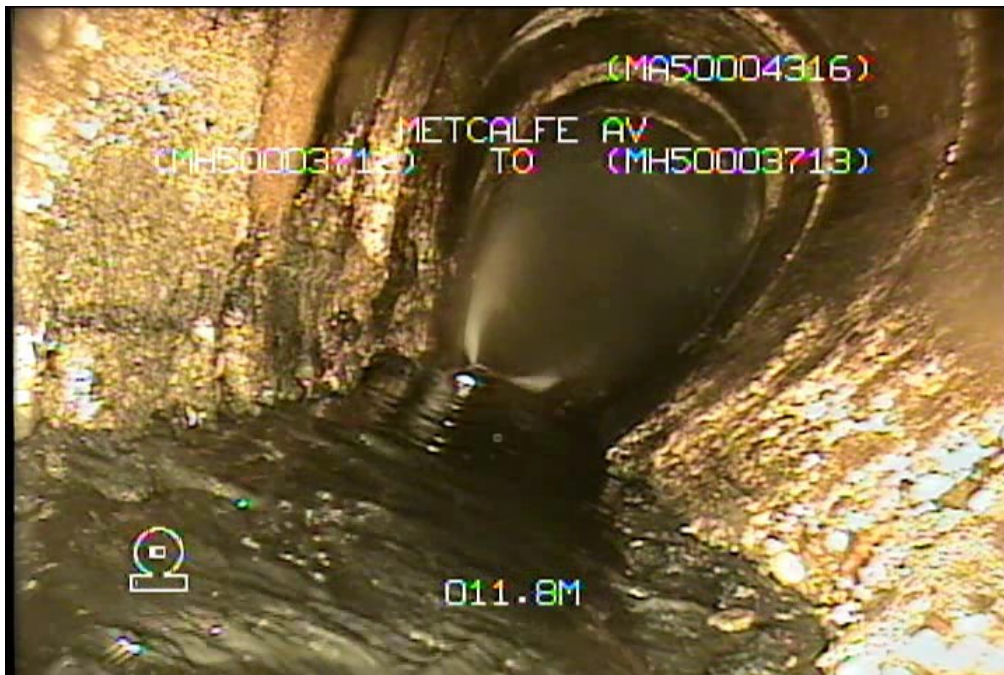
Figure 16 - Site 4: Metcalfe Av S-MA50004316 - General Conditions w/ Surface Spalling

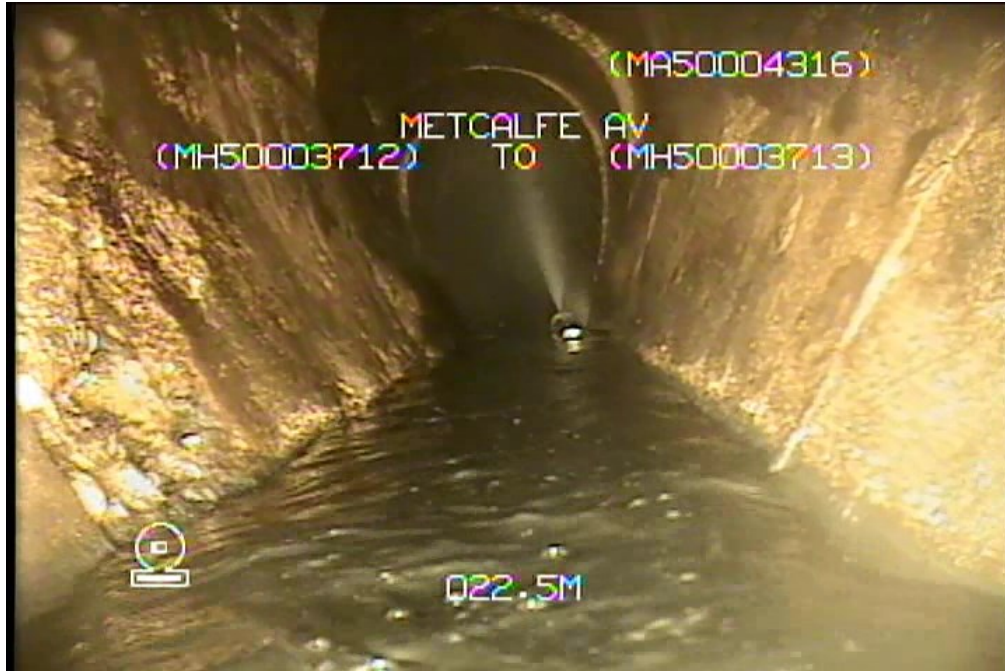
Figure 17 - Site 4: Metcalfe Av S-MA50004316 - General Conditions w/ Surface Spalling

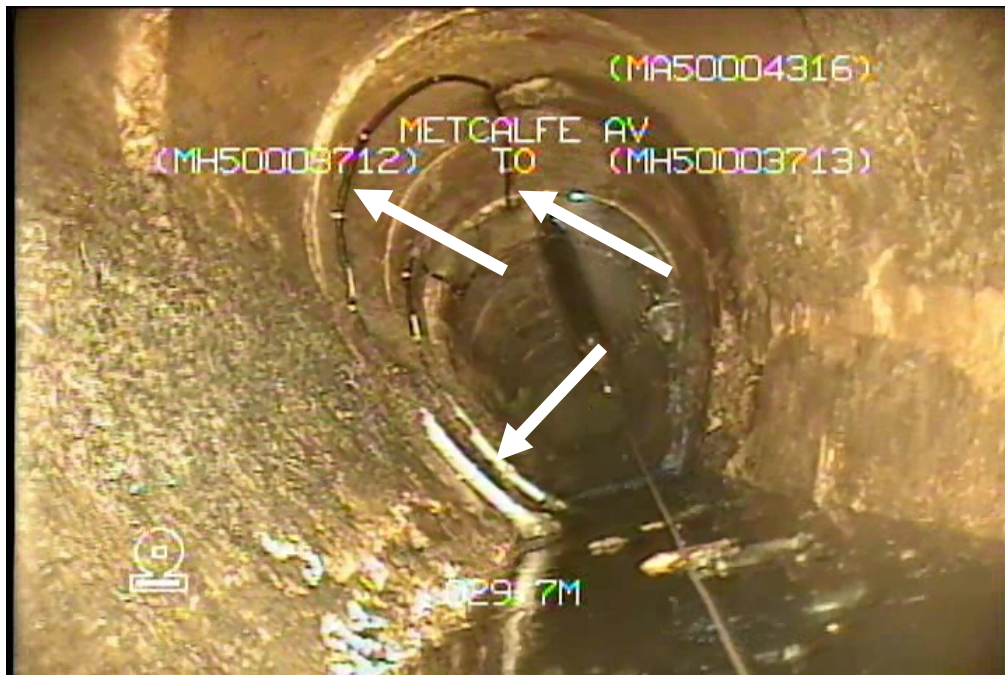
Figure 18 - Site 4: Metcalfe Av S-MA50004316 - Instrumentation and Cabling at S-MH50003713

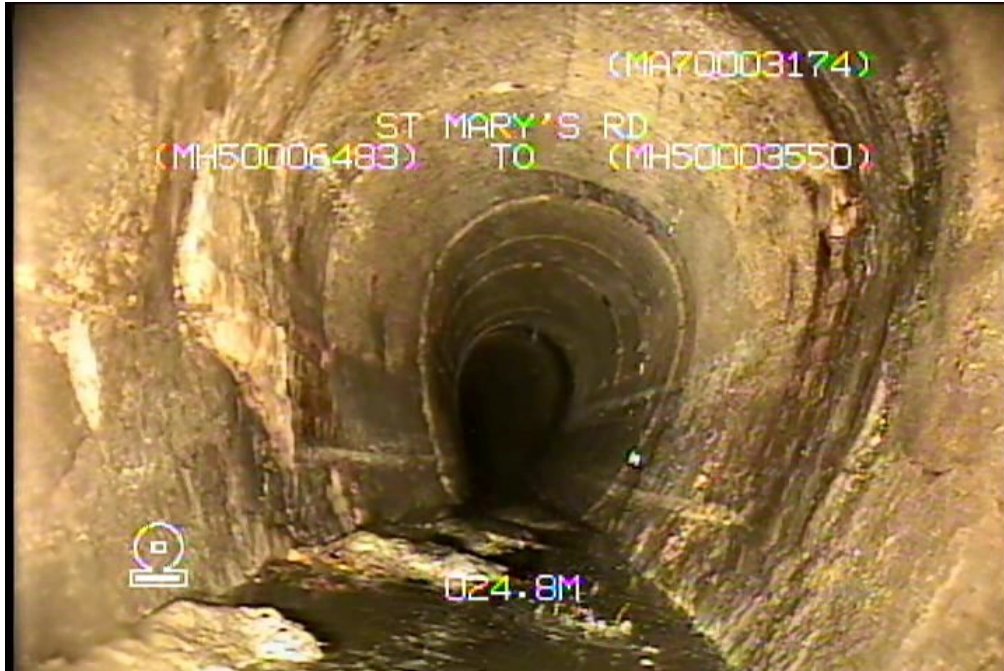
Figure 19 - Site 4: St Mary's Rd S-MA70003174 – General Conditions w/ Surface Spalling

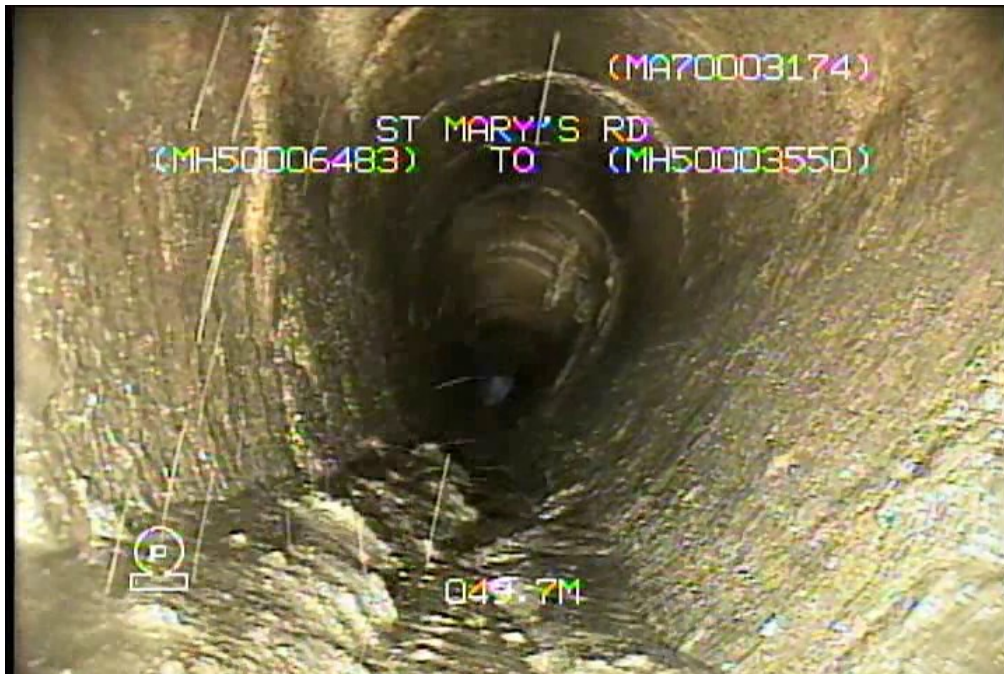
Figure 20 - Site 4: St Mary's Rd S-MA70003174 – General Conditions

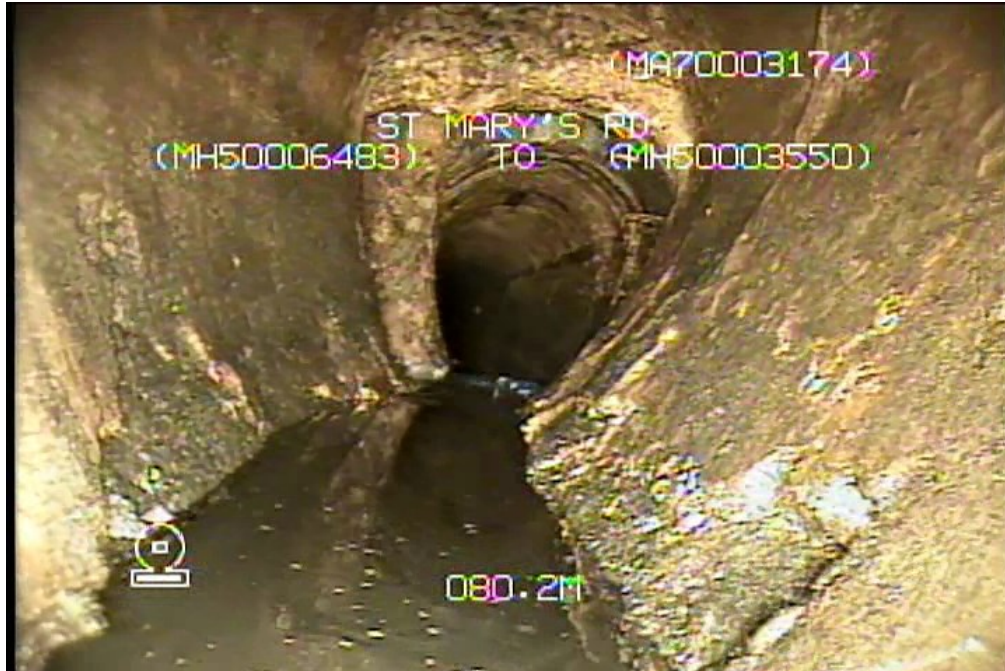
Figure 21 - Site 4: St Mary's Rd S-MA70003174 – General Conditions w/ Surface Spalling
