APPENDIX E

ASBESTOS INVENTORY CONTROL – 4540 PORTAGE AVENUE

| Building Name: | John Blumberg GC - Service Bldg | Inspection Date: | May 27, 2019 |

| Building Name: | John Blumberg GC - Clubhouse Bldg | Inspection Date: | May 27, 2019 |

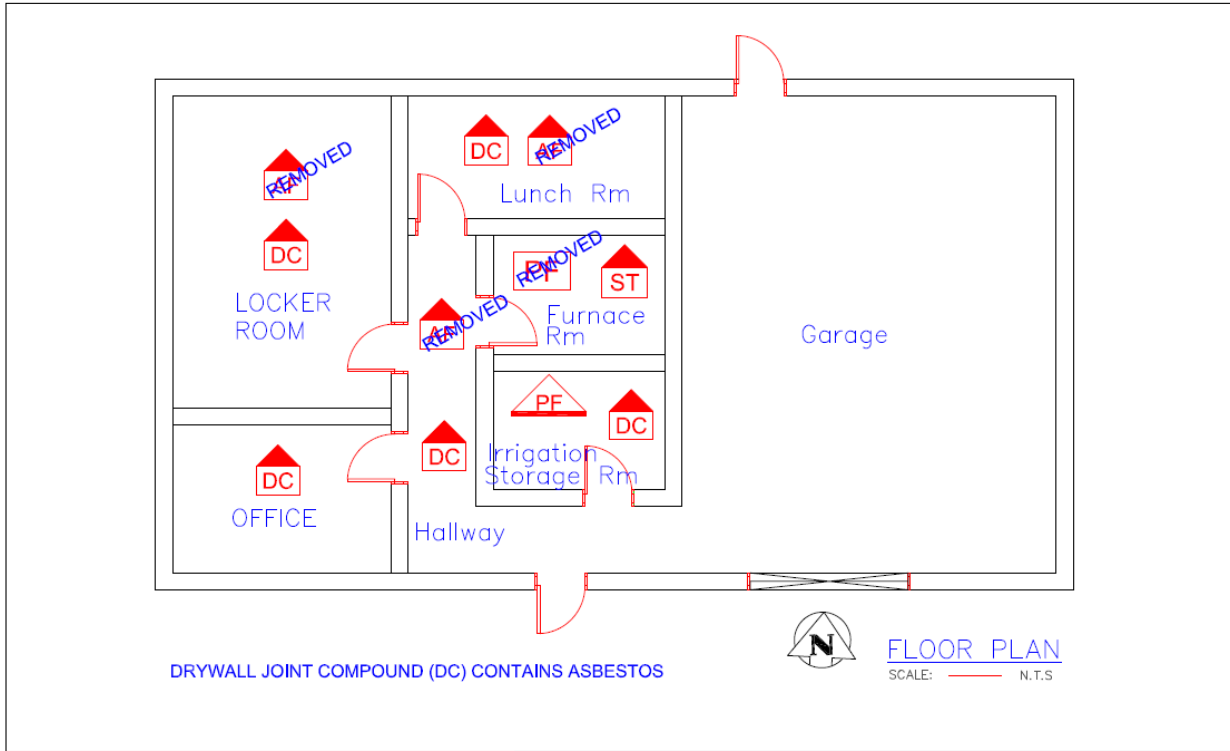
GC-14

| Material Location | Material Description | Drawing Label | Material Condition | Testing Status | Date M/Y | Test % | Est. % |
|---|--|---|---|---|---|---|---|
| Furnace Room | Stucco Ceiling | ST | Needs Repair | TESTED | Apr'11 | 1 | |
| | Pipe Fitting Insulation | PF | Removed5/15 | TESTED | Apr'11 | 25 | |
| Various Rooms/Hallway | Heat Shields (for 10 ceiling mount light fixture) | AF | Removed8/15 | TESTED | Apr'14 | 60 | |
| | Drywall Joint Compound | DC | Needs Repair | | | | 3 |
| Locker Room | Drywall Joint Compound - Ceiling | DC | Needs Repair | TESTED | May'15 | 3 | |

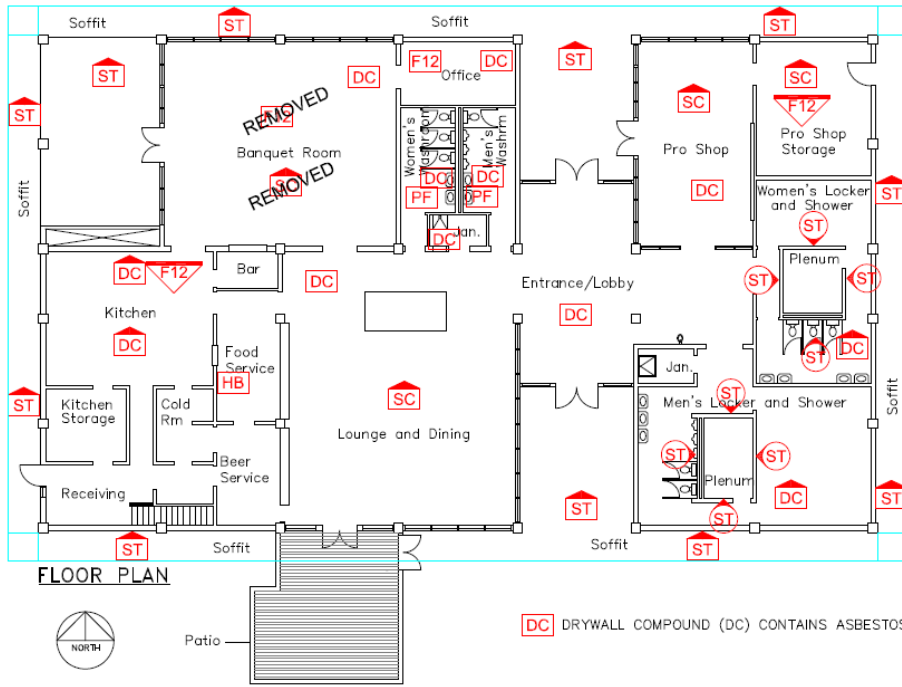
GC-16

DC DRYWALL COMPOUND (DC) CONTAINS ASBESTOS

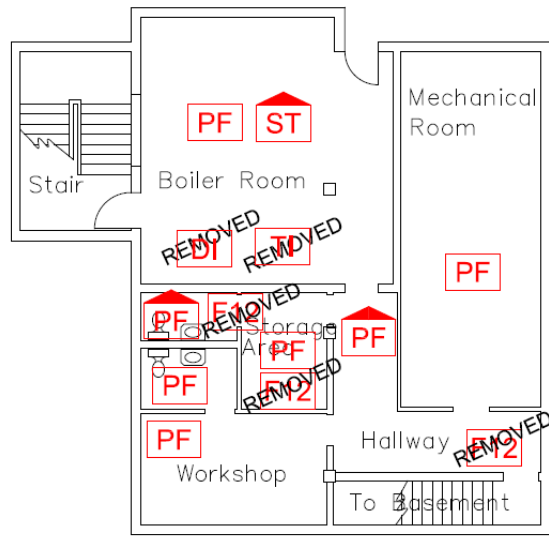
**BASEMENT FLOOR PLAN**

| Material Location | Material Description | Drawing Label | Material Condition | Testing Status | Date M/Y | Test % | Est. % |
|---|---|---|---|---|---|---|---|
| | Pipe Fitting Insulation | PF | Good | | | | 40-50 |
| Boiler Room | Pipe Fitting Insulation | PF | Good | TESTED | Dec/09 | 40-50 | |
| | Stucco Ceiling | ST | Needs Repair | TESTED | | Trace | |
