# BONIVITAL - ARCHIBALD POOL

prepared by SDO Architecture Inc. | JAN. 2020 |

EXISTING ELEVATIONS | SCALE 1/24" = 1'-0"

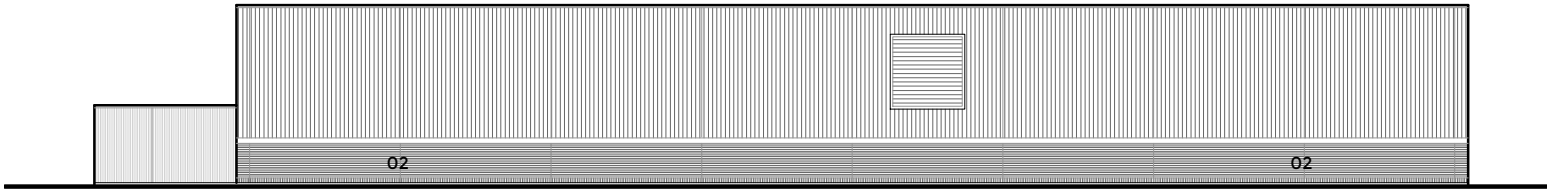
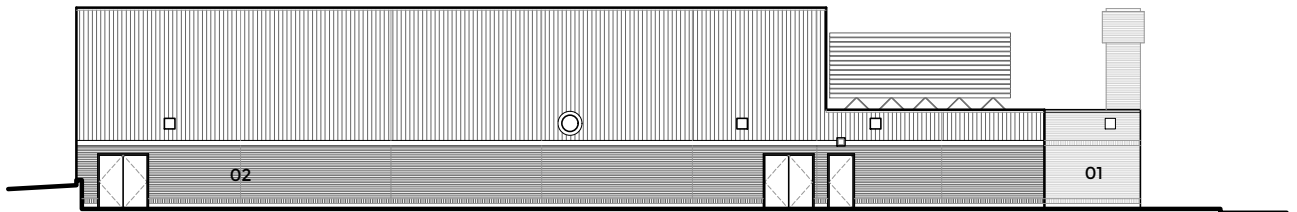
- 01 DETERIORATED MORTAR
- 02 MASONRY CONTROL JOINT CAULKING DETERIORATED

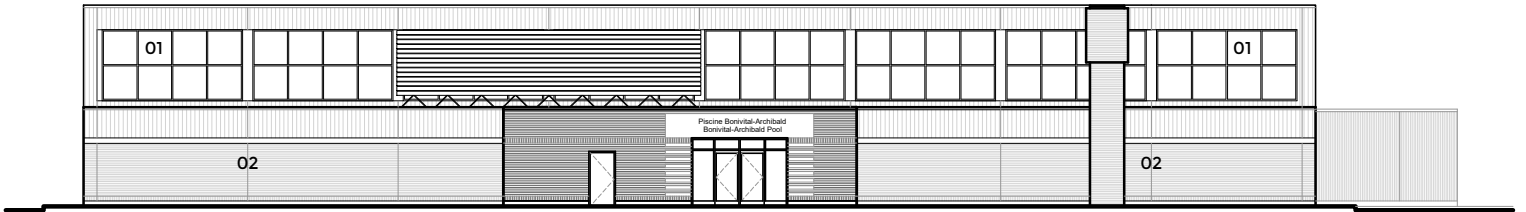
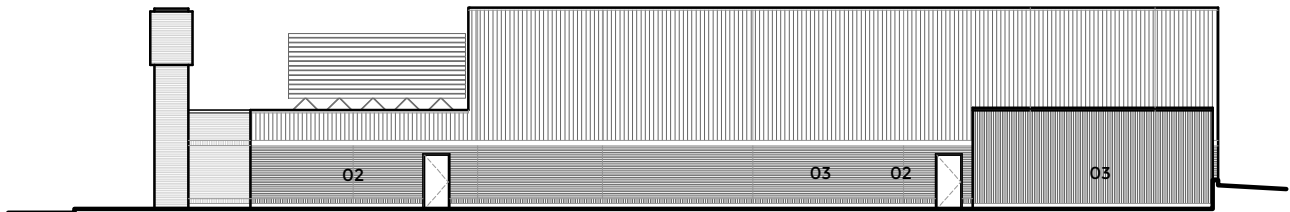
**EXISTING ELEVATIONS** | SCALE 1/24" = 1'-0"

- 01 EVIDENCE OF SEAL FAILURE IN WINDOW
- 02 MASONRY CONTROL JOINT CAULKING DETERIORATED
- 03 DETERIORATED MORTAR

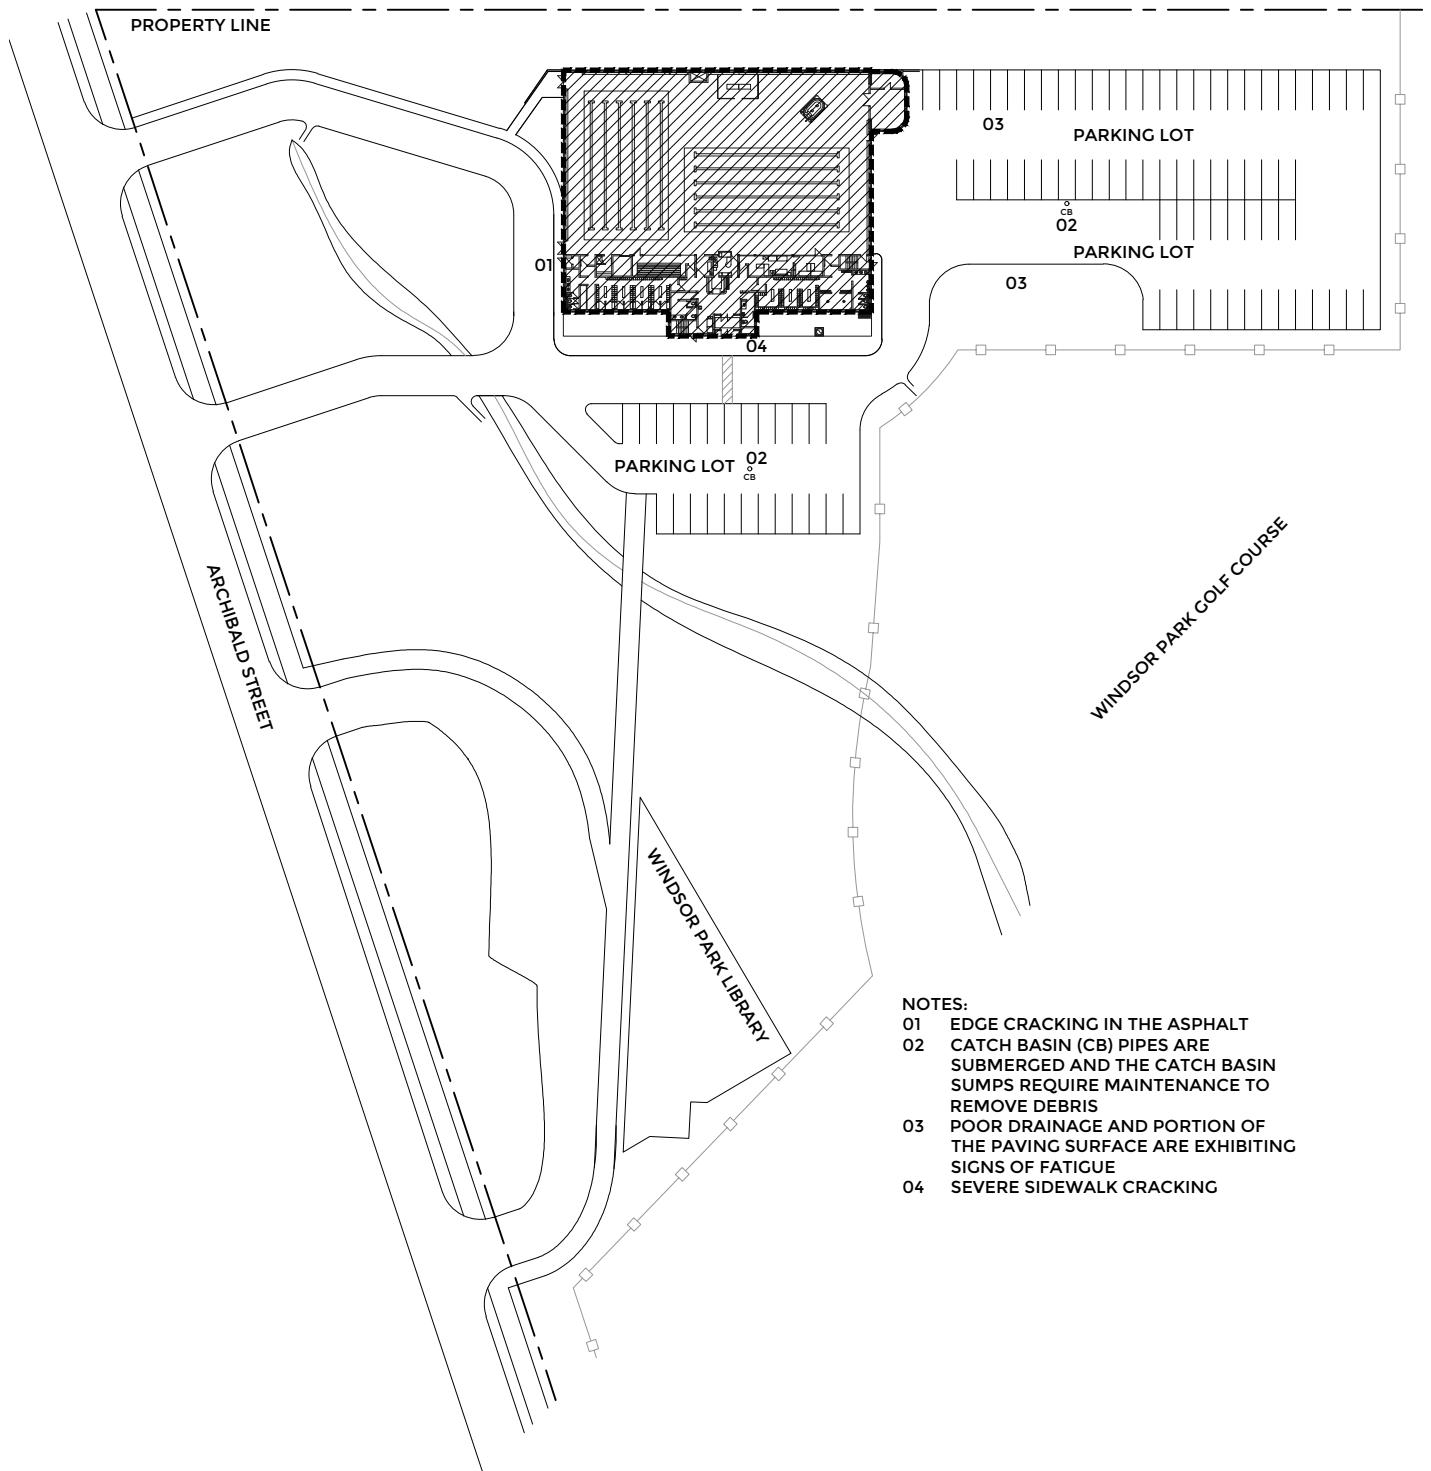
**SITE PLAN** | NTS

- NOTES:**
- 01 EDGE CRACKING IN THE ASPHALT
  - 02 CATCH BASIN (CB) PIPES ARE SUBMERGED AND THE CATCH BASIN SUMPS REQUIRE MAINTENANCE TO REMOVE DEBRIS
  - 03 POOR DRAINAGE AND PORTION OF THE PAVING SURFACE ARE EXHIBITING SIGNS OF FATIGUE
  - 04 SEVERE SIDEWALK CRACKING
