# ASBESTOS INVENTORY CONTROL

<b>Building Name:</b>	River Heights Library	<b>Inspection Date:</b>	October 6, 2020
<b>Building Code:</b>	LB-21	<b>Inspected By:</b>	Ryan Matthews & Willl Deller
<b>Building Address:</b>	1520 Corydon Avenue	<b>Construction Date:</b>	1962

**LB-21**

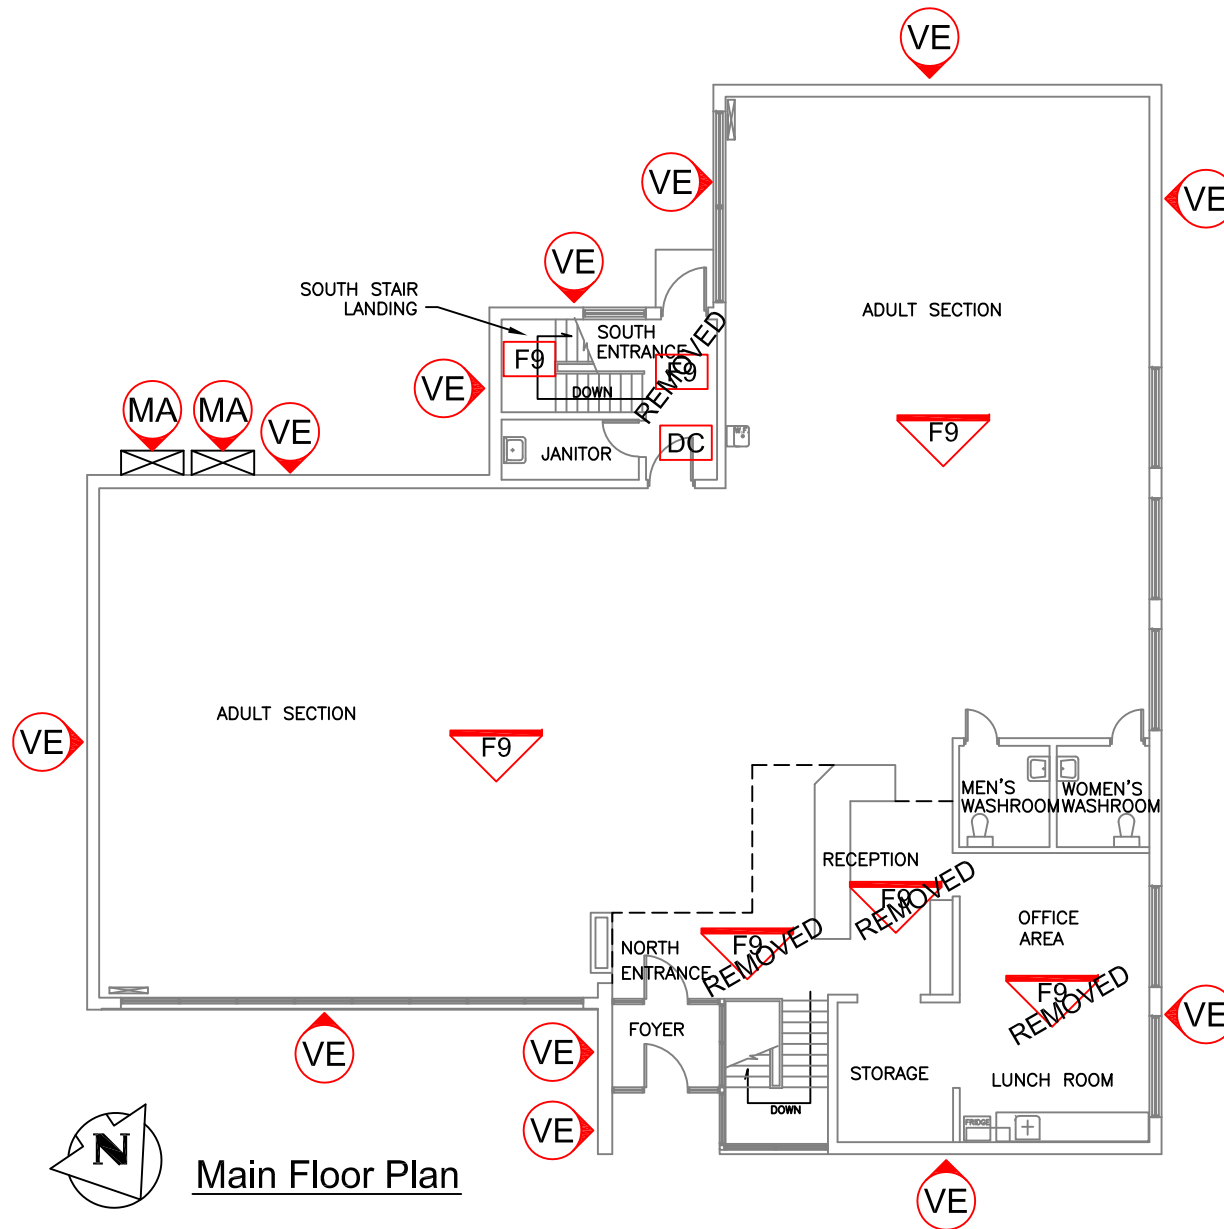
Main Floor Plan

Material Location	Material Description	Drawing Label	Material Condition	Testing Status	Date M/Y	Test %	Est. %
North Stair Treads	Sheet Flooring	FS		TESTED	Nov/'18	0	
South Stair Landing	9x9 Floor Tile	F9	Good				10
South Stair Treads	Sheet Flooring	FS	Good	TESTED	Mar/'12	0

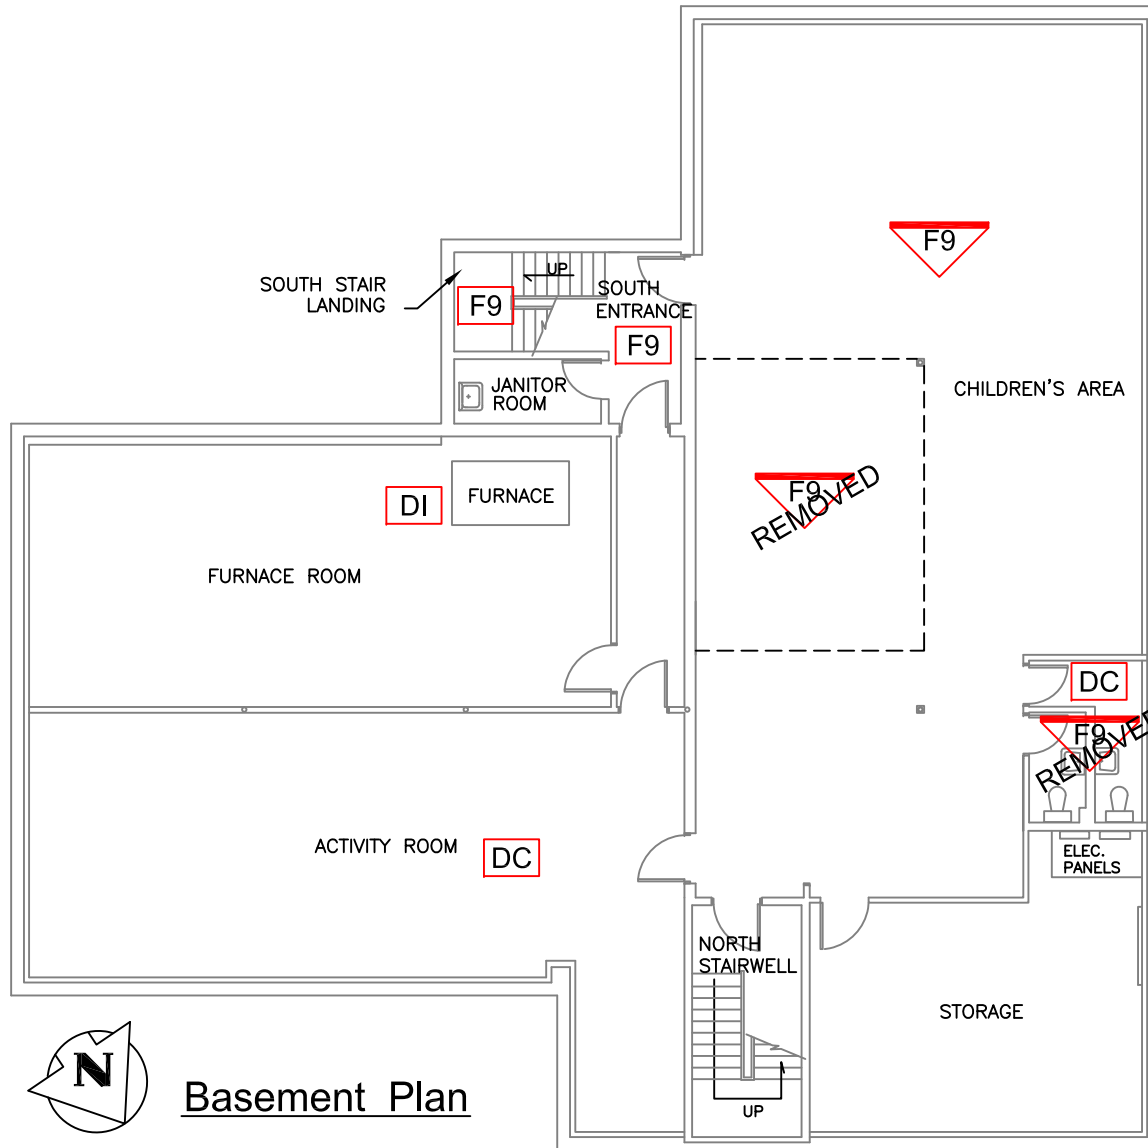
**Basement Plan**

<b>Basement</b>							
Washrooms	9x9 Floor Tile	F9	Removed 2/09		Feb/'09		
	Drywall Compound	DC					3
Children's Area	9x9 Floor Tile - Under Carpet	F9	Good				10
	9x9 Floor Tile - Under Carpet - see plan (Mastic <1%)	F9	Removed 7/12	TESTED	Aug/12	10	
	12x12 Ceiling Tile - Non-asbestos	C12					
Furnace Room	Duct Insulation	DI	Good	TESTED	Dec/'08	30-40	
	Drywall Compound (unfinshished wall)	DC	Good	TESTED	Oct'17	0	
	Isolation Gasket	AF	Good	TESTED	Aug/12	0	
Activity Room	Drywall Compound (Chrysotile)	DC	Good	TESTED	Oct'17	3	
Janitor Room	Duct Insulation	DI		TESTED	Dec/'08	0
