**APPENDIX A**  
**ASBESTOS INVENTORY**

# ASBESTOS INVENTORY CONTROL

<b>Building Name:</b>	Margaret Grant Indoor Pool & Bldg	<b>Inspection Date:</b>	August 10, 2020
<b>Building Code:</b>	PI-04	<b>Inspected By:</b>	Ryan Matthews
<b>Building Address:</b>	685 Dalhousie Drive	<b>Construction Date:</b>	1971

**PI-04**

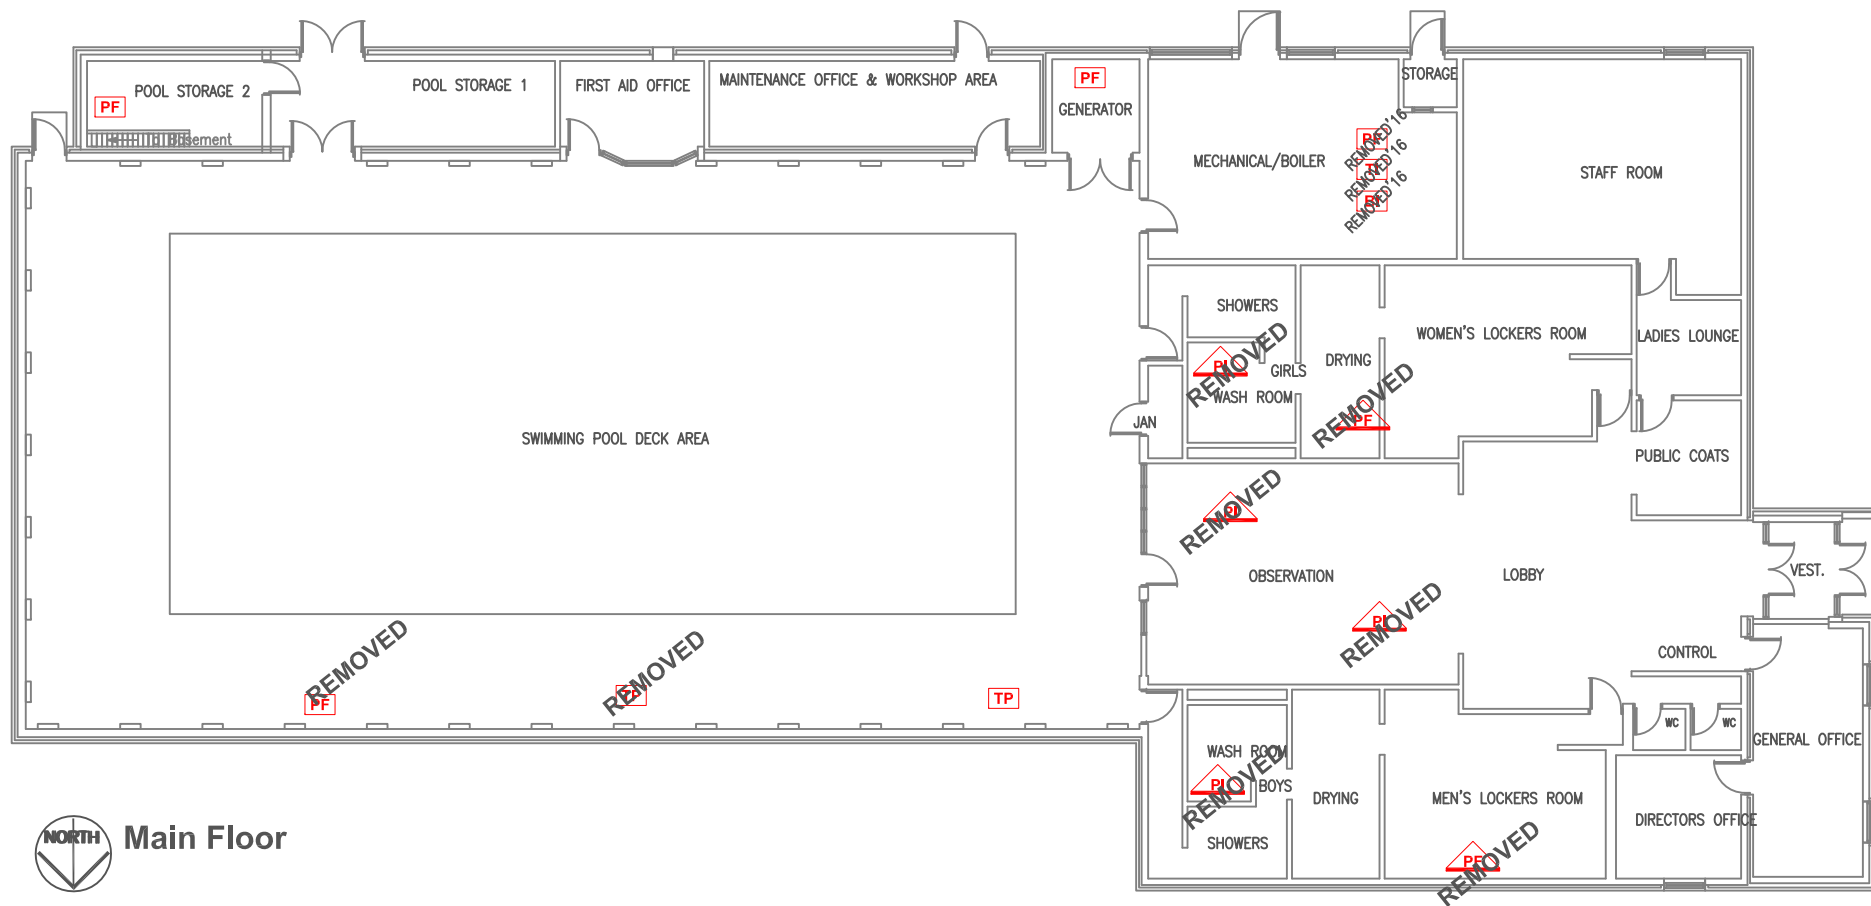
**Main Floor**

Material Location	Material Description	Drawing Label	Material Condition	Testing Status	Lab Report #	Date M/Y	Test %	Est. %
<b>Main Floor</b>								
Observation Area	Pipe Insulation - Above Ceiling	PI	Removed '13	TESTED	88623	Jul/'10	5	
Women's Washroom and Change Room	Pipe Fitting Insulation - above ceiling	PF	Removed '13					
	Pipe Insulation - above ceiling	PI	Removed '13					5
	Plaster - Ceiling	PL		TESTED			0	
Men's Washroom and Change Room	Pipe Fitting Insulation - above ceiling	PF	Good	TESTED			0	
	Pipe Insulation - above ceiling	PI	Removed '13					5
	Plaster - Ceiling	PL		TESTED	83820	Mar/'10	0	
Men's Locker Area	Pipe Fitting Insulation	PF	Removed '13					
Mechanical - Boiler Room	Pipe Fitting Insulation	PF	Good	TESTED	92886	Nov/'10	80	
	Tank Insulation (Tank left in place - check interior for asbetos)	TI	Removed '16	TESTED			40-50	
	Duct Insulation	DI	Good	TESTED		Jan/'16	0	
	Breeching Insulation	BI	Removed '16	TESTED			82

Duct Insulation	DI	Good	TESTED			0	
	Duct wrap insulation tar paper	DI	Good	TESTED			0	
	Gasket (Black)	GA	Good	TESTED	189474	Aug/'17	0	
Generator Room	Pipe Fitting Insulation	PF	Good					
Lifeguard Room	Drywall Compound - Ceiling	DC	Good	TESTED	208484	Sep/'18	0	
Maintenance Office and Workshop Area (Storage 'A')	Pipe Fitting Insulation	PF	Good	TESTED		Dec/'11	0	
	Pipe Fitting Insulation (2 Samples Tatken)	PF	Good	TESTED	136885	Feb/'14	0	
	Pipe Fitting Insulation	PF	Good	TESTED		Jan'14	0	
	Lead Paint (Beige)	LP		TESTED	EC65229	May'13	.1	
Storage 'B'	Pipe Fitting Insulation	PF	Good	TESTED	136885	Feb/'14	0

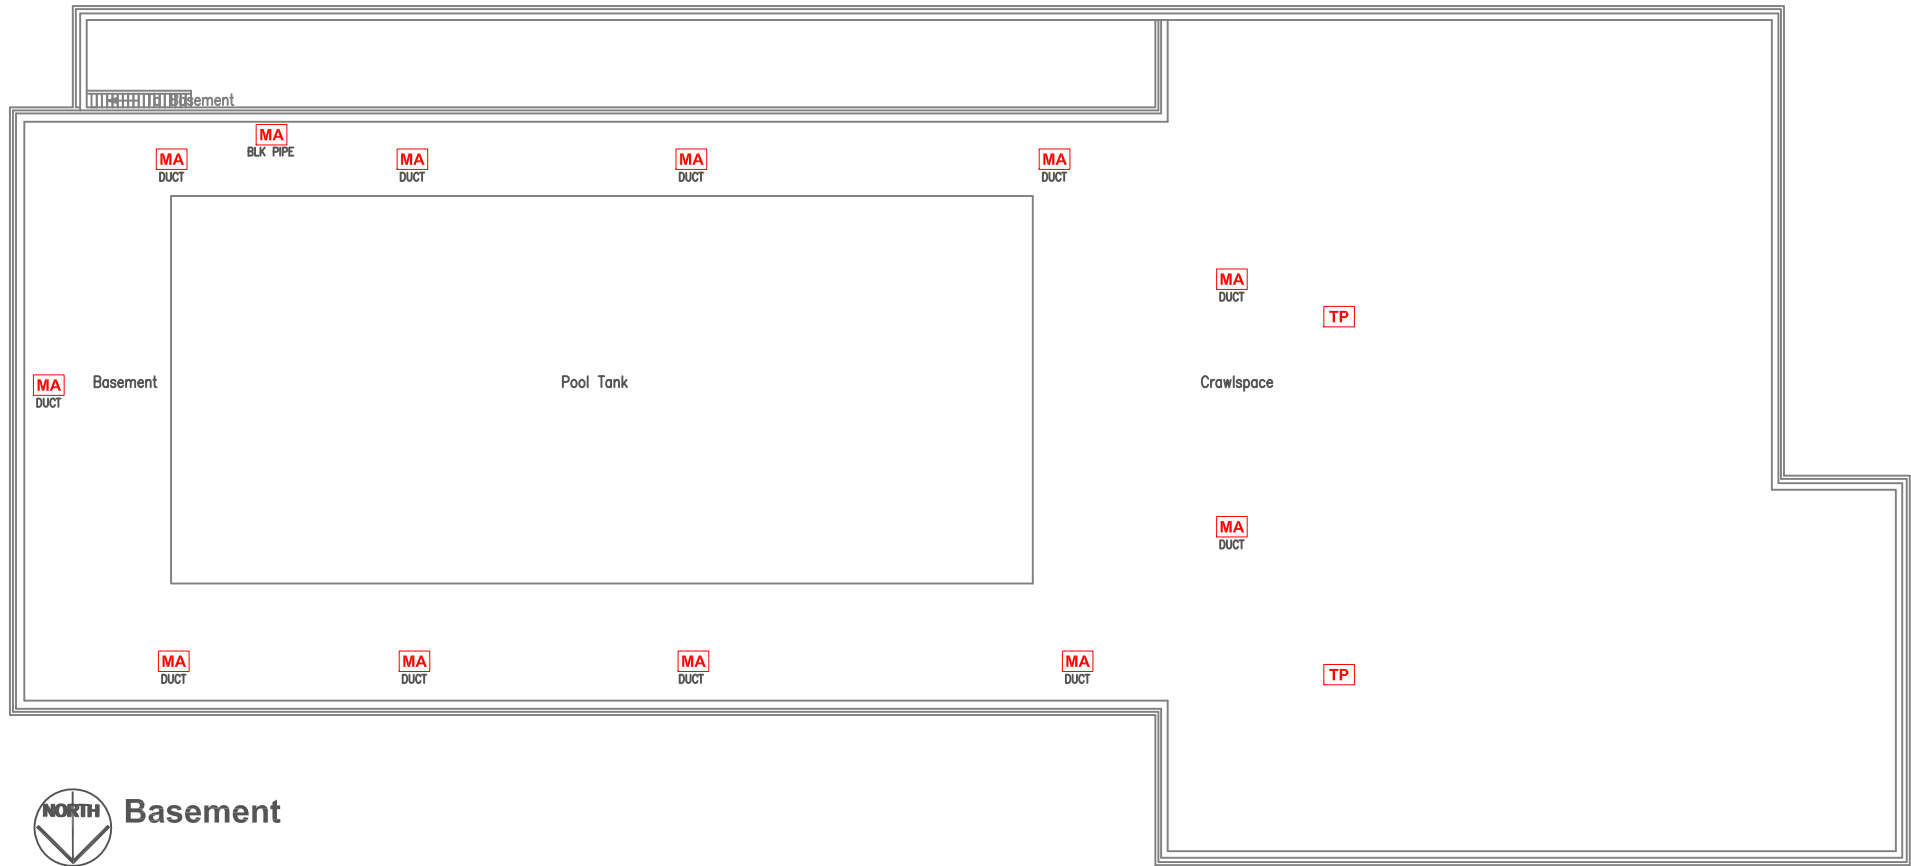
ASBESTOS LOCATIONS			
BUILDING:		PI-04 Margaret Grant Pool 685 Dalhousie Dr Winnipeg, Manitoba	
REVISED BY:	DATE:	SCALE:	SHEET #:
REM	September 24, 2018	N.T.S.	2/2

Material Location	Material Description	Drawing Label	Material Condition	Testing Status	Lab Report #	Date M/Y	Test %	Est. %
Pool Deck Area	Ceiling Tile		Removed					
	Duct Insulation	DI		TESTED		Jan'14	0	
	Spray On Insulation -Upper Wall Cover	SO		TESTED			0	
North Side Pool Deck	Transite Pipe - Roof Drain	TP	Good					
	Pipe Fitting Insulation	PF	Removed'14					
Pool Deck Storage Room 1 & 2 (Storage Rm 'B')	Pipe Fitting Insulation (2 Samples Taken)	PF	Good	TESTED	136216	Jan'14	0	
<b>Basement</b>								
West Side of Pool Tunnel	Pipe Fitting Insulation	PF	Good	TESTED	127815	Jun'13	0	
	Black Pipe Wrap	MA		TESTED		May'13	0	
	Mastic - Duct	MA	Removed	TESTED	126459	May'13	10	
South Side of Pool Tunnel	Black Pipe Wrap	MA	Good	TESTED	208484	Sep/'18	10	
	Mastic - Pipe	MA	Good	TESTED	208484	Sep/'18	3	
All Ducts Around Pool Tunnel	Mastic - Duct	MA	Removed'17	TESTED	179807	Dec'16	5	
	Mastic - Duct	MA	Removed'17	TESTED	192920	Oct/'17	10

Mastic - Duct (Brown - Brush-on)	MA	Good	TESTED	192920	Oct/'17	3	
Crawl Space	Transite Pipe - Sewer	TP	Good					
	Pipe Fitting Insulation	PF	Good	TESTED	127815	Jun'13	0	
	Pipe Insulation	PI	Good	TESTED	127815	Jun'13	0
