COVER PAGE

1.0 LIFT STATION INFORMATION

Station Name:	<u>Riverbend Lift Station</u>
Location of Station:	<u>1736 Portage Avenue</u>
Date of Inspection:	<u>February 11, 2010</u>
Inspected By:	<u>Damir Muhurdarevic, EIT</u>
Inspecting Firm:	<u>MMM Group Limited (MMM)</u>
Client:	<u>City of Winnipeg – Water and Waste Department</u>

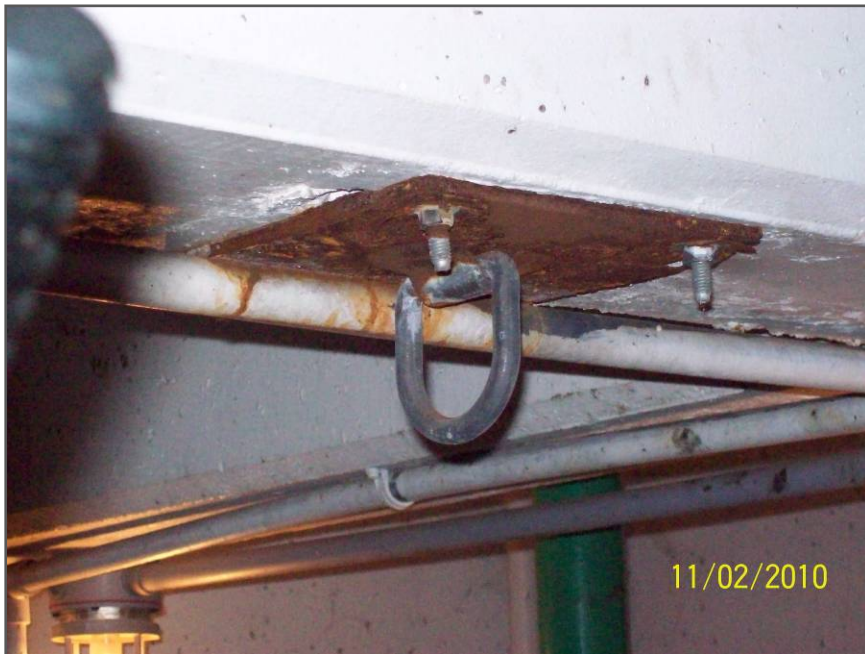
Photograph No. 1

The pump room also has a U-shaped lifting hook that is welded to a steel plate anchored into the underside of the third floor cast-in-place concrete slab with four (4) 12.8mm anchor bolts. Significant corrosion was observed in the U-shaped hook, and loss of section area is suspected.

The analysis of the U-shaped hook welded to a steel plate determined a rating of 1.0 ton due to the bending of the plate. However due to significant corrosion and suspected loss of section area, this hook needs to be replaced and **not rated for safe use**.

U-shaped lifting hook welded to a steel plate, located in the pump room

Ref.	Description	Priority
4.1	Replace U-Shaped Lifting Hook located in Pump Room before further use	A

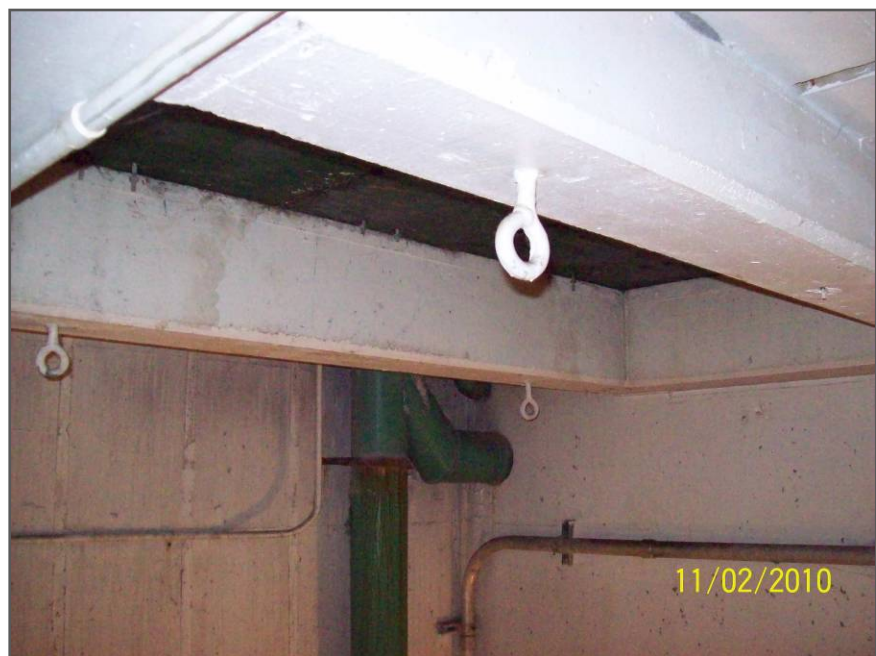
Photograph No. 2

The motor room has one (1) eye-shaped lifting hook, which is fabricated of 19.4mm diameter steel rod and is embedded into the underside of the second floor cast-in-place concrete slab..

The eye-shaped lifting hooks were analyzed for pullout resistance of the embedment and the tension resistance of the hooks. The thickness of the floor slabs was 200mm thick and an embedment length of 150mm was used. The governing factor was the pullout resistance, which was calculated to be 3.5 tons. However, it is recommended that a factor of safety of 3.5 is applied to yield a **load rating of 1.0 ton**.

Eye-shaped lifting hooks, located in the motor room

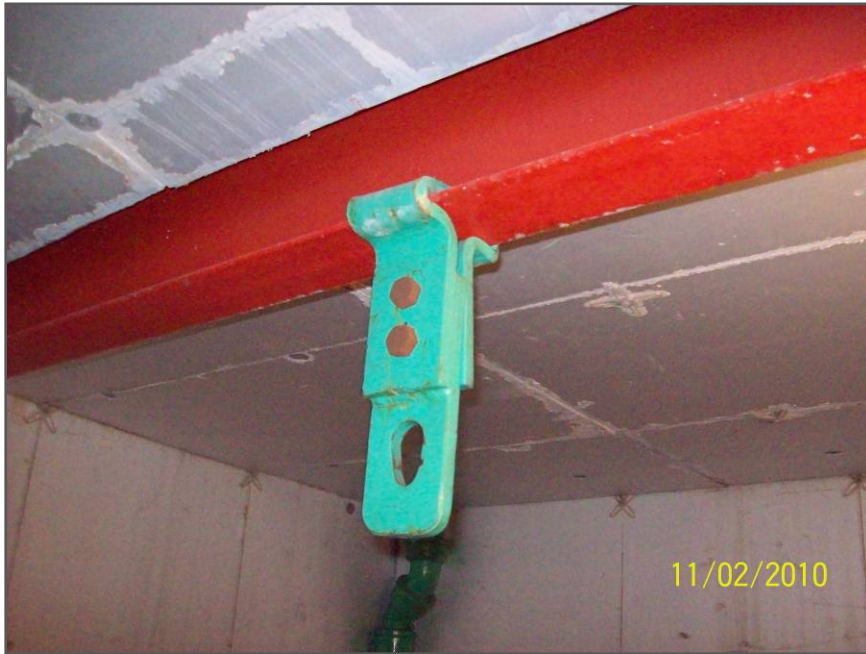
Photograph No. 3

The main floor has a lifting W-Beam (175mm high by 93mm wide) that spans 3600mm from wall to wall, where the underside of its flange is welded to a shelf angle on each side. The shelf angles are anchored to the wall with two (2) 17mm anchor bolts. The beam has a sliding hook attached to it.

The W-beam on the main floor was analyzed for moment resistance of the beam and the shear resistance of the bolted connection. The shear resistance was found to be the governing factor at 3.0 tons. This was reduced by a factor of 3.0 for a **load rating of 1.0 ton**.

Lifting beam located on the main floor

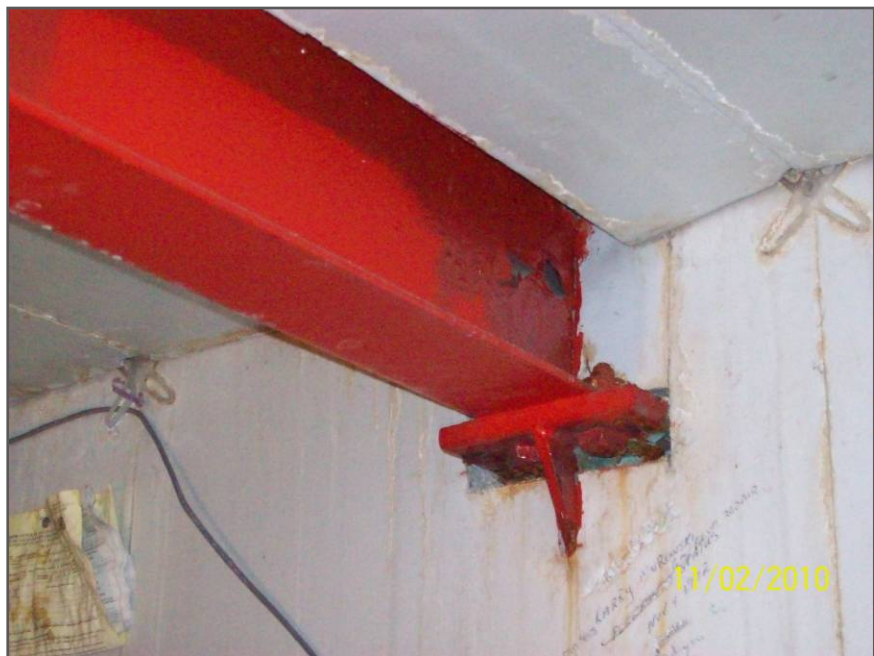
Photograph No. 4

Lifting beam wall connection detail, covered by dry-wall
