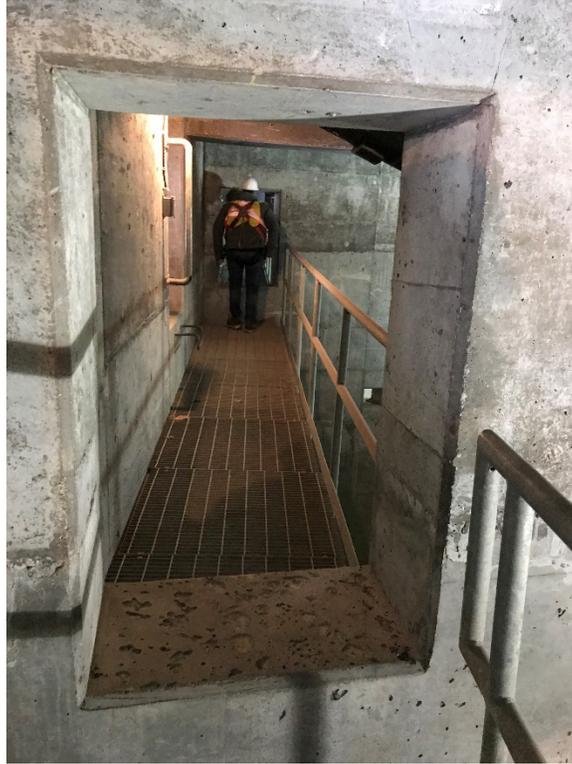
Site 1 – North abutment looking west, typical abutment access hole.

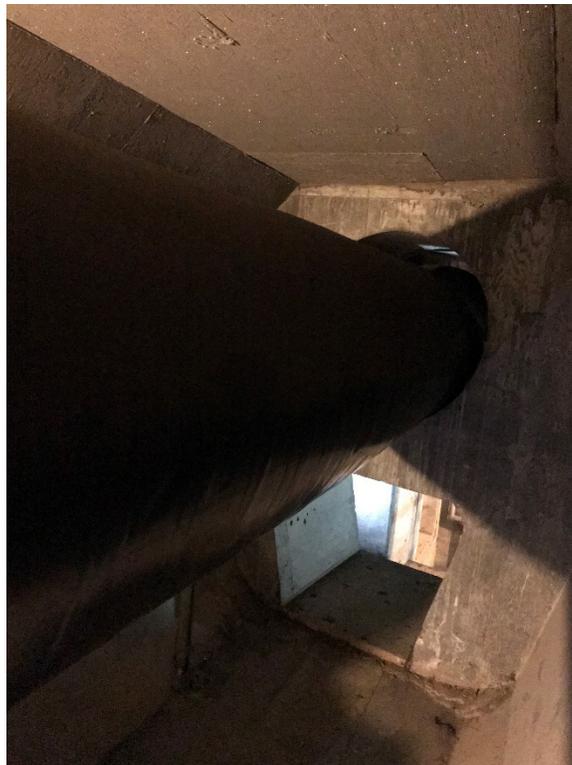
Site 1 – 500 mm FRM at south abutment wall, typical access hole in box girders.

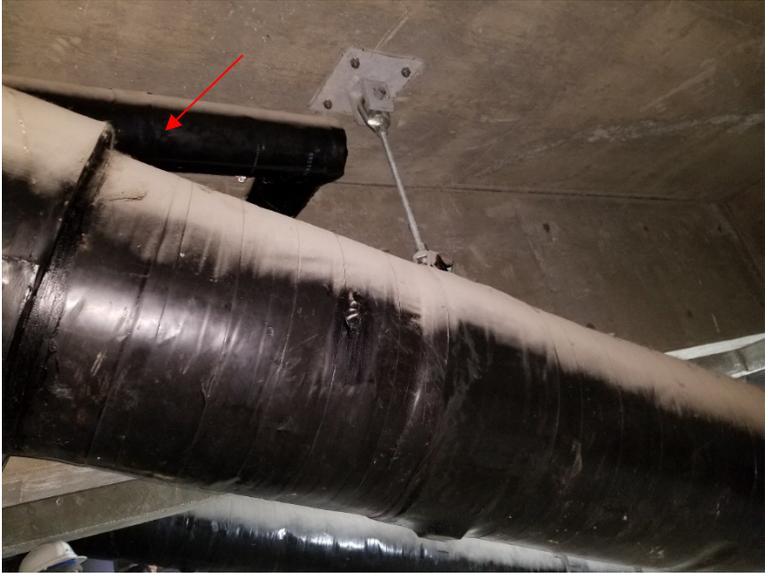
Site 1 – North abutment looking west, air release piping.

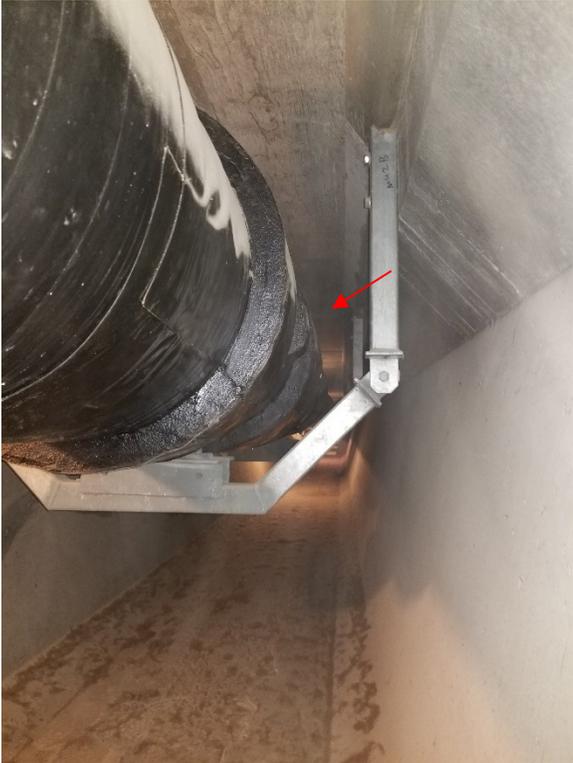
Site 1 – 500 mm FRM, expansion joint in box girder.

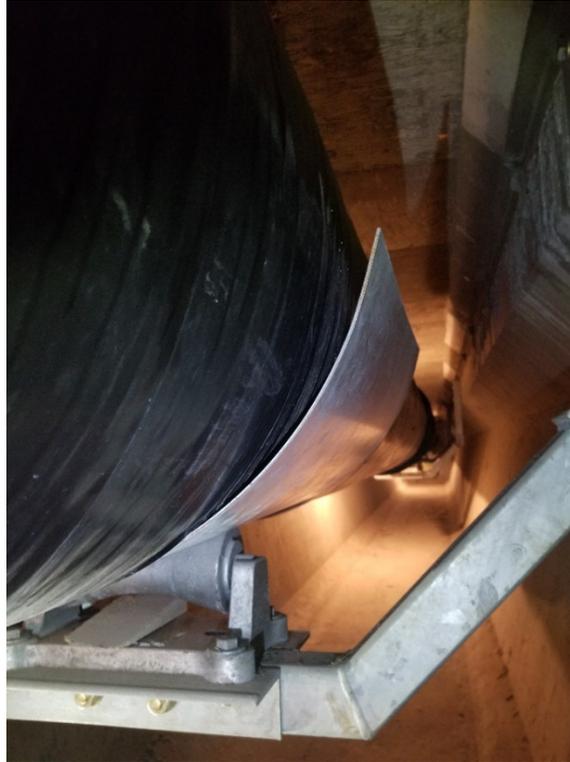
Site 1 – Typical roller support and weight distribution plate.

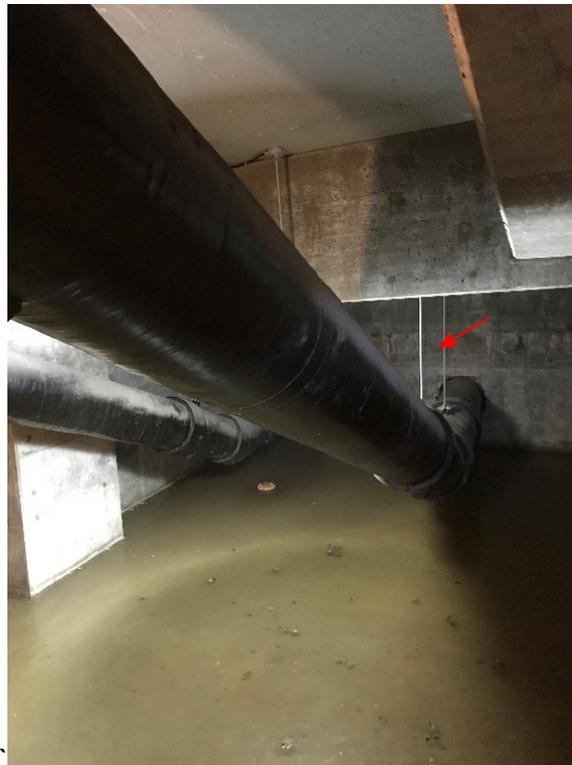
Site 1 – South abutment chamber looking south, wall penetration, hanger supports, elbow and couplers.

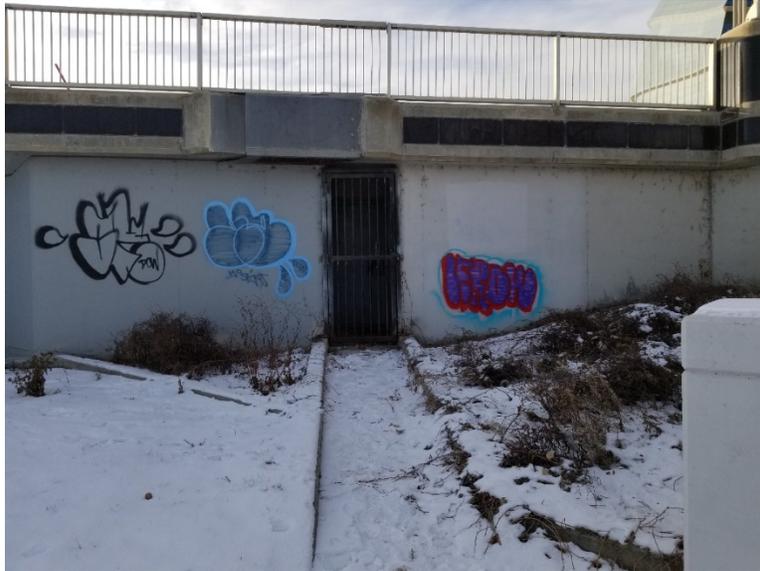
Site 2 – West abutment access door looking south.

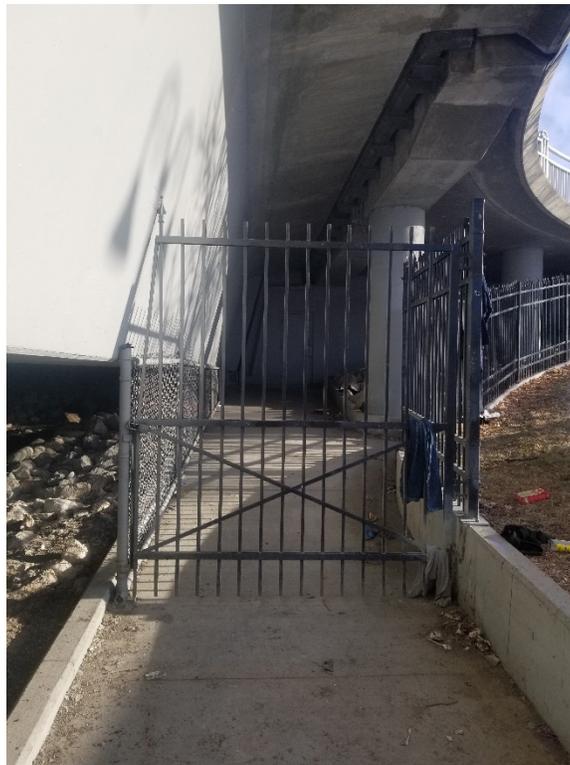
Site 2 – East abutment access gate and door looking east.

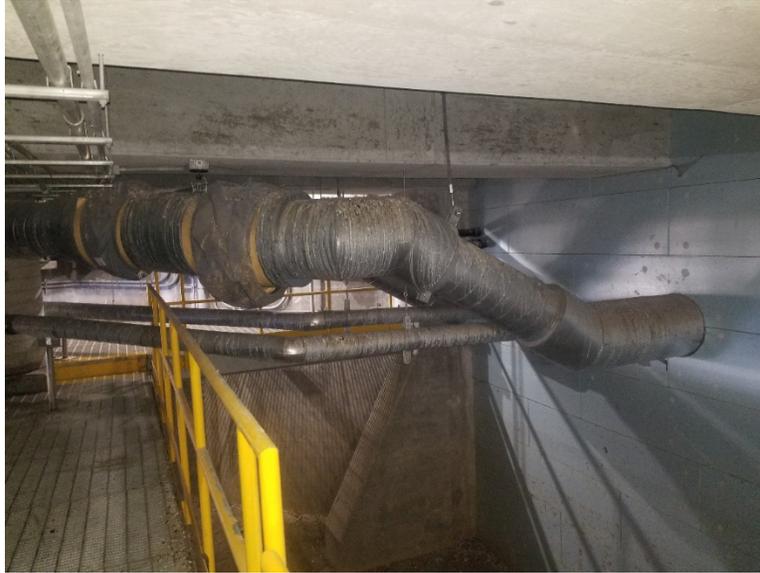
Site 2 – West abutment piping looking south, expansion joints, pipe hanger, and welded joints.

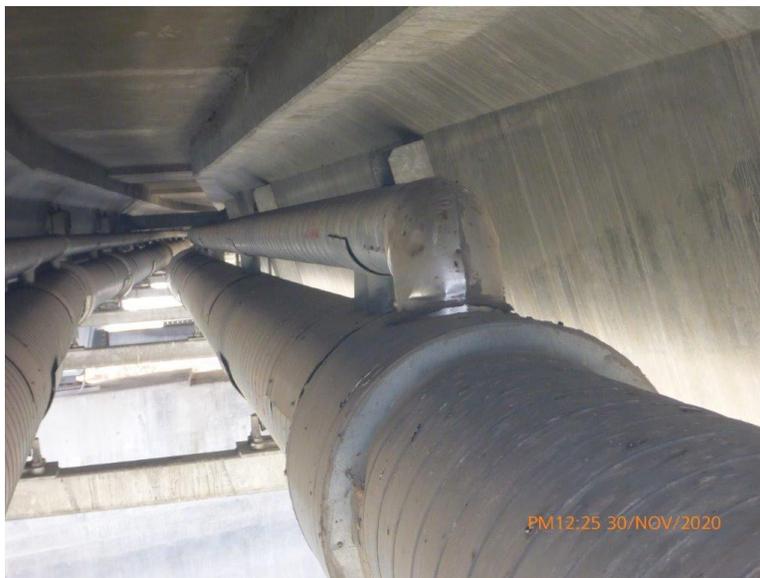
Site 2 – Air release connection at mid span of bridge, looking west.

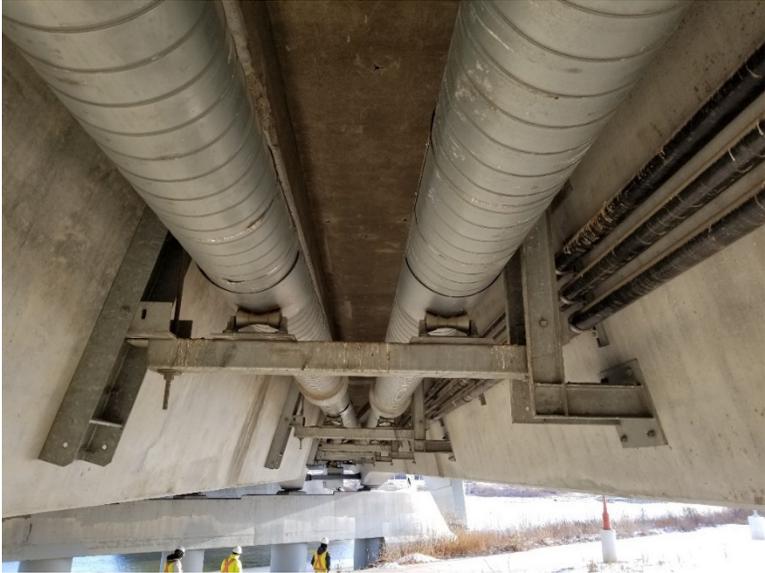
Site 2 – West river bank looking east.

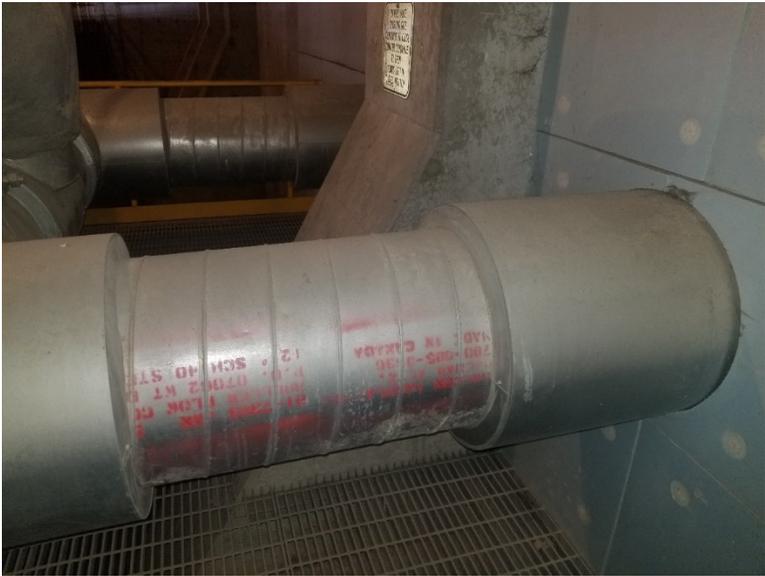
Site 2 – East abutment looking north, pipe wall penetrations.

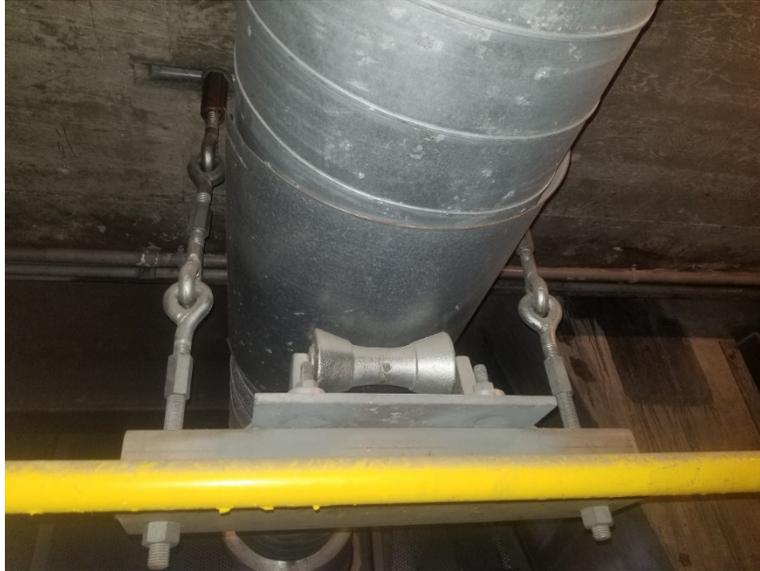
Site 2 – East abutment looking west, pipe roller support.

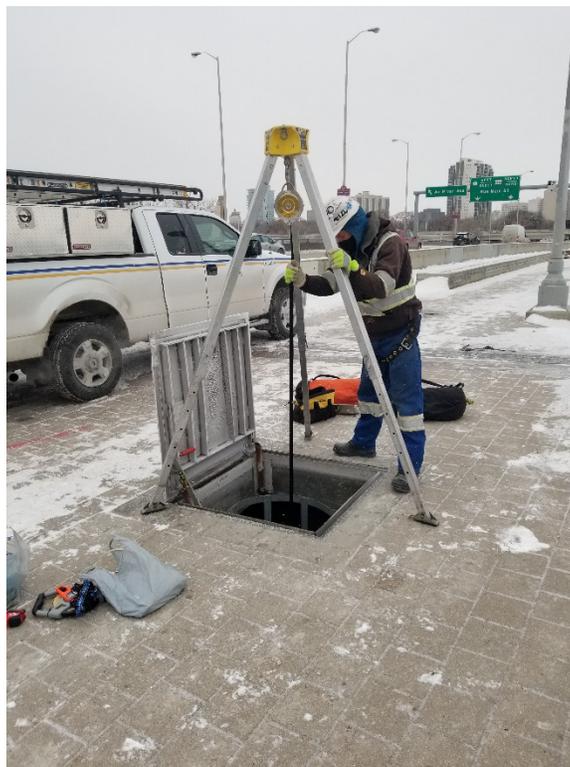
Site 3 – Typical sidewalk access hatch.

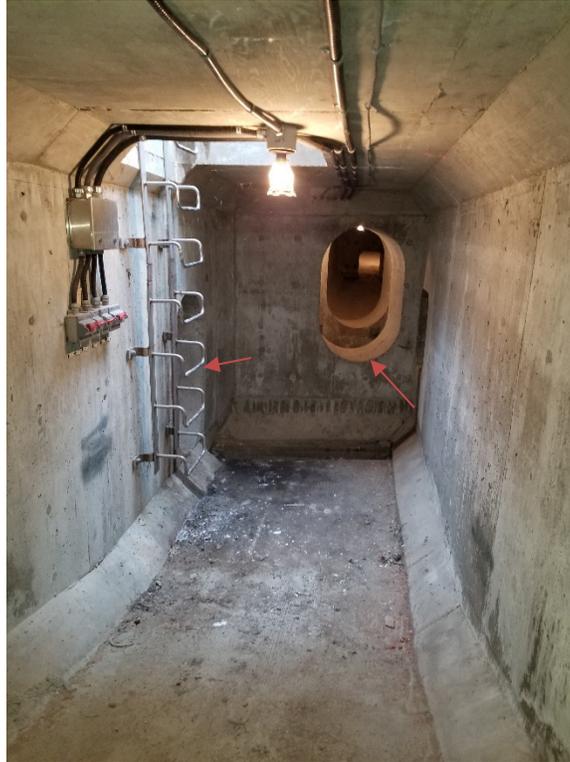
Site 3 – Hatch access girder looking west, pier access hole (west), bridge girder access hole (south).

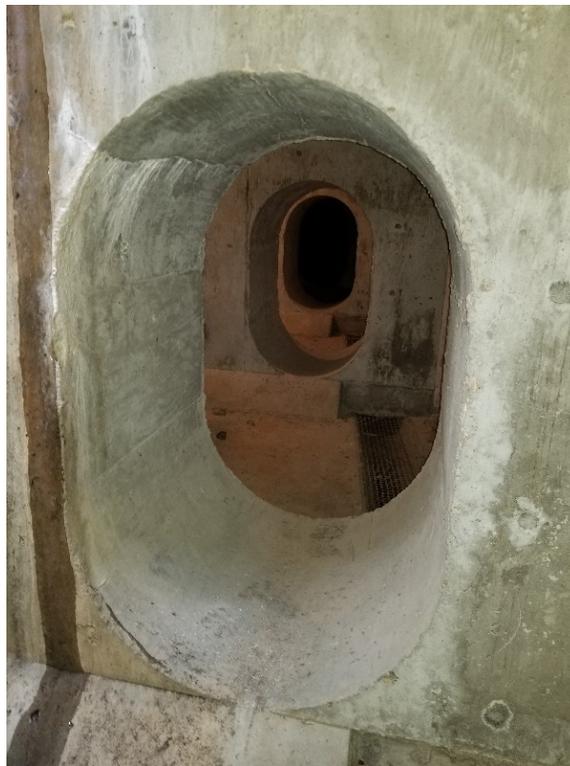
Site 3 – Typical bridge girder access holes looking south.

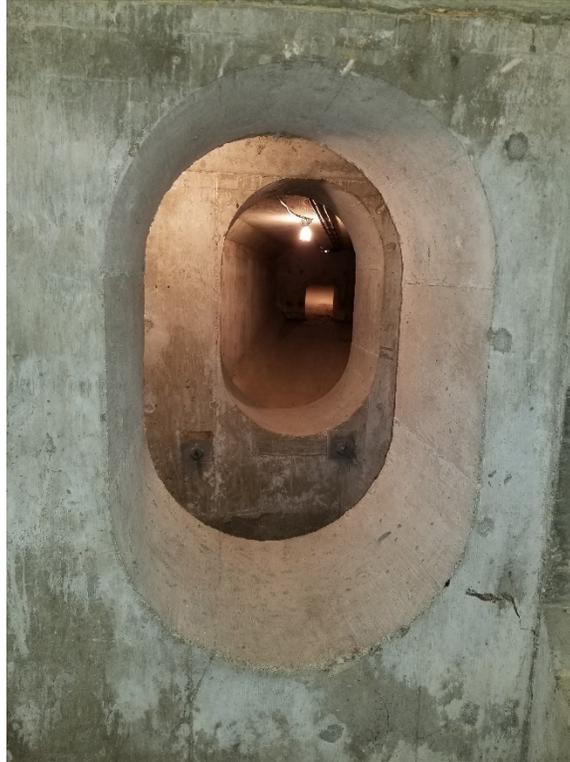
Site 3 – Typical bridge pier access hole looking west.

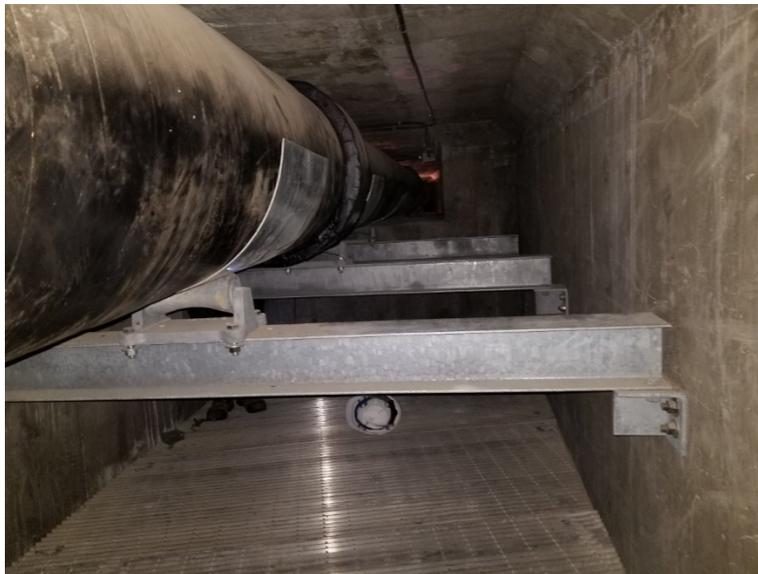
Site 3 – Force main piping and typical inspection platform at bridge piers.

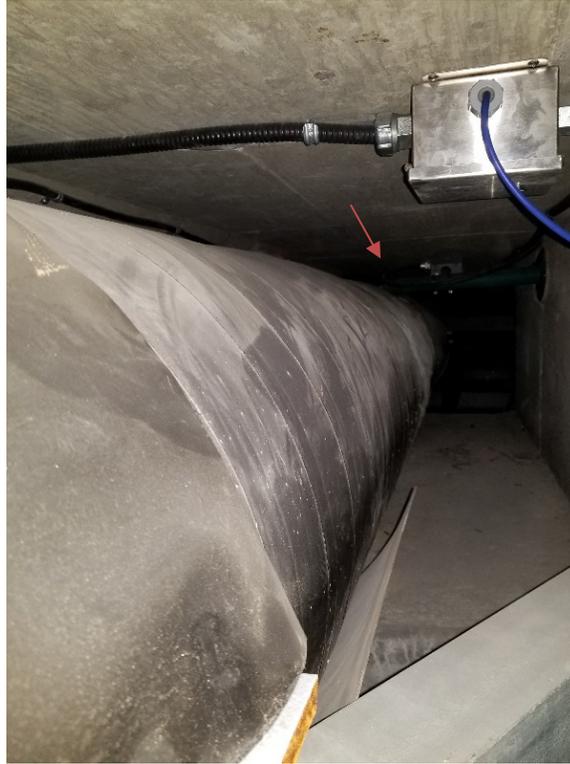
Site 3 – Air release tap within bridge pier looking west.

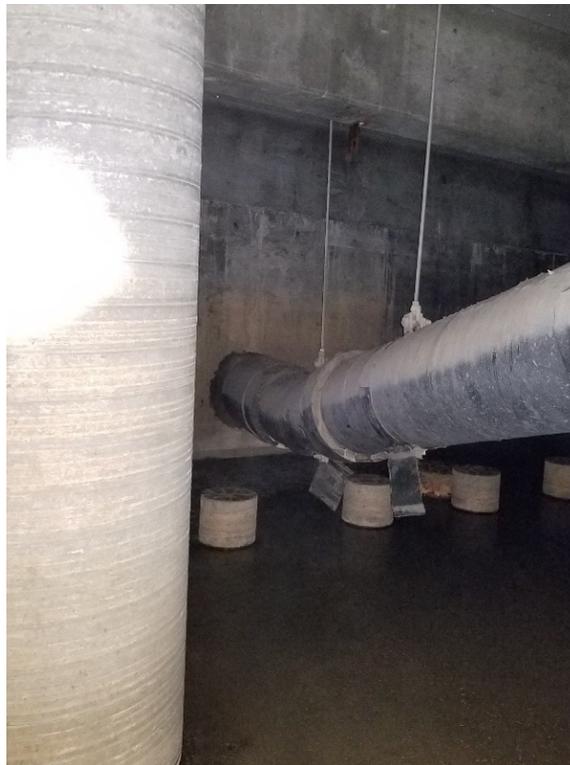
Site 3 – North abutment looking northeast, wall penetration, elbow, couplers, expansion joint, and hanger supports.

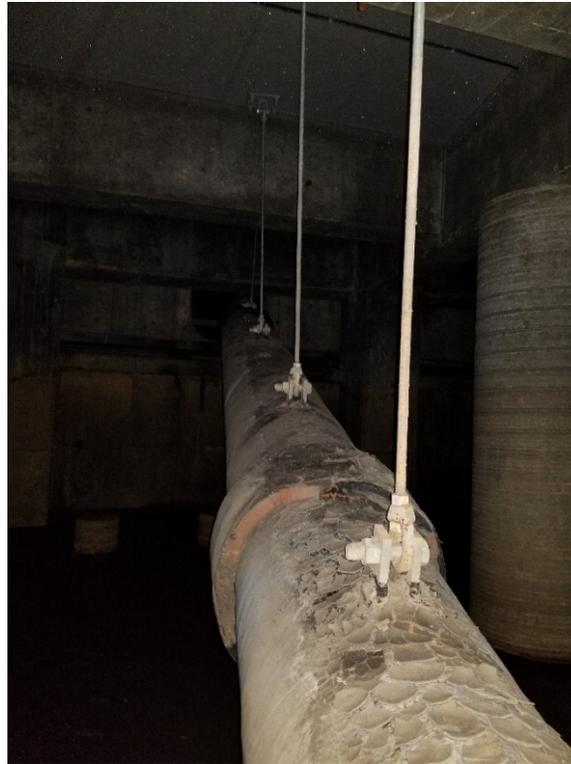
Site 3 – North abutment piping looking east.

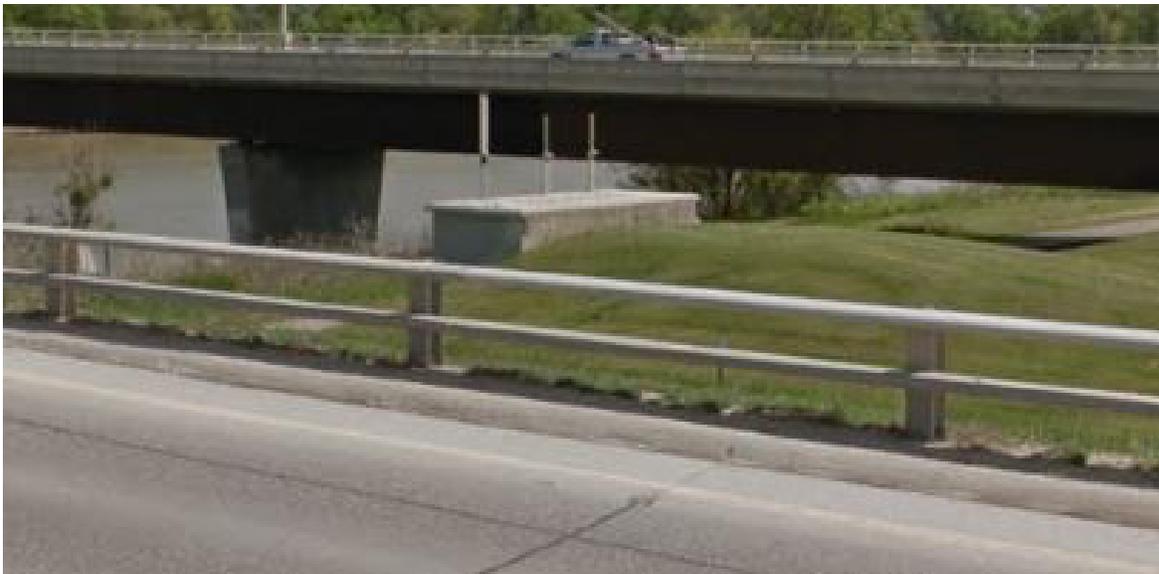
Site 4 – Siphon Inlet and Overflow Structure on West Bank.

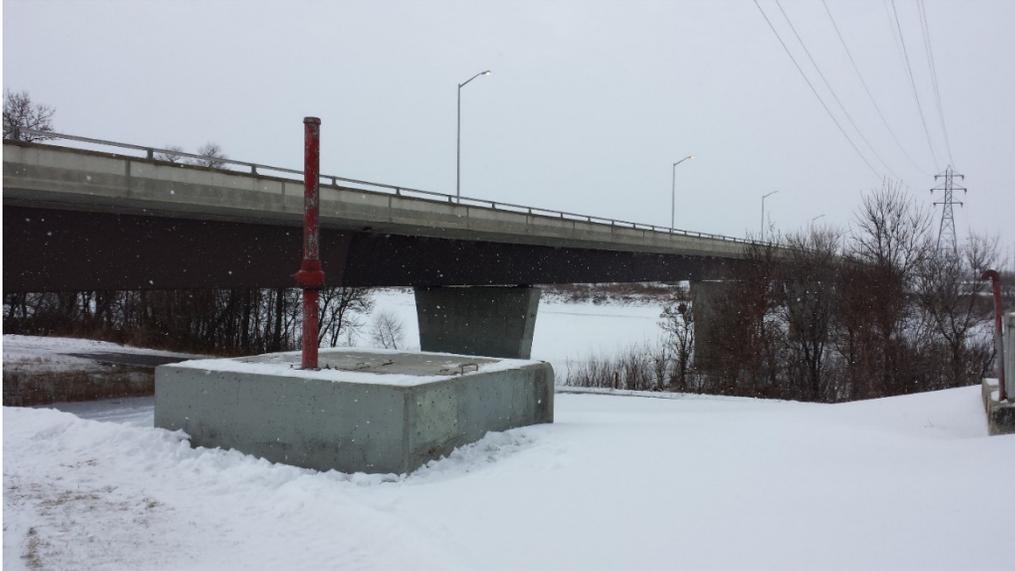
Site 4 – Siphon Outlet Chamber on East Bank.

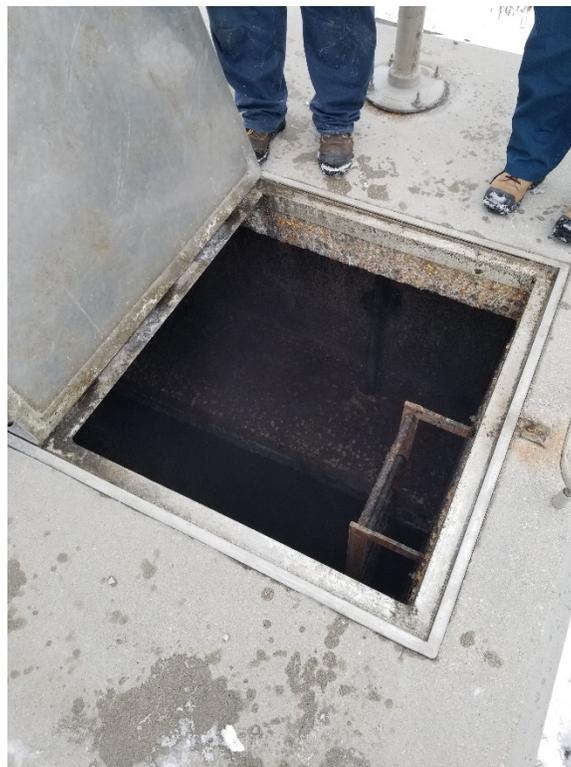
Site 4 – Inlet chamber south access panel looking northeast.

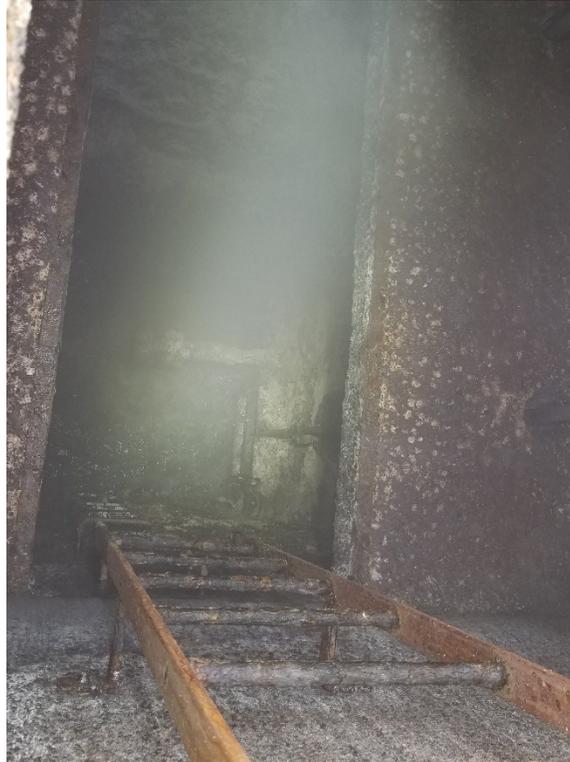
Site 4 – Inlet chamber south access ladder looking north.

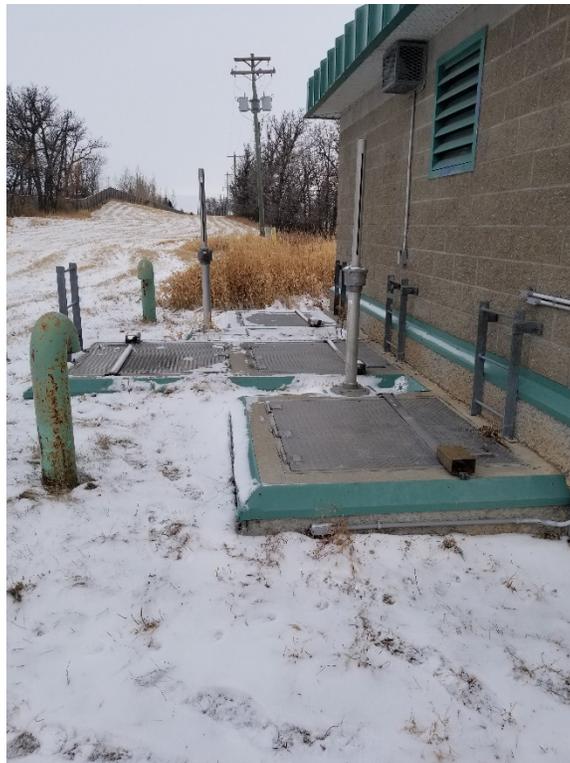
Site 5 – Wet wells at pumping station, looking north.

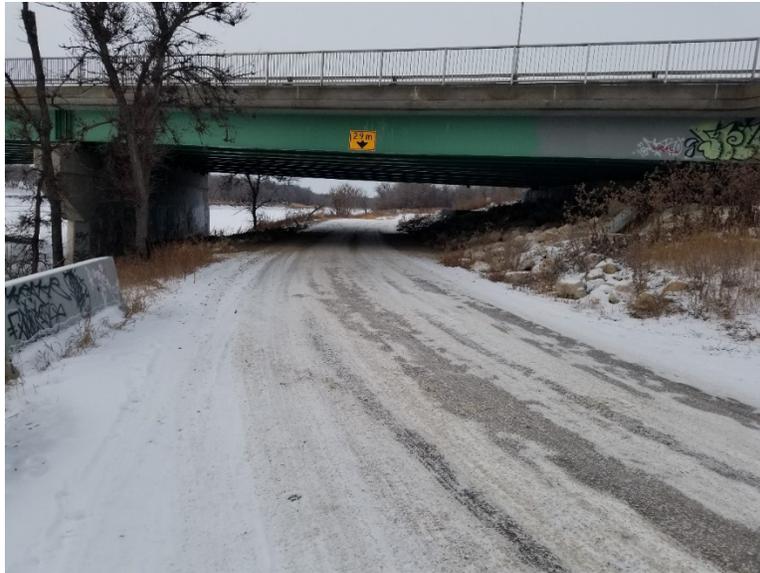
Site 5 – Bridge overpass on Oxbow Bend Rd, looking west.

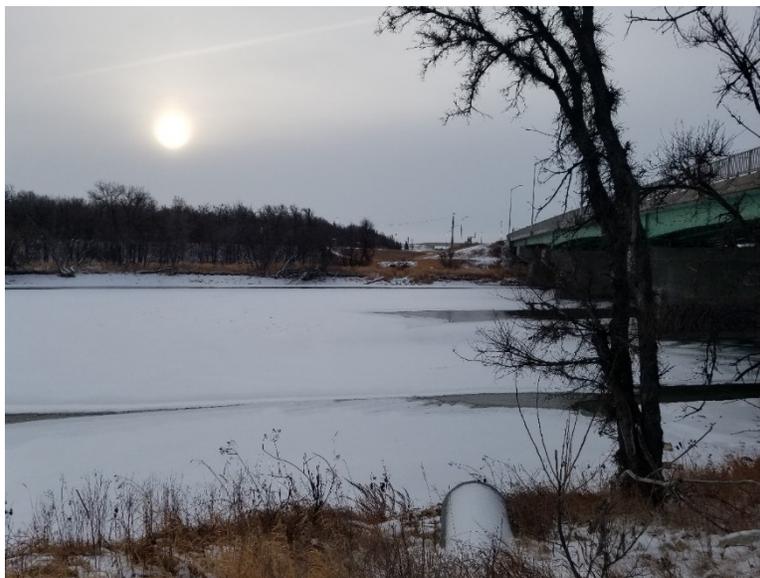
Site 5 – North bank looking south.

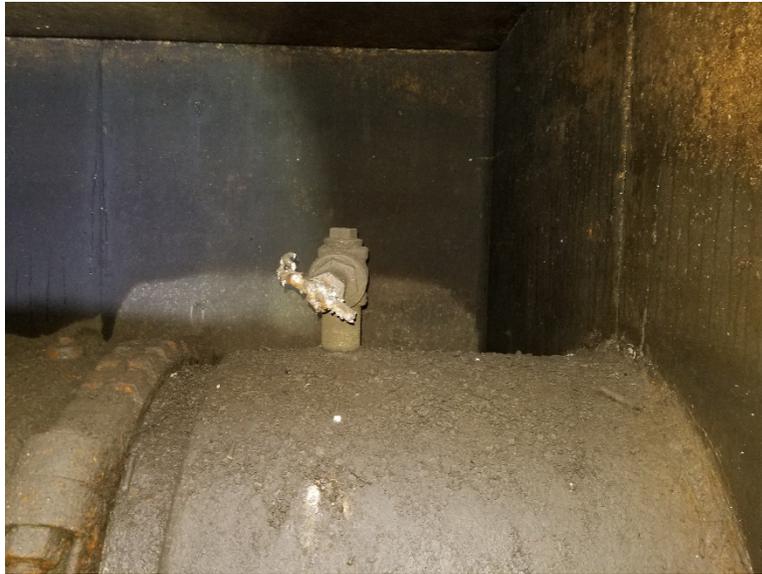
Site 7 – Existing West 50 mm Gate Valve, looking South from bottom of ladder.

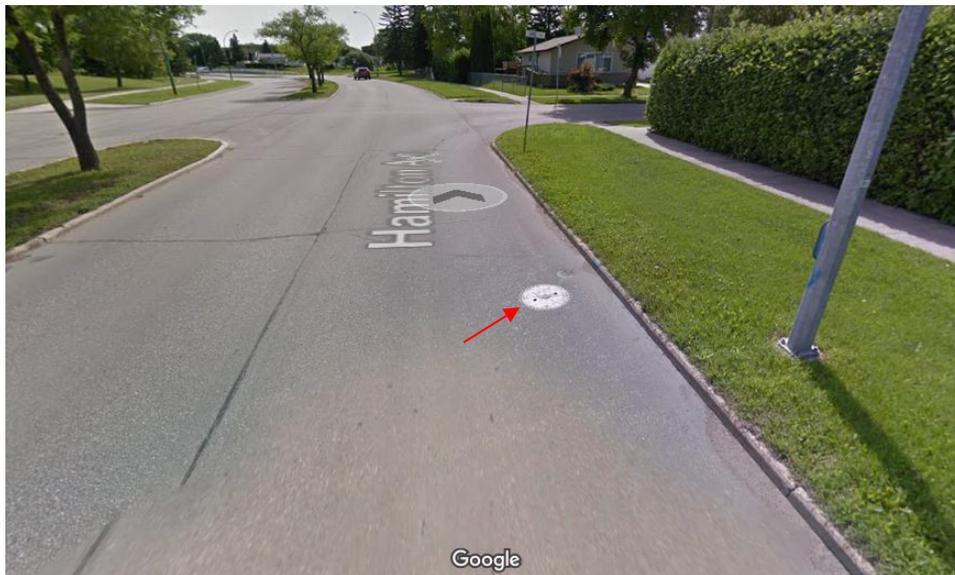
Site 7 – Existing manhole cover to valve chamber, eastbound Hamilton Avenue looking east.

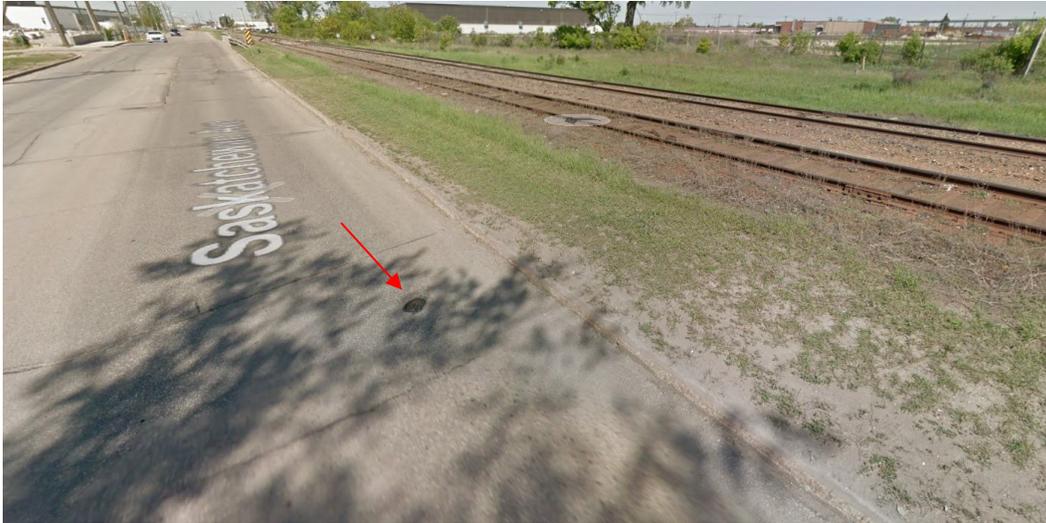
Site 8 – Existing air release valve in roadway, looking north.

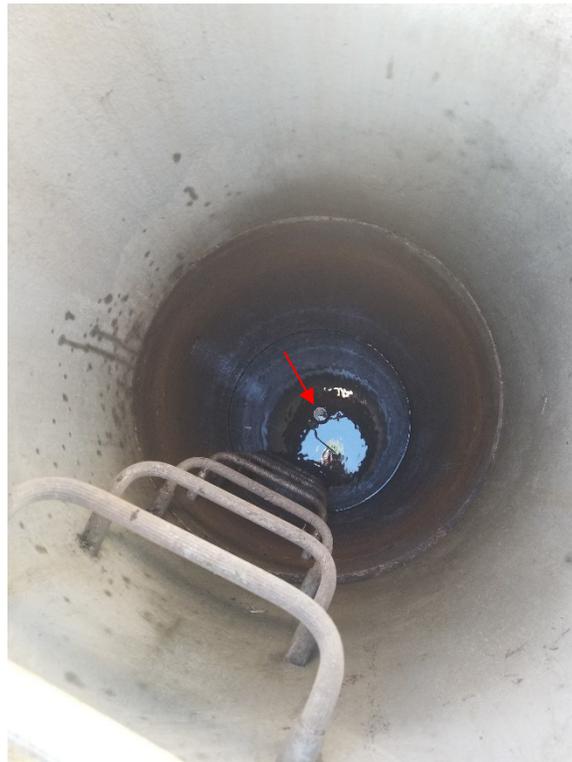
Site 9 - Existing air release valve in existing 750 manhole, looking south.

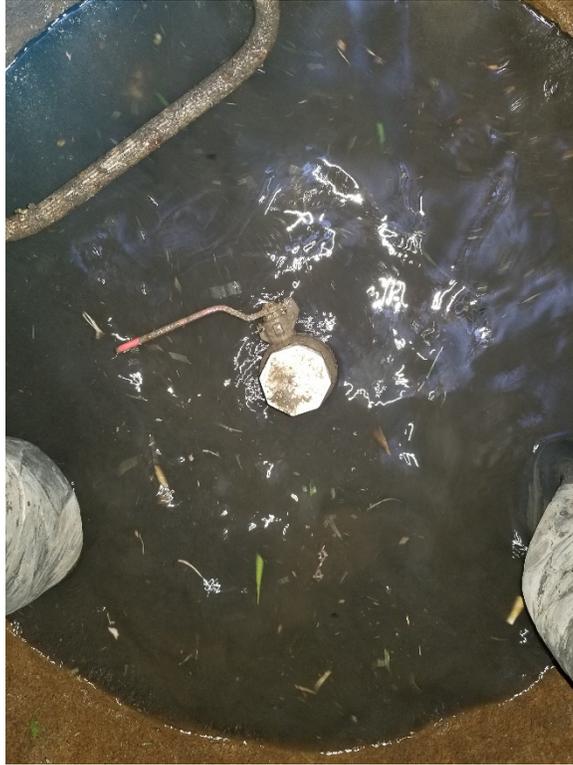
Site 9 – Existing air release valve in existing 750 manhole.

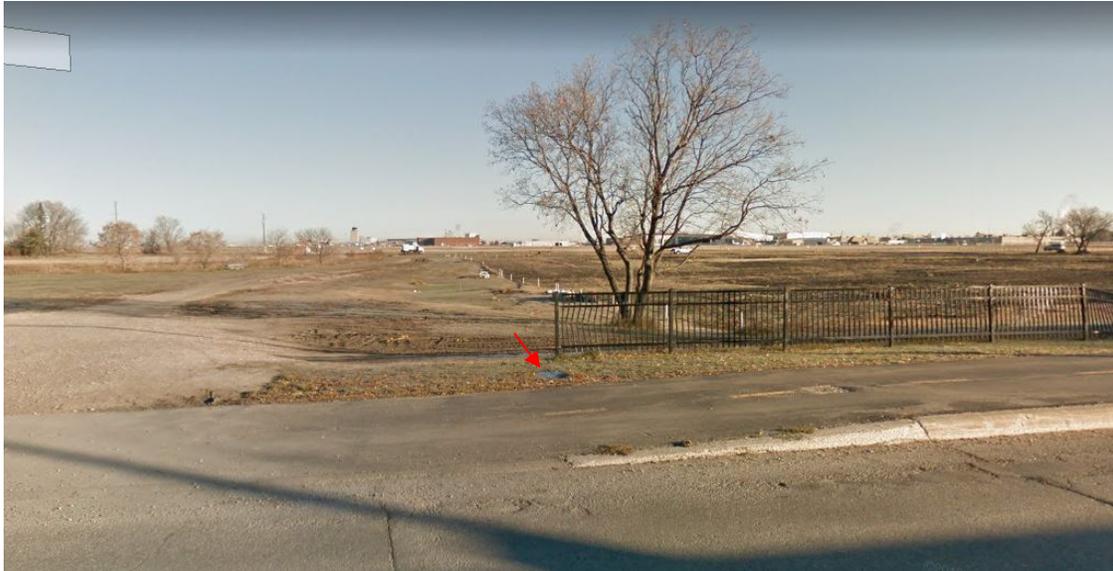
Site 9 – 750 manhole lid to air release valve, looking north from Silver Avenue.

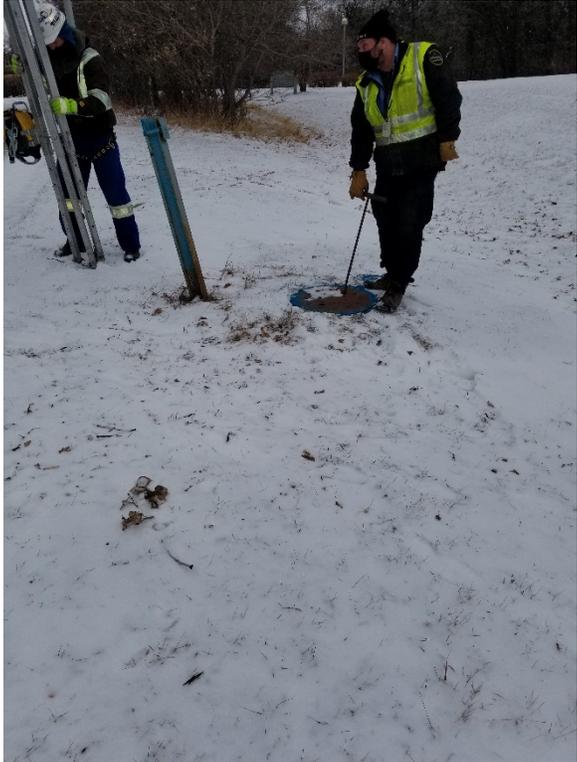
Site 10 – South chamber cover, looking north.

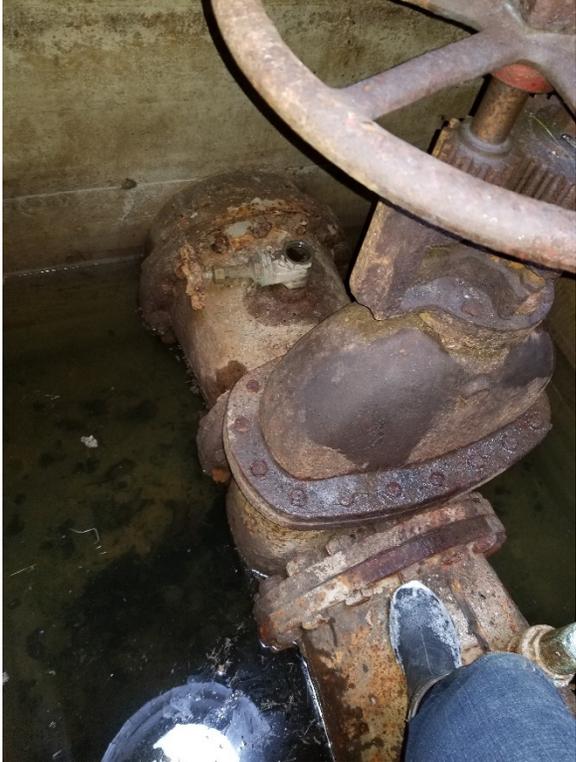
Site 10 – Existing 50 mm air valve in south chamber, looking north.

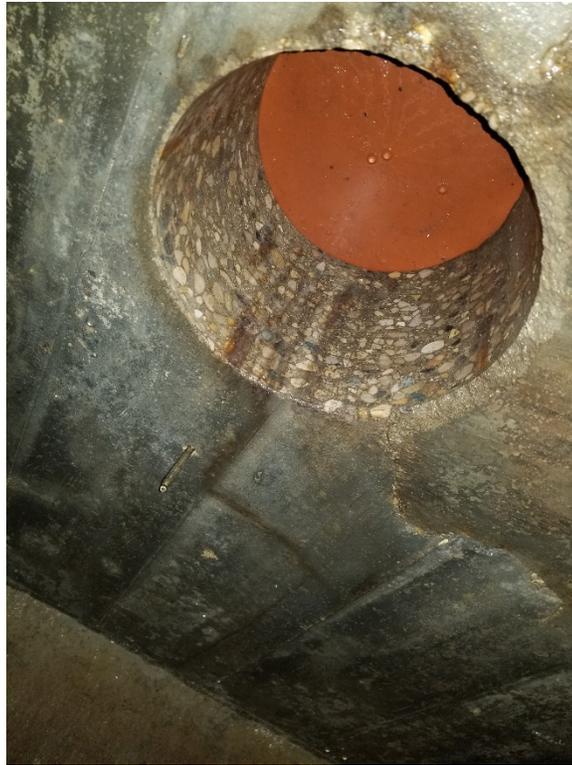
Site 10 - Existing core hole in south chamber roof slab, looking north.

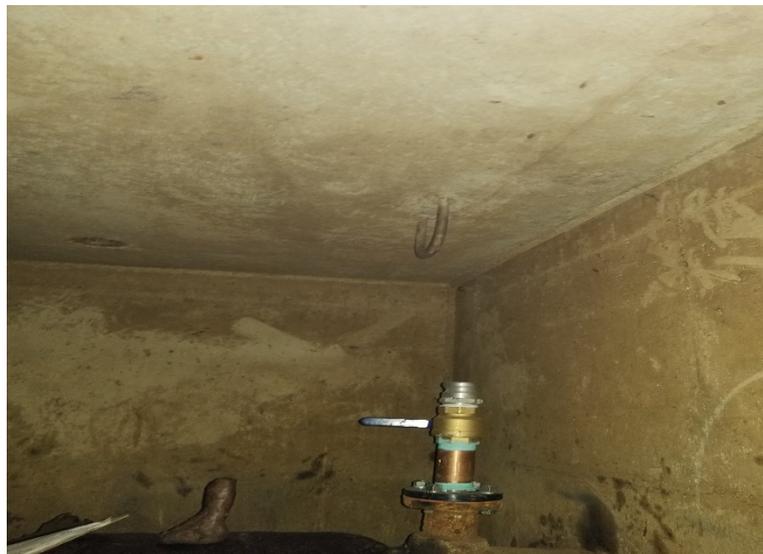
Site 11 – Existing 50 mm air valve and roof slab in chamber located west of McPhillips Street.

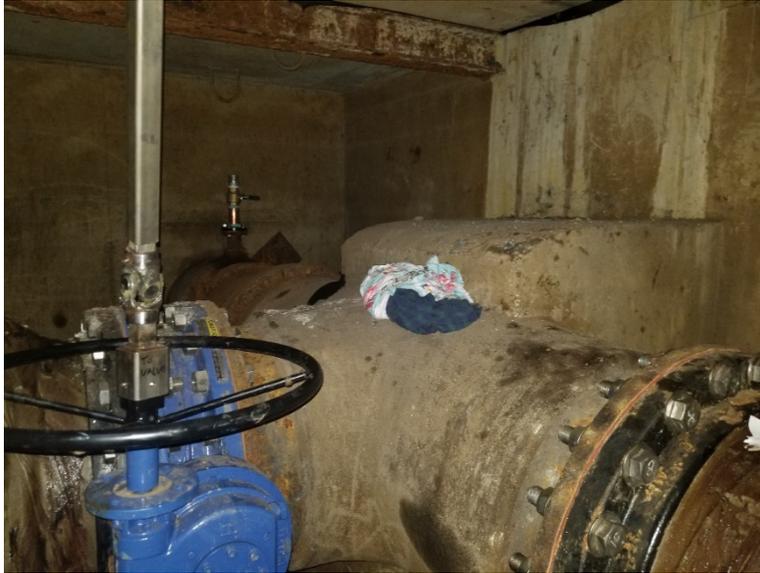
Site 11 – General layout of chamber, looking northwest.
