**Station Name:** Syndicate Lift Station

**Date of Inspection:** January 26, 2010

**Inspecting Firm:** MMM Group Limited (MMM)

**Client:** City of Winnipeg – Water and Waste Department

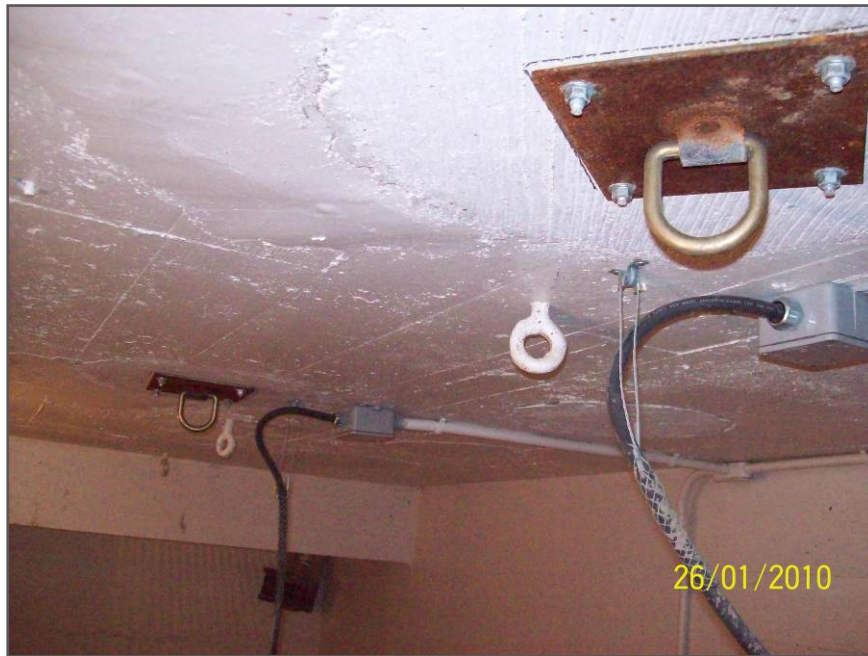
**Photograph No. 1**

The pump room located three floors below ground has two (2) eye-shaped lifting hooks, fabricated of 19.4mm diameter steel rod, embedded into the underside of the motor room cast-in-place concrete floor slab. There are also two (2) U-shaped lifting hooks that are welded to steel plates anchored in the underside of the motor room cast-in-place concrete floor slab with anchor bolts.

The analysis of the U-shaped lifting hooks welded to steel plates determined a rating of 1.1 tons due to the bending of the plates. A factor of safety of 2.0 was applied to yield a **load rating of 0.5 ton**.

Various lifting hooks located in the pump room

Ref.	Description	Priority
4.1	Paint U-shaped lifting hooks in pump room to prevent further corrosion	B

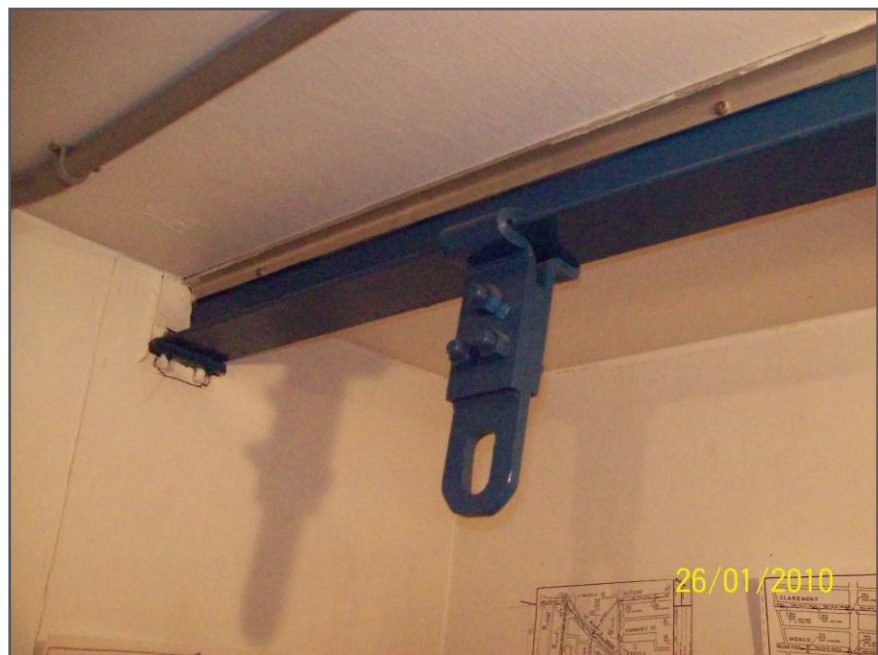
**Photograph No. 2**

The main floor has a lifting beam spanning 2700mm along the entire width of the room. It is a W-Beam (175mm high by 93mm wide) and has a sliding hook attached to it. The wall connections are not visible on either side of wall due to insulation.

The W-beam on the main floor was analyzed for moment resistance in the beam and the shear resistance of an assumed bolted connection. The shear resistance was found to be the governing factor at 3.0 tons. This was reduced by a factor of safety of 3.0 to yield a **load rating of 1.0 ton**

Lifting beam located on the main floor
