# ASBESTOS INVENTORY CONTROL

<b>Building Name:</b>	Pan Am Pool - Building	<b>Inspection Date:</b>	February 11, 2021
<b>Building Code:</b>	PI-13	<b>Inspected By:</b>	Ryan Matthews & Will Deller
<b>Building Address:</b>	25 Poseidon Bay	<b>Construction Date:</b>	1967

# PI-13

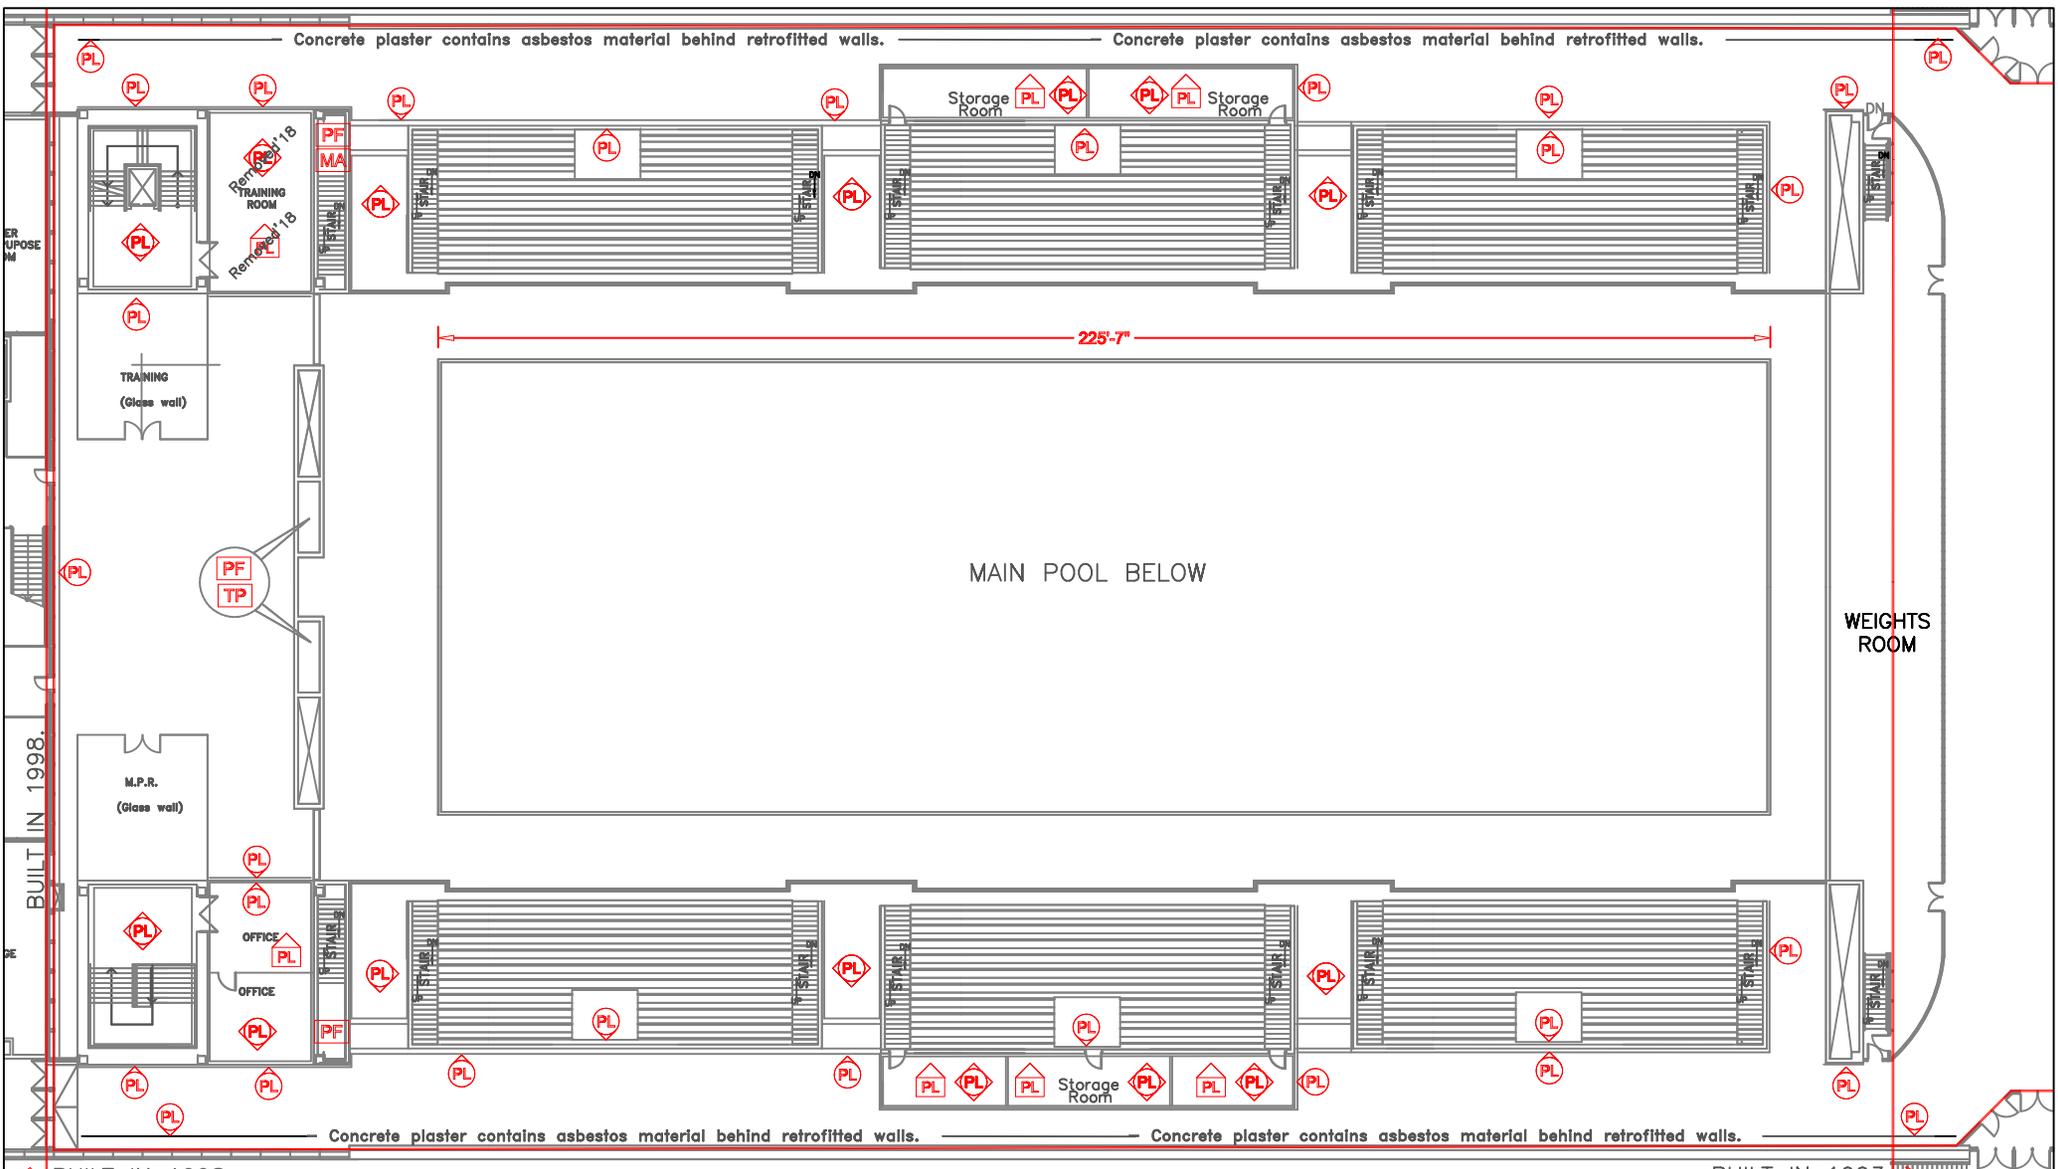
**SECOND FLOOR PLAN – Mezzanine level**  
 SCALE: NTS

Remark:  
 - All concrete plasters in ceilings and walls contained asbestos materials except for the retrofitted walls in north & south exterior concrete wall of which asbestos materials located behind that walls.

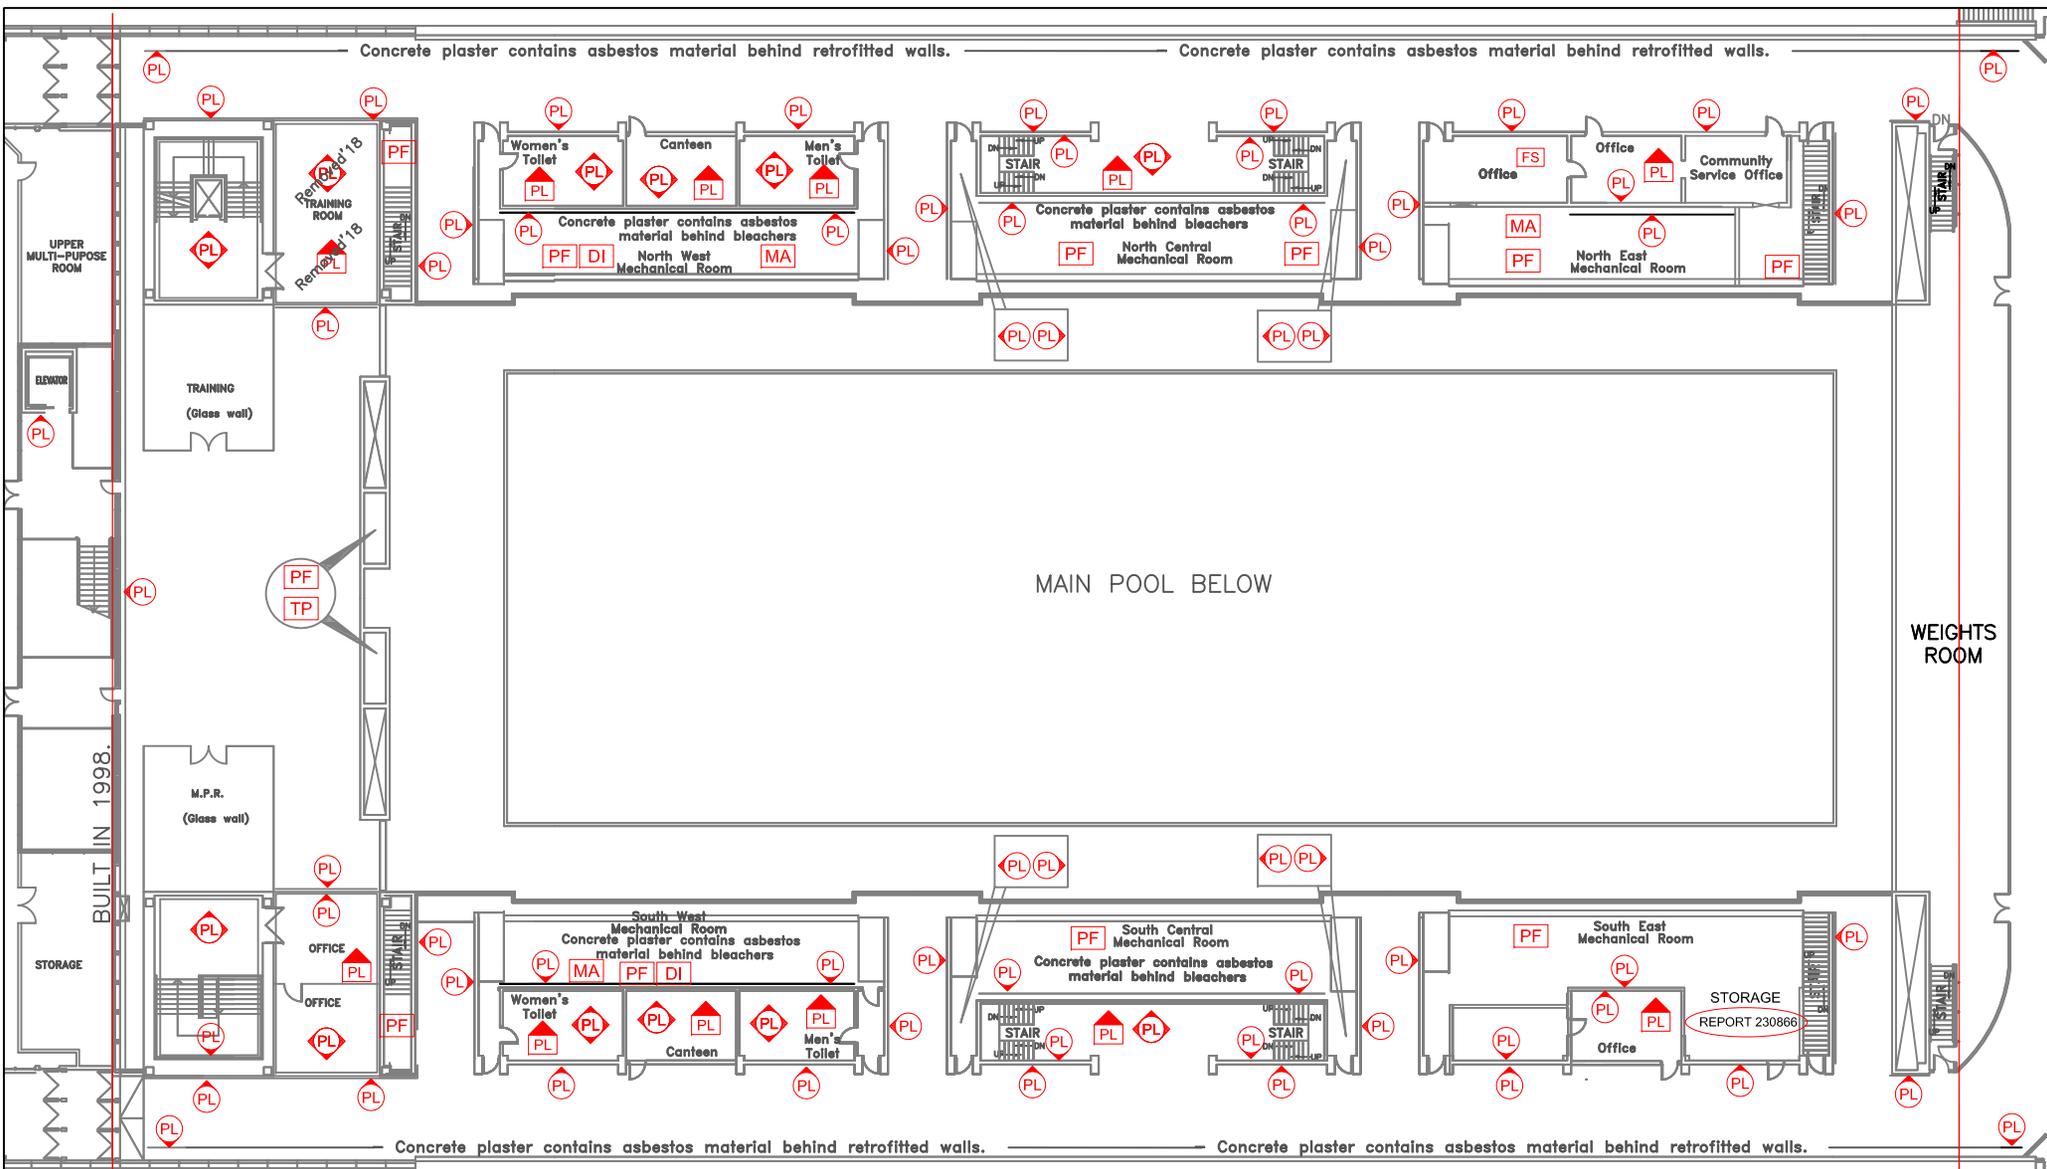
**SECOND FLOOR PLAN without bleachers**  
SCALE: NTS

**Remark:**  
- All concrete plasters in ceilings and walls contained asbestos materials except for the retrofitted walls in north & south exterior concrete wall of which asbestos materials located behind that walls.

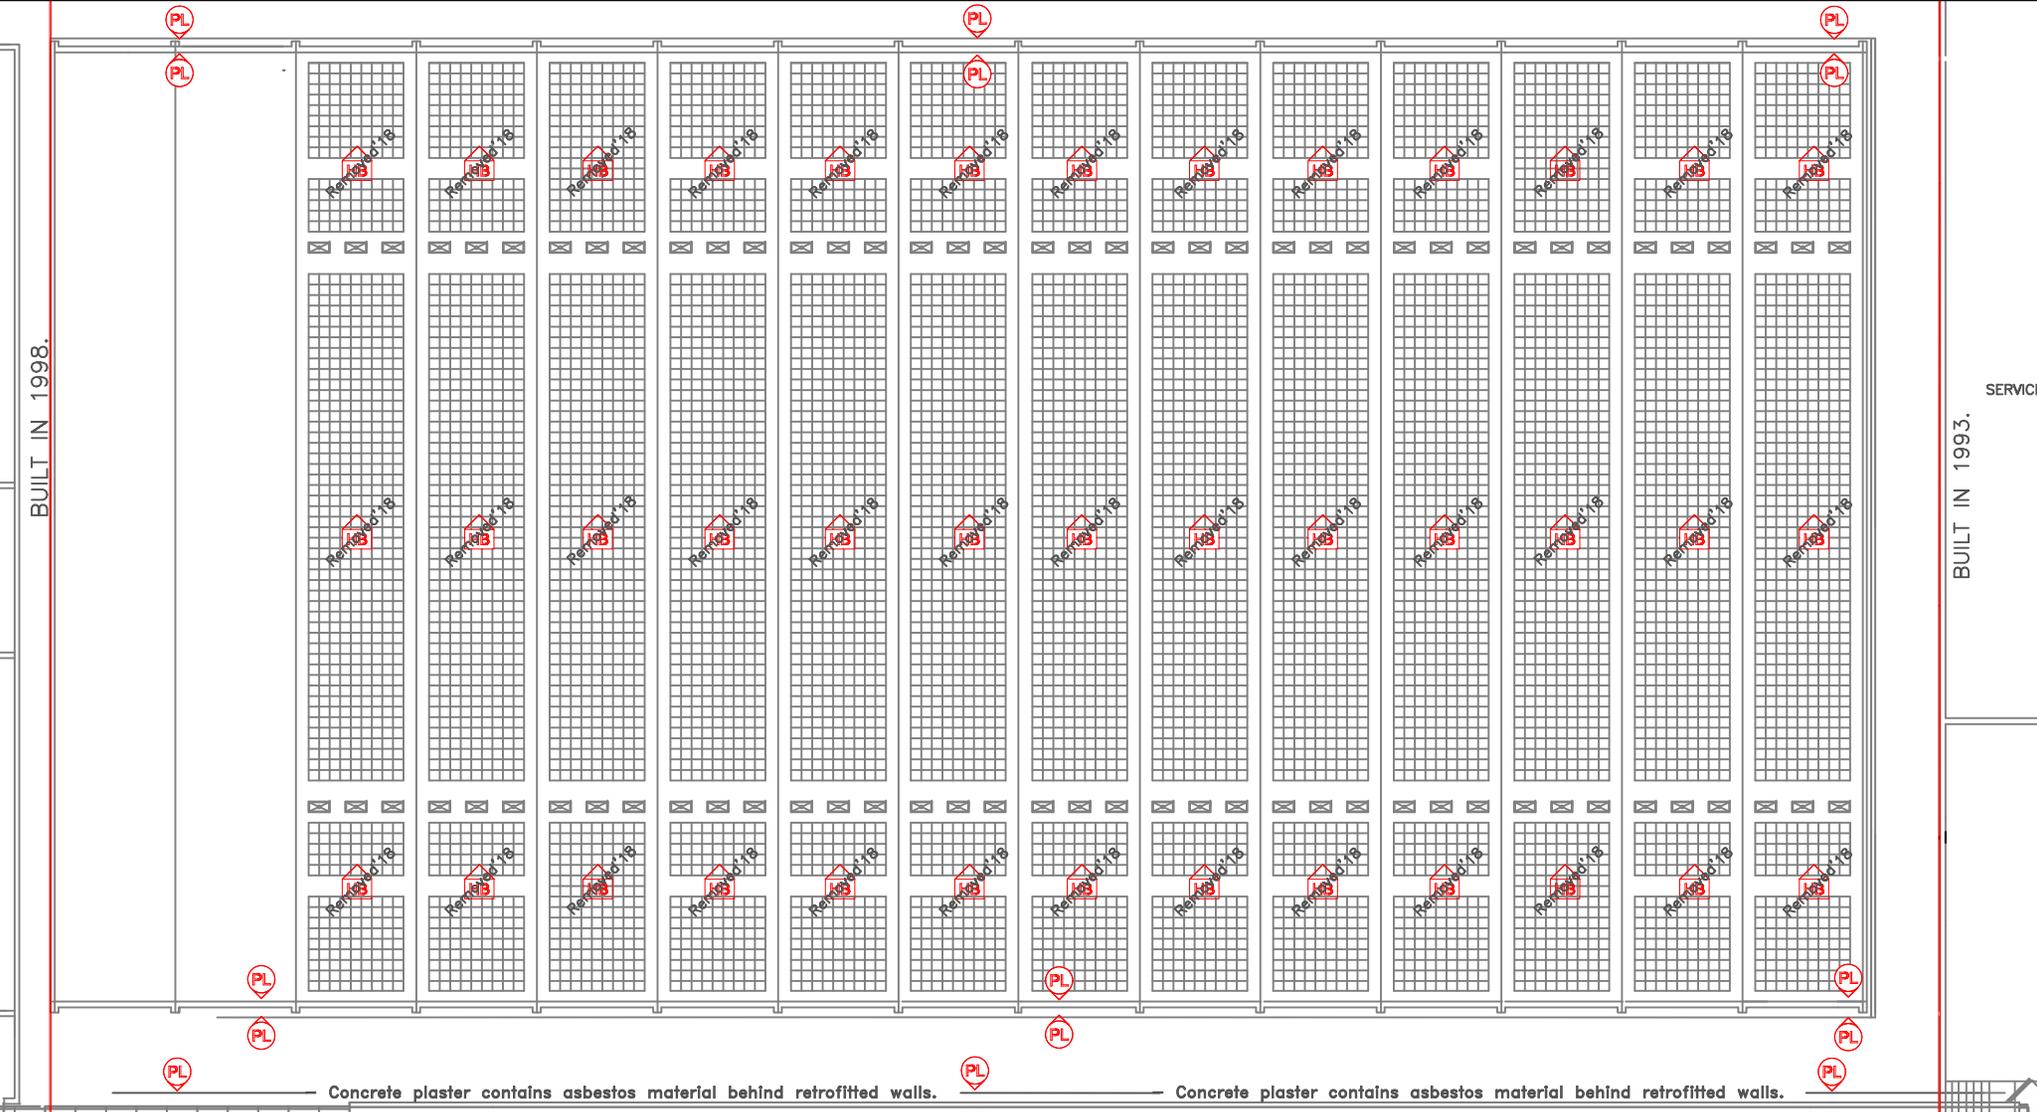
**SECOND FLOOR CEILING PLAN**  
SCALE: NTS

Concrete plaster contains asbestos material behind retrofitted walls.

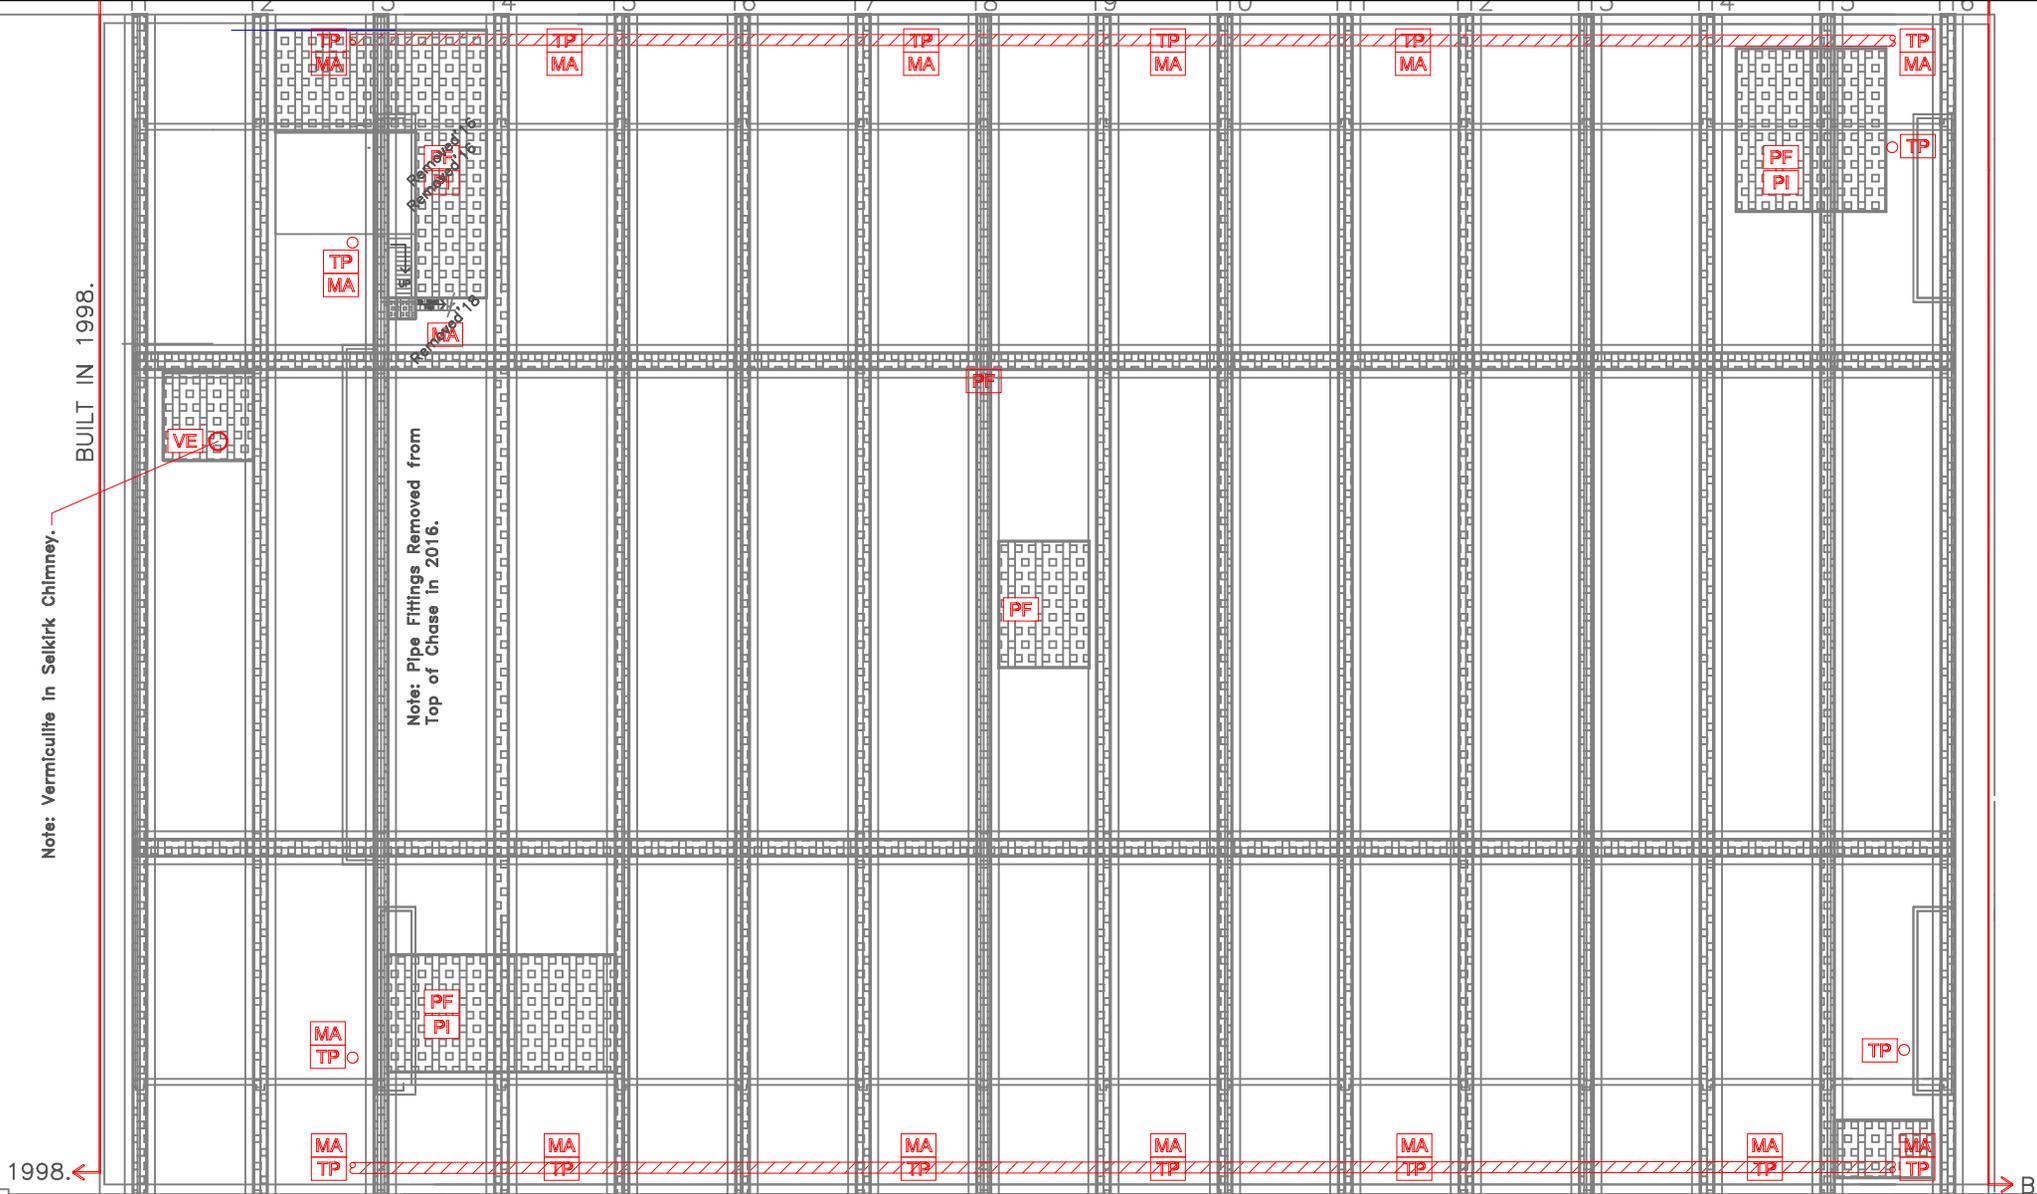
**ROOF CATWALK PLAN**  
SCALE: NTS

Note: Vermiculite in Selkirk Chimney.

Remark:  
- Asbestos containing pipe fittings are through out catwalk area in various locations.
