THE CITY OF WINNIPEG

TENDER NO. 896-2021

NEWPCC UV TRANSFORMER REPAIR

Transformer Inspection Report

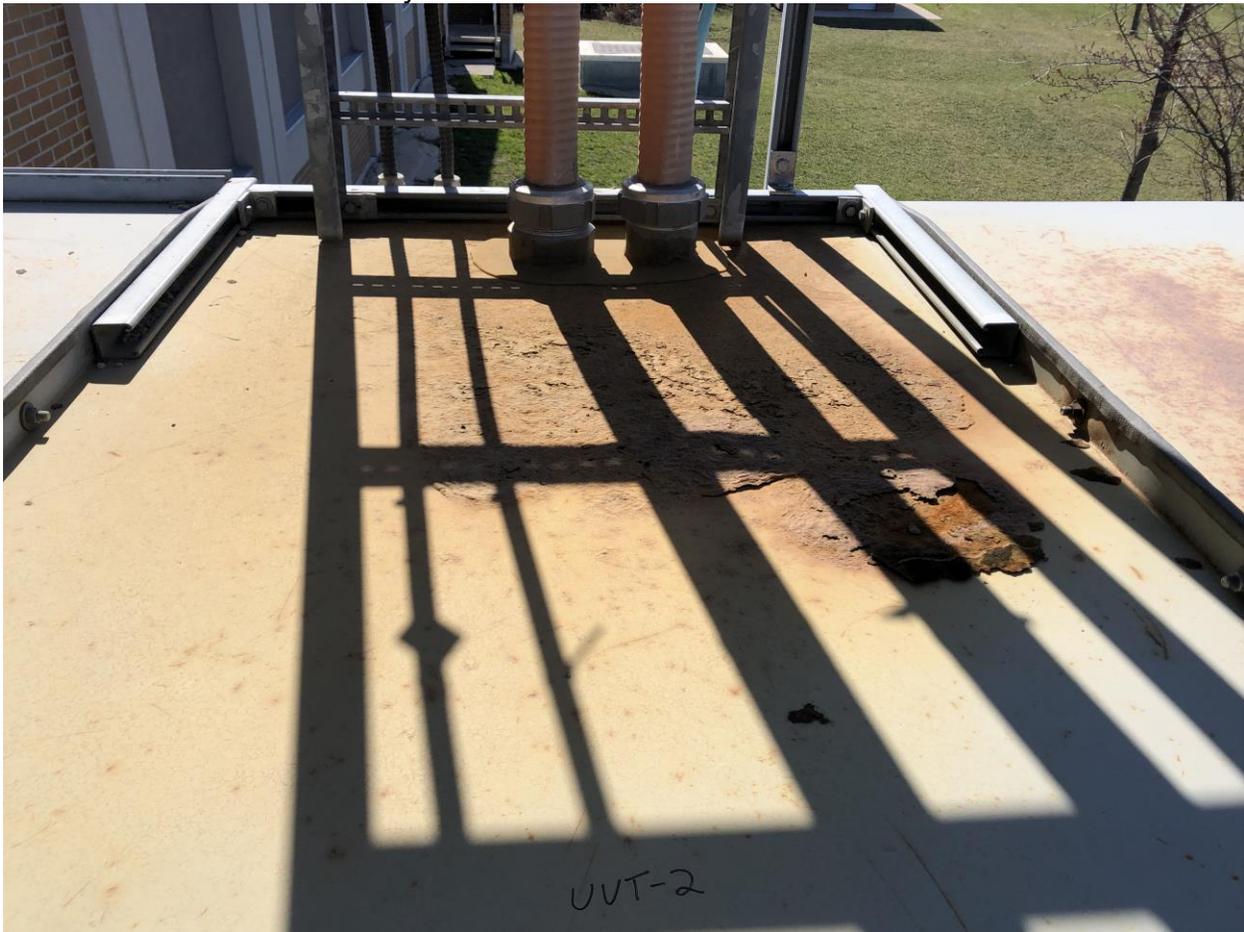
- All 4 outdoor 4160V dry type UV transformers have top entry cable and bus duct. That combined with 3 piece poorly designed enclosure roofs have caused water entry and corrosion of the roof tops. IER recommends continued monitoring of transformers.
- UVT-2 Severely corroded enclosure roof.

Exterior / Interior Condition: top rusting, inside cleaned

Cleaning and inspection only cannot isolate secondary for testing due to ground current of 72A at XO.
 Insulation Resistance High to Low and Ground @ 5KVDC for 1 minute = 43.1G ohms. Test includes primary cables.
 H1 Primary cables heat shrink split exposing tape shield. Shield is broken in 2 places.
 Top of transformer enclosure severely corroded.

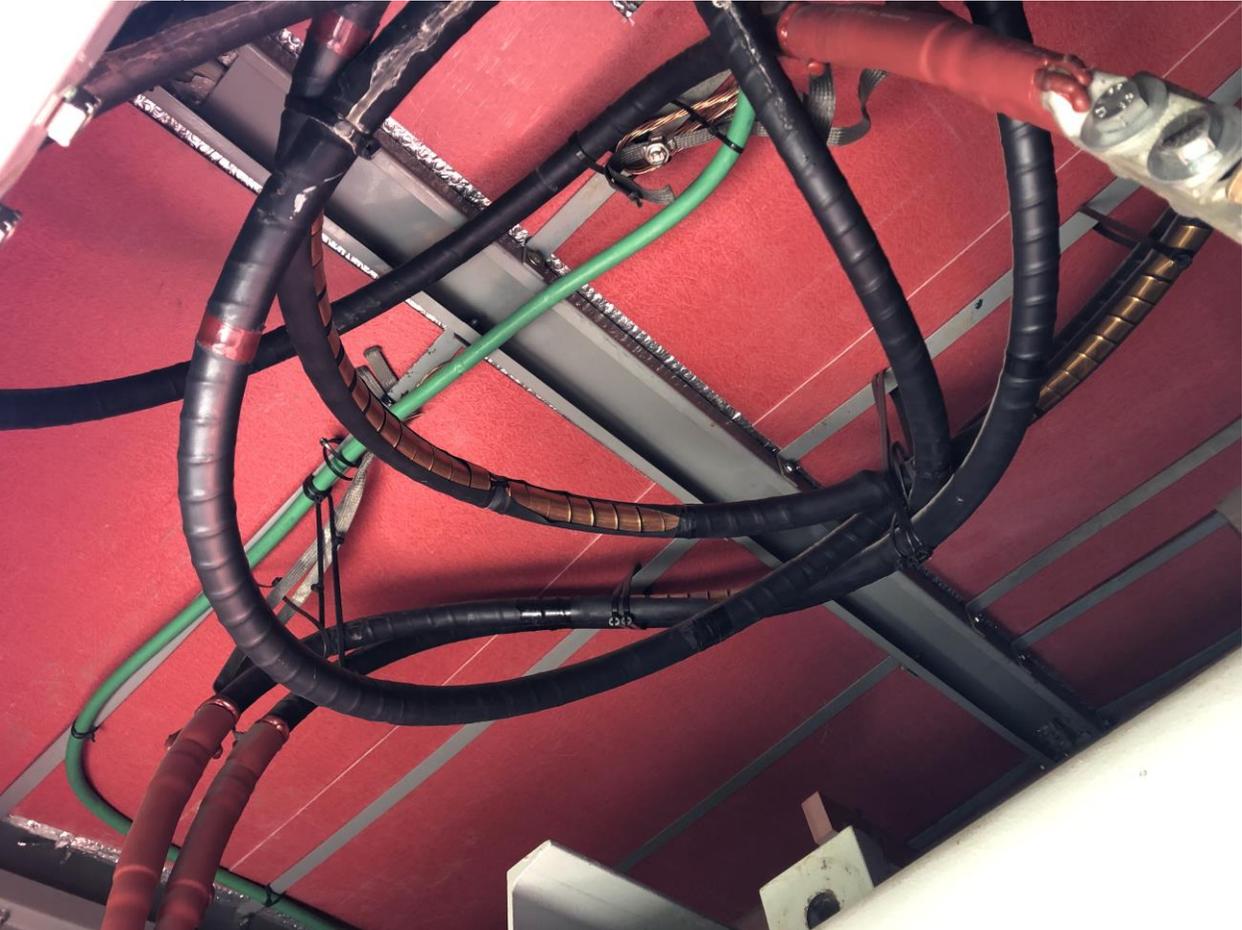
- UVT-2 4160V primary H1 cable heat shrink has split due to transformer heat. This has exposed the tape shield which was found to be broken in 2 places.

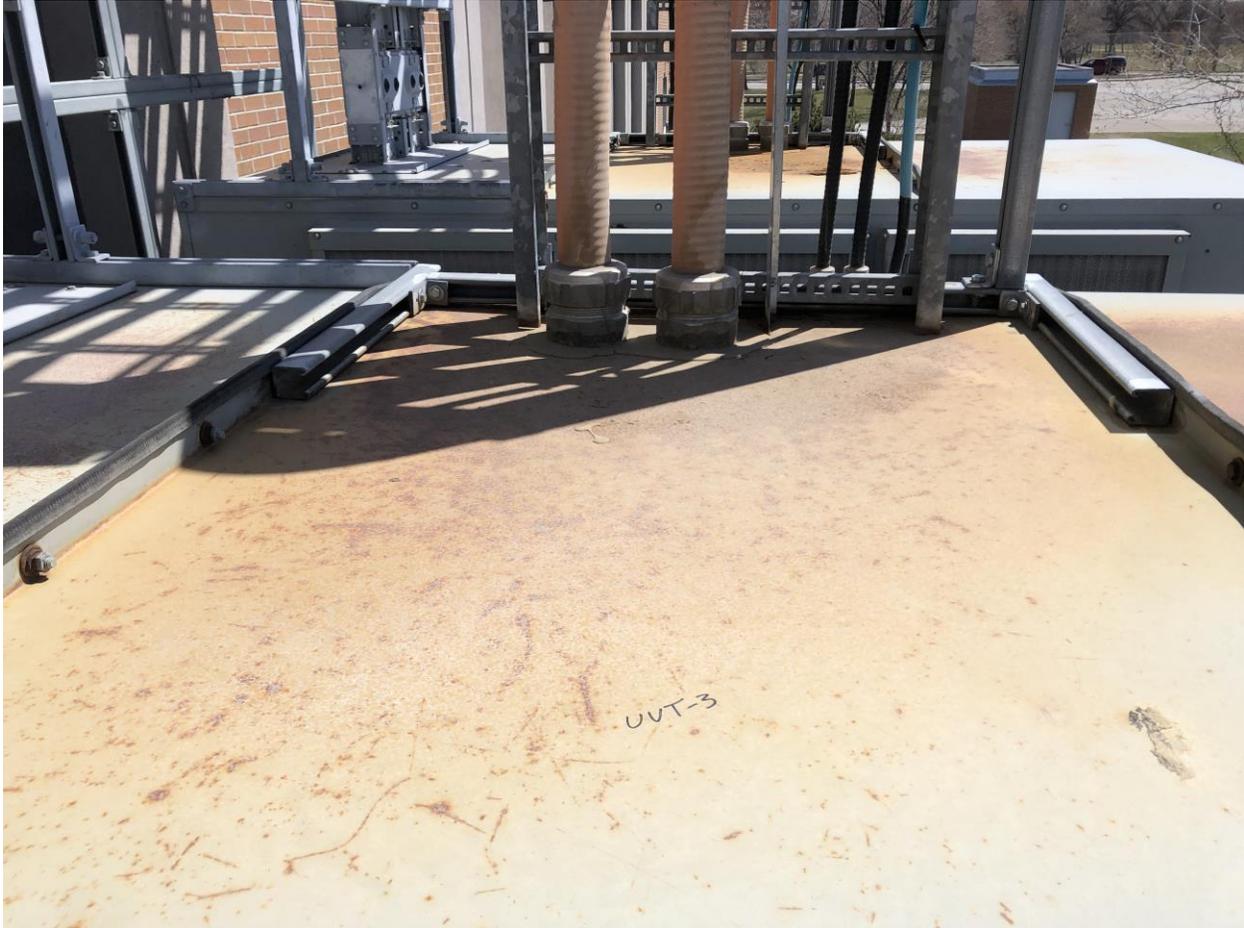
- UVT-3 Corroded Enclosure Roof.

Exterior / Interior Condition: top rusting, inside cleaned.

Cleaning and inspection only cannot isolate secondary for testing due to ground current of 24A at XO.
 Insulation Resistance High to Low and Ground @ 5KVDC for 1 minute = 43.7G ohms. Test includes primary cables.
 Top of transformer enclosure corroded.

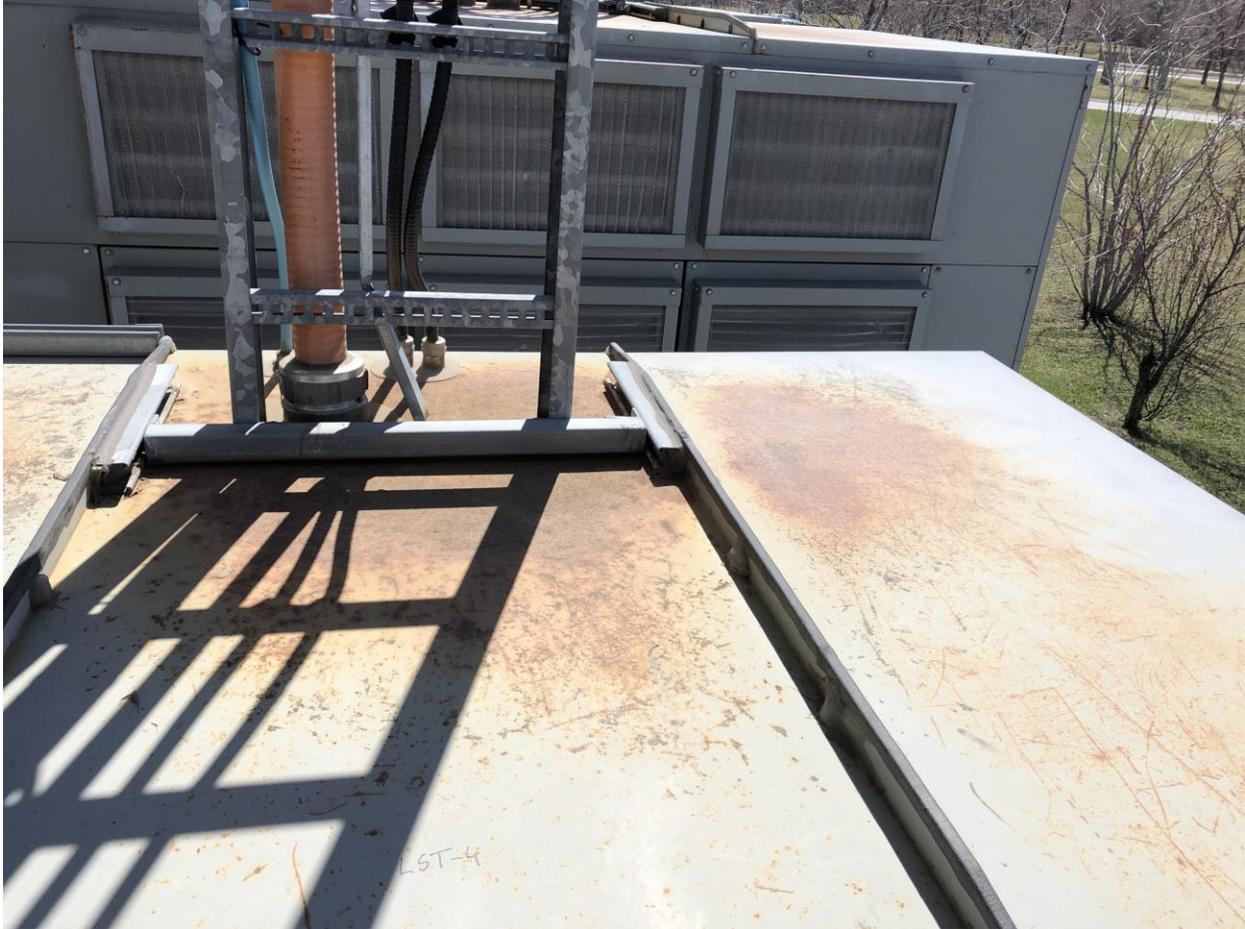
- LST-4 Corroded Roof.

Exterior / Interior Condition: top rusting, inside dirty, cleaned

Secondary disconnected for testing.
 Insulation Resistance High to Low and Ground @ 5KVDC for 1 minute = 40.4G ohms. Test includes primary cables.
 Top of transformer enclosure corroded.

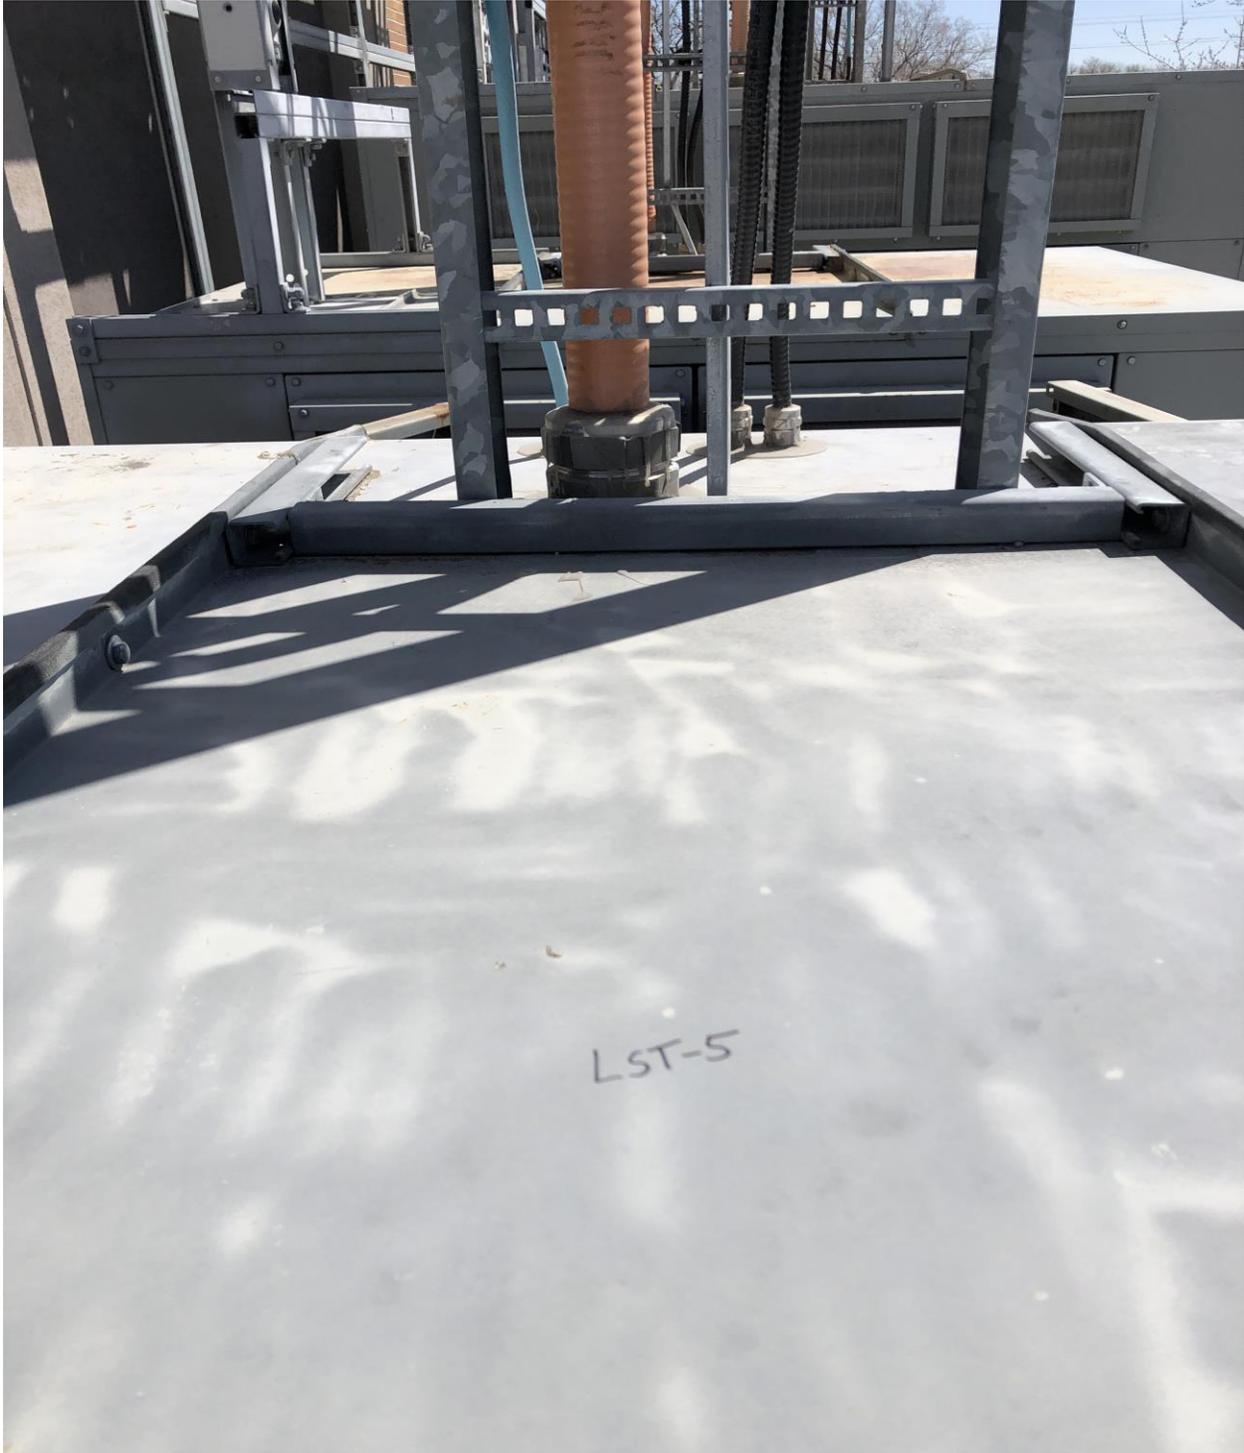
- LST-5 Minor Roof Corrosion.

Secondary disconnected for testing.
 Insulation Resistance High to Low and Ground @ 5KVDC for 1 minute = 47.8G ohms. Test includes primary cables.
 Top of transformer enclosure minor corrosion.
