# **The City of Winnipeg**

## **Water And Waste Department**

### **FLOOD PUMPING STATION CONDITION ASSESSMENT**

**APPENDIX B5**  
**BANNATYNE FLOOD PUMPING STATION - FINAL REPORT**  
**DECEMBER 2006**

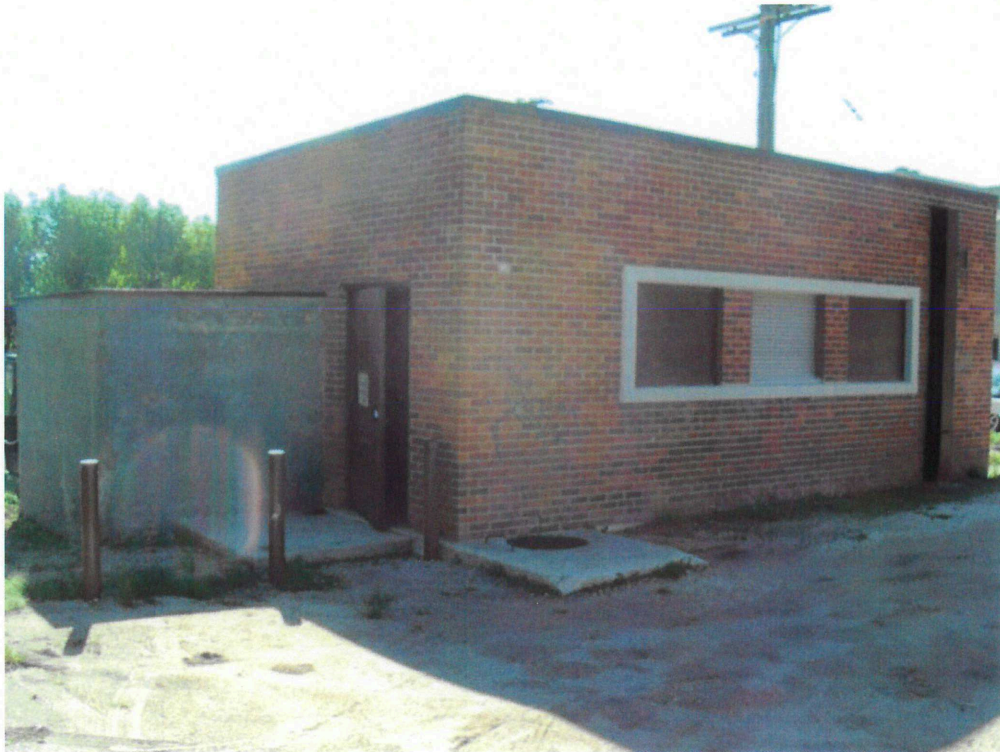
**PHOTO A5-1**

**NORTHWEST CORNER - DISCHARGE BLOCK (LEFT)**

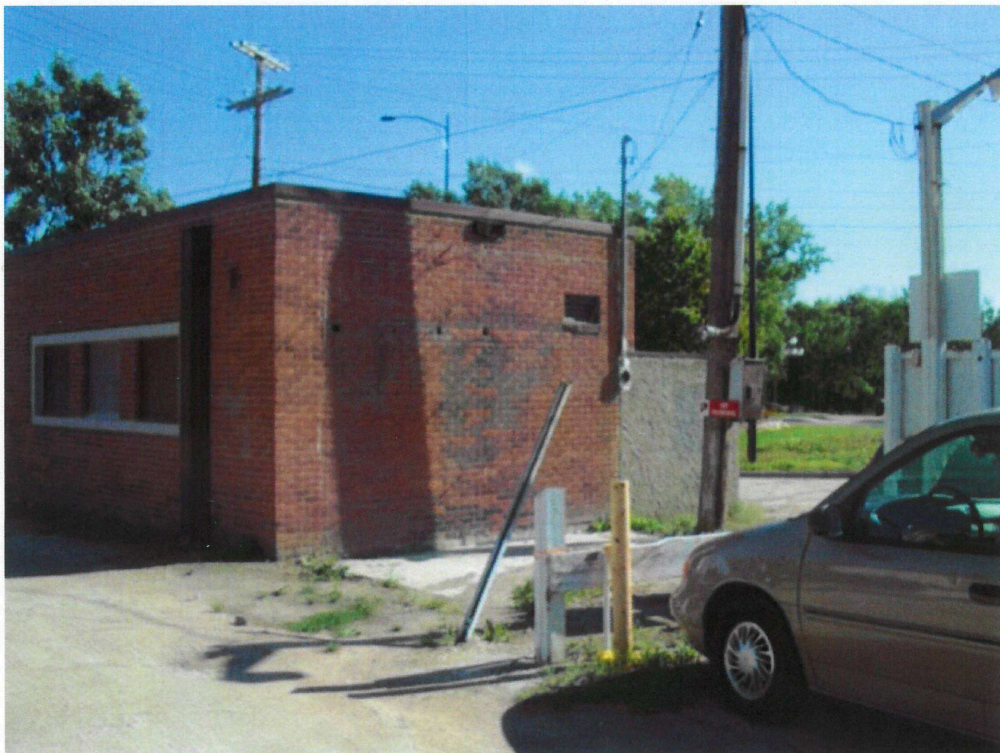
**PHOTO A5-2**

**SOUTHWEST CORNER - HYDRO AREA (REMOVED)**

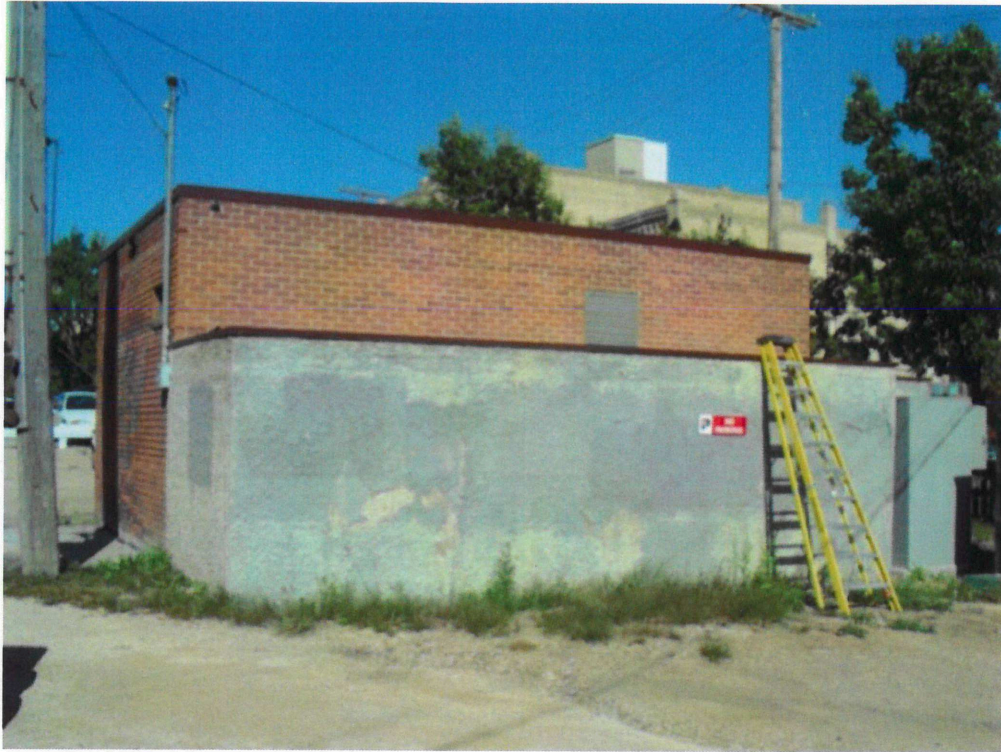
**PHOTO A5-3**

**EAST SIDE - DISCHARGE BLOCK**

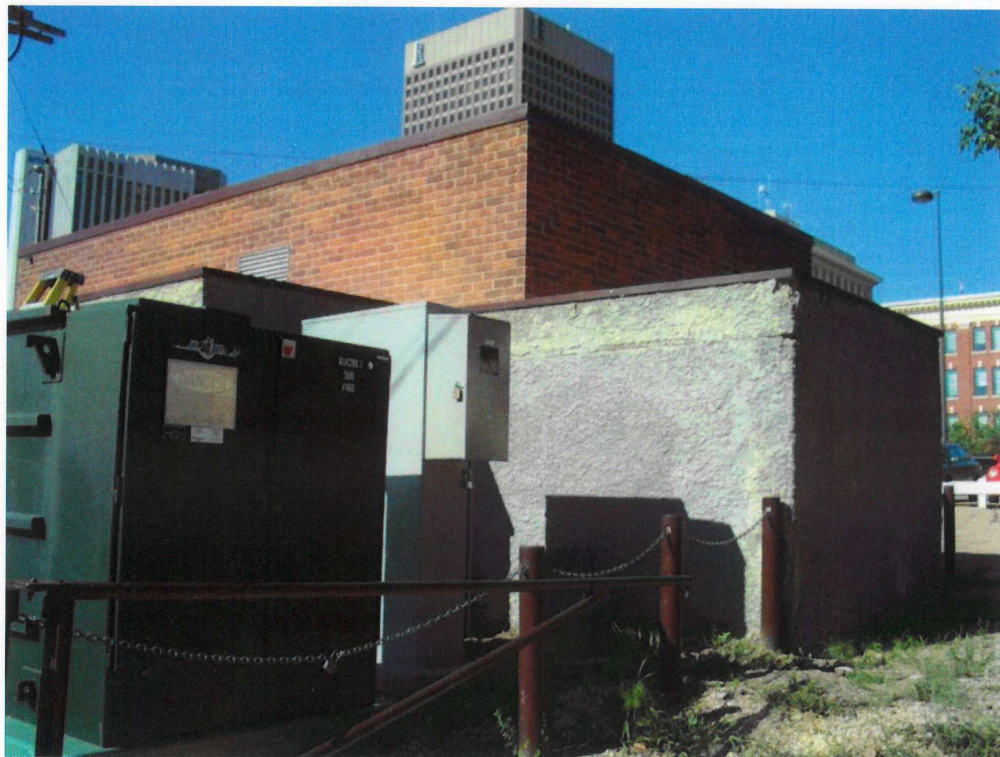
**PHOTO A5-4**

**NORTHEAST CORNER - TRANSFORMER AND DISCHARGE BLOCK**

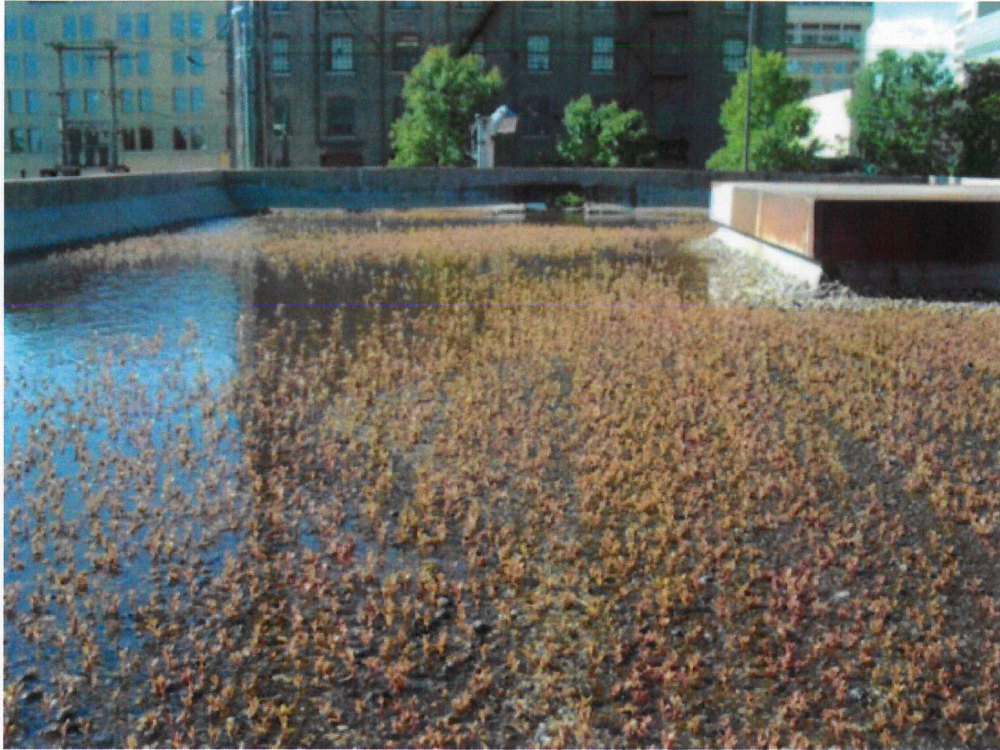
**PHOTO A5-5**

The felt and gravel built-up roofing is in poor condition, and is nearing the end of its life. Most of the roof was covered with water and had small vegetation growing on it (Photos B5-5 & B5-6). The roof is drained by a single overflow scupper.

**ROOF - LOOKING SOUTH - VEGETATION / PONDING**

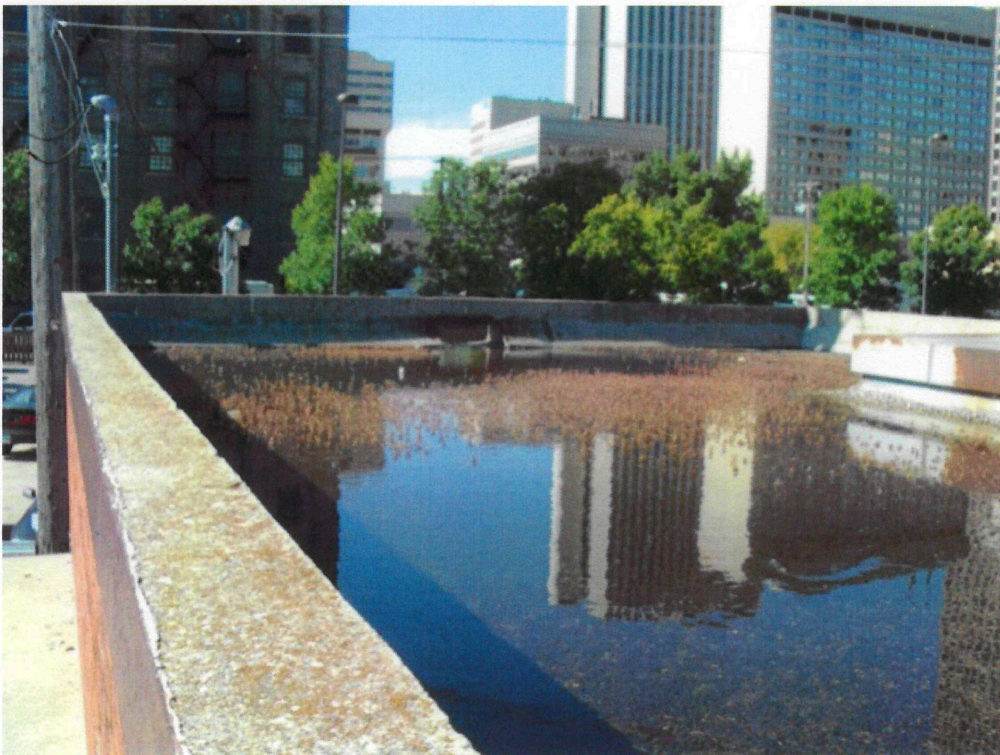
**PHOTO A5-6**

**ROOF - LOOKING SOUTHWEST (AGING WALL CAP)**

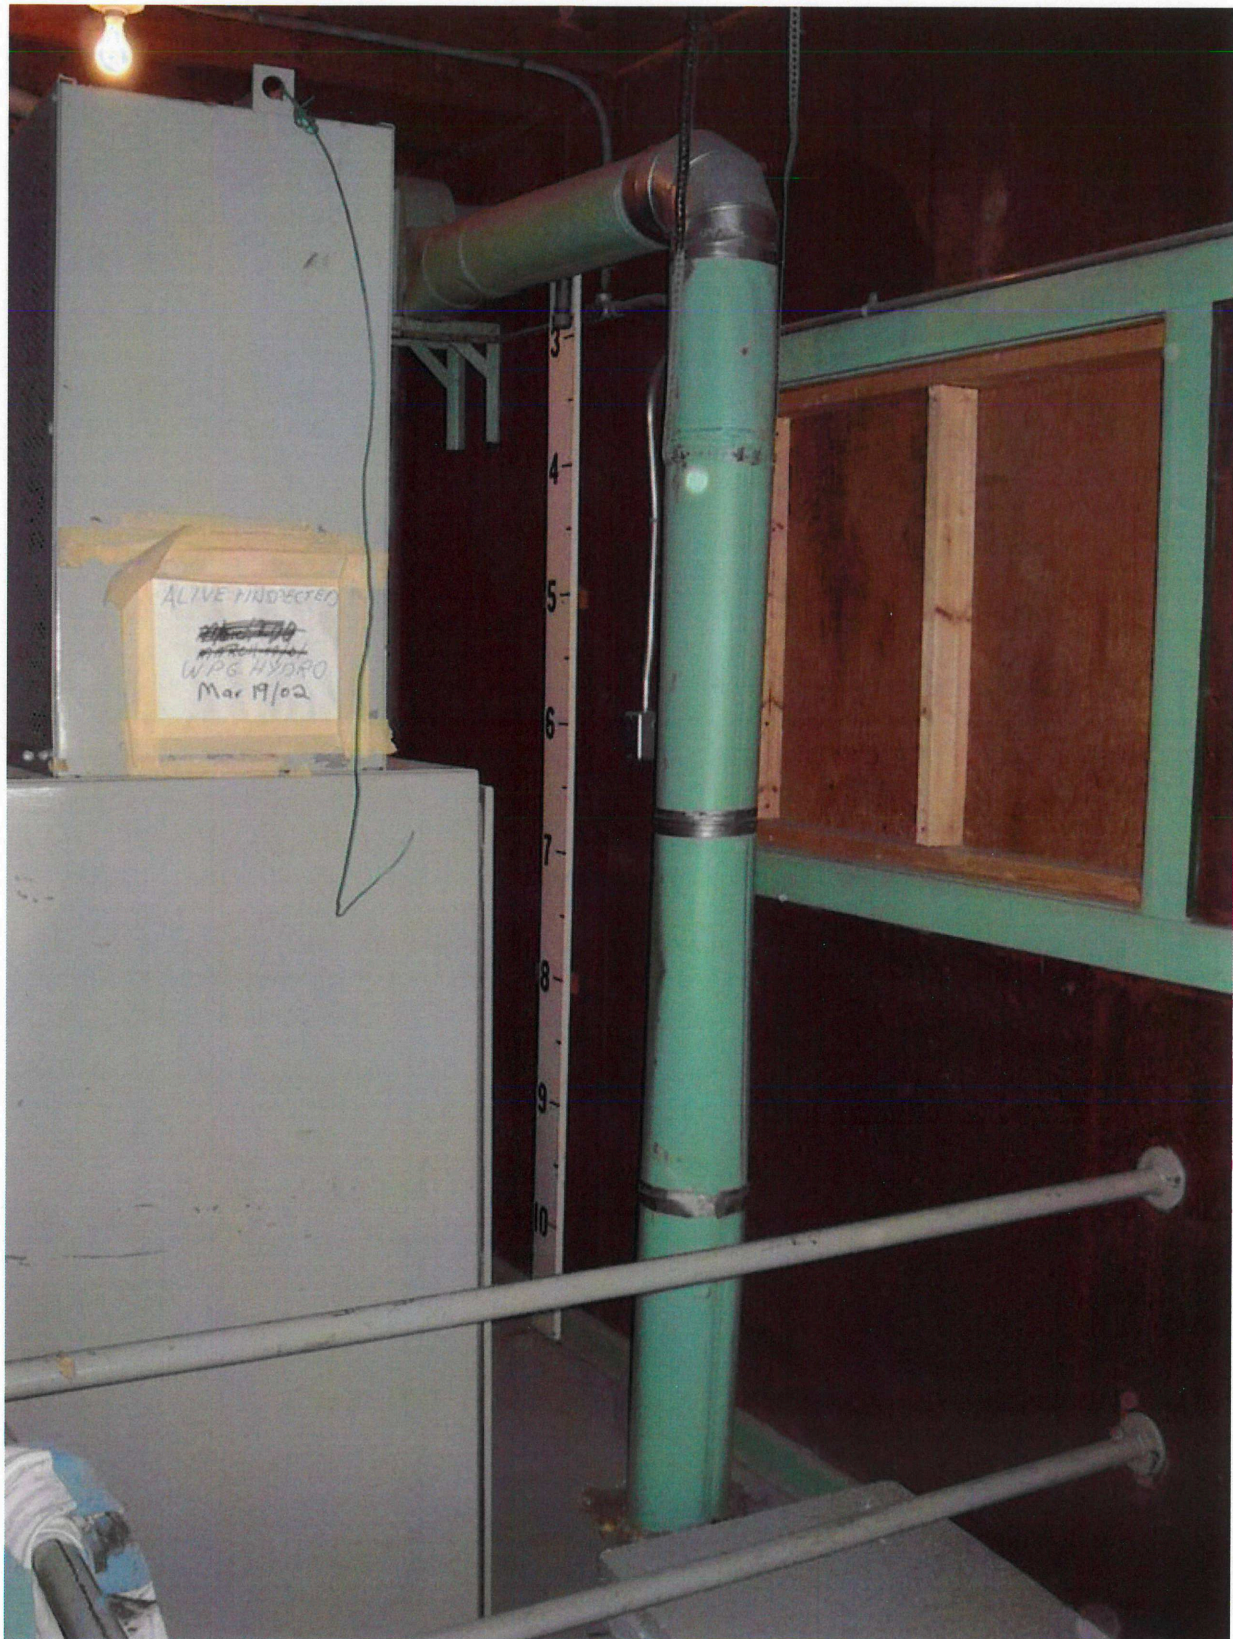
PHOTO A5-7

Permanent steel guardrails are provided around the main floor equipment hatches (Photo A5-7). A galvanized steel stair, with intermediate landings provides access to the drywell below (Photos A5-9 & A5-10). The stairs are steep but allowable by code for service areas. Due to the installation of the foamed plastic insulation around the top of the drywell there is no hand clearance along the stair handrails at these locations creating an unsafe condition when using the stair. The height of the guardrails around the intermediate landings is approximately 900 mm (less than the 1 070 mm required by the current Manitoba Building code), and only a top rail is provided.

BUILDING INTERIOR - GRAURDRAIL AROUND FLOOR HATCH

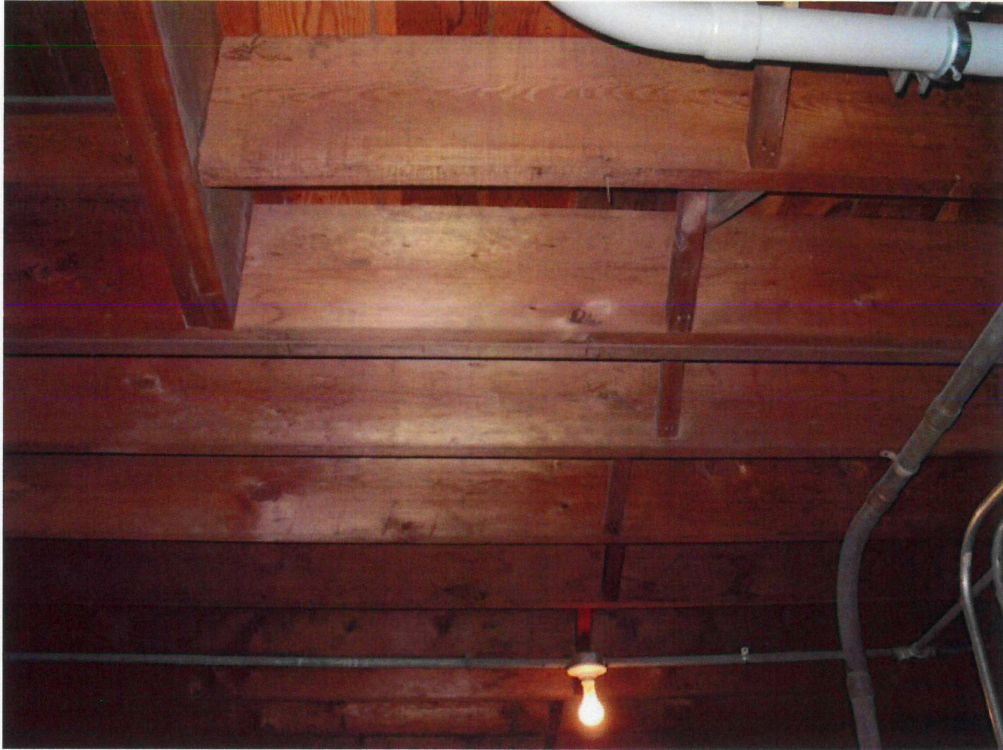
**PHOTO A5-8**

With the exception of some moisture staining on the exposed roof framing and the interior wall paneling the structure appears to be sound. The exterior face brick is generally in fair condition. In general the exterior brick veneer is in fair condition. A few exterior bricks are broken and some joints require repointing. The recent removal of some Hydro equipment has left the north south east west wall with a number of holes and a few damaged bricks. Some brick is below grade level on the west side due to poor site grading but no adverse effects are noticed.

**WOOD FRAMED ROOF STRUCTURE**

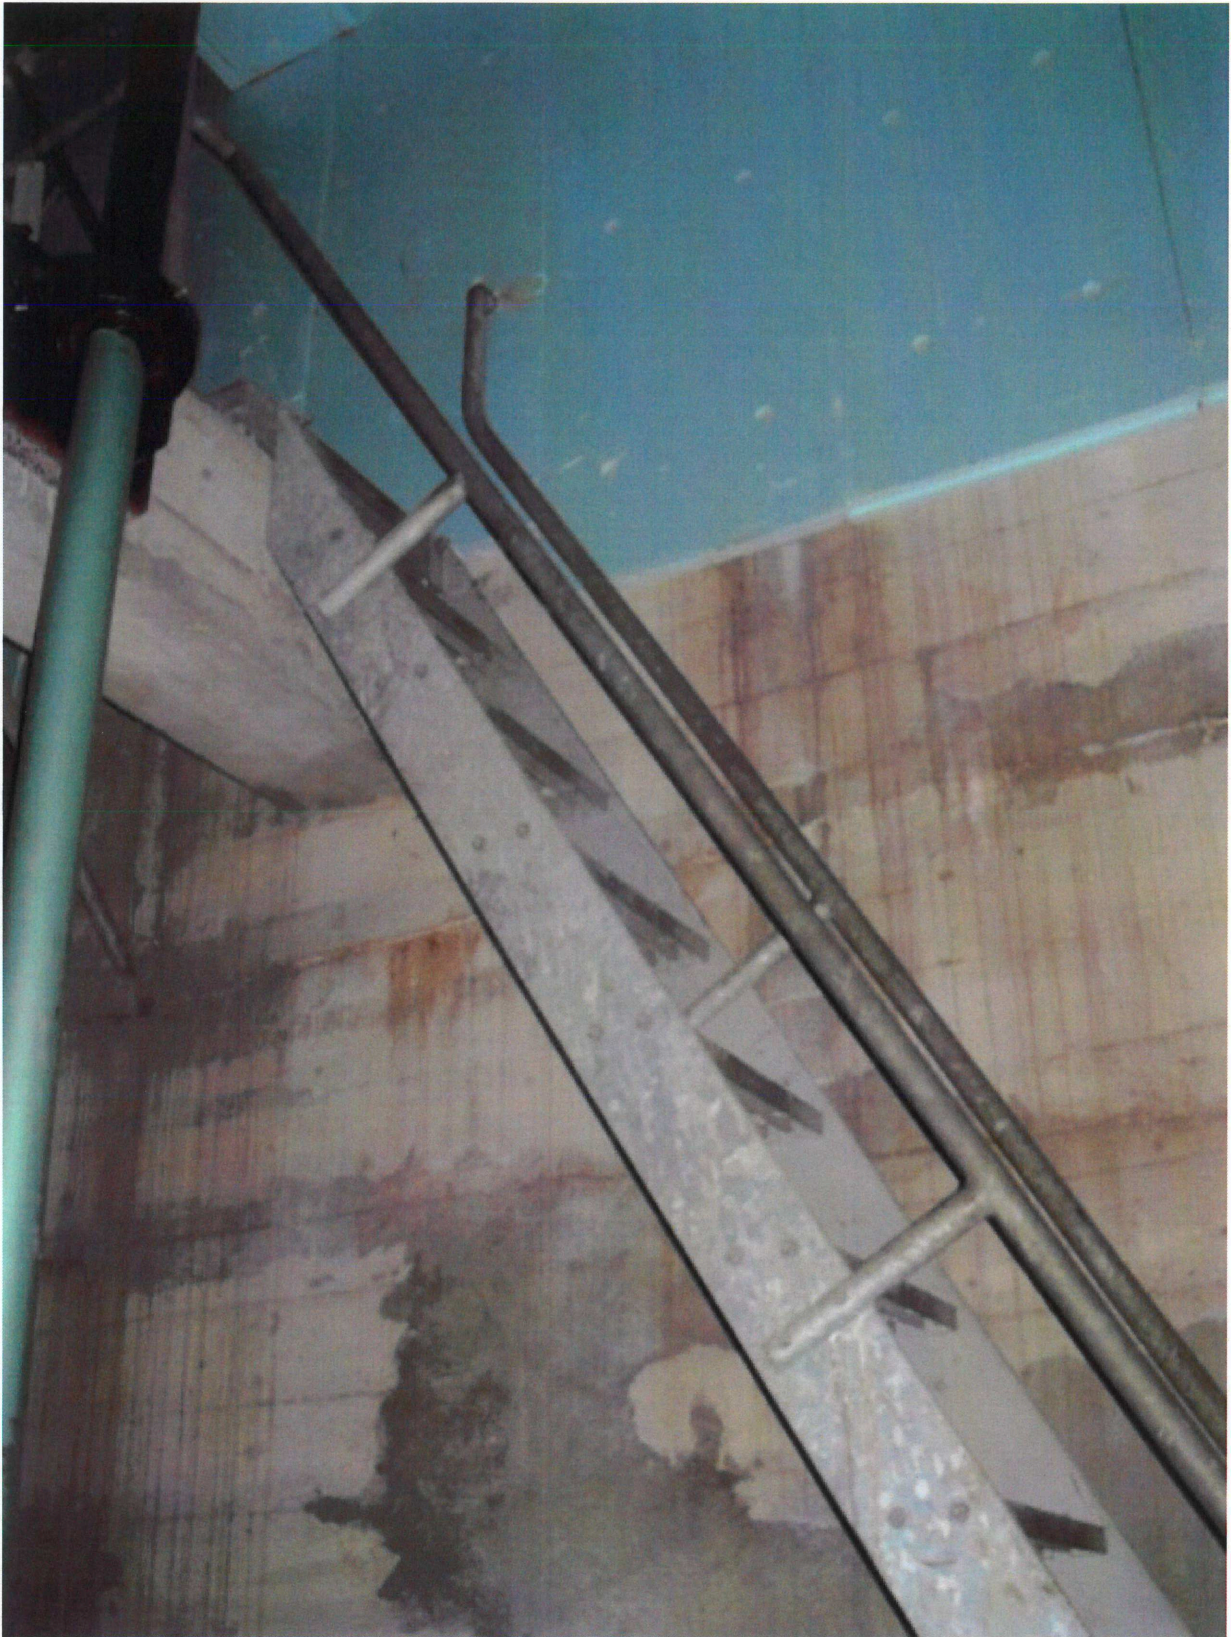
**PHOTO A5-9**

The drywell ceiling and the upper 2400mm of the drywell walls are lined with 50mm of flammable foamed plastic insulation (extruded polystyrene – STYROFOAM) which is a potential fire/safety hazard (Photos A5-9 & A5-10).

**DRYWELL - ACCESS STAIR (STEEP)**

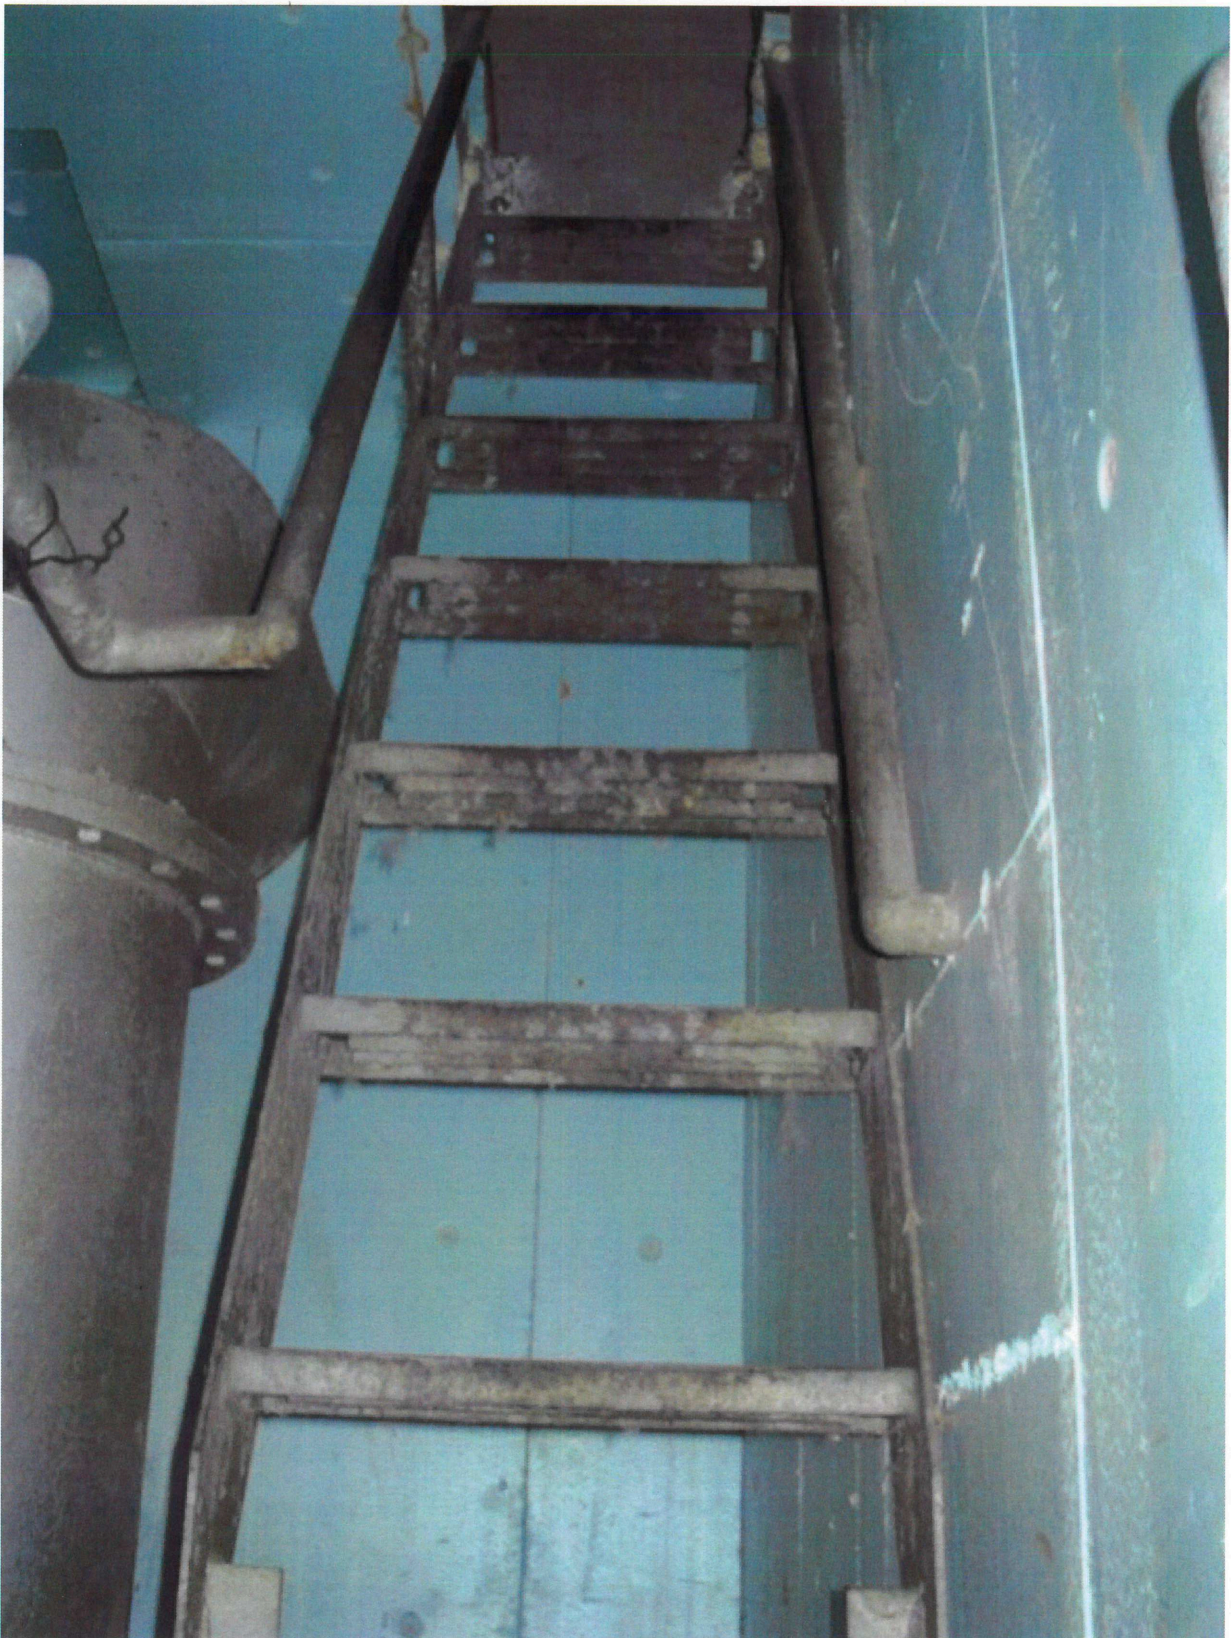
**PHOTO A5-10**

**DRYWELL ACCESS STAIR - REDUCED HANDRAIL CLEARANCE. AT FOAMED PLASTIC INSULATION**

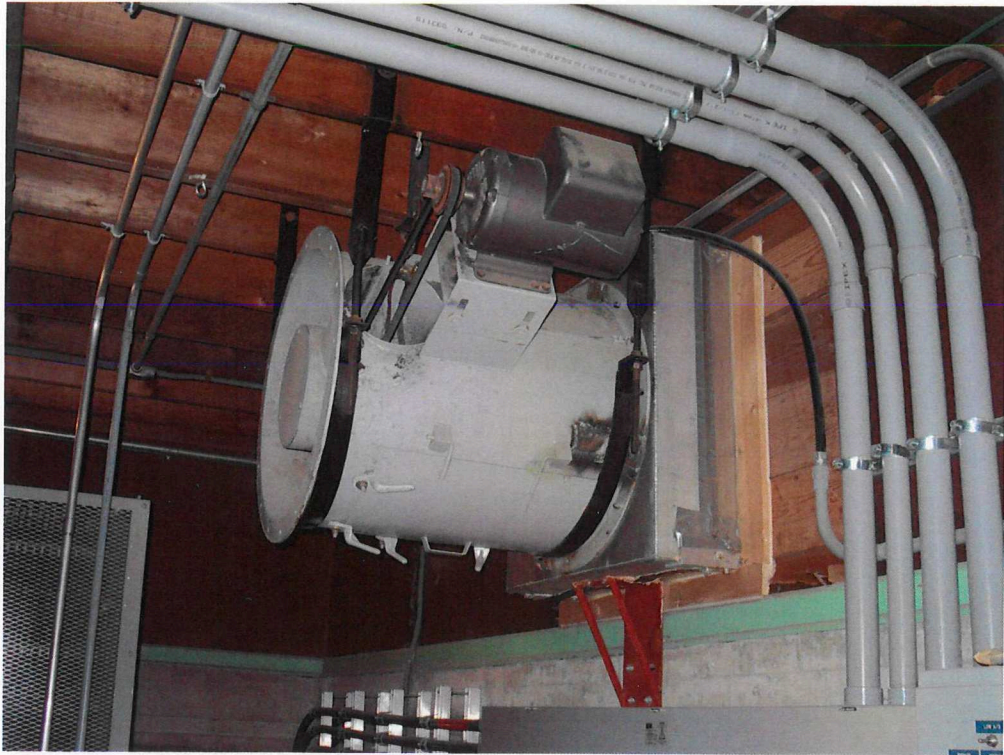
**PHOTO B5-1**  
**COOLING FAN**

There are four separately coupled, overhung impeller centrifugal pumps installed in the FPS drywell. This station is serviced with a drywell electric resistance unit heater and drywell pressurization fan. The main floor of this station is provided with an 11 000 cfm permanent cooling fan (Photo B5-1).

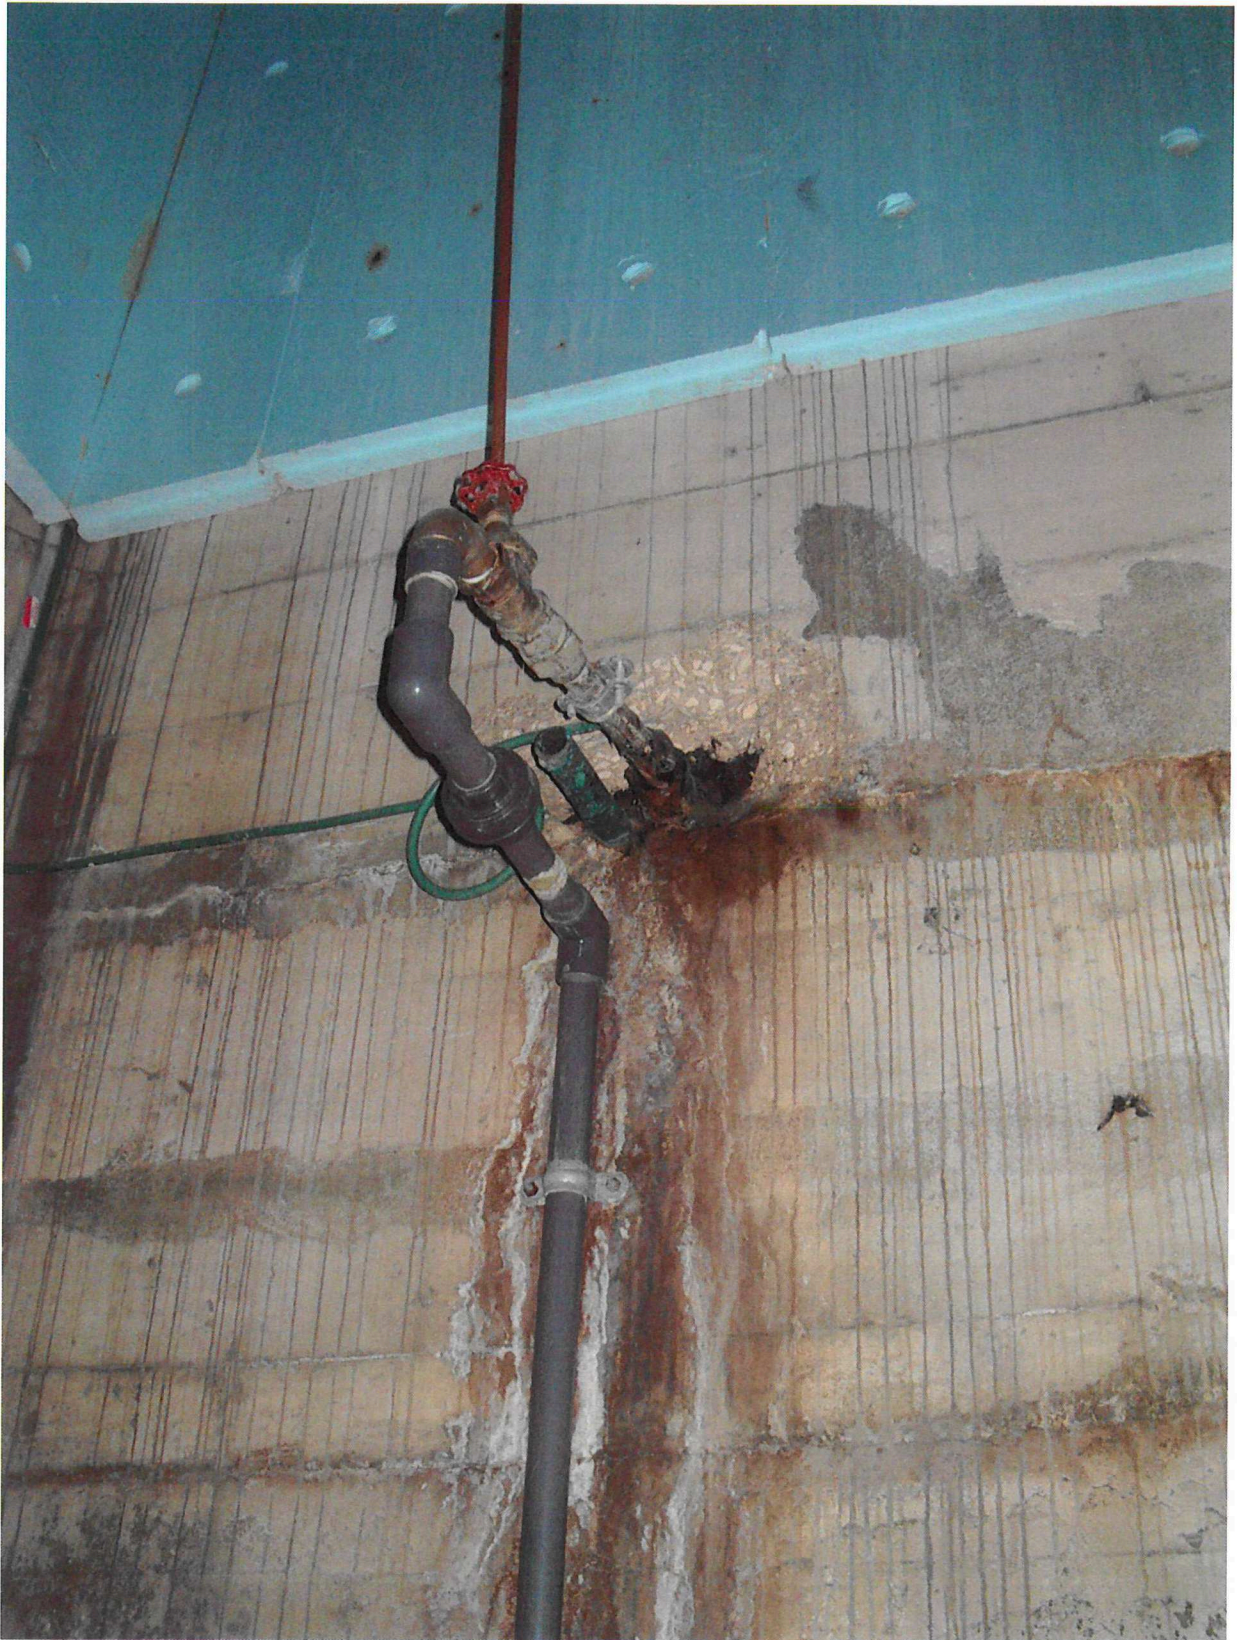
**PHOTO B5-2**

The shaft seal water line provides water to the packing gland for cooling and lubrication. This station's shaft seal water line has been converted over to PVC for the most part; however, some copper piping is still present on the main line and where the line ties-in to the pump seal water connections. The copper piping is badly corroded where the pipe penetrates the drywell wall (Photo B5-2). The shaft seal water line valves are all in very good condition (Photo B5-3). Corroded piping should be considered for replacement.

**SHAFT SEAL WATER LINE PENETRATING DRYWELL - CORROSION ON COPPER PIPING**

3. **Replace Copper Pipe at Drywell Entry Point** – The copper shaft seal water piping at the entry point to the drywell should be replaced to prevent it from further surface corrosion resulting in loss of base material and structural integrity.

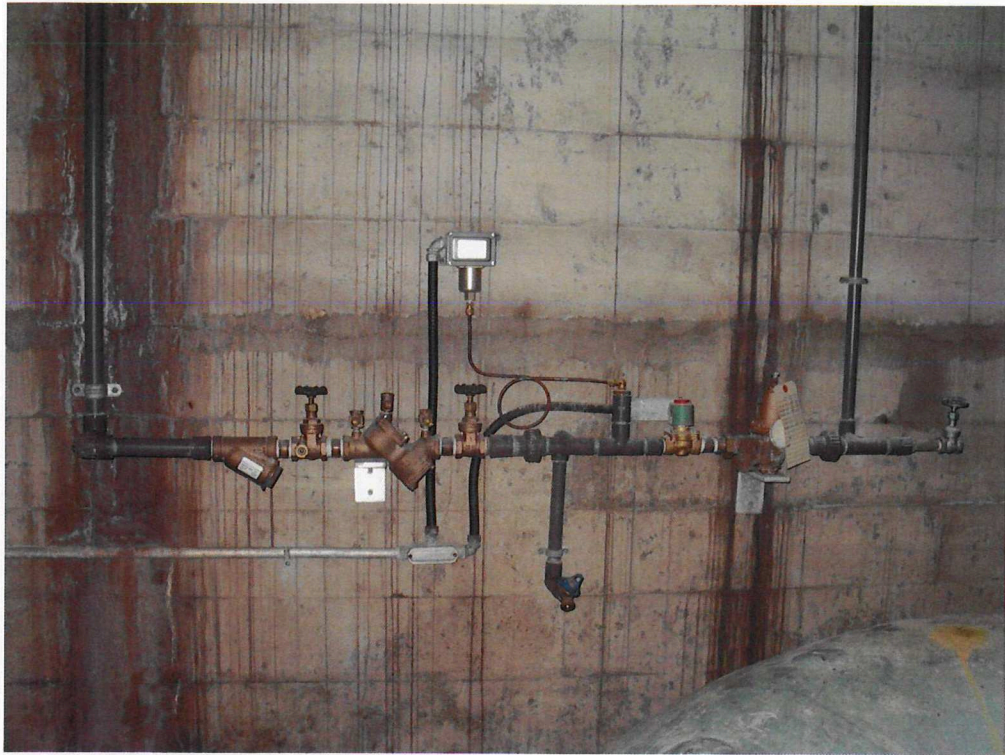
**PHOTO B5-3**

**SHAFT SEAL WATER MAIN LINE VALVES**

2. **Replace Existing Valves** – The main line valves (strainer, check, solenoid, PRV, and gate valves) and the valves (swing check and gate valves) on the branch lines to the pumps do not need to be replaced. Although this conclusion is not anticipated to change, the condition of these valves and their potential need for replacement should be re-evaluated in 8 to 10 years.

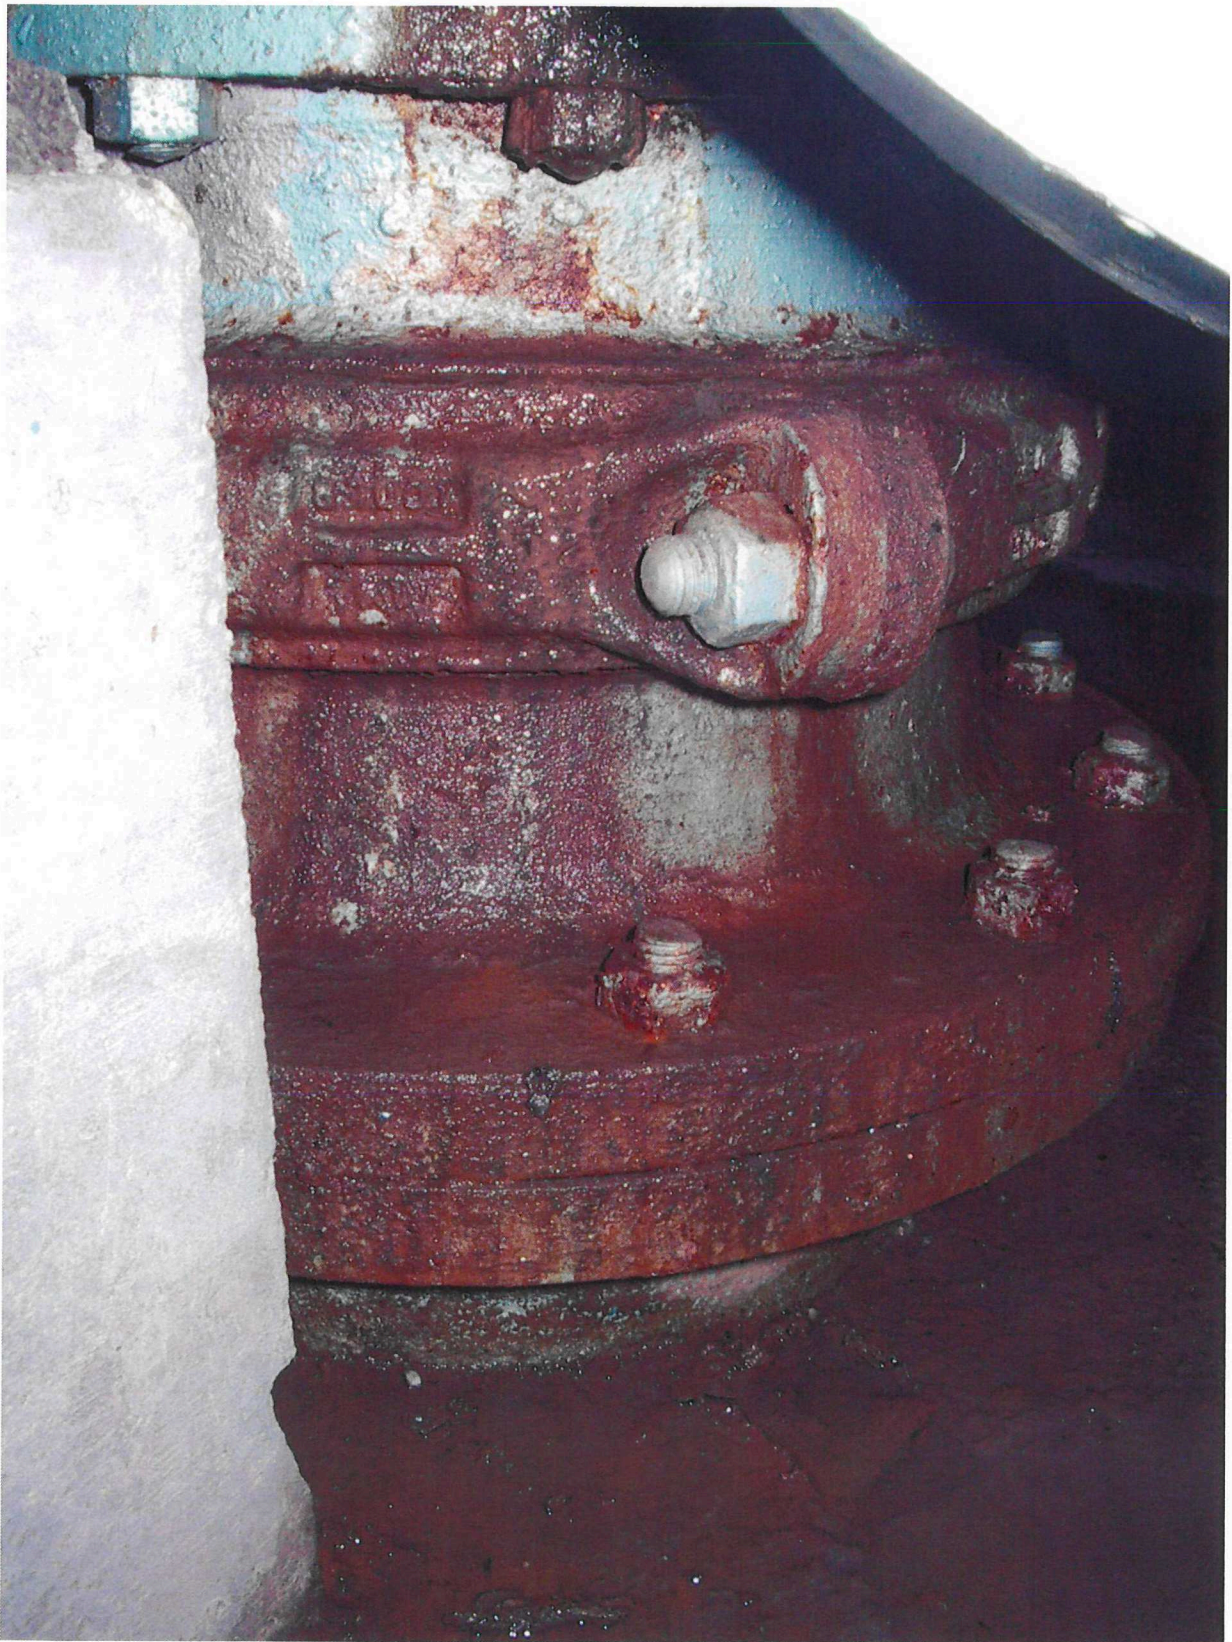
PHOTO B5-4

Some surface corrosion is present on the suction side flange hardware and the victaulic coupling of Pump 5 (Photo B5-4). However, the corrosion on these components is not advanced enough to warrant consideration for replacement.

CORROSION ON PUMP 5 SUCTION LINE

1. **Replace Flood Pump Pipe Victaulic Couplings and/or Flange Nuts and Studs** – None of the suction or discharge side victaulic couplings or flange couplings' nuts and studs on any of the pumps need to be replaced. Although this conclusion is not

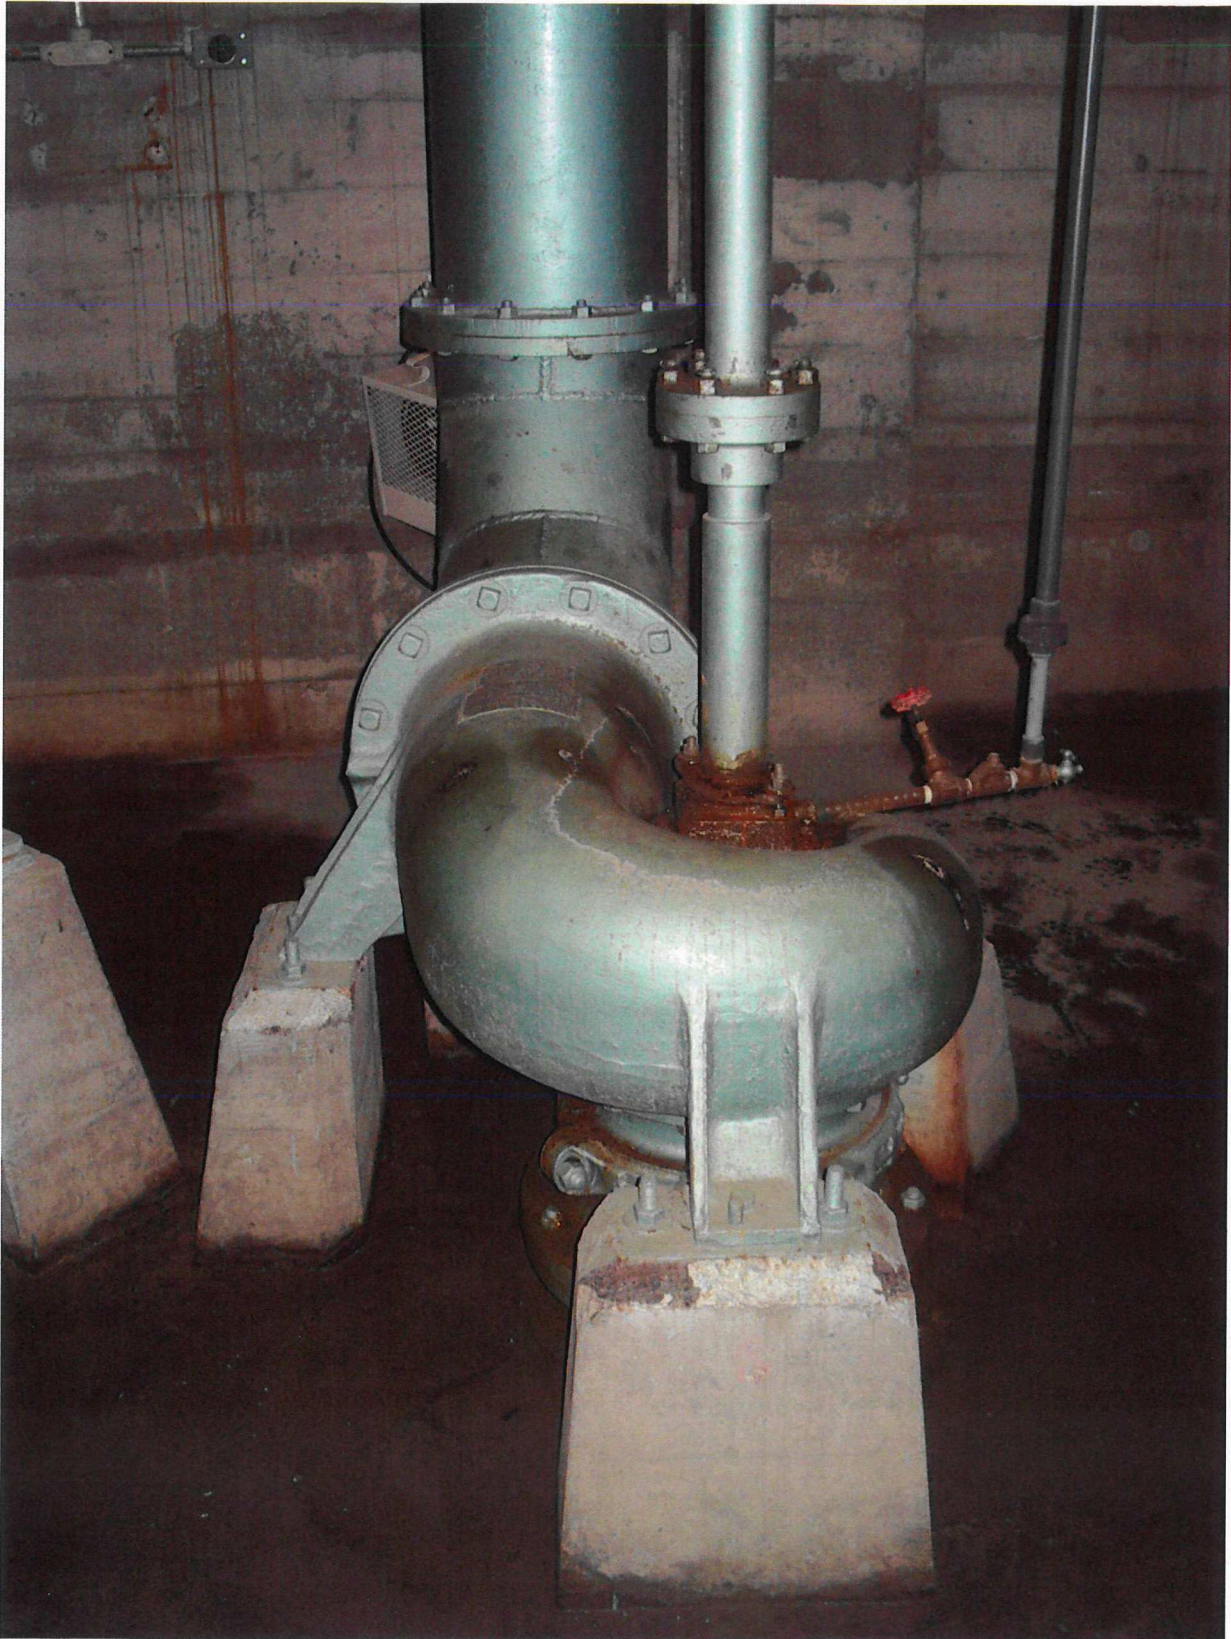
PHOTO B5-5

Pump 5 is shown in Photo B5-5. A concern for this pump is that the pump bowl paint is flaking due to corrosion on and around the bearing cover (Photo B5-6) and down the side of the pump bowl to the pump suction (Photo B5-7).

PUMP 5

The corroded surfaces should be sandblasted and re-painted. All other components not addressed above as areas of concern are considered to be in acceptable condition, this assessment should be re-evaluated in another 8 to 10 years.

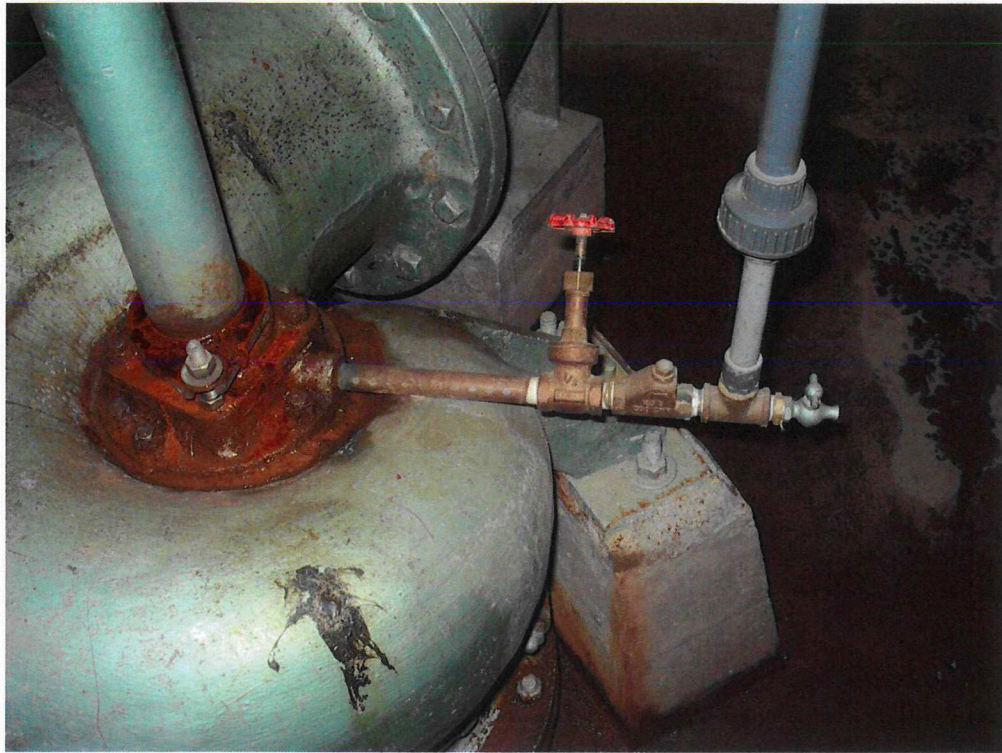
**PHOTO B5-6**

**PACKING GLAND COVER ON PUMP 5 - CORROSION DUE TO LEAKING PACKING GLAND**

On Pump 5, the nuts and studs securing the packing gland cover should be tightened to prevent further leakage.

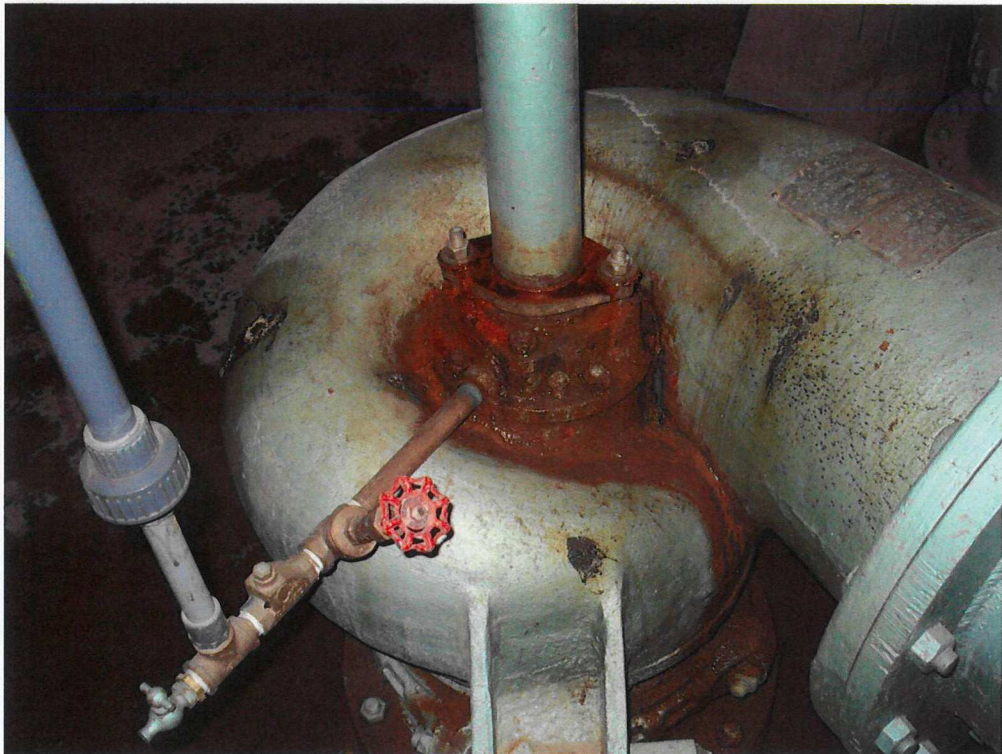
**PHOTO B5-7**

**PUMP 5 CASING - CORROSION DOWN THE SIDE OF BOWL**
