# **The City of Winnipeg**

## **Water And Waste Department**

### **FLOOD PUMPING STATION CONDITION ASSESSMENT**

**APPENDIX B5**  
**BANNATYNE FLOOD PUMPING STATION - FINAL REPORT**  
**DECEMBER 2006**

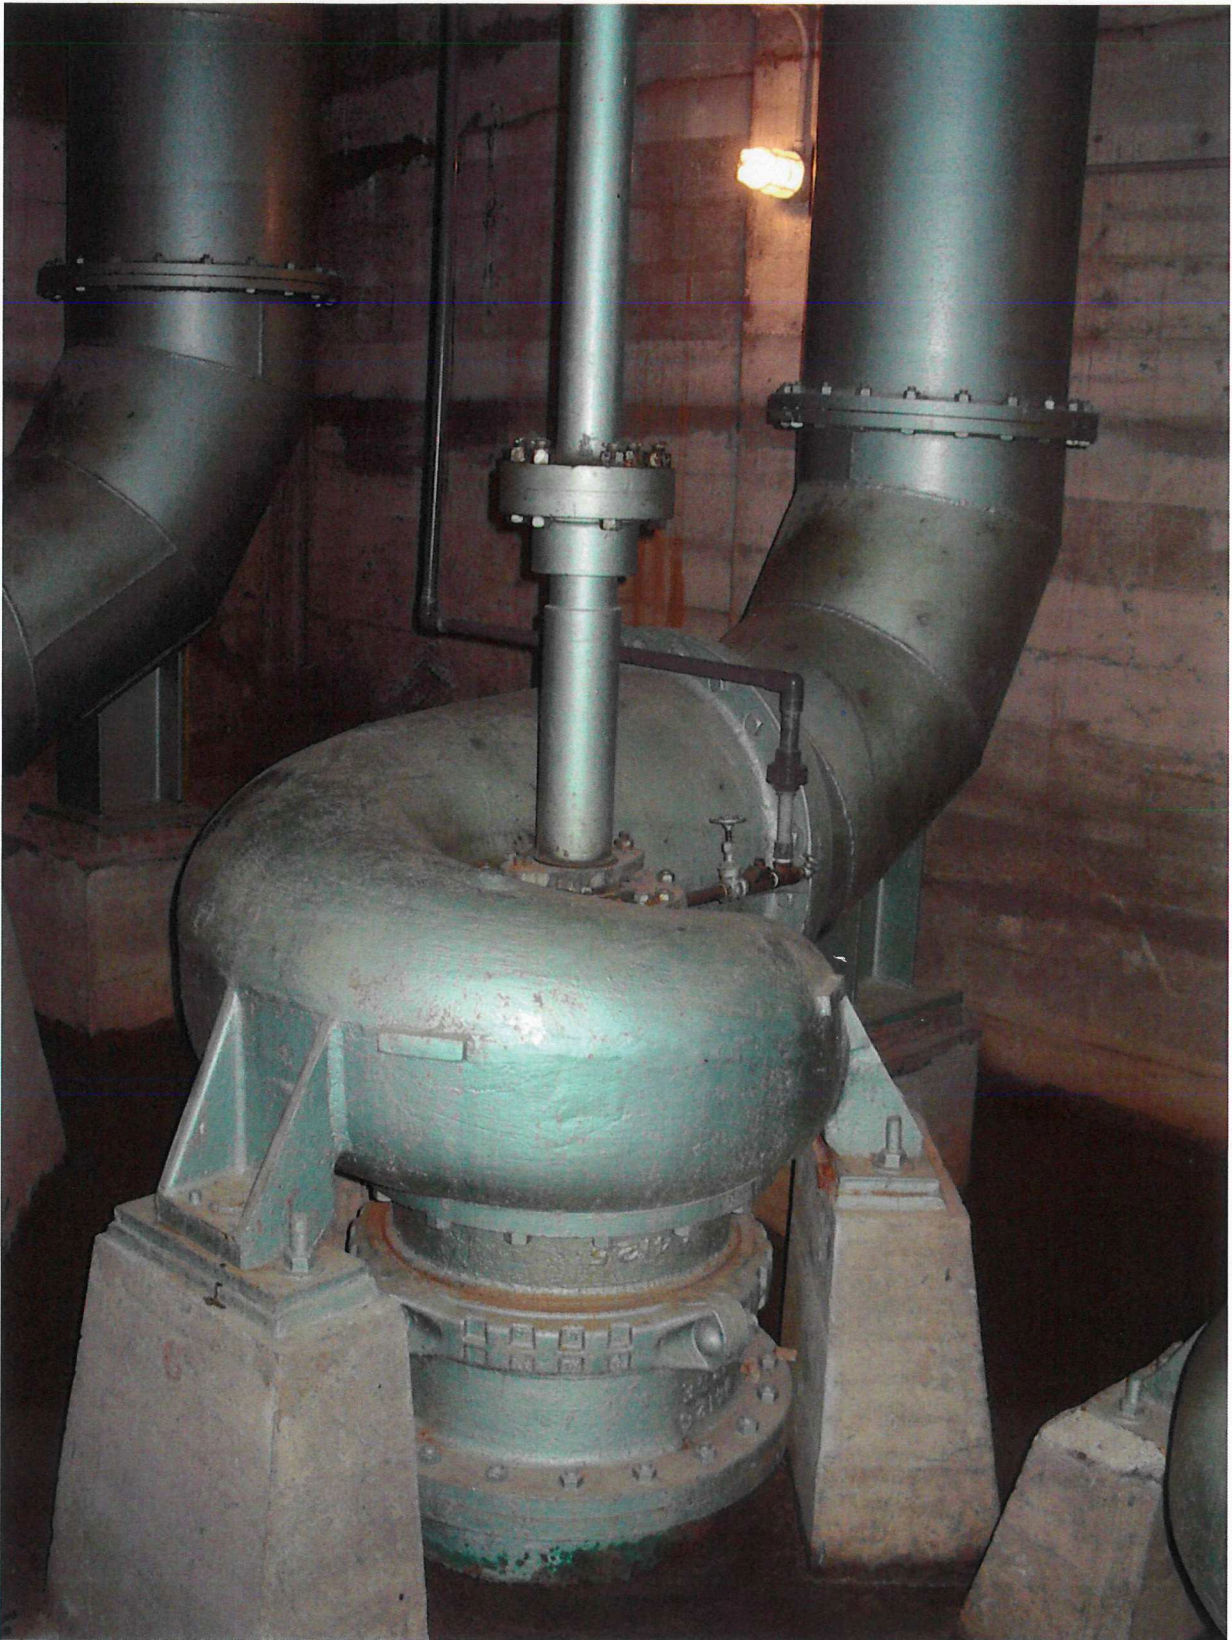
**PHOTO B5-8**

Pumps 6,7, and 8 are shown in Photos B5-8, B5-9, and B5-10, respectively. There are no areas of concern for these pumps; the pump casing, the packing gland cover and its nuts and studs, and the bearing cover's nuts and studs are all in good condition.

**PUMP 6**

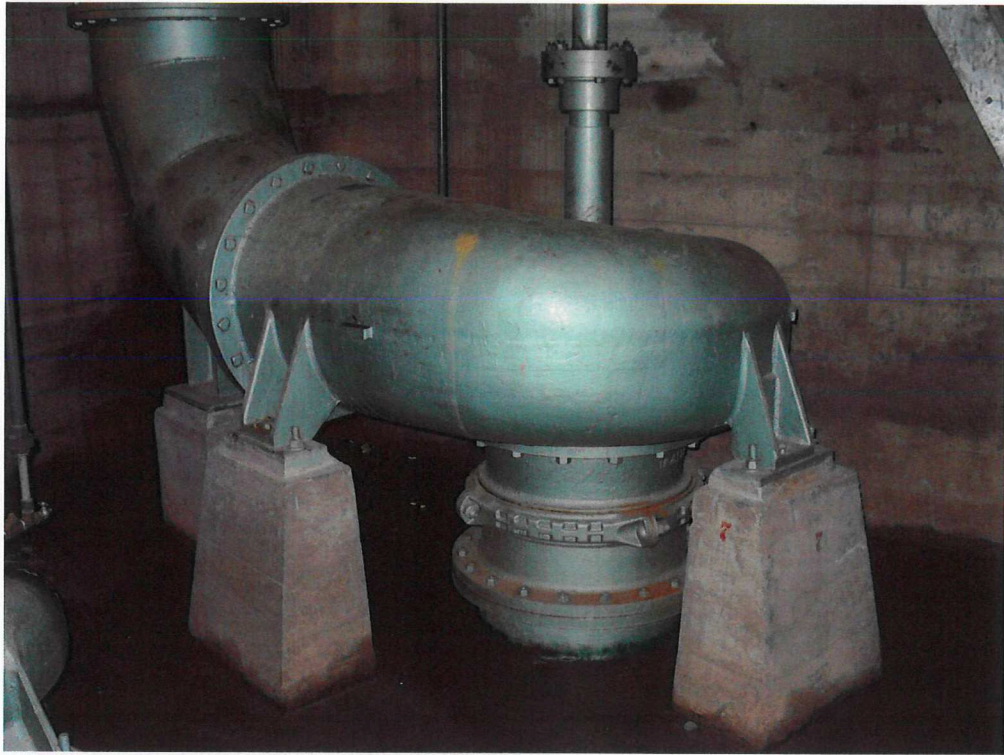
**PHOTO B5-9**

**PUMP 7**

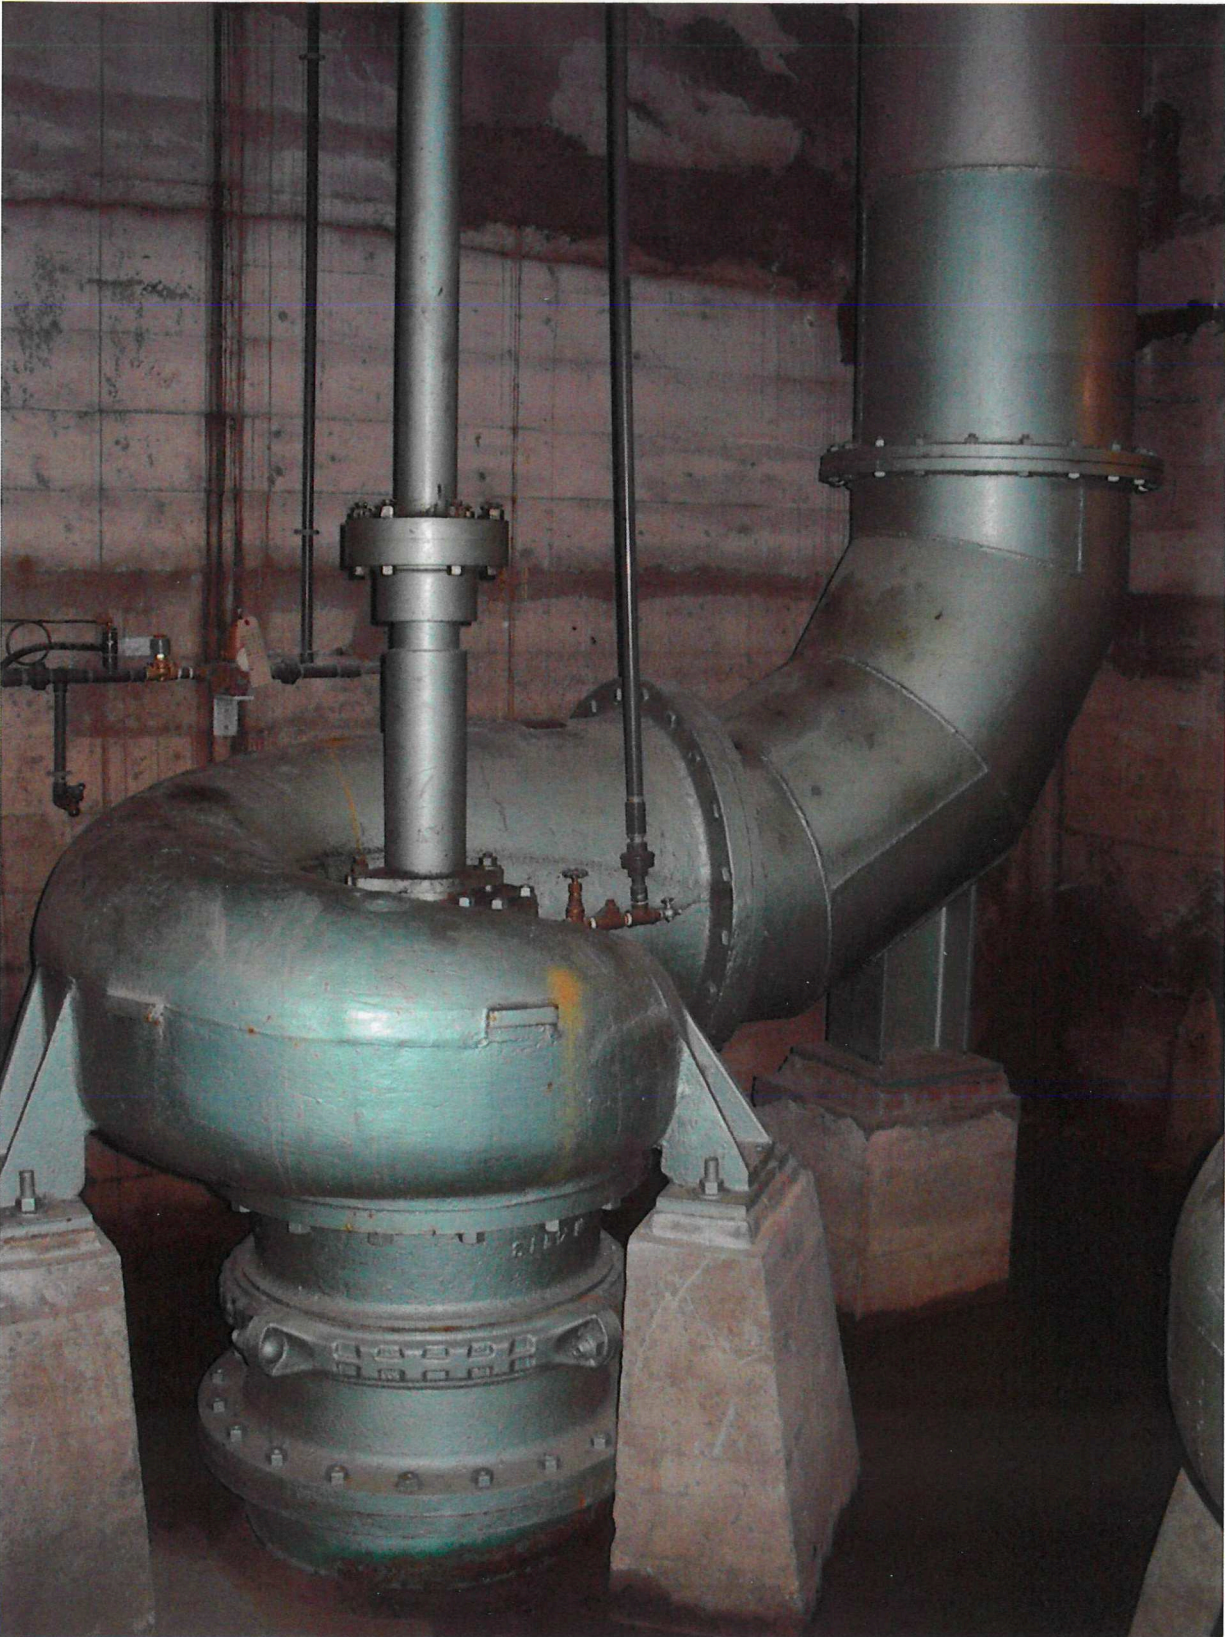
PHOTO B5-10

PUMP 8
