Asbestos Reassessment

Deacon Road Booster Pumping
Station and Reservoir
Deacons Road
Winnipeg, Manitoba

**City of Winnipeg Water and
Waste Department**

October 14, 2021

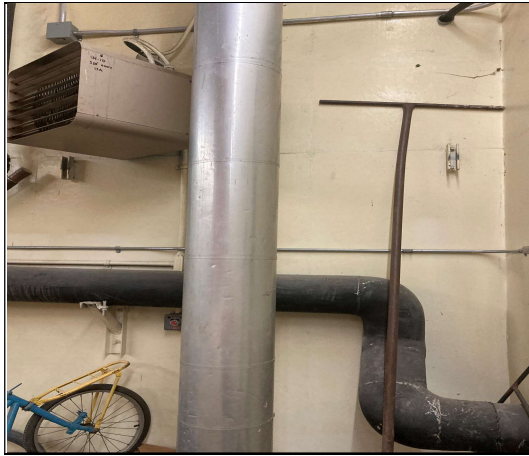
Generator exhaust within the Garage, Location No.6 is jacketed with metal. Magblock has been confirmed present beneath the metal jacketing. The Magblock is presumed to contain asbestos. It is friable and is in GOOD condition.

Asbestos-containing Magblock jacketed with metal..

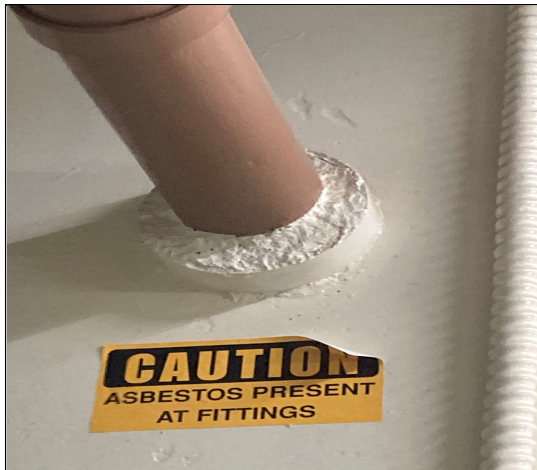
Parging cement encapsulated with paint is present as firestop where pipes pass through walls in Basement 3 located in the Storage Room (Location No. 7), Stairwell Hallway (Location No. 8), Stairwell (Location No. 9), Mechanical Room (Location No. 10) and Control Room Hallway (Location No. 13). Parging cement is a friable material which is in GOOD condition. Previously noted damage within Location No.13 was repaired.

Asbestos-containing parging cement present as firestop.

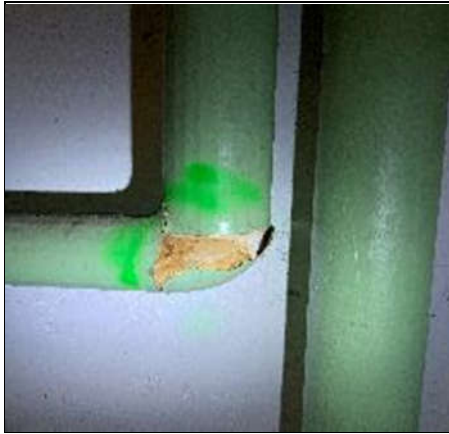
- Damaged/exposed parging cement on 1 fitting in FAIR condition on the Hot Water Heating System within the Boiler Storage Room, Location No.33. Five SF of parging cement debris is present on the floor under the damaged fitting.

Damaged/exposed parging cement Location No.33

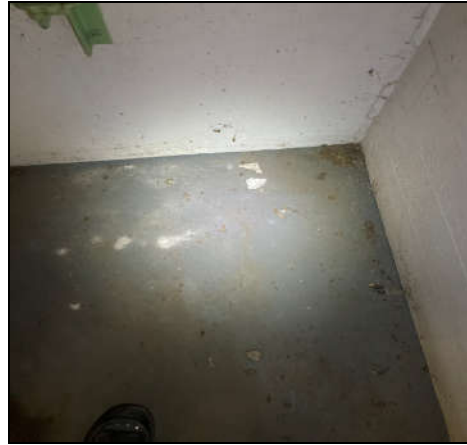
Parging cement debris Location No.33

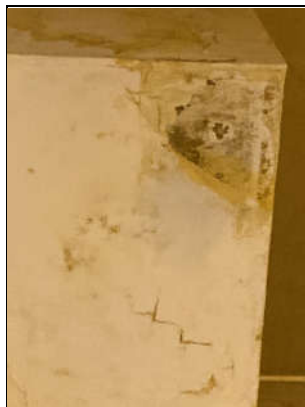
Asbestos-containing parging cement is present on the fresh intake ducting within Location No.'s 2, 6, 7, 11, 19, and 41. Parging cement is jacketed with canvas and is generally in GOOD condition except for damage rated in FAIR condition and debris present within Location No's 6 and 7.

Damaged/exposed parging cement on intake ducting within Location No.'s 6 and 7

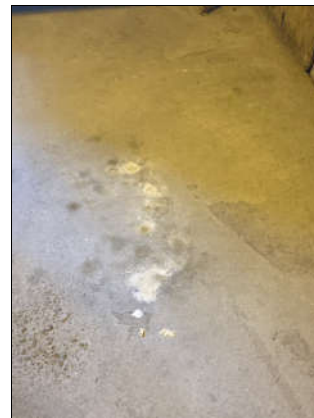
Parging cement debris present under the damaged ducting within Location No.'s 6 and 7.

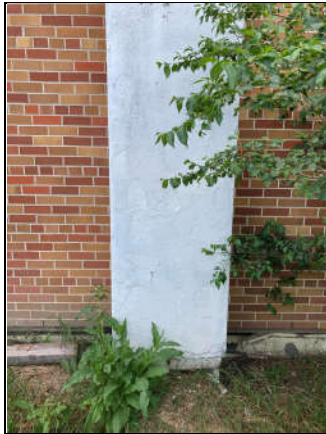
Plaster on the exterior wall of the Digester Building (back area) (Location No. 62) contains Chrysotile asbestos. Plaster finishes are non-friable while in place but can become friable during disturbance. Plaster finishes are in GOOD condition.

Asbestos-containing plaster present on exterior wall.

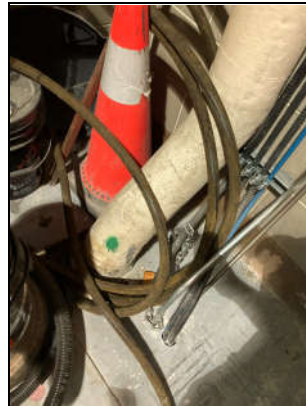
Location	Quantity and Condition of Damage
Upper Walkways Location No. 12	Damaged/exposed parping cement on 3 fittings of the Rainwater Leader System rated in FAIR condition

Damaged/exposed parping cement on 3 rainwater leader fittings within Location No.12.

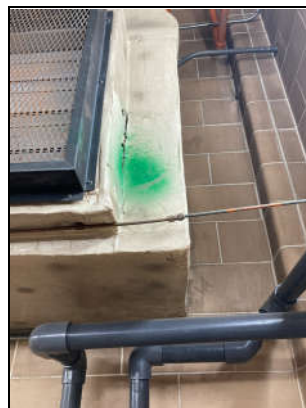
Asbestos-containing parping cement is present as duct insulation within the Chlorine Analyser Room (Location No. 6), Chlorine Scale Room (Location No. 7), Ammonia Room (Location No. 11), Fan Room (Location No. 16), and Pump Floor (Location No. 19). Parping cement is a friable material which is jacketed with canvas and is in GOOD condition except for 1 SF of damage rated in FAIR condition within Location No.6.

Damaged/exposed parping cement on 1 SF of ducting within Location No.6.

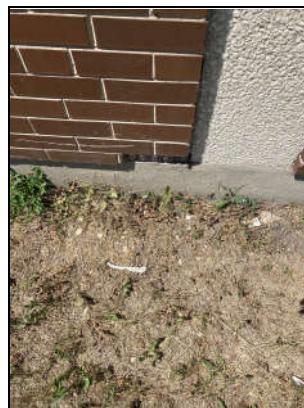
Asbestos-containing beige and grey caulking present on the exterior wall finish (Location No. 22) is non-friable material which is generally in GOOD condition with the exception of 4 SF of debris present on the back North side of the building.

4 SF of asbestos-containing caulking debris on exterior of building.

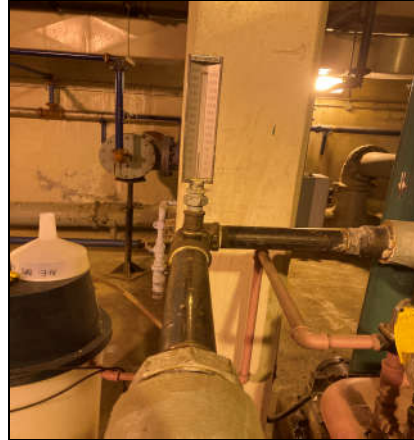
Damaged fittings removed, Location No.11

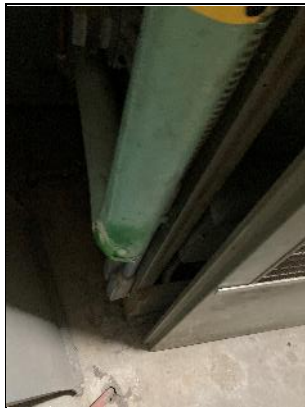
Damaged/exposed parging cement within the Old Pump Building Furnace Room Location No.21

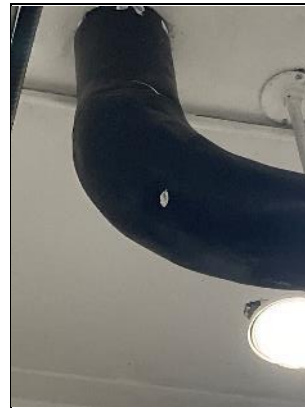
Damaged/exposed parging cement within the Chlorine Building, Chlorinator Room, Location No.9

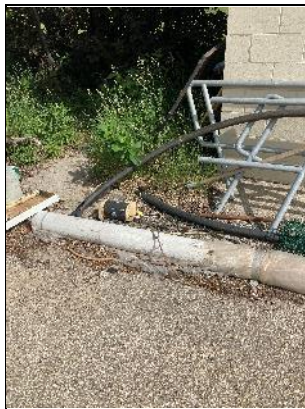
Eight linear feet of transite cement debris is present on the ground at the exterior of the Garage (Building F).

Asbestos-containing transite cement pipe debris exterior of Garage Building F..

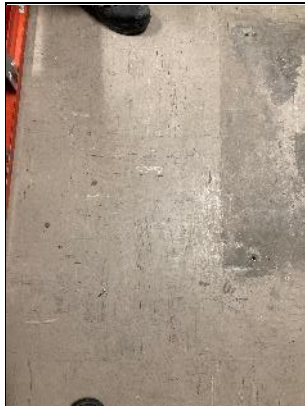
Vinyl floor tiles present within the Pump Building Electrical Room, Location No.6 were confirmed to contain asbestos (Samples 0002A-C). Vinyl floor tiles are non-friable and in GOOD condition.

Asbestos-containing vinyl floor tiles within Electrical Room
Location No.6.

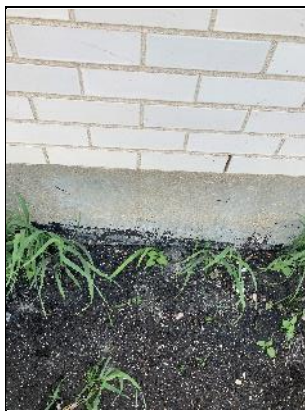
Asbestos-containing black tar mastic is applied as a sealant on the exterior lower wall finish of the Pump Building (Location No. 42) and Chlorine Building (Location No. 43). Mastic is a non-friable material which is in GOOD condition.

Asbestos-containing tar mastic in GOOD condition.

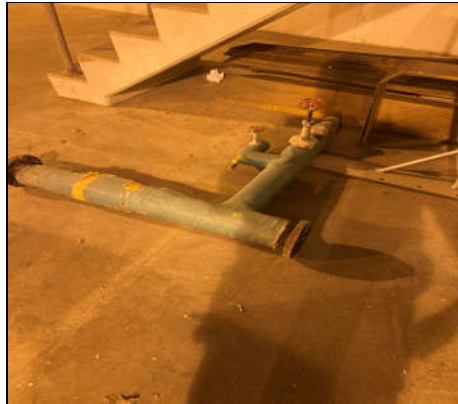
Asbestos-containing parging cement is present on pipe fittings of the heating water, glycol, rainwater leader, and well water systems throughout the building. Parging cement is a friable material. The parging cement was jacketed with canvas and in GOOD condition except for debris in POOR condition (cut section of pipe, 1 fitting) on the floor from a cut section of pipe within the North Basement, Location No.30.

Parging cement debris present on cut section of pipe within Location No.30

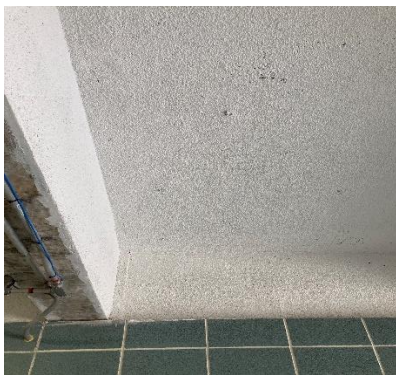
Asbestos-containing texture finishes are present within the Pump and Screen Building Viewing Gallery (Location No. 44) and Motor Room- (Location No. 49), and within the Unox Building, Unox Equipment Room, Location No.98. Texture finish is a friable material. The texture finishes are painted and are in GOOD condition.

Asbestos-containing textured ceiling finish observed in GOOD condition.

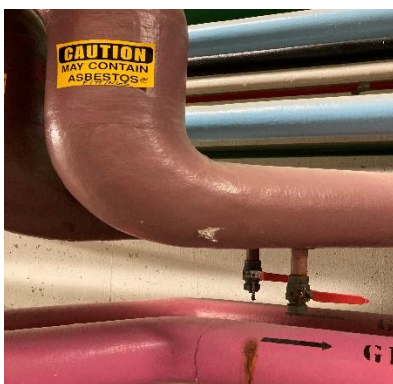
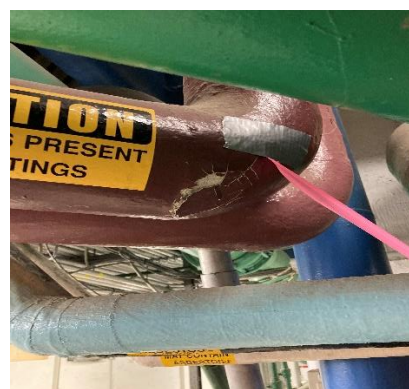
Damaged/exposed parging cement on 3 fittings within the Grit Building Location No. 59.

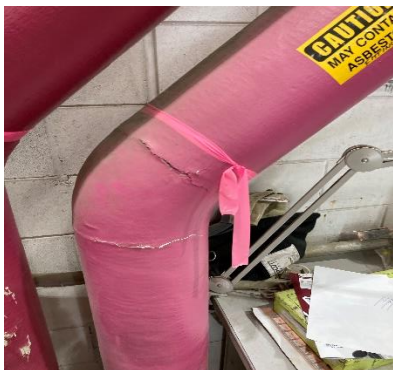
Damaged/exposed parging cement on 1 fitting within the Service Building Location No. 68.

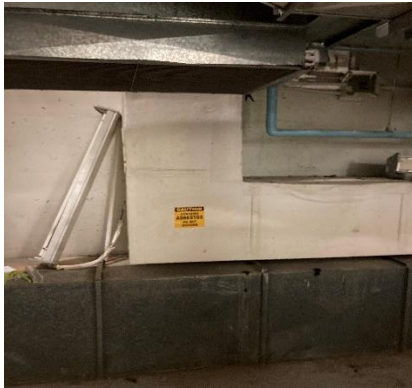
Asbestos-containing parging cement is present on ducts within the Pump and Screen Building (Location No's. 42 and 51), Service Building (Location No's. 66, 68, 71, 73 and 76), Primary Clarifier Service Area (Location No. 81), Secondary Clarifier (Location No's. 89, 90, 93, and 101) and Unox Equipment Room (Location No. 98). The parging cement is friable, was jacketed with canvas, and is in GOOD condition.

Asbestos containing parging cement insulating ducting in various location observed in good condition.

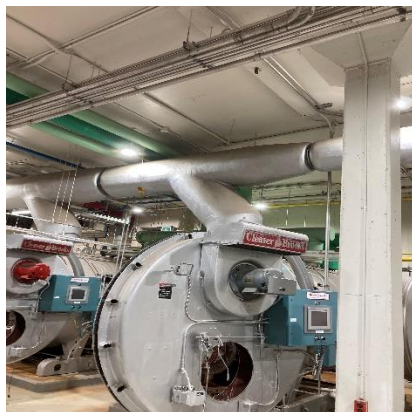
Asbestos-containing parging cement is present on mechanical equipment (Boiler Breeching, Heat Exchangers, Boilers) within the Administration Building – Mechanical Room (Location No. 30), Service Building Boiler Room (Location No. 76) and Primary Clarifier East Walkway (Location No. 79). Parging cement is a friable material. It is covered with canvas jacket. It is in GOOD condition.

Asbestos-containing parging cement present on mechanical equipment in various locations in GOOD condition.

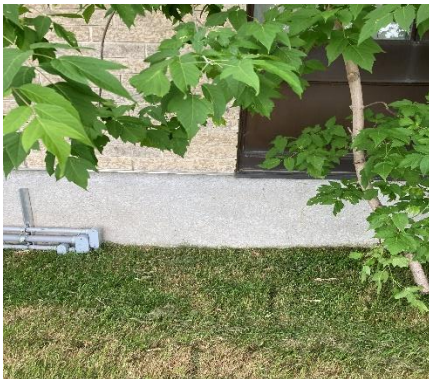
Plaster on the exterior walls of the Primary Clarifier, Secondary Clarifier, Administration, Pump & Screen, Service and Oxygen Reactor Buildings has been confirmed to contain asbestos. Plaster finishes are non-friable while in place but can become friable during disturbance. All exterior plaster is in GOOD condition.

Presumed and confirmed asbestos-containing plaster in various locations observed in GOOD condition.

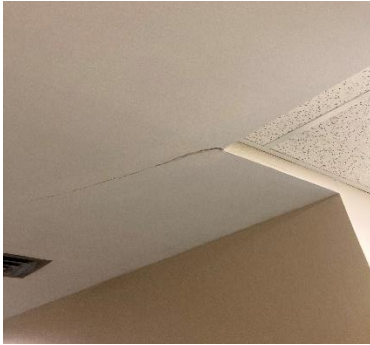
Drywall (gypsum board) and drywall joint compound is present as wall and ceiling finishes throughout the facility. Three samples of drywall joint compound were collected during this years reassessment confirming the presence of asbestos (Samples 0001A-C). In the absence of additional sampling all drywall finishes should be treated as asbestos-containing. Drywall joint compound is non-friable while in place but can generate friable dust upon removal. All drywall joint compound is in GOOD condition except for 2 SF of damage rated in FAIR condition within the Admin Building Location No.11.

Damaged asbestos-containing drywall joint compound in FAIR condition within the Admin Building Location No.11.

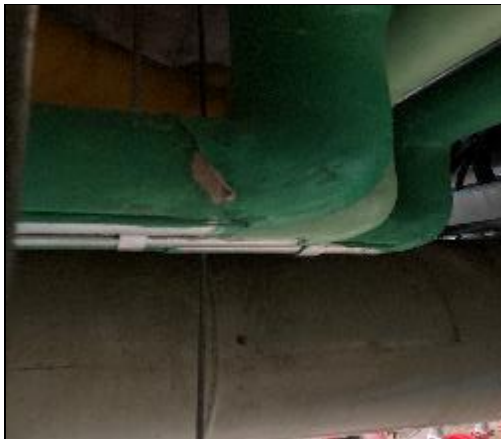
Location	Quantity and Condition of Damage
Central Basement (Location No. 34)	Damaged/exposed parging cement on 1 fitting of the Heating water return system is rated in FAIR condition

Damaged/exposed parging cement in FAIR Condition, Location No,34.

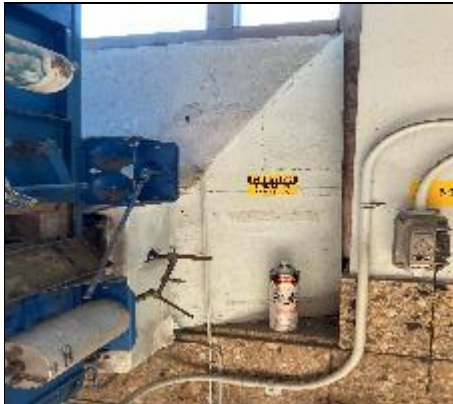
Asbestos-containing parging cement on ducting in GOOD condition.

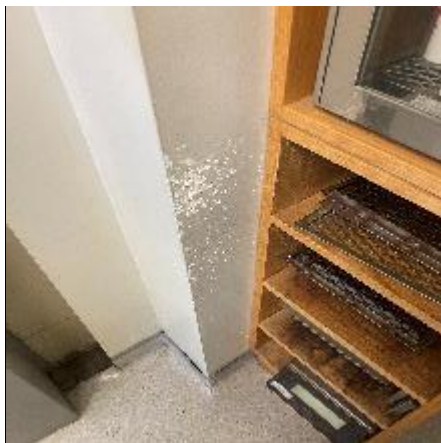
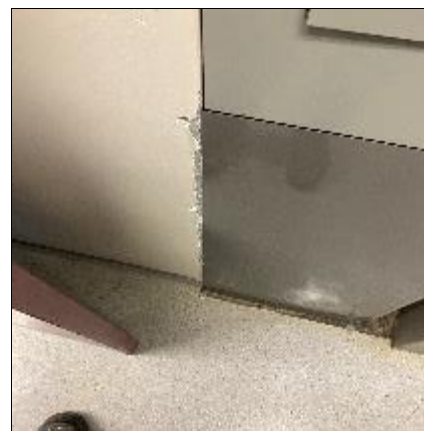
Drywall (gypsum board) and drywall joint compound is present as wall and ceiling finishes throughout the building. No sampling has been conducted. In the absence of sampling all drywall joint compound must be presumed to contain asbestos. Drywall joint compound is a non-friable material while in place but can generate friable dust upon removal. All drywall joint compound is in GOOD condition except for 10 SF of damaged rated in FAIR condition within the Balance Room, Location No.26.

Damaged drywall joint compound, Location No.26

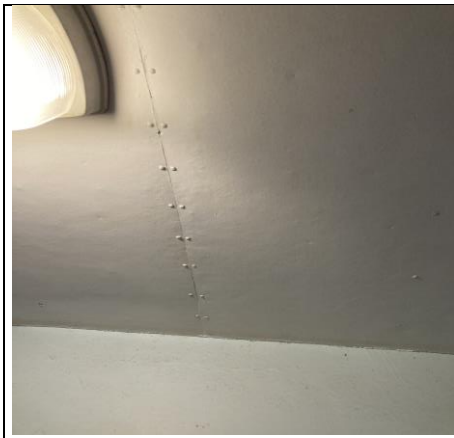
Transite board presumed to contain asbestos is present as ceiling finish within the Entrance/Exit, Location No.10. The transite board is non-friable and is in GOOD condition.

Transite cement board presumed to contain asbestos in GOOD condition.

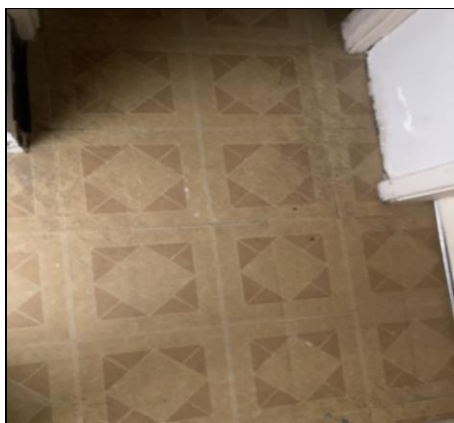
Vinyl floor tiles present within Corridor, Location No.39 are presumed to contain asbestos. Vinyl floor tiles are non-friable and are in GOOD condition.

Vinyl floor tiles presumed to contain asbestos, Location No.39.

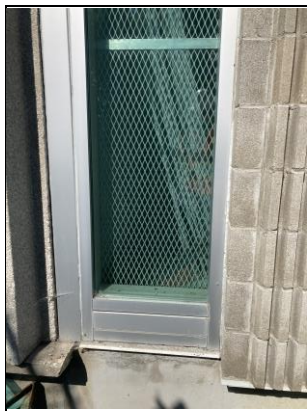
Asbestos-containing grey caulking is present on exterior wall finish of the Main Building (Location No. 19). Caulking is a non-friable material which is in GOOD condition.

Asbestos-containing caulking in GOOD condition.
