REPORT FOR:

Seven Oaks Pool 444 Adsum Drive Building Condition Assessment

Submitted to: City of Winnipeg
Planning, Property, and Development Department
Accommodation Services

Date: April 4, 2019

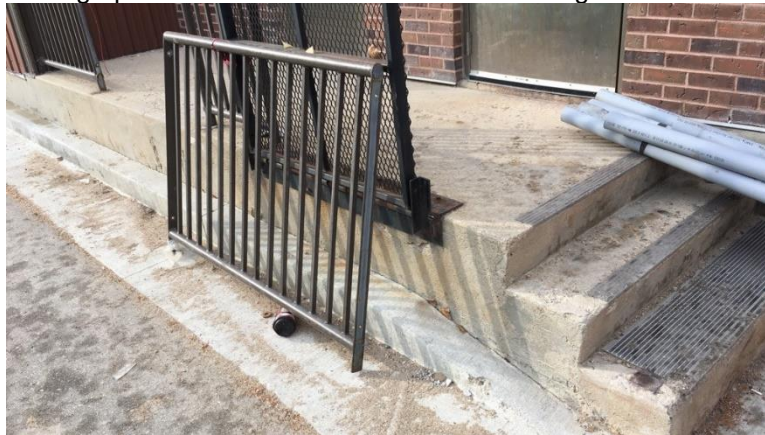
- .1 Minor concrete deterioration was observed on the on concrete loading dock and exterior stairs on the east elevation was observed.

Photograph 3.1.1.1-1: Partial view of east loading dock.

Recommendation 3.1.1.1-1: Localized concrete repairs are required to address existing deterioration. Repairs are relatively limited at present and are considered normal maintenance.

Estimated Cost: \$3,000

Priority: Medium Term, recommended within 1 to 5 years.

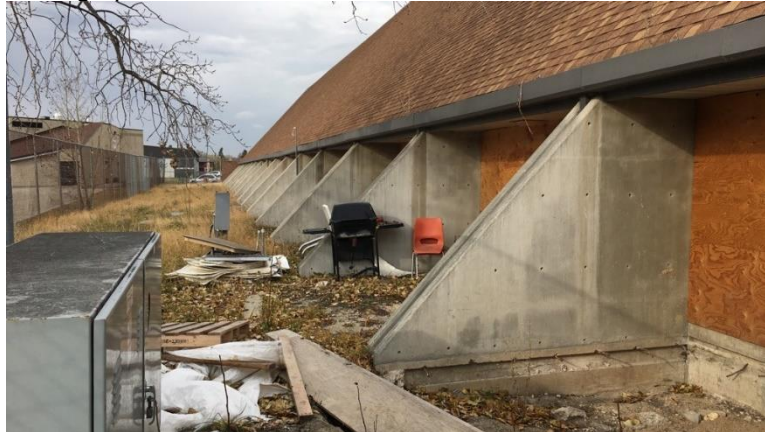
- .1 The east and south elevations consist of hard landscaping surfaces such as concrete and asphalt. No obvious deficiencies were noted.
- .2 Access to the west elevation was limited due to construction process.
- .3 Access to the south elevation was not available at the time of the site visit. Landscaping on the south elevation consists of sod (Photograph 3.1.2.3-1). The grade appears to slope away from the building.

Photograph 3.1.2.3-1: Partial view of south elevation.

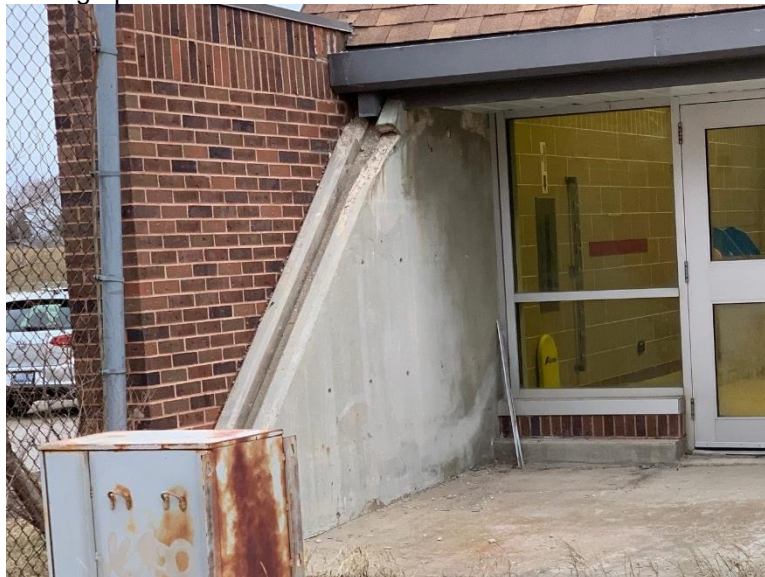
- .4 A visual review of the concrete buttresses showed evidence of concrete deterioration (Photographs 3.1.2.4-1). The pattern and location of deterioration is consistent with freeze-thaw deterioration caused by repeated exposure to roof runoff from the rain water leaders which direct water down the formed in channel along the top edge of the buttress.

Photograph 3.1.2.4-1: Partial view of concrete buttress.

Recommendation 3.1.2.4-1: Concrete repairs are required to address existing deterioration. Modification and extending the rainwater leaders is also recommended to direct roof runoff away from the buttress and structure.

Estimated Cost: \$40,000

Priority: Short Term, recommended within 1 year.

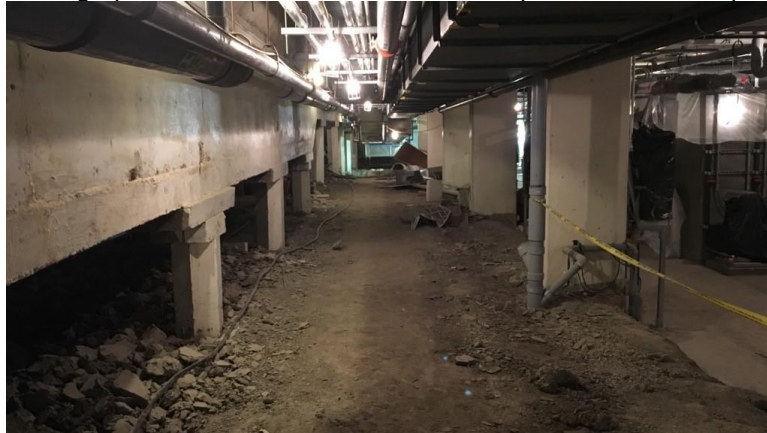
- .1 A crawlspace is located below the pool deck and tanks. The existing vapour retarder was not observed over large portions of the crawlspace including the north side (Photographs 3.2.1.1-1) and below the pool tank (Photograph 3.2.1.1-5 and 3.2.1.1-6). Where a polyethylene vapour retarder was visible, it was generally discontinuous and in poor condition (Photograph 3.2.1.1-1).

Photograph 3.2.1.1-1: Partial view of crawlspace below north pool deck.

Recommendation 3.2.1.1-1: The crawlspace does not have a functioning vapour barrier. Remediation of the crawlspace is required including grading of the existing soil to direct water away from structural members, installation of a new drainage system and sump pits (if required, see mechanical), and installation of a vapour retarder and sand cover. Installation of new sub-surface drainage, vapour barrier, and sand cover is recommended within 5 years.

Estimated Cost: \$400,000

Priority: Long Term, recommended within 5 to 10 years.

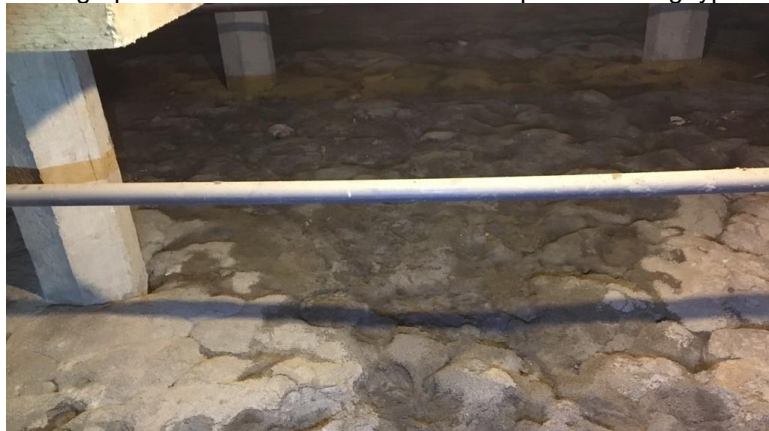
Photograph 3.2.1.1-6: Partial view of crawlspace showing typical ground cover.

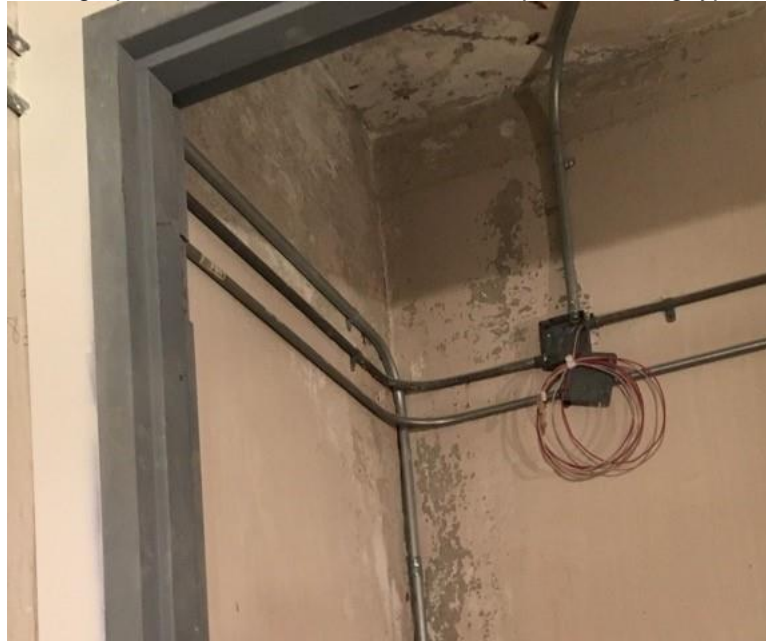
- .3 Evidence of water seepage was observed through the foundation walls at the northwest stair (Photograph 3.2.1.3-1). It is our understanding that renovation work will include renovations to the exterior which may address leakage. No repairs are currently recommended.

Photograph 3.2.1.3-1: Partial view of crawlspace showing typical ground cover.

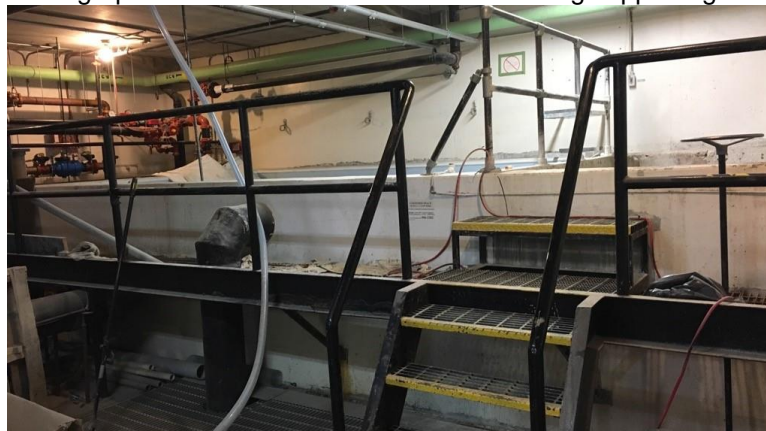
- .4 The pool filtration tank at the northeast corner of the building have evidence of concrete deterioration. Site personnel indicated that concrete repairs will be completed as part of the renovation.
- .5 A raised steel grate floor is provided around the filtration tank. Minor to moderate corrosion was observed on the steel framing members. visible.

Photograph 3.2.1.5-1: Corrosion on steel framing supporting filtration room platform.

Recommendation 3.2.1.5-1: Sandblast and coat existing steel platform.

Priority: Medium Term, recommended within 1 to 5 years.

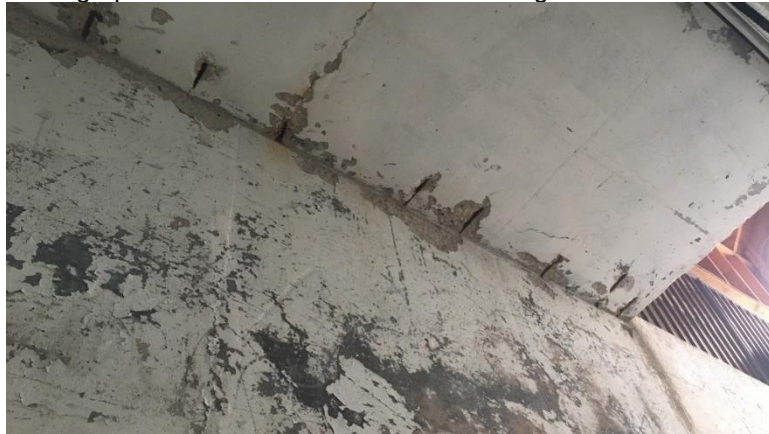
- .6 An exterior stair provides egress from the east end of the basement. The concrete stair treads appear to be in good condition. Shallow surface spalling and exposed reinforcing steel was observed along the soffit of the concrete roof over the stair (Photograph 3.2.1.6-1).

Photograph 3.2.1.6-1: Corrosion of reinforcing steel and shallow surface spalling

Recommendation 3.2.1.6-1: Complete localized concrete repairs.

Estimated Cost: \$10,000

Priority: Short Term, recommended within 1 year.

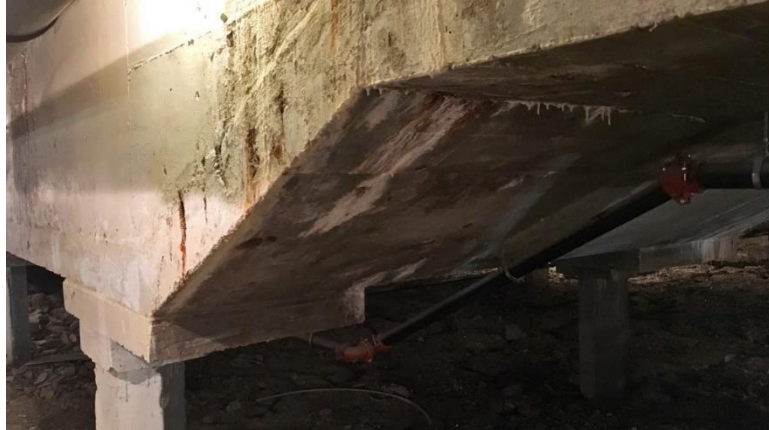
Shallow delamination and surface spalling was observed along north edge of pool basin where it transitions to the deep end (Photograph 3.2.2.1-1) The delamination is a result of water seepage and is made worse by exposure to chlorinated water and insufficient cover over reinforcing steel. Efflorescence also visible along slab soffit.

Photograph 3.2.2.1-1: Soffit delamination and spalling at pool tank drain.

Recommendation 3.2.2.1-1: Structural concrete repairs are required to address existing deterioration. Given the extent of leakage and the fact that the pool water contains chlorine which enhances corrosion, the likelihood of a rapid increase in corrosion and delamination is very high. Repairs are therefore required in the short term to address existing deterioration. Repairs will include removal of all loose concrete down to a sound substrate, exposing all corroding reinforcing steel, sandblasting existing concrete and reinforcing steel, and infilling with a proprietary concrete repair material.

Priority: Short Term, recommended within 1 year.

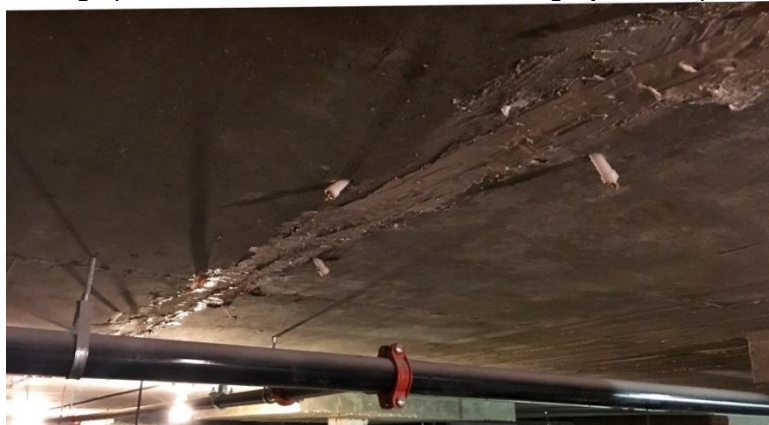
Cracking in the pool basin with evidence of leakage and efflorescence was visible in numerous areas. Attempts to address leakage by injecting the cracks with a urethane resin were visible in some areas (Photograph 3.2.2.1-2). It could not be determined if the repairs were successful at stopping leakage. It is reported that the cracks repaired by injection in 2010. Cracking and delamination of the concrete was observed despite the injection work which indicates that corrosion is continuing.

Photograph 3.2.2.1-2: Soffit delamination along injection repair.

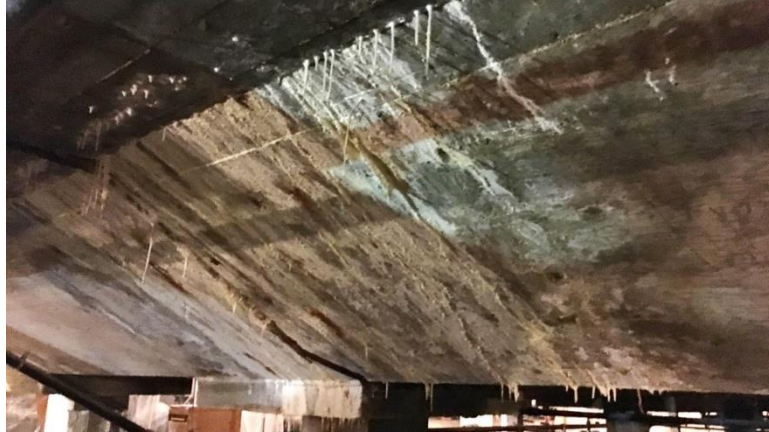
Evidence of significant leakage was observed at the transition from shallow end to deep end (Photograph 3.2.2.1-3). The leakage is presumably occurring through a construction joint in the slab. Similar conditions were observed along the construction joint between the pool walls and deck.

Hammer soundings did not detect any evidence of delamination. Based on the observed conditions combined with exposure to chlorides from the pool water, the likelihood of that corrosion of the reinforcing steel is occurring is very high and is expected that concrete delamination will occur over the short to medium term.

Photograph 3.2.2.1-3: Leakage and efflorescence along construction joint in pool tank.

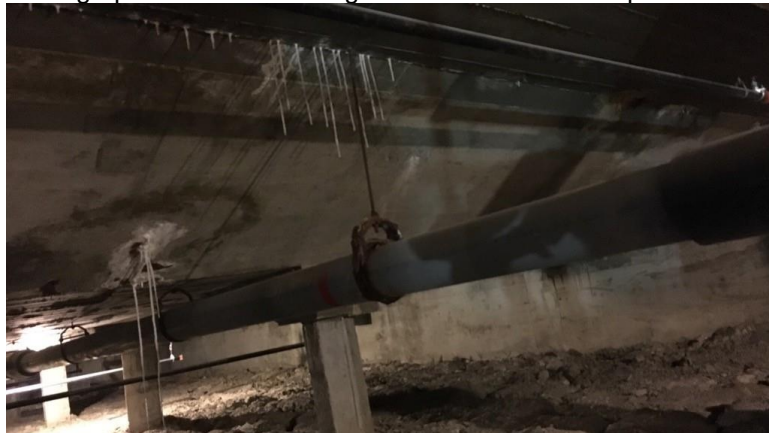
Photograph 3.2.2.1-4: Leakage and efflorescence in pool tank.

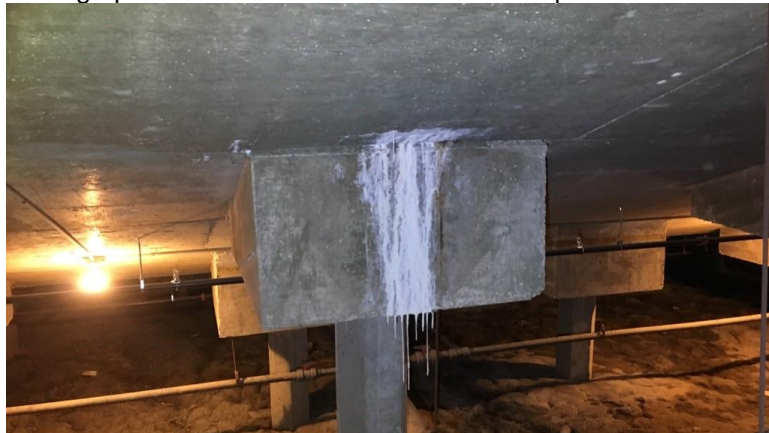
Photograph 3.2.2.1-5: Efflorescence at leak in pool tank.

Evidence of leakage was also observed at cracks and penetrations in the concrete joist framing at the east and west pool decks (Photographs 3.2.2.1-5 and 3.2.2.1-6).

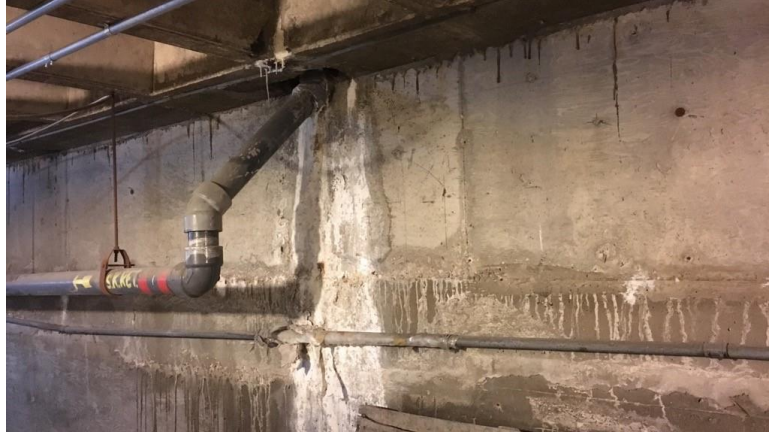
Photograph 3.2.2.1-6: Efflorescence at crack in pool tank wall.

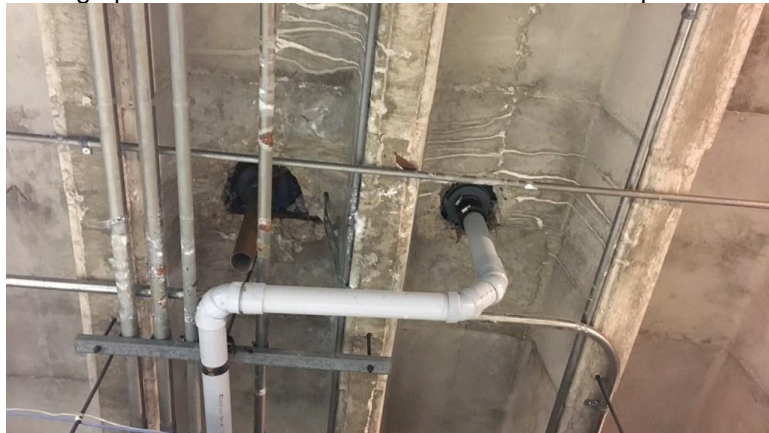
Photograph 3.2.2.1-7: Localized leaks below the east pool deck at a mechanical line.

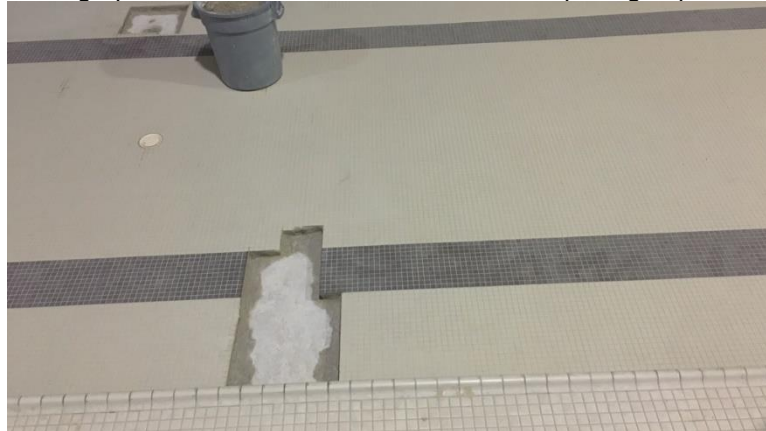
- .2 A visual inspection with localized chain drag soundings was completed on the top surface of the pool decks. Localized areas of debonding of the tile was observed within the pool tanks. Water seepage through the pool slabs and walls indicating that the existing tile is not providing an effective waterproof barrier. It is our understanding that localized repairs are being completed as part of the ongoing renovations and were ongoing during the site visit (Photograph 3.2.2.2-1). Localized repairs are considered a short term repair.

Photograph 3.2.2.2-1: Soffit delamination and spalling at pool tank drain.

Recommendation 3.2.2.2-1: Over the long term, to address the root cause of the concrete deterioration and extend the service life of the repairs, it is recommended that the existing tile be removed and replaced with a new pool lining and tile finish.

Recommendation 3.2.2.2-2: As an interim measure, injection of the cracks using a hydrophobic urethane resin can be completed to allow repairs to be deferred. It is anticipated that repairs will be required periodically until the tile is replaced

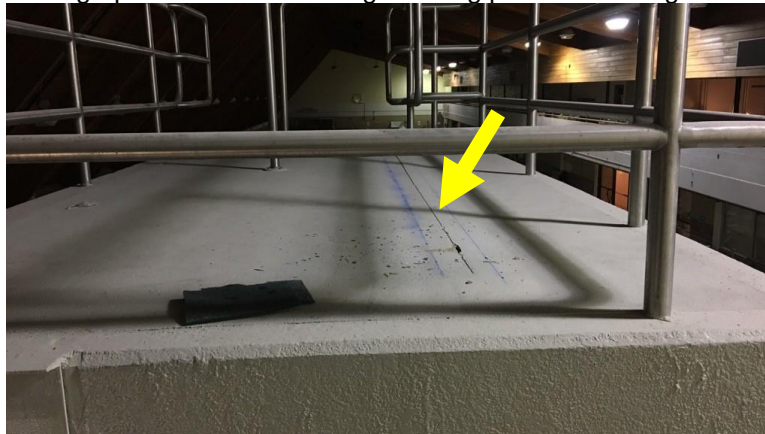
- .3 Structural concrete repairs had been completed along the soffit of main floor beams on Grid C between 2 and 3 and Grid 2 between B and C. Repairs appear sound.
- .4 The diving platform is constructed of cast-in-place concrete. The platform and stair treads have been covered with a surface coating. The type of coating could not be determined. Evidence of cracking in the surface coating was visible on top diving platform (Photograph 3.2.2.4-1). Corrosion staining was also visible on the stair nosings (Photograph 3.2.2.4-2). Concrete repairs were underway at the time of the site visit and it was reported that the coating will also be repaired as part of this renovation.

Photograph 3.2.2.4-1: Cracking in diving platform coating.

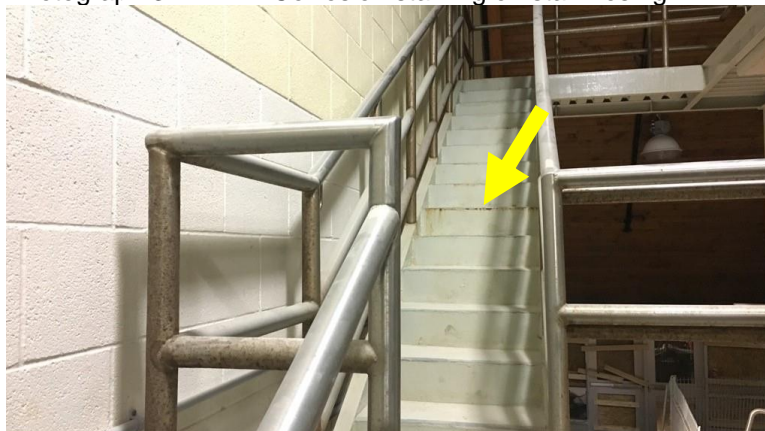
Photograph 3.2.2.4-2: Corrosion staining on stair nosing.

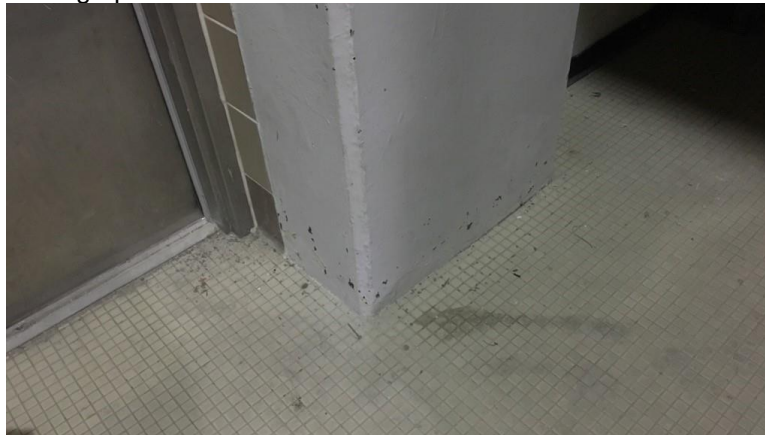
- .5 Exposed concrete framing appears to be in good condition. Minor deterioration at bottom of column at northwest corner.

Photograph 3.2.2.5-1: Deterioration of concrete column.

Recommendation 3.2.2.5-1: Complete localized concrete repairs.

Estimated Cost: \$3,000

Priority: Short Term, recommended within 1 year.

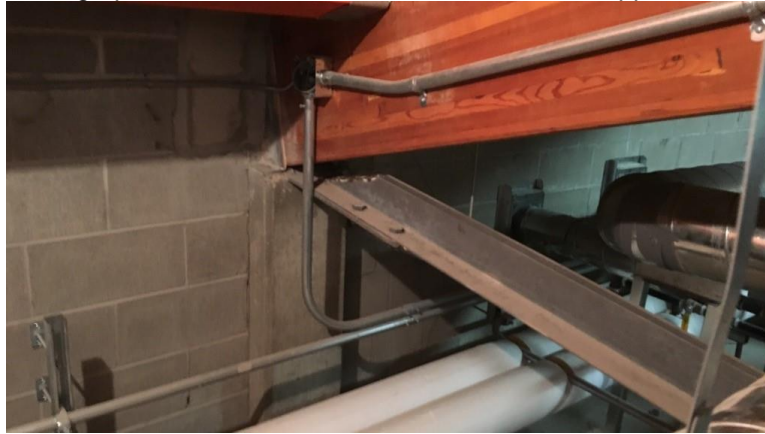
Photograph 3.2.4.2-1: Glulam tension tie at north support.

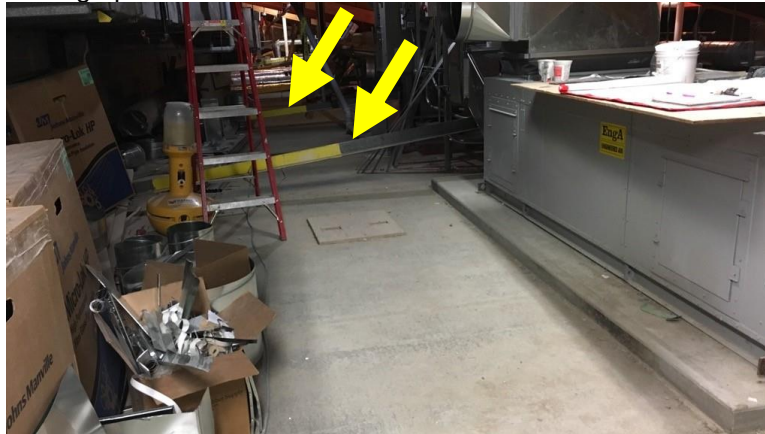
glulam roof beams. The tension ties were reviewed and appear to be in good condition (Photograph 3.2.4.2-2). The tension ties cross a walking aisle in the mechanical room. The tension ties have been painted yellow as a warning.

Photograph 3.2.4.2-2: Glulam tension tie connection to floor structure.

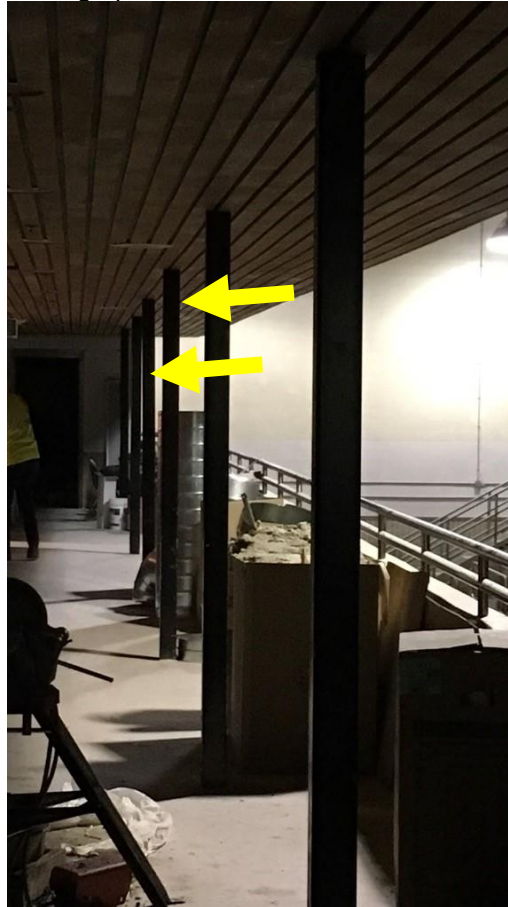
Two of the glulam beams at the entrance lobby are omitted and was part of the original design. Evidence of lateral movement of two of the two HSS columns supporting the two glulam beams where the tension ties have been removed was observed (Photograph 3.2.4.2-3). The cause of the displacement could not be determined. Further investigation beyond the scope of this assessment is warranted.

Photograph 3.2.4.2-3: Lateral deflection of HSS columns.

Recommendation 3.2.4.2-1: Complete further investigation to assess cause of apparent column displacement.

Priority: Short Term, recommended within 1 year.

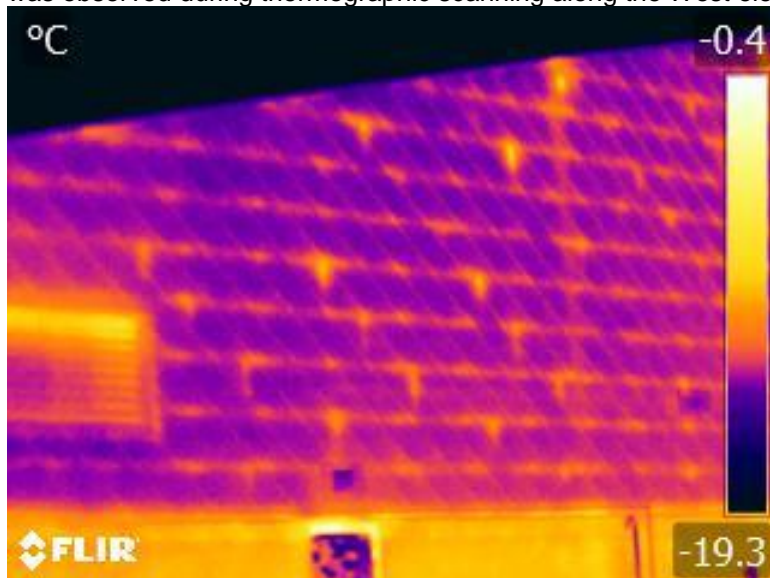
Photograph 3.3.1.4-2: Thermal bridging at the existing metal cladding steel girt support was observed during thermographic scanning along the West elevation.

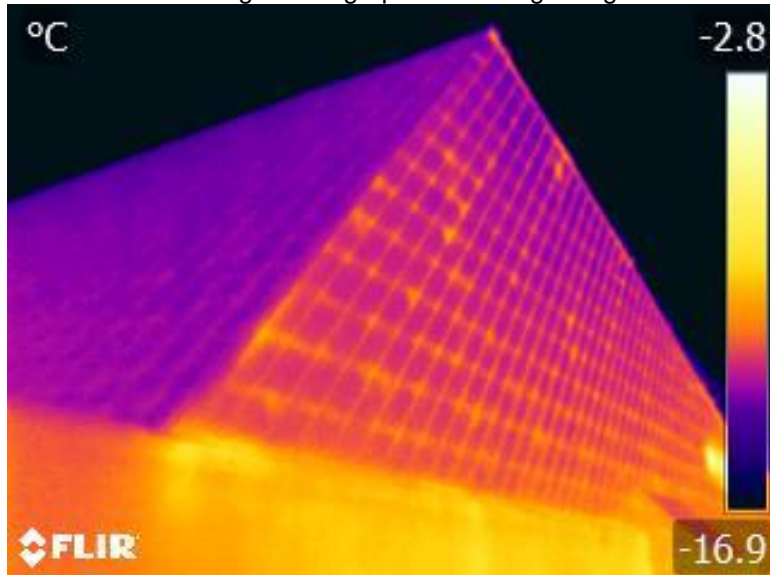
Photograph 3.3.1.4-4: Thermal bridging at the existing metal cladding steel girt support was observed during thermographic scanning along the East elevation.

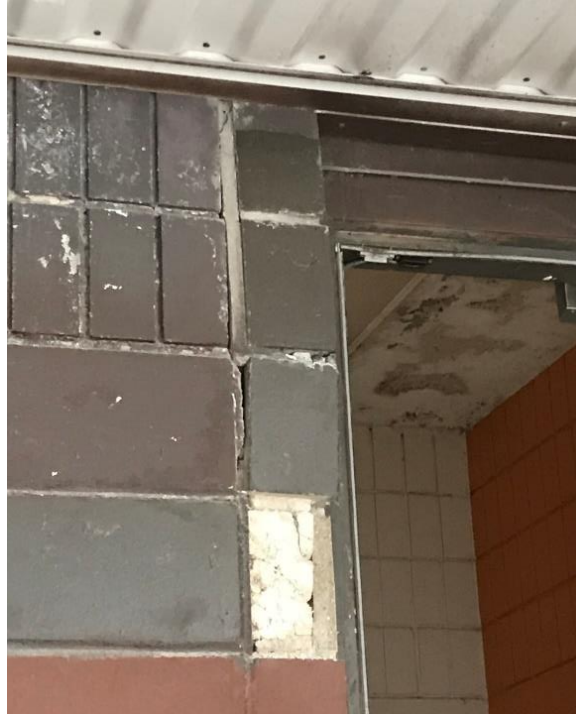
Photograph 3.3.1.4-5: Localized mortar joint and brick deterioration was observed at the top corner of the door opening.

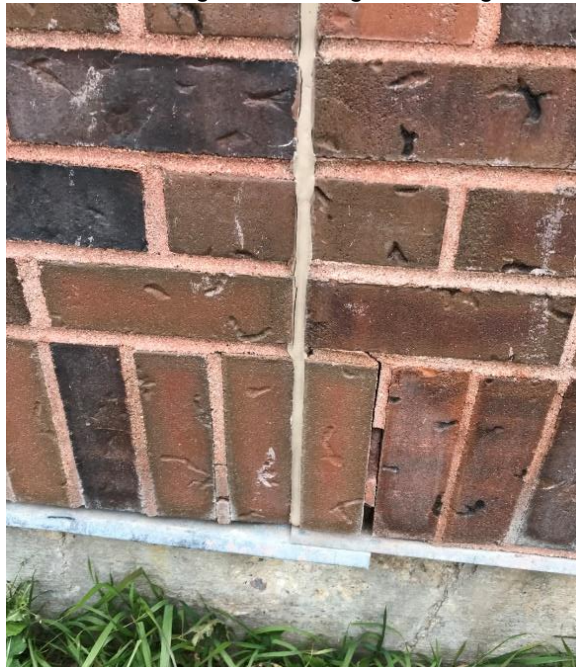
Photograph 3.3.1.4-6: Localized mortar joint deterioration at the bottom ledger course of the brick cladding and caulking debonding at the brick masonry control joint was observed.

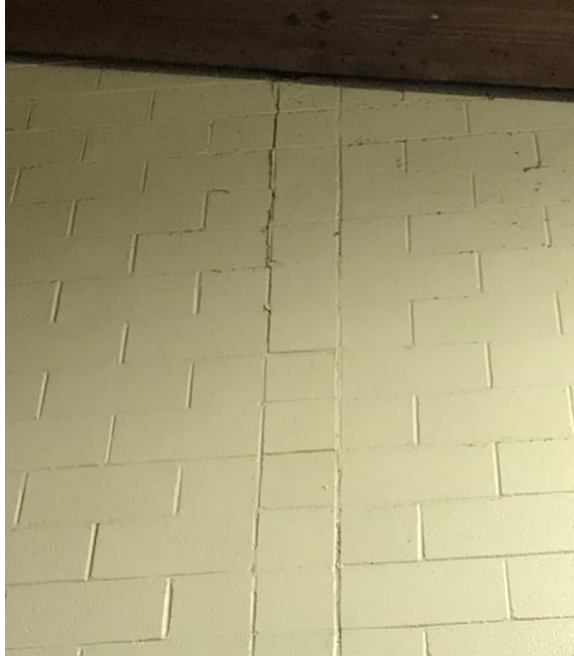
Photograph 3.3.1.4-7: Cracking observed at the interior face of the existing masonry block back-up adjacent to the control joint.

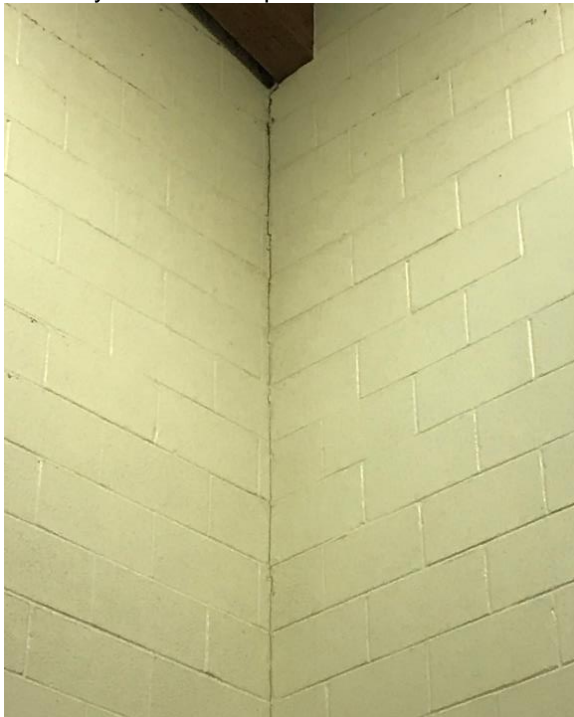
Photograph 3.3.1.4-8: Corner cracking observed at the interior face of the existing masonry block back-up.

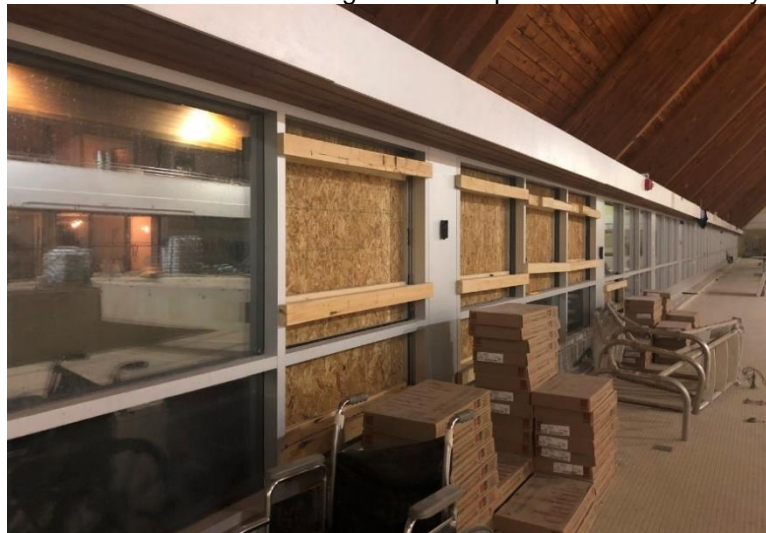
Photograph 3.3.2.1-1: Partial interior south elevation showing glazing unit configuration within the curtain wall framing. Boarded up units were broken by vandalism.

Recommendation 3.3.2.1-1: Existing aluminum curtainwall windows, a third of which have been broken by vandalism, are exhibiting sealed unit failure. Short term replacement is recommended to increase thermal performance, visibility, and occupant comfort. It is recommended that associated flashing and sealant replacement and repairs be conducted simultaneously to increase the performance and durability of the window tie in to the overall envelope system.

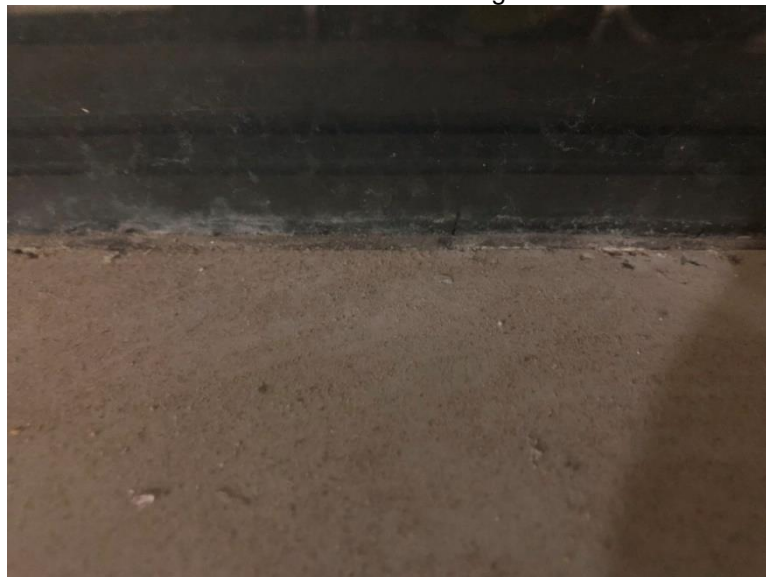
Photograph 3.3.2.1-2: Typical example of dry and stiff interior gasket and desiccant residue on interior surface of lite indicating sealed unit failure

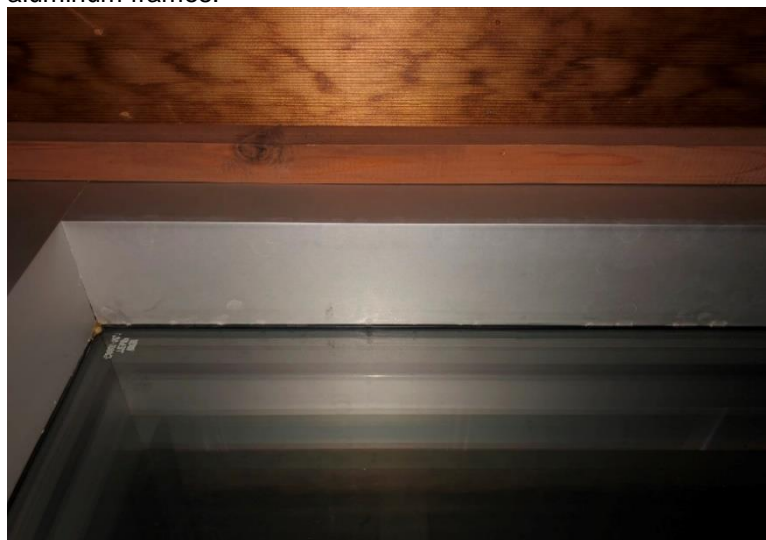
Photograph 3.3.2.1-3: Typical example of condensation and water staining on the aluminum frames.

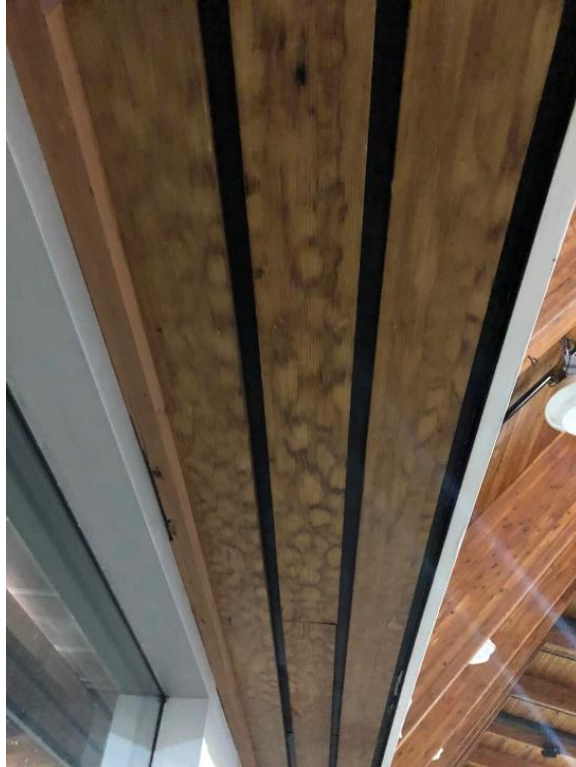
Photograph 3.3.2.1-4: Typical example of condensation and water staining on the aluminum frames and surrounding surfaces.

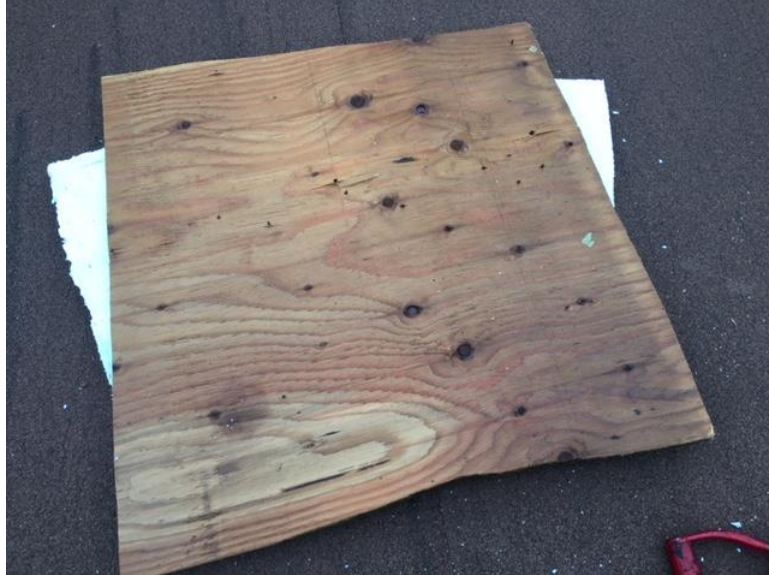
Photograph 3.3.3.1-3: Showing saturated plywood support panel.

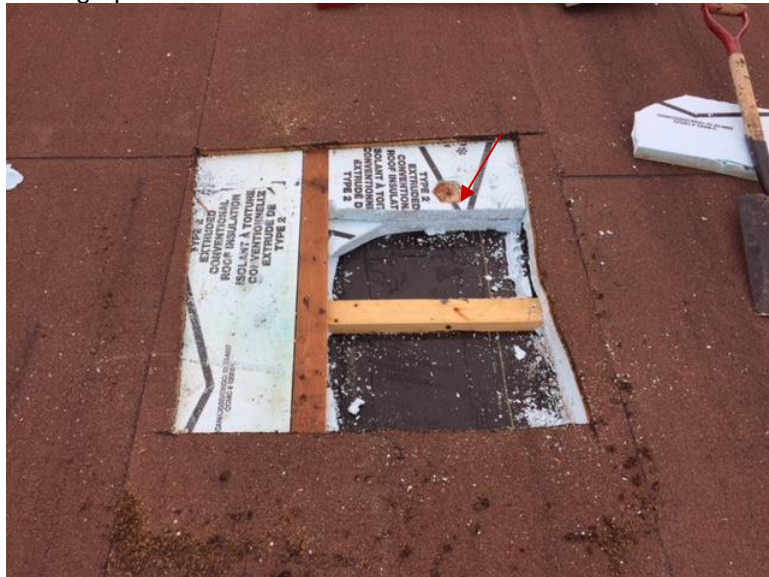
Photograph 3.3.3.1.4: View rusted fastener.

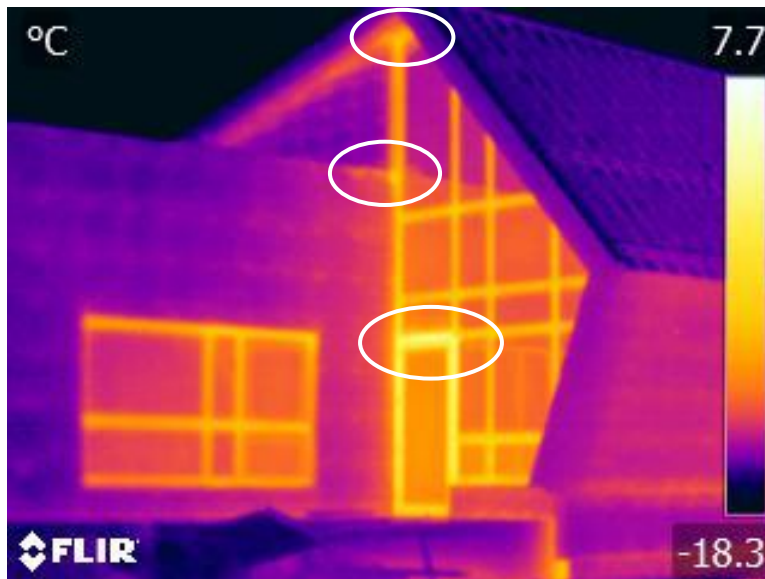
Figure 1: Partial east elevation showing anomalies caused by air leakage at the top of the wall and along the head of the door.

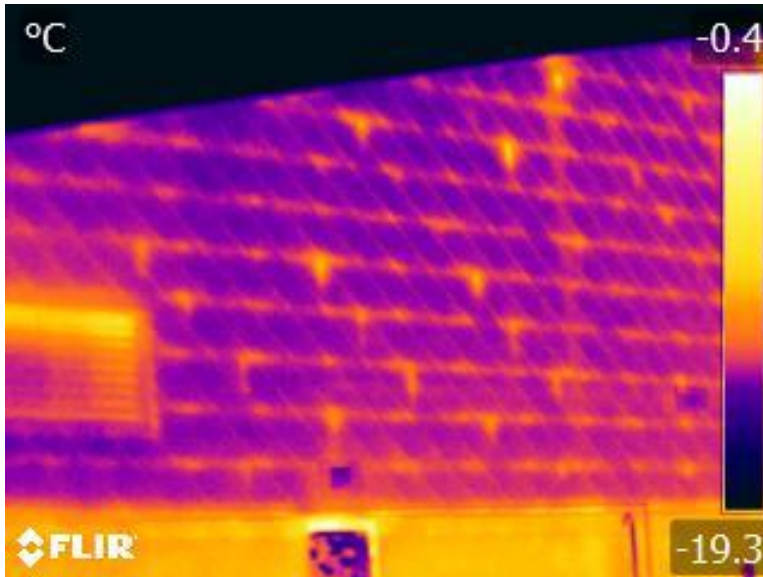
Figure 2: Overall view of anomalies likely caused by diffused air leakage at gable wall cladding.

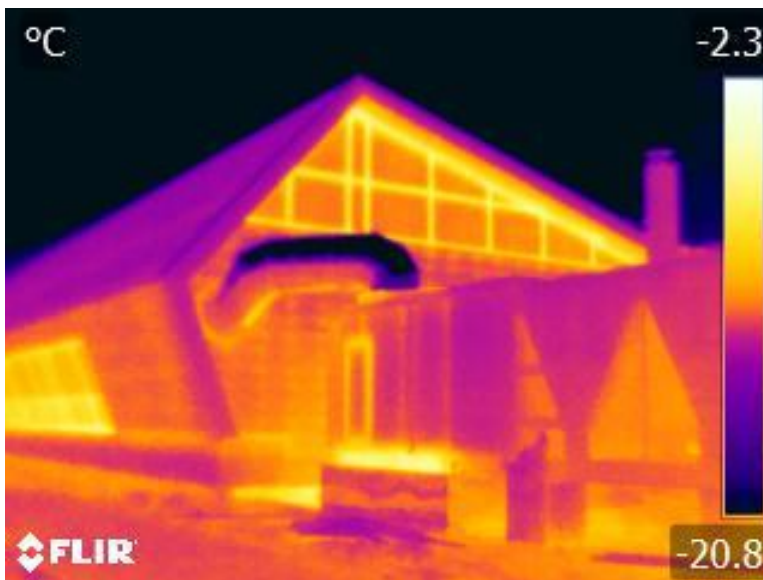
Figure 3: Detailed view of west soffit area. Note numerous thermal anomalies caused by air leakage and thermal bridging.

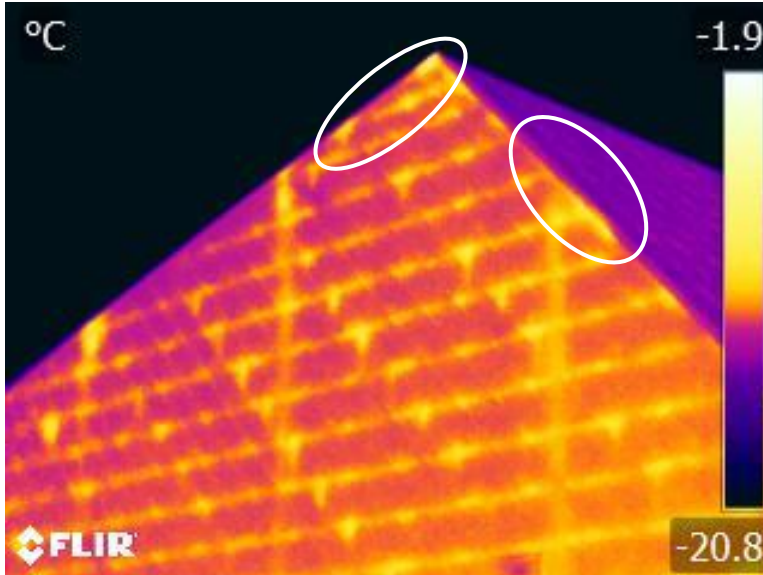
Figure 4: Detailed view of east gable wall showing thermal bridging at horizontal cladding supports as well as apparent air exfiltration at numerous cladding and fascia locations.

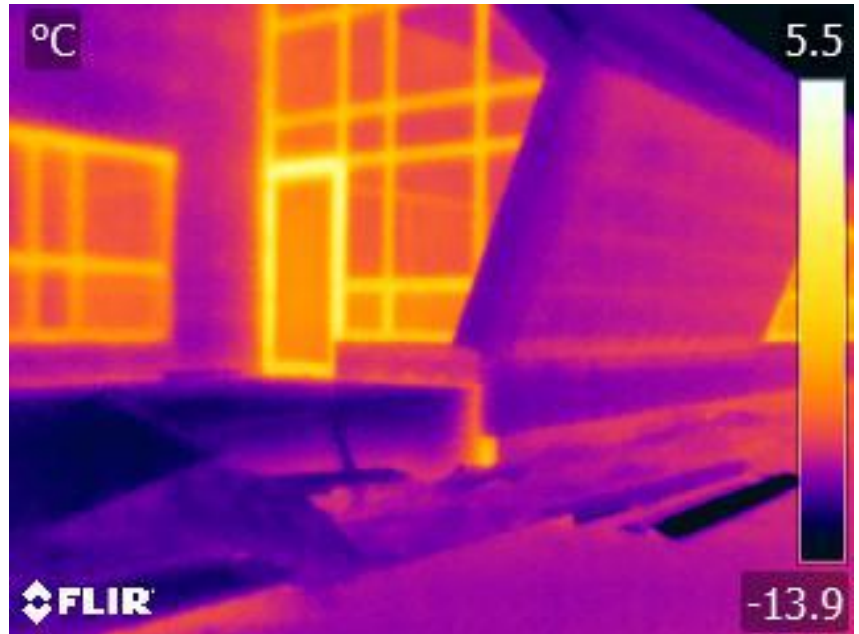
Photograph #26:

Detail view of partial east elevation. Note thermal bridging at curtainwall mullions. Also note apparent air leakage around door.

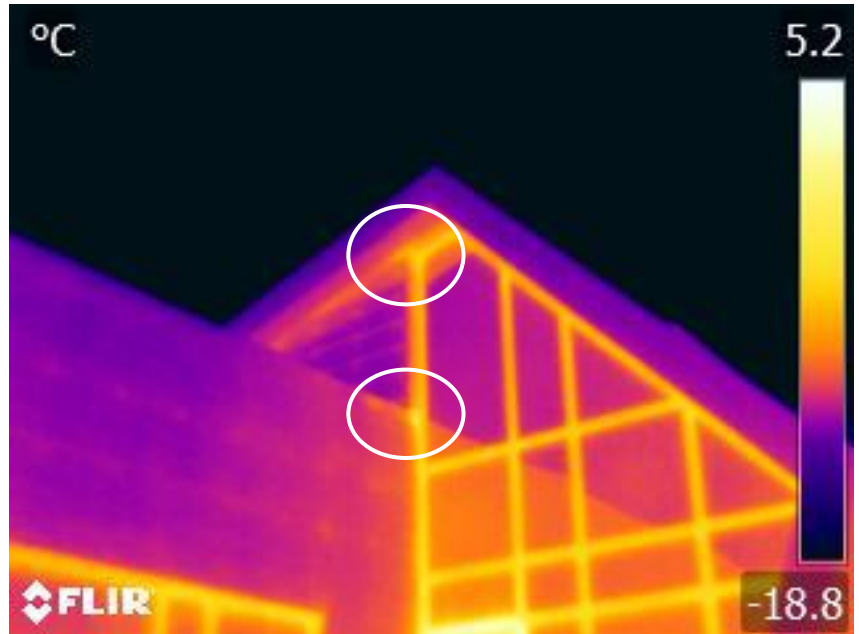
Detail view of curtainwall on east elevation. Note possible air leakage locations at transitions (highlighted).

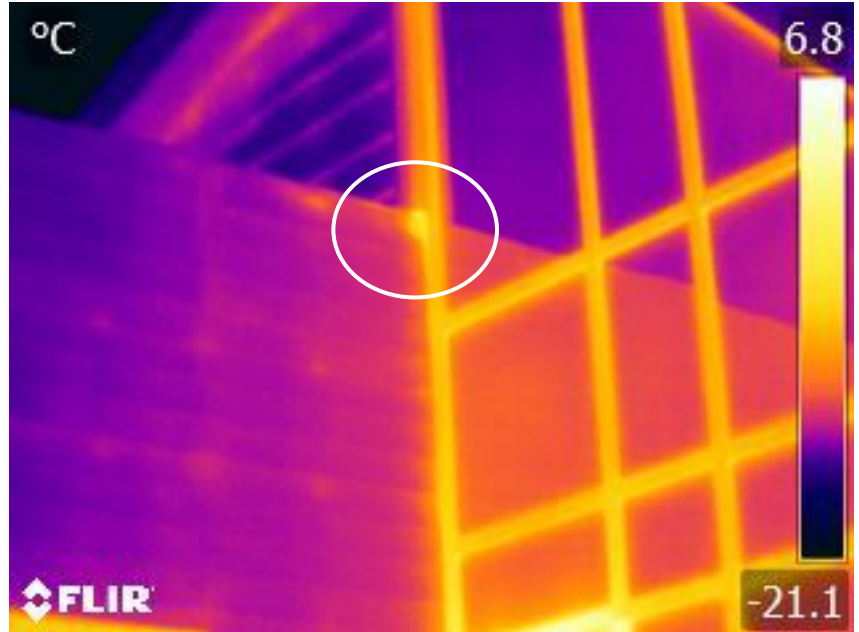
Detail view of curtainwall on east elevation. Note possible air leakage location (highlighted).

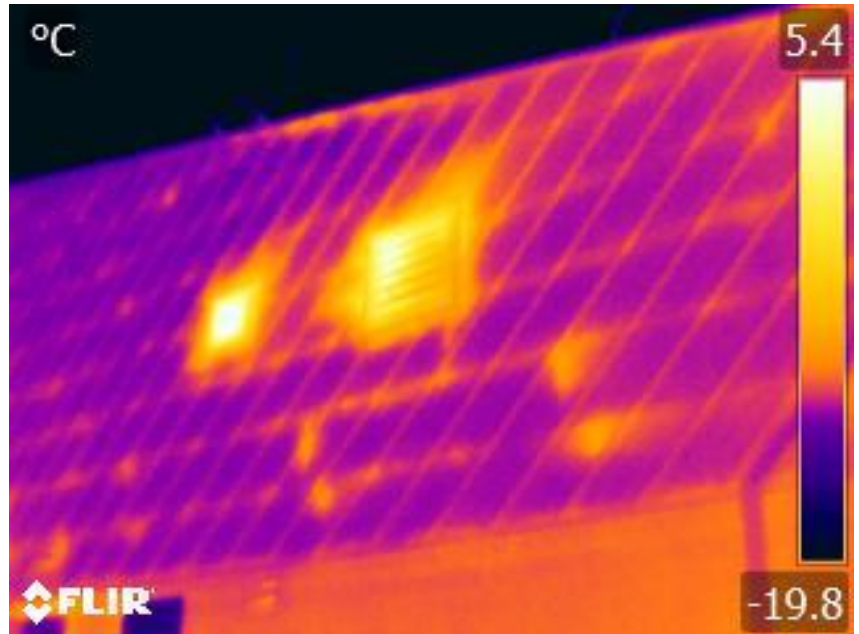
Partial east elevation. Note thermal anomalies at diagonal cladding caused by thermal bridging and air leakage.

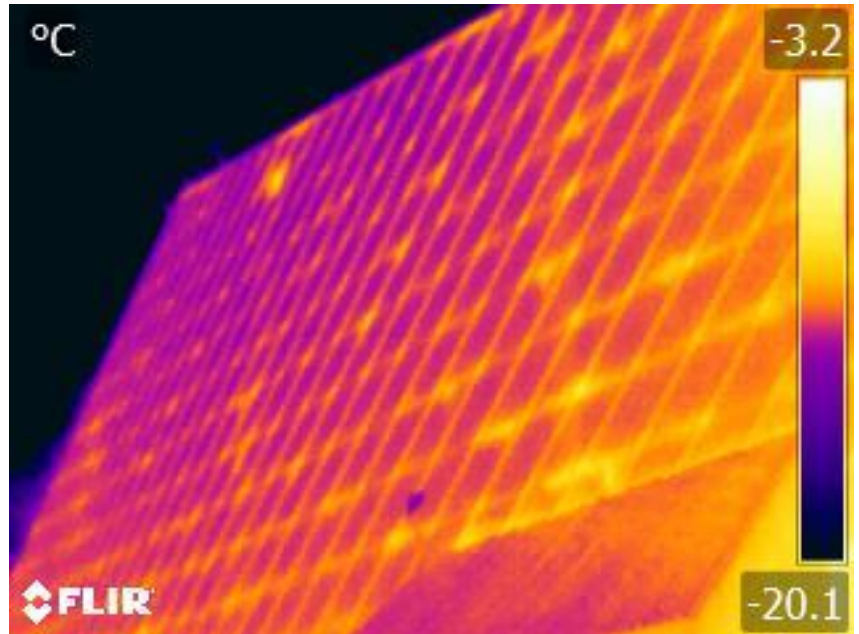
Partial east elevation. Note thermal anomalies at diagonal cladding caused by thermal bridging and air leakage.

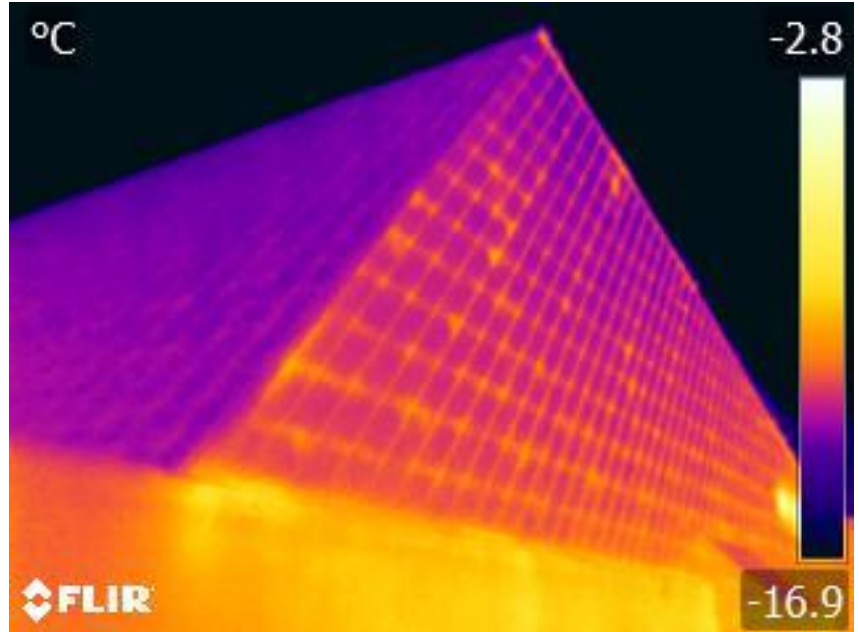
Partial east elevation. Note thermal anomalies at diagonal cladding caused by thermal bridging and air leakage.

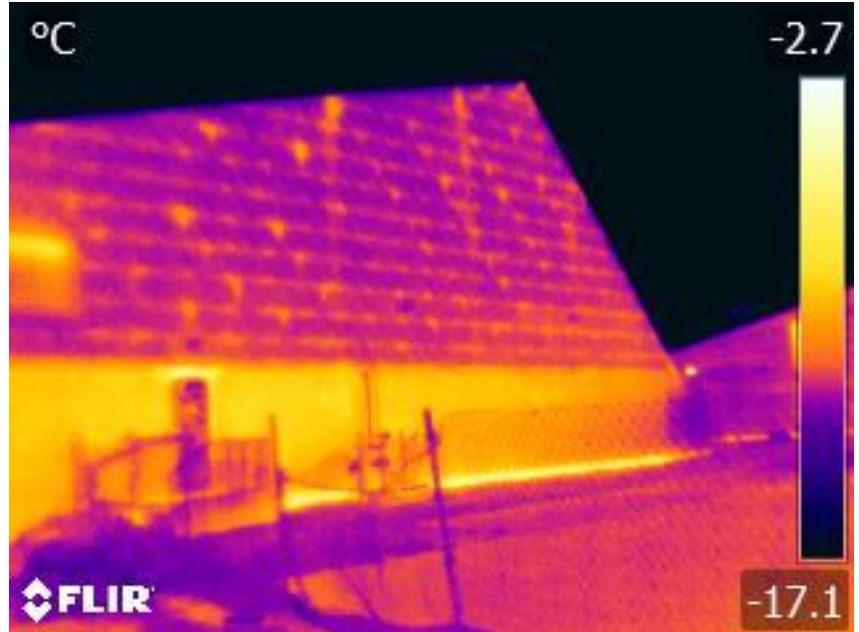
Partial west elevation. Note anomalies on diagonal cladding caused by thermal bridging and air leakage.

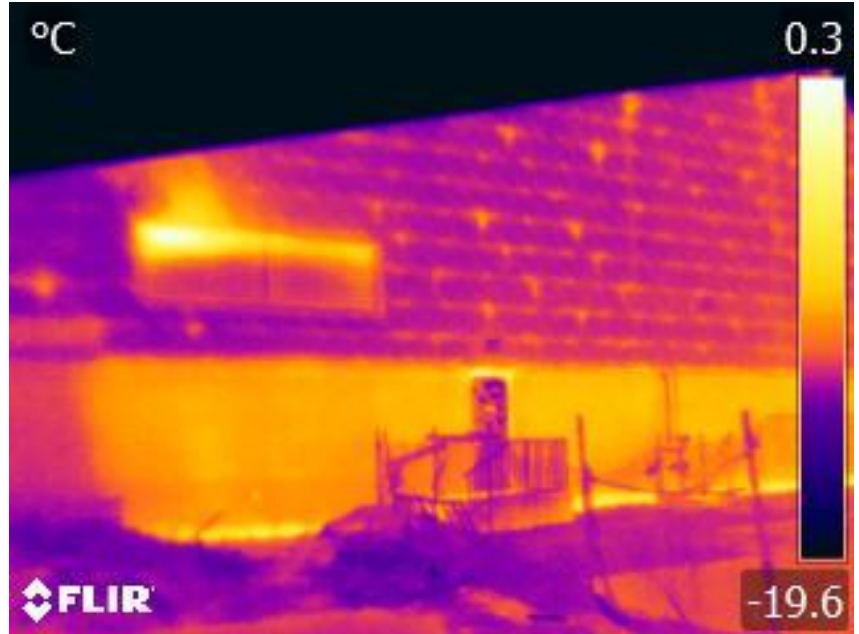
Partial west elevation. Note anomalies on diagonal cladding caused by thermal bridging and air leakage.
